Southeast Transportation Consortium

Final Report 541

Mitigation Strategies of Reflection Cracking in Pavements

Mostafa Elseifi, Ph.D., P.E.
Nirmal Dhaka

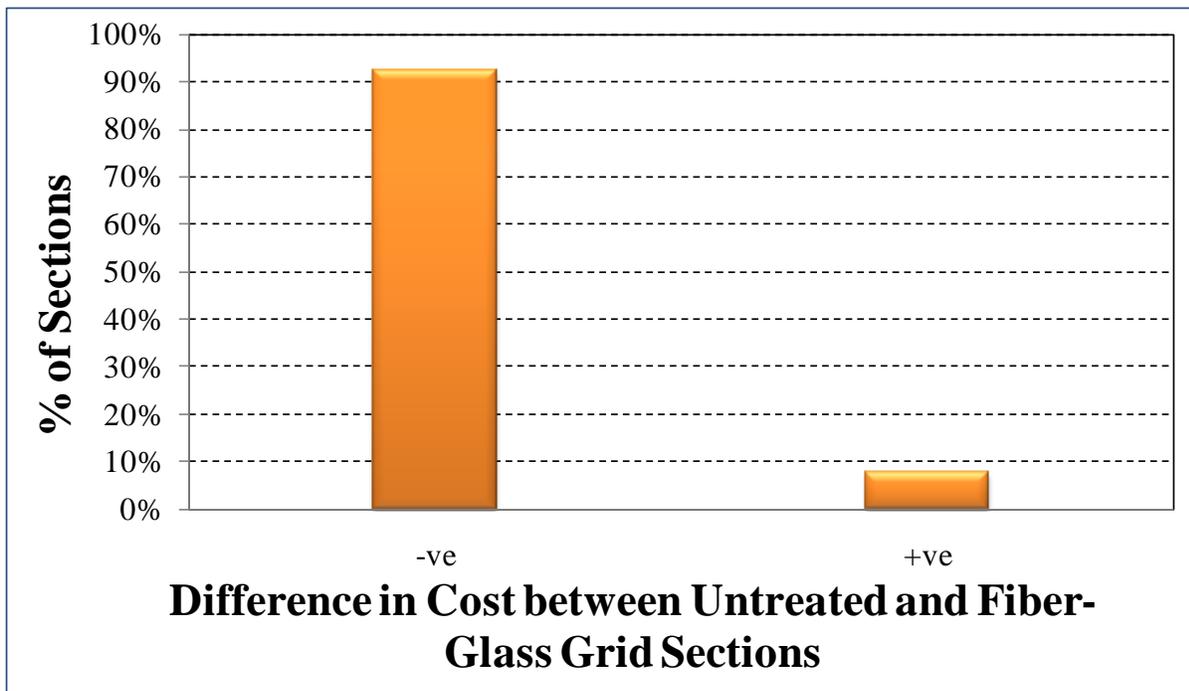
Figure 25
Cost effectiveness of fiberglass grid treatment method

Figure 25 compares the cost of reinforced HMA overlays to the cost of regular HMA overlays. In this figure, a positive cost difference indicates that the use of fiberglass grid is economical, while a negative cost difference indicates that the interlayer is not cost-effective when compared to regular HMA overlays. As shown in this figure, the majority of the sections (92%) indicate that fiberglass grid is not cost-effective when compared to regular HMA overlays. Based on these results, the use of this interlayer will be more costly to highway agencies than economical as shown by the majority of sections in which the reinforcement was not cost-effective.

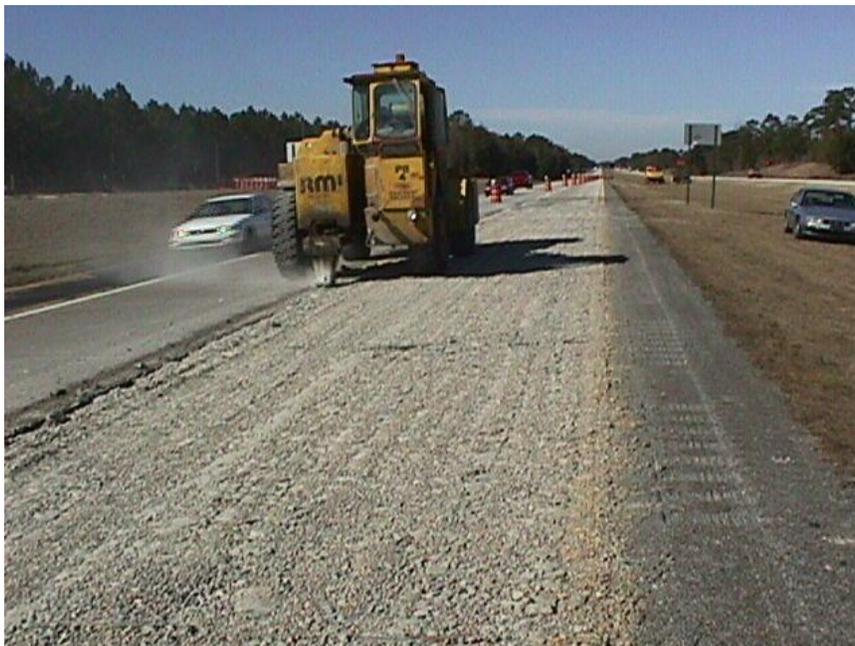
Figure 26
Rubblized concrete pavement [63]

The rubblization process is critical in ensuring satisfactory long-term performance of the overlay. It can be achieved using two types of equipment: resonant breaker and multiple-head breaker. The resonant pavement breaker (RPB) employs vibrating hammers to destroy the concrete layer as well as to break the bond between the concrete and steel reinforcement. This approach has been less favored in recent years given that it may require numerous passes to completely destroy the concrete layer, which may not be feasible if the subgrade conditions are not adequate. The second approach, based on the multiple head breaker (MHB), allows rubblization to be completed in one pass. It employs a series of 12 to 16, 102 to 123 lbs. hammers to crush a concrete width ranging from 2 to 12.5 ft. (0.6 to 3.8 m). with a production rate of 0.75 to 1.0 lane-mile/day.

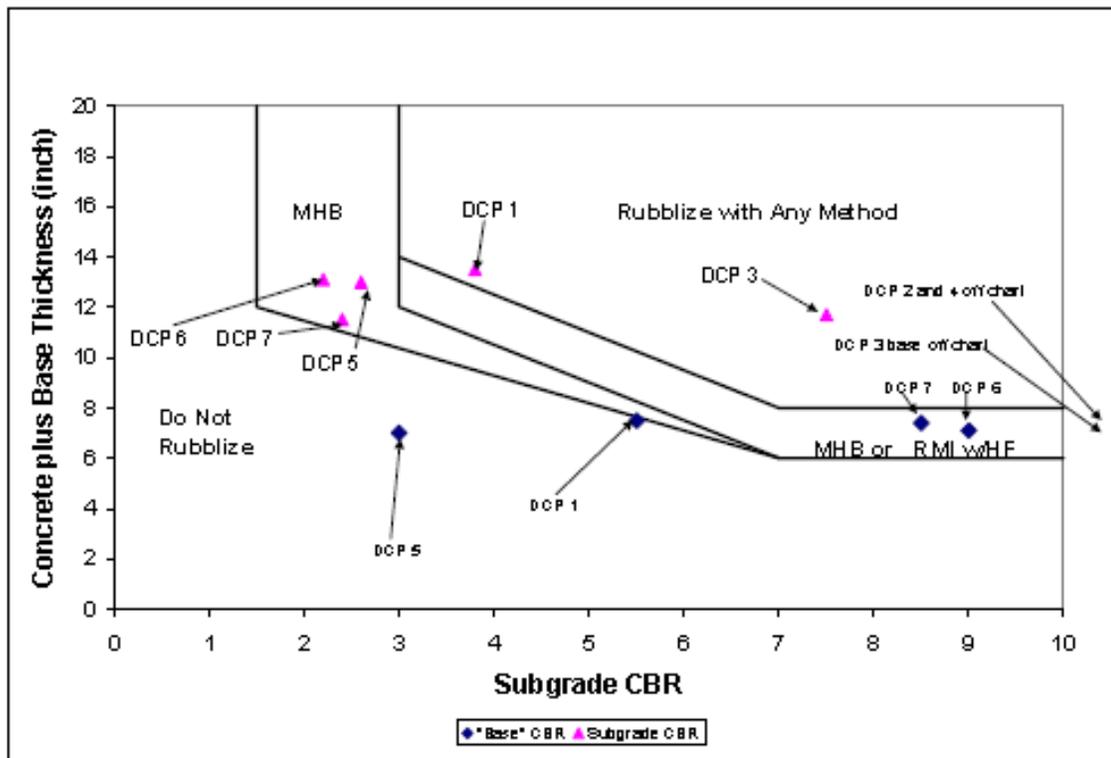
Figure 27
IDOT rubblization selection chart

Sebasta and Scullion (2007) evaluated the performance of rubblization as a rehabilitation technique for concrete pavements in Texas [64]. Through a series of field investigation, projects were evaluated prior to and after construction using non-destructive test (NDT, i.e., ground penetrating radar [GPR], falling weight deflectometer [FWD], and dynamic cone penetrometer [DCP]). GPR surveys were used to identify areas of moisture accumulation in the subgrade, which may impact the rubblization process, as well as section breaks in the supporting structure. DCP data were used to assess the support beneath the slab as well as support at larger depths beneath the slab. The support at large depth is important to avoid shear failures with the resonant breaker. The Illinois DOT rubblization selection chart was used in assessing the section suitability for rubblization, see Figure 27.

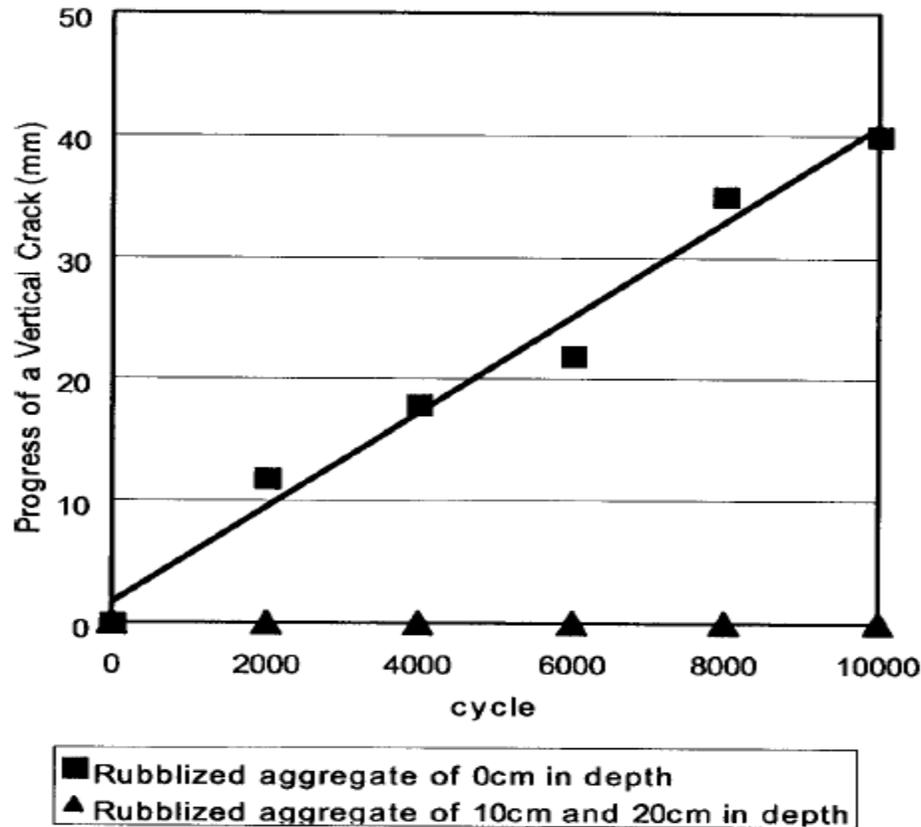
Figure 28
Vertical crack propagation in shear failure test [66]

in an asphalt overlay. The initiation of reflection cracks due to bending and shear failures was simulated in the experiment. These modes of failure were tested for rubblized depths of 0, 4.0 in. (101.6 mm), and 8 in. (203.2 mm). A vertical dynamic load was applied to simulate the shear strain due to traffic loading in the pavement. Repeated loading was applied and the crack initiation and propagation was analyzed for different depths of rubblization. A vertical load of 1212 lb. was applied to simulate a tire pressure of 100 psi (689.5 kPa) and to determine the required depth against shear failure. The test was carried out until the cracks propagated through the entire depth of the specimen. To check the depth of rubblization against bending failure, a repeated moving load was applied and the growth and propagation of reflection cracks was monitored for every 500th loading, see Figure 28. It was observed that for both modes of failure, no reflection cracks were observed for a rubblization depth of 4 in. (101.6 mm) or more.

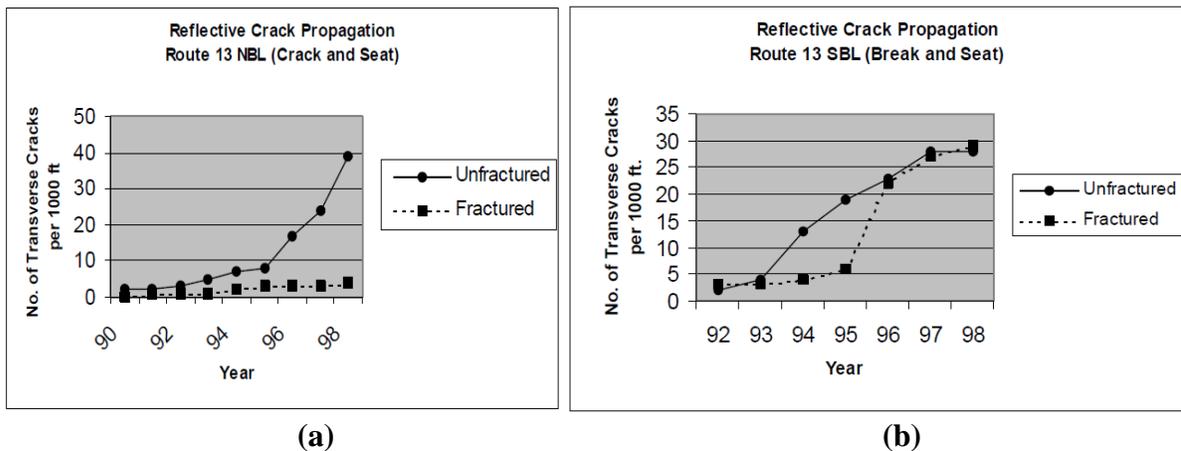
Figure 29
Reflection cracking over time for Site 1 (JPCP) and Site 4 (JRCP) [70]

Freeman (2002) conducted a research study to evaluate concrete fracturing and seating techniques to arrest or delay reflection cracking in asphalt overlays placed over severely distressed JPCP and JRCP [70]. Five projects (two JPCP projects and three JRCP projects) were evaluated for a period of eight years. Prior to rehabilitation, vertical displacements ranging from ¼ to ¾ in. (6.4 to 19.1 mm) were measured across the transverse joints; further, patched slabs representing 8 to 15% of the total number of slabs were recorded in the test and control sections. The test sections were fractured with a guillotine drop hammer and then seated with a 50-ton pneumatic tire roller. A detailed crack survey was performed each year and the number of cracks formed in the test and control sections were compared to determine the effectiveness of the crack and seat technique. In the case of JPCP, crack and seat was effective in reducing the formation of reflection cracking; see Figure 29a. In the case of JRCP, this technique was less effective as it only delayed reflection cracking for three years; see Figure 29b. After three years, the performance was found to be similar as the control sections. Based on these findings, it was concluded that slab fracturing and sealing is an effective technique to delay reflection cracking in asphalt overlay given the nominal cost of crack and seating operation.

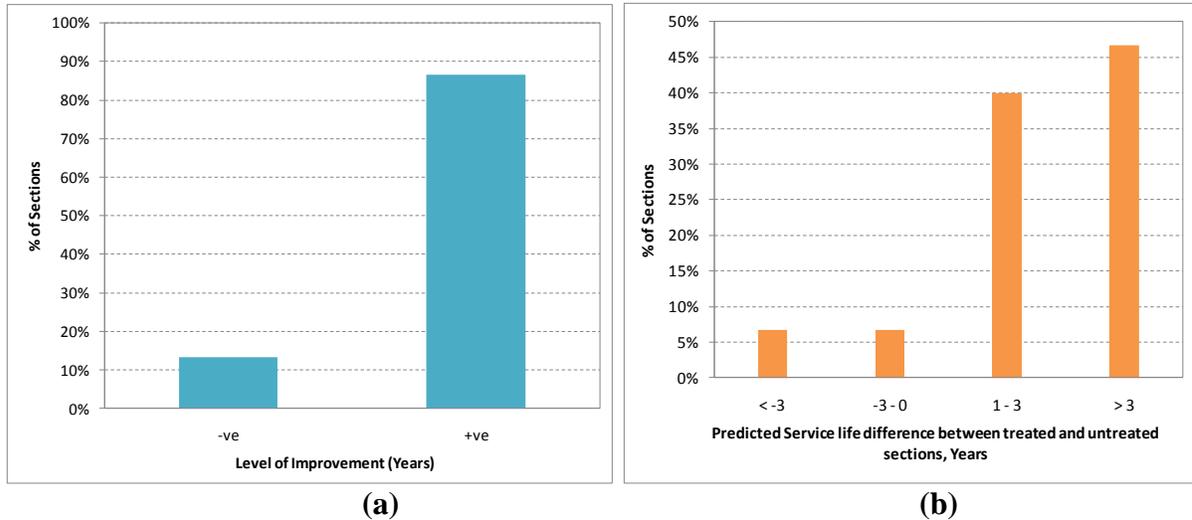
Figure 30
Contribution of the saw and seal method to the predicted pavement service lives [84]

Elseifi et al. (2011) evaluated the performance of saw and seal in the pavements with HMA overlaid on existing PCCP [84]. The evaluation was conducted for a period of six to 14 years. Based on the analysis of 15 pavement sections, the authors concluded that 87% of the test sections showed positive improvement in performance for a service life of 1 to 12 years while 13% showed negative results. As shown in Figure 30, the evaluated sections performed well with a majority (47%) showing an improvement in service life ranging from 4 to 12 years. Based on the analysis, an average improvement of 4 years was estimated. A video crack survey was conducted to examine the cracking pattern at joints and to determine the presence of secondary cracking near the sawed joints. It was determined that the percentage of secondary cracks in the sites in which the saw and seal method did not perform well or similar to the untreated sections was 0.6%. This low level of secondary cracks in the evaluated sites indicates that the approach adopted in Louisiana to locate the joints after placement of the overlay is effective in minimizing secondary cracks. Theoretical investigation conducted using 2 dimensional FE analysis indicated that the use of saw and seal method significantly reduced the strain levels at the PCC joints. This will result in the control of crack initiation at the bottom of the overlay and propagation with repetition of loads. The saw and seal dissipated the energy due to wheel loading and expansion and contraction of the concrete and allows the movement of the slabs underlying the HMA without formation of the cracks.

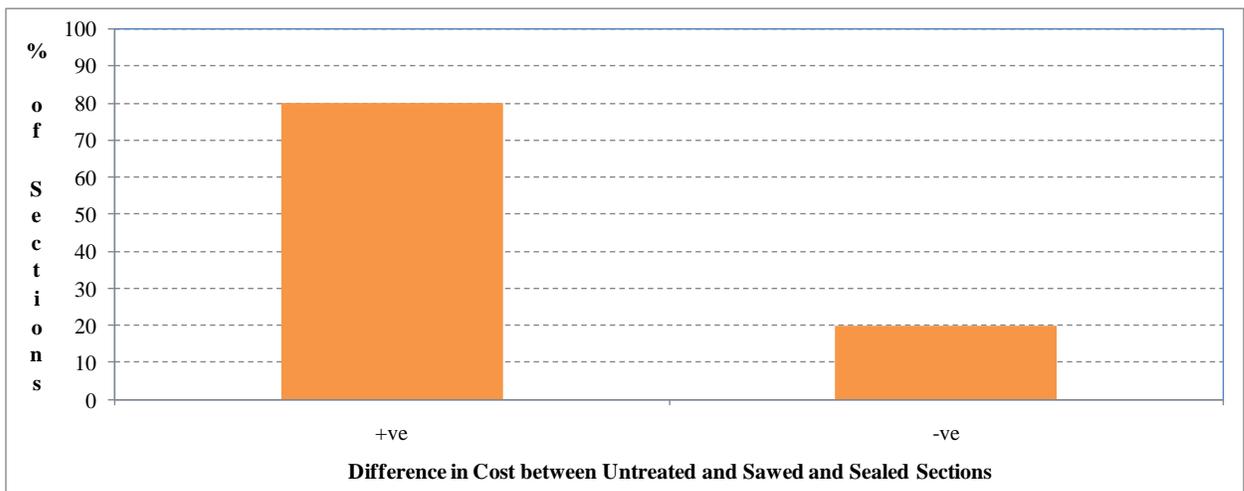
Figure 31
Cost effectiveness of the saw and seal treatment method [84]

Elseifi et al. (2011) also evaluated the cost effectiveness of saw and seal in pavements with an overlay on top of an existing concrete pavement [84]. The evaluation was conducted for a period of 6 to 14 years. The cost effectiveness was determined by comparing the inflated Total Annual Cost (TAC) of the treated and untreated sections. Of the 15 sections evaluated, 80% of the sections showed positive results in terms of cost effectiveness especially in the sections with low to medium traffic volumes. One possible reason for this trend is that the increase in traffic loading may result in minor rutting in the wheel paths, which may cause the sealant to come off with time and, therefore, gradually decrease the serviceability of the pavement structure. Figure 31 presents the cost of treated and untreated sections based on the concept of TAC.

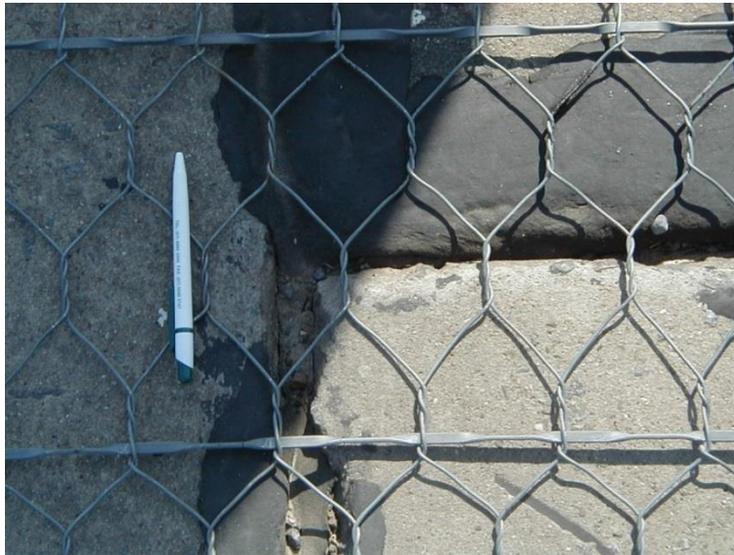
Figure 32
Steel reinforcing mesh [85]

One of the oldest interlayer systems used in flexible pavement is steel reinforcement. The idea, which appeared in the early 1950s, was based on the general concept that if HMA is strong in compression and weak in tension, then reinforcement could be used to provide needed resistance to tensile stresses [85]. However, the concept of using steel reinforcement in HMA materials was abandoned in the early 1970s after tremendous installation difficulties were encountered. The idea reappeared in Europe in the early 1980s with the development of a new class of steel reinforcement products. Many of the problems encountered earlier appeared to have been solved, and satisfactory experiences with the new class of steel reinforcement were reported. The current steel mesh product consists of a double-twist, hexagonal mesh with variable dimensions, which is transversally reinforced at regular intervals with steel wires (either circular or torsioned flat-shaped) inserted in the double twist, as shown in Figure 32. No welding is used in the new generation of steel reinforcement. This eliminates installation difficulties and any variation in HMA densities caused earlier by welded reinforced steel.

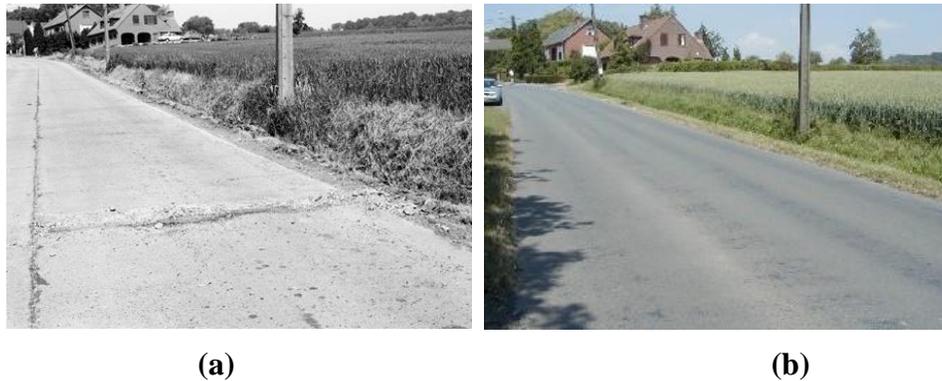
Figure 33
Comparison between a road in Belgium: before repair and 11 years after repair [85]

Figure 33. In 1989, steel reinforcement was installed after minor repairs to the existing pavement structure. A 3-in. overlay was then applied on top of the steel netting. Figure 33(b) illustrates the same road after 11 years of service (2000). After 10 years of service, inspections of this site showed a reflection cracking occurrence of only 1%. To date, the new class of steel reinforcement has only been installed in the US in a limited number of experimental sections starting with the Virginia Smart Road in 1999 and several test sites in Pennsylvania, Delaware, and Maryland. Pioneer work conducted in the evaluation of the new class of steel reinforcement in the US has been conducted by Al-Qadi et al. [85, 86].

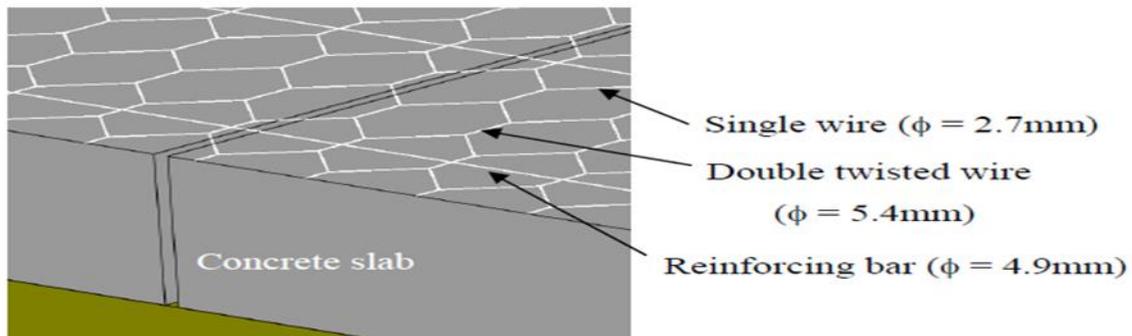
Figure 34
Steel reinforcement netting configuration and placement in concrete slab [89]

A design project was conducted by Baek and Wang (2007) to evaluate steel netting as a long-lasting rehabilitation technique to mitigate reflection cracking in airfield pavements [89]. They performed a FE analysis to demonstrate the performance of steel mesh installed at the bottom of a 3-in. (76.2 mm) asphalt overlay on top of an existing concrete pavement, see Figure 34. One gear loading of Boeing 747-400, one of the heaviest aircrafts, was applied on the pavement structure. However, they did not consider temperature and moisture variation in the pavement in the FE analysis. Results showed that steel reinforcing netting was able to reduce reflection cracks due to underlying transverse and longitudinal cracks by factors of 8.4 and 1.4, respectively. The authors recommended that pavement conditions, temperature and moisture variations, and the design parameters for overlay and existing slab such as size, depth, thickness, etc. should be carefully examined before rehabilitating the pavement with steel netting.

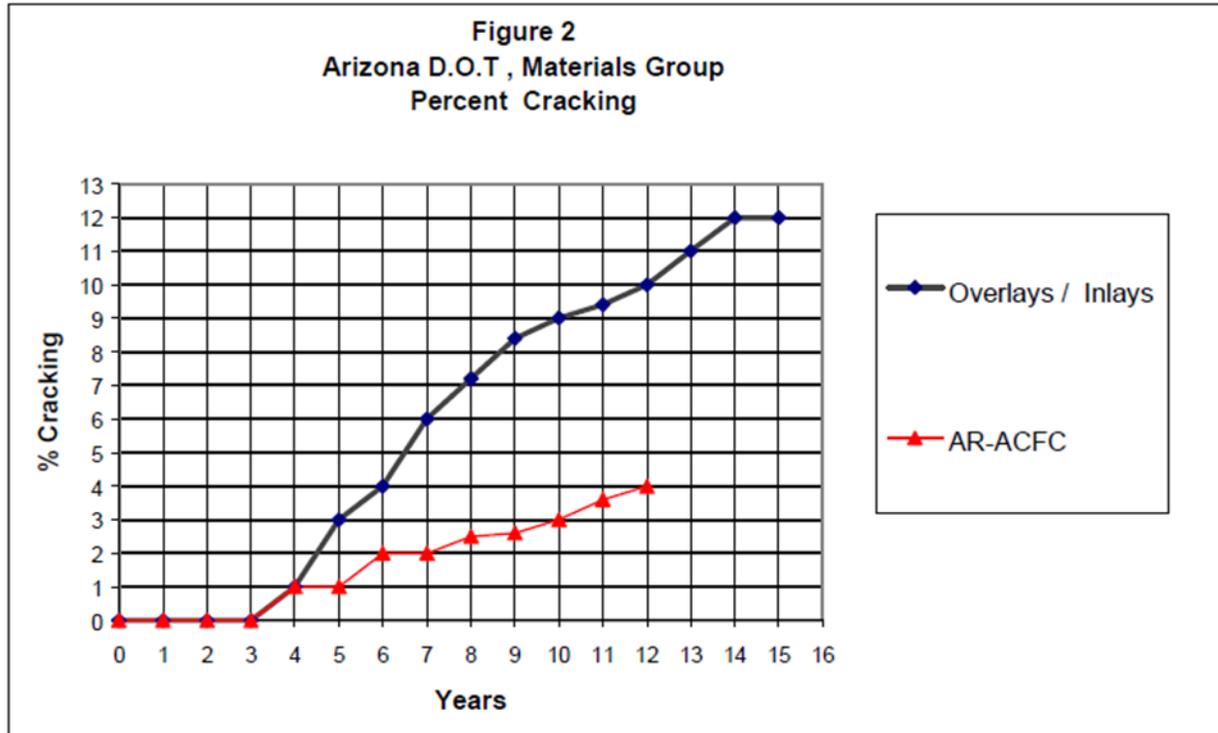
Figure 35
Comparison of the performance of AR mixes to conventional overlays [90]

Way presented ADOT's experience in using asphalt-rubber (AR) to delay reflection cracking [92]. Since the late 1980s, asphalt-rubber has been used in open-graded or gap-graded mixes that are ½ to 1 in. (12.7 to 25.4 mm) thick and 1 to 2 in. (25.4 to 50.8 mm) thick, respectively. The percentage of AR binder in open graded mixes ranges from 9 to 10% and in gap graded mixes; it ranges from 7.5 to 8.5%. In one project constructed in 1988, a 1-in. (25.4 mm) open-graded asphalt-rubber layer was placed on interstate 19. The mix contained 10% asphalt-rubber by weight the mix and was placed on top of a JPCP. No cracks reflected until 1996 and only a few transverse cracks appeared at the joints. Since this first project, dozens of projects were constructed using a similar approach. Figure 35 compares the performance of a project built with AR and a control section built with a conventional overlay. The grade of asphalt binder used as a base to make AR is a PG 58-22 (AC-10), in contrast to typically stiffer grade of PG 64-16 (AC-20) used in the mountains. In the desert, the AR base asphalt grade is PG 64-16 (AC-20) compared to PG 70-10 (AC-40) typically used for dense grade mixes. AR can be graded from a PG 70-22 to a PG 82-28 using the Superpave specification system.

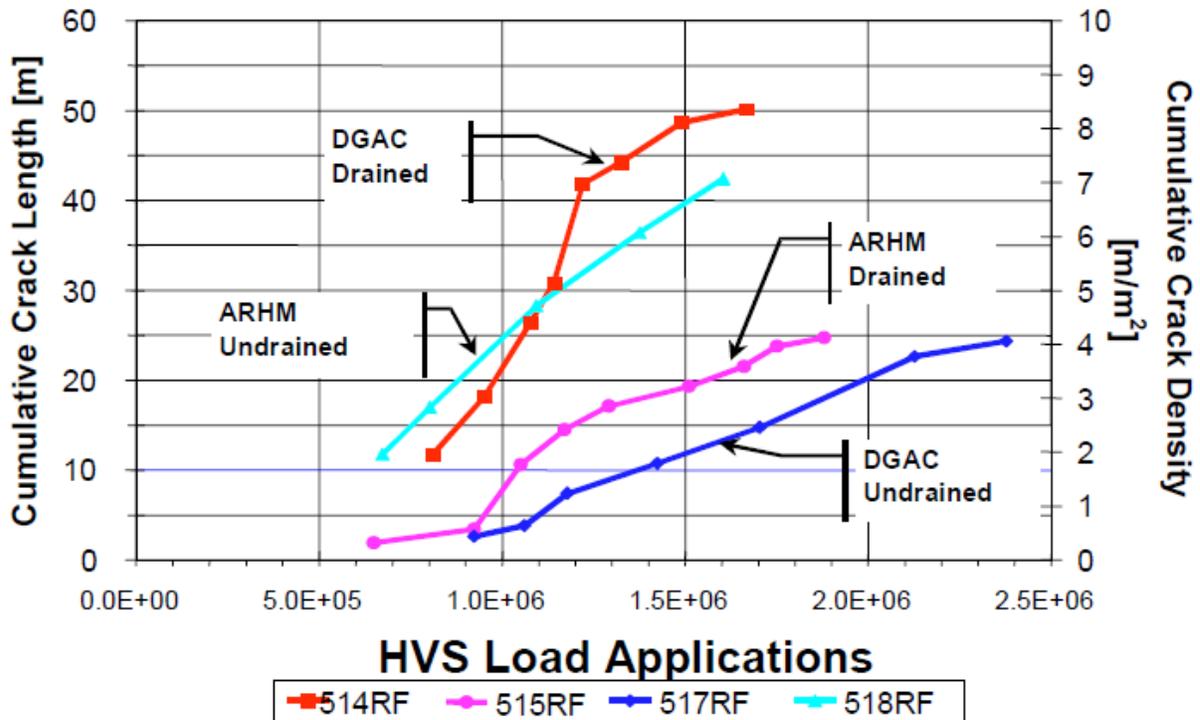
Figure 37
Crack length accumulation [111]

the overlays. From the rutting study, it was determined that dense-graded and asphalt-rubber mix performed similarly. From the cracking study, all four test sections failed by reflection cracking. However, both overlay strategies exceeded the expected performance of 1.0 million ESALs. Results presented in Figure 37 show that the half thickness overlays (ARHM) performed similarly to the full thickness dense-grade asphalt overlay (DGAC). However, the authors cautioned that this performance may not entirely represent field conditions due to the minimal construction variability in the APT experiment.

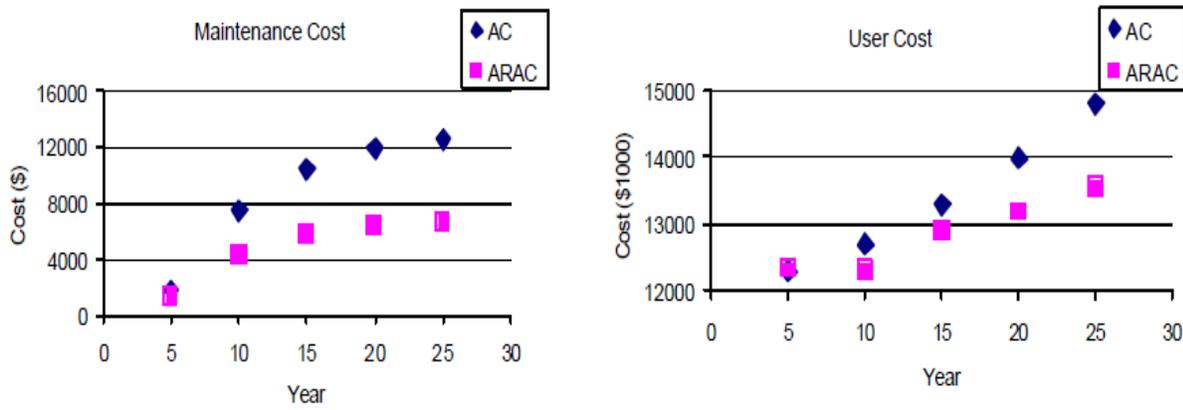
Figure 38
Maintenance and user cost comparison [112]

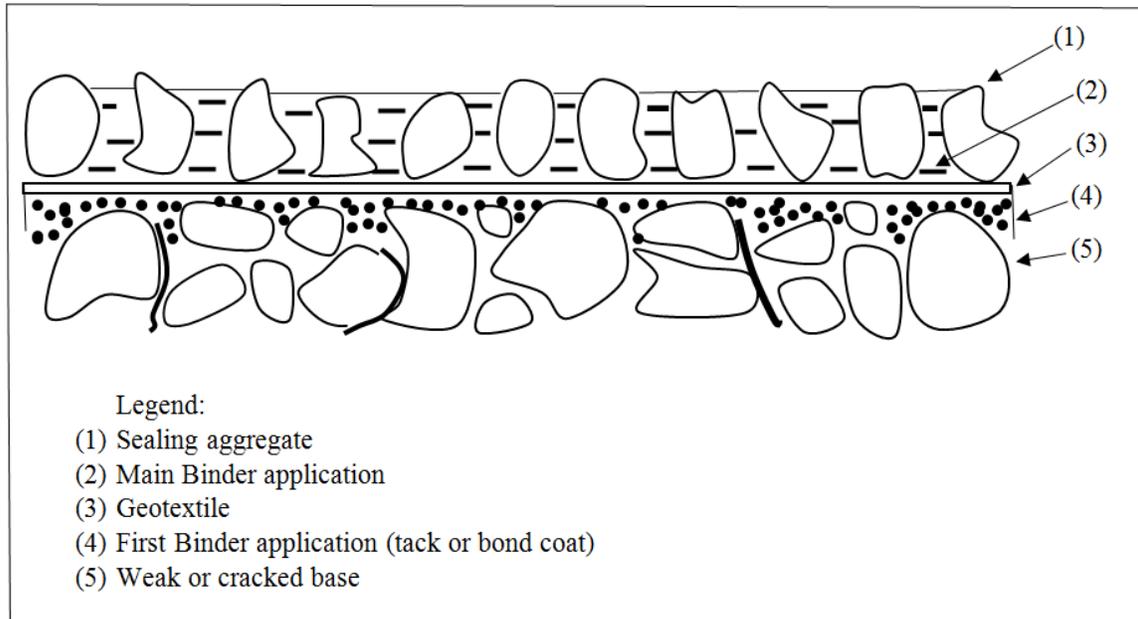
Figure 39
Paving fabric placed under single chip seal [113]

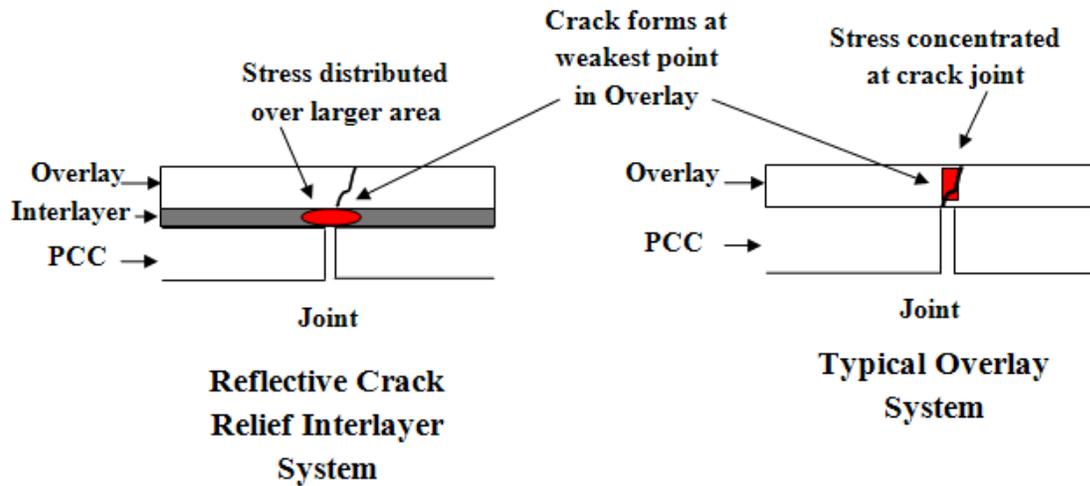
Figure 40
Mechanism of Strata[®] in mitigating reflection cracking 115]

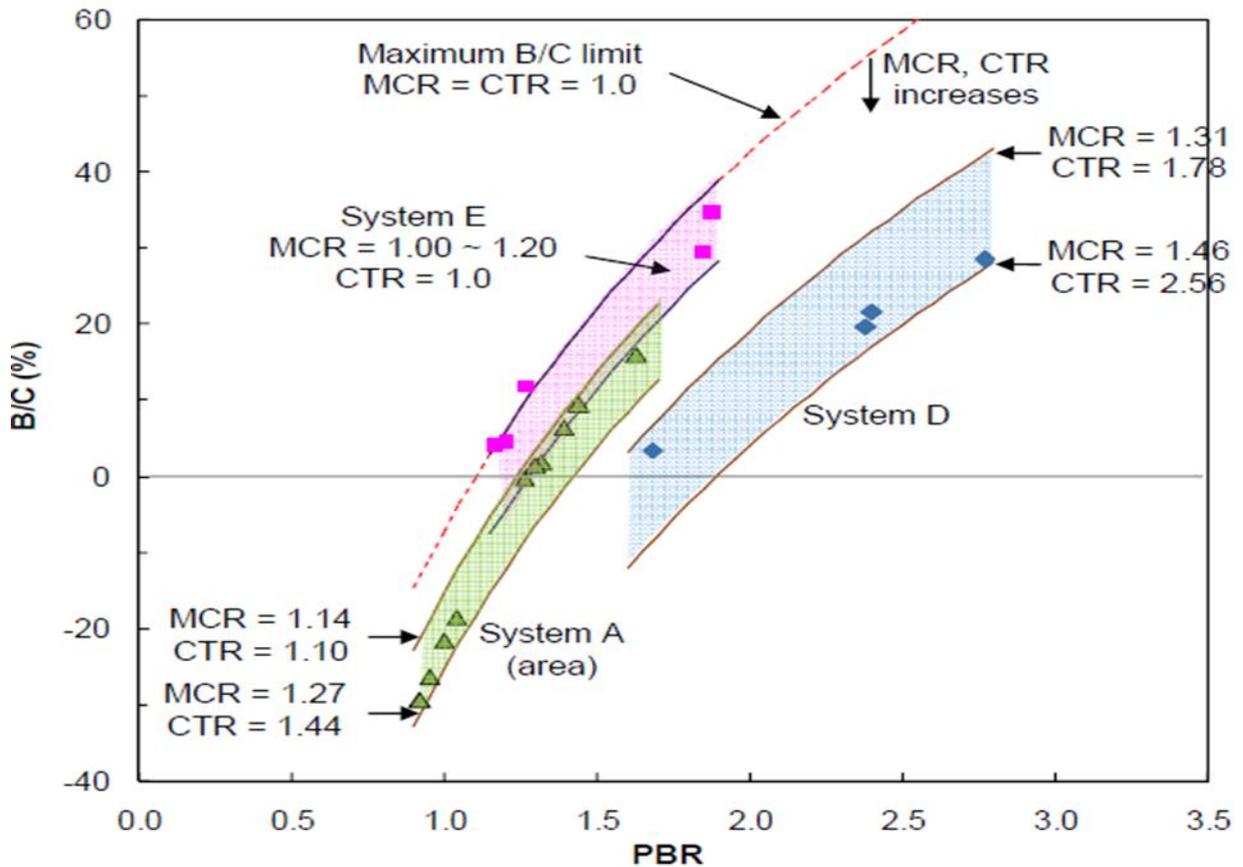
Figure 41
Upper and lower B/C limits for area-type non-woven fabric system A, system D (SAMI), and system E (ISAC) at AADT of 5,000 [120]
