# ***Louisiana Transportation Research Center***

Technical Assistance Report No. 13-02TA-P

**Assessment of Mitigating Transverse Joint Faulting on  
Portland Cement Concrete Pavement with Polyurethane Foam on  
LA 1 Bypass, State Project Number 034-30-0023**

Kevin Gaspard and Zhongjie Zhang

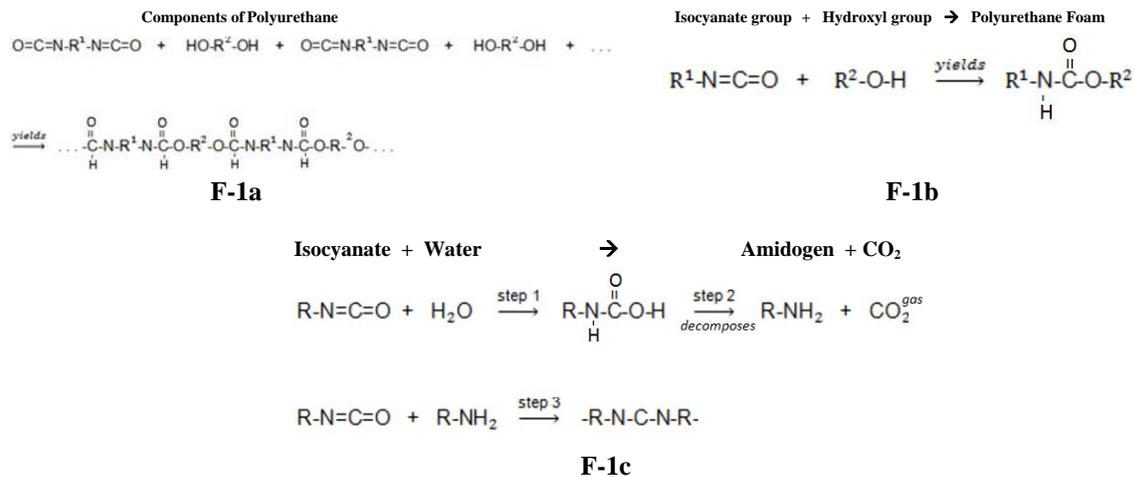
Polyurethane foam (PF) is polyurethane modified by reacting an isocyanate group with a blowing agent such as a hydroxyl group, hydrofluorocarbons (HFC), liquid carbon dioxide, or acetone as shown in Figures 1b and 1c [2-8].

**Figure 1**  
**Polyurethane foam properties**

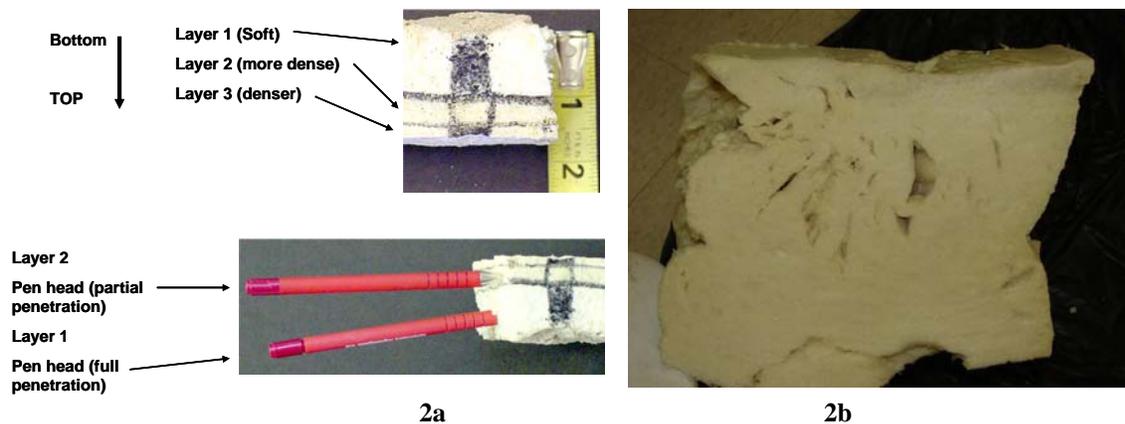
Injecting PF into a void can cause the material to have both varying layers of density and strength as shown in Figure 2a. Practically speaking, injecting PF into a highway pavement structure produces a heterogeneous material [7-8]. Highway pavement conditions typically provide both free rise and confining conditions. *Free rise* refers to allowing the PF to expand with minimal confinement [2-5]. As shown in Figure 2b, when a PF is allowed to expand without confinement it will split and fracture, adversely impacting its strength and density. *Confinement* refers to conditions that provide restraining forces to retard the expansion of the PF. The density and strength of the PF should increase when confining forces are present [2-5]. For instance, consider the situation where PF is injected into a void that is 2 in. deep beneath a concrete slab. As the PF begins its expansion, the first 2 in. will be free rise conditions since confining pressures are not present during this time. Once the PF contacts the concrete slab and begins to lift it, confining pressures should begin to affect the PF density and strength. These confining pressures may differ during the lifting process depending upon conditions such as slab stiffness, load transfer efficiency at the joints, slab thickness, and the profile geometry of the slab [7-8].

**Figure 2**  
**Polyurethane heterogeneous samples**

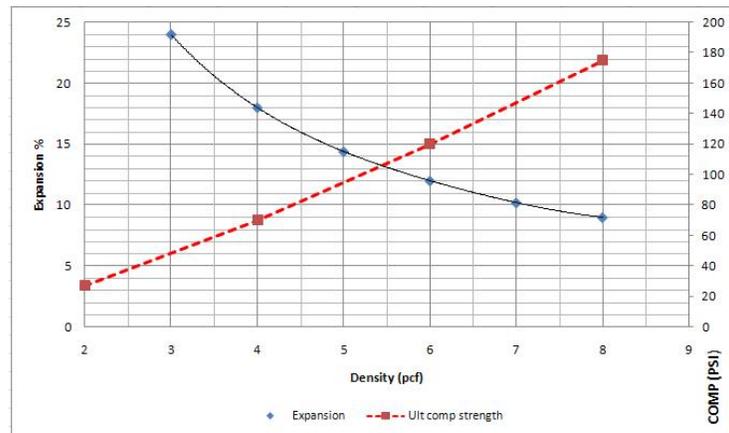
The relationship of unconfined compressive strength at ultimate load, density, and expansion characteristics for PF are presented in Figure 3. As PF expansion increases, its density decreases. Conversely, unconfined compressive strength (UCS) increases as density increases. The density of polyurethane is approximately 72 lbs. per cubic foot (pcf). The expansion of polyurethane into a PF is calculated by dividing the density of polyurethane by the desired density of polyurethane foam. For example, 72 pcf divided by 4 pcf corresponds

**Figure 3**  
**Expansion/density/UCS**

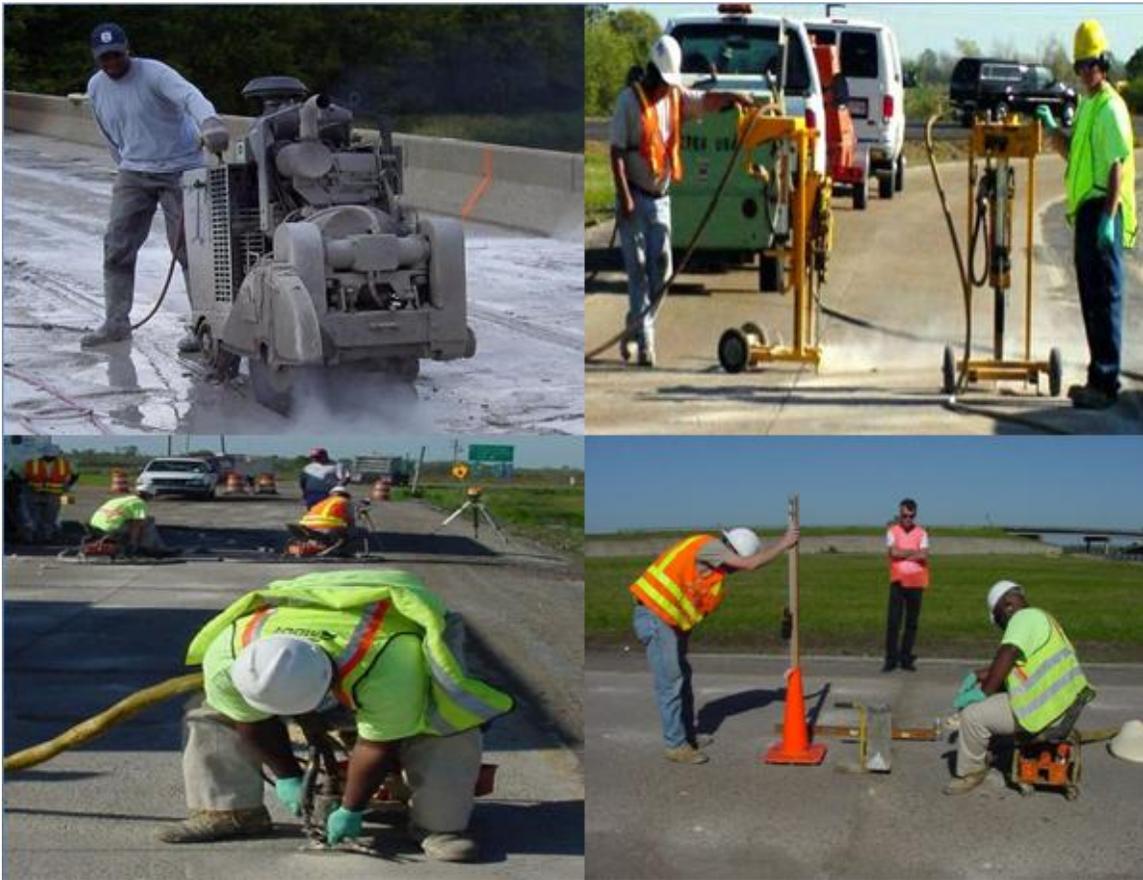
4. Drill holes through the slab and base course in intervals (typically 4 to 6 ft.) (longitudinal and transverse) determined by the PF contractor and/or project specifications.
5. Inject PF material through the holes and simultaneously monitor both changes in the fault height and vertical displacement of the slab. Once the desired fault height (0.25 in.) is reached, stop injecting PF near the joint. PF is then injected at additional slab locations until 1 mm of vertical movement is measured. This is called undersealing and its purpose is to fill any voids that may have been created beneath the slab by lifting the joints to minimize the fault.

**Figure 4**  
**PF fault correction process**

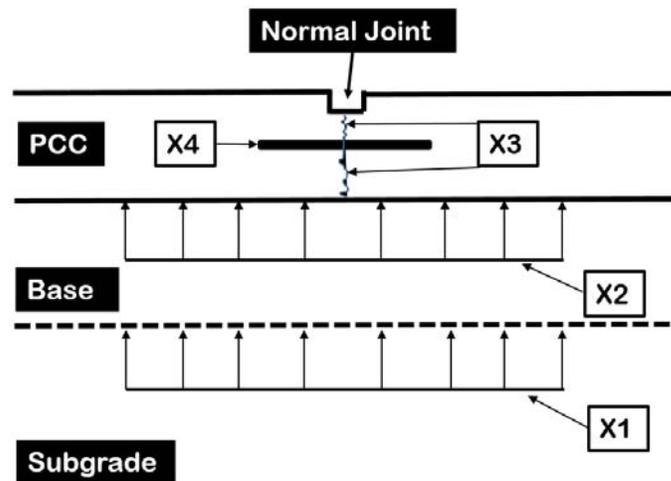
Support from the subgrade (X1) and base course (X2) can be represented in terms of their dynamic modulus whereas the support from the aggregate interlock (X3) and dowel bars (X4) can be represented by their corresponding shear strengths.

**Figure 5**  
**Normal joint**

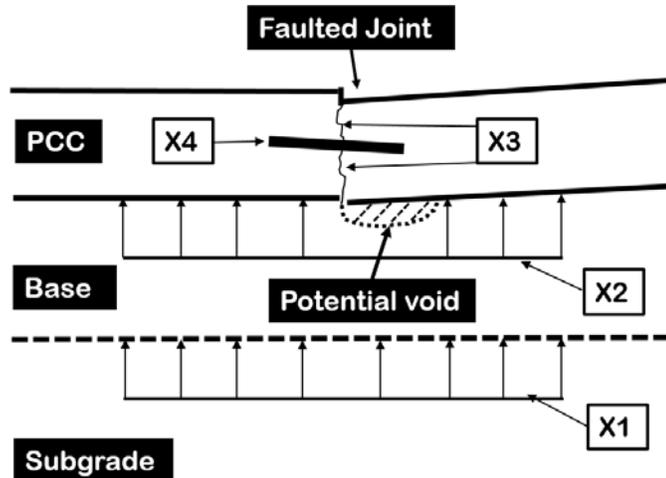
While in service, factors such as traffic loading, seasonal temperature and moisture fluctuations, base course erosion, subgrade erosion, and dowel bar failures lead to faulting at the joints as presented in Figure 6 [9-11].

**Figure 6**  
**Faulted joint**

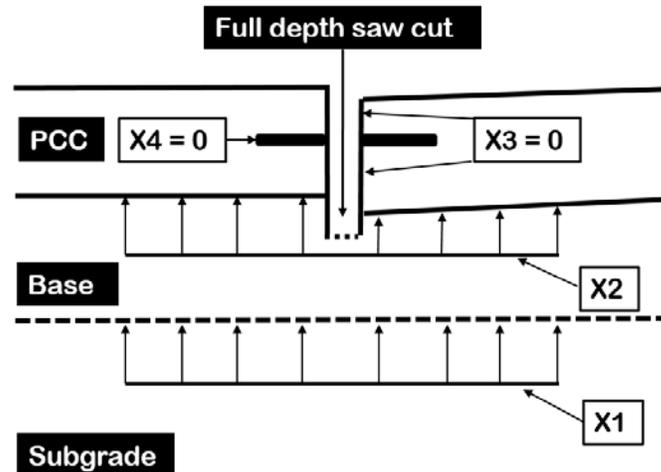
Scenario 2 differs from Scenario 1 in that full depth saw cuts are performed through the joints prior to the PF fault correction process as presented in Figure 7. From there, the PF fault correction process continues uninhibited until the faulting is reduced to at least 0.25 in. On this project, full depth saw cuts were performed at all joints.

**Figure 7**  
**Joint with full depth saw cut**

During the PF fault reduction process, LTE at the joint is severely reduced due to several factors. First, the full depth saw cut completely eliminates whatever support was available from aggregate interlock (X3) and the dowel bars (X4). Second, PF has a lower dynamic modulus than the subgrade and base course [6-8]. Therefore, once PF is injected into the subgrade, it can expand not only into the subgrade, but also into the base course and voids beneath the PCC slab [7][8]. The addition of PF into the subgrade/base course/void matrix, effectively reduces the support (X1 & X2) thus contributing to a loss in LTE [7][8]. So after the PF fault correction process, LTE is equal to the sum of subgrade-PF (X1) and base course-PF (X2) moduli, with (X1 + X2) after treatment being less than (X1 + X2) before treatment due to the incorporation of PF.

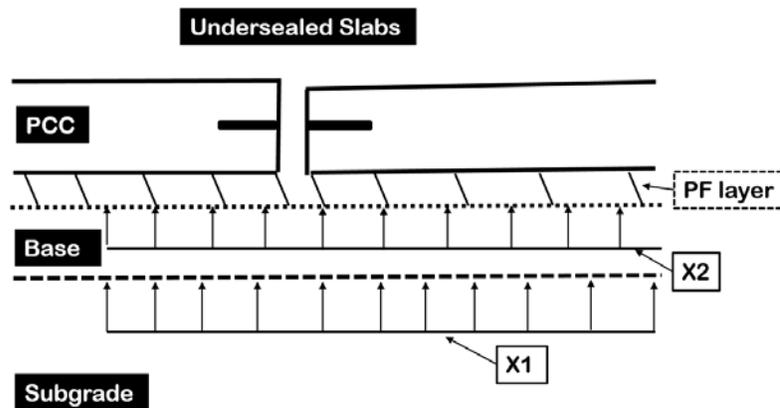
as rubblization and pavement replacement in conjunction with base course and subgrade restabilization may be prohibited. Regarding rubblization, the change in dynamic modulus of the base course and subgrade brought about by the increased “bounce” from PF may inhibit the fracturing of the pavement with resonant frequency breakers, multihead breakers, or guillotine devices. Restabilization of the base course and subgrade may also be prohibited because PF may not break up into small pieces with current pulverization devices. Large pieces of PF would interfere with cementitious stabilization of the soil or base course and create weak spots within the cement-soil-PF matrix. If that were the case, then the base course-subgrade-PF zone would have to be completely removed and replaced with select soils, which in turn, could be stabilized with cement. In either case, major issues due to the presence of PF in the subgrade or base course manifest in regards to future rehabilitation treatment selection.

**Figure 8**  
**Undersealed slabs**

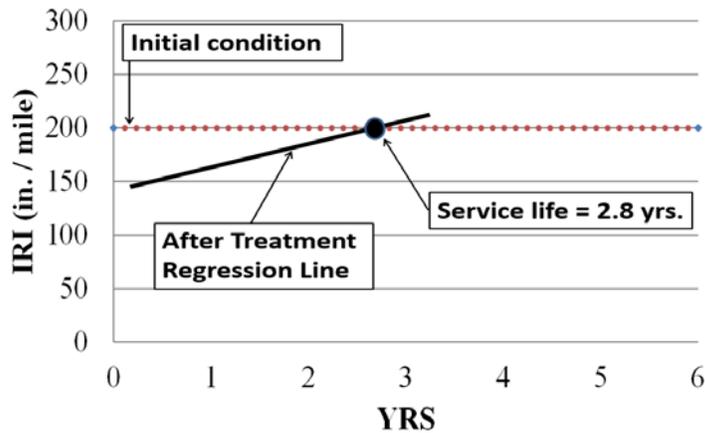
The service life of a treatment was determined from the point of intersection between the initial roadway condition (before treatment) with the after treatment regression line as presented in Figure 9. For example, the intersection of the after treatment regression line with the before treatment (initial condition) IRI value “200” occurred at occurred at 2.8 years. Therefore, the service life of the treatment was 2.8 years.

**Figure 9**  
**IRI versus years of service**

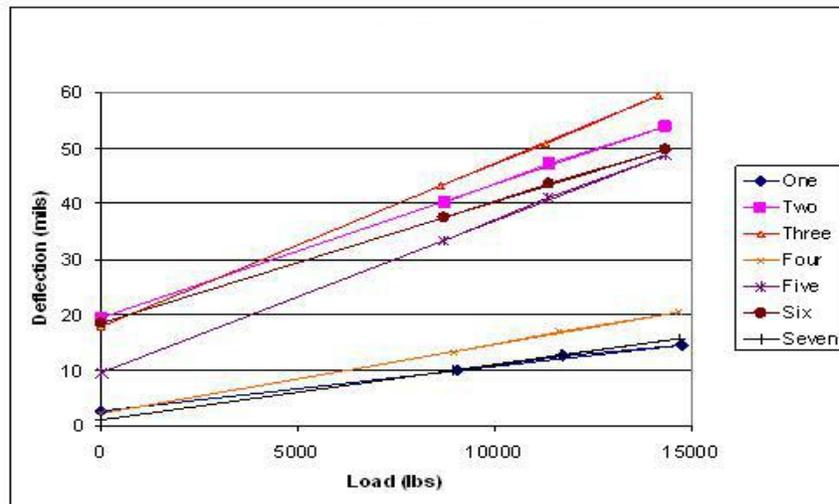
Void potential or loss of subgrade support, hereafter referenced as void potential was determined by plotting the deflections of the first sensor versus load and determining the Y intercept as presented in Figure 10 [7], [16-18]. According to the AASHTO 1993 Pavement Design Guide, a Y intercept value greater than 0.002 in. (2 mils) represents either a void or a loss of support [16]. In a previous study conducted by LTRC, the void potential method was validated with coring [7].

**Figure 10**  
**Deflections vs. load**

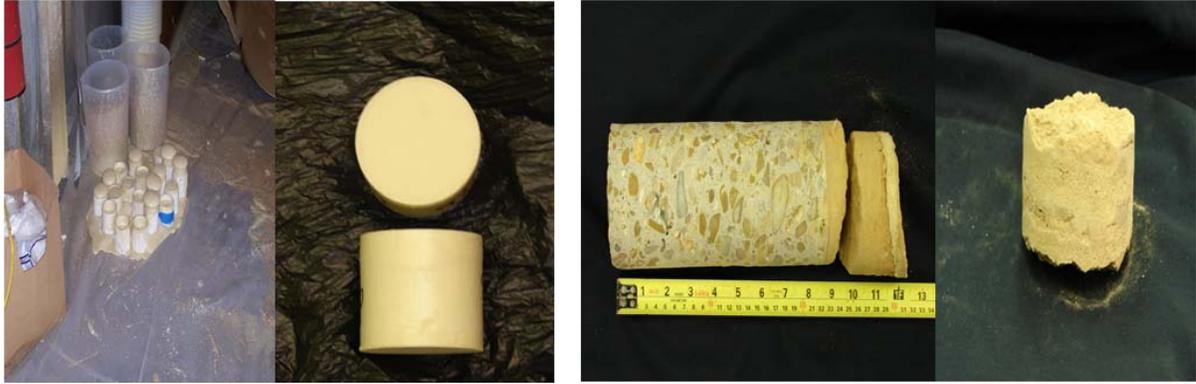
The density and strength of polyurethane foam is influenced by the confining pressure present when it is expanding/curing. In order to determine the difference in density and strength in the PF between its free rise state (no confining pressure during curing) and its confined state (injected beneath the slab), samples were taken. Thirty free rise samples were obtained by injecting the PF into 3-in. diameter x 3-in. height molds. The PF was allowed to expand inside the mold with no confining pressure as shown in Figure 11a. In-place PF specimens were obtained by coring through the concrete and base course as shown in Figure 11b. Though 17 cores were taken and the site was trenched in two locations, only eight usable PF specimens could be obtained from two cores. Unconfined compression testing and density testing were conducted in accordance with ASTM D 1621 and D 1622.

The parameters examined in the ANOVA statistical analysis (free rise versus in-place) were density, UCS at 3 percent strain and UCS at 10 percent strain, which is near ultimate load. The UCS at 3 percent strain is the parameter typically used to evaluate semi-rigid cement base courses in Louisiana.

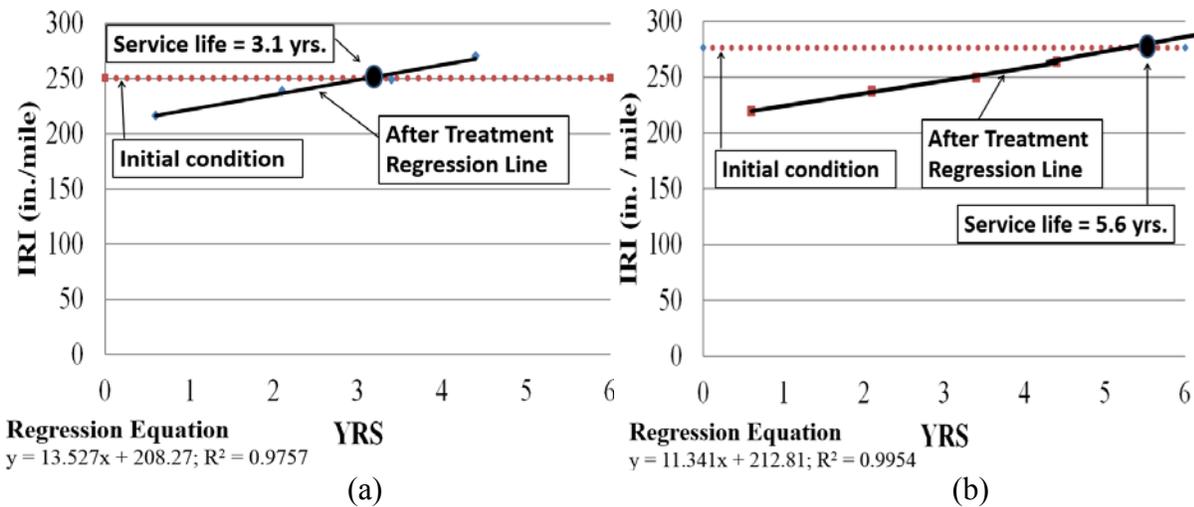
**Figure 12**  
**12(a) Northbound IRI regression graph, 12(b) Southbound IRI regression graph**

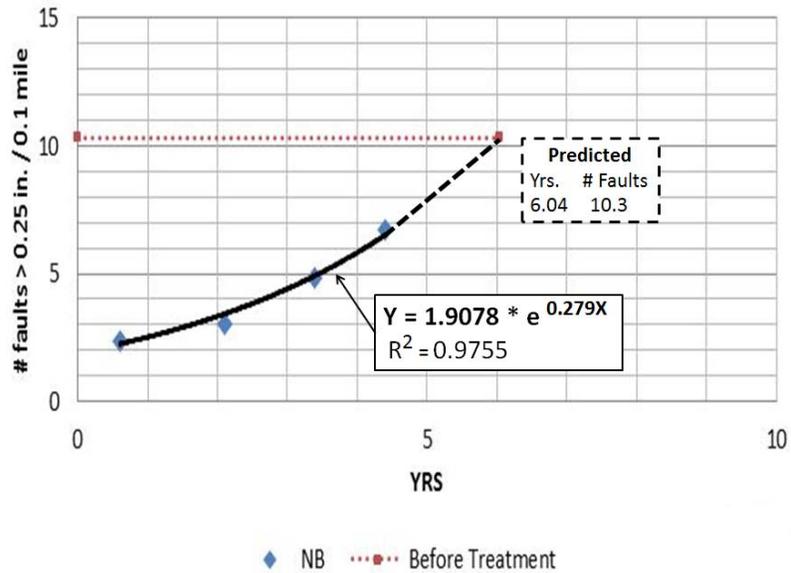
**Figure 13**  
**Faulting vs. years for northbound roadway**

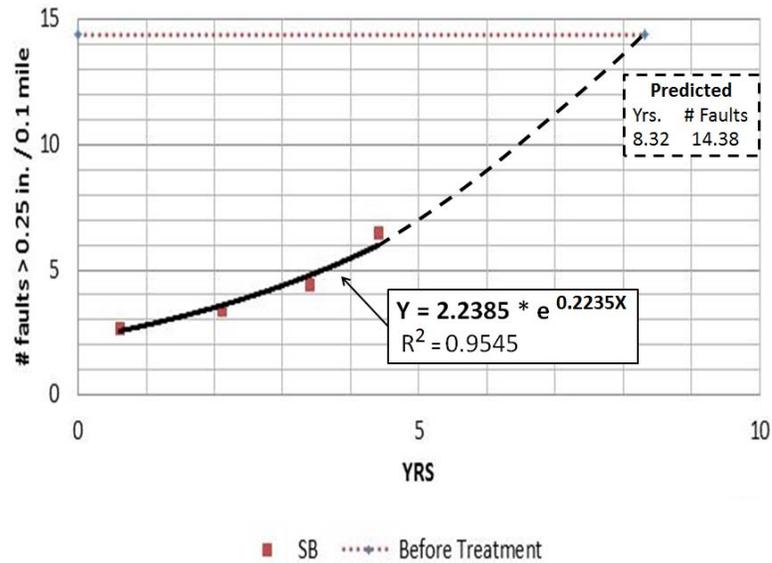
**Figure 14**  
**Faulting vs. years (southbound roadway)**

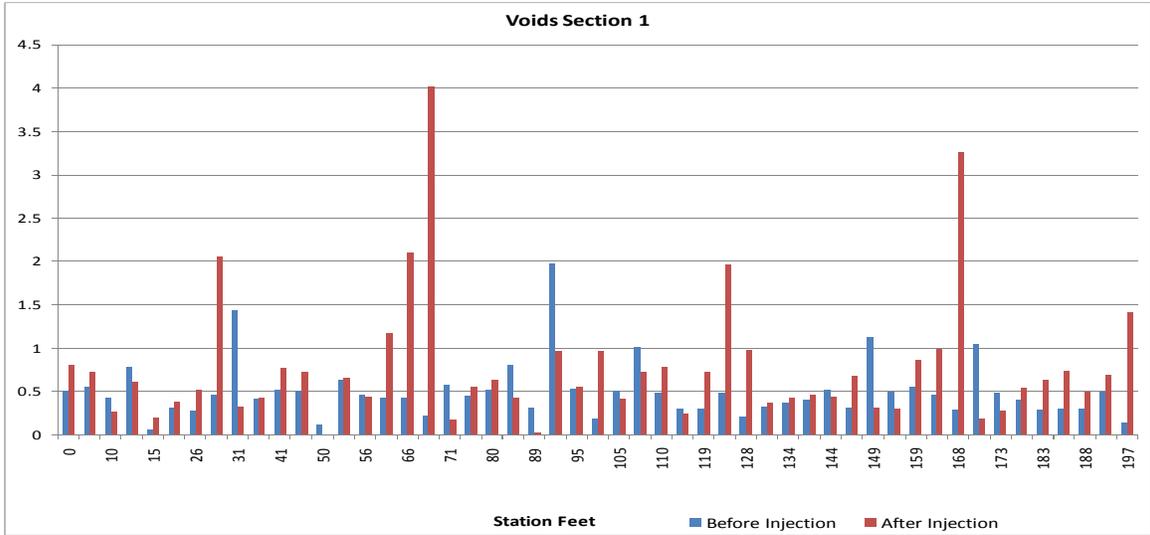
**Void Potential.** Prior to the fault correction process, tested locations did not indicate a potential for voids, whereas 12 locations did after injection as presented in Figures 15 to 17. This indicates that the potential for voids was increased by approximately 8 percent by the process. This can be attributed to slab uplift movements caused by the fault correction process and issues with filling the voids beneath the slab during the undersealing process.

**Figure 15**  
Void potential test section 1

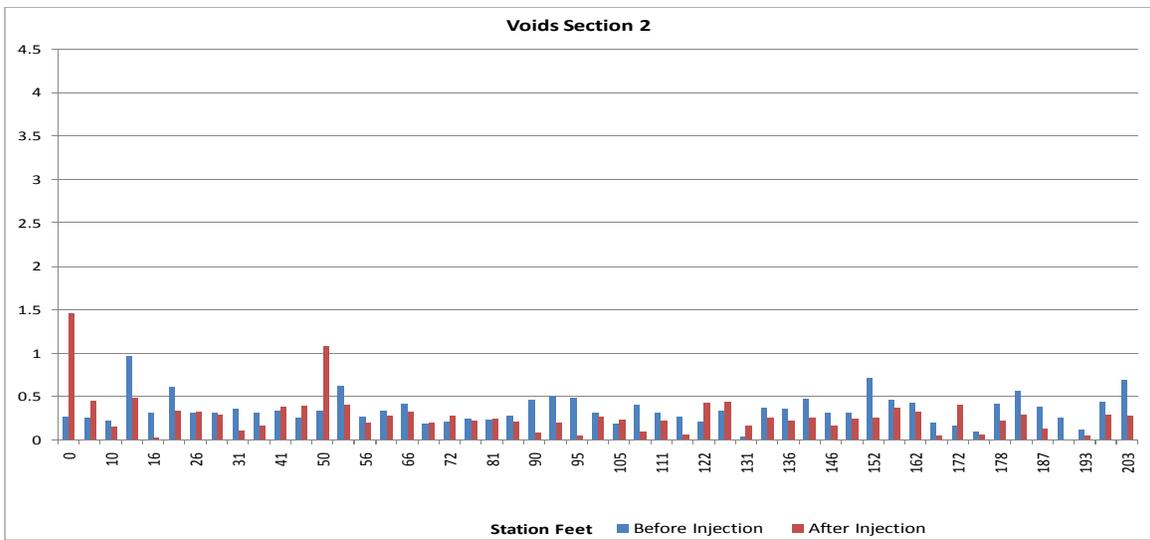
**Figure 16**  
Void potential for test section 2

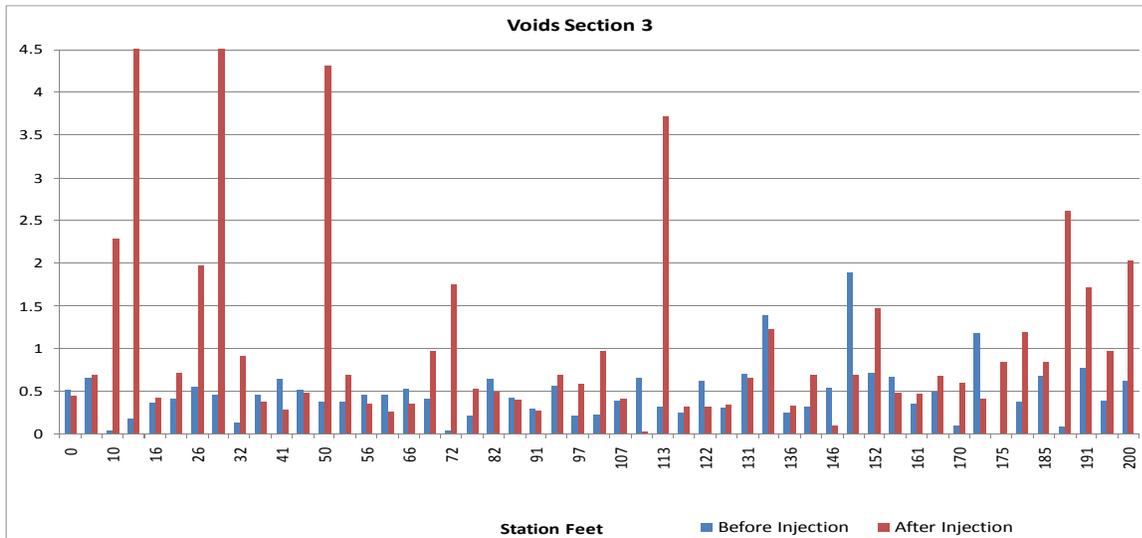
**Figure 17**  
**Void potential for test section 3**

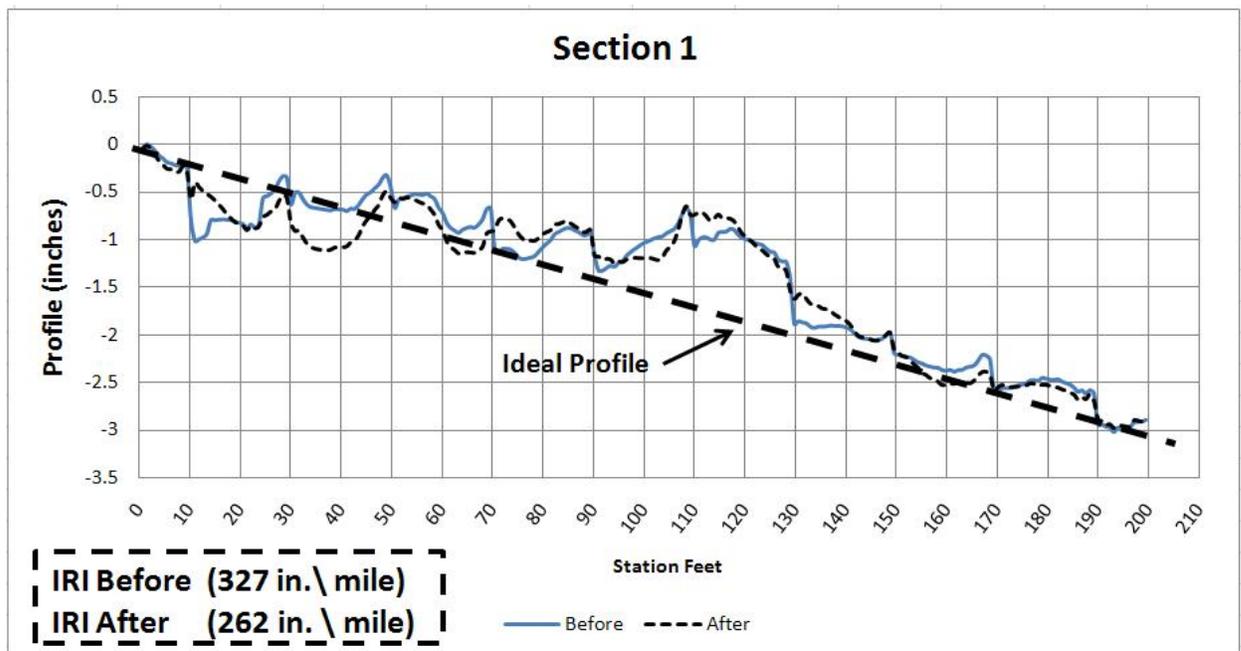
Profile measurements and IRI readings were taken before and after fault corrections on the test sections as shown in Figures 18 to 20. Clearly, the figures illustrate the extreme slab roughness and excessive joint faulting were present before PF injection. The PF process did reduce faulting, but a “bumpy” profile was still present after PF injection. Improvements in ride quality, were realized by the process on the test sections as demonstrated by the reduction of the average IRI from 282 (before treatment) to 192 (after treatment) on the three test sections. However, as previously mentioned, the after treatment IRI did not produce a smooth to moderate (80 to 130) ride, as presented in Table 2. Unless the profile can be corrected during the PF fault correction and undersealing process, smooth or moderate ride quality cannot be obtained on roadways.

**Figure 18**  
Profile and IRI for test section 1 (walking profiler)

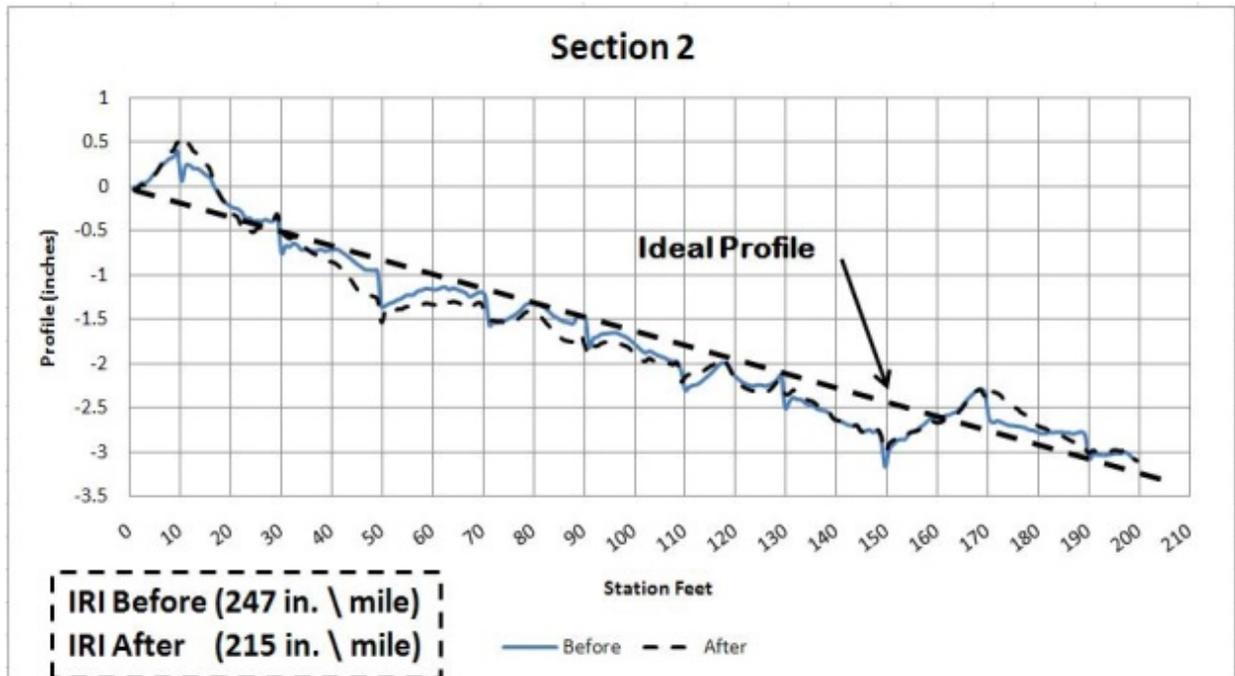
**Figure 19**  
Profile and IRI for test section 2 (walking profiler)

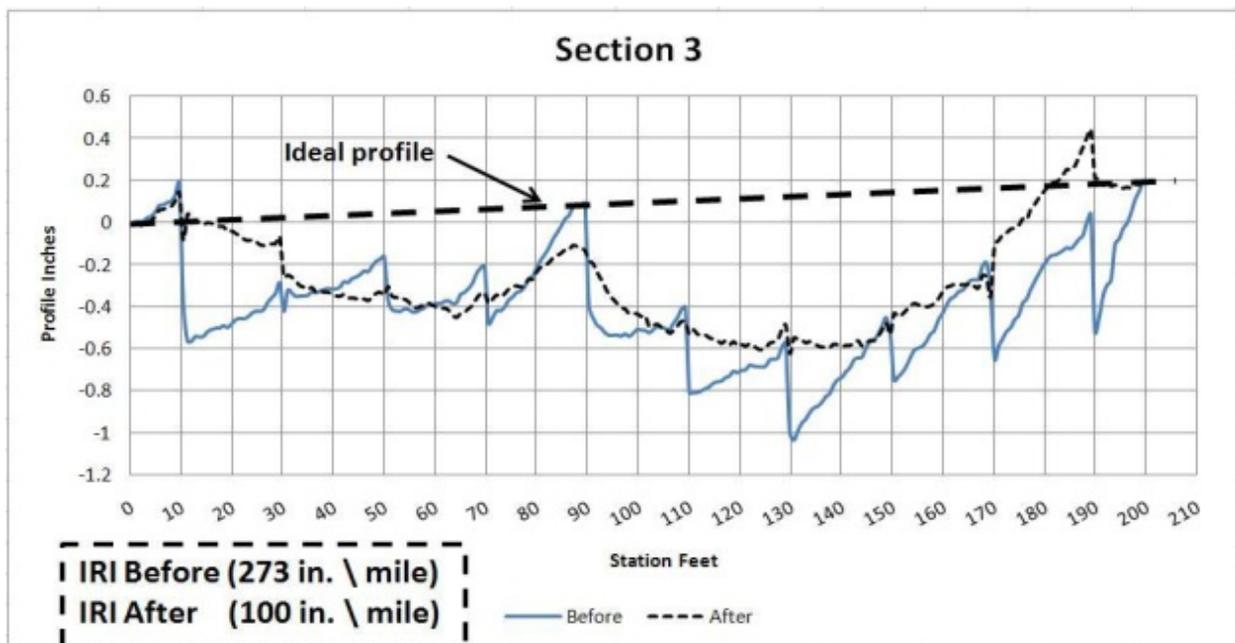
**Figure 20**  
Profile and IRI for test section 3 (walking profiler)

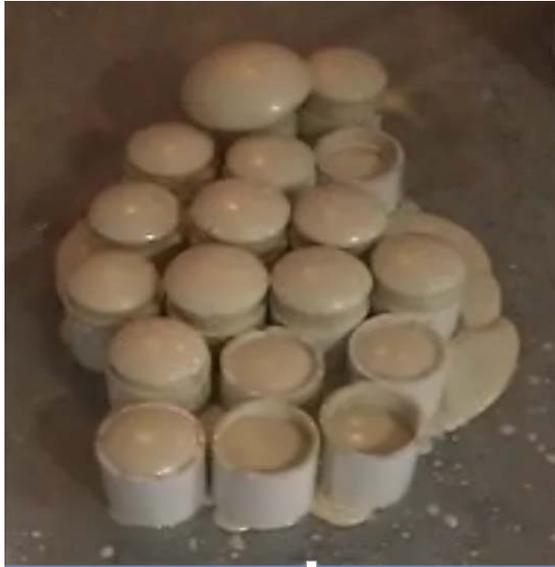
In order to capture the density and unconfined compressive strength of PF in “free rise” conditions, injection molds were constructed with 3-in. diameter and 6-in. diameter PVC pipes. The height of the molds was approximately 4-in., as presented in Figure 21. *Free rise* is a term used to represent the properties of PF in conditions where PF is allowed to expand and cure without vertical confinement under dry conditions [1-6]. The walls of the PVC pipe, though, do provide some horizontal confinement, which affects both the density and UCS of samples as test data will later show. It has been well documented that both the density and unconfined compressive strength should increase under three dimensional confined conditions (vertical and horizontal) as compared to the free rise conditions [1-6]. With that being the case, free rise specimens from the molds were used as the control for this experiment. Target PF densities were, 4 pcf, 6 pcf, 8 pcf, and 12 pcf under dry conditions. Injecting into a wet environment was not attempted with the molds, because the expanding PF simply pushes the water out of the molds during expansion.

**Figure 21**  
**PVC injection molds**

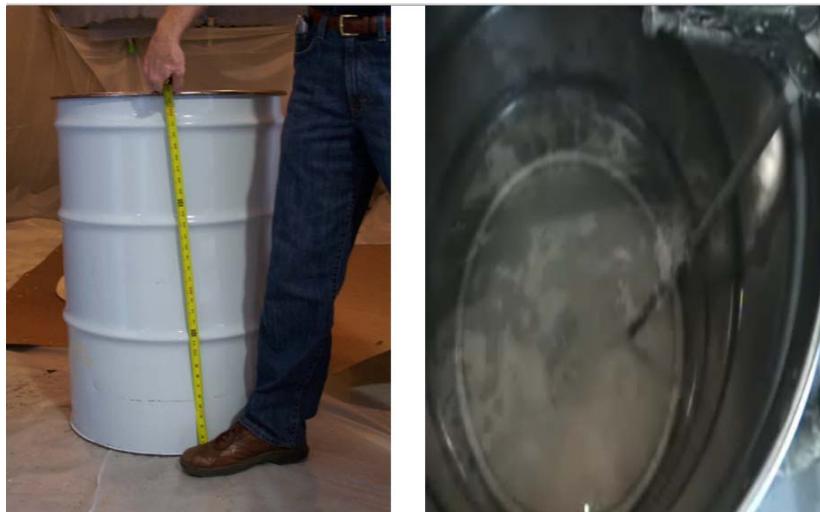
The purpose of this test was to simulate the effect of injecting PF into a large void where minimal horizontal and no vertical confinement was present under both wet and dry conditions and capture its properties, as presented in Figure 22. The procedure entails injecting approximately 9 lbs. of PF into the barrel and allowing it to expand uninhibited other the side containment from the barrel. Once the PF fully expanded, it was removed from the barrel as seen in Figure 23.

**Figure 22**  
**Barrel test**

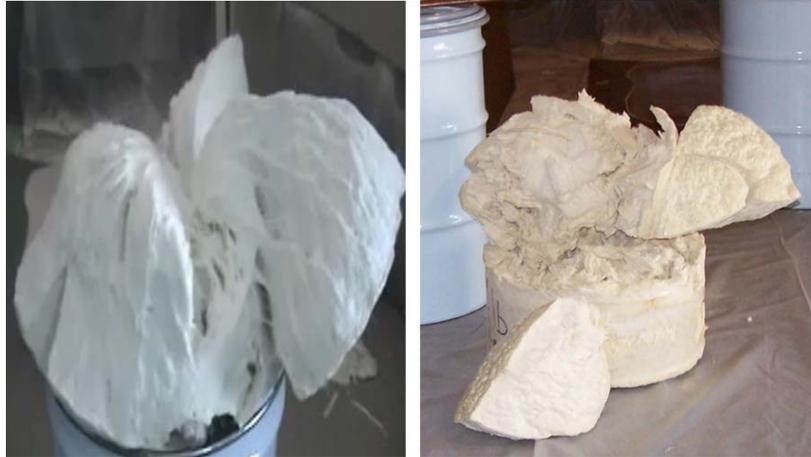
**Figure 23**  
**PF in barrel**

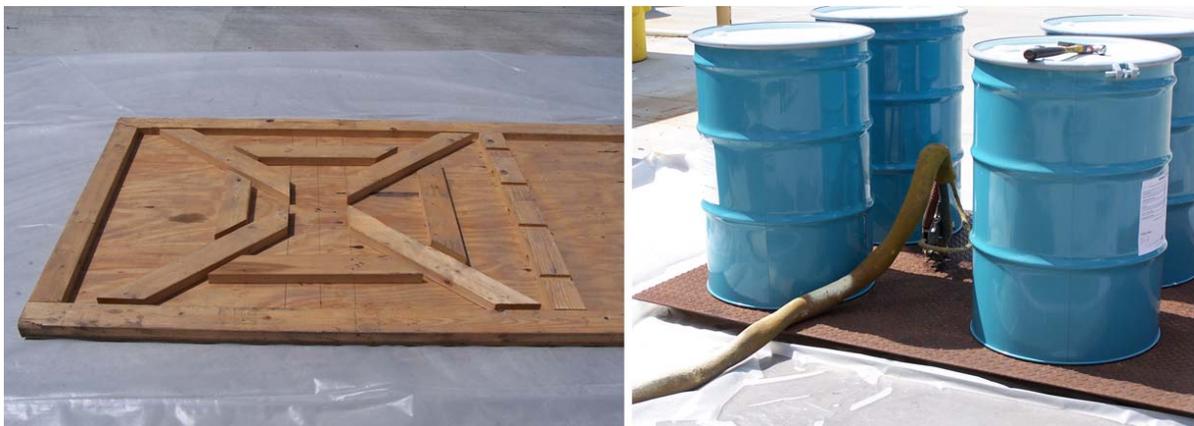
This test was intended to simulate conditions that may exist beneath the pavement. A box was constructed and covered with a metal plate, as shown in Figure 24. Four 55-gallon drums filled with liquid were then placed on top of the metal plate. PF was injected through the metal plate into the void (approximately 1.75 in. deep) and allowed to expand. Figure 25 presents the PF in the box once the metal plate has been removed. Once PF expansion occurred, samples were taken in accordance with ASTM D1621. This process was repeated with the void being filled with water. PF with free rise design densities of 4, 6, 8, and 12 pcf were tested.

**Figure 24**  
**Box test**

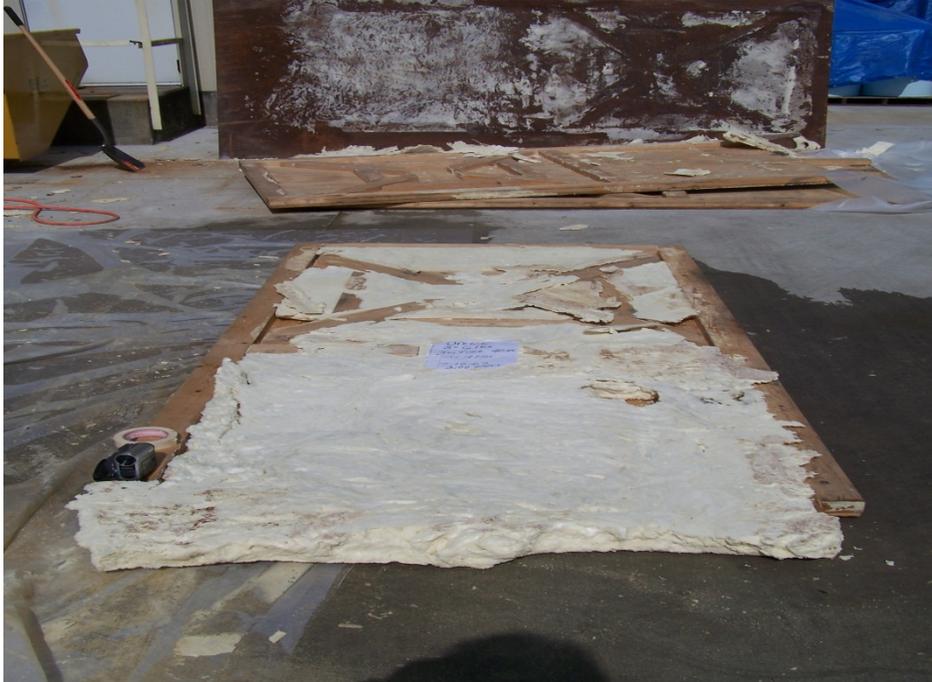
**Figure 25**  
**Expanded PF in box**

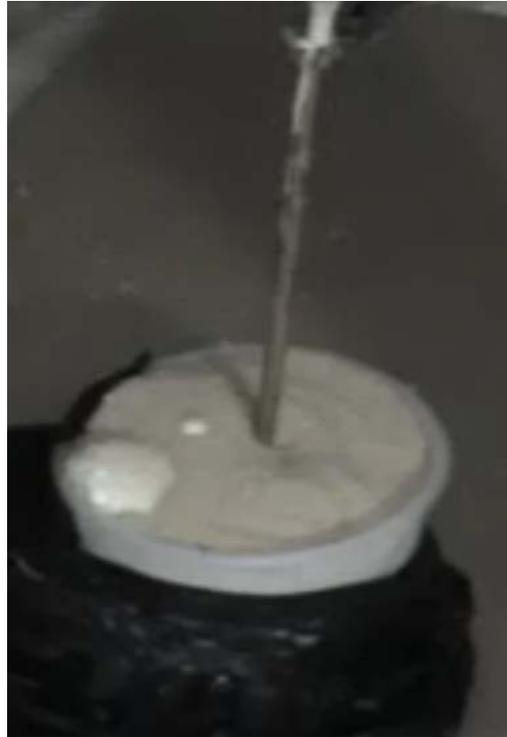
The purpose of this test was to discover the properties of the sand/PF mixture and demonstrate how PF mixes with sand while expanding. A five gallon bucket was filled to 0.75 percent of its capacity with sand. PF was injected into the bottom of the bucket and allowed to expand, as presented in Figure 26.

**Figure 26**  
**Sand bucket test**

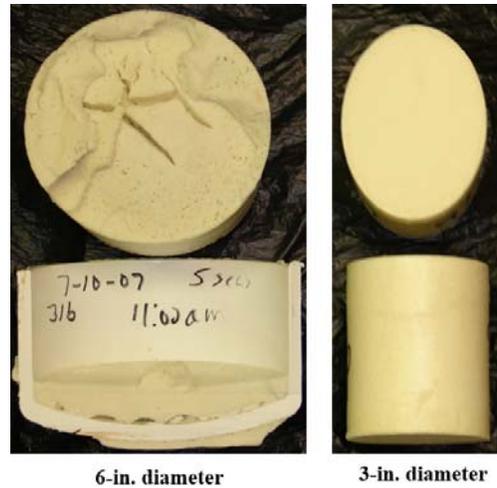
Based upon the visual inspection of the specimens, it was clear that the PF split and cracked during its expansion in the 6-in. diameter mold while the PF sample in the 3-in. mold remained intact. According to Scott Brown of Bayer Industries, once the mold diameter exceeds 3 in., fracturing and tearing will occur in the specimens, and this experiment proved that point. For that reason, only specimens from the 3-in. diameter molds were used for density and unconfined compression testing.

**Figure 27**  
**Specimens from 6-in. and 3-in. diameter molds**

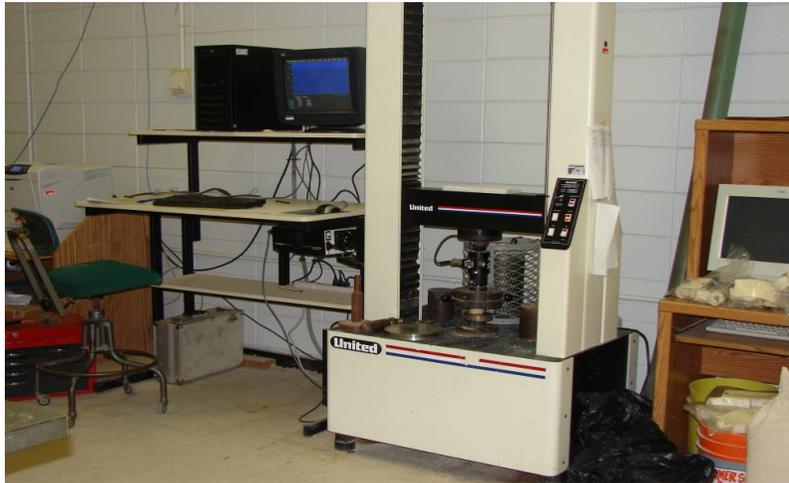
**Figure 28**  
**United testing machine**

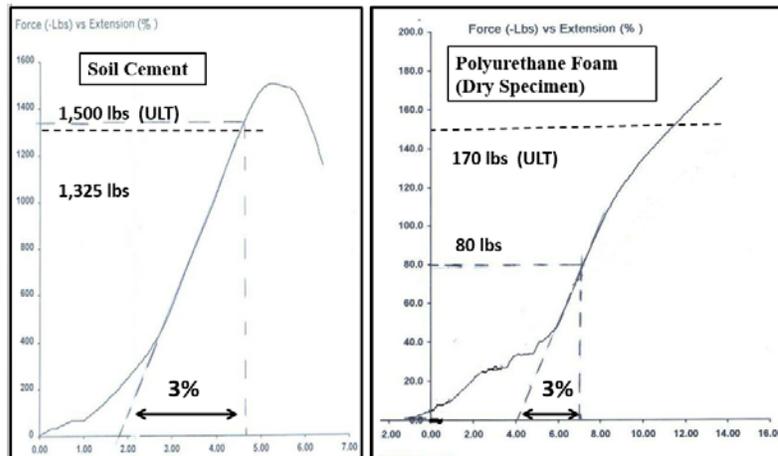
presented in Figure 29. Because of that, the load at three percent strain was also used to determine the UCS of the free rise PF as well. As presented in Table 12, the UCS for 4-, 6-, 8-, and 12-pcf were 65-, 113-, 181-, and 393-psi, respectively. As the density of PF increases so should the UCS, which this experiment has demonstrated. When comparing the UCS of PF with typical UCS design values of soil cement (300 psi) in Louisiana, all UCS values for PF fall below that value.

**Figure 29**  
**Load versus extension graphs**

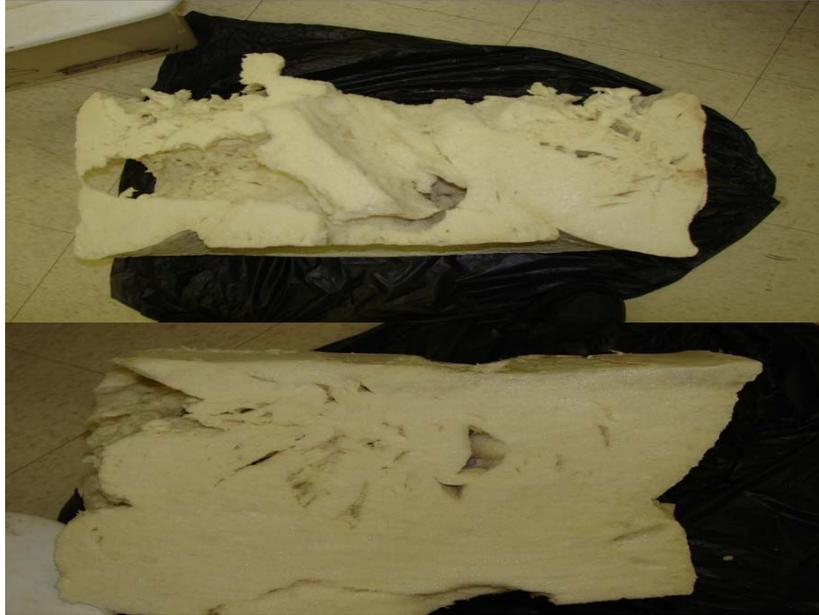
tearing and fracturing occurred during the PF expansion process. Tearing and fracturing of PF during its expansion process in “unconfined” environments is normal, according to Scott Brown of Bayer Industries. Because of that, obtaining random specimens from the samples were not possible, so specimens were obtained from locations that appeared intact, which means the results are biased.

**Figure 30**  
**Specimens from barrel test**

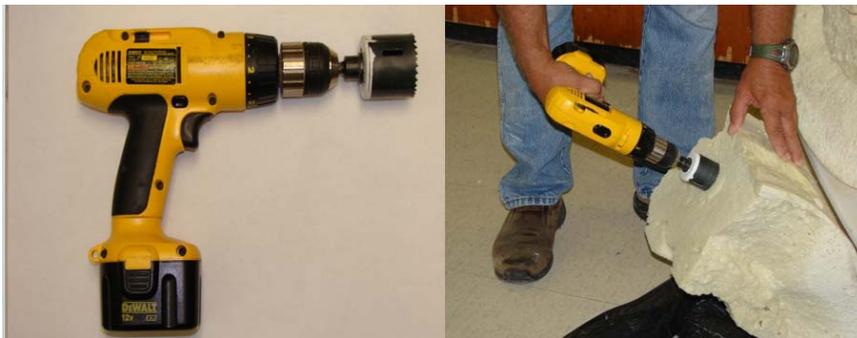
Specimens were obtained from the sample by using a drill and coring device as presented in Figure 31. The cored samples and specimens are presented in Figures 32 and 33. For the barrel test, specimens were available from wet and dry conditions for the densities of 4 and 6 pcf. Dry condition testing only was conducted for the PF densities of 4, 6, 8, and 12 pcf. The specimens obtained met ASTM D1622 standards.

**Figure 31**  
**Drill and coring device**

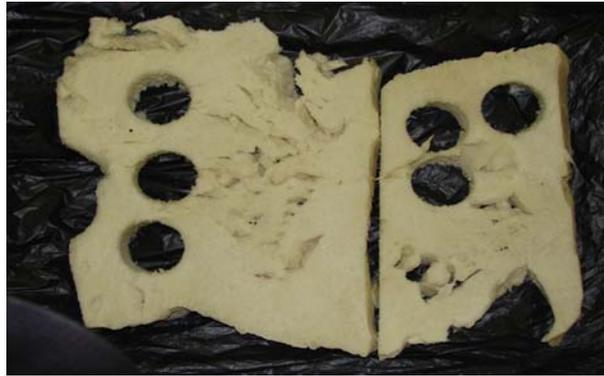
**Figure 32**  
**Cored barrel sample**

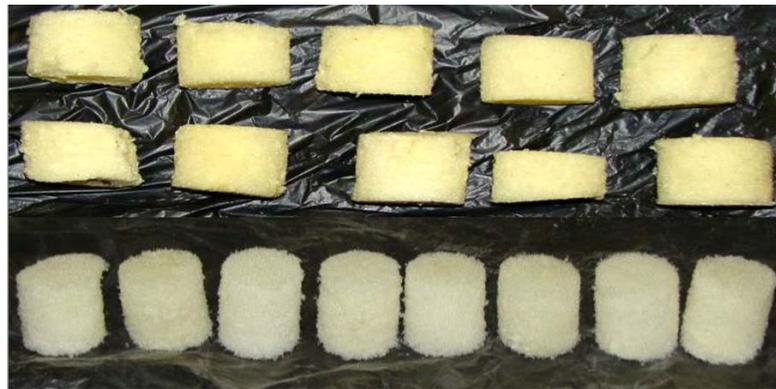
**Figure 33**  
**Specimens from barrel test**

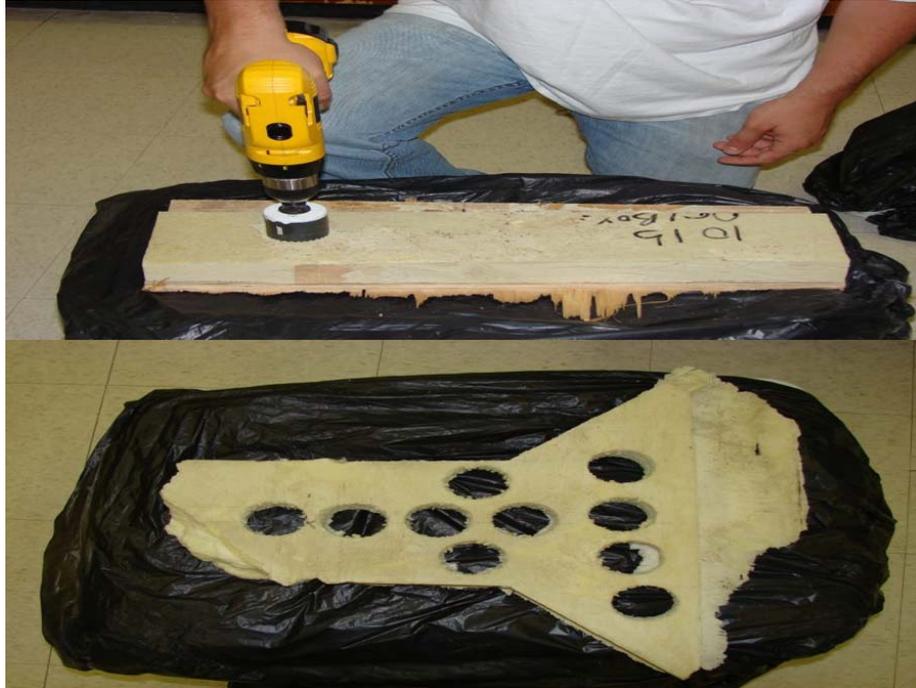
As with the barrel test, samples were obtained from the boxes and subjected to visual inspection, density testing (ASTM D1621), and unconfined compression testing (ASTM D1622). Figure 34 presents a sample from one of the box tests. Visual inspection of the samples indicated that the samples were intact during the PF expansion process for both wet and dry conditions, unlike with the barrel test. Because of that, it was possible to obtain random specimens from the samples.

**Figure 34**  
**Samples from box test**

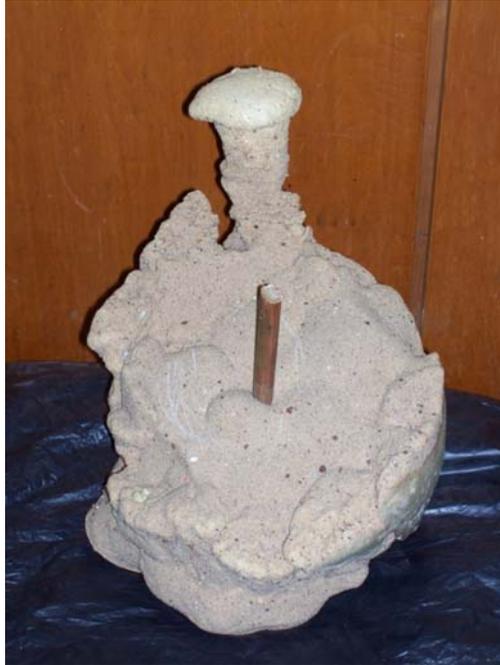
After PF was injected into the sand and allowed to expand, the sand/PF mixture was removed from the bucket, as shown in Figure 35. The sample was cored using a drill and 2-in. diameter core barrel to obtain specimens, as presented in Figures 36 - 38. All four specimens had some tearing and fracturing within them as presented in Figure 37. The sand/PF mixture was heterogeneous throughout the specimens. As presented in Figure 38, approximately 1- to 2-in. of the top and bottom of the specimen were a composite of sand/PF while approximately 3- to 4-in. of the mid region of the specimen was predominately PF, indicating that uniform mixing of sand and PF did not occur during the PF expansion process.

**Figure 35**  
**Sand/PF sample**

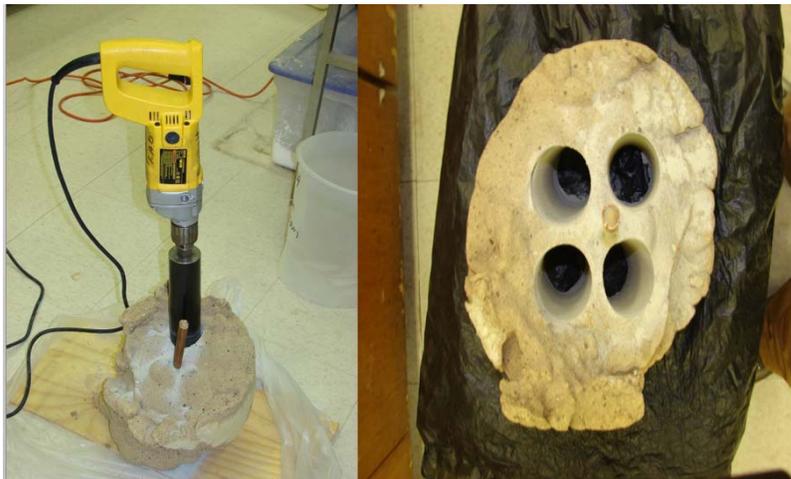
**Figure 36**  
**Coring sand/PF bucket sample**

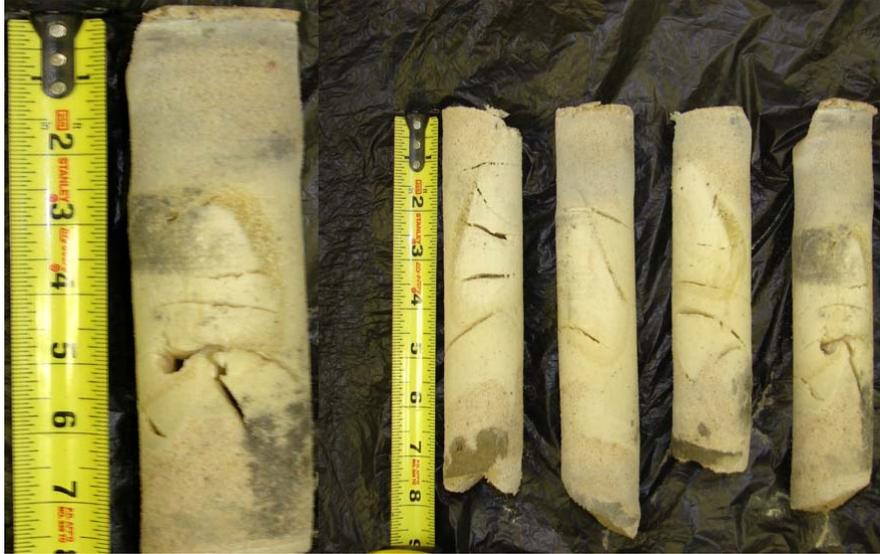
**Figure 37**  
**Sand/PF specimens**

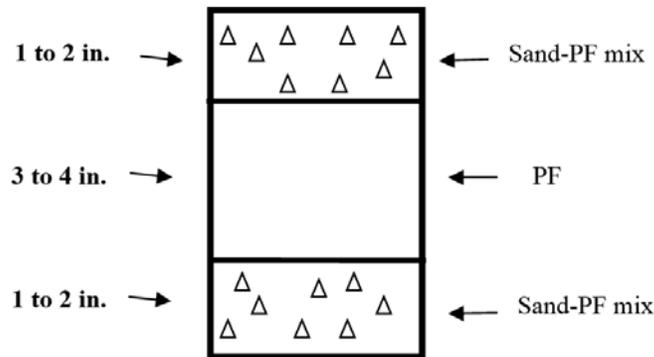
**Figure 38**  
**Diagram of sand/PF mixture**

5. PF does not mix uniformly with granular materials such as sand. When compared to free rise conditions, the density of a PF-granular-material-mixture increases while it's UCS is significantly less, depending upon where the specimen is taken.
6. The high variability in PF densities and UCS obtained from the different test environments warrant extreme caution. Very conservative design considerations should be employed when using this material.

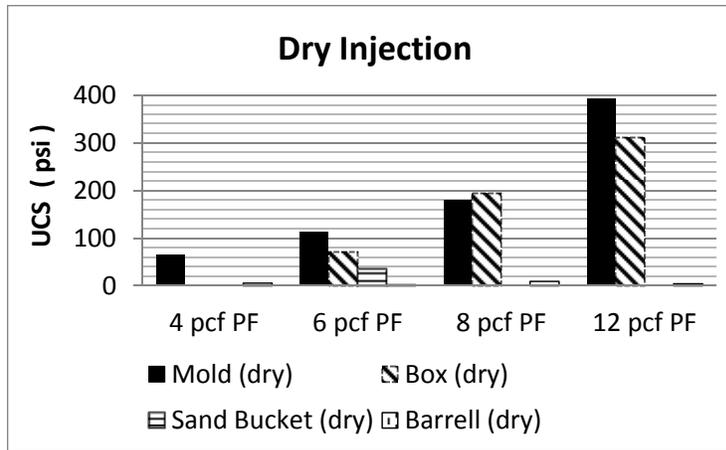
Data were grouped from varying tests and densities in order to provide an overall snapshot of the test results. Beginning with the UCS strengths from molds, box test, sand bucket test, and barrel tests, it was obvious that UCS strengths from the mold specimens exceeded the UCS strengths from the box, barrel and sand bucket test as presented in Figure 39. This implies that if samples were procured from field tests where dry conditions were present, the UCS strengths would be less than in free rise conditions, which the 3-in. diameter molds were postulated to simulate. Regarding density relationships, with the exception of the sand bucket test, densities from the box and barrel tests were generally less than densities from the mold specimens. The results from the testing implies that when confining environments exist both the UCS and density are not increased as originally hypothesized.

**Figure 39**  
**UCS dry injection sample comparison**
