# ***Louisiana Transportation Research Center***

Technical Assistance Report No. 13-02TA-P

**Assessment of Mitigating Transverse Joint Faulting on  
Portland Cement Concrete Pavement with Polyurethane Foam on  
LA 1 Bypass, State Project Number 034-30-0023**

Kevin Gaspard and Zhongjie Zhang

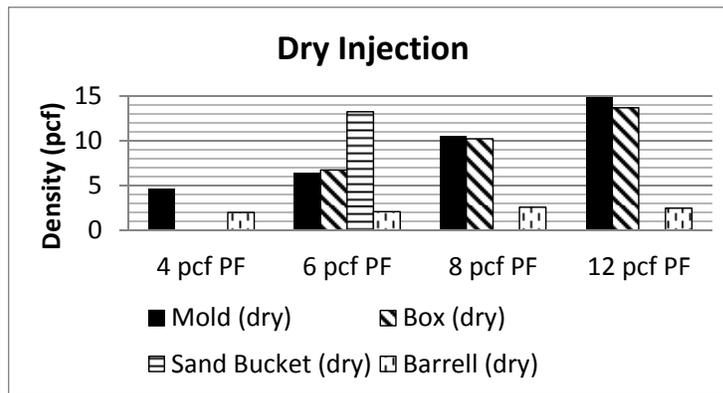
Data were grouped from varying tests and densities in order to provide an overall snapshot of the test results. Beginning with the UCS strengths from molds, box test, sand bucket test, and barrel tests, it was obvious that UCS strengths from the mold specimens exceeded the UCS strengths from the box, barrel and sand bucket test as presented in Figure 39. This implies that if samples were procured from field tests where dry conditions were present, the UCS strengths would be less than in free rise conditions, which the 3-in. diameter molds were postulated to simulate. Regarding density relationships, with the exception of the sand bucket test, densities from the box and barrel tests were generally less than densities from the mold specimens. The results from the testing implies that when confining environments exist both the UCS and density are not increased as originally hypothesized.

**Figure 40**  
**Density dry injection sample comparison**

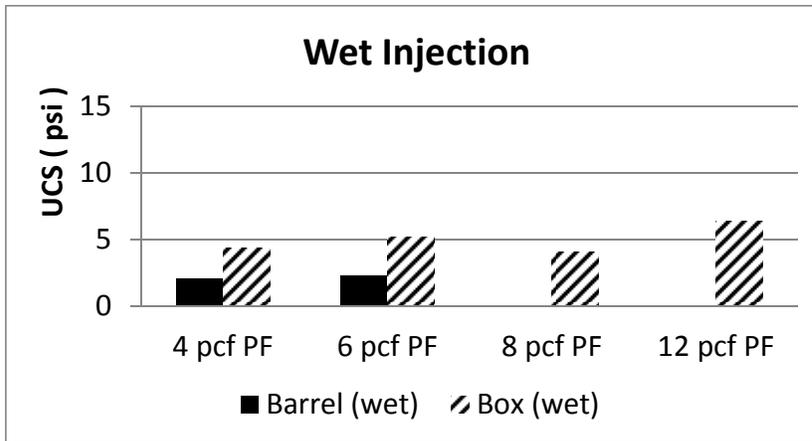
Figures 41 and 42 present the UCS and density results from barrel and box tests when water was present. The UCS strength was higher in the box test than the barrel test at the PF densities of 4, 6, and 12 pcf. Extremely weak UCS strengths were present in all tests. The measured densities from the box tests were larger than the measured densities from the barrel tests. The results of testing from the wet environments indicate that the hydrophobic Uretek 486 used in this experiment was extremely sensitive to water as evidenced from the UCS tests.

**Figure 41**  
**UCS wet injection sample comparison**

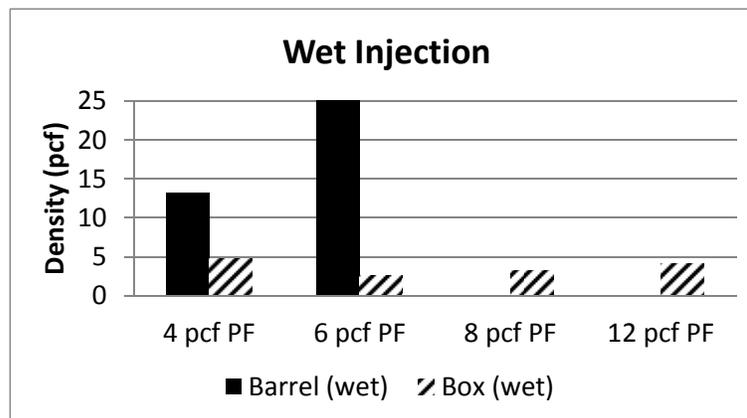
**Figure 42**  
**Density wet injection sample comparison**

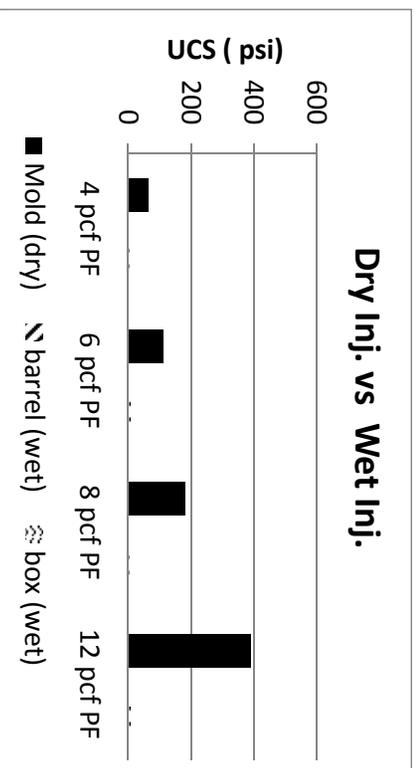
Figure 43

Figures 43 and 44 present comparisons between samples for the molds (dry injection) to samples from the box and barrel when water was present. The UCS strengths from the wet samples were extremely weak when compared to the samples from the molds. The UCS strengths from wet specimens ranged from about 2 to 9 psi implying that wet environments do not allow PF to gain much strength as presented in Figure 43. PF densities ranged from about 2 to 5 pcf when injected into wet environments indicating extreme sensitivity to water, as presented in Figure 44.

UCS wet injection versus dry injection sample comparison

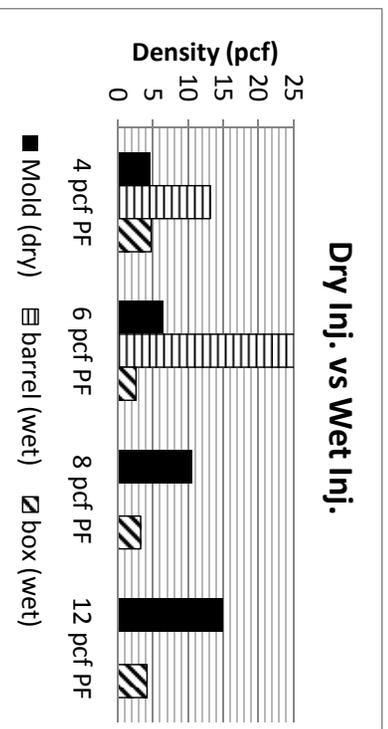
Figure 44

Density wet injection versus dry injection sample comparison
