# ***Louisiana Transportation Research Center***

Final Report 608

## **Impact of Inundation on Roadway Pavements: Case Study – LA 493**

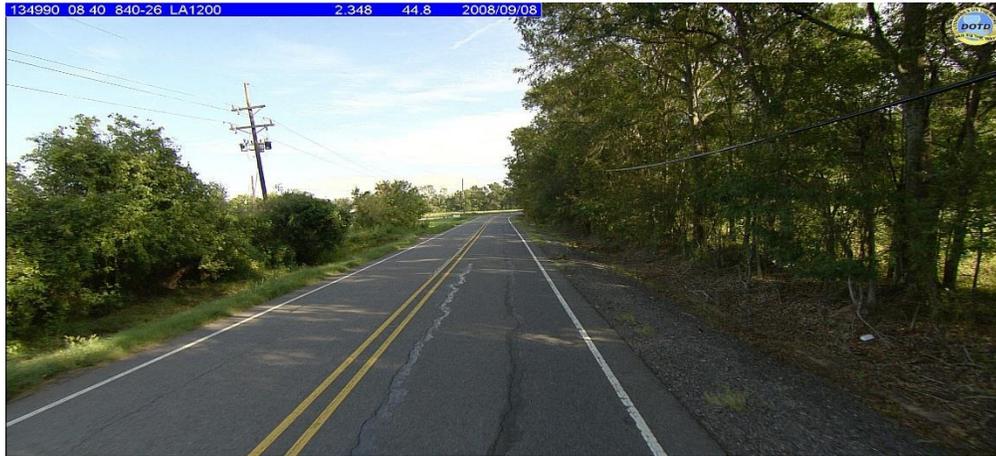
**Figure 1**  
**Longitudinal cracks: LA 1200: CSLM 2.348**

stress exceed the tensile strength of the soil, a crack will form as shown in Figure 5 [39-41]. When this occurs beneath the pavement, it is possible for the crack to propagate through the pavement structure as presented in Figures 1 to 3.

When the yearly rainfall is insufficient to return the active zone (the depth of soil layer(s) impacted by evapotranspiration) to its field capacity (equilibrium saturation), a zone of permanent desiccation is created as presented in Figure 6 [36-38, 47,48]. If permanent desiccation occurs either near the pavement edge or beneath it, permanent settlement (dynamic settlement) at that location may be the culprit of both multiple longitudinal cracks and subsidence as shown in Figures 1, 2, 6, 7, and 8 [47].

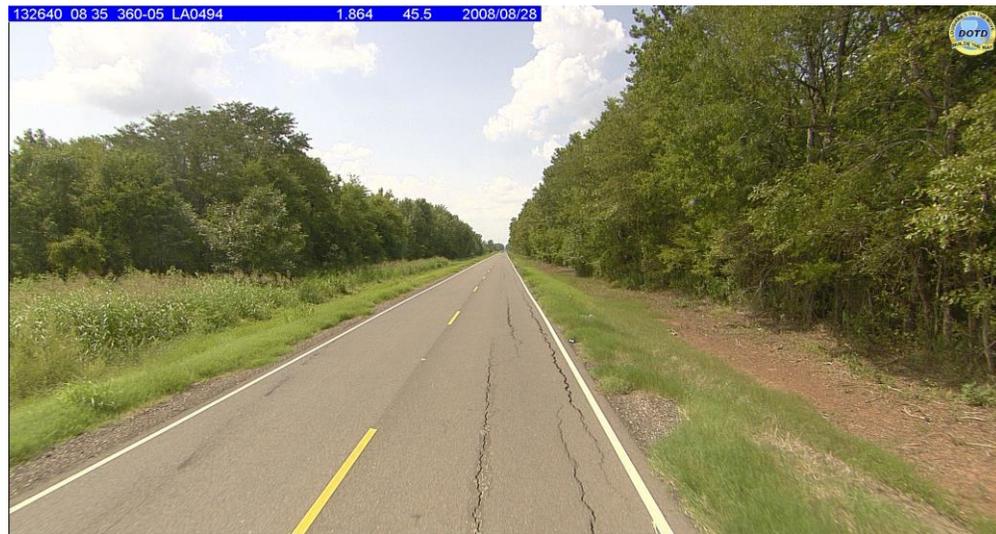
**Figure 2**  
**Multiple longitudinal cracks: La 494: CSLM 1.864**

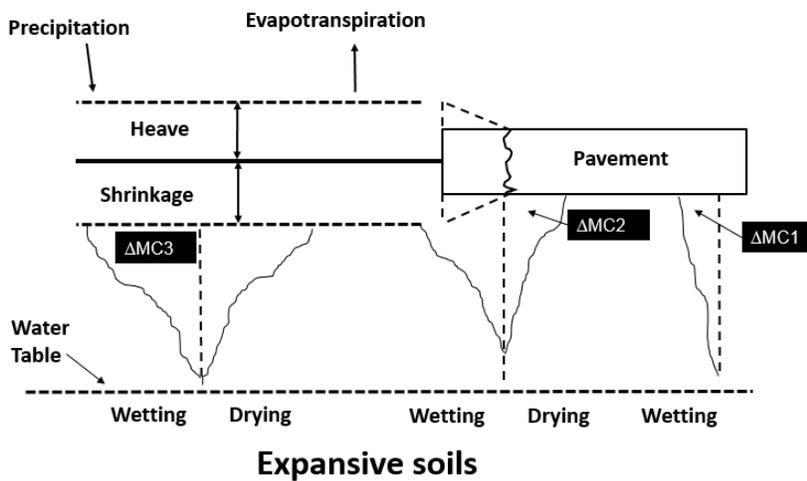
**Figure 3**  
Effect of moisture change on pavement structure

Volumetric changes in the subgrade and/or base course differ in the travel lane(s) in that the volume change at the center line of the pavement differs significantly from the volume change at the pavement edge. Near the pavement edge, movement may be significant enough to cause damage as presented in Figure 3. Such a volumetric differential can manifest either as single or multiple longitudinal crack(s) beginning approximately 1 to 3 ft. from the pavement edge due to pavement bending (heave and subsidence) as presented in Figures 1, 2, and 3 [42-46]. As a result of continual bending, alligator cracking patterns have been known to occur in the asphaltic (AC) surface as presented in Figure 4. The volume change also occurs longitudinally along the travel lane(s) which can lead to bumps and depressions in the pavement. This in turn contributes to decreased ride quality due to the changes in the roadway profile.

For example, let's assume that the volumetric moisture content (VMC) beneath the pavement ( $\Delta MC1$ ) normally ranges from 65 to 85 percent, and the VMC at the edge of the pavement ( $\Delta MC2$ ) normally ranges from 35 to 65 percent while the VMC at a location away from the pavement ( $\Delta MC3$ ) (natural ground) ranges from 15 to 55 percent seasonally; refer to Figure 3.

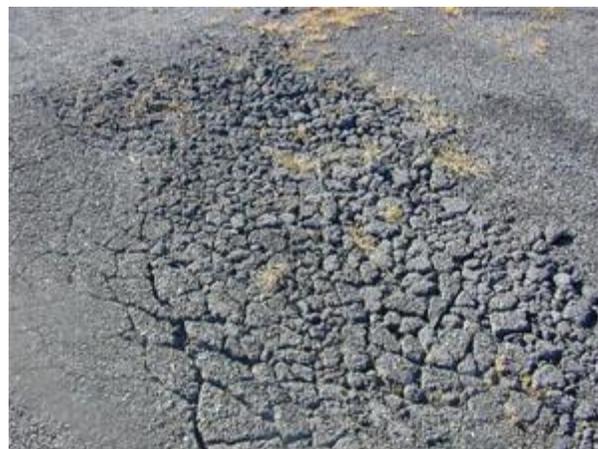
**Figure 4**  
Alligator cracking in AC surface

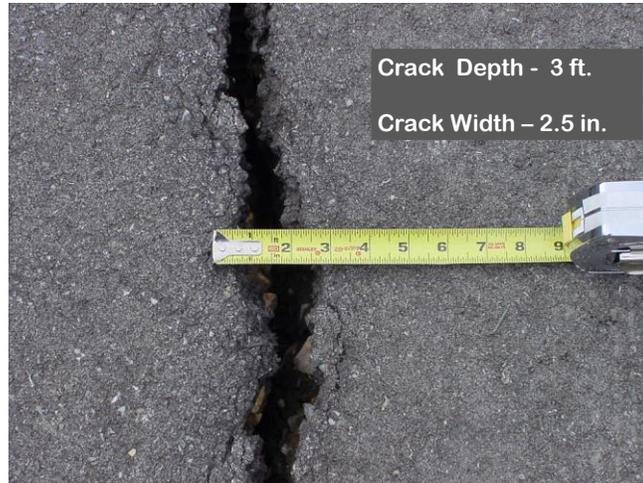
**Figure 5**  
**Parish road: St. Martin Parish**

Longitudinal cracks in the pavement may also be caused by desiccation in the expansive clay subgrade. When the soil suction stresses induced by desiccation coupled with net normal

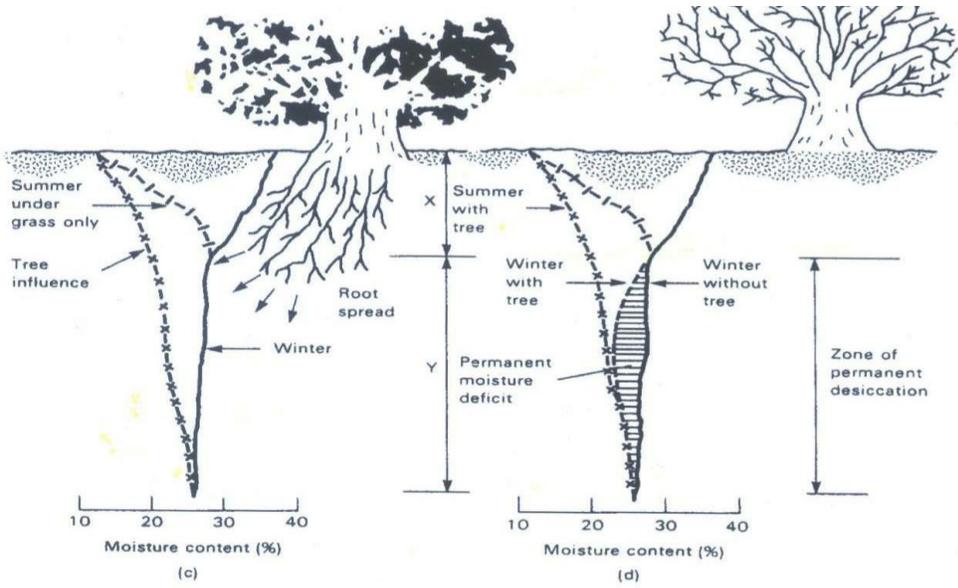
**Figure 6**  
**Permanent desiccation: Source Roberts [48]**

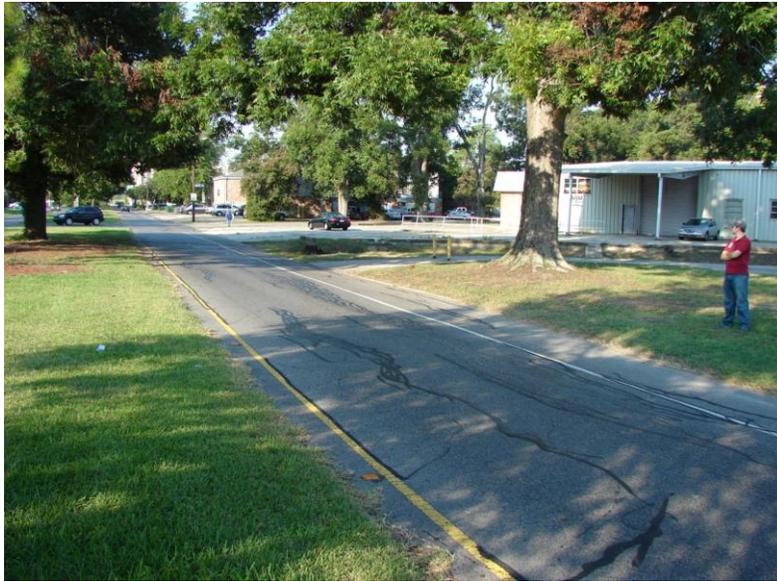
**Figure 7**  
**Multiple longitudinal cracks and subsidence: West Parker Ave. near LTRC**

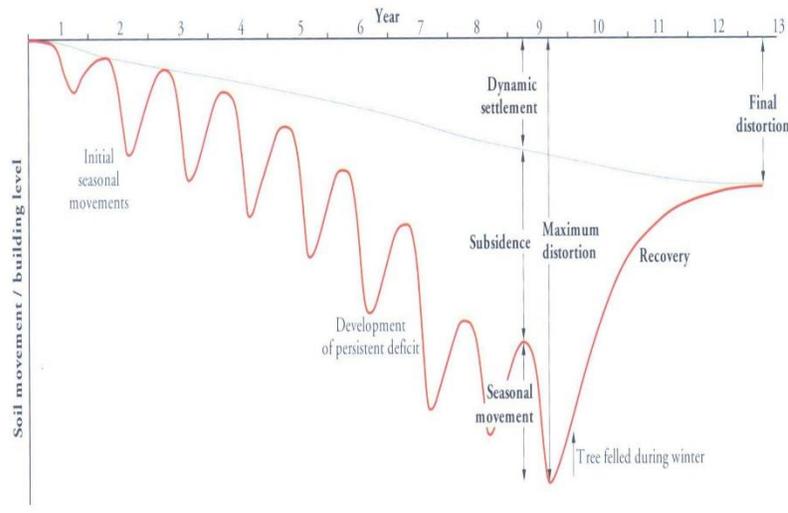
**Figure 8**  
**Dynamic settlement: Source Biddle [47]**

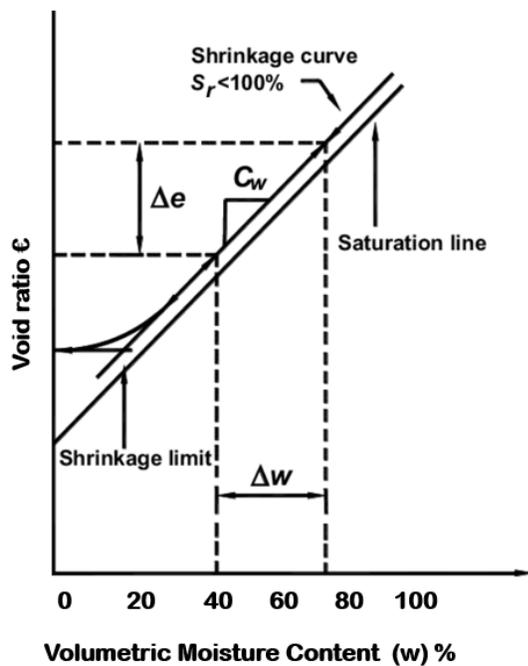
**Figure 9**  
**Volumetric moisture content versus void ratio**

After an inundation event, it is possible and probable for the soil to fully saturate (VMC = 100 percent) at  $\Delta MC1$ ,  $\Delta MC2$ , and  $\Delta MC3$ . Once the flood waters recede and the roadway, embankment, and natural ground become exposed to the atmosphere and sunlight, evaporation will occur. If it is in the spring and summer, evaporation will be even greater where trees are present due the transpiration of the trees and other flora. So instead of  $\Delta MC1$ ,  $\Delta MC2$ , and  $\Delta MC3$  ranging from their normal VMC maximums of 85 percent, 65 percent, and 55 percent, they now range respectively from 100 percent to 65 percent, 100 percent to 35 percent, and 100 percent to 15 percent. Such changes in the VMC in an expansive soil will increase the magnitude of its swell, thus, leading to a larger range of ground movement due to swell. Furthermore, as evaporation and transportation remove water from the ground and beneath the pavement surface, shrinkage will occur leading to subsidence in the ground. However, under this circumstance, the range between swelling and shrinking is greater than the normal range experienced for this area under normal seasonal variation. Such a range in movement can damage the pavement leading to premature failures and cracking with subsequent service life reductions. Figure 9 presents the general relationship of void ratio ( $e$ ) versus VMC for an expansive soil. Through formulas, the volume change and subsequent change in height or ground movement can be calculated. As the soil varies in its mineralogical composition, so will the relationship between void ratio and VMC [39-41].

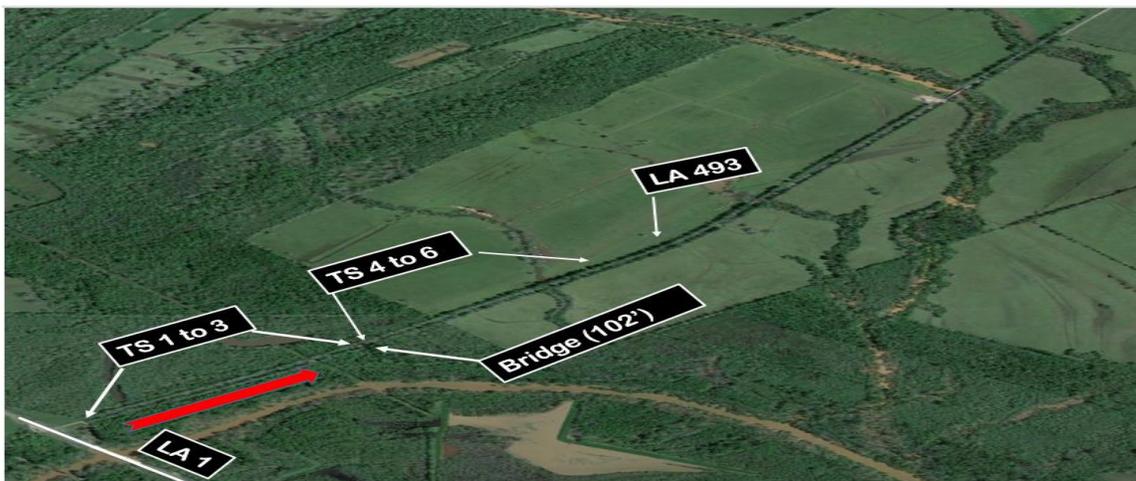
**Figure 10**  
**Aerial view of LA 493 test site locations**

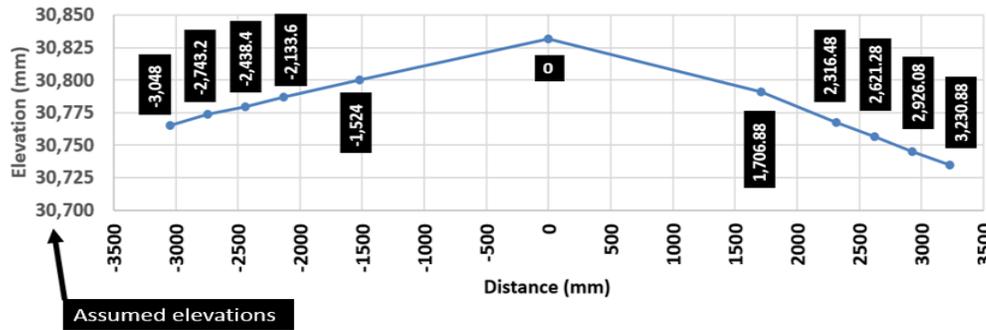
**Figure 11**  
**Cross-section point locations**

LTRC conducted cross-section surveys at the points on the roadway’s AC surface shown in Figure 11. Doing so provided insight on the magnitude of movement translating to the surface of the roadway due to inundation. Measurements, both vertical and horizontal, were converted and are presented in metric units (mm) for convenience purposes.

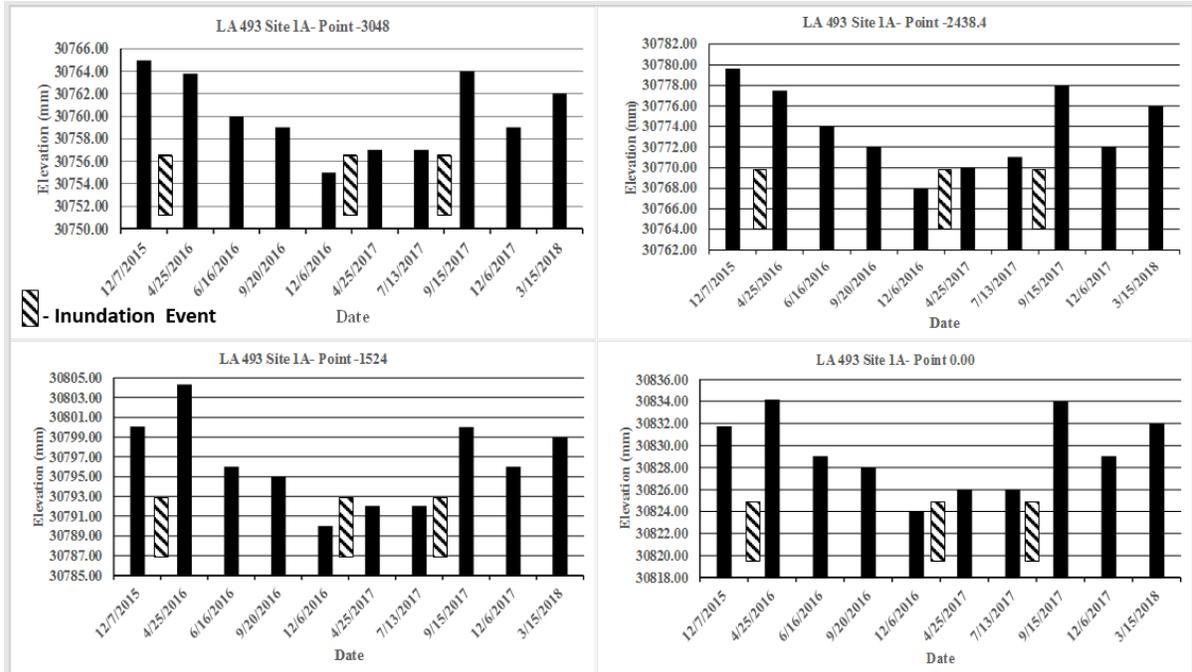
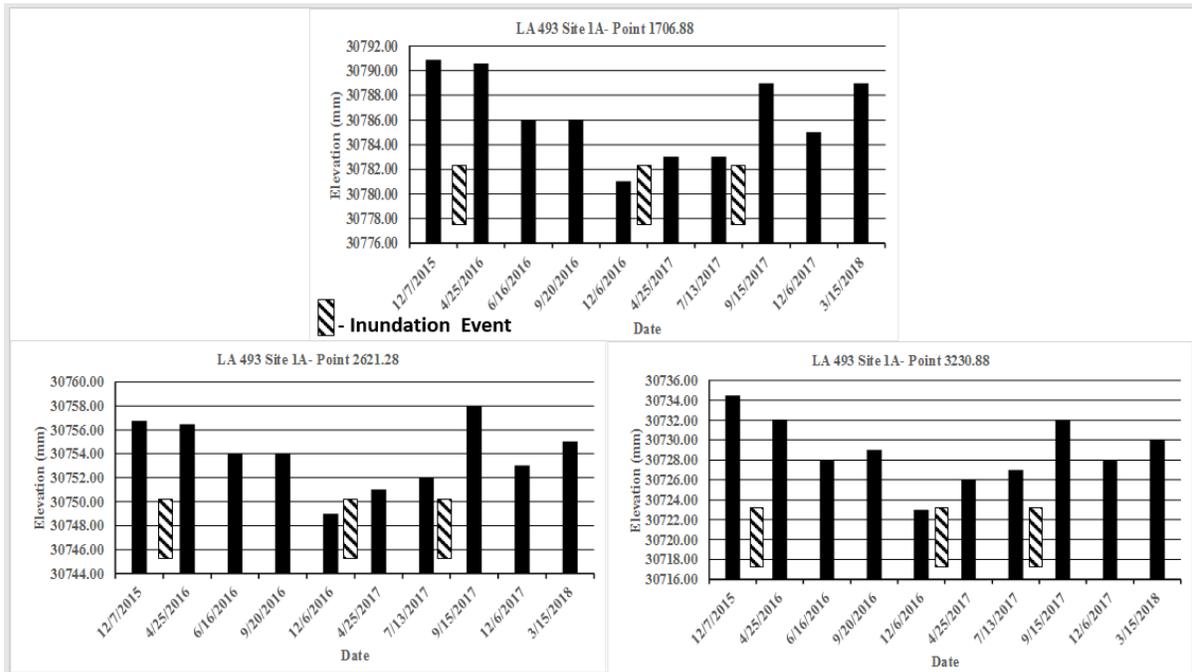
Figure 12  
Charts of cross-section points for Site 1A

Figure 13  
Charts of cross-section points for Site 1A

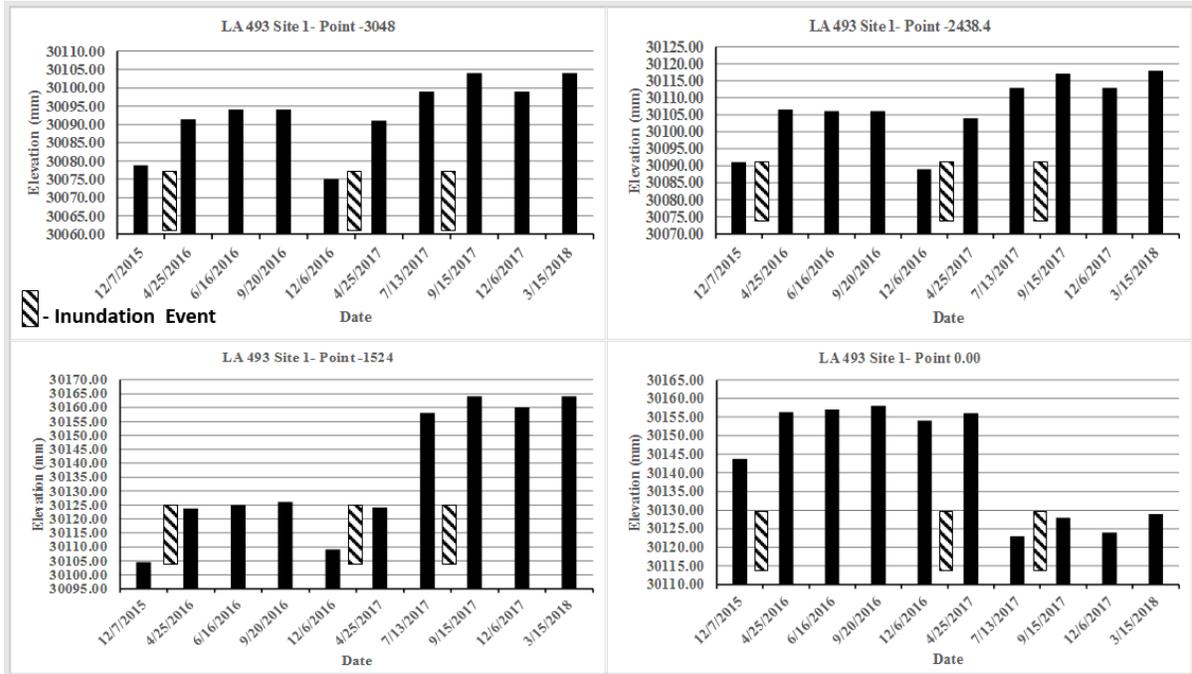
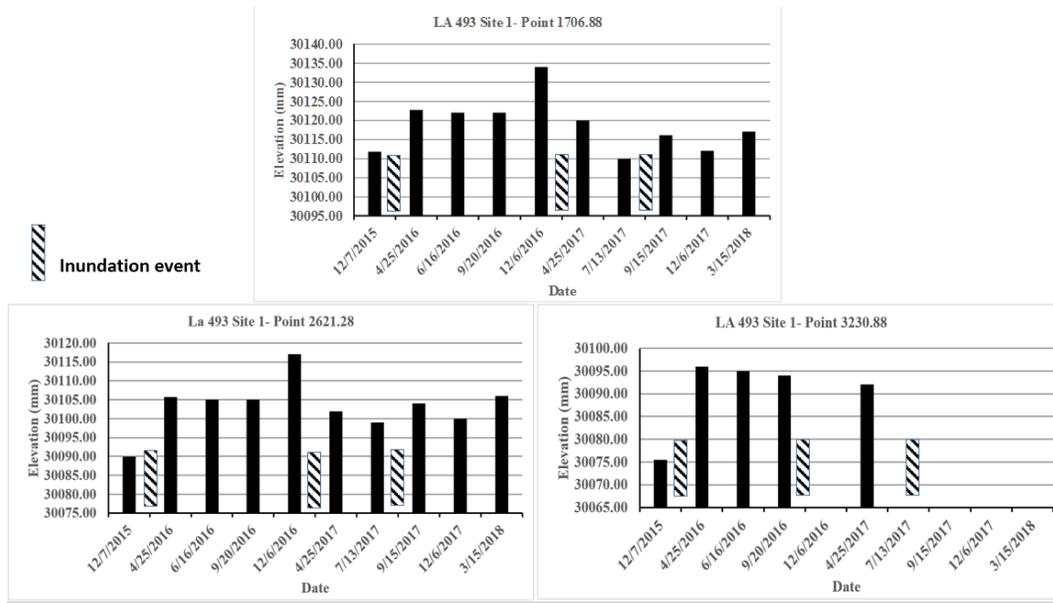
**Figure 14**  
**Charts of cross-section points for Site 1**

**Figure 15**  
**Charts of cross-section points for Site 1**

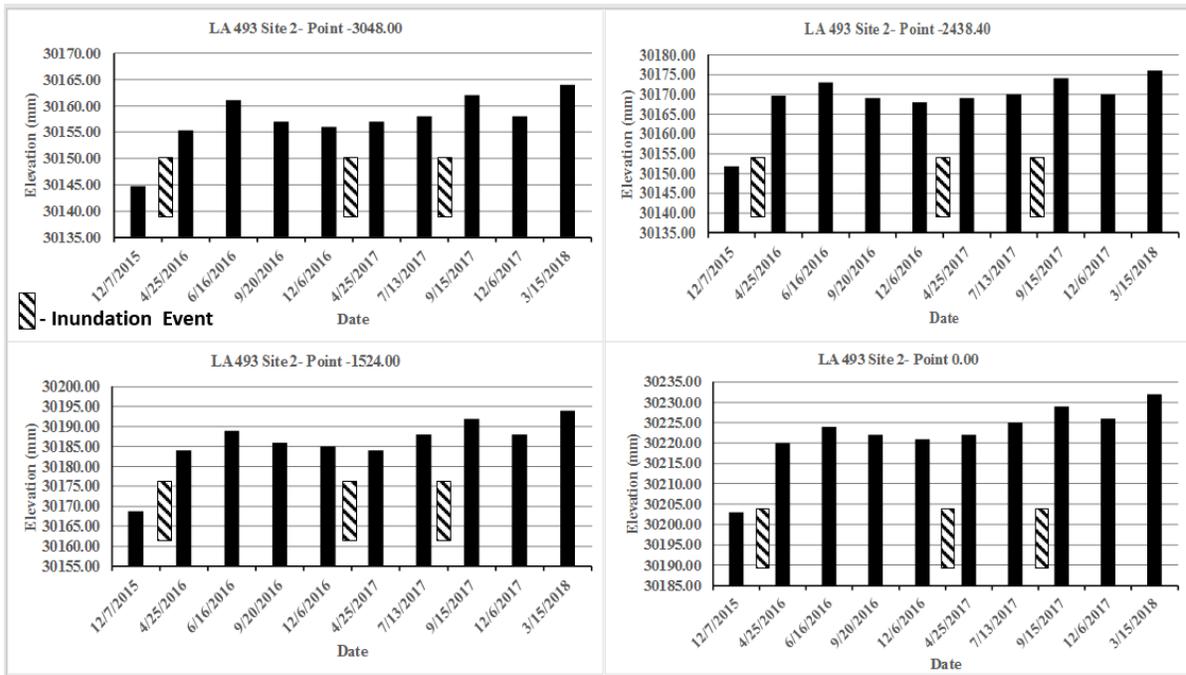
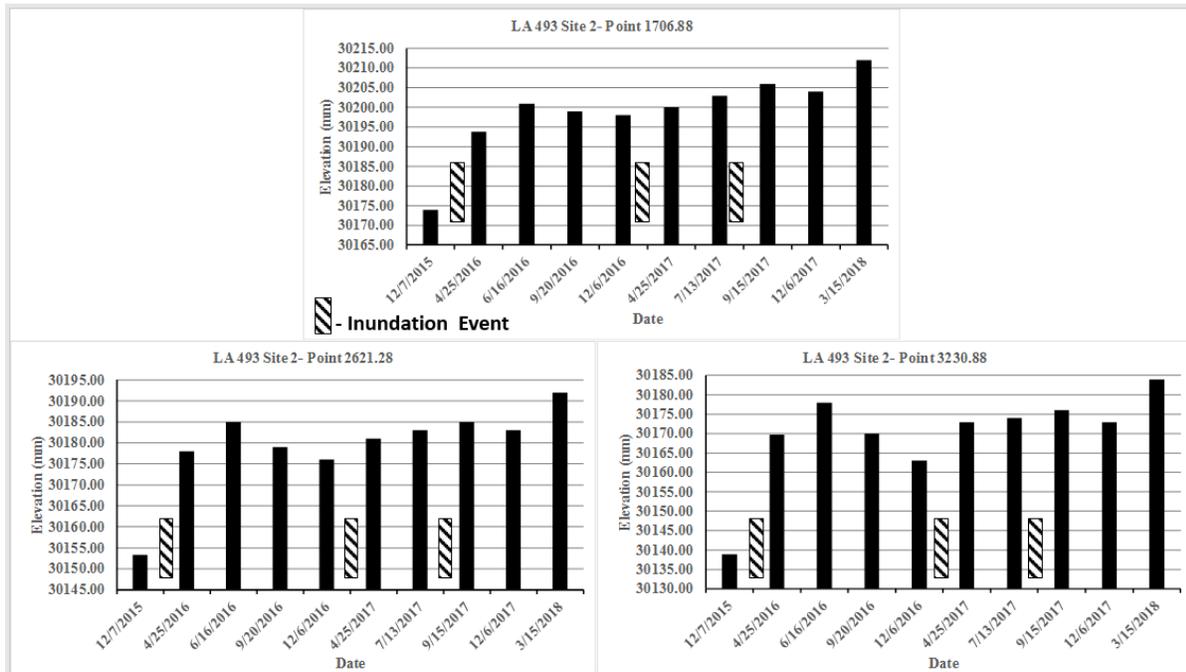
**Figure 16**  
**Charts of cross-sections for Site 2**

**Figure 17**  
**Charts of cross-sections elevations from 12/7/2015 for Site 2**

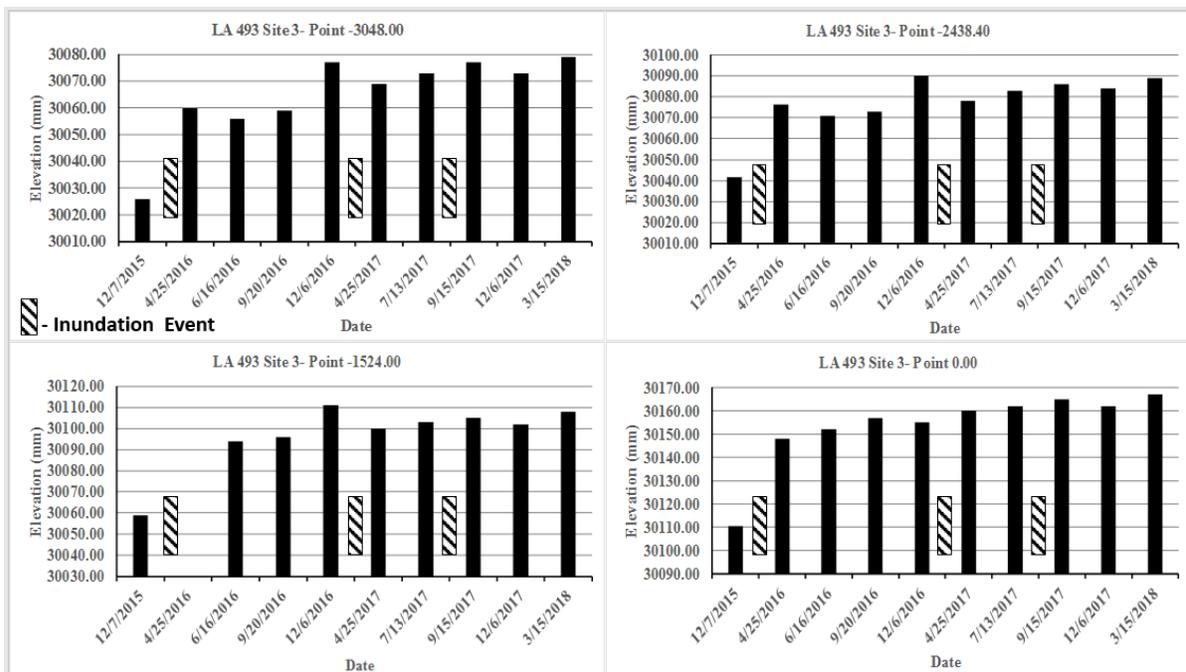
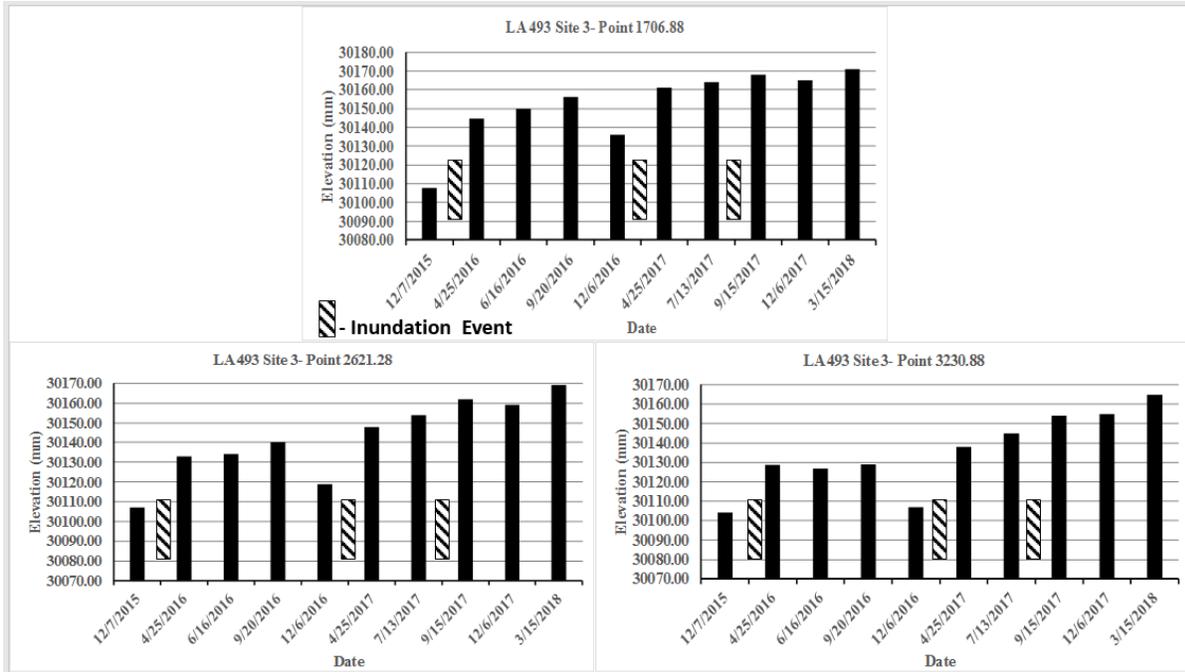
**Figure 18**  
**Charts of cross-section points for Site 3**

**Figure 19**  
**Charts of cross-section points for Site 3**

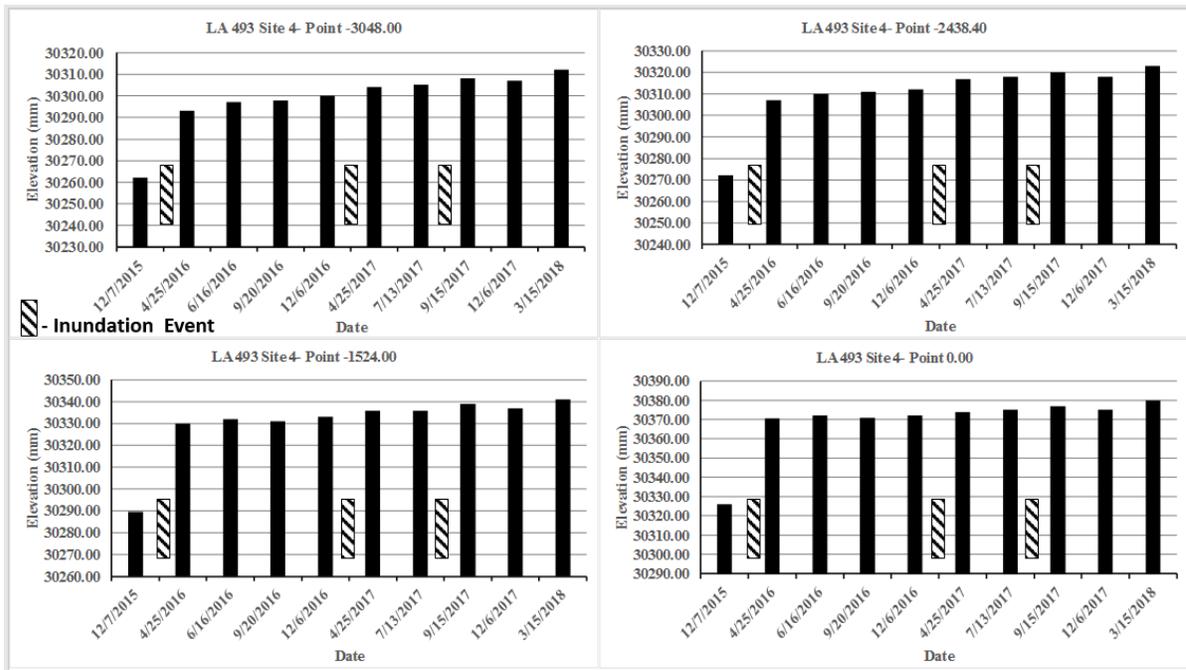
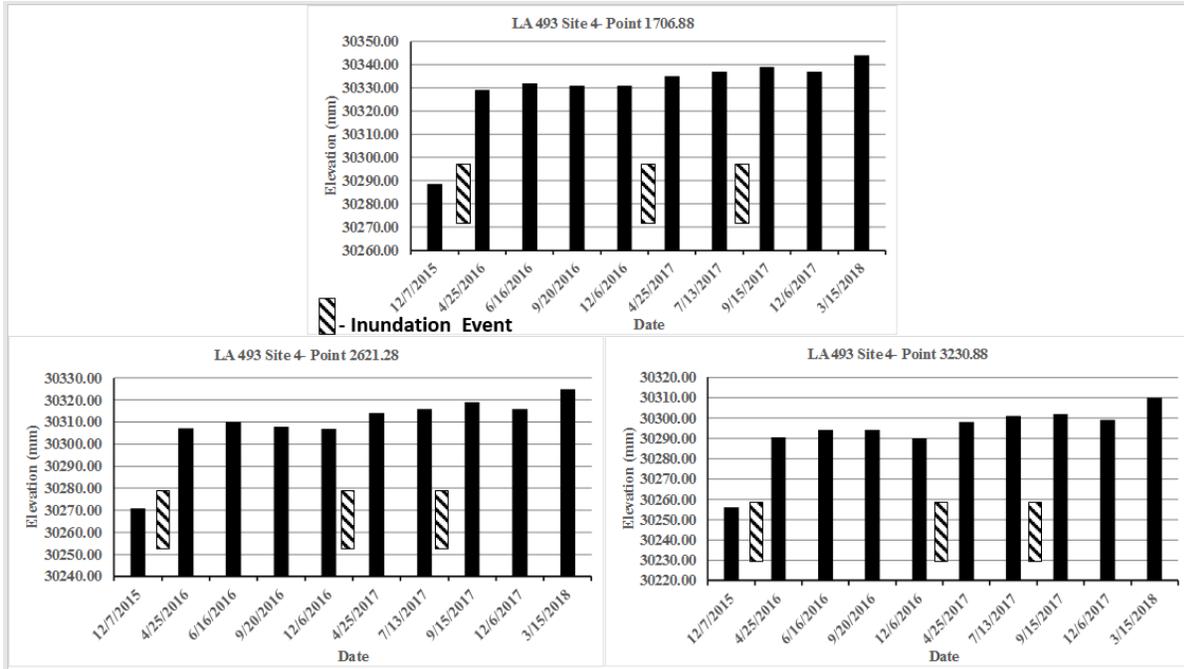
**Figure 20**  
**Charts of cross-section points for Site 4**

**Figure 21**  
**Charts of cross-section points for Site 4**

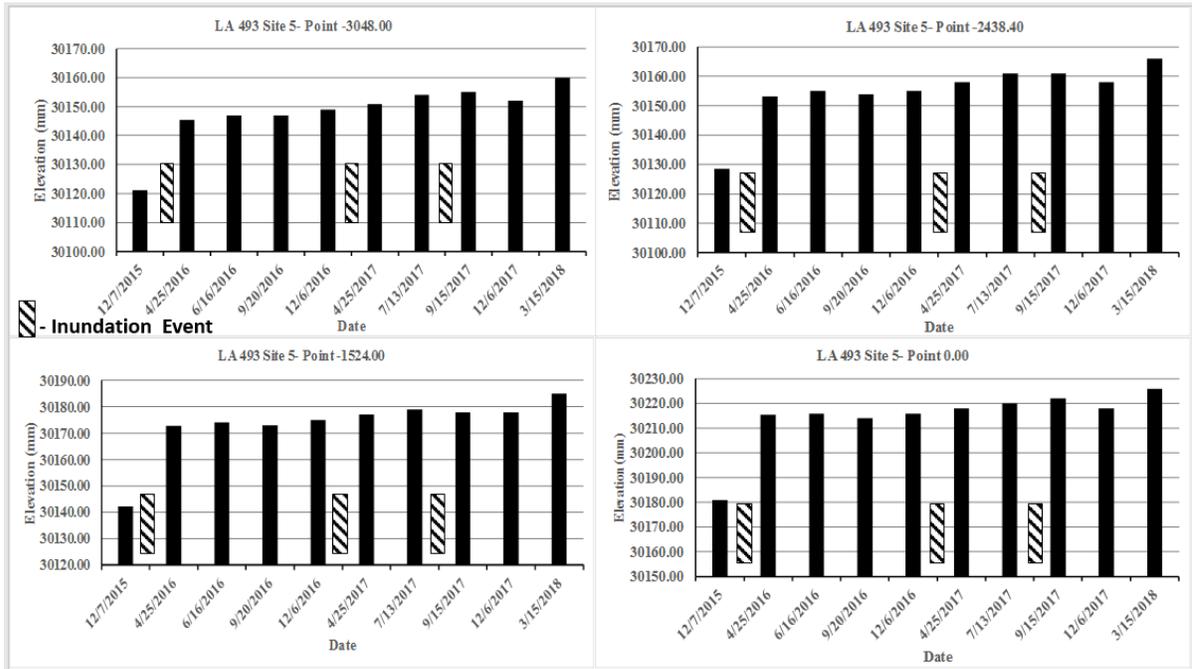
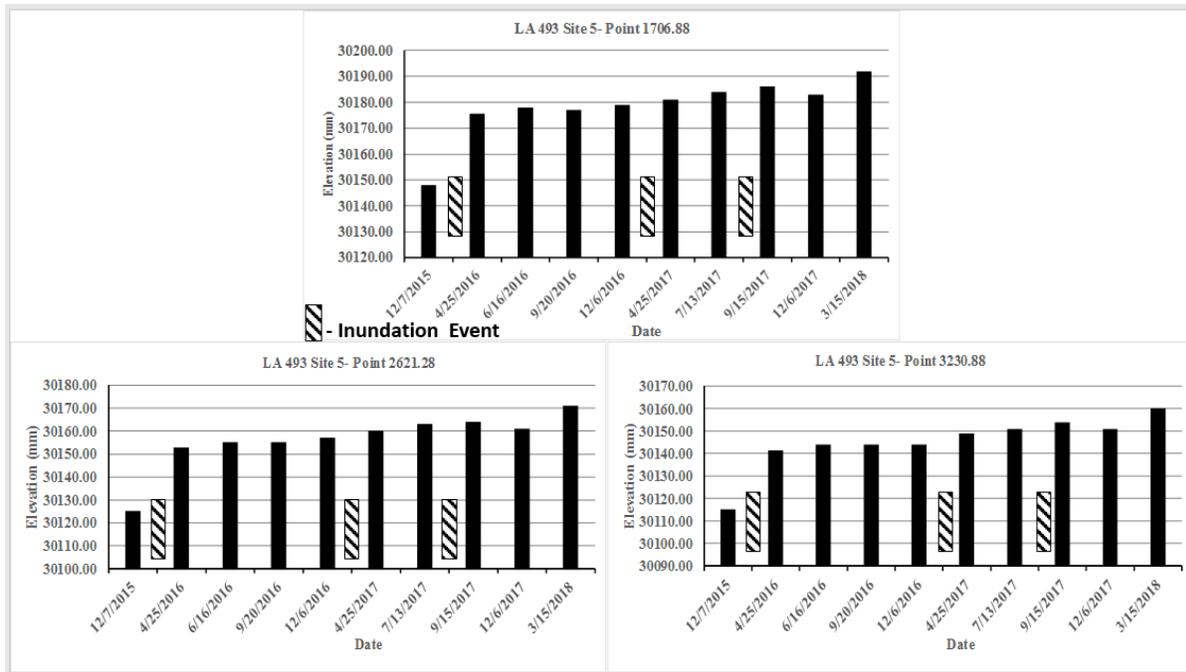
**Figure 22**  
**Charts of cross-section points for Site 5**

**Figure 23**  
**Charts of cross-section points for Site 5**

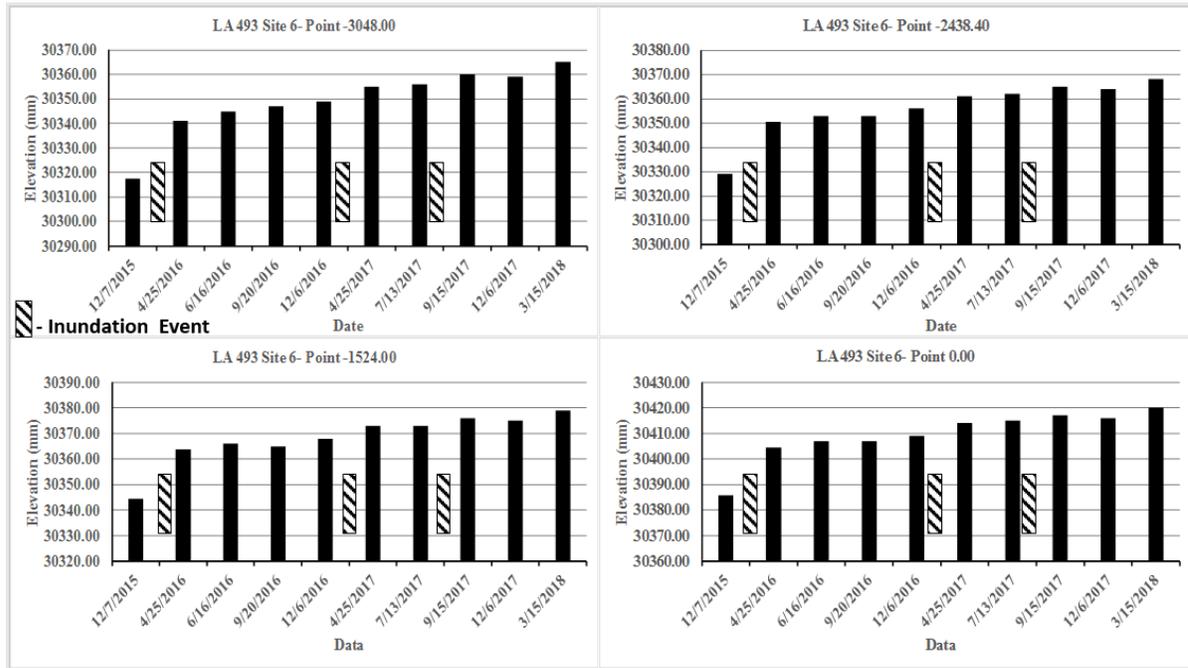
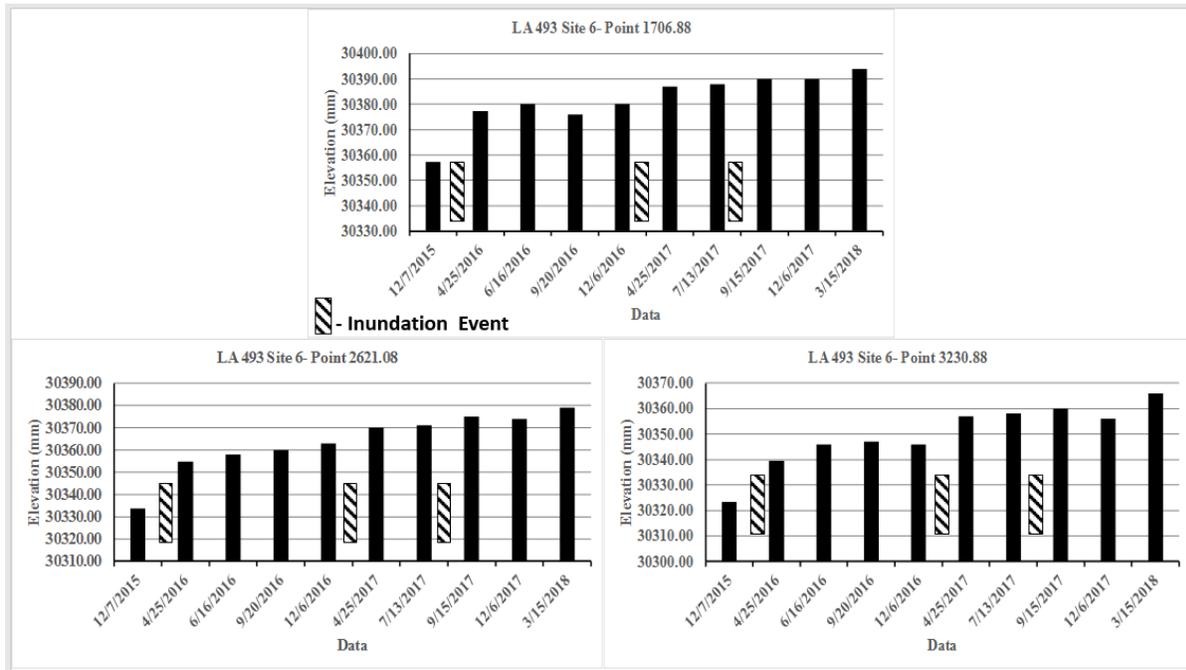
**Figure 24**  
**Charts of cross-section points for Site 6**

**Figure 25**  
**Charts of cross-section points for Site 6**

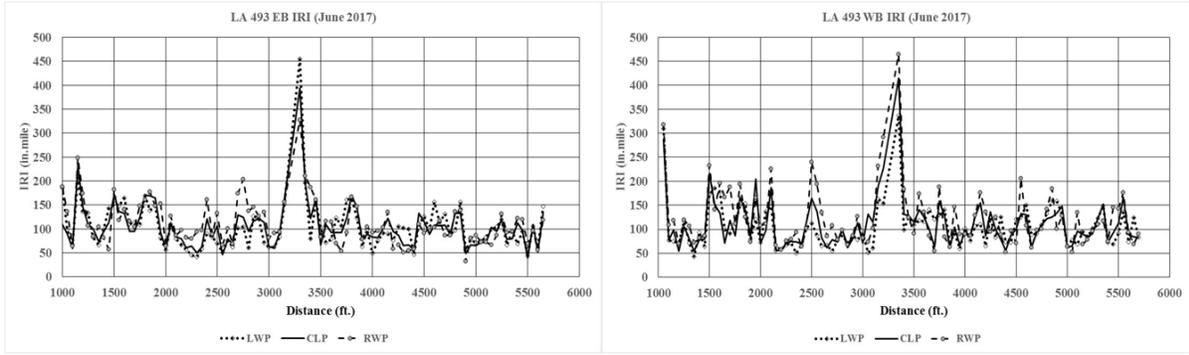
**Figure 26**  
**EB and WB IRI values for the June 2017 assessment**

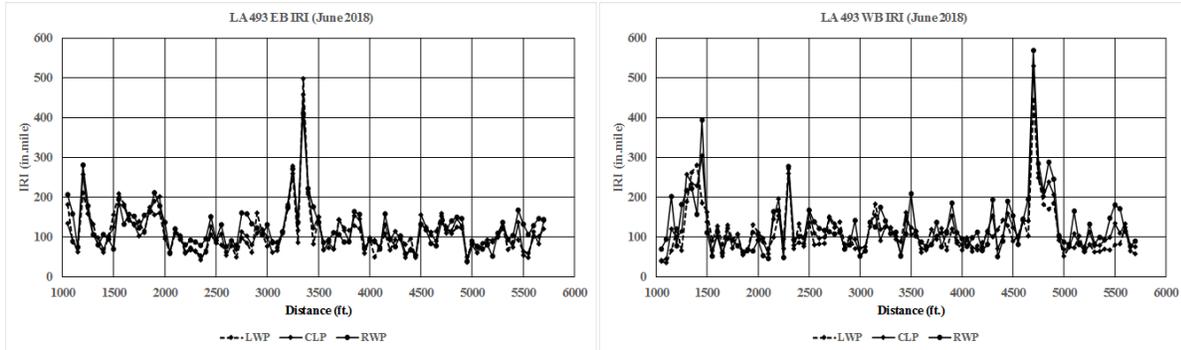
**Figure 27**  
**EB and WB IRI values for the June 2018 assessment**

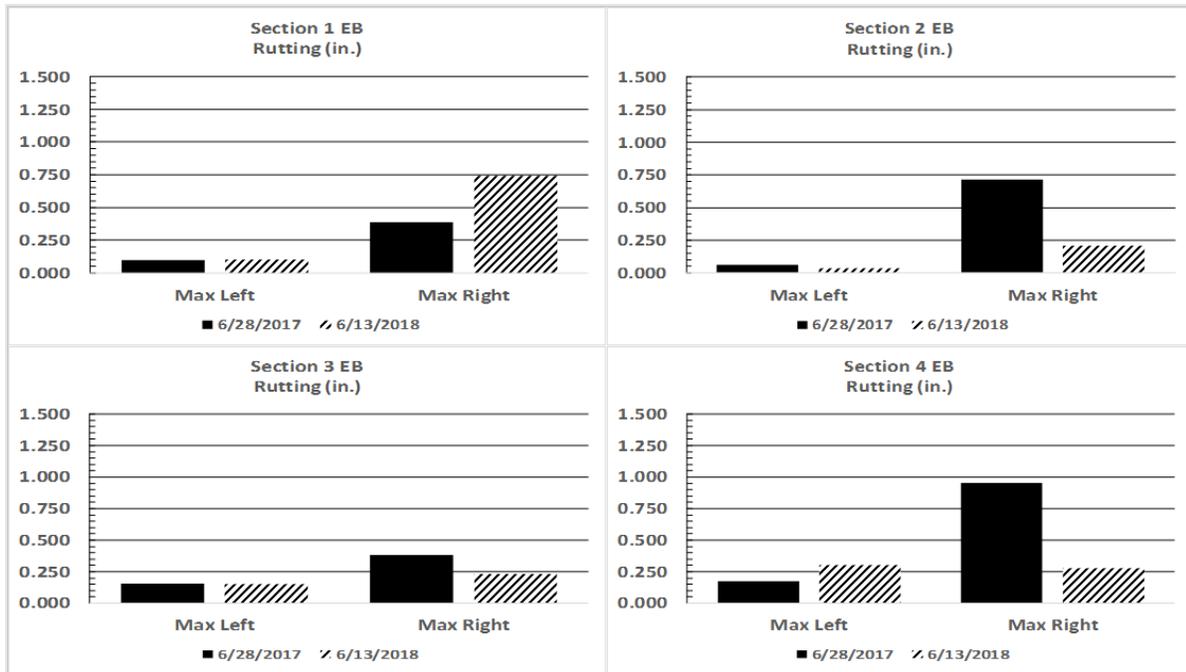
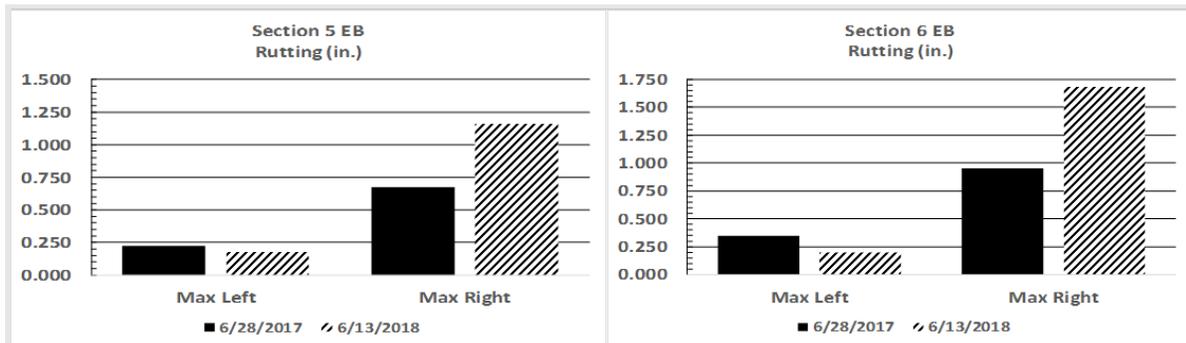
**Figure 28**  
EB maximum rutting for Sites 1 to 4

**Figure 29**  
EB maximum rutting for Sites 5 and 6

Figures 28 and 29 present the rutting measurements for Sites 1 to 6 on the assessment dates of June 2017 and June 2018. DOTD considers rutting values greater than 0.5 in. to be significant and in need of mitigation. It is probable that the significant rutting at some locations were due to weakening of the pavement structure due to volumetric changes in the embankment as well as depressions caused by movements in the embankment. For Site 1, the maximum rutting in June 2017 in the RWP was 0.386 in. and 0.74 in. a year later in June 2018 indicating that rutting in those locations are increasing. Site 2 showed a similar pattern with the maximum rutting in the RWP being 0.713 in. in June 2017 and 0.205 in. on June 2018. The reason for the decrease in the maximum rutting between June 2017 and June 2018 is unknown. The maximum rutting values for Site 3 in the RWP were 0.382 in. on June 2017 and 0.232 in. on June 2018. Site 4 had maximum rutting values in the RWP of 0.953 in. on June 2017 and 0.28 in. on June 2018. As with Site 2, the authors are uncertain of the decrease in maximum rutting between June 2017 and June 2018. The maximum rutting values in the RWP for Site 5 were 0.673 in. and 1.2 in. on June 2017 and June 2018, respectively. Site 6 had maximum rutting values in the RWP of 0.953 in. and 1.685 in. on June 2017 and June 2018, respectively. Site 6 had the highest maximum rut depth in the EB direction.

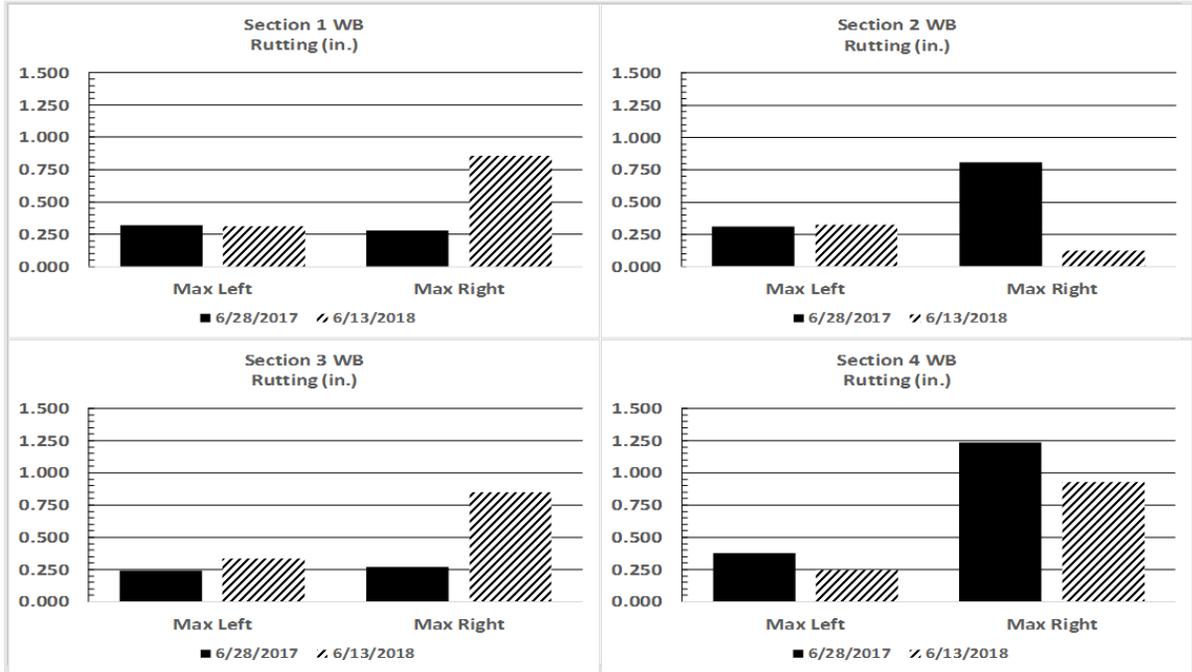
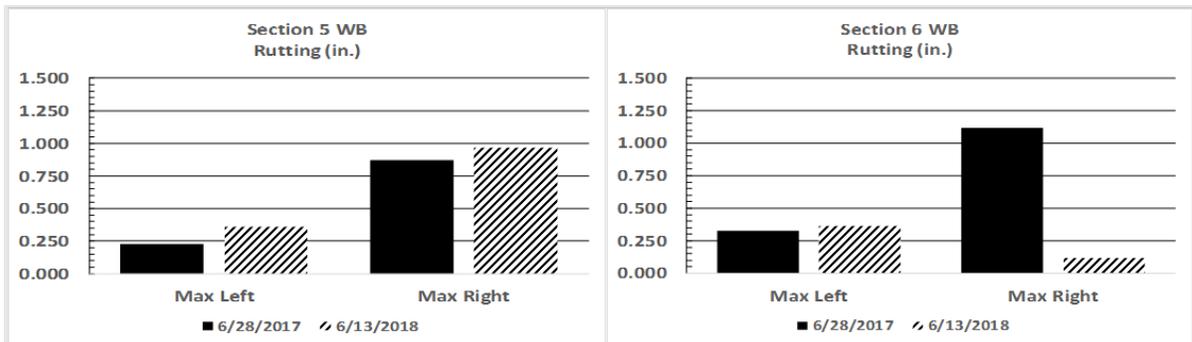
**Figure 30**  
WB maximum rutting for Sites 1 to 4

**Figure 31**  
WB maximum rutting for Sites 5 and 6

Figures 30 and 31 present the rutting measurements for Sites 1 to 6 on the assessment dates of June 2017 and June 2018. On Site 1, the maximum rutting depth in the RWP was 0.276 in. and 0.858 in. on June 2017 and June 2018 respectively. Site 2 had maximum rutting depths in the RWP of 0.807 in. for June 2017 and 0.122 in. for June 2018. The reason for the decrease in the rutting depths between June 2017 and June 2018 is unknown but may be due to volumetric changes in the embankment. The maximum rutting depth in the RWP for Site 3 was 0.268 in. and 0.850 in. on June 2017 and June 2018. respectively. Site 4 had maximum

rutting depths on the RWP of 1.236 in. and 0.929 in. in June 2017 and June 2018, respectively. Regarding Site 5, the maximum rutting depth in the RWP in June 2017 was 0.824 in. and in June 2018 it was 0.965 in. On Site 6, the maximum rutting depth on the RWP was 1.118 in. in June 2017 and 0.118 in. in June 2018.

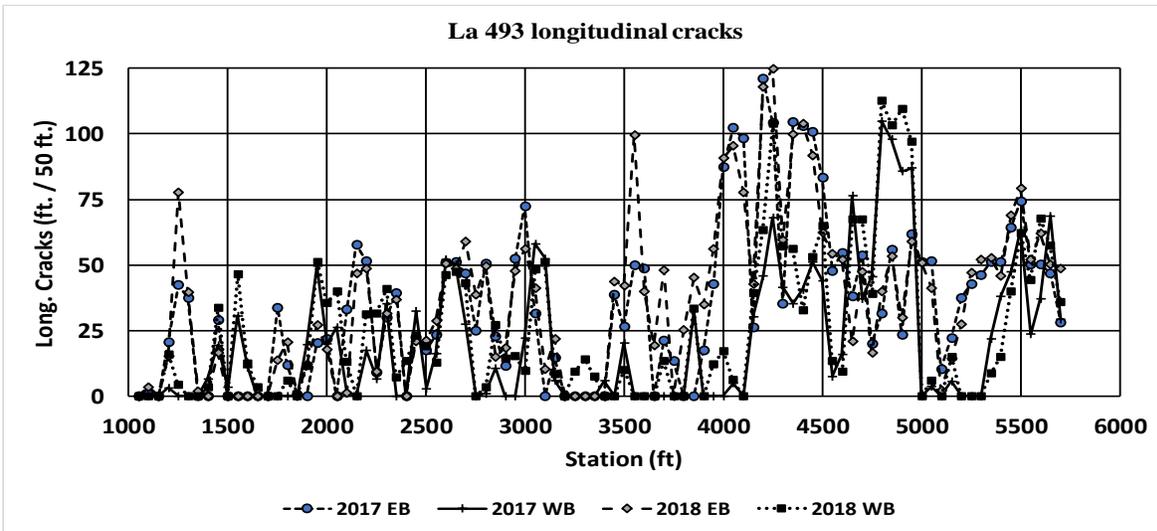
**Figure 32**

Longitudinal cracks for the EB and WB directions for the June 2017 and June 2018 assessments
