# ***Louisiana Transportation Research Center***

Final Report 608

## **Impact of Inundation on Roadway Pavements: Case Study – LA 493**

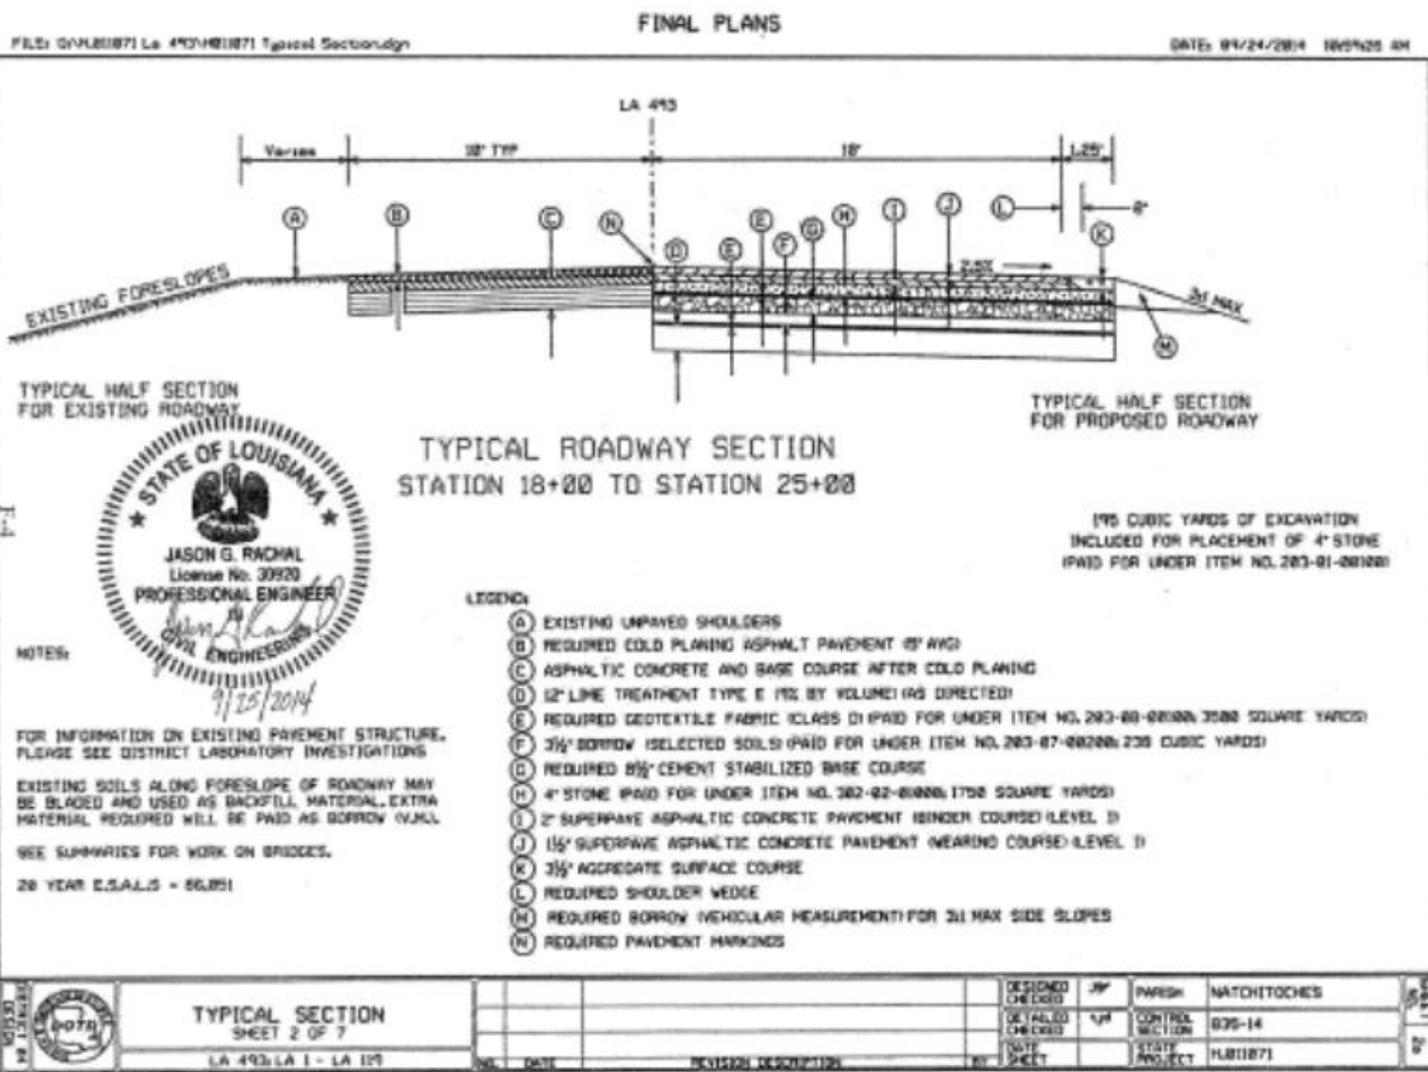
Figure 35  
Typical section for Site 2

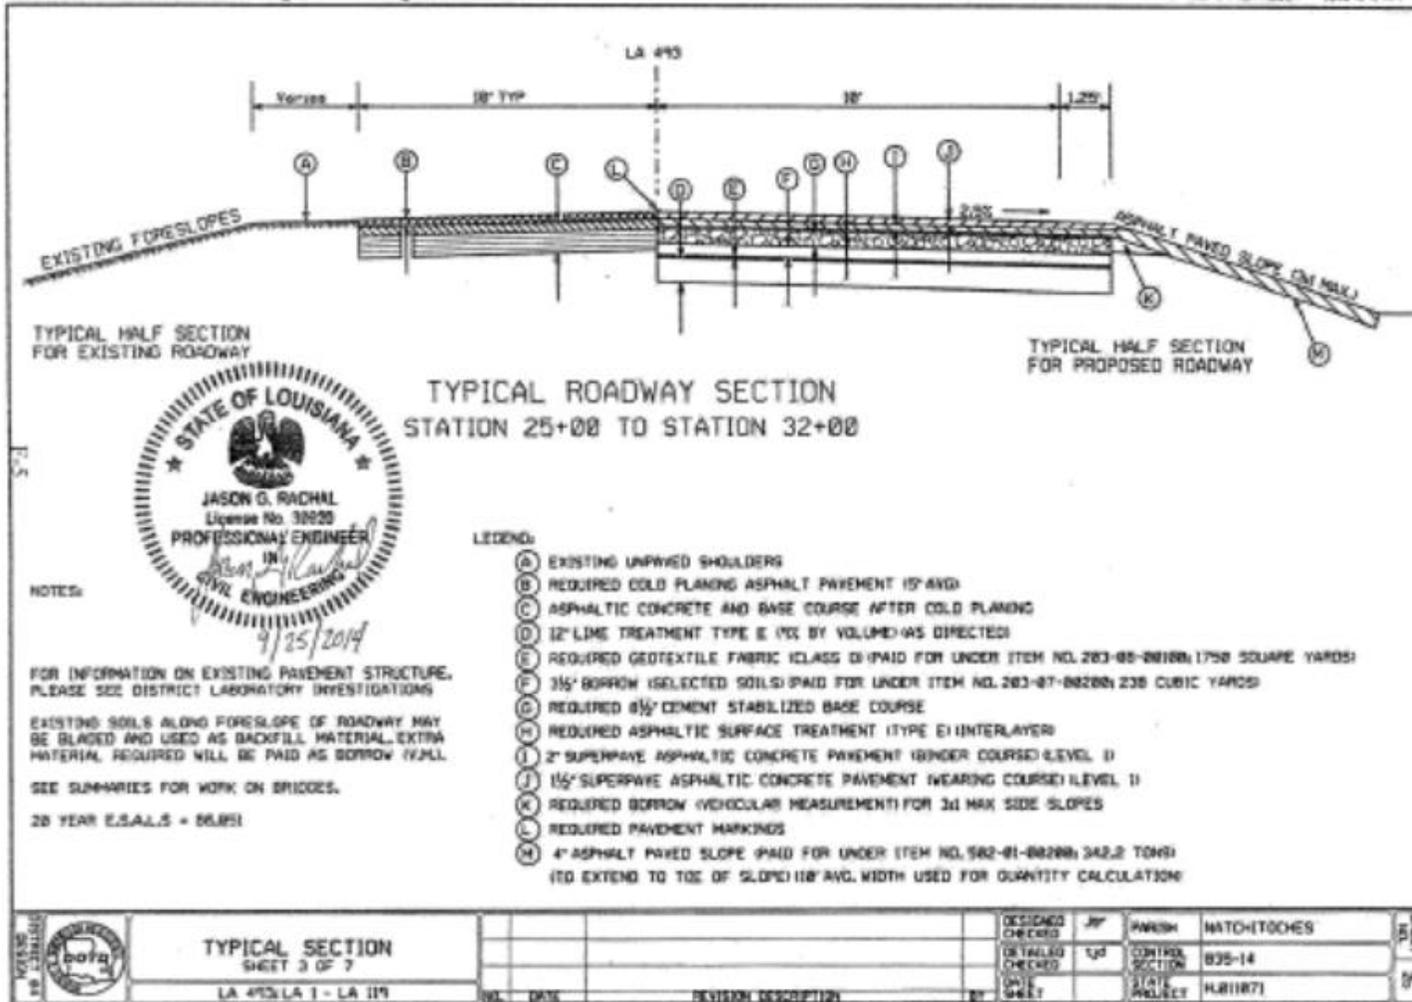
Figure 36  
Typical section for Site 3

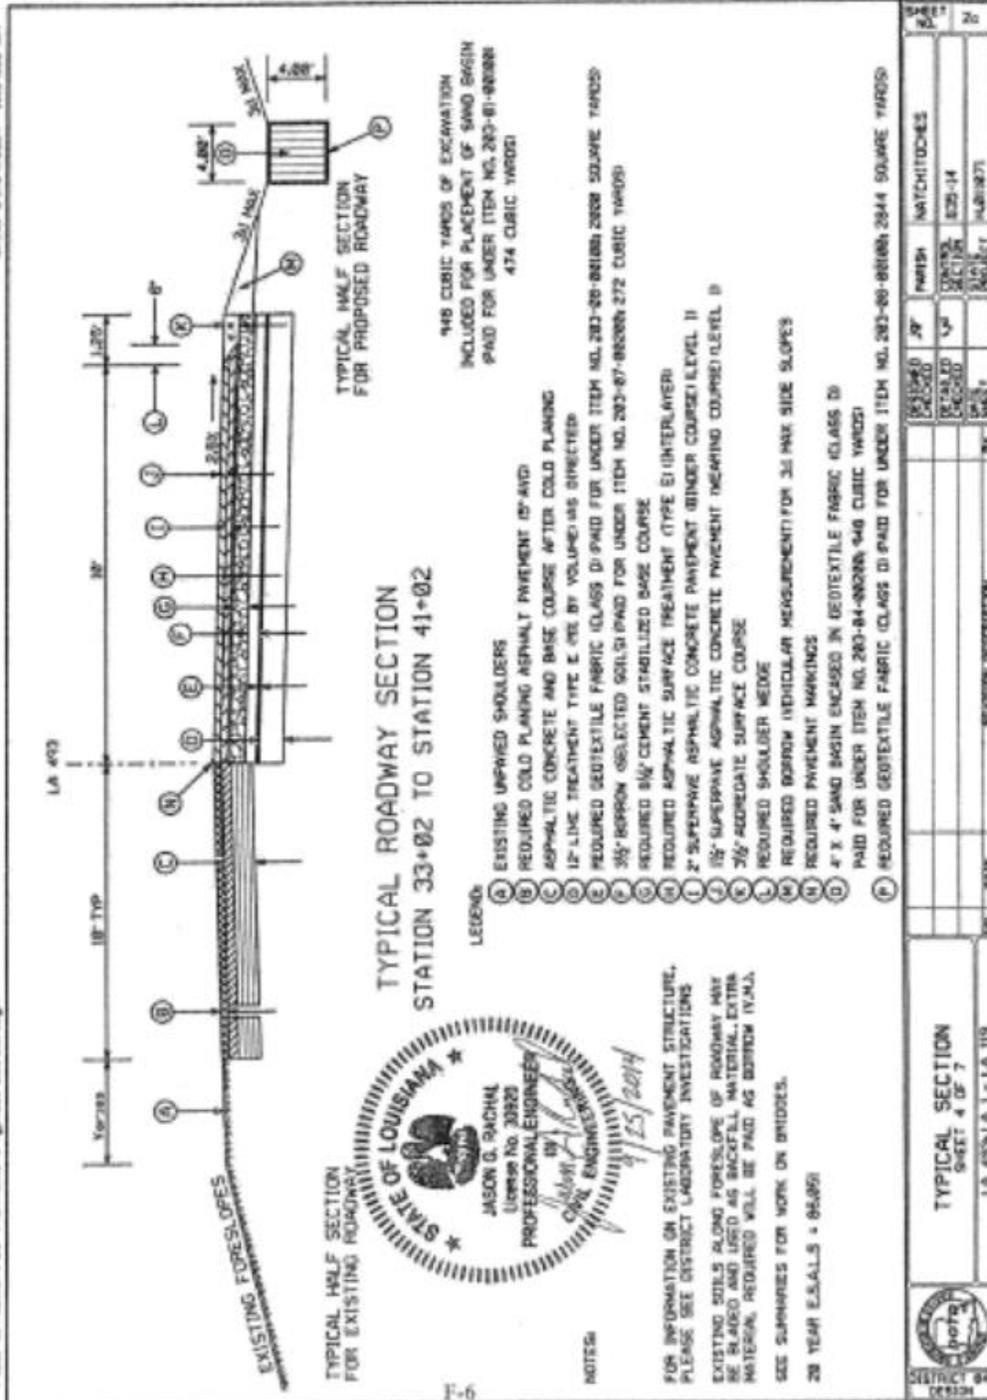
Figure 37  
 Typical section for Site 4

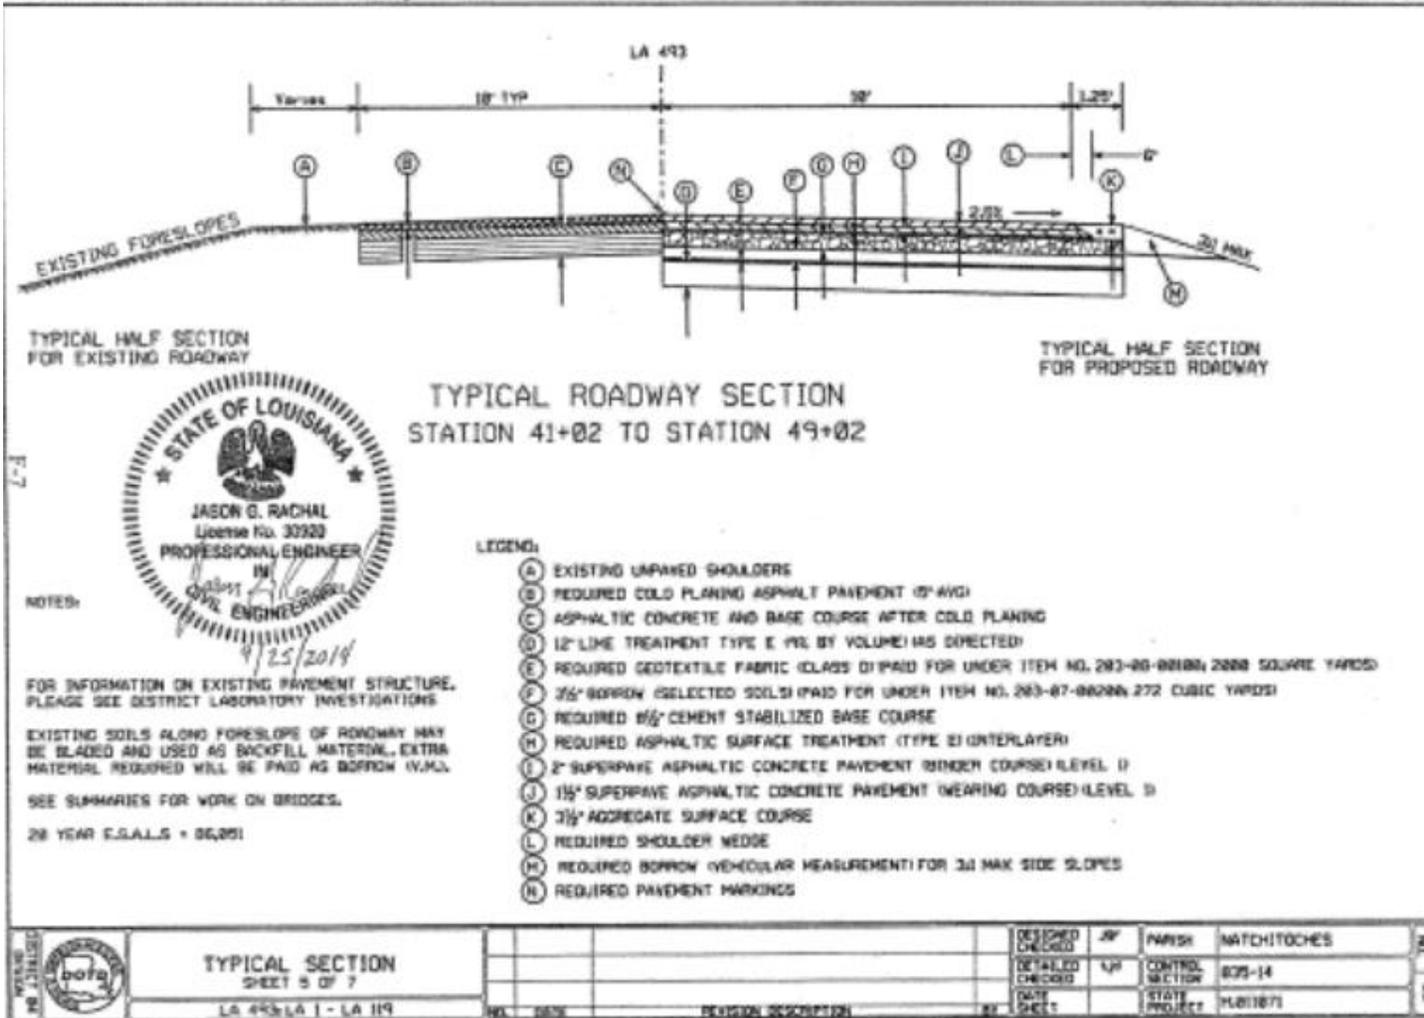
Figure 38  
Typical section for Site 5

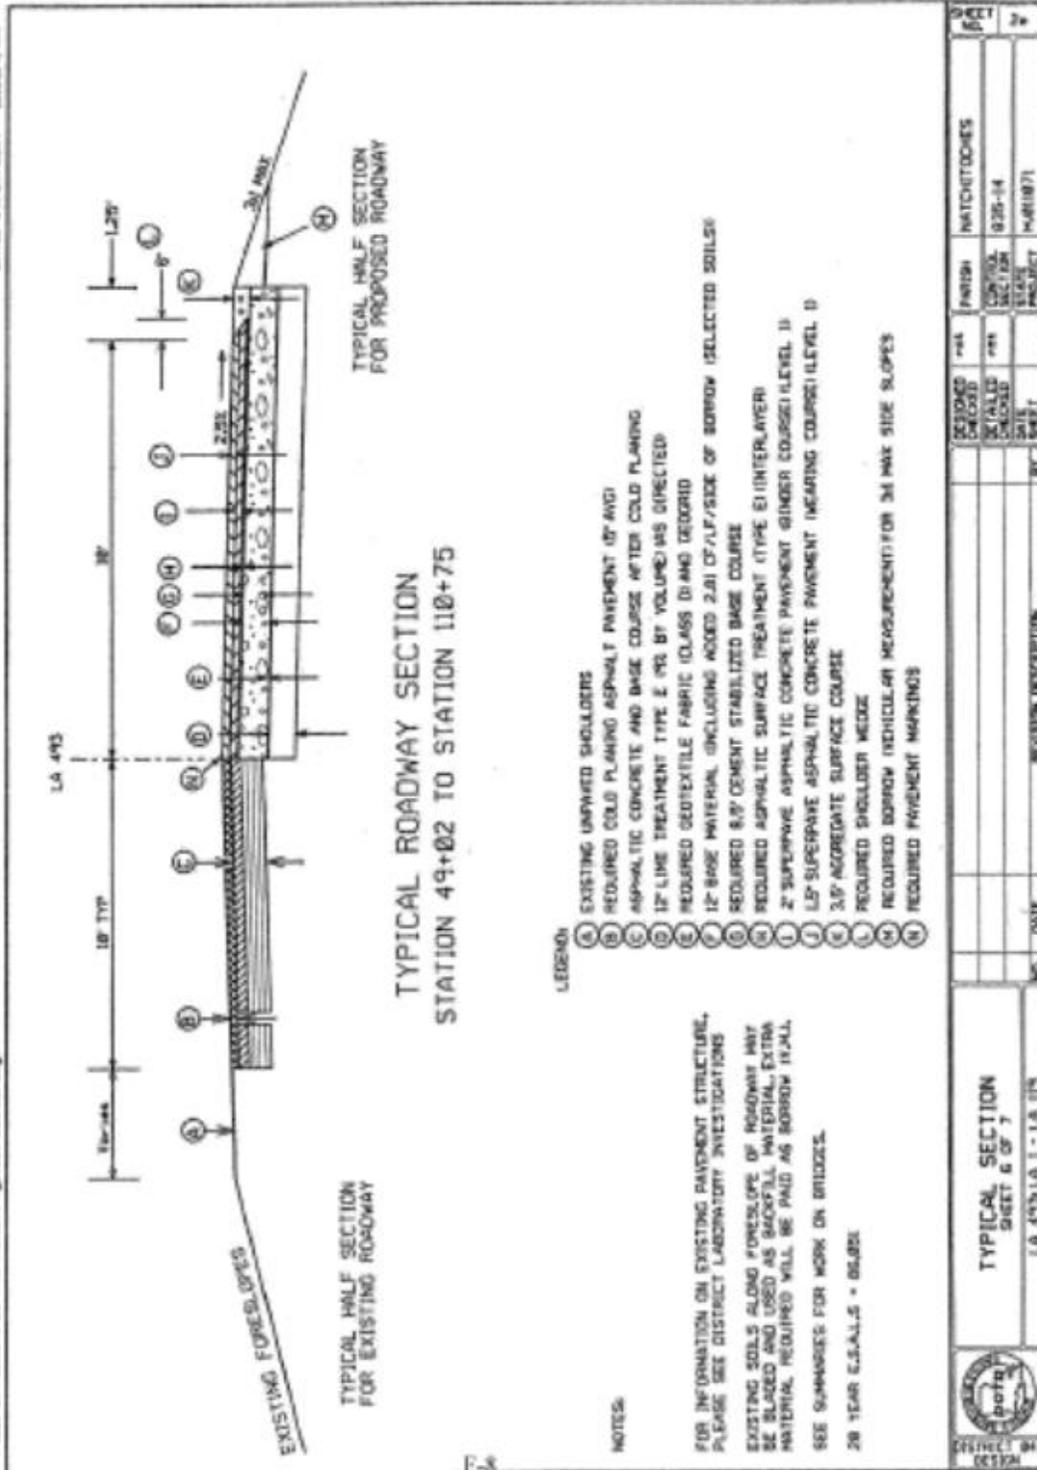
Figure 39  
Typical section for Site 6
