TECHSUMMARY December 2020

State Project No. 30001660 / LTRC Project No. 14-1ST

Evaluating Louisiana New Continuity Detail for Girder Bridges

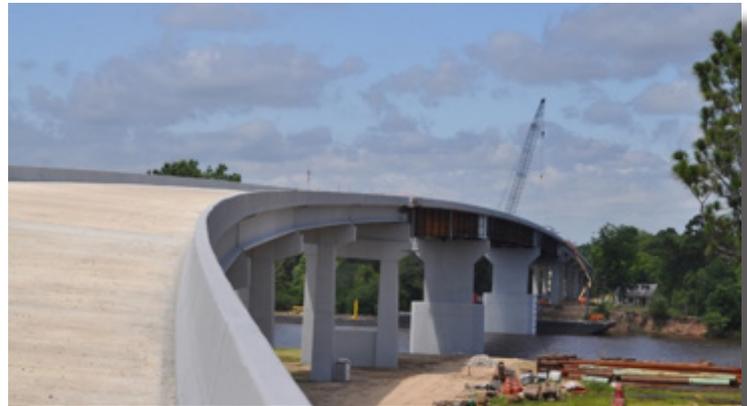
Figure 1
Ouachita River Bridge project

Over a period of 3 years, data collected from the Ouachita River Bridge in Harrisonburg, Louisiana was used to study the behavior of a partial continuity jointless deck detail (See Figure 1). The detail joins decks of adjacent spans with a link slab over supporting bents. Partial continuity introduces less restraint in comparison to full continuity details, which leads to lower straining actions and associated stress concentrations.
