Louisiana Transportation Research Center

Final Report 657

Cost-Effective Detection and Repair of Moisture Damage in Pavements

5. Report No.
FHWA/LA.17/657
6. Report Date
December 2021
7. Performing Organization Code
LTRC Project Number: 18-4P
SIO Number: DOTLT1000241
8. Type of Report and Period Covered
Final Report
05/2018 – 05/2021

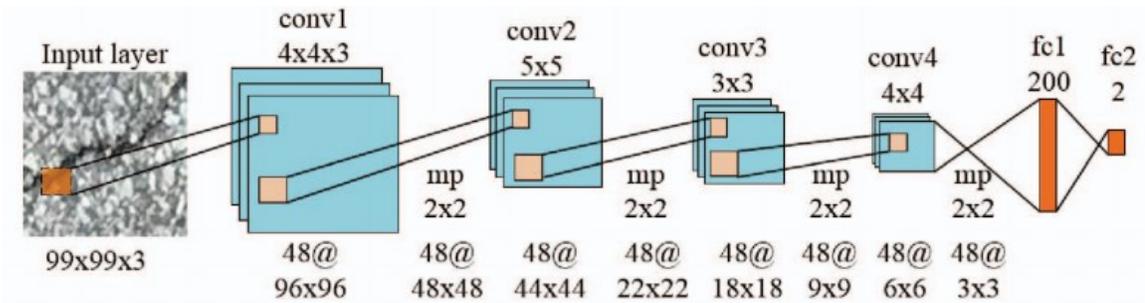
Figure 5. Architecture of proposed DCNN [36]

Zhang et al. developed an automatic crack detection DCNN based on manually-annotated image patches as inputs [36]. The dataset consisted of 500 pavement images of size 3264x2448 collected using a smart phone. The collected pavement images were sampled to generate one million three-channel (RGB) 99*99 pixel image patches; 640,000 samples were used for training, 160,000 samples were used for validation, and 200,000 samples were used for testing. The developed solution classified the crack and non-crack pixels referred to as positive and negative patches respectively based on a ConvNet trained in square image patches. The training process was amplified using the rectified linear units (ReLU) activation function. Figure 5 illustrates the architecture of the proposed DCNN [36].

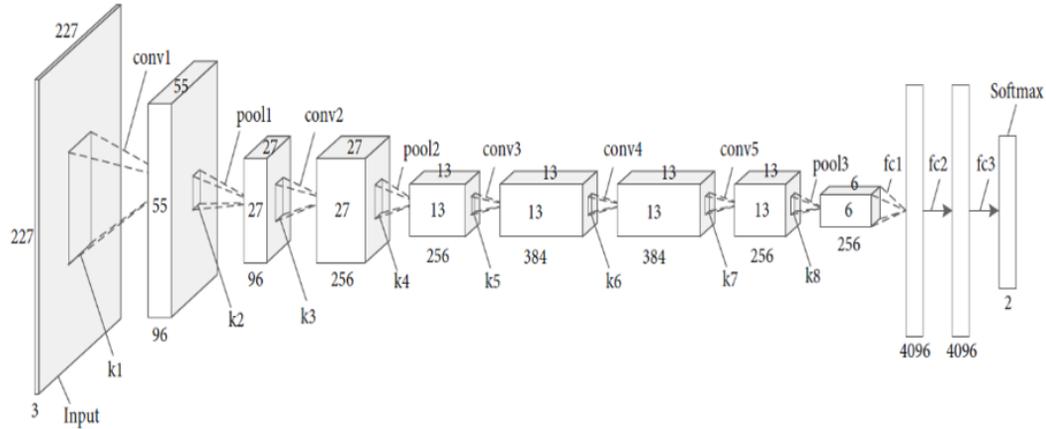
Figure 8. Illustration of a CNN’s overall architecture [43]

conv# = Convolution; pool# = Pooling; fc# = Full Connection; k# = Kernel of each Operation

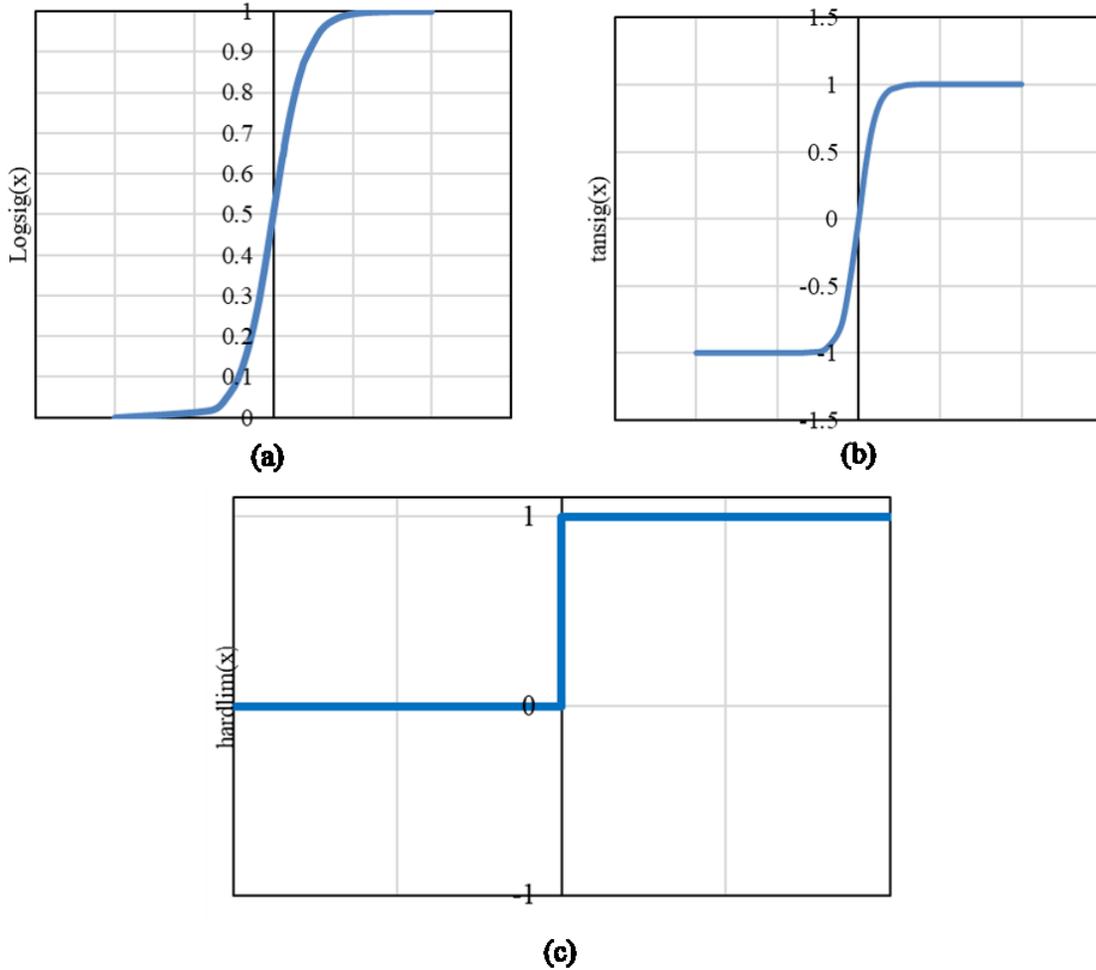
Figure 11. ANN transfer functions, (a) logsig, (b) tansig, (c) hardlim [12]

ANN Transfer Functions. The output of the network training is provided by different activation functions, which are assigned to the weighted input of the neurons. The transfer functions or the activation functions are the differentiable non-linear functions, which allow the neural network to acquire non-linearity. The logistic sigmoidal function (logsig), tan sigmoidal function (tansig), and “hardlim” are three major transfer functions used in ANN as shown in Figure 11. The logsig transfer function produces the output between “0” and “+1,” tansig produces the output between “-1” and “+1.” The hardlim is the most commonly used activation function and produces an output either “0” or “+1,” which allows the ANN to perform the classification [12].

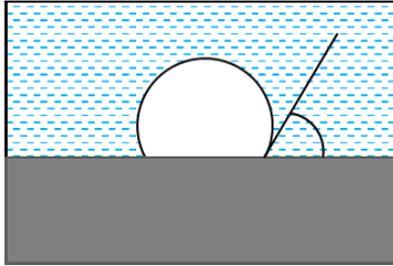
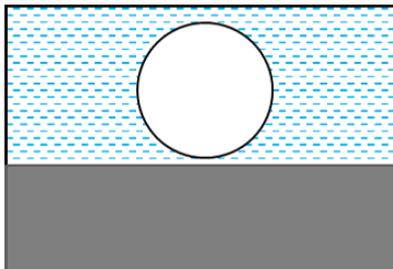
Figure 12. Schematic of the stripping process [50]

The moment at which the aggregate, with the drop of binder is immersed in water. The contact angle is less than 90° .

The water begins to remove the binder drop from the aggregate surface and the contact angle decreases.

A state is reached where the contact angle is less than 0° and the binder loses contact with the aggregate surface.

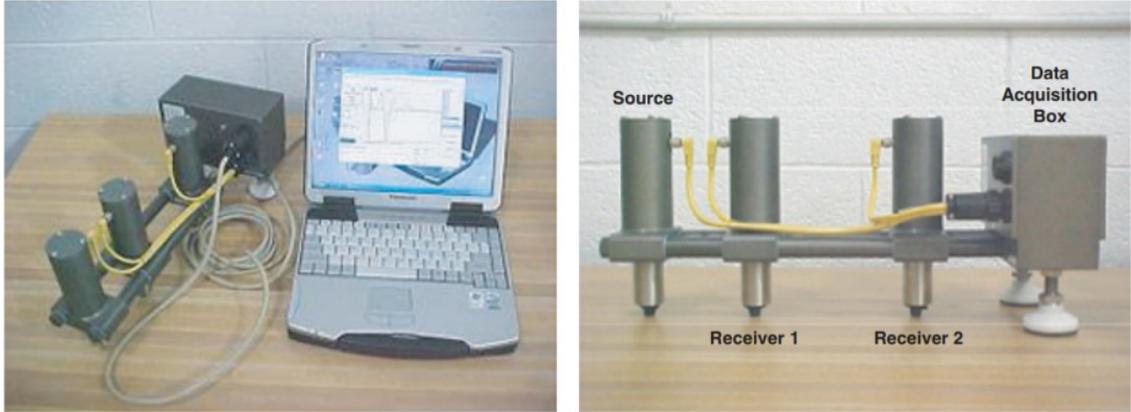
Figure 13. Portable seismic property analyzer [52]

The analysis of PSPA measurements is based on calculating the stress propagation velocity in the material, which is related to its linear elastic modulus. The USW method estimates the modulus of the material without back calculation using the following equation:

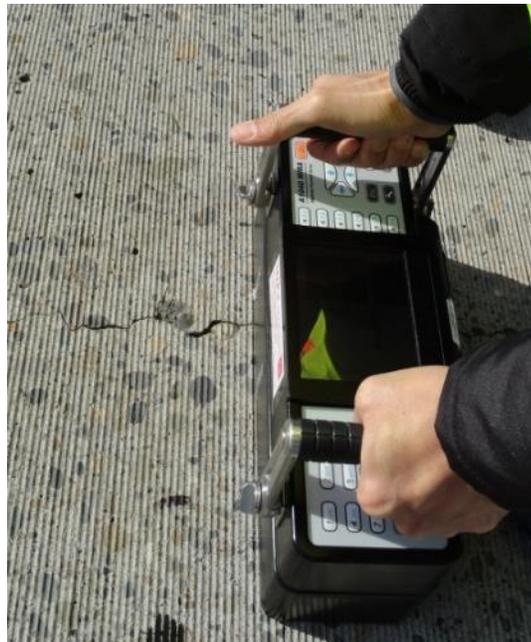
Figure 15. MIRA tomographer

MIRA Tomography. The MIRA tomographer, as shown in Figure 15, is a state-of-the-art instrument, which is capable of producing three dimensional (3-D) representations (tomogram) of flaws that are present inside a concrete structure [54, 55]. It does not require surface preparation as the subsurface condition of concrete elements can be investigated using an array of dry point contact (DPC) “touch and go” transducers. The antenna is composed of an array of DPC transducers and it sends low-frequency shear waves into the structure. Unlike traditional ultrasonic techniques, which generally produce one pair of waves per measurement, MIRA allows for 45 transmitting and receiving pair measurements in each approximately 1-second scan, which can achieve high productivity [56]. The received data are then used to create a 2-D image of the reflecting interfaces inside the concrete element. A proprietary software is used to assemble the stacks of 2-D images into a 3-D model of the test specimen. The test results can be interpreted by manipulating the generated 3-D image [55].

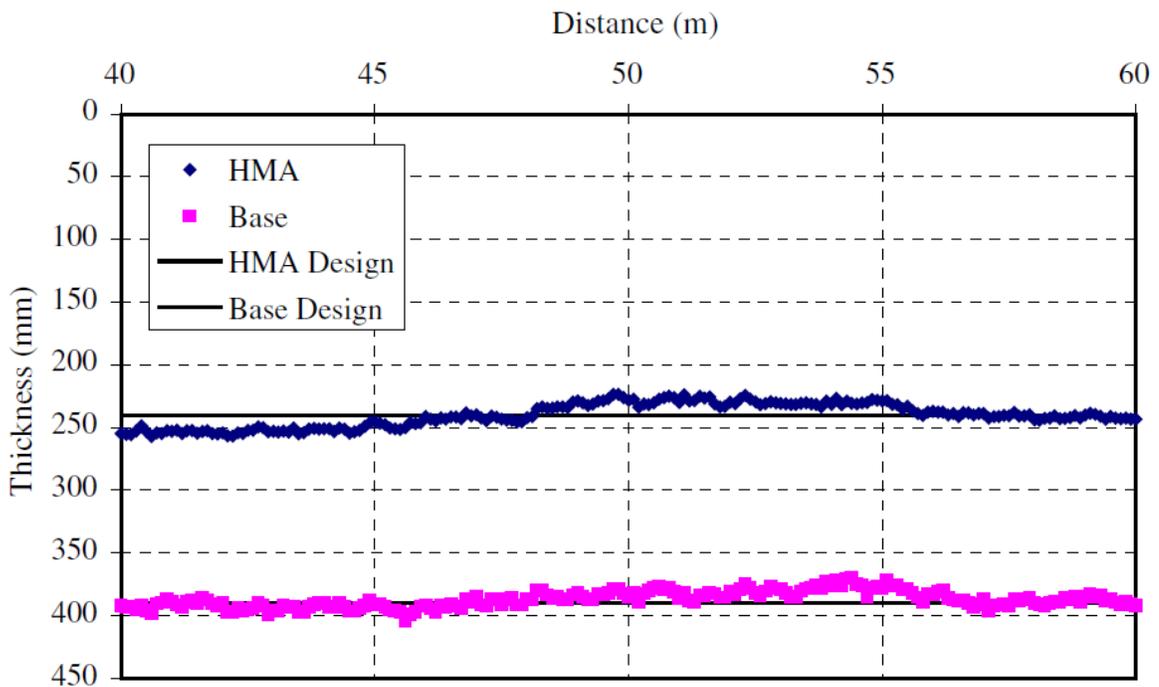
Figure 19. Comparison between GPR estimated thicknesses and design thicknesses for the HMA and base layers of Route 288 [57]

Al-Qadi and Lahouar used a GPR system to estimate pavement layer thicknesses and presented the limitations of the system using field tests. The results indicated GPR to be a reliable tool to estimate pavement thickness (see Figure 20). However, the accuracy of GPR was observed to decrease where at least one thin layer existed in the pavement structure. The authors recommended using signal processing techniques to minimize errors in pavements with thin layers [57].

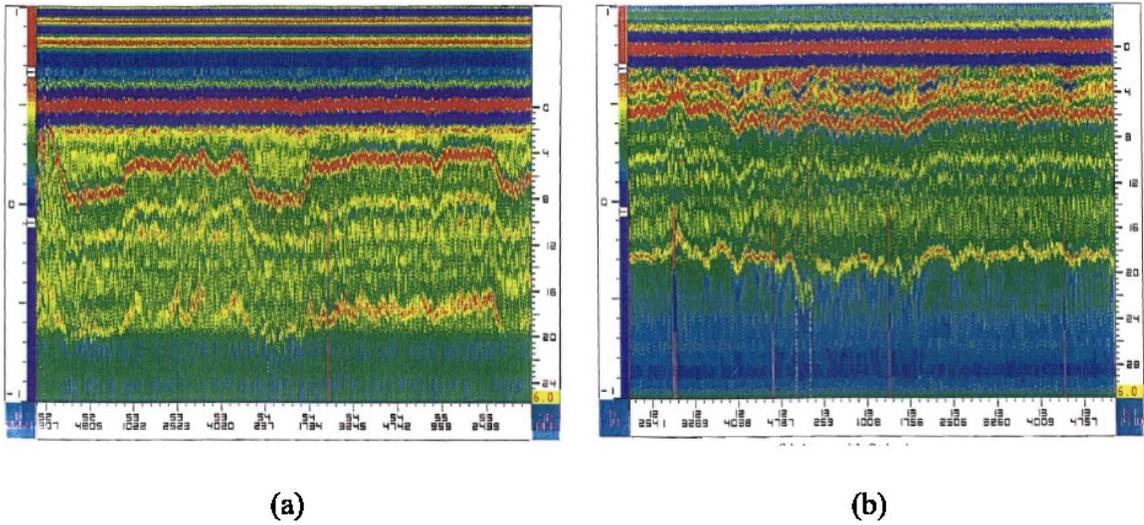
Figure 20. A comparison between (a) a sound pavement structure and (b) a pavement with stripping [2]

It was reported that asphalt sections with stripping had higher moisture contents, higher air voids, or both; which resulted in an anomalous change in the dielectric constant of the stripped layers. It was also concluded that intermittent negative peaks within the surface layer in a GPR scan was typically an indication of the presence of stripping in the asphalt layer of the pavement as shown in Figure 21. As shown in this figure, GPR was successful in identifying pavements with moderate to severe deterioration as there has to be a distinct difference in the dielectric properties between the layers.

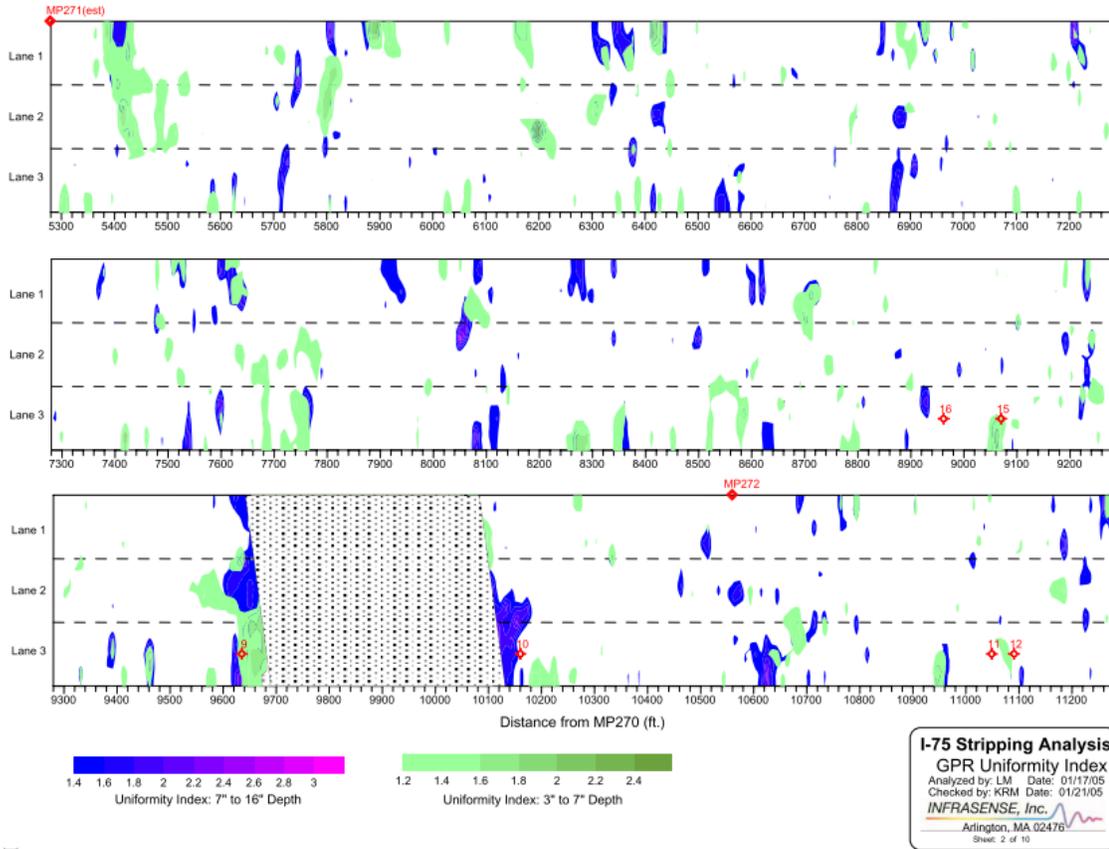
Figure 23. Uniformity index plot for I-75 project [3]

Hammons et al. introduced the uniformity index (UI) to identify potential locations that might have experienced damages related to moisture [[3]]. The uniformity index was defined as follows:

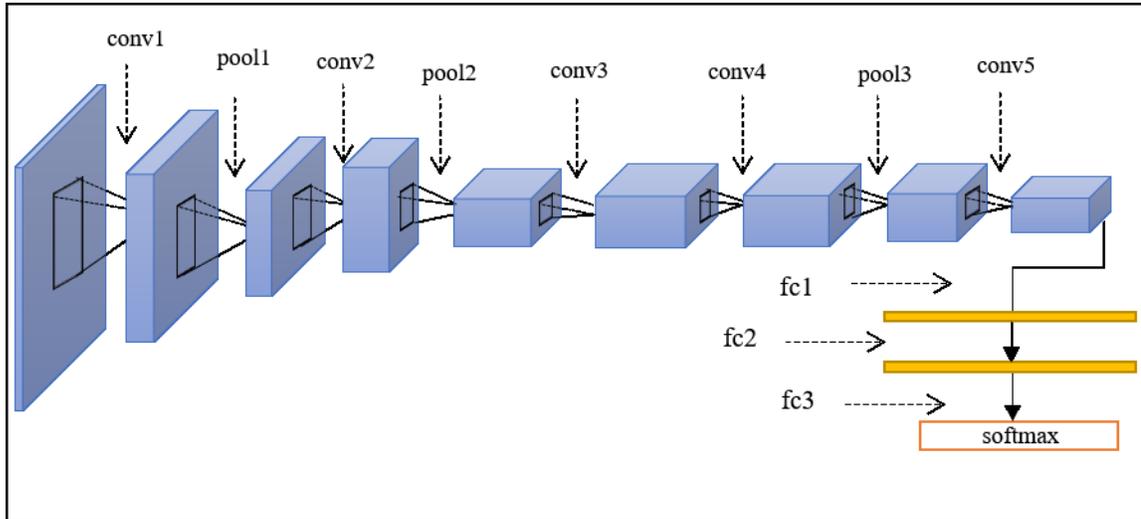
Figure 32. CNN's overall architecture [43]

conv# = convolution, pool# = pooling, fc# = full connection

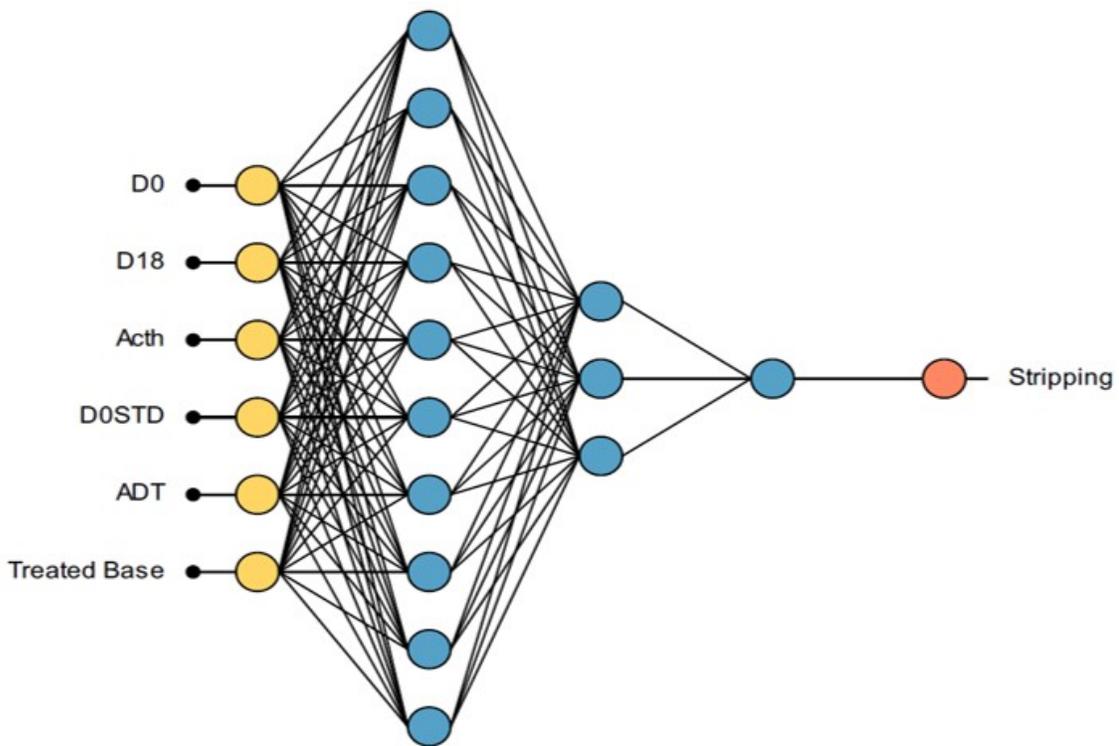
Figure 38. Neural network architecture

ANN Structure. The set of inputs were incorporated into the system such as it produces the highest classification accuracy. The input layer consisted of six neurons of input variables, which were subjected to a scaling method called “StandardDeviation” that normalizes the inputs. The input layer was fed with center deflection (D_0), deflection at 18 in. distance from center deflection (D_{18}), asphalt layer thickness (ACth), standard deviation of RWD measurements within 1-mile (D_0 STD), annual daily traffic (ADT), and if a base is treated or not noted as Treated Base (1=if treated, 0=if not treated). The neural network had two hidden layers of 10 and 3 neurons, respectively, as shown in Figure 38.

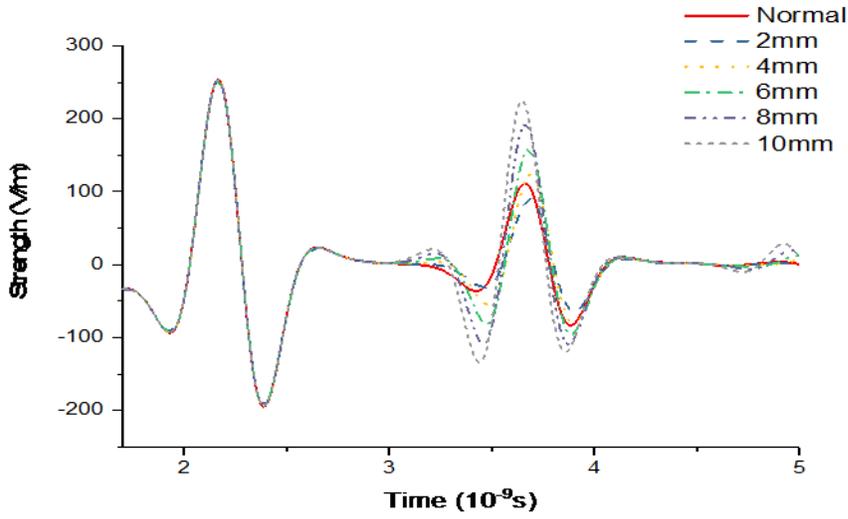
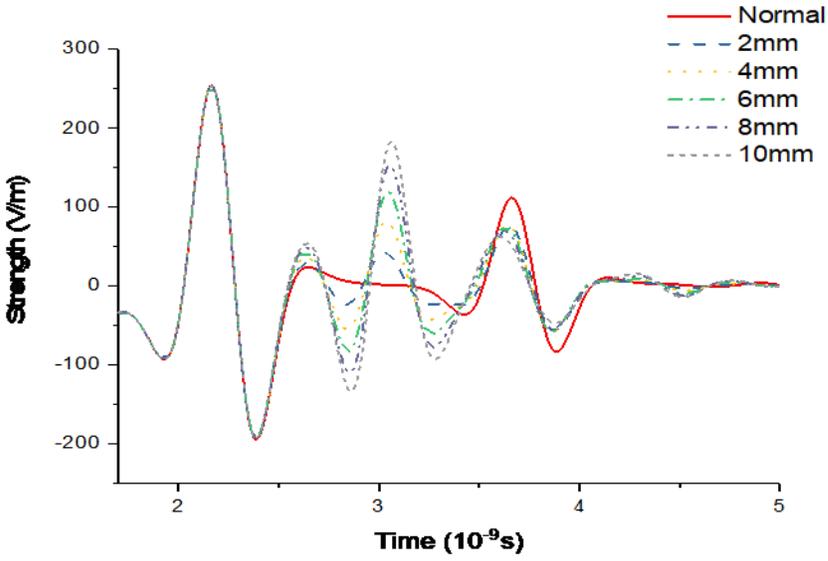
Figure 40. A-scan results of simulated GPR signal for (a) a void at bottom of the AC layer and (b) a void in middle of the AC layer

Figure 40 presents the A-scan results of the simulated GPR signal. The curves represent the reflection of the electromagnetic wave from the transmitter to the receiver. A negative peak was observed between two intermittent positive peaks when the EM waves were transmitted from a material with low dielectric constant to a material with high dielectric constant. In contrast, a positive peak appeared between two intermittent negative peaks when the EM waves were transmitted from a material with high dielectric constant to a material with low dielectric constant. In a regular non-stripped pavement, two positive peaks were observed in the reflected signal, where the first peak represents the reflected wave of air-AC interface and the second reflected peak represents the wave from the interface between AC and the base layers.

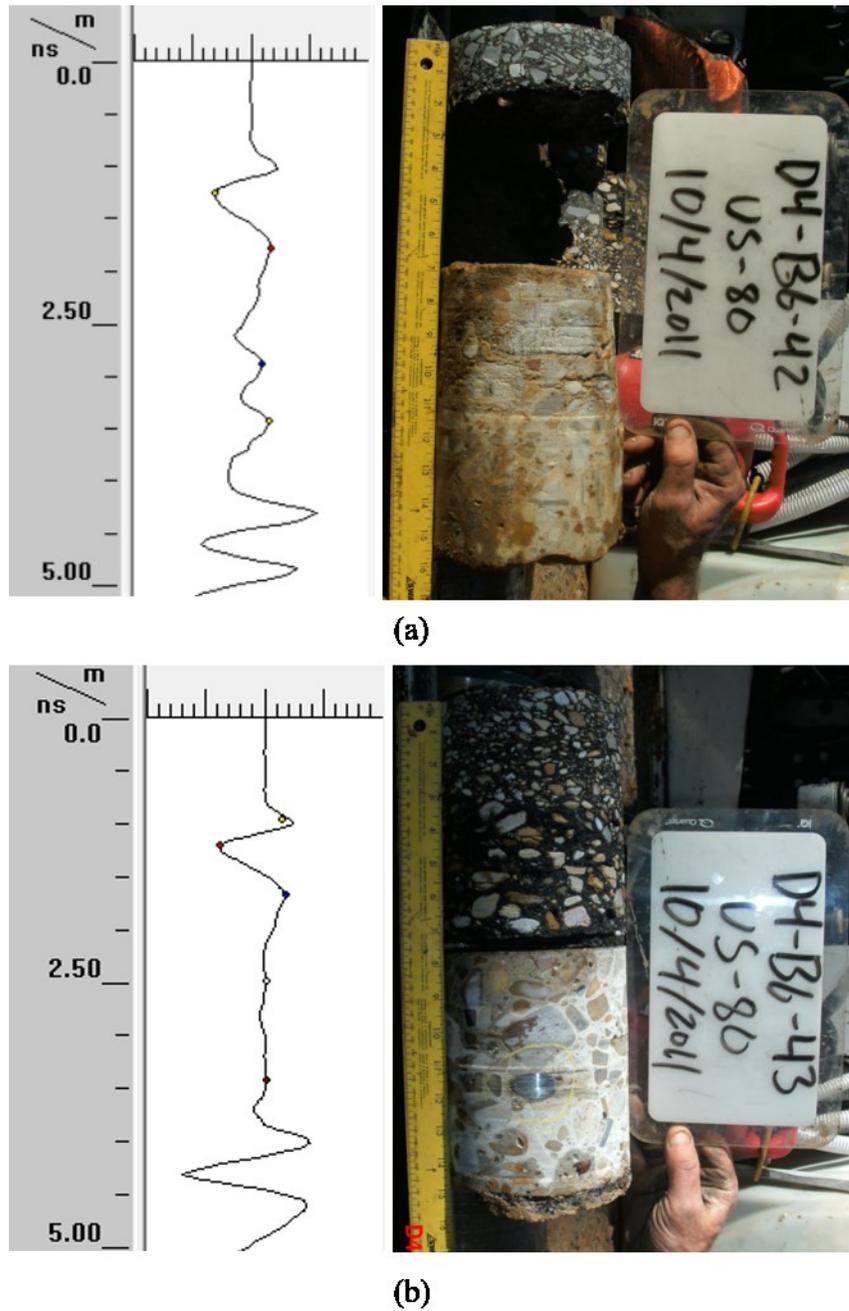
Figure 44. Comparison of GPR traces for stripped and non-stripped sections and visual inspection of each core, (a) stripped section, (b) non-stripped section

Example of GPR Data Analysis. As described earlier, the GPR data were processed for the core locations based on distance correlation. The pattern of GPR traces was studied and compared with the condition of the extracted cores at that location. Figure 44 presents the GPR traces at the stripped and non-stripped core locations for a control section located in Bienville parish in Louisiana. The pavement structure consisted of an AC layer, a PCC base layer, and a subgrade. The time range of the GPR traces covered the reflected waves from the pavement surface to the interface between the AC and base layers. The colored data points in the GPR trace represent the interfaces between the layers or the rebars in case of the reinforced concrete layer. As shown in the figure, in the non-stripped location, there were three positive peaks from top to bottom that correlated with the surface and layer interfaces. In the stripped section, intermittent positive peaks can be observed between the layer interfaces, which indicate loss of integrity within the AC layer.

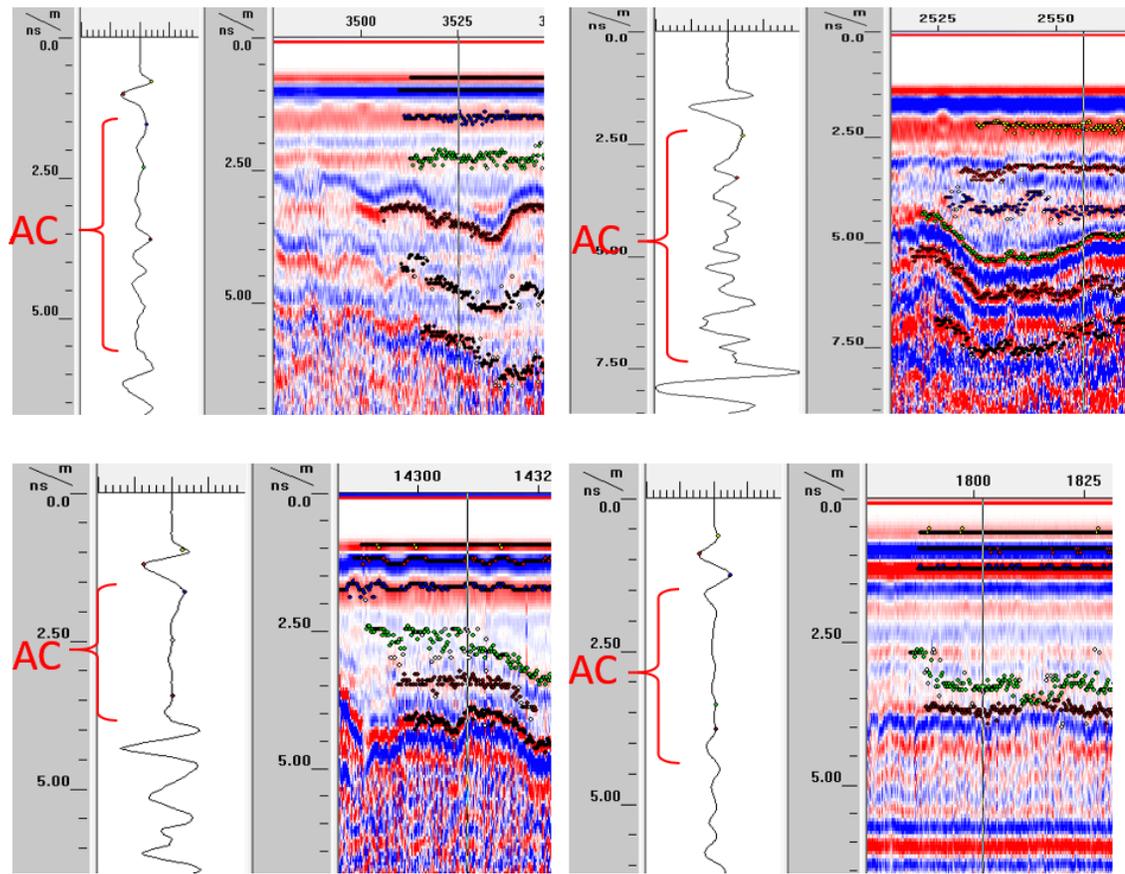
As shown in Figure 46, the stripped sections contained relatively higher levels of layer noises compared to the non-stripped sections. Figure 47 presents an illustration of amplitudes computation for a stripped pavement section (112-07-1). An AIP of 1.48 was calculated for the section presented in Figure 47.
