TECHSUMMARY December 2021

State Project No. DOTLT1000241 | LTRC Project No. 18-4P

Cost-Effective Detection and Repair of Moisture Damage in Pavements

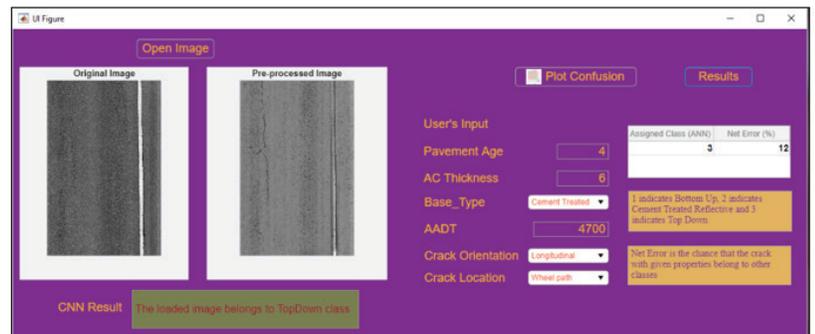
Windows-Based Application for Crack Identification and Classification Using ANN and CNN Models

The developed CNN model for crack identification and classification was found to achieve an accuracy of 93.8% and 91.0% in the testing and validation phases, respectively. The ANN-based decision-making tool achieved an overall accuracy of 92% indicating its effectiveness in cross-checking the prediction from the CNN model in crack identification and classification. A windows-based application was developed based on validated CNN- and ANN-based models.

Based on the results of this project, a windows-based application was developed based on validated CNN- and ANN-based models. This tool may be used to allow the PMS section in DOTD to classify surface cracks as top-down, bottom-up, and cement-treated reflective cracks. Furthermore, the developed GPR-based indicator, known as the Accumulating In-layer Peaks (AIP), may be used to detect AC stripping damage in asphalt pavements based on GPR measurements. An image-based CNN model was developed to predict the IRI value of the pavement section based on surface images. The developed model, which accurately predicted the IRI values, provides numerous implementation opportunities into PMS activities. The developed model may also be incorporated into predict pavement surface roughness using camera-captured pavement images during pavement evaluation and management.
