Develop a Methodology for Pavement Drainage System

Rating

FHWA/LA.25/719

Final Report

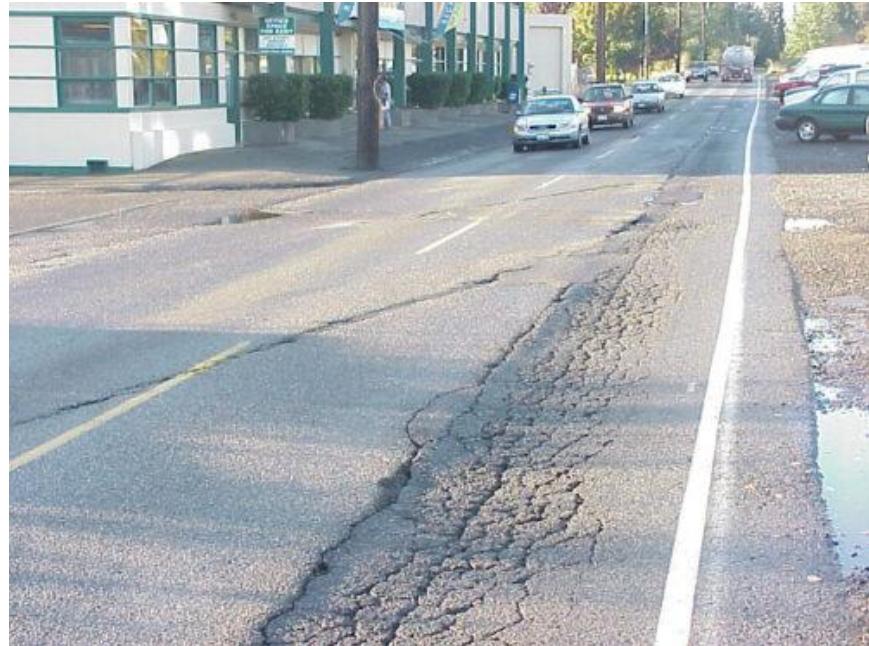
Figure 1. Weakening of base, subbase, or subgrade

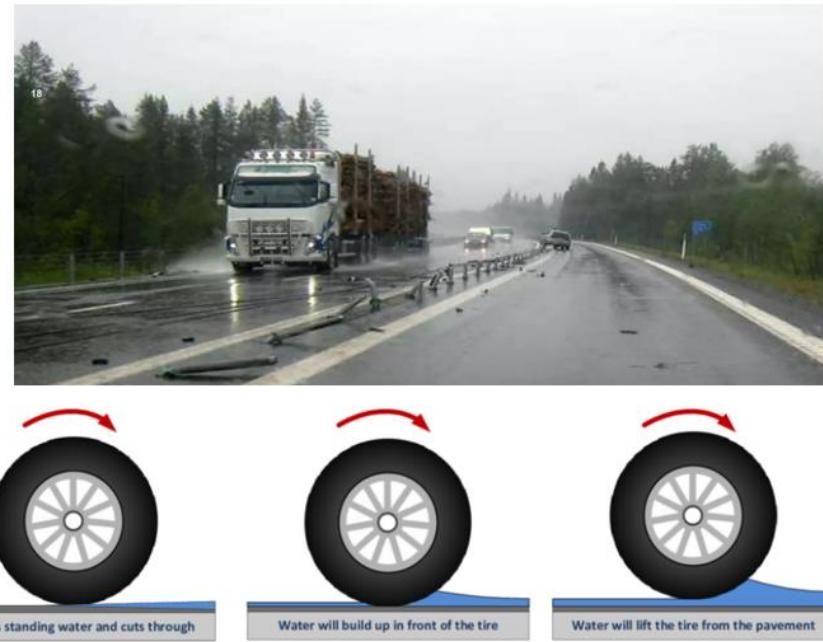
Figure 4. Hydroplaning

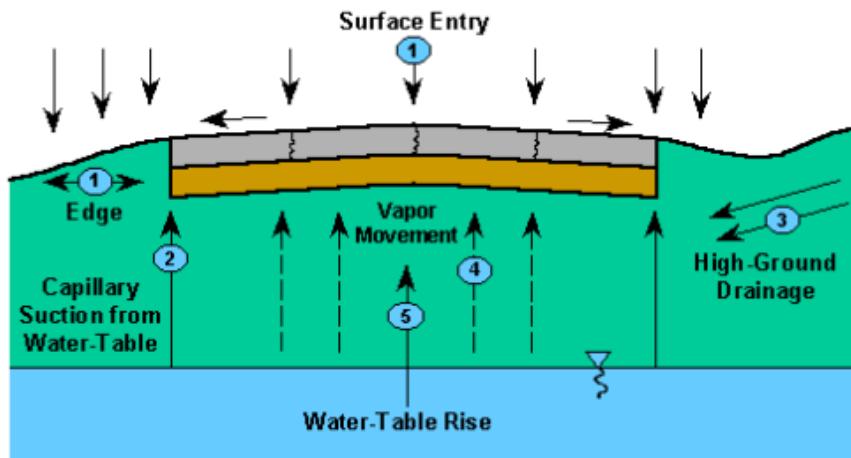
Figure 5. Sources of water to a pavement [1]

Water in pavements primarily comes from surface water, such as rainfall and runoff, which may enter the pavement through joints, cracks, shoulders, or backup in ditches, and from groundwater, which may enter the pavement through the rise of the groundwater table or capillary forces; see Figure 5. These water sources pose significant challenges to the durability and stability of roadways. Engineers employ various strategies to mitigate these issues, primarily through drainage systems, which consist of surface, subsurface, and roadside drainage.

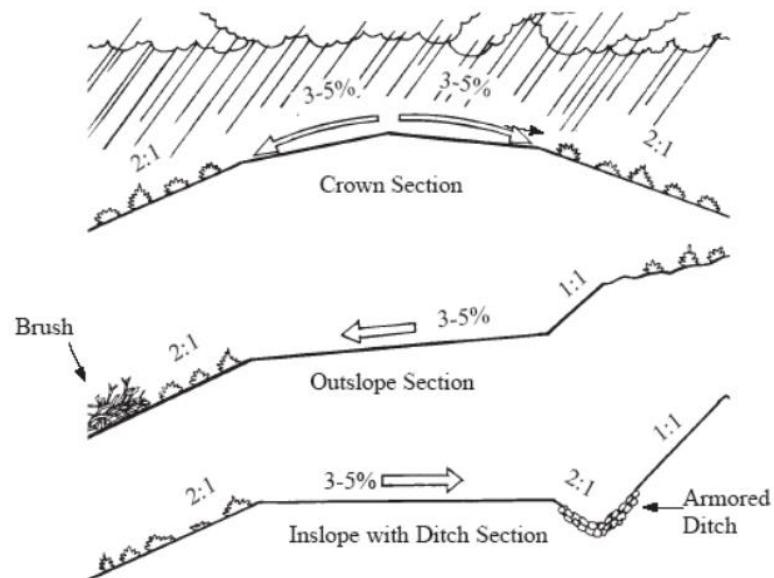
Figure 6. Typical road cross section grading [2]

Water flows across the road surface in two ways: laterally (i.e., side to side) and longitudinally (i.e., along the length of the road). Lateral drainage is achieved by crowning or by in- or out-sloping of road surfaces; see Figure 6. Longitudinal grade is of greater significance on urban roadways than on rural roadways. This is because on urban roadways, surface water is collected by curbs and gutters, then conveyed longitudinally to a drainage system.

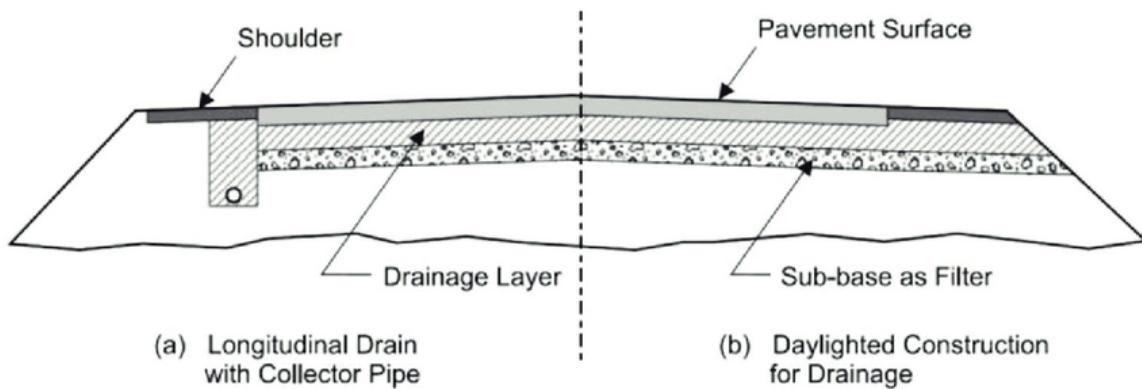
Figure 7. Typical pavement subsurface interceptor drainage system components [3]

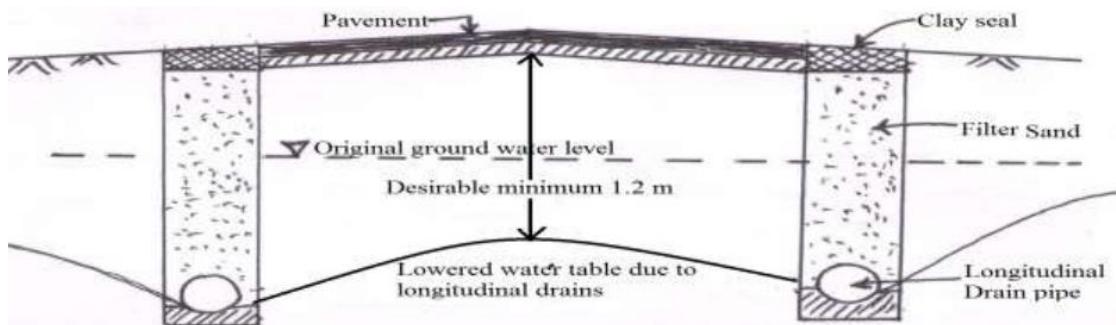
Figure 8. Subsurface relief drainage system to lower the groundwater table [4]

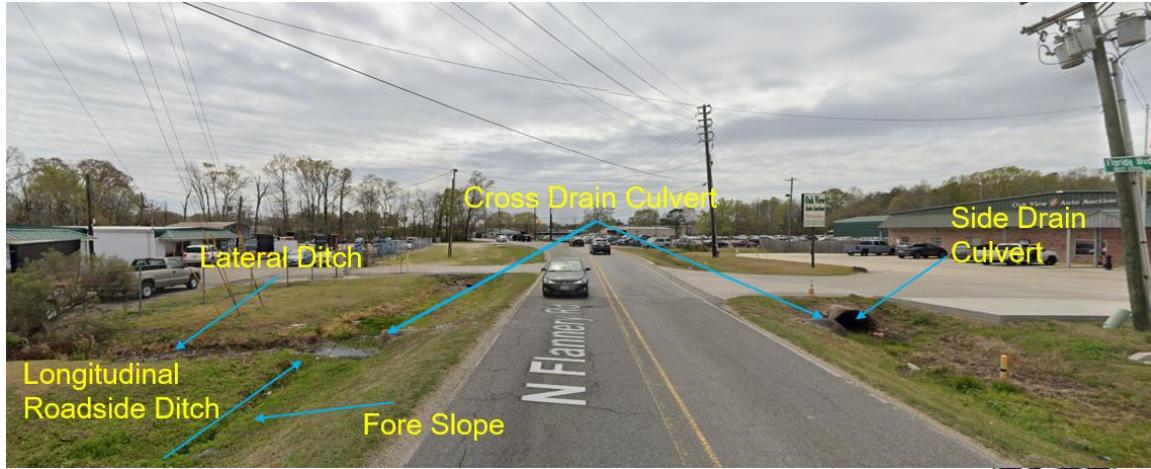
Figure 9. Roadside drainage components

Roadside drainage is designed to collect and transport water from the surface and structure of the road so that there will be no ponds on the road or backup in the ditches, as shown in Figure 9. Roadside drainage consists of following elements: foreslope, side ditches, cross drains, side drain, lateral channels, curb and gutter, drainage inlet, catch basin, storm sewer line, etc. Typically, it is more cost-effective and less risky to prevent moisture from entering and accumulating within pavements using surface drainage rather than relying on subsurface drainage for moisture removal.

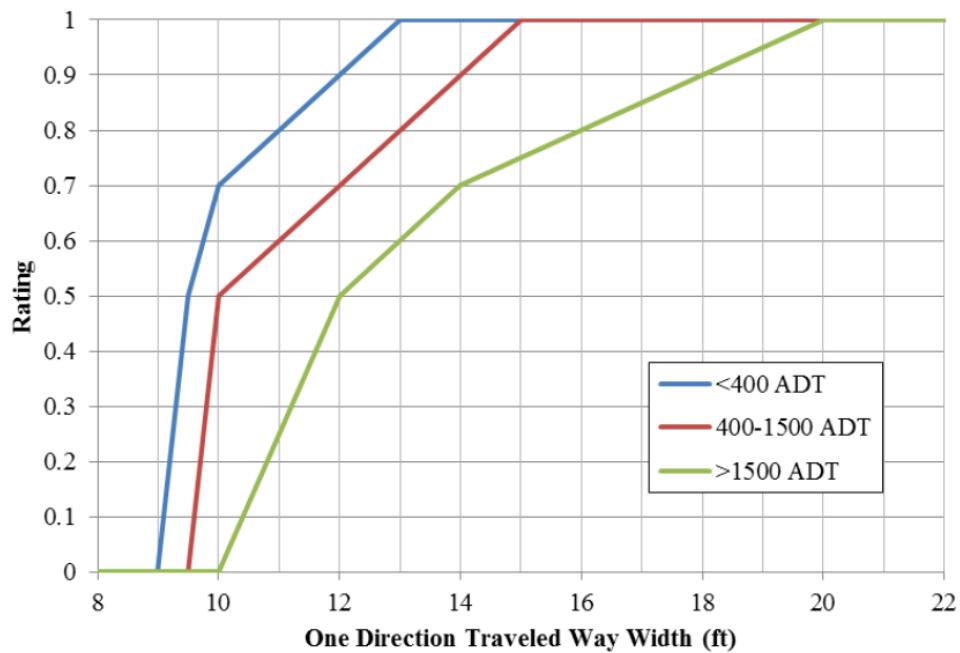
Figure 10. Roadway lane width rating [11]

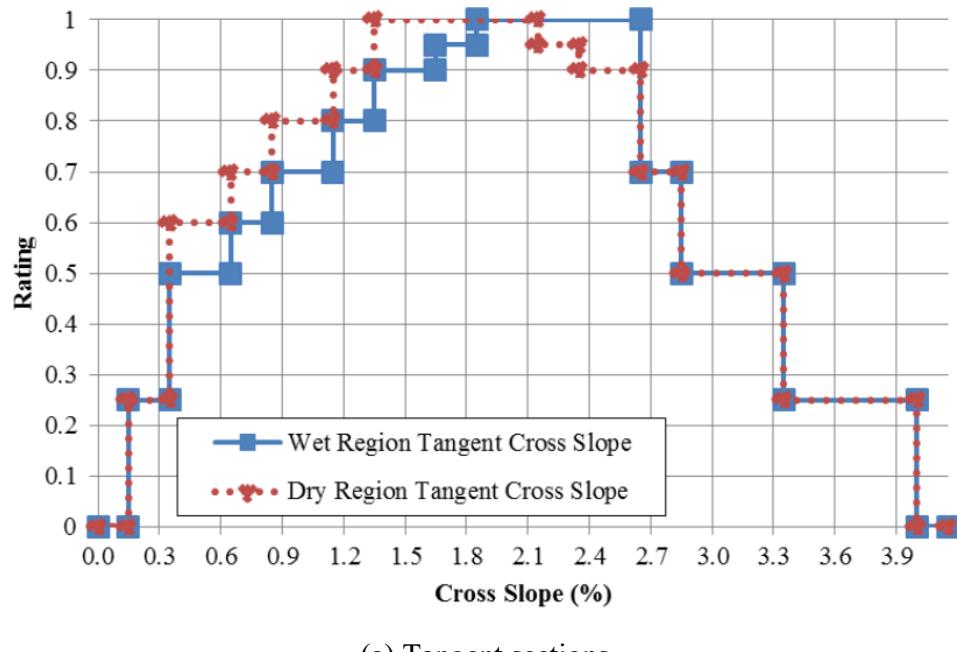
Figure 11. Travel lane cross-slope rating [11]

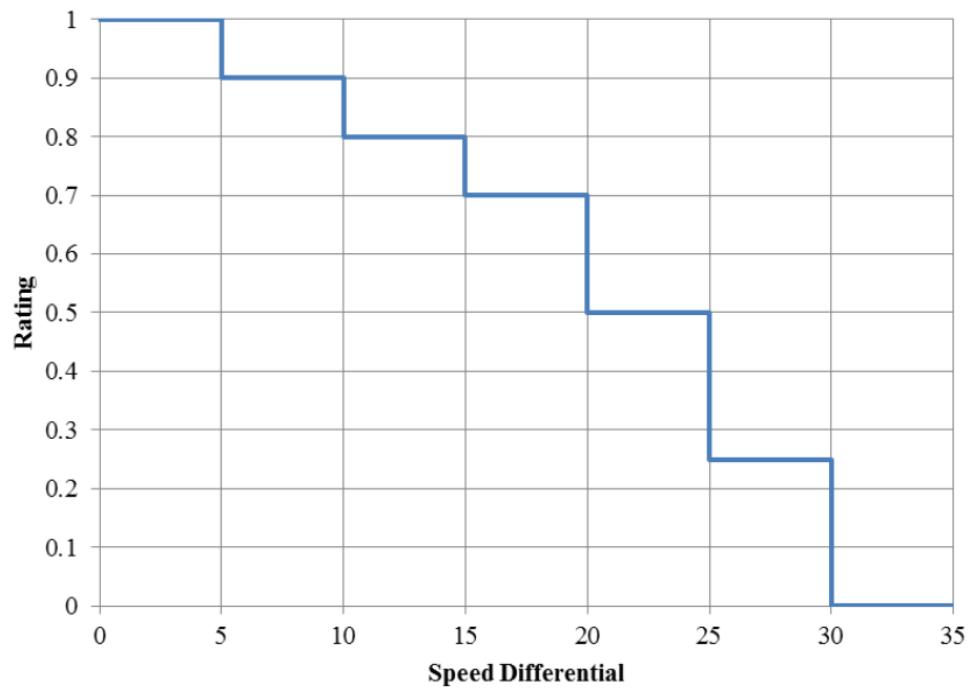
Figure 12. Hydroplaning potential rating [11]

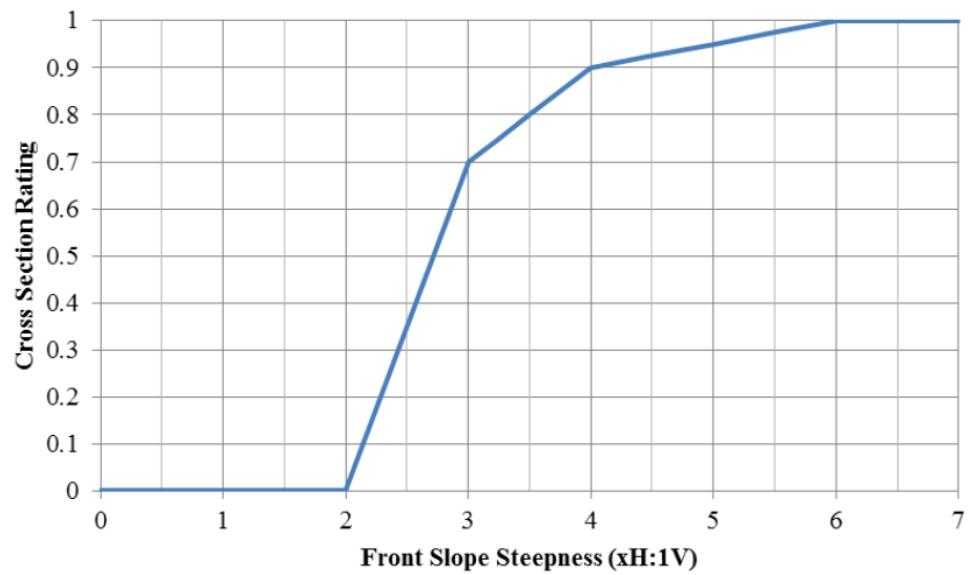
Figure 13. Front slope rating [11]

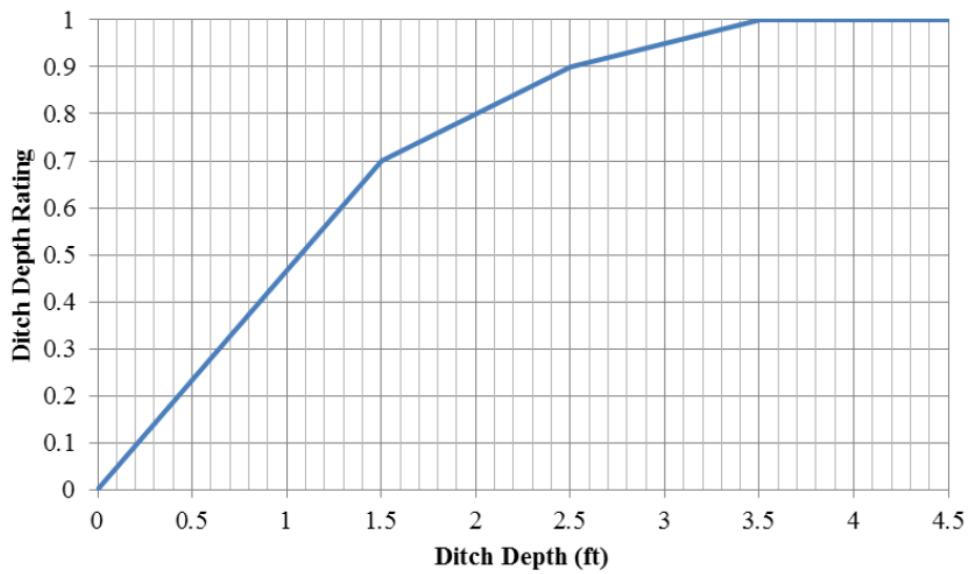
Figure 14. Ditch depth rating [11]

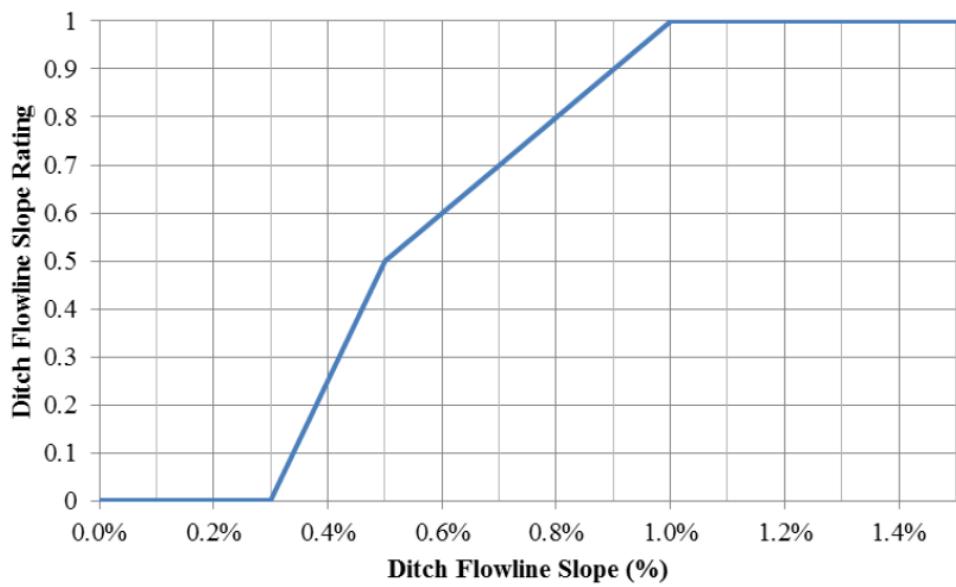
Figure 15. Ditch flowline slope rating [11]

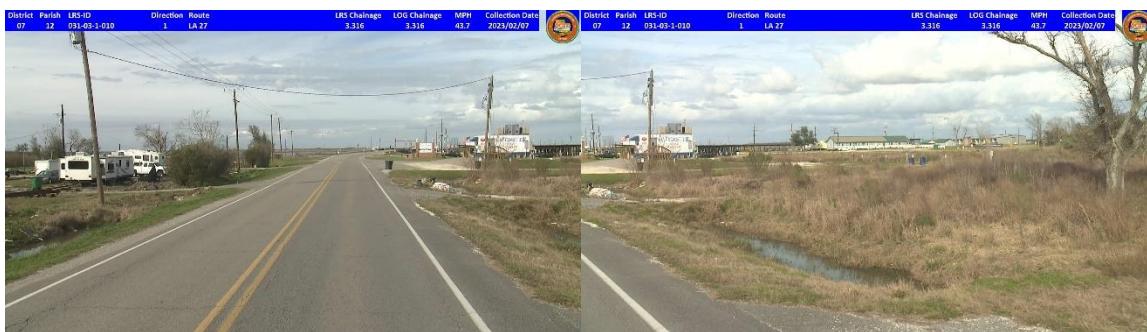
A segment of LA 27 in Hackberry was selected to test the USGS LiDAR workflow; see Figure 20. The segment features narrow grass-lined ditches (0.4–1.0m depth) common in rural Louisiana. This pavement segment was reported to have a drainage issue by the district engineer, as indicated in the statewide survey.

Figure 20. Segment of LA 27 in Hackberry (Source: PMS images)

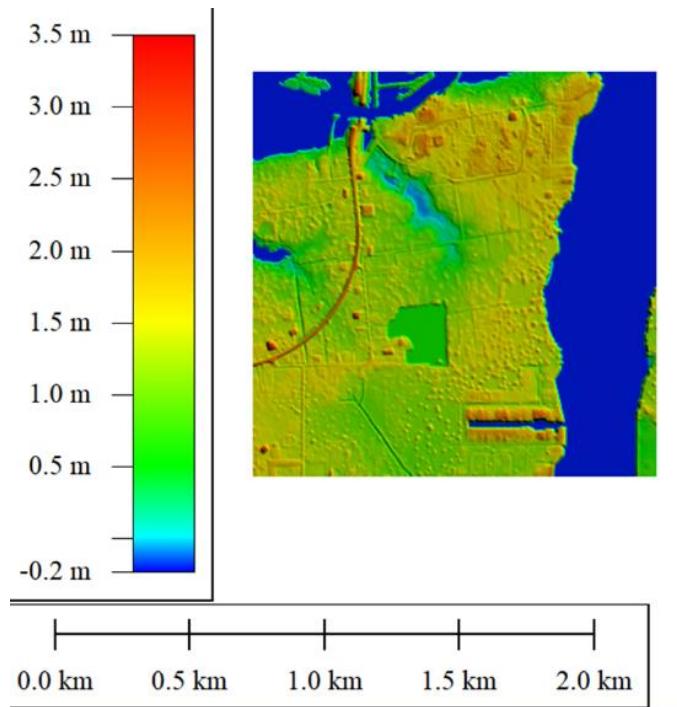
During the LA 27 demonstration, attempts to extract roadside ditch geometry from the USGS 3DEP LiDAR were unsuccessful. The nominal point density ($\approx 1-2$ points/m 2) and resulting Digital Terrain Model (DTM) resolution (1m/pixel) produced substantial smoothing of narrow features within the roadway corridor. As a result, researchers were unable to reliably locate the roadway edge or ditch boundary from the LiDAR surface; centerline offsets and pavement edge positions could not be identified with sufficient confidence, as shown in Figure 21. Because the ditch bottom was either under-sampled or obscured by interpolation/vegetation artifacts, automated and manual cross-section extraction from the USGS data produced inconsistent and non-physical ditch depths, as shown in Figure 22. Consequently, ditch height could not be estimated from the USGS LiDAR for this segment, and the dataset is not considered applicable for quantitative ditch metrics in the drainage rating workflow.

Figure 21. USGS LiDAR image of area covering LA 27

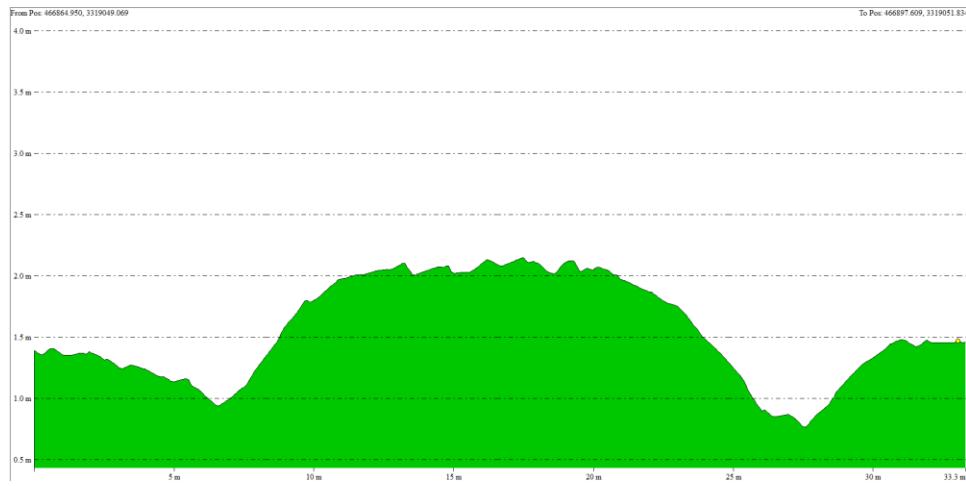
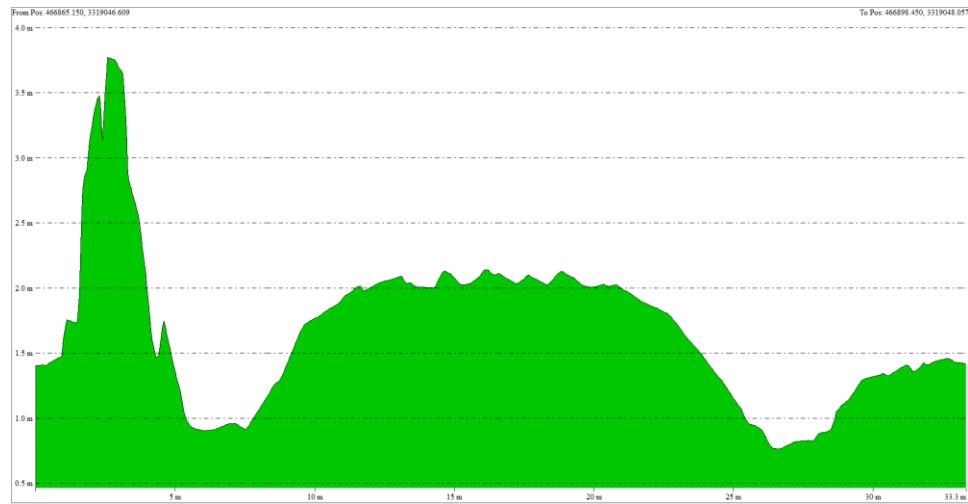
Figure 22. Roadway and ditch cross-sections at two adjacent locations

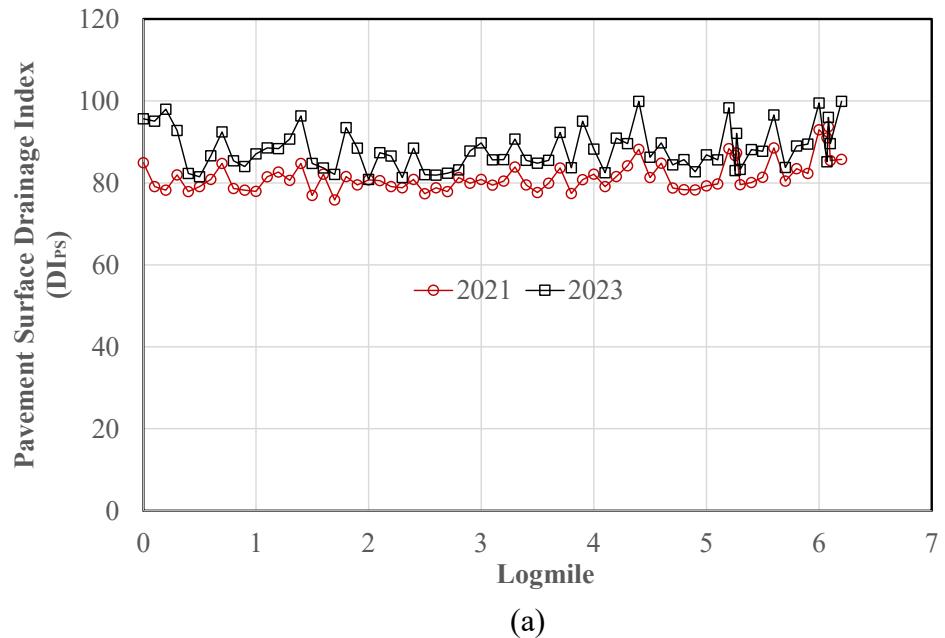
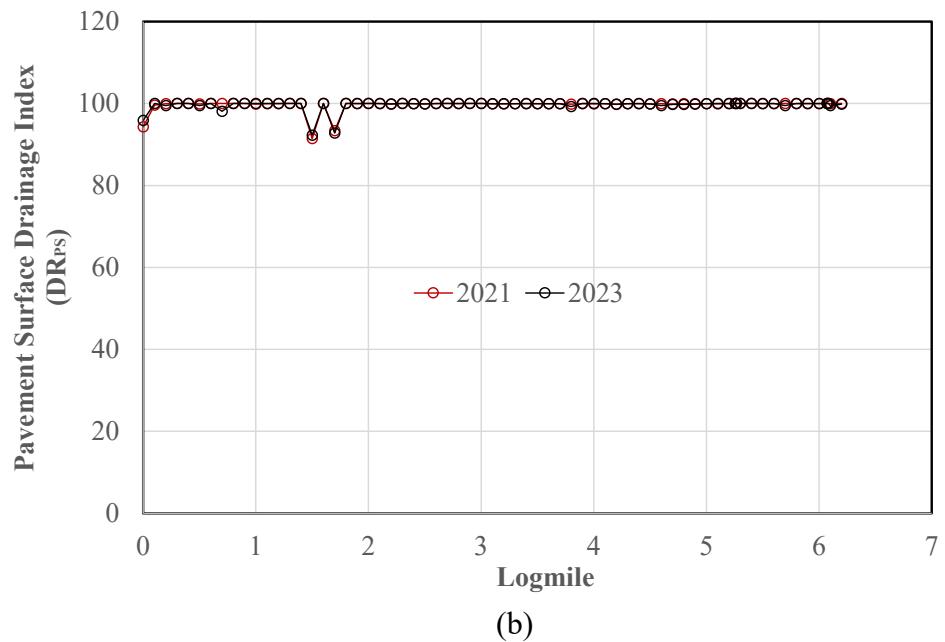
Figure 23. Pavement surface drainage index for Control Section 270-03

(a) with longitudinal grade (b) without longitudinal grade

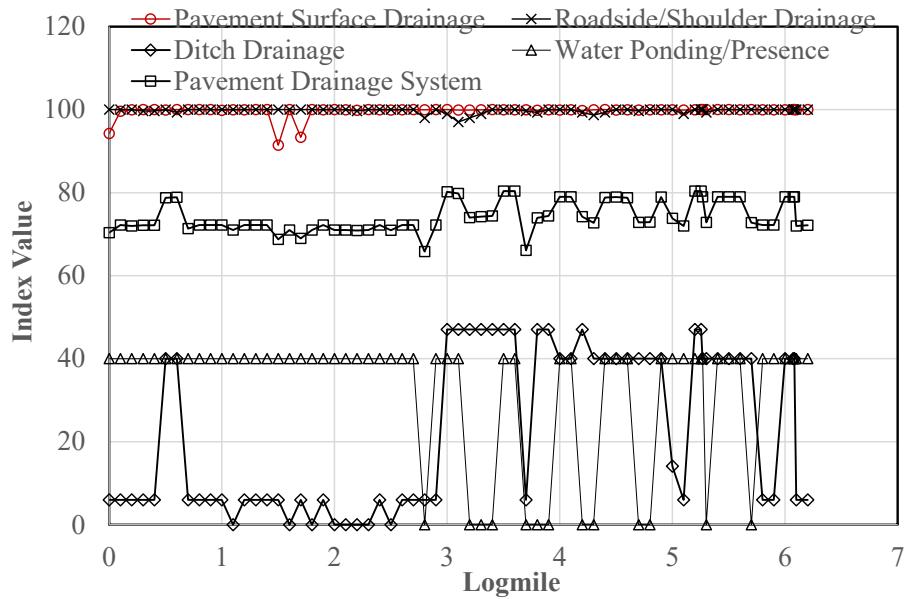
Figure 25. Drainage index values for Control Section 270-03

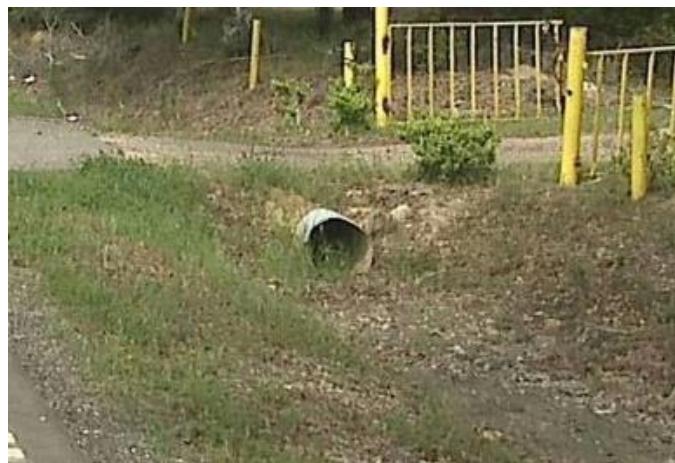
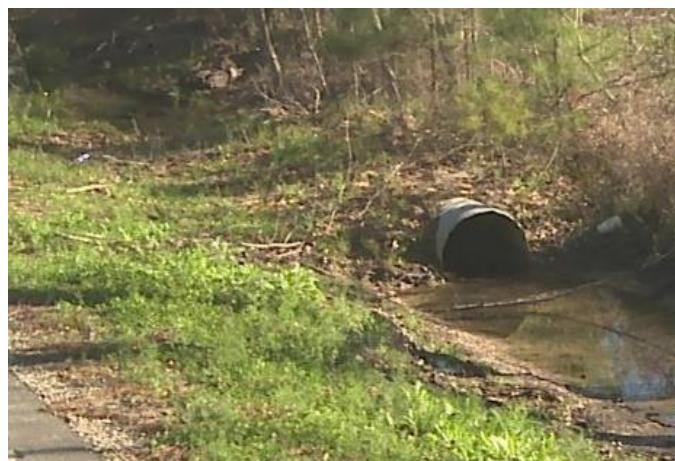
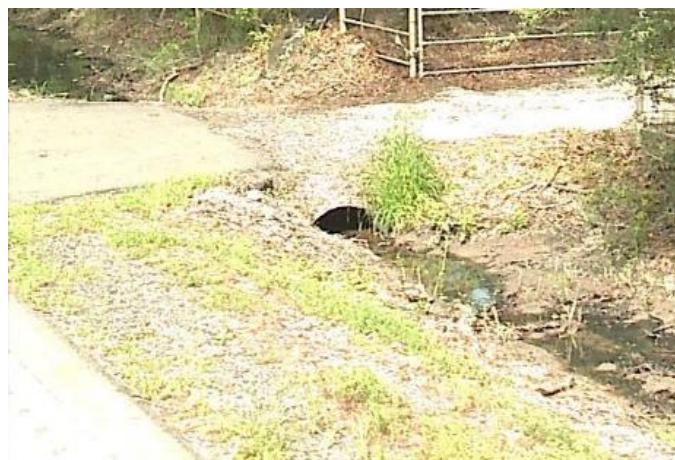
Figure 26. Sediment in ditches for Control Section 270-03 (Source: PMS images)

Ditch drainage conditions were evaluated through windshield surveys using 2021 PMS right-of-way and forward-right camera images. The 2023 PMS imagery revealed widespread standing water along nearly the entire section, making direct ditch condition assessment difficult. Consequently, the authors used 2021 imagery for ditch condition ratings.

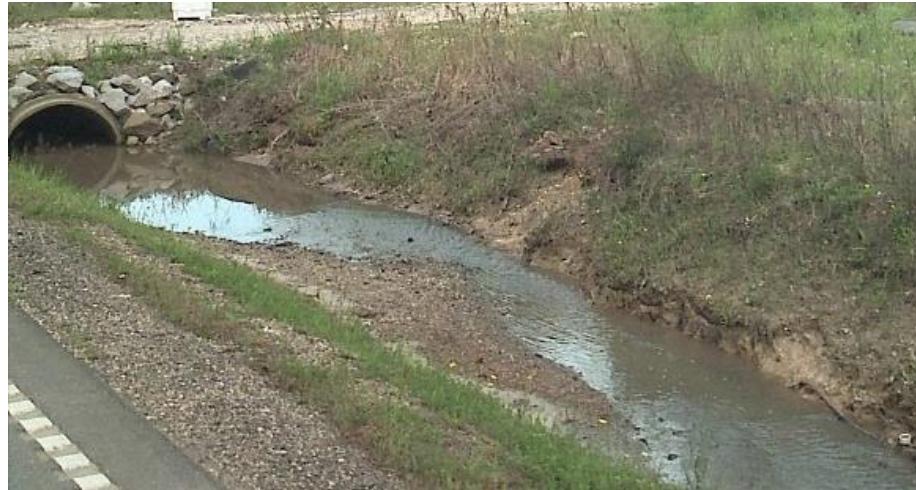
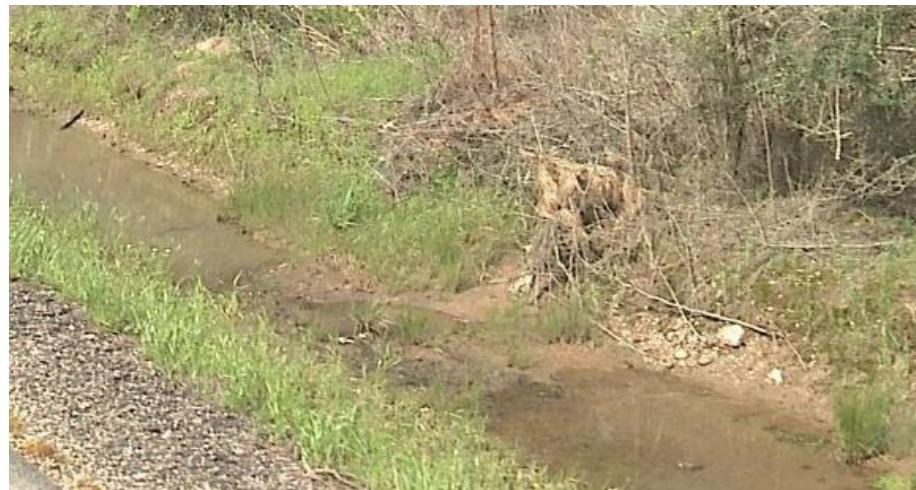
Most locations showed only minor erosion (Score 1), but some exhibited noticeable soil wash into the ditch that slowed flow (Score 3), as shown in Figure 27a, and others showed sloughing or sliding that created sediment dams (Score 5), as shown in Figure 27b.

Figure 27. Erosion in ditches for Control Section 270-03 (Source: PMS images)

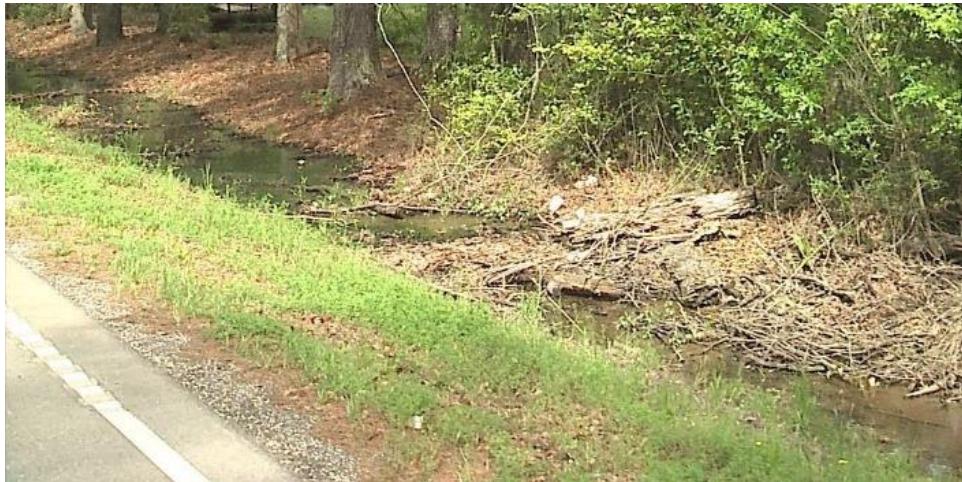
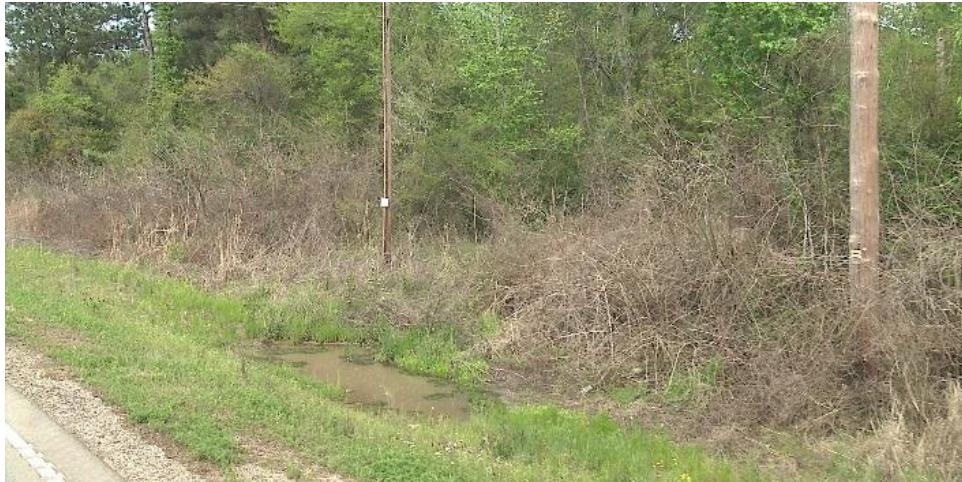
Light vegetation/debris was mostly observed along the section (Score 1), with moderate vegetation/debris causing partial obstruction (Score 3) and dense vegetation/debris significantly blocking flow and causing ponding (Score 5) were seen in some locations, as shown in Figure 28a and Figure 28b, respectively.

Figure 28. Vegetation and debris in ditches for Control Section 270-03 (Source: PMS images)

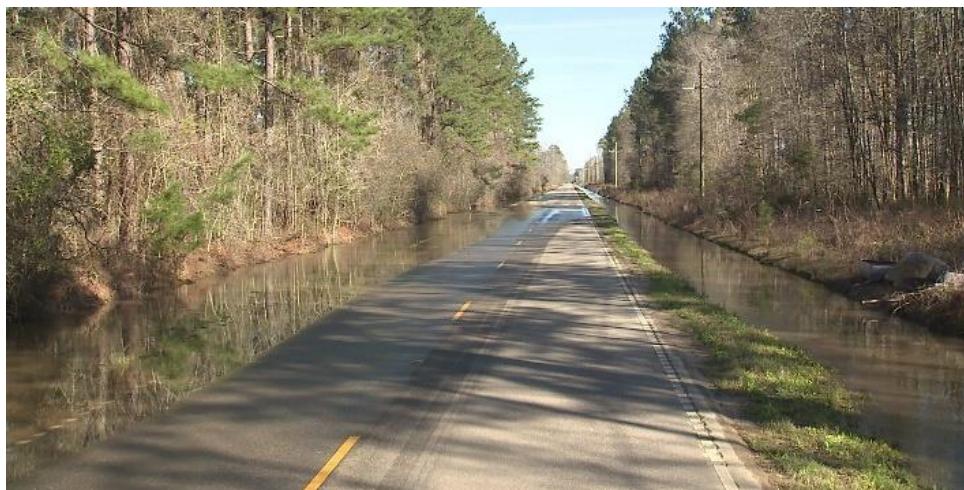
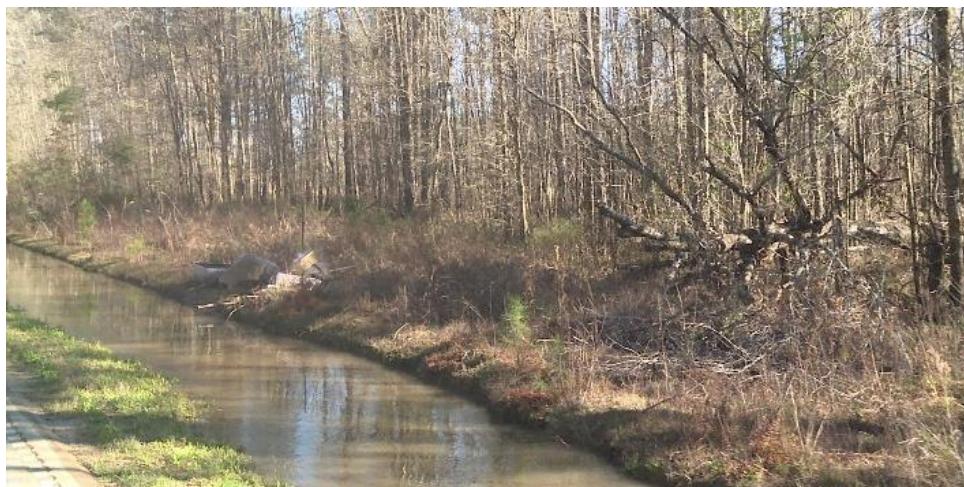
Figure 29. Water ponding and presence for Control Section 270-03
(Source: PMS images from 2023 survey)

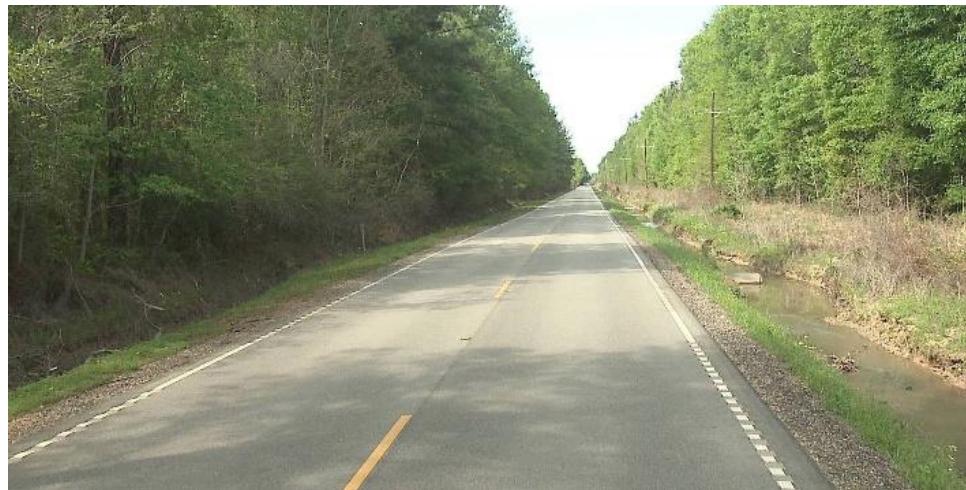
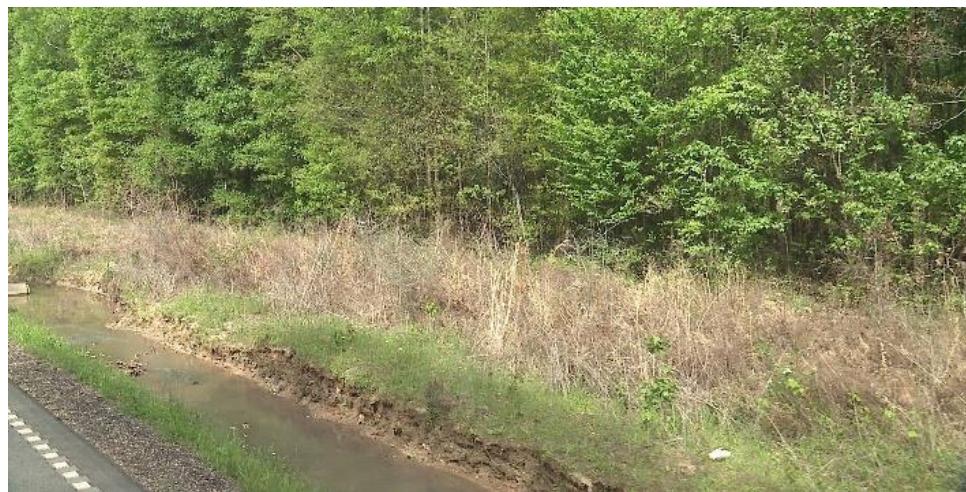
Figure 30. Water ponding and presence for Control Section 270-03
(Source: PMS images from 2021 survey)

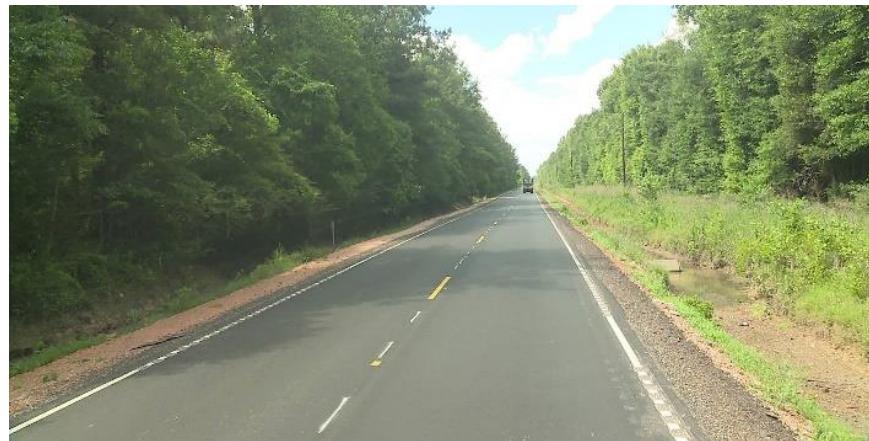
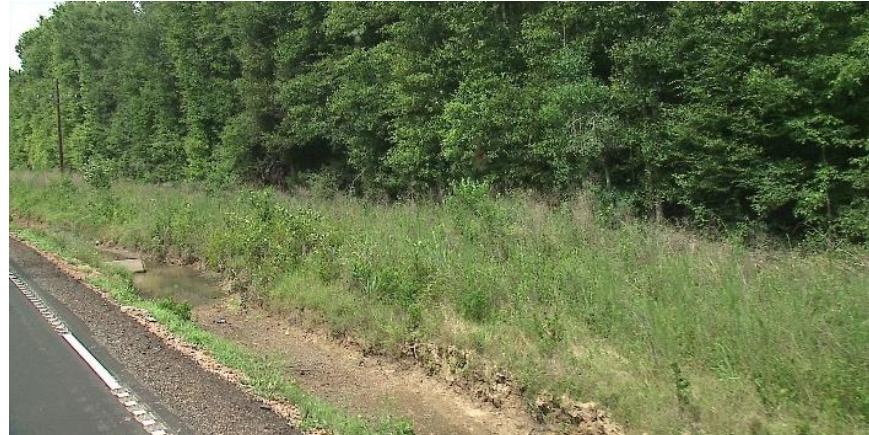
Figure 31. Water ponding and presence for Control Section 270-03
(Source: PMS images for 2019 survey)

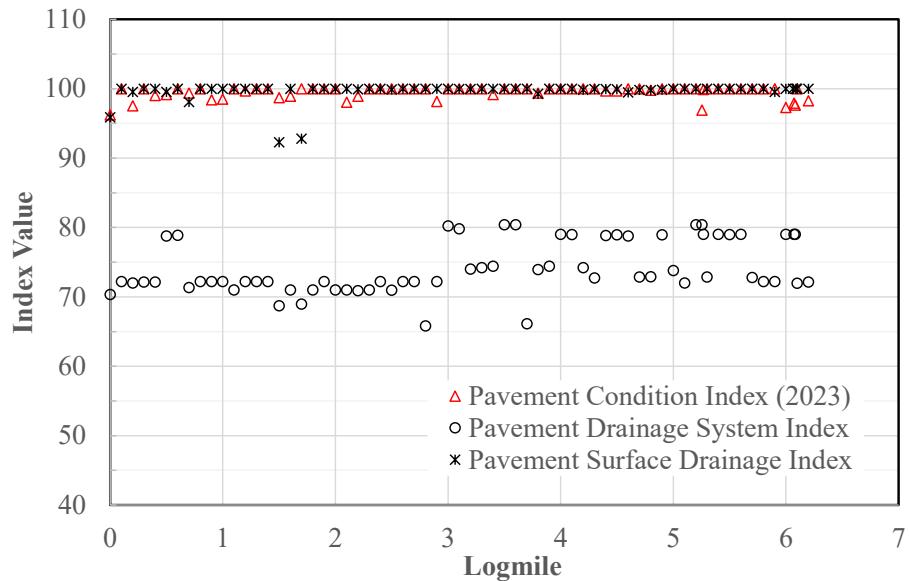
Figure 32. Pavement and drainage condition indices for Control Section 270-03

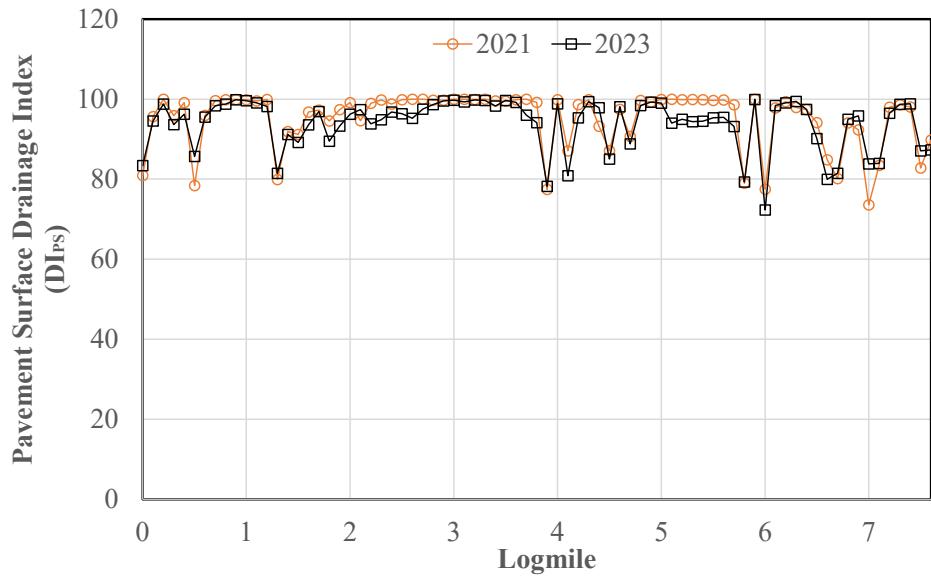
Figure 33. Pavement surface drainage index for Control Section 177-04

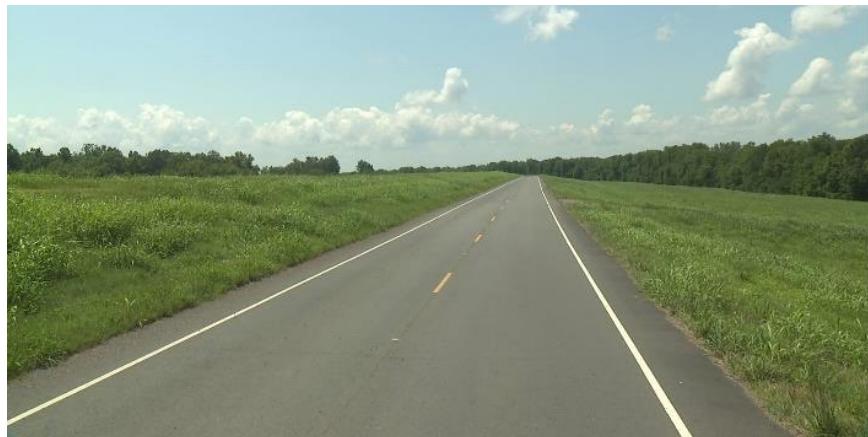
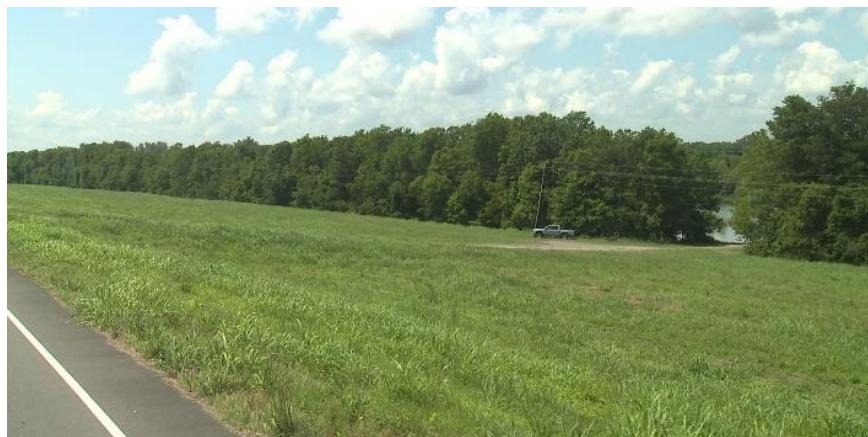
Edge drop-off was assessed using PMS data. Windshield surveys based on PMS right-of-way and forward-right images showed overgrown grass along the pavement edge and foreslope; see Figure 34. This dense vegetation may obstruct surface water flow, contributing to drainage issues. As such, an obstruction score of 3 was assigned.

Figure 34. Overgrown grass along the pavement edge and foreslope Control Section 177-04
(Source: PMS image)

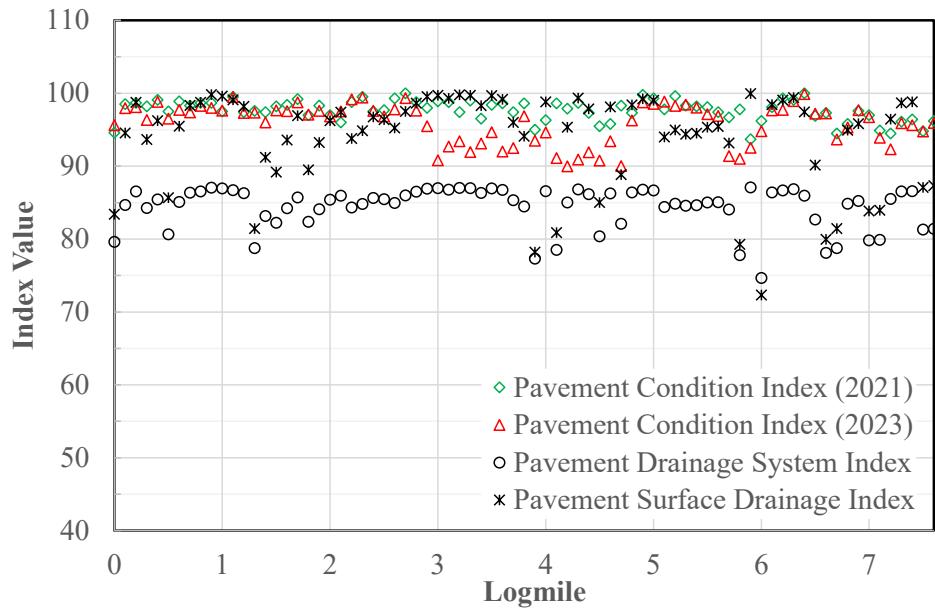
Figure 35. Pavement and drainage condition indices for Control Section 177-04

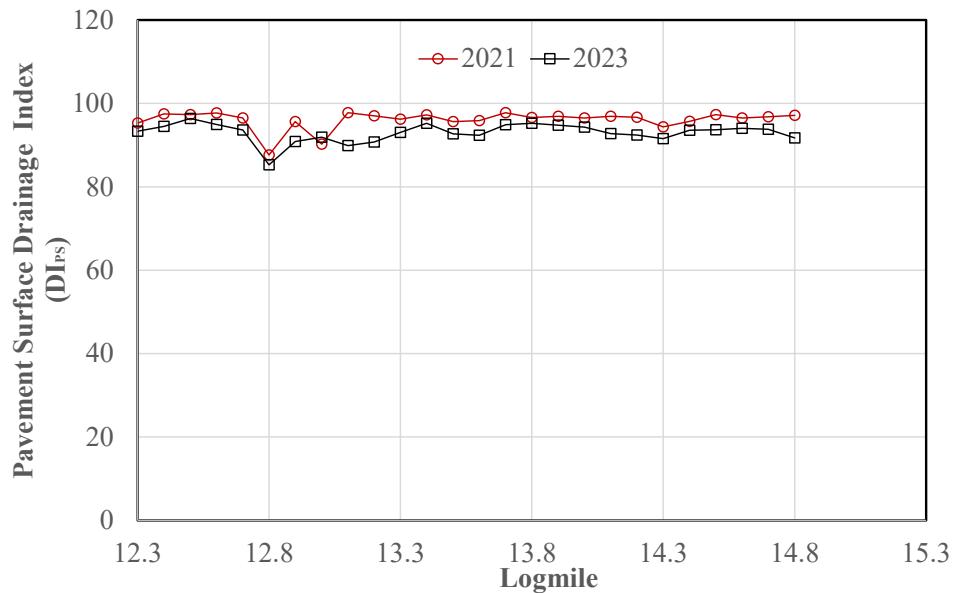
Figure 36. Pavement surface drainage index for Control Section 066-07

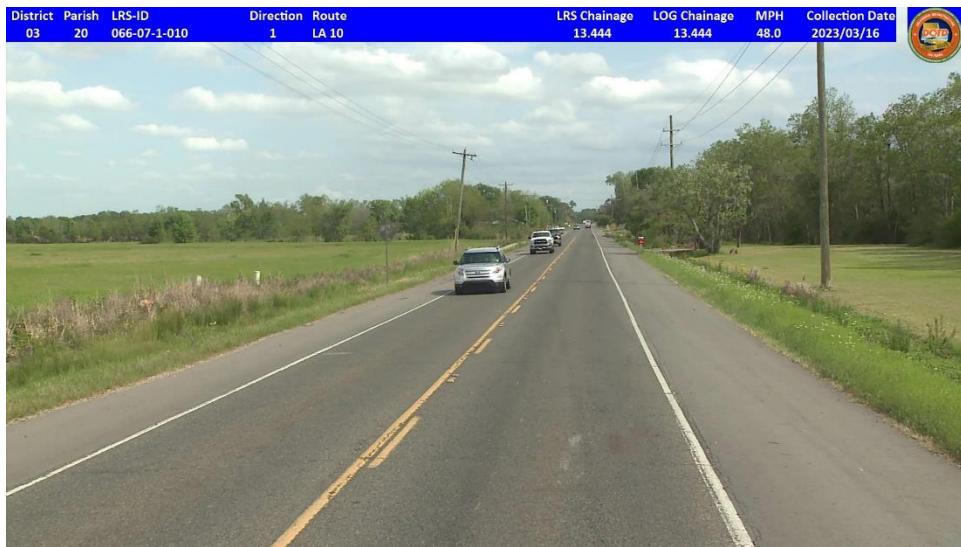
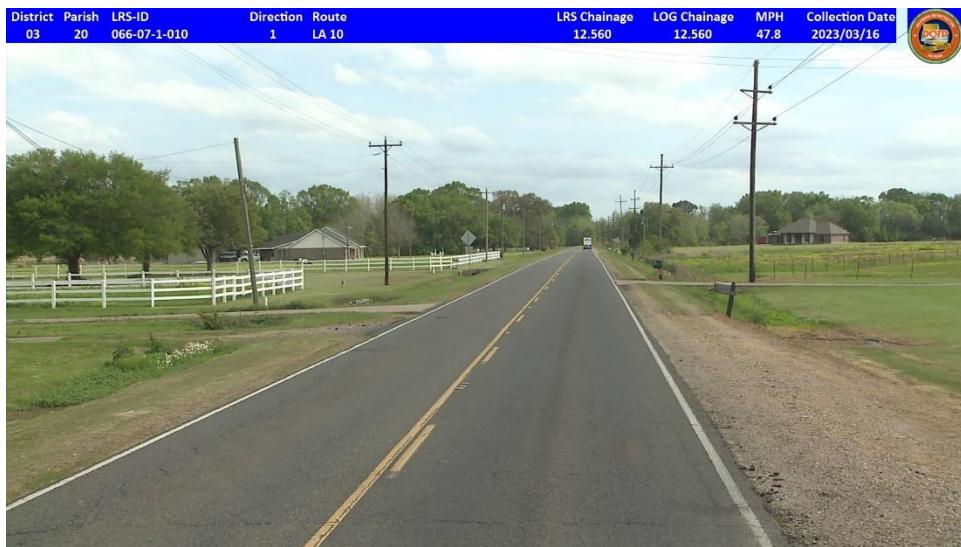
Edge drop-off was assessed using PMS data. Windshield surveys from PMS right-of-way and forward-right images indicated that shoulders were either paved or gravel, with vegetation set back from the pavement edge; see Figure 37. Accordingly, an erosion score of 0 and an obstruction score of 1 was assigned. The final roadside/shoulder drainage rating is presented in Figure 38.

Figure 37. Pavement shoulder for Control Section 066-07

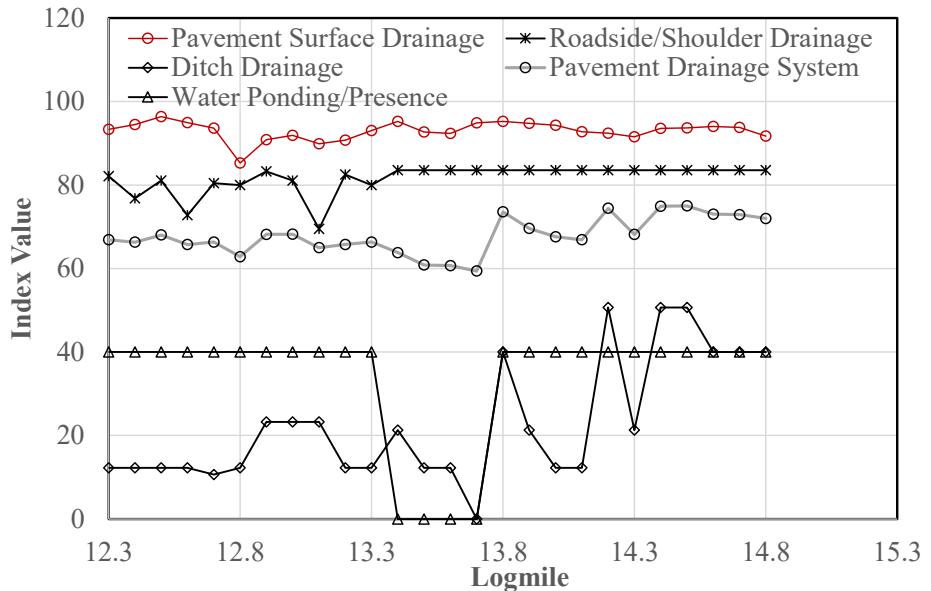
Figure 38. Drainage index values for Control Section 066-07

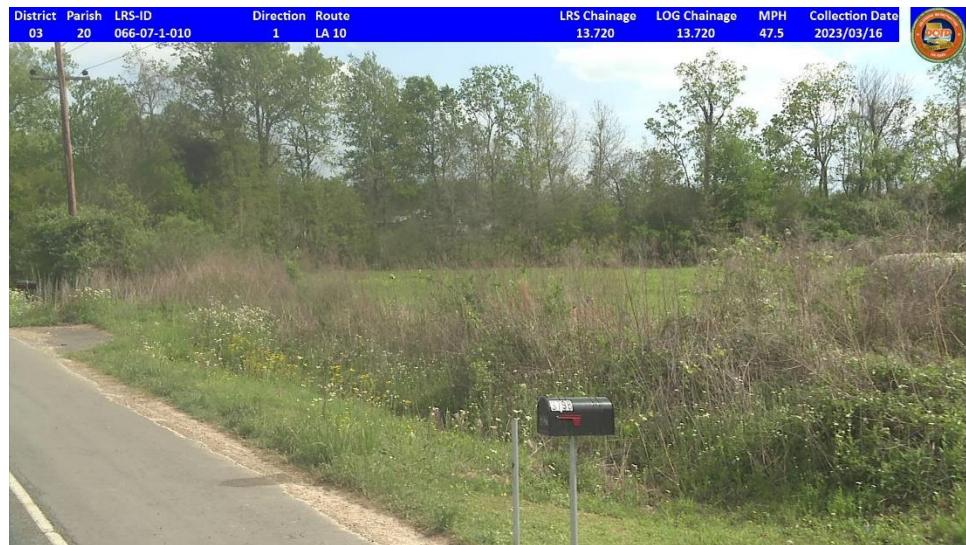
Figure 39. Dense vegetation in ditch for Control Section 066-07 (Source: PMS image)

Ditch drainage conditions were evaluated through windshield surveys using 2023 PMS right-of-way and forward-right camera images. As discussed earlier, sediment levels were rated based on the proportion of the side drain cross-sectional area obstructed.
