Develop a Methodology for Pavement Drainage System

Rating

FHWA/LA.25/719

Final Report

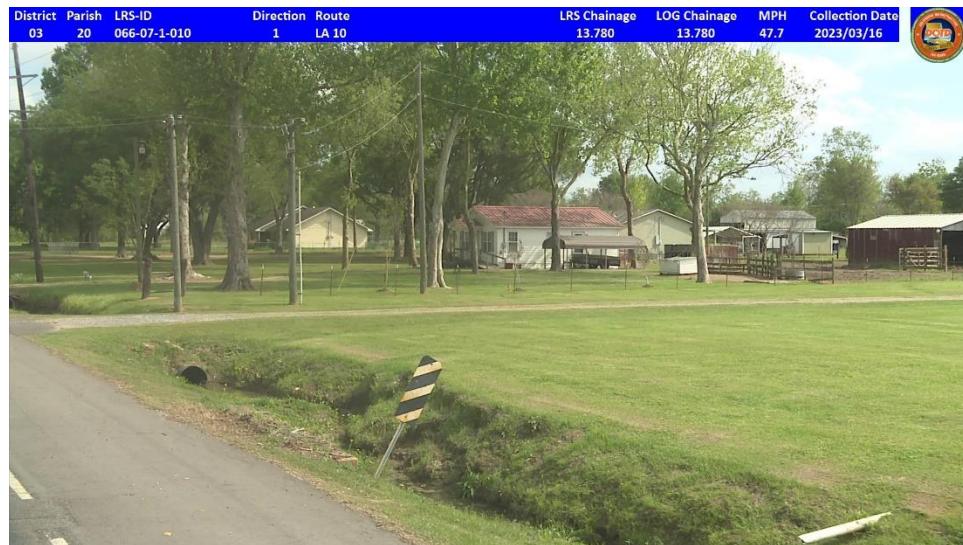
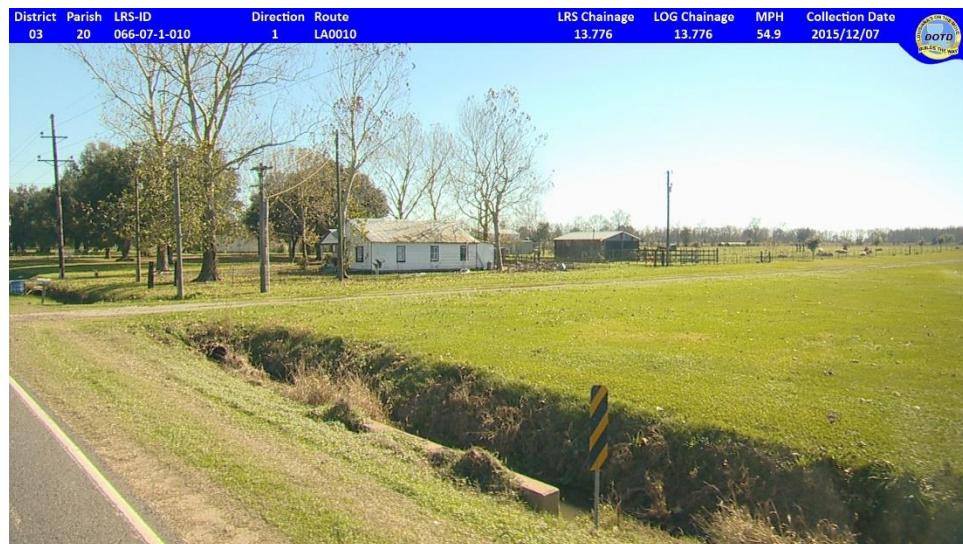
Figure 40. Ditch slope failure for Control Section 066-07 (Source: PMS images)

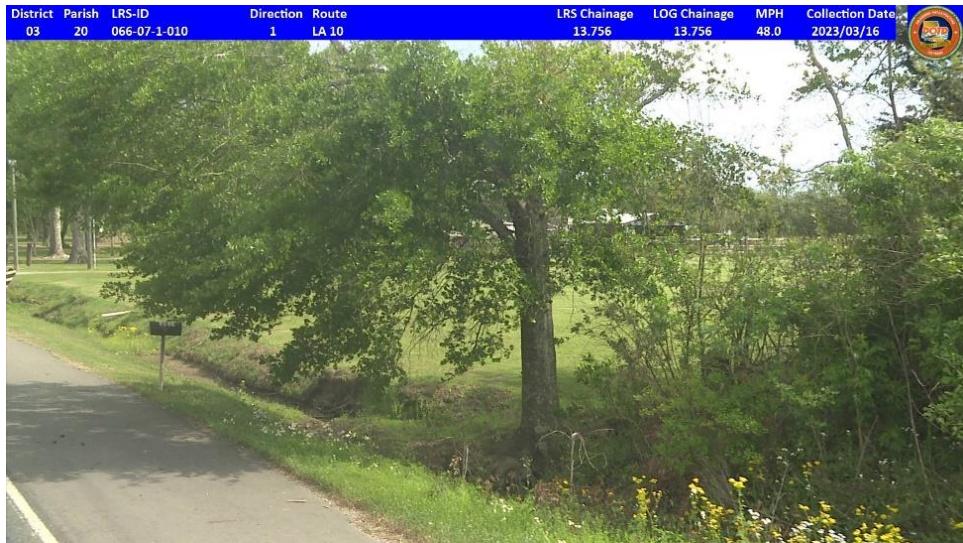
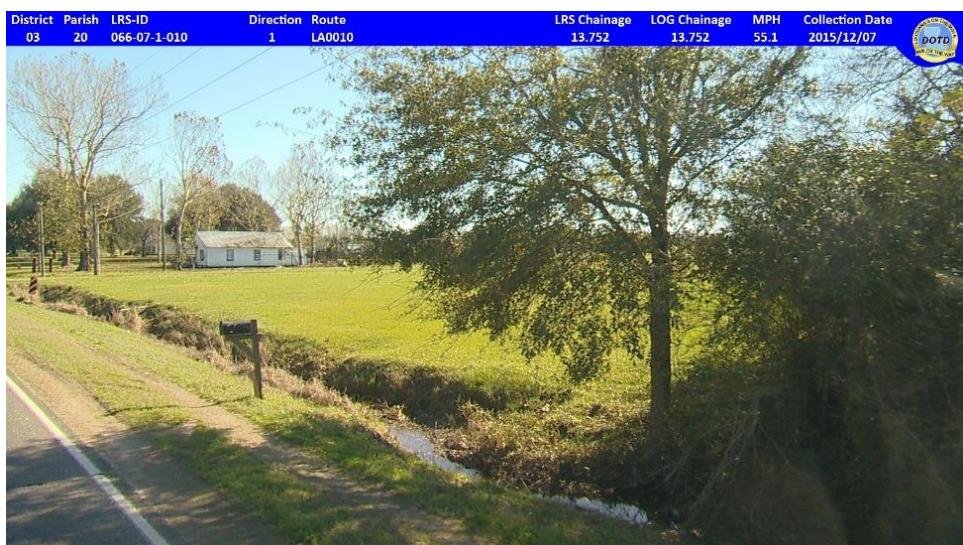
Figure 41. Temporary dam from ditch erosion for Control Section 066-07 (Source: PMS images)

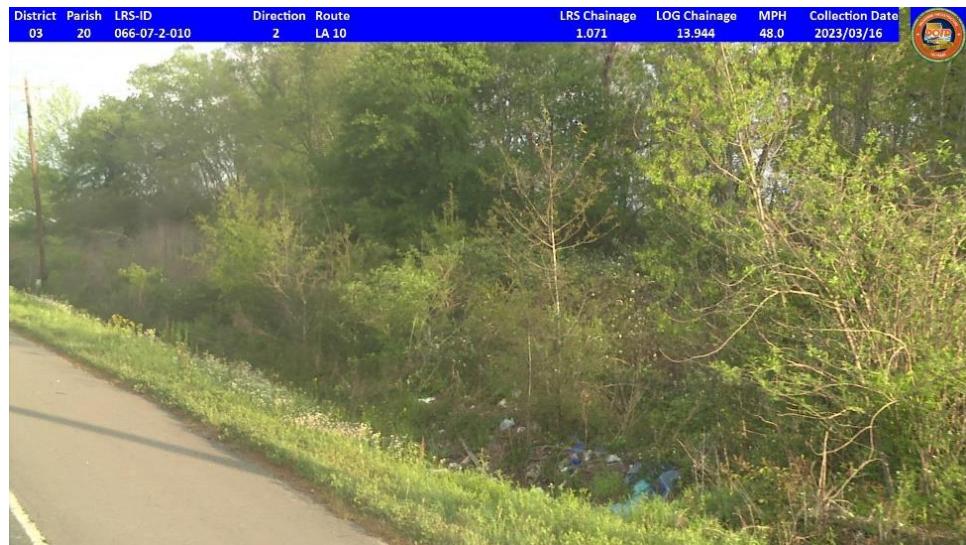
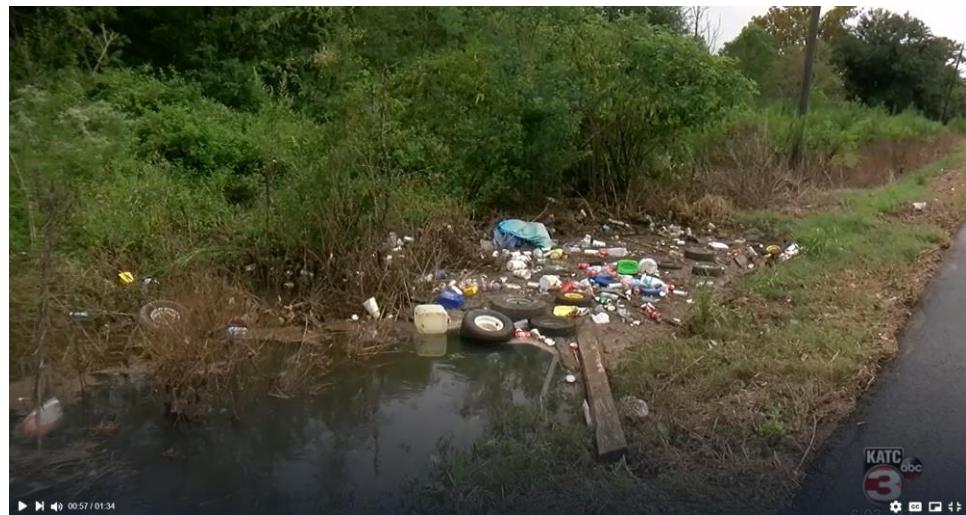
Figure 42. Debris/trash in ditches for Control Section 066-07 (Source: PMS images)

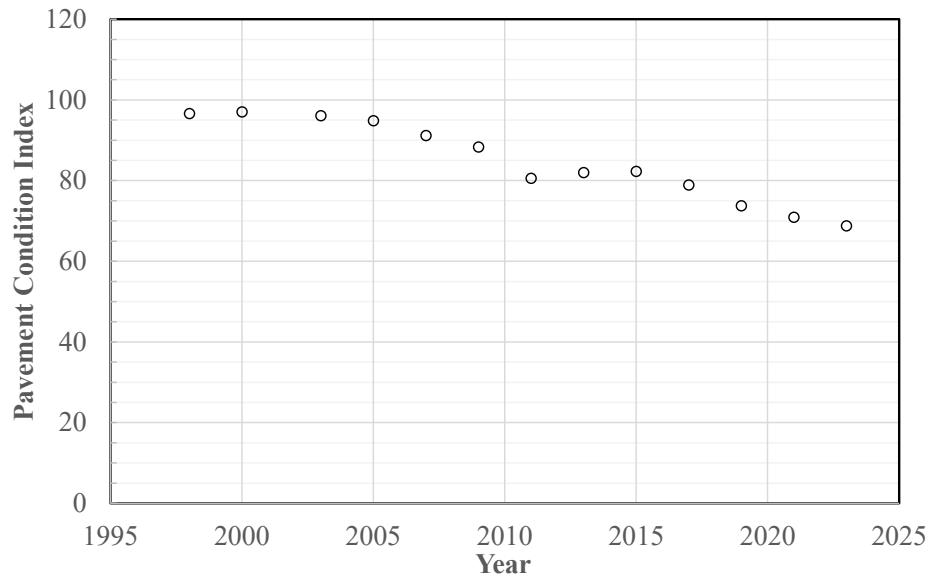
Figure 43. Variation of PCI with time for Control Section 066-07

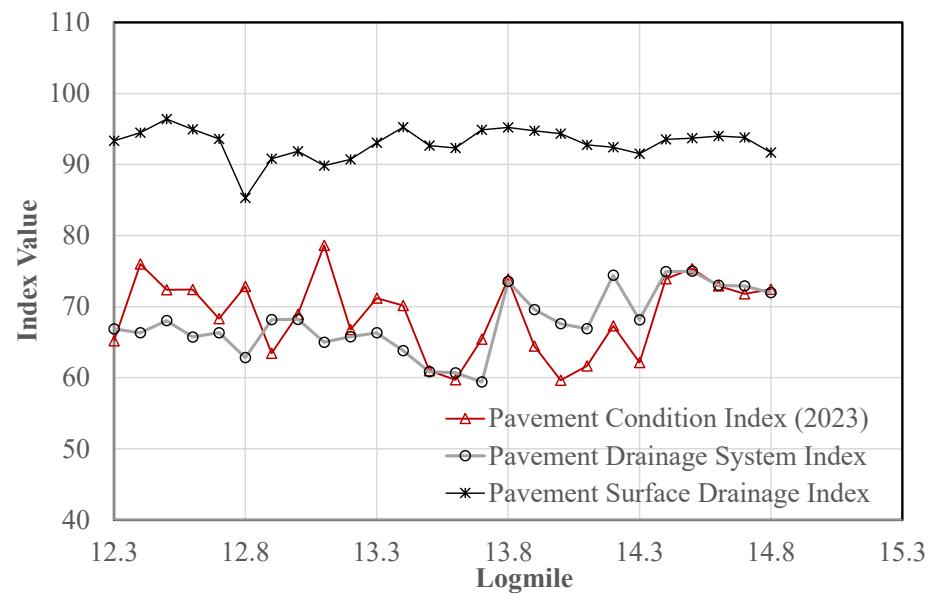
Figure 44. Pavement and drainage condition indices for Control Section 066-07

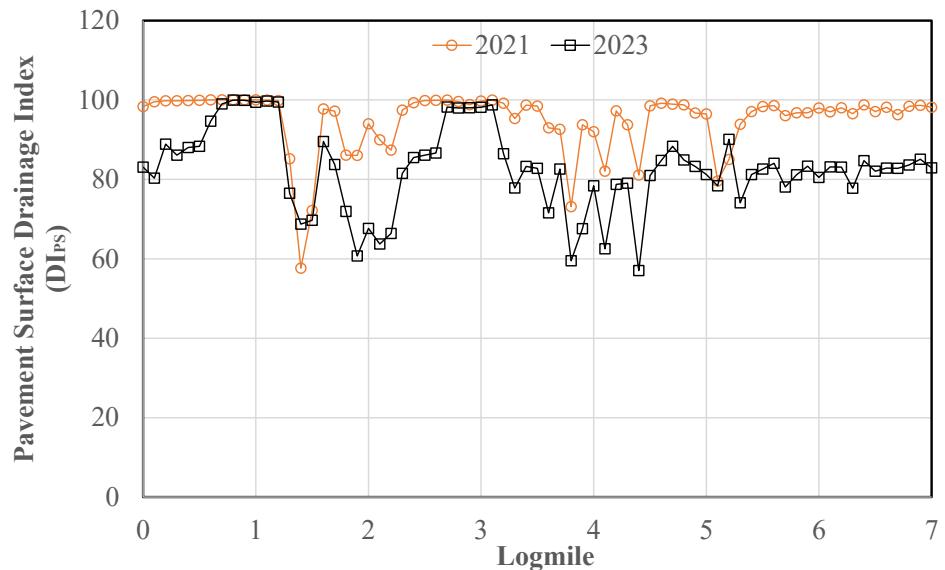
Figure 45. Pavement surface drainage index for Control Section 012-04

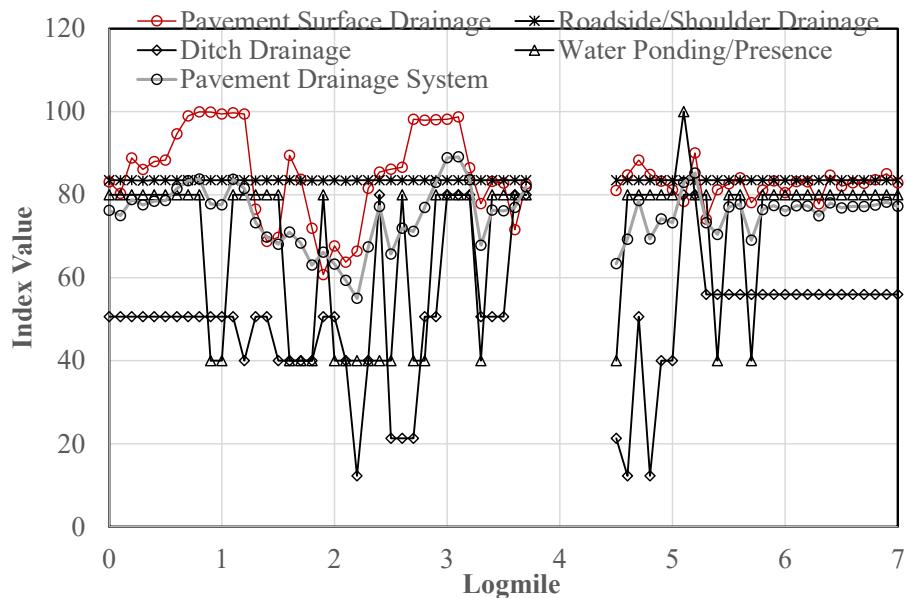
Edge drop-off was evaluated using PMS data. Shoulders are mostly paved; the erosion score is 0, and obstruction score is 1. The urban segment at log mile 3.8 to 4.4 with curb and gutter was excluded. The final roadside/shoulder drainage rating is presented in Figure 46.

Figure 46. Drainage index values for Control Section 012-04

Ditch drainage conditions, taken from 2023 PMS imagery, revealed light to moderate vegetation. Several segments of roadway exhibited erosion-related issues, including sloughing or soil sliding into the ditches. The final ditch drainage index is presented in Figure 46.

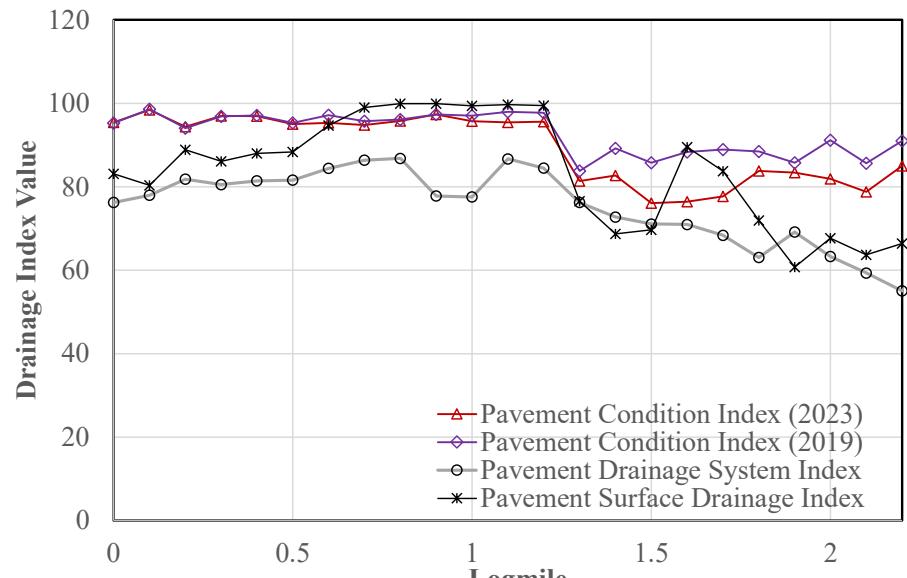
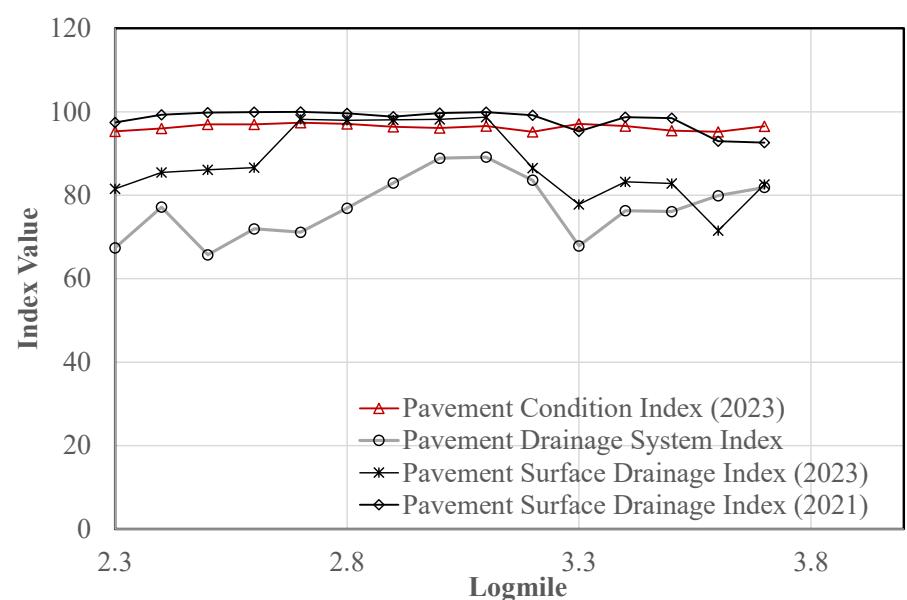
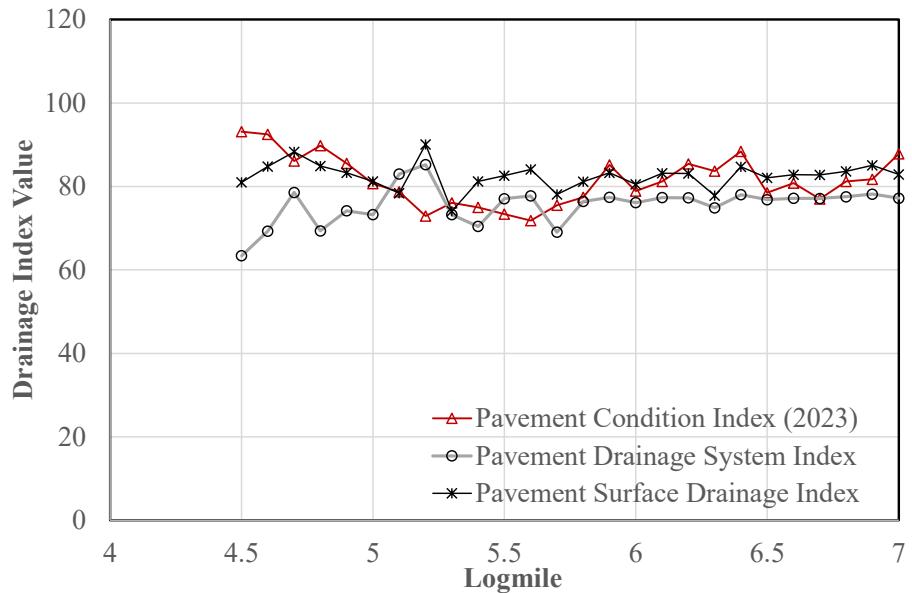
Figure 48. Pavement and drainage condition indices for Control Section 012-04

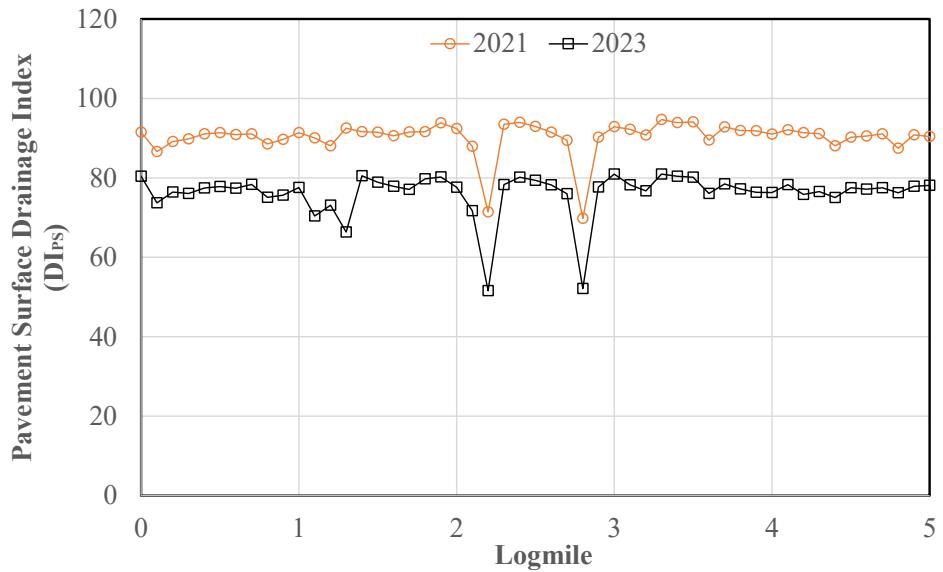
Figure 49. Pavement surface drainage index for Control Section 193-31

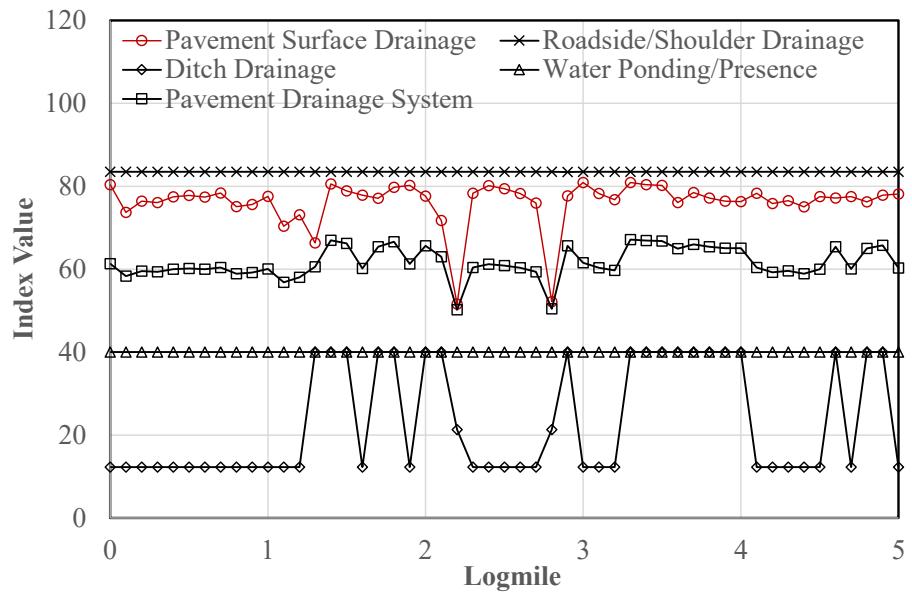
Shoulders are paved with vegetation set back. The erosion score is 0, and the obstruction score is 1. Results are shown in Figure 50.

Figure 50. Drainage index values for Control Section 193-31

Windshield surveys indicated moderate to heavy vegetation, obstructing flow and causing ponding. No erosion was observed. Final ratings are shown in Figure 50.

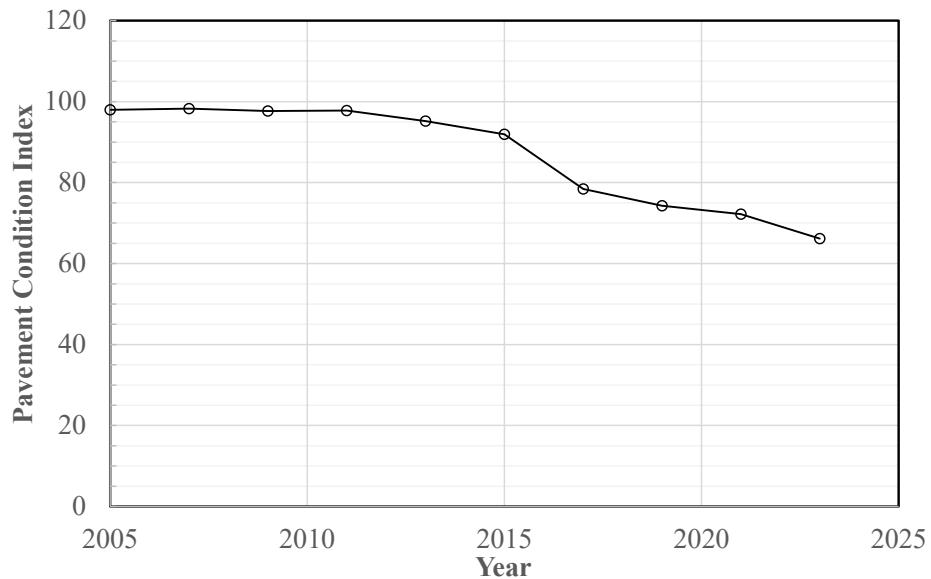
Figure 51. Variation of PCI with time for Control Section 193-31

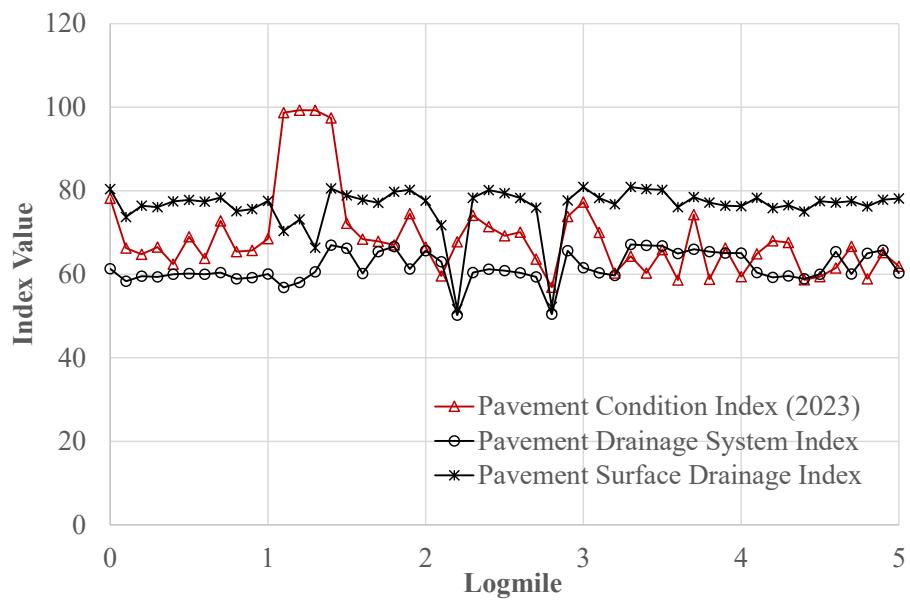
Figure 52. Pavement and drainage condition indices for Control Section 193-31
