1. Report No. FHWA/LA.03/379	2. Government Accession No.	3. Recipient's Catalog No.
4. Title and Subtitle Evaluation of Interaction Properties of Geosynthetics in Cohesive Soils: LTRC Reinforced-Soil Test Wall	5. Report Date January 2004

16. Abstract <p>This report presents the construction and performance evaluation of the LTRC reinforced-soil test wall. The 20 ft. high, 160 ft. long wall was constructed using low quality backfill. Its vertical front facing was constructed with modular blocks. It consisted of three sections reinforced with various geogrid reinforcement types and spacing. The backside of the wall was a one-to-one slope reinforced with woven and non-woven geotextiles.</p> <p>The test wall was constructed to evaluate the design procedure and performance of geosynthetic-reinforced structures constructed with marginal silty-clay backfill over soft clay foundation. The instrumentation program consisted of monitoring wall deformation, foundation settlement, strains in the reinforcement, vertical and horizontal stresses in the soil, and pore water pressure under the wall. Results of the monitoring program from construction through four months after completion of the wall

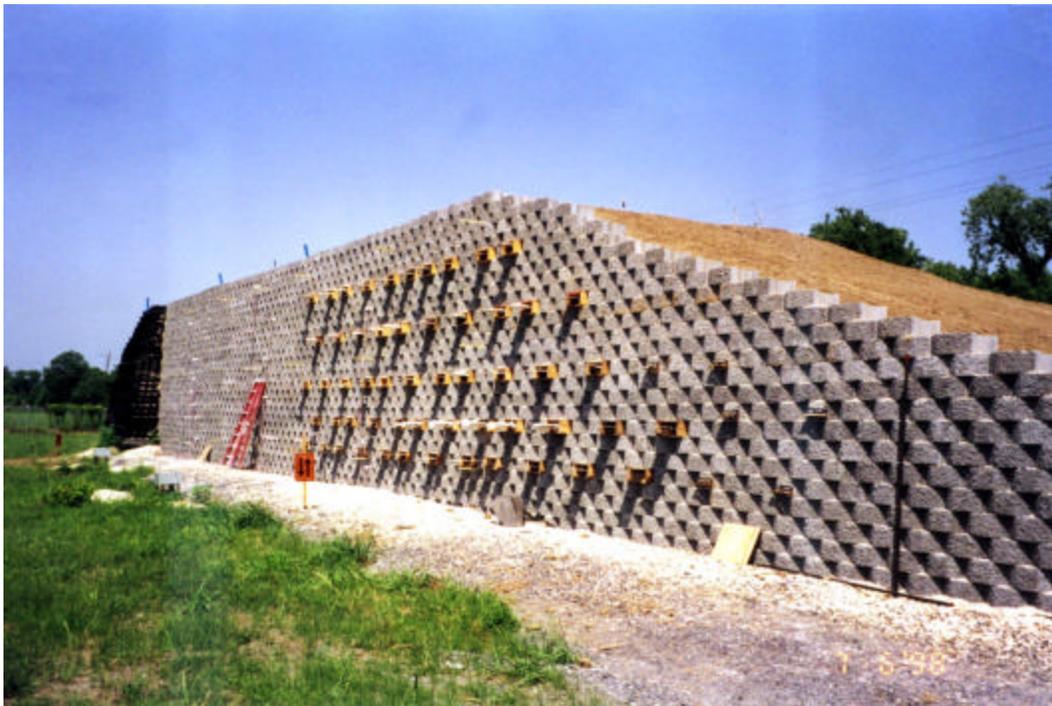
Figure 1
View of the LTRC test wall

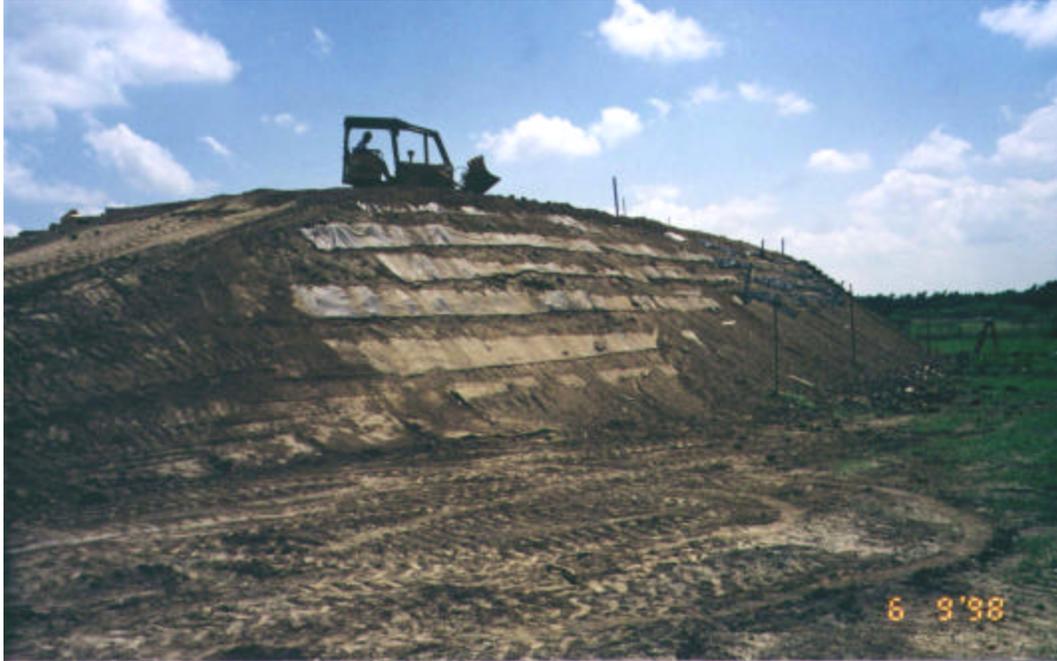
Figure 3
The slope side of the wall during construction

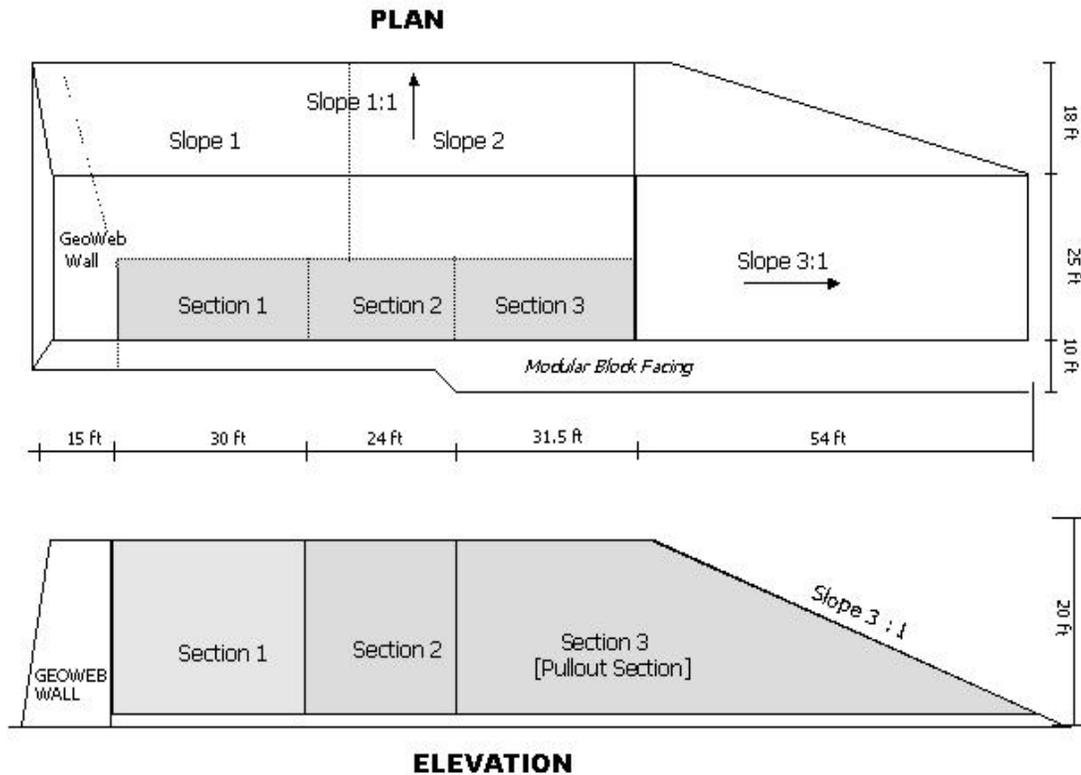
Figure 4
Plan and Elevation of the test wall

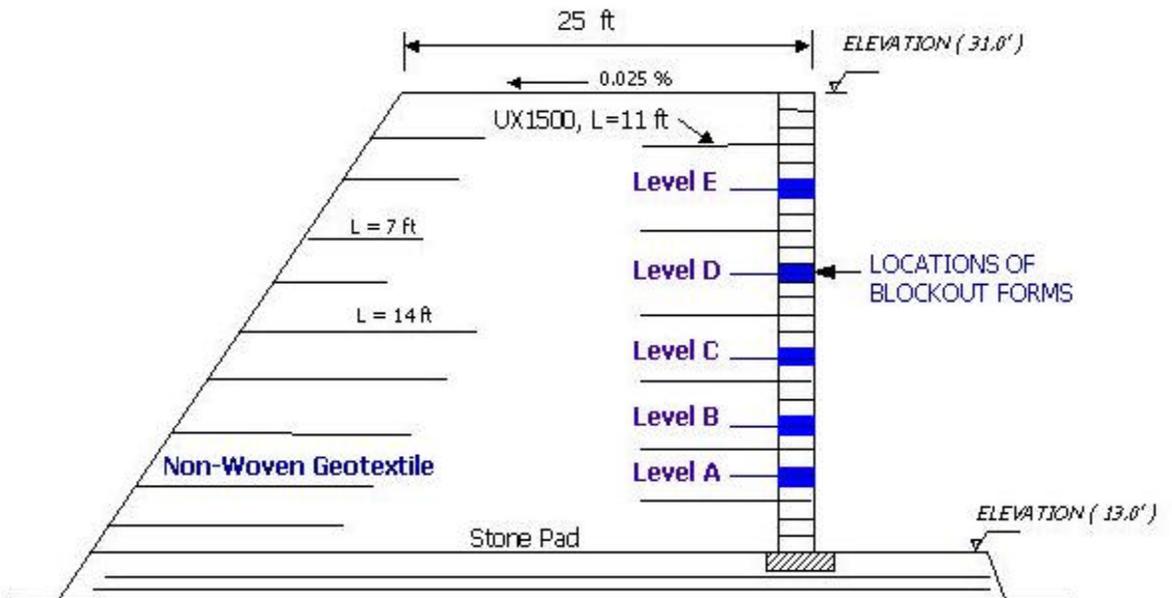
Figure 7
Cross-section of section 3 of the wall

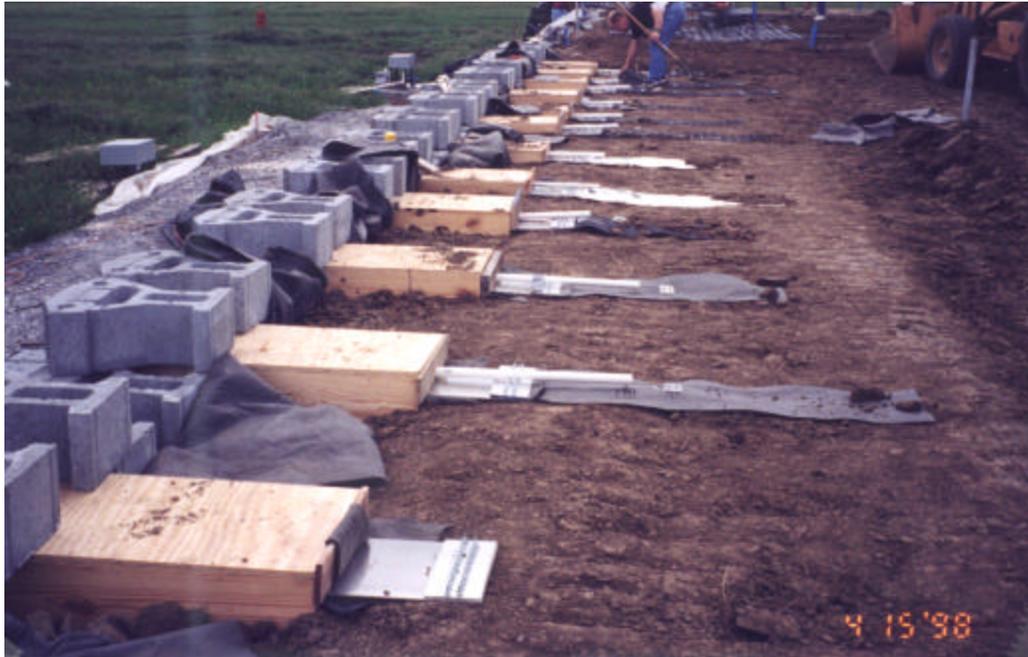
Figure 8
View of the pullout specimens in section 3 of the wall

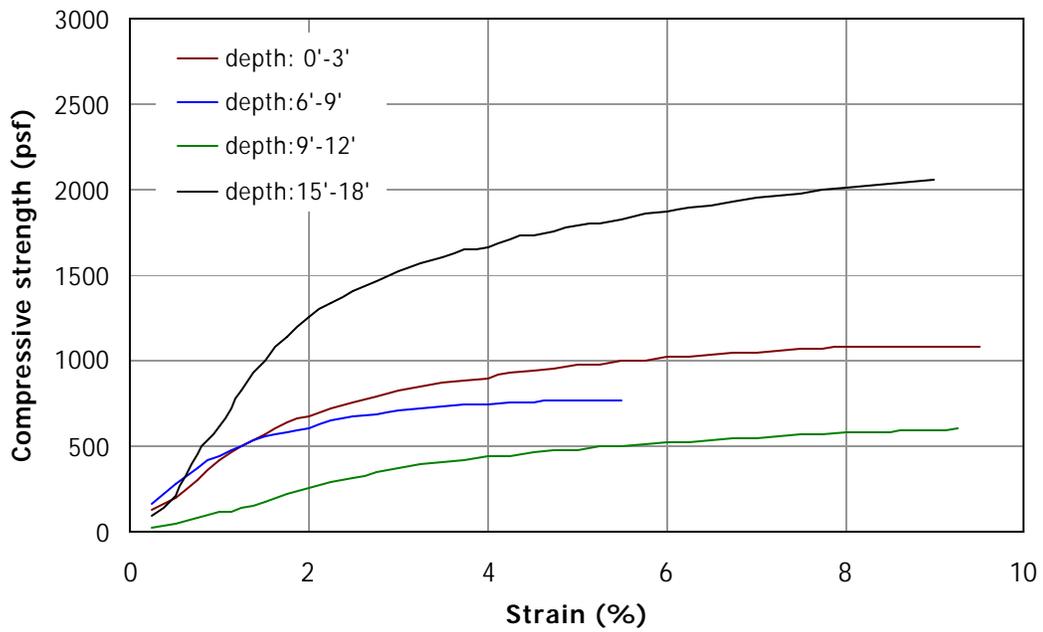
Figure 9
Unconfined compression tests on foundation soil

The test wall was constructed over a soft soil foundation which consisted of a soft to medium 3-to-4 ft.-deep organic-clay layer, a 20-ft.-deep soft-clay layer, followed by a stiff-clay to a very stiff-clay layer. The results of unconfined compression tests on samples from various depths are shown in figure 9.

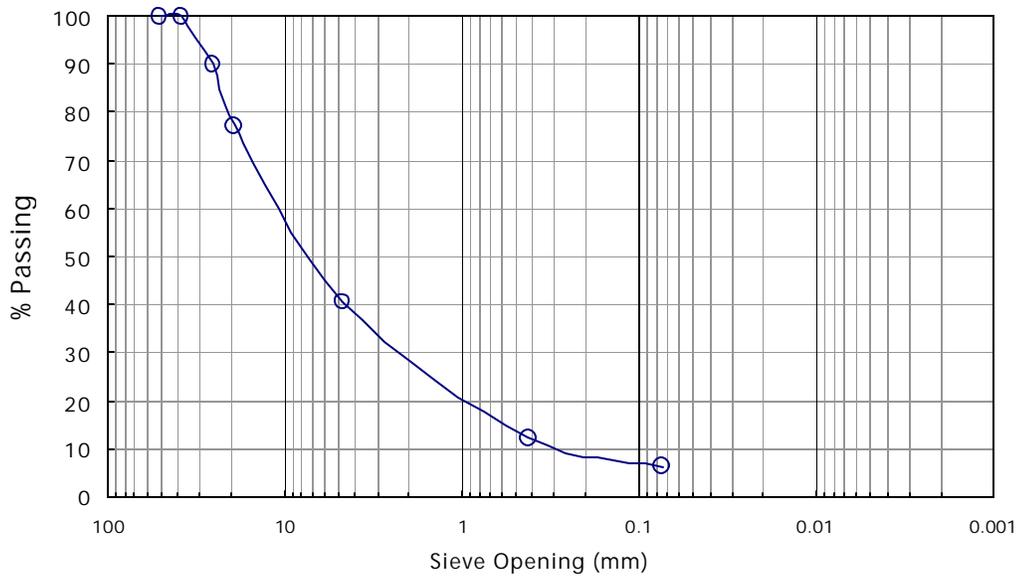
Figure 10
Grain size distribution of the stone base layer

A 2-ft.-thick stone base soil layer was placed on the top of the foundation soil. The stone was reinforced with two layers of geogrid Tensar UX-1600 in order to provide a leveled base and to increase the global stability of the wall. Figure 10 shows the grain size distribution of the stone base layer.

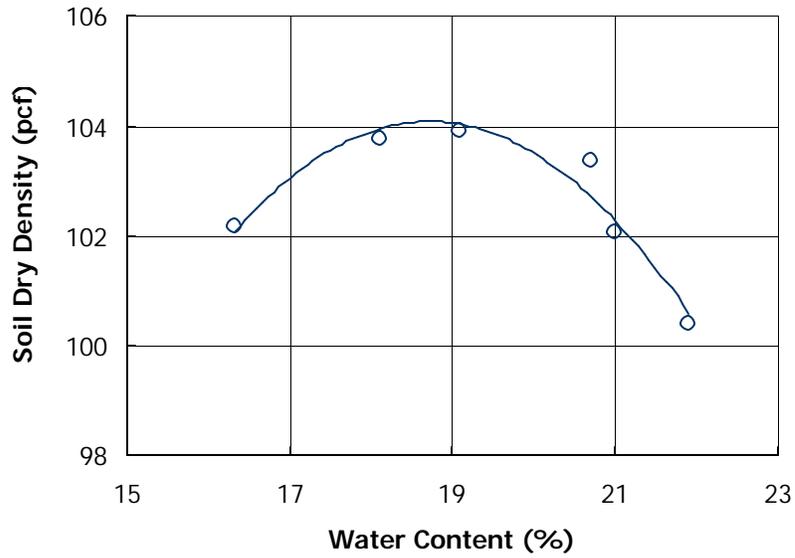
Moisture-density relationship of the silty-clay soil

The backfill used in the wall was a silty-clay soil, AASHTO classification A-4, with the properties shown in table 1. The shear strength parameters were measured in the direct shear test according to ASTM D-6528. Maximum soil dry density and optimum moisture content were determined from the Standard Proctor test according to AASHTO test T-99. Figure 11 shows the moisture-density relationship obtained from the compaction test.

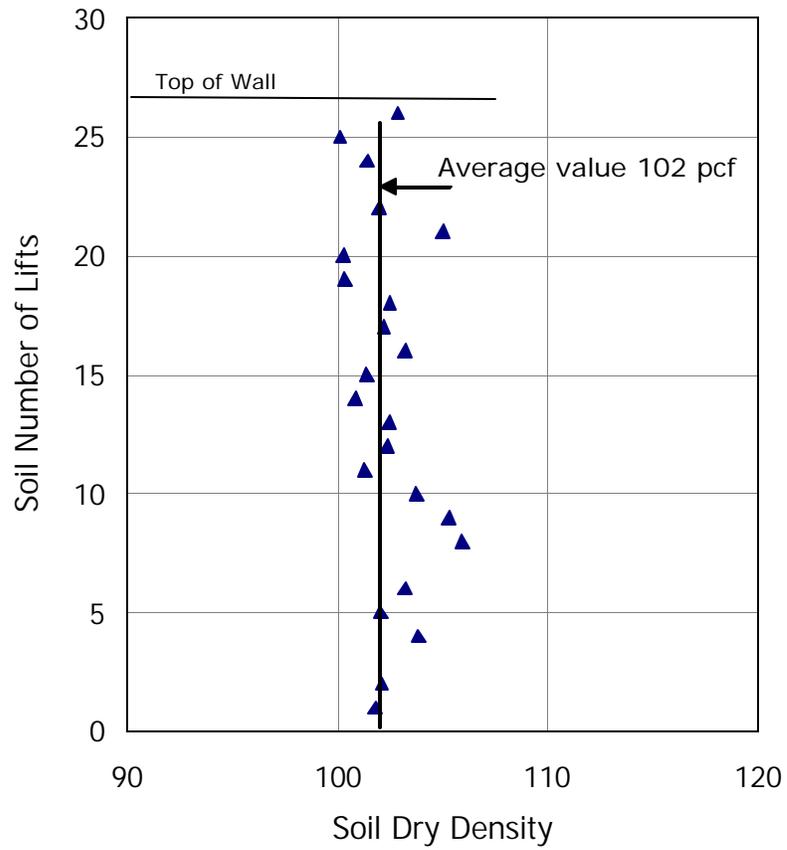
Figure 12 Profile of soil dry density at each soil lift if the wall

The soil was compacted in the wall in 8-inch lifts (equals the height of the modular block facing). Measurements of soil densities and moistures were performed at each compacted layer using the Nuclear Density Gauge. Figure 12 shows the average dry soil density in each soil layer. The figure shows an average dry soil density of 102 pcf which was about 95 percent of the maximum dry density.

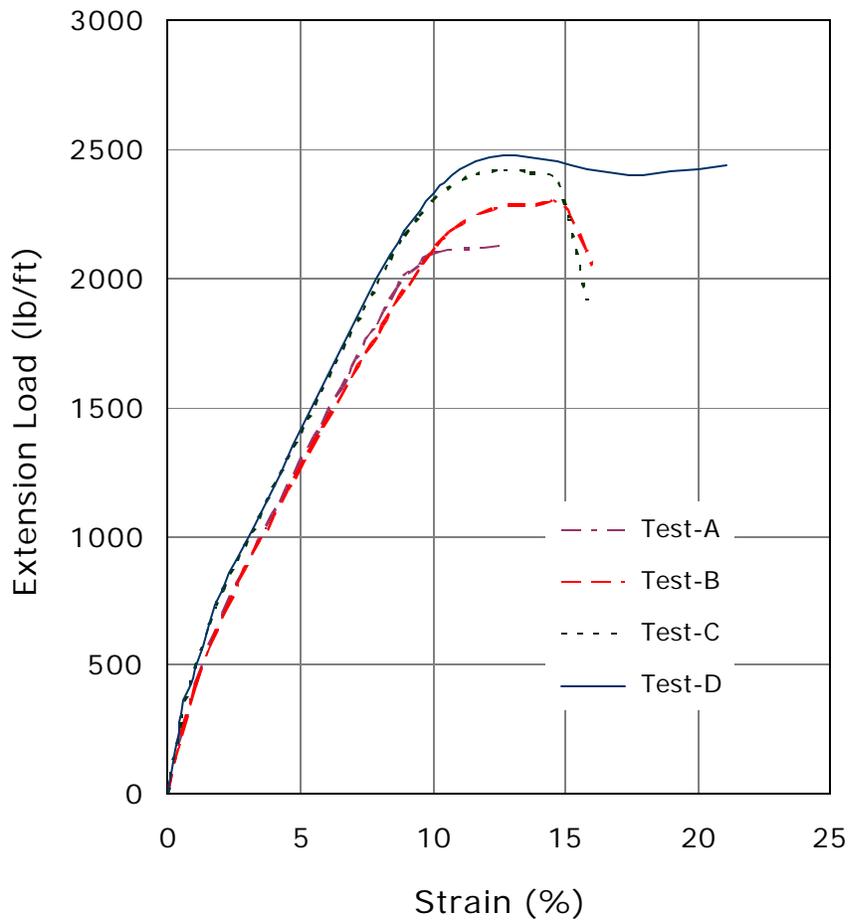
Figure 15
Wide-width strength tests on the UX-750 geogrid

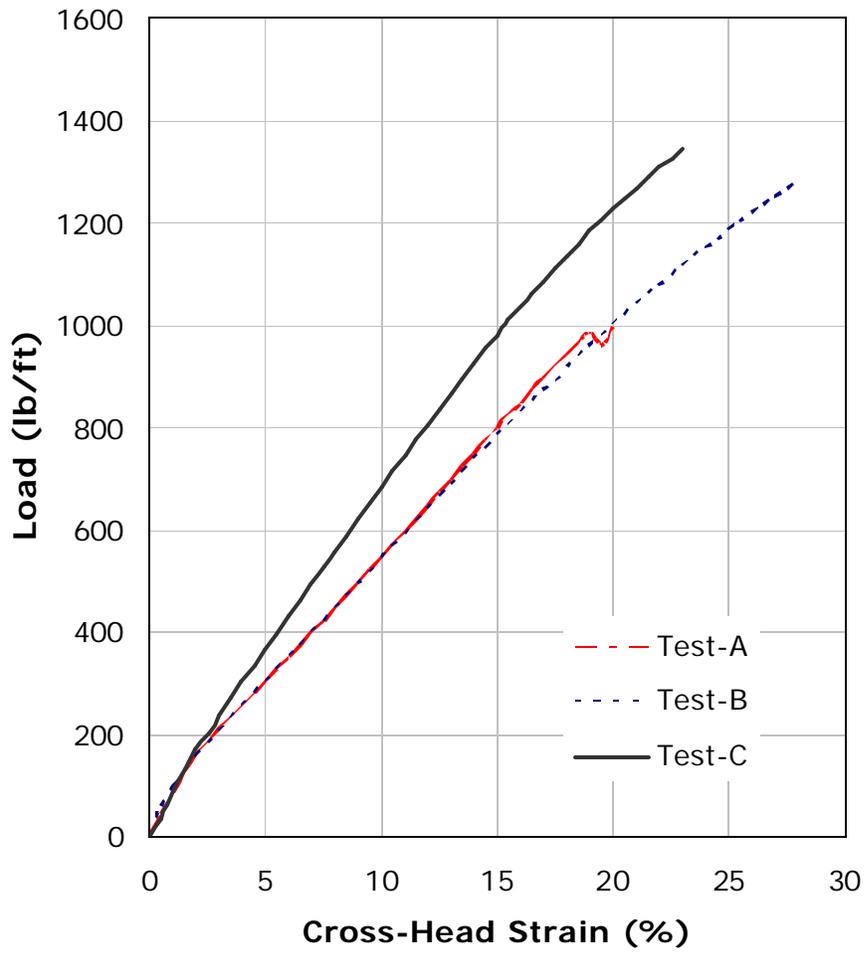
Figure 16
Extension tests on the non-woven geotextile TG-700

The non-woven geotextile used in the test slope was type “Evergreen TG700”. It is a polypropylene (PP) fabric with mass/unit area of 8 oz/yd³. Figure 16 shows results of extension tests on 8-in. wide and 20-in. long specimens.

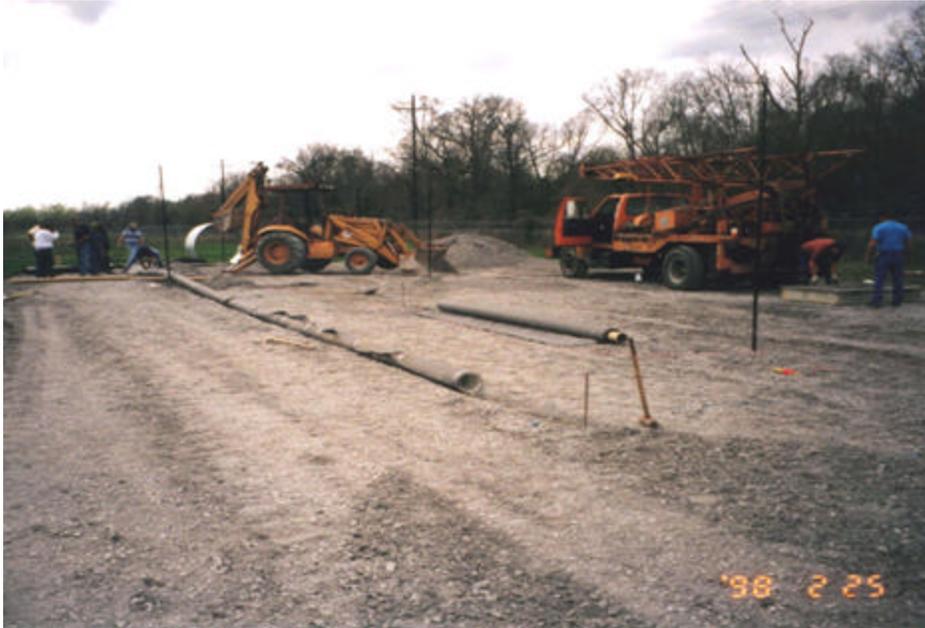
Figure 17
Placement of the drainage pipe in the stone base layer

- A 2-ft.-thick stone base layer was compacted on the top of the foundation soil. A woven geotextile layer was placed as a separator between the stone base and the foundation soil. A drainage pipe was installed in the layer (figure 17). The stone base was reinforced with two layers of geogrid UX-1600 placed at the bottom and at mid-height of the stone base. Figure 18 shows the placement of the stone base on the top of the first geogrid layer.

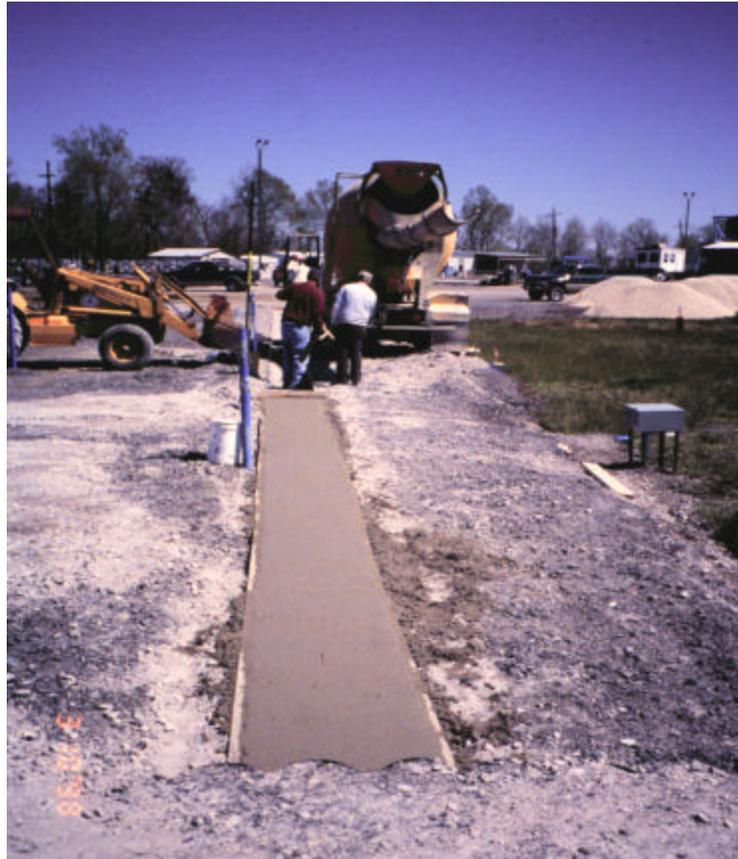
Figure 19
Construction of the leveling pad of the block facing

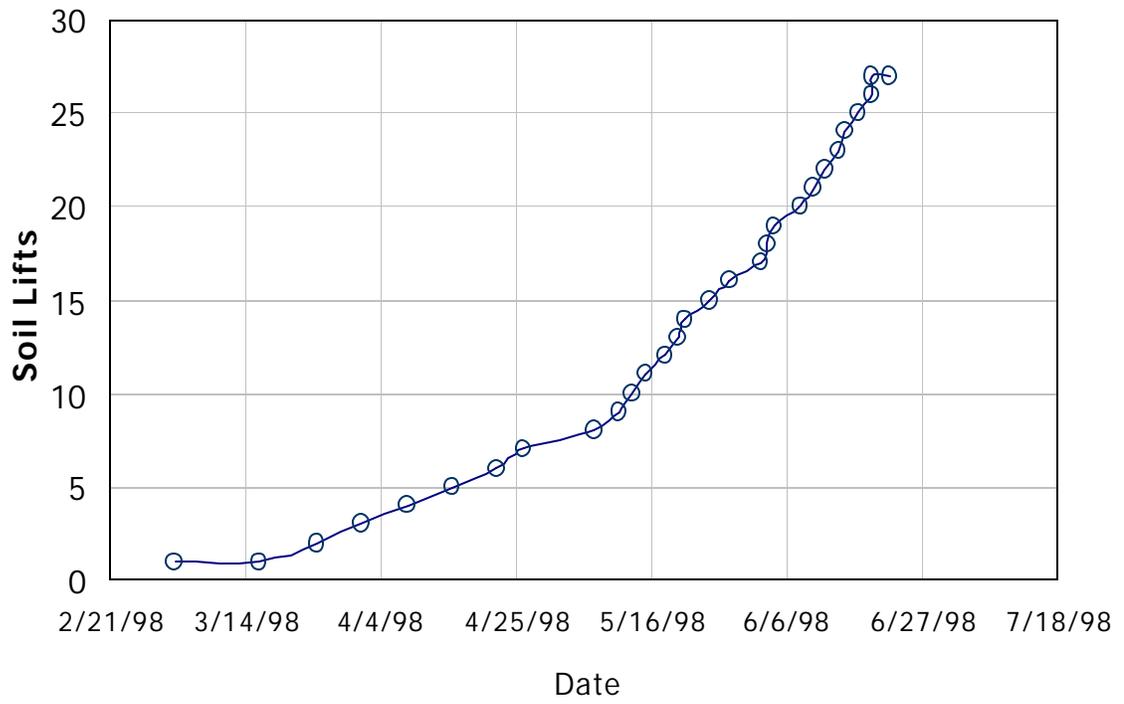
Figure 25
Construction of the test wall with time

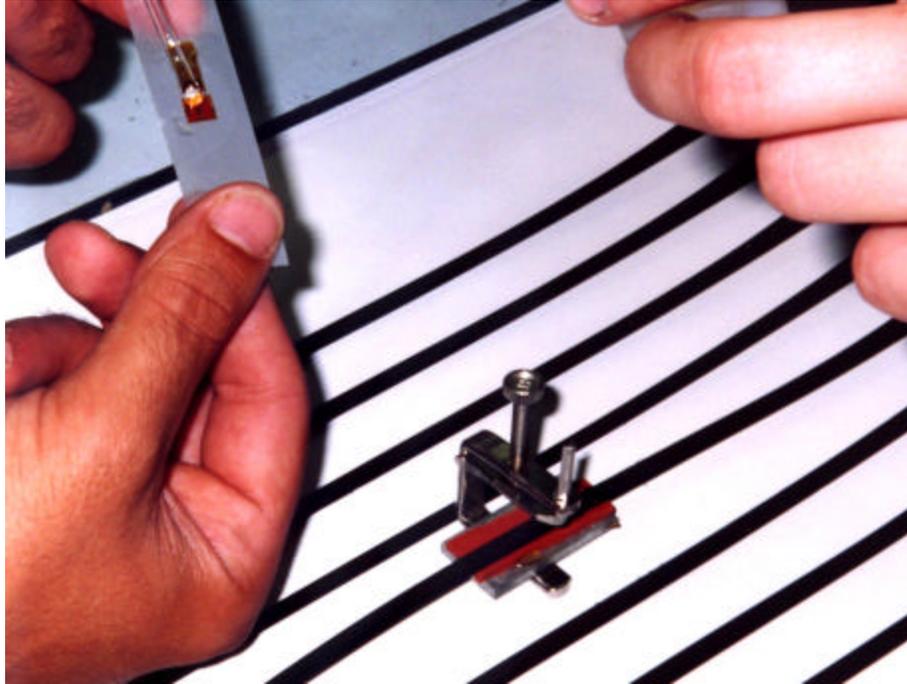
Figure 26
Installation of the strain gauge on the geogrid

Bondable terminals were installed 1/16 in. from the gauges. Flexible jumper wires were used as lead wires and the bondable terminals used were type MM CPF-75C. For the HDPE geogrid and the PP geotextiles, which do not absorb water, a two-component epoxy adhesive was used (M-Bond A-15). This adhesive is transparent with medium viscosity and has elongation capability of 15 percent at room temperature. The components were mixed to the recommended manufacturer's ratio (10 parts by weight of the "AE Resin" to 0.8 parts of the "Curing Agent 15"). The adhesive was thoroughly mixed for five minutes and then allowed to stand for additional five minutes before being applied to the surface. The gauges were placed on the adhesive and were clamped to the geogrid specimen during curing. Figure 26 shows the installation of the gauge on the geogrid.

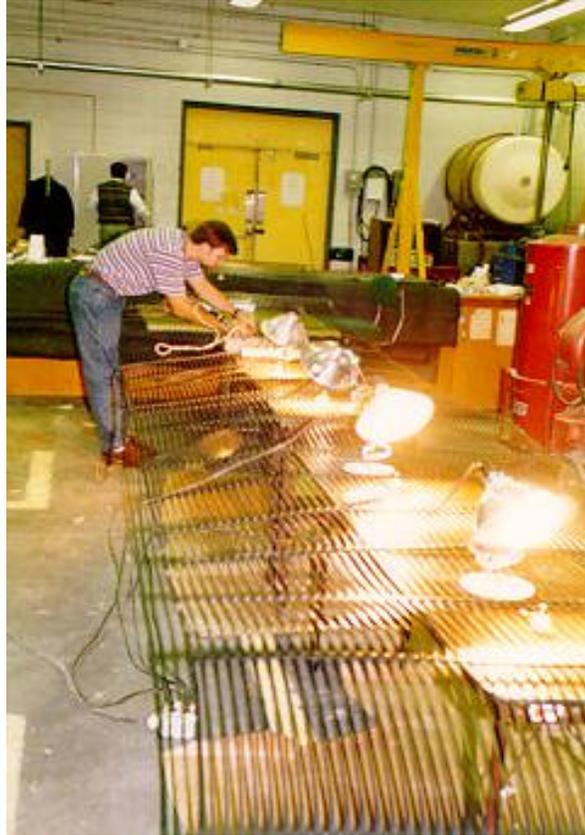
Figure 27
Curing the gauges at elevated temperature

The adhesive required a minimum curing time of six hours at elevated temperature of 125°F. Heat lamps were placed on top of the strain gauges in order to produce the curing temperature, which was measured by thermometers at the surface of the gauge. Figure 27 shows the curing of the instrumented geogrid in the lab.

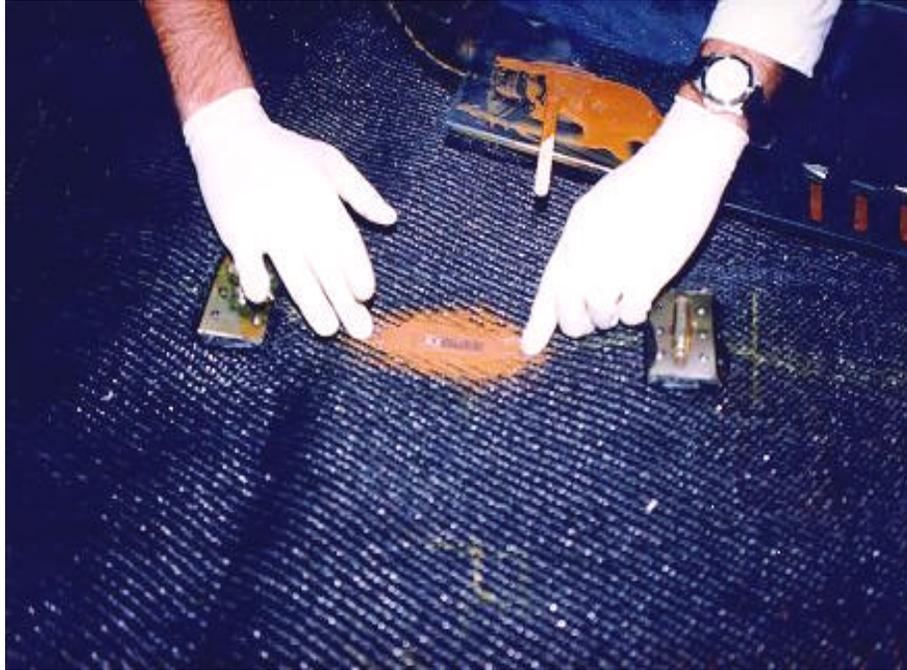
Figure 29
Installation of the gauges on the woven geotextile

For the woven geotextiles and polyester-coated geogrids, another adhesive type (M-Bond A-12) was used. This adhesive had similar elongation capabilities. However, it was more easily absorbed through the fabric, which produced better moisture insulation. The A-12 adhesive has two components, which were mixed to a ratio of two-to-three. The mix was blended with a spatula to a uniform color (figure 28). Dead weights were placed on the gauges to produce a uniform pressure and the gauges were cured for six hours at a temperature of 120°F. Figure 29 shows the installation of the gauge on the woven geotextile.

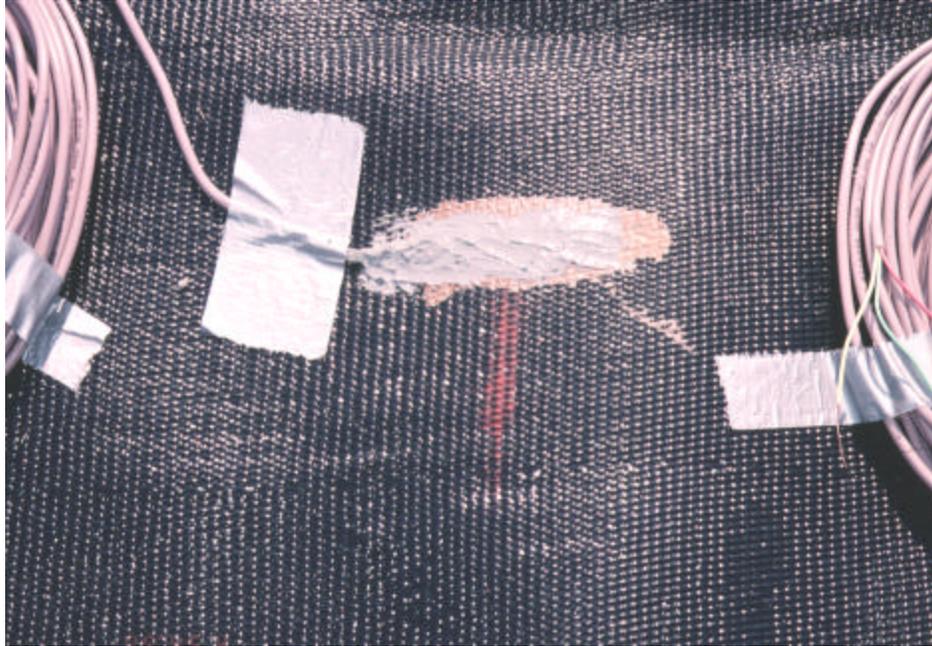
Figure 30
The coated strain gauge in the woven geotextile

- A Teflon film layer was placed on the gauges. The gauges and lead wires were coated with a layer of RTV silicon rubber. A non-corrosive type of 'Measurements Group' RTV 3145 was used. The coating was cured at elevated temperature for 24 hours.
- A layer of aluminum foil was placed around the coating.
- A layer of M-Coat FBT is placed on the gauge. M-Coat FBT is a butyl rubber compound, which forms an effective sealant to moisture without restricting the flexibility of the system. Figure 30 shows the coated strain gauge in the woven geotextile specimen.

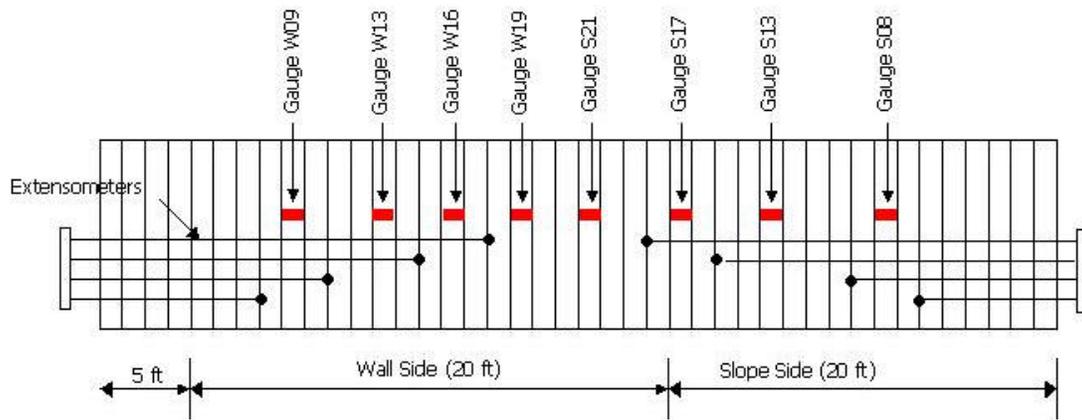
Figure 37
Locations of strain gauges and extensometers in the base reinforcement

Vibrating wire (VW) extensometers model “Geokon 4420-X” of 2-inch extension were also mounted on the cross ribs in order to measure the elongation of the longitudinal ribs. Measurements of the rod extensometers and the VW extensometers did not show consistent readings and many of them did not respond at later stages of wall construction. Most of the extensometer failures could be due to wall settlement, which resulted in large deformations in the extensometer pipes. These deformations consequently restrained the movement of the extensometer rods.

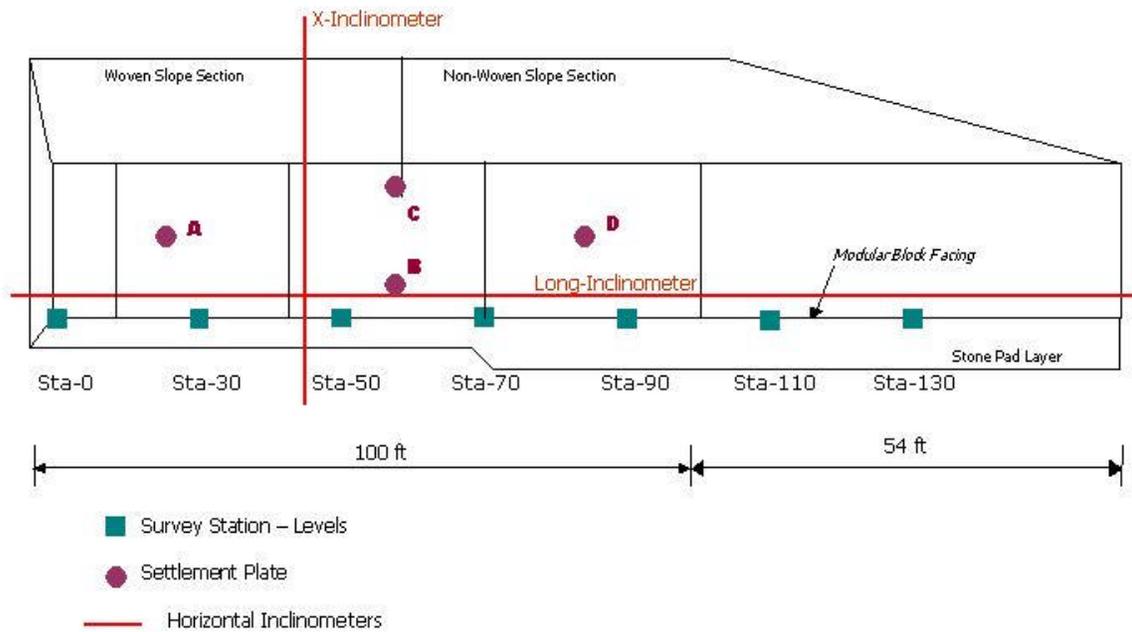
Figure 41
Schematic of the instruments used in monitoring wall settlement

The vertical movement of the wall due to the settlement of the soft foundation soil was monitored during and after construction. The monitoring procedure included the measurements of the elevations at the base of the wall, elevations of settlement plates installed at the wall base, and measurements of horizontal inclinometers. Figure 41 shows the locations of these instruments.

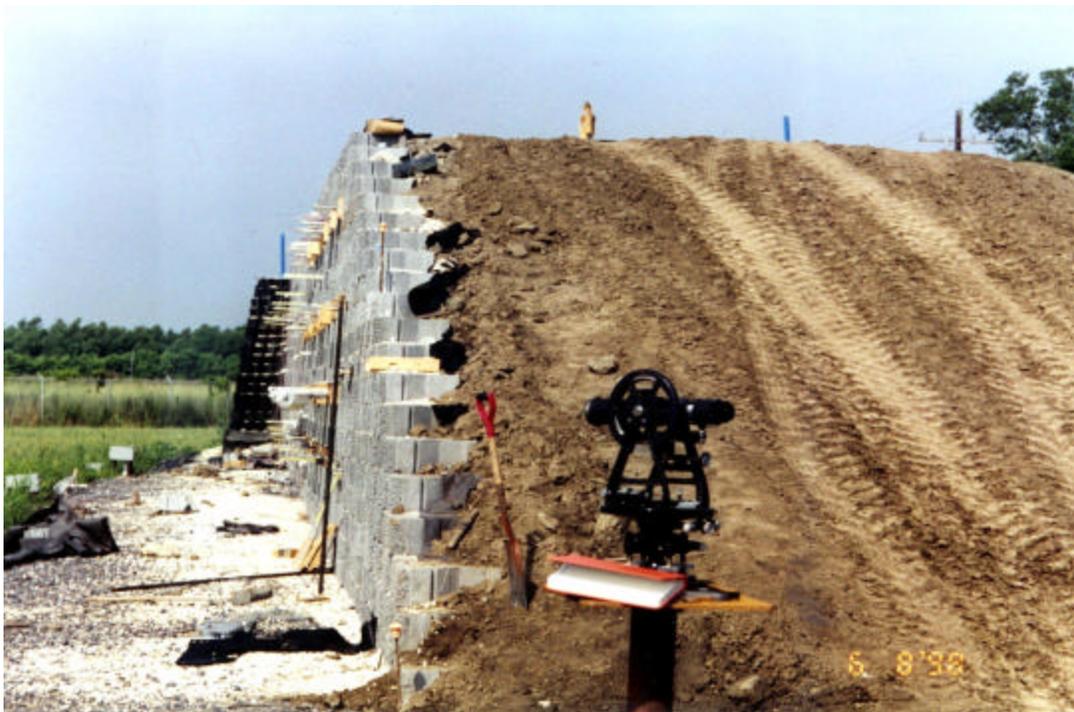
Figure 46
View of the measurements on the wall facing

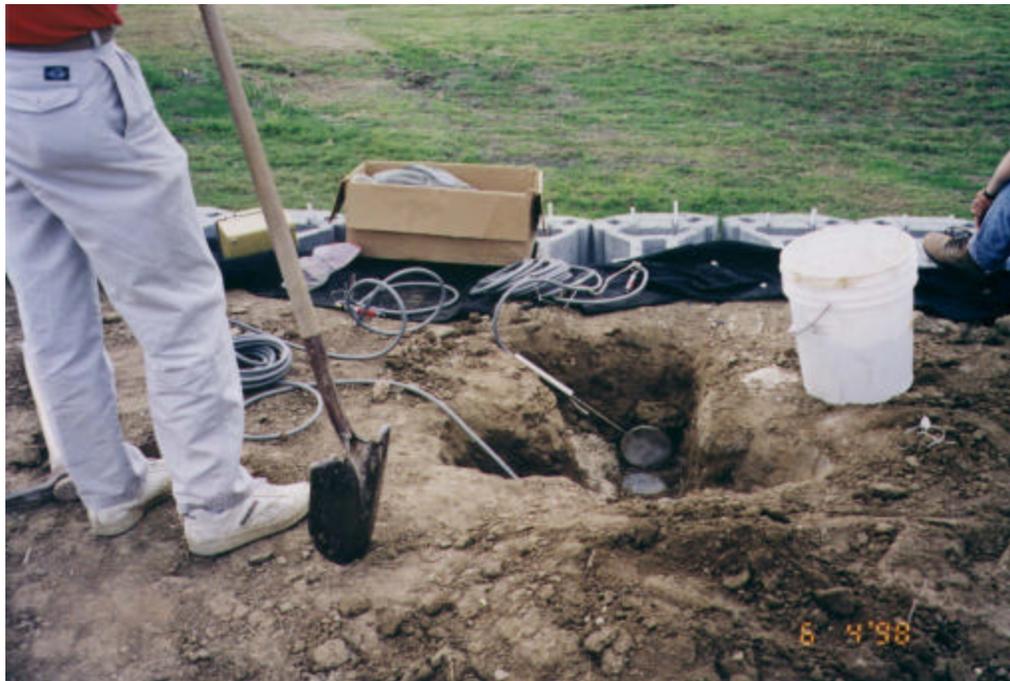
Figure 51
Installation of earth pressure cells near the wall facing

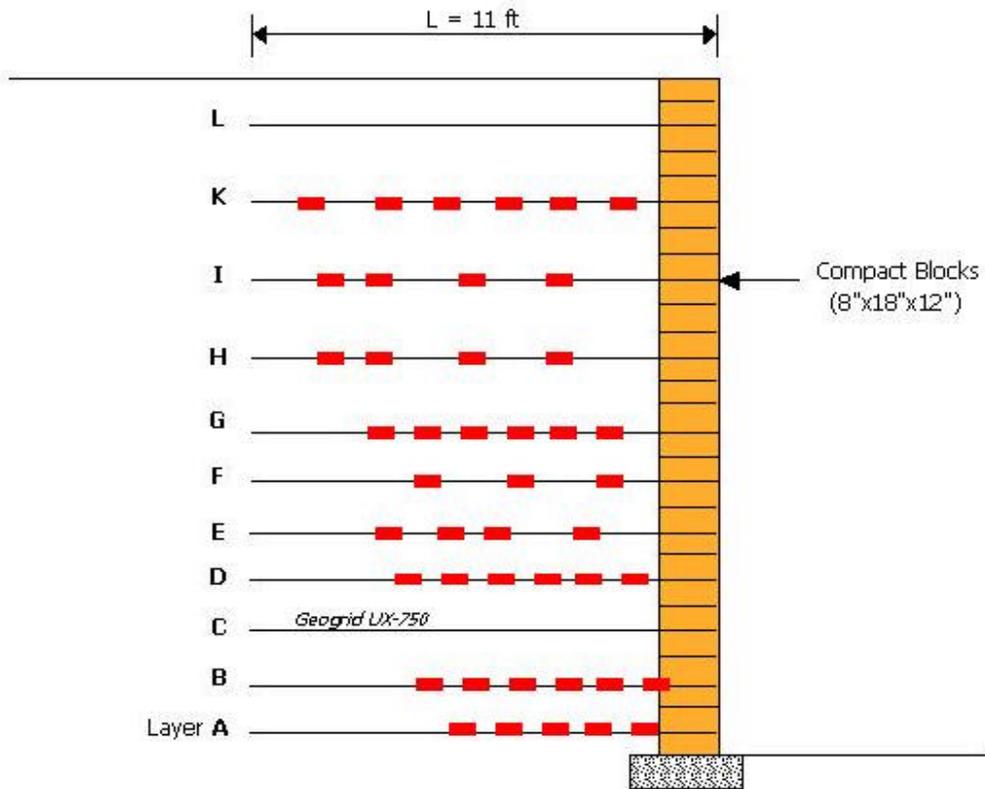
Figure 52
Schematic of the locations of strain gauges in the UX-750

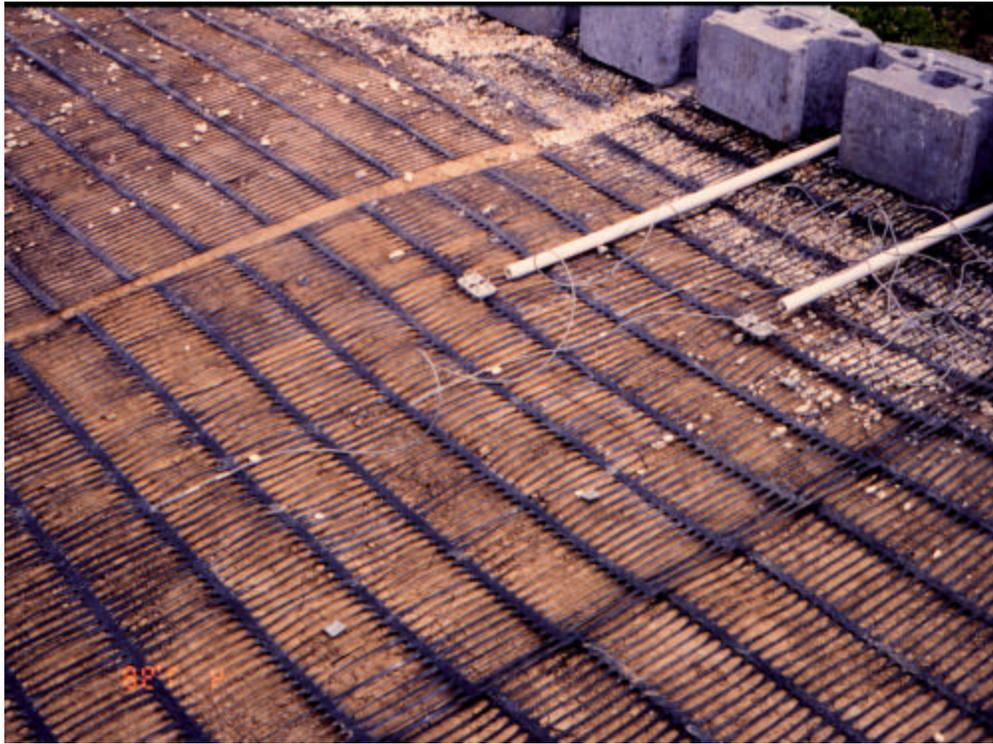
Figure 53
The instrumented section of the UX-750 geogrid in the wall

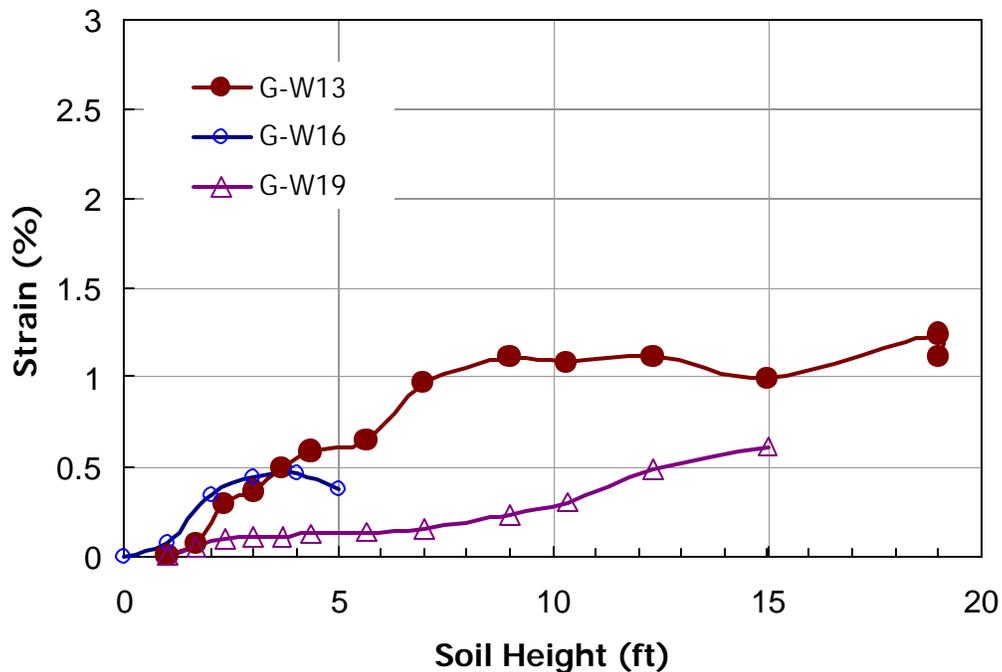
Figure 58
Strain measurements during construction of the vertical wall side

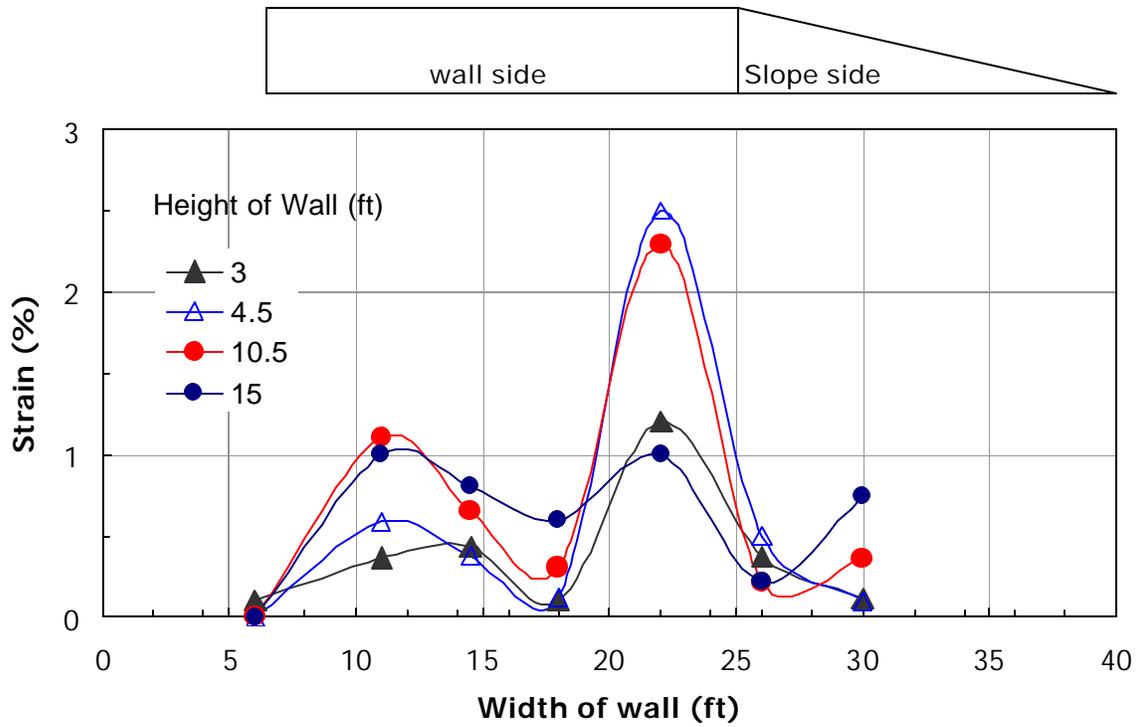
Figure 60
Strain distribution along the wall cross-section

The distribution of strains along the wall cross-section is shown in figure 60. The lower strain values at the end of construction indicate strain relaxation, possibly due to wall settlement and redistribution of strains along the base reinforcement. The figure also shows that the maximum strains did not occur at the center of the wall, but rather suggests the locations of the slip circles in both sides of the wall as shown in figure 61.

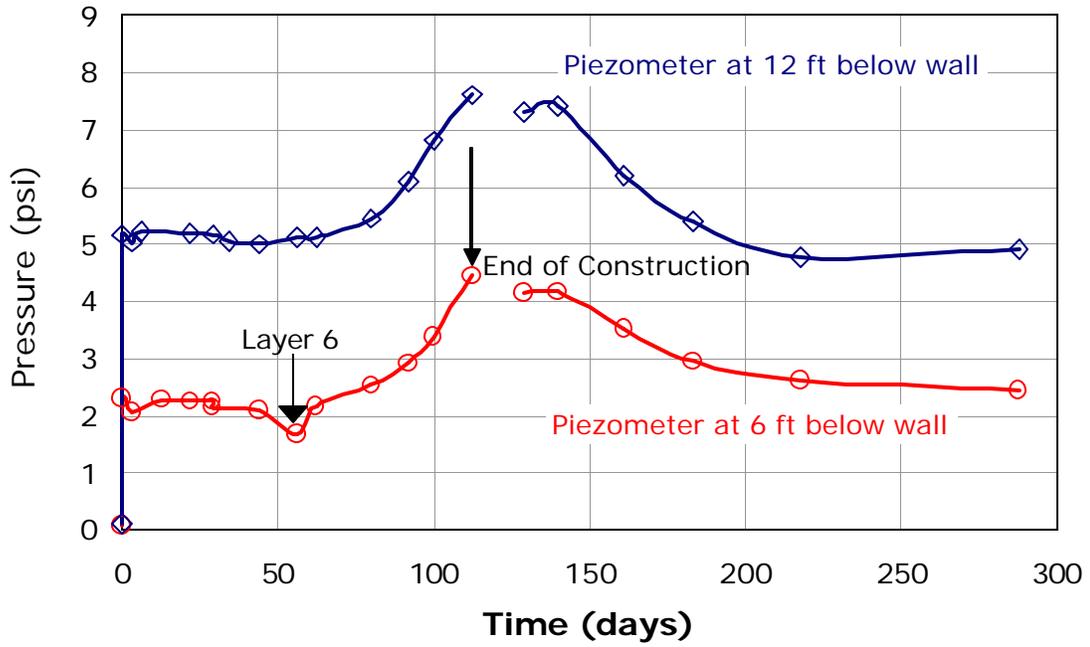
Figure 62
Piezometer readings during construction

The duration of the test wall construction was about four months. With the exception of the first month, little rainfall occurred during construction, and the ground water level did not significantly change. The relatively long period of construction allowed for partial dissipation of the pore water pressure. The measurements, however, showed an increase in pore water pressure at the late stages of construction. This stage was characterized by faster construction activities of about one soil layer per day. Refer to figure 25 for the display of construction activity with time. Figure 62 shows the measurements of pore water pressure during and after construction. The change of pore pressure with respect to the total earth pressure above the piezometers is shown in figure 63.

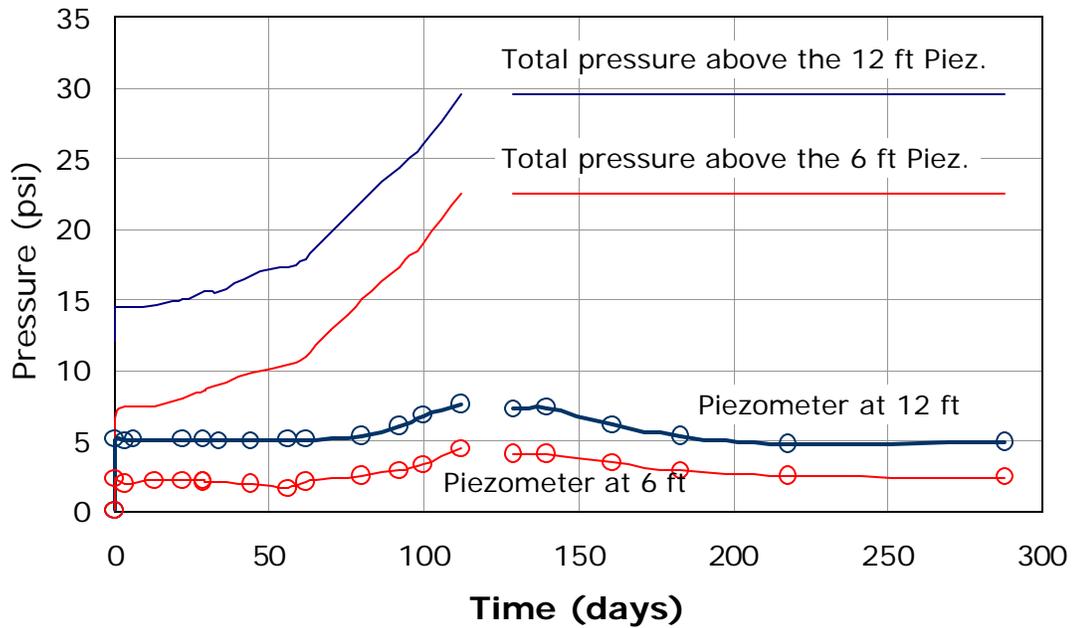
Figure 63
Development of total pressure and pore pressure during construction

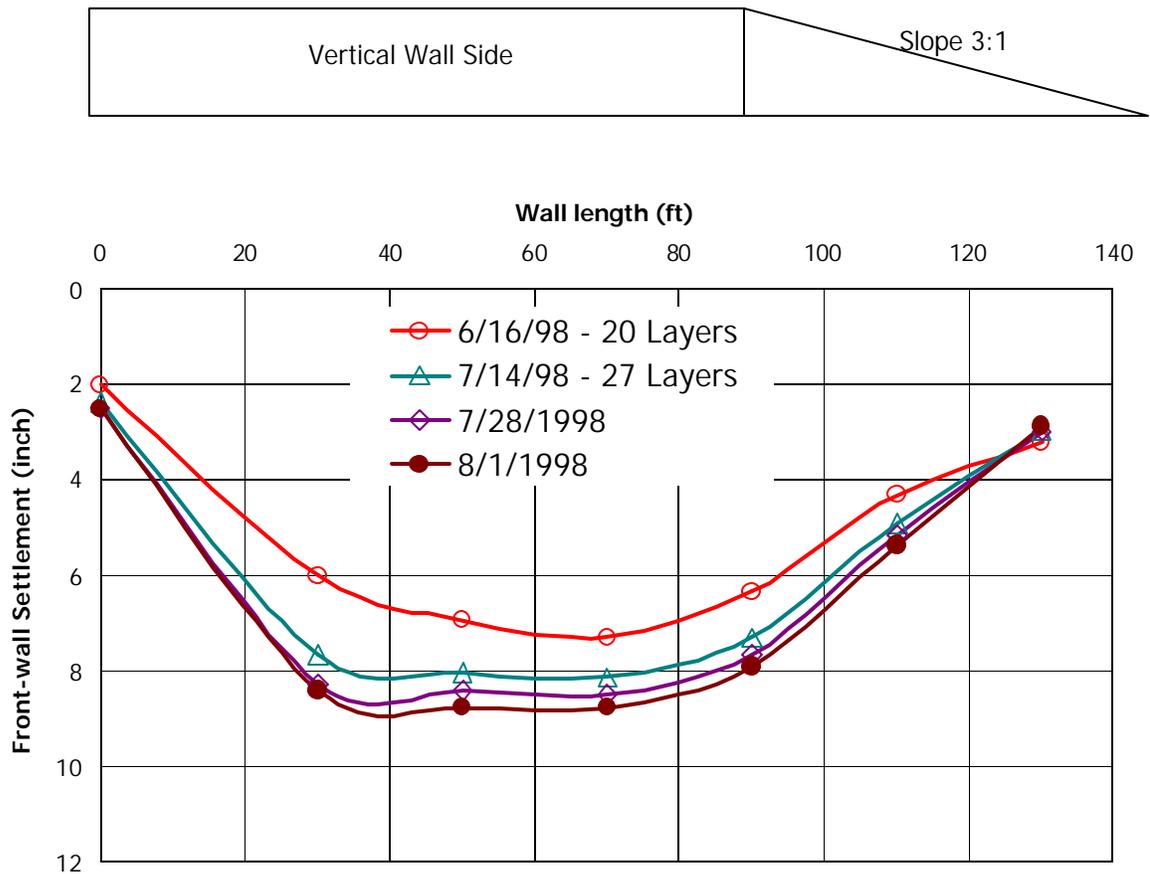
Figure 65
Settlement of the modular block facing of the wall

The results of the survey of the levels at the base of the vertical modular block facing are shown in Figure 65. The initial zero readings were taken on March 10, 1998, after the placement of the 2-ft. stone base layer and the first soil layer of the wall. The facing settlement was approximately uniform along the constant height of the wall and it linearly decreased to zero along the 3:1 slope at the side of the wall. A maximum settlement of about 8.5 in. was measured at the middle of the facing at the end of construction. It should be noted that this value is at the facing and it is not the maximum settlement under the wall.
