1. Report No. FHWA/LA.03/379	2. Government Accession No.	3. Recipient's Catalog No.
4. Title and Subtitle Evaluation of Interaction Properties of Geosynthetics in Cohesive Soils: LTRC Reinforced-Soil Test Wall	5. Report Date January 2004

16. Abstract <p>This report presents the construction and performance evaluation of the LTRC reinforced-soil test wall. The 20 ft. high, 160 ft. long wall was constructed using low quality backfill. Its vertical front facing was constructed with modular blocks. It consisted of three sections reinforced with various geogrid reinforcement types and spacing. The backside of the wall was a one-to-one slope reinforced with woven and non-woven geotextiles.</p> <p>The test wall was constructed to evaluate the design procedure and performance of geosynthetic-reinforced structures constructed with marginal silty-clay backfill over soft clay foundation. The instrumentation program consisted of monitoring wall deformation, foundation settlement, strains in the reinforcement, vertical and horizontal stresses in the soil, and pore water pressure under the wall. Results of the monitoring program from construction through four months after completion of the wall

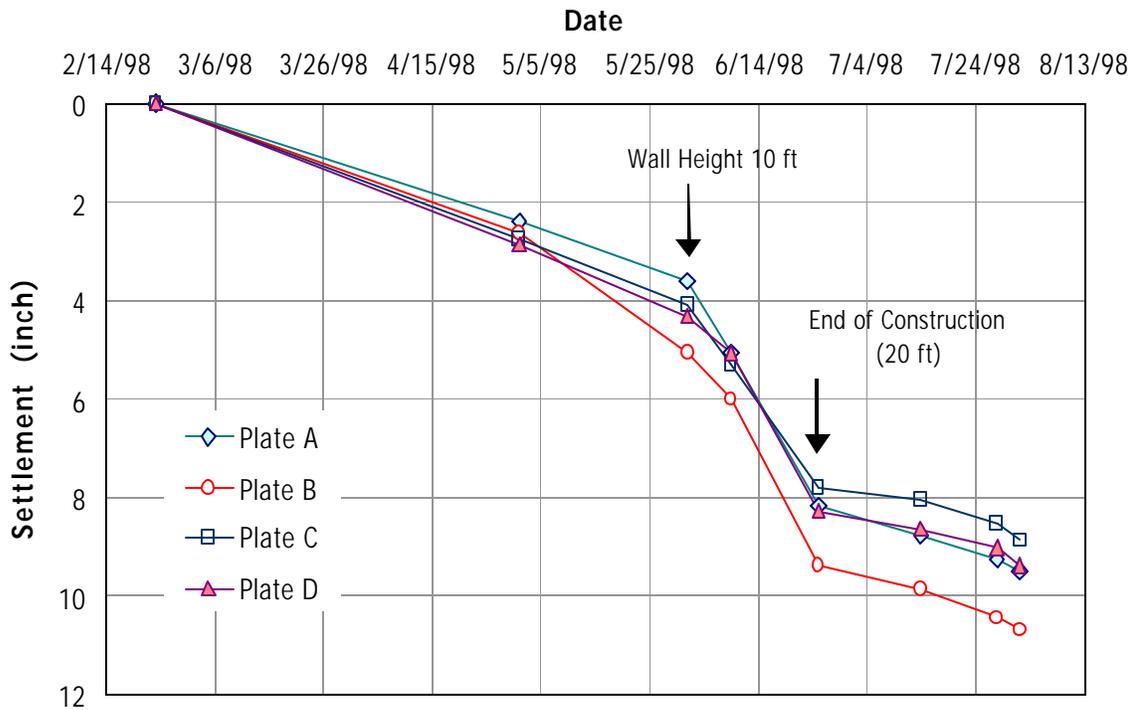
Figure 66
Measurements of the settlement plates at the base

The survey results of the settlement plates are shown in figure 66. The figure shows the measurements in the four plates during the four-month construction period. Refer to figure 41 for the locations of the settlement plates. The measurements show a maximum settlement of about 9.5 in. near the vertical wall facing, which compares well with the survey measurements at the facing. The measurements at the other plates show a uniform wall settlement of about 8.5 in. at the end of construction. It should be noted that figure 66 shows settlement measurements until one month after the completion of construction. Consolidation settlement continued to increase during the three-month post-construction monitoring period.

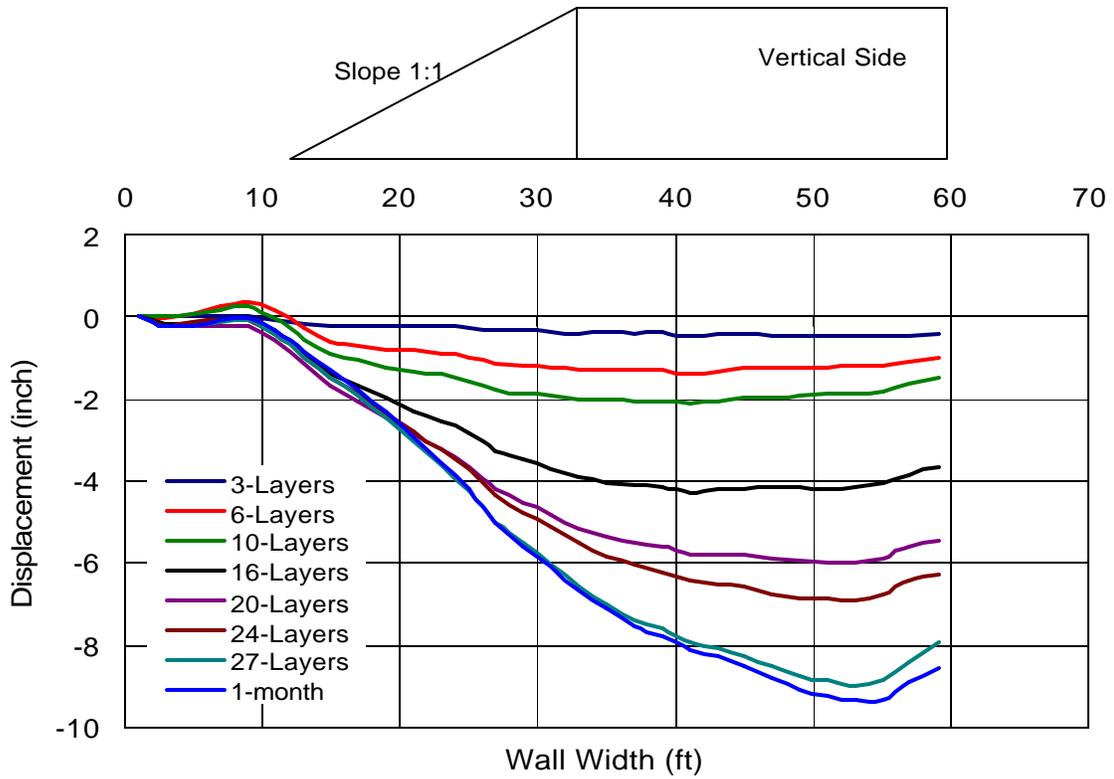
Figure 67
Settlement profile from cross-inclinometer

Settlement measurements from the cross and longitudinal horizontal inclinometers are shown in figures 67 and 68, respectively. Refer to the locations of the inclinometers in figure 41. The results of the cross-inclinometer showed a maximum settlement of about 10 in. near the wall facing at the end of construction. The longitudinal inclinometer readings were taken only for 40 ft. along the length of the wall since the remaining part of the inclinometer pipe was damaged during construction. The results of the inclinometers compared well with each other and with the settlement plates and survey measurements.

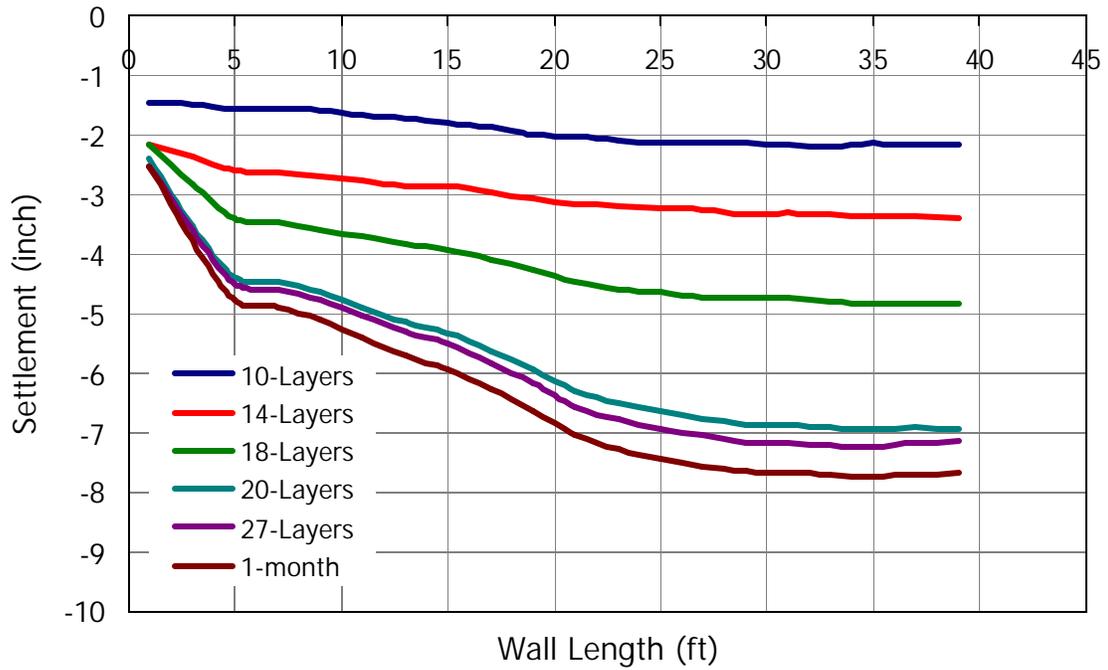
Figure 68 Settlement profile from longitudinal-inclinometer

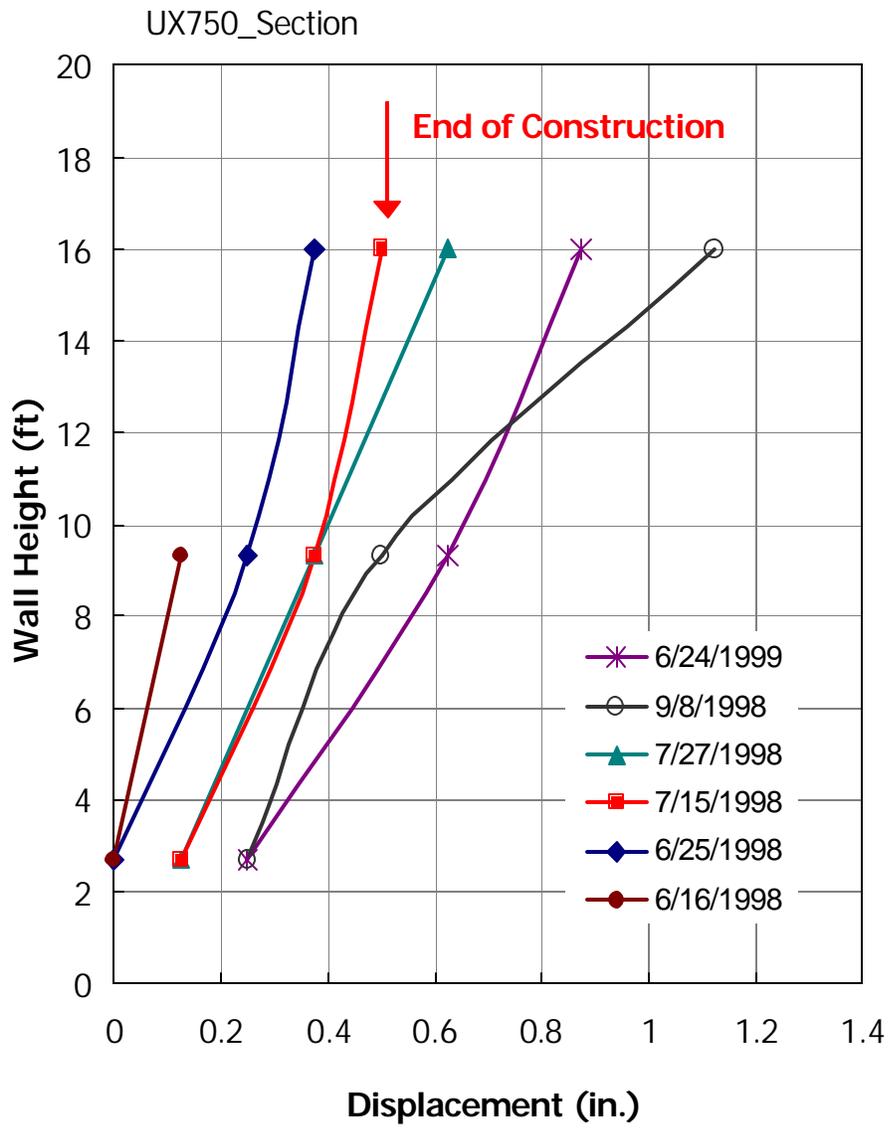
Figure 69
Deformations at the facing of wall section 1

Most of the deformations occurred during construction and during the first 3 months after the completion of the wall. Smaller deformations were monitored in the period from 3 months (9/1998) to one year (6/1999) after construction.

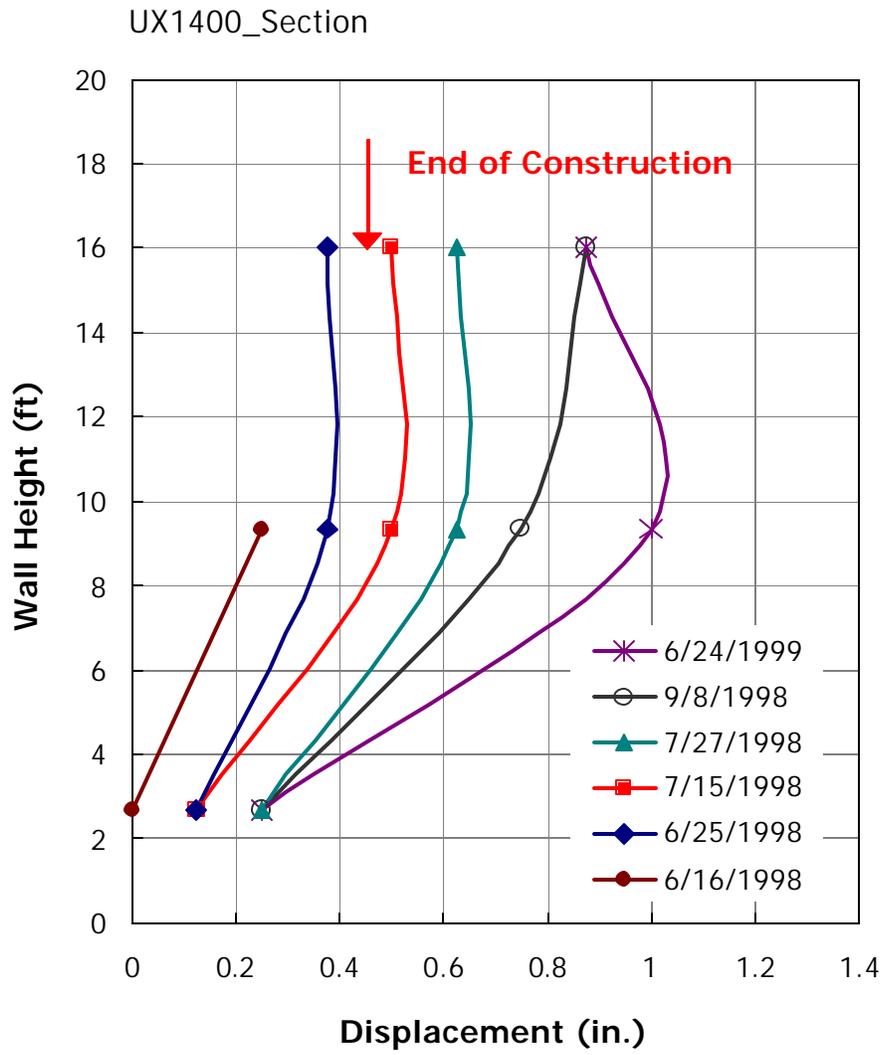
Figure 70
Deformations at the facing of wall section 2

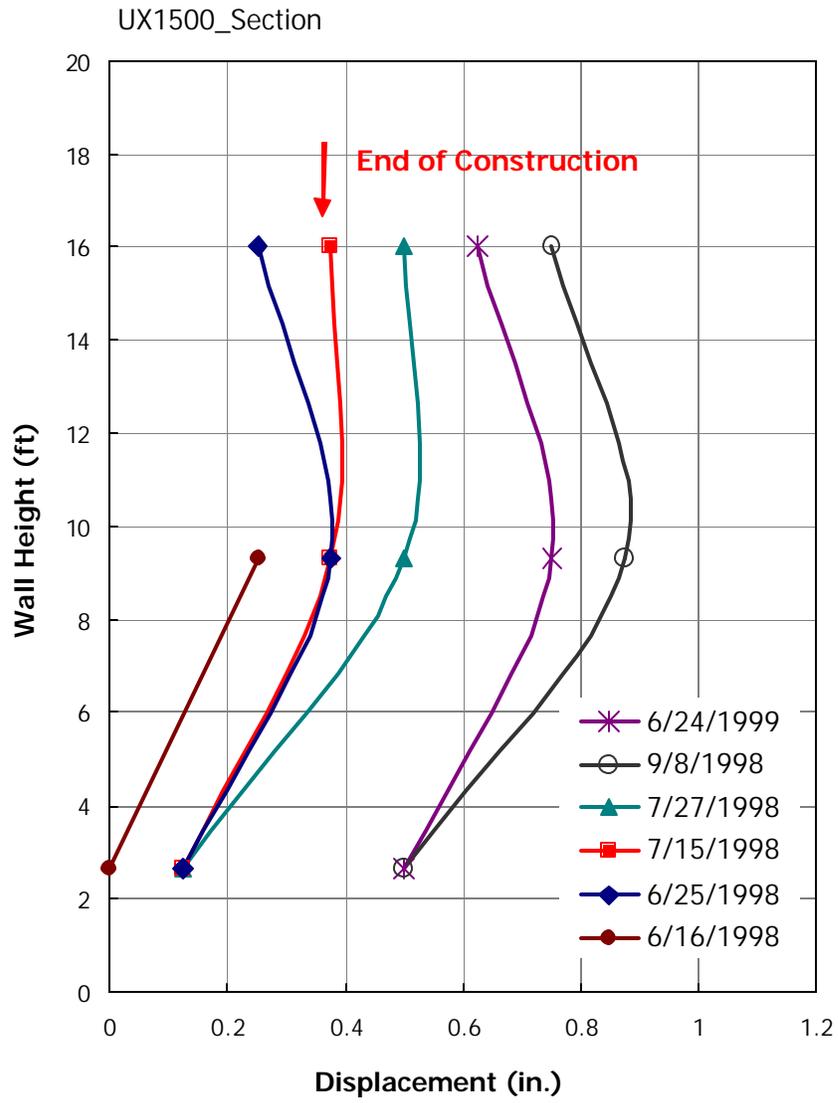
Figure 71
Deformations at the facing of wall section 3

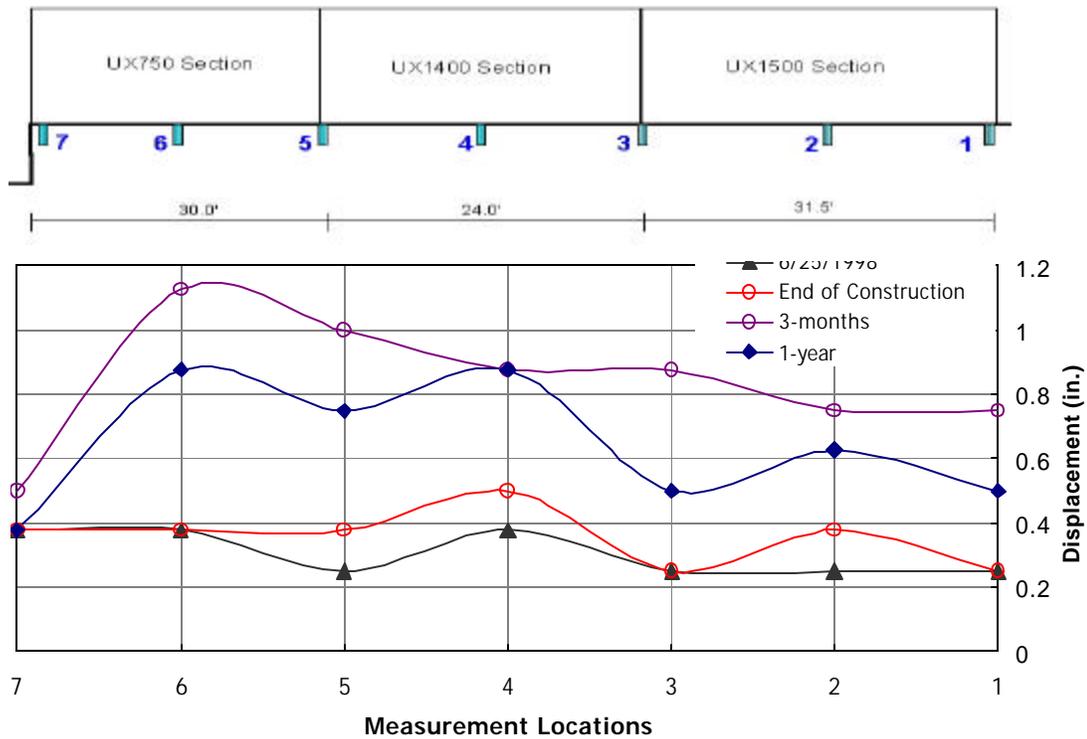
Figure 72
Longitudinal profile of displacement at top level of wall

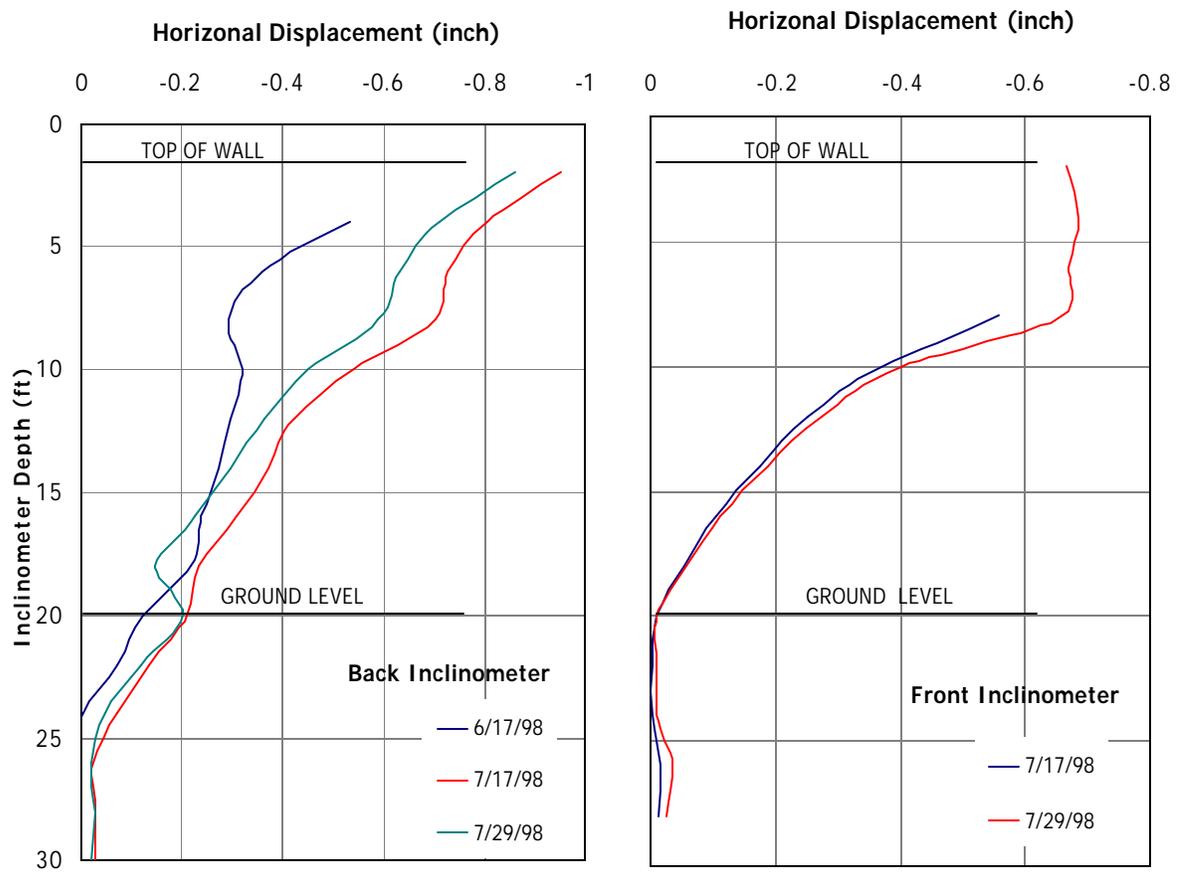
Figure 73
Vertical inclinometer measurements in wall section 1

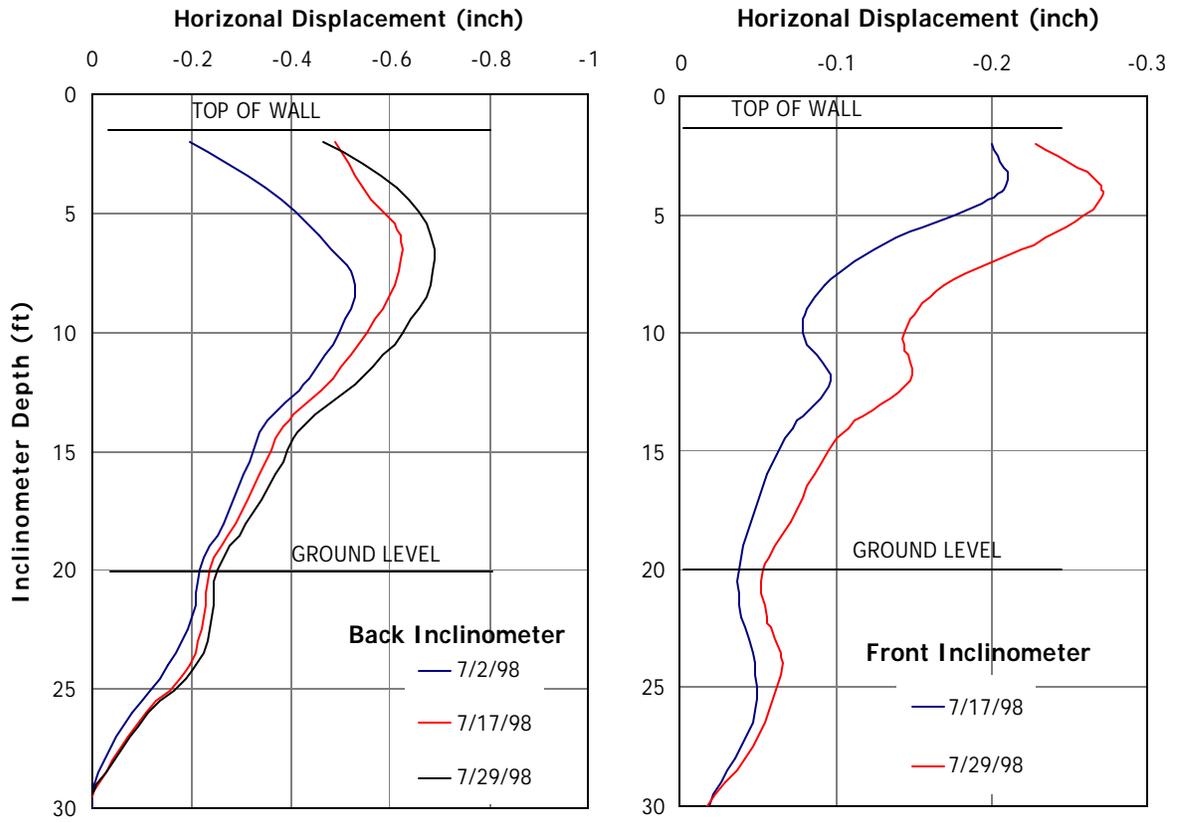
Figure 74
Vertical inclinometer measurements in wall section 2

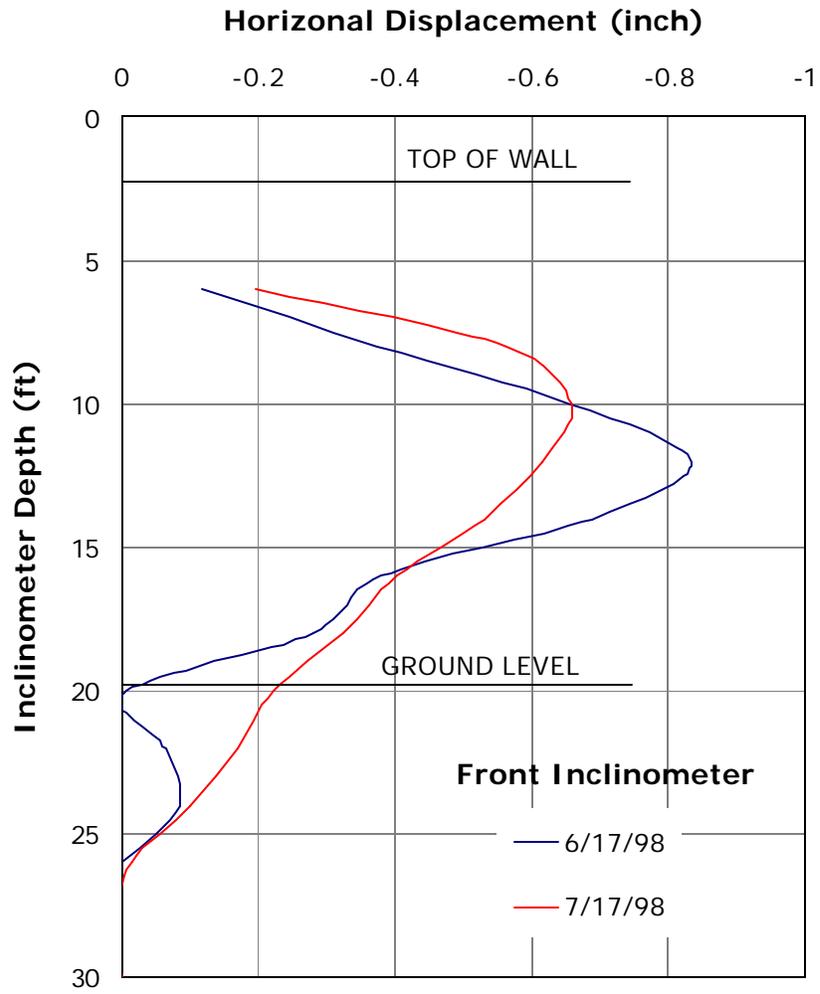
Figure 75
Measurements of front inclinometer in woven slope section

The results of the vertical inclinometer at the top of the woven slope are shown in figure 75. The measurements of the inclinometer at the mid-height of the slope were not successful due to the damage of the inclinometer pipe during construction. The results show that the movement of the slope reached a maximum of 0.8 in. with the maximum deformation measured at the mid-height of the slope.

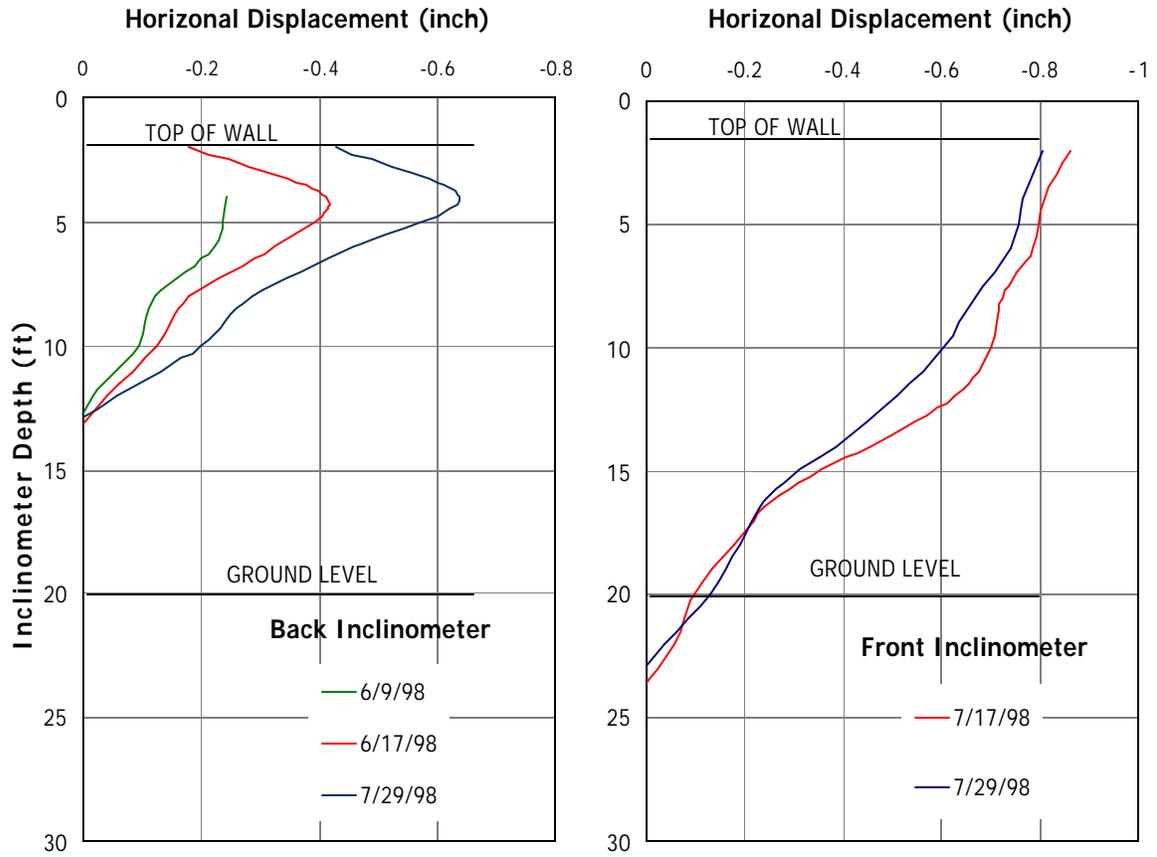
Figure 76
Vertical inclinometer measurements in the non-woven slope

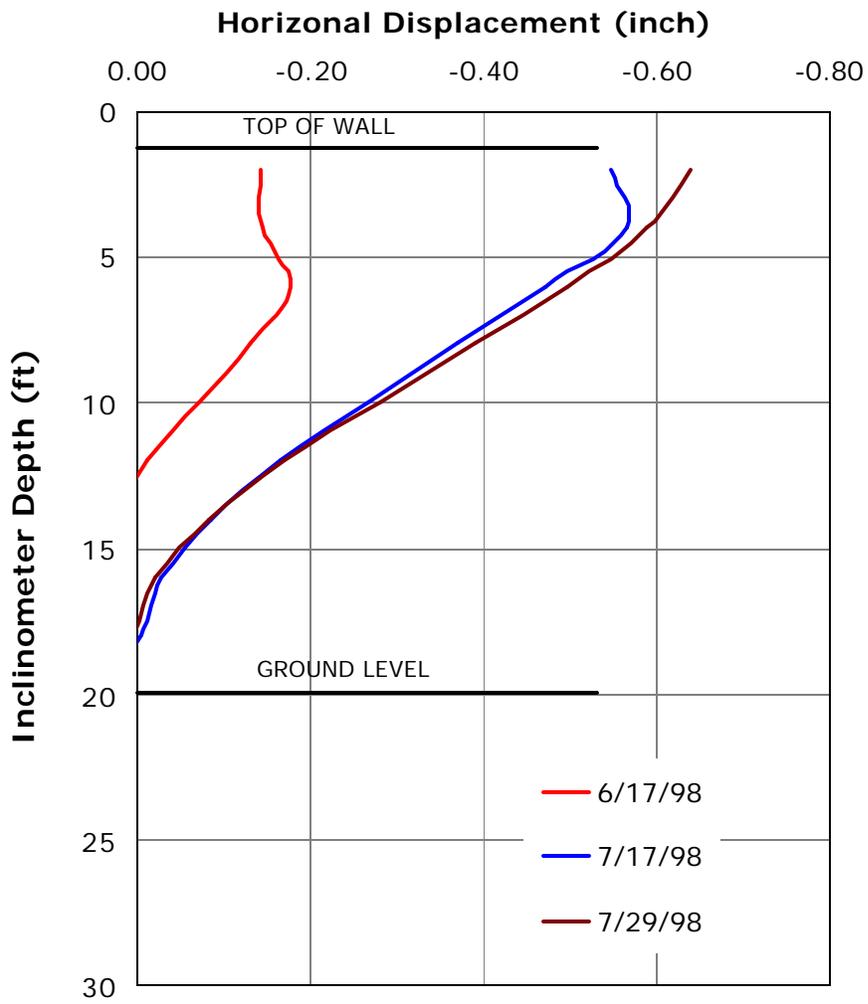
Figure 77
Vertical inclinometer measurements in the Geoweb section

The results of the inclinometer readings in the vertical side of the Geoweb section are shown in figure 77, which show that the maximum deformation was 0.6 in. with most of this value occurring during the late stages of construction.

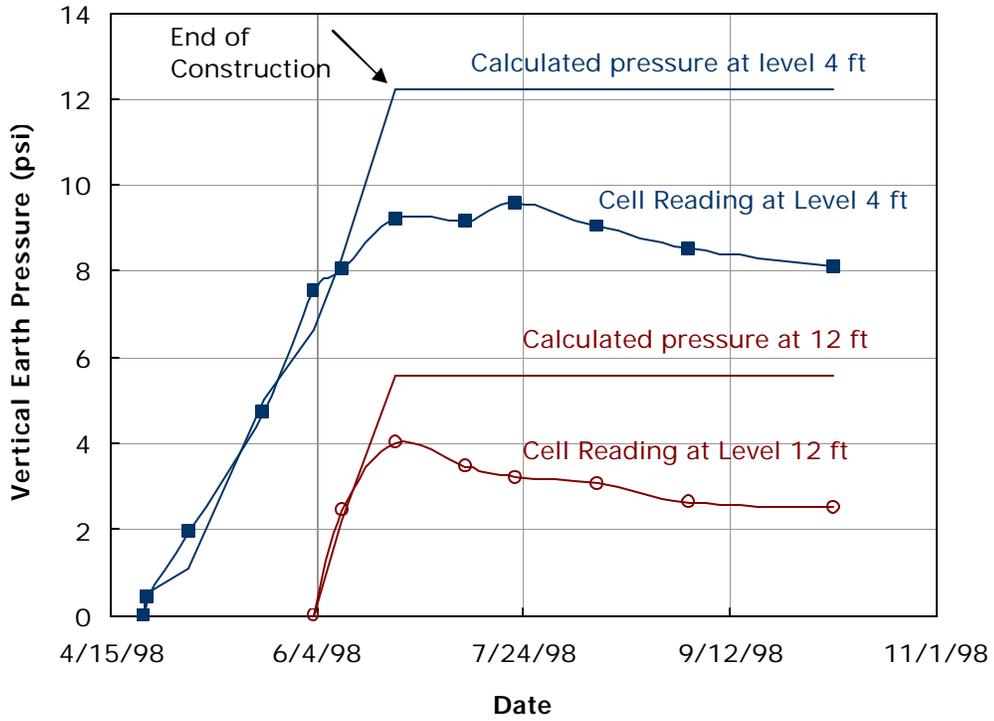
Figure 81
Measurements of vertical soil pressure

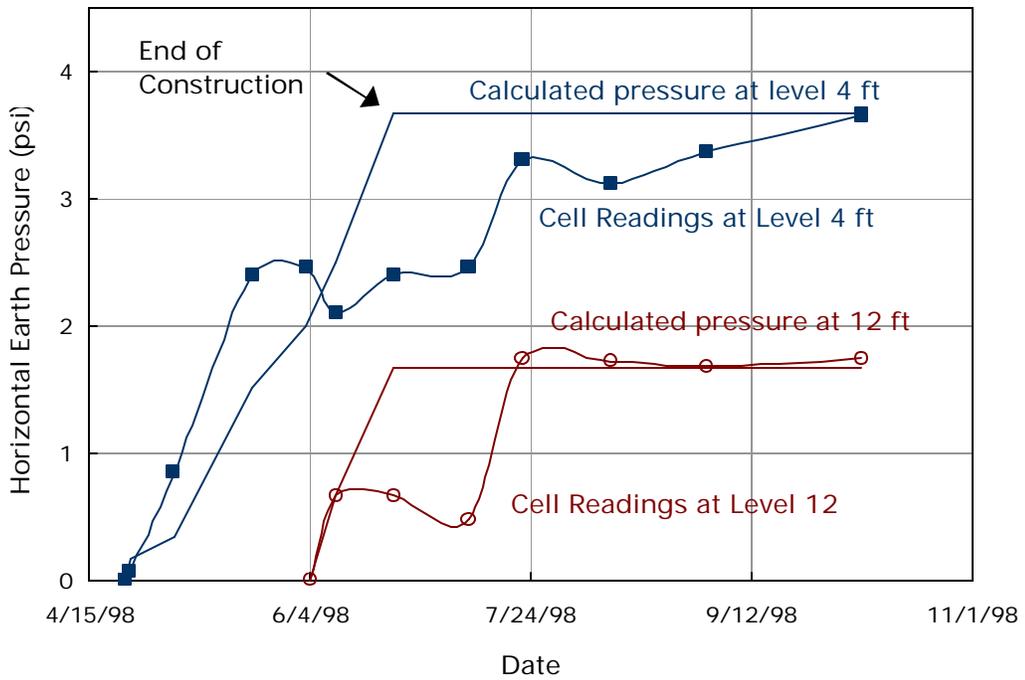
Figure 82
Measurements of horizontal soil pressure

Similarly, the measurement of the horizontal earth pressures were measure by vertical pressure cells at the same locations. The results are shown in figure 82 along with theoretical earth pressure values (based on $K_a = 0.3$). The results show that horizontal earth pressure did not fully mobilize till the end of construction.

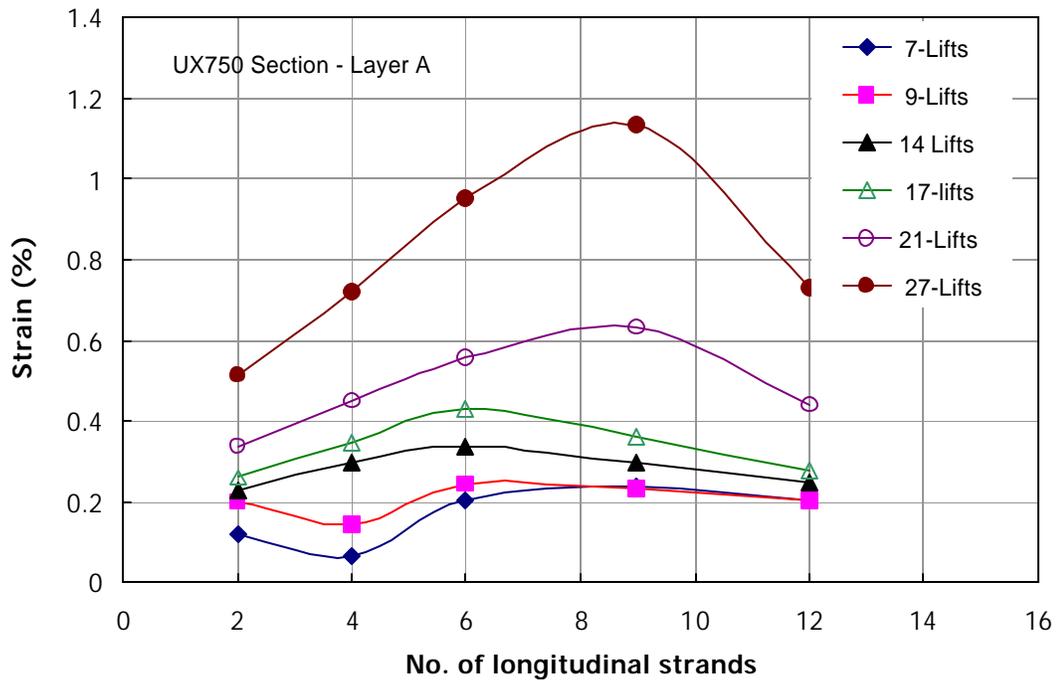
Figure 84
Distribution of strains along the reinforcement in layer A

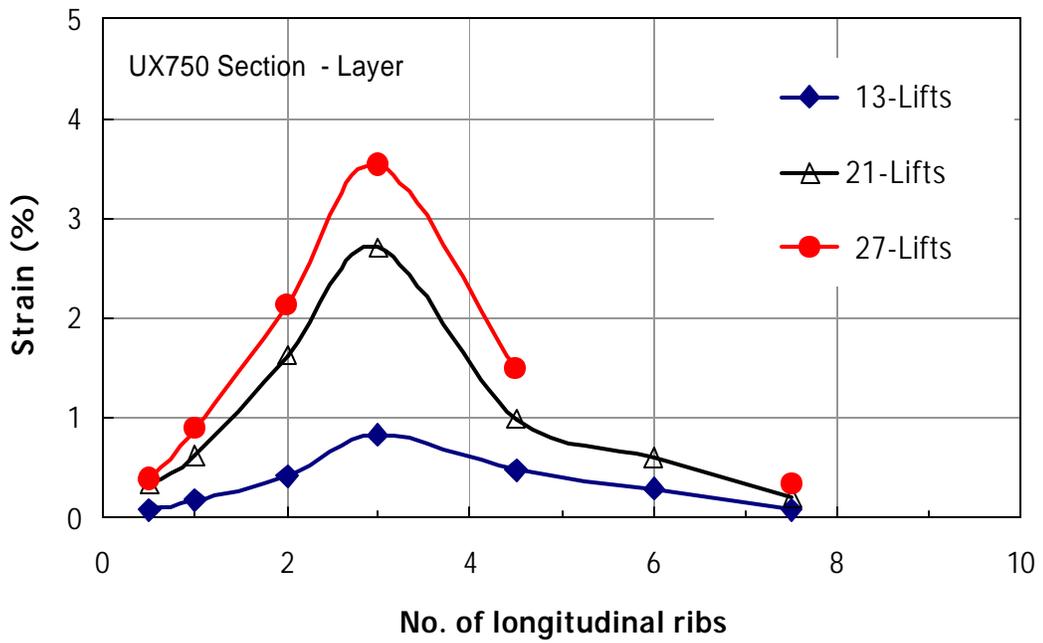
Figure 88
Distribution of strains along the reinforcement in layer D

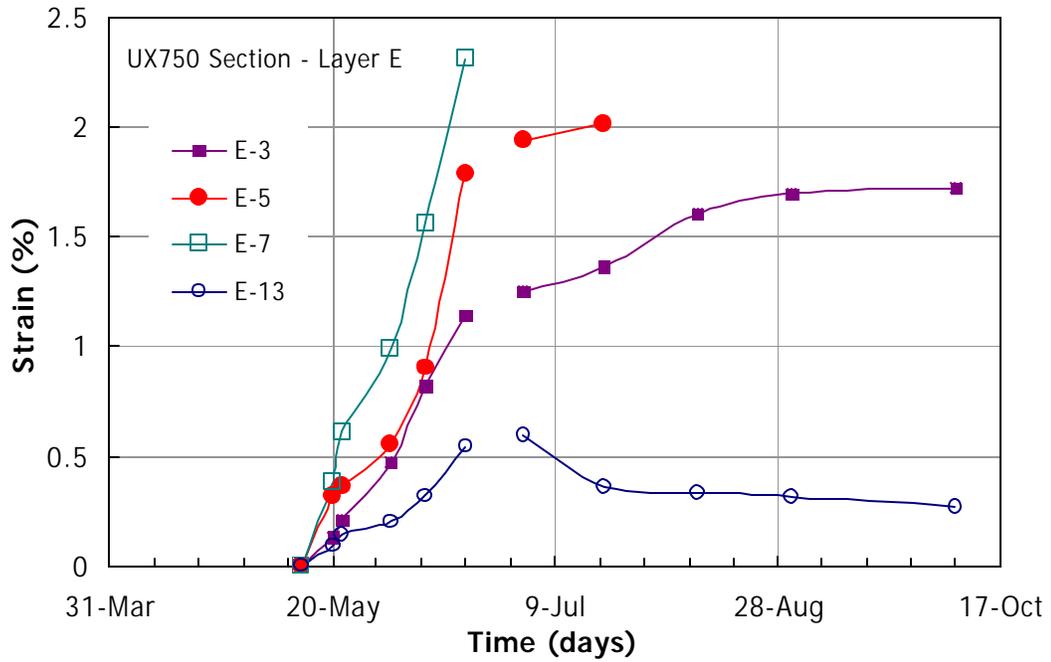
Figure 89
Strain measurements of layer E in test section 1

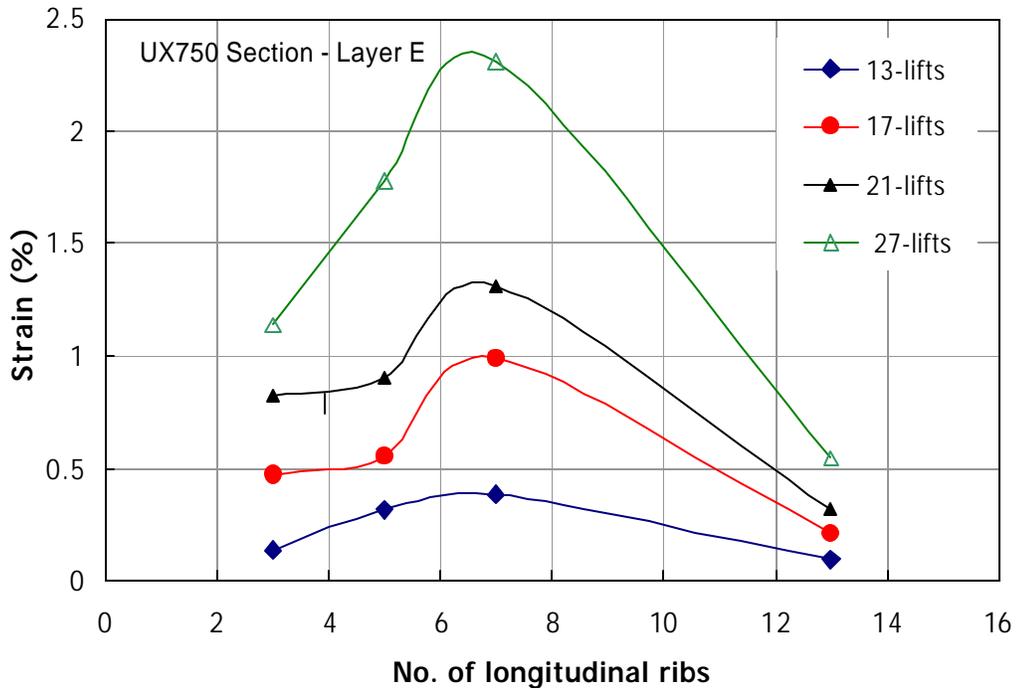
Figure 90
Distribution of strains along the reinforcement in layer E

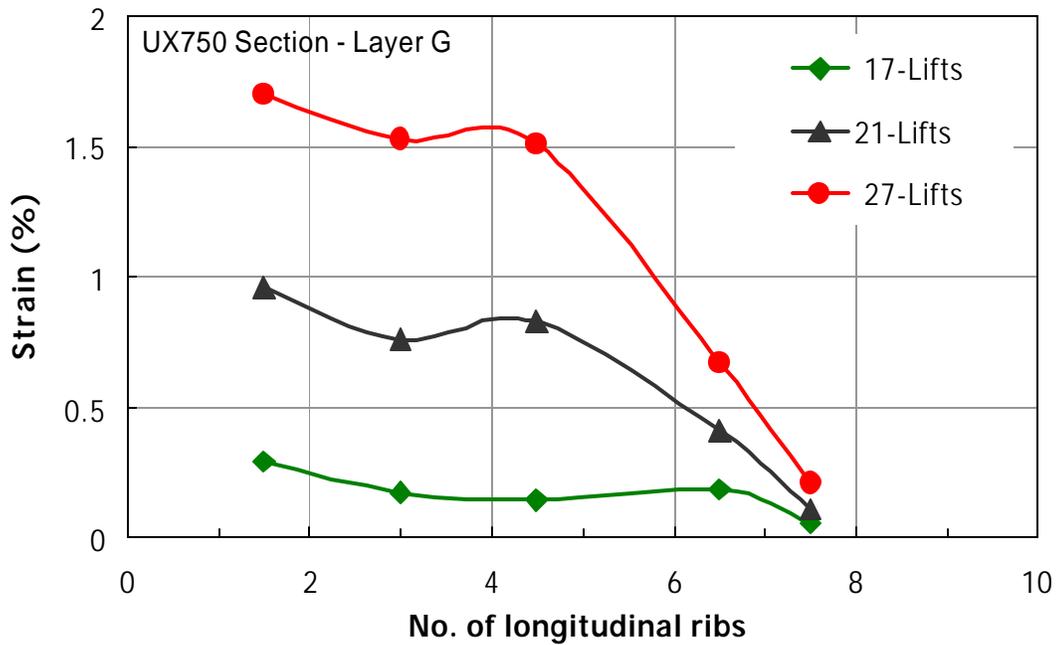
Figure 94
Distribution of strains along the reinforcement in layer G

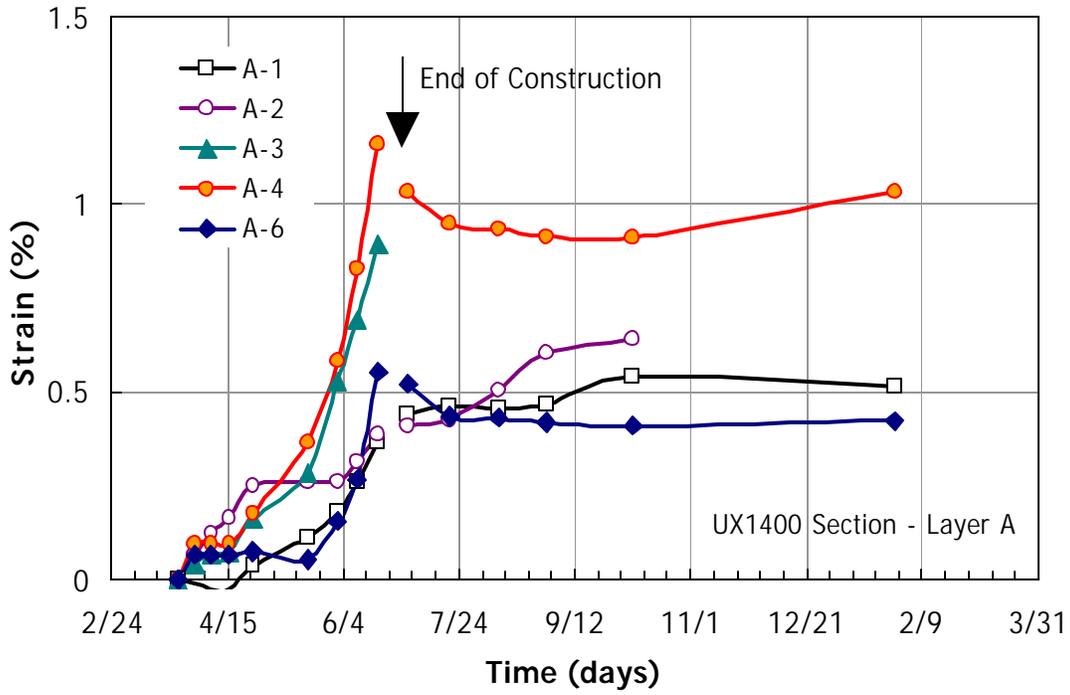
Figure 101
Strain measurements of layer A in test section 2

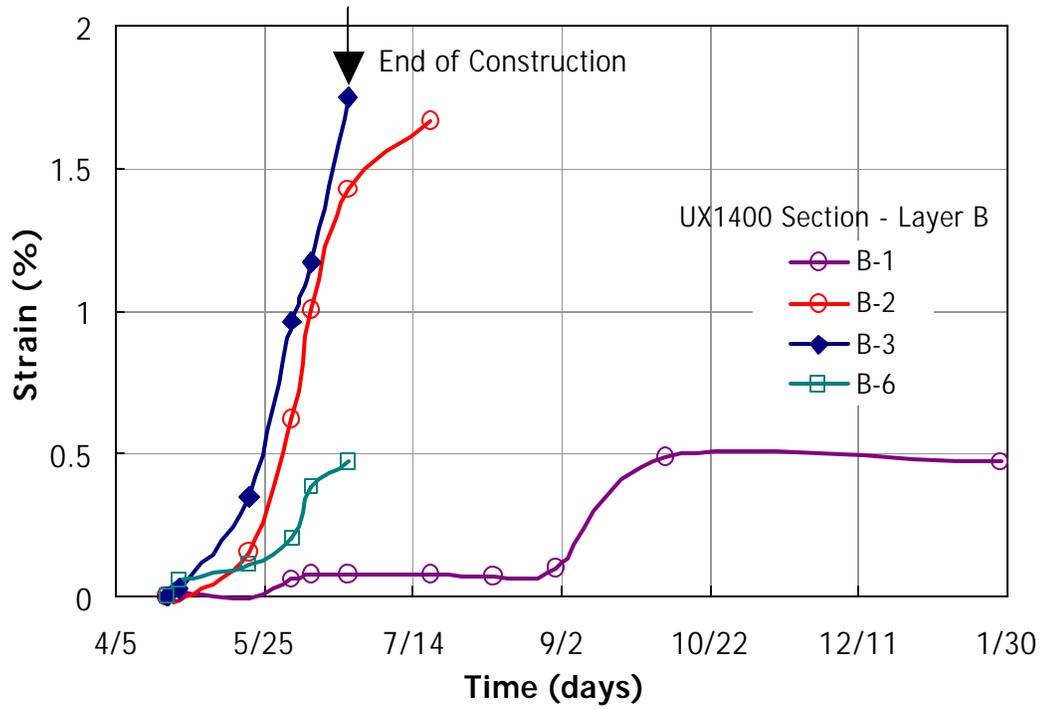
Figure 103
Strain measurements of layer B in test section 2

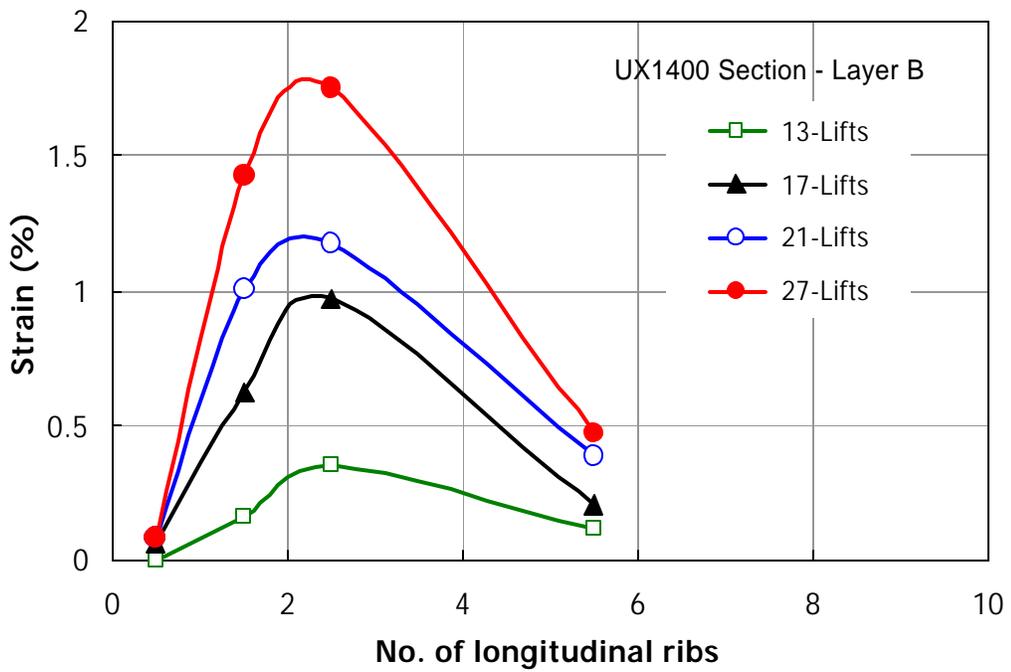
Figure 104
Distribution of strains along the reinforcement in layer B

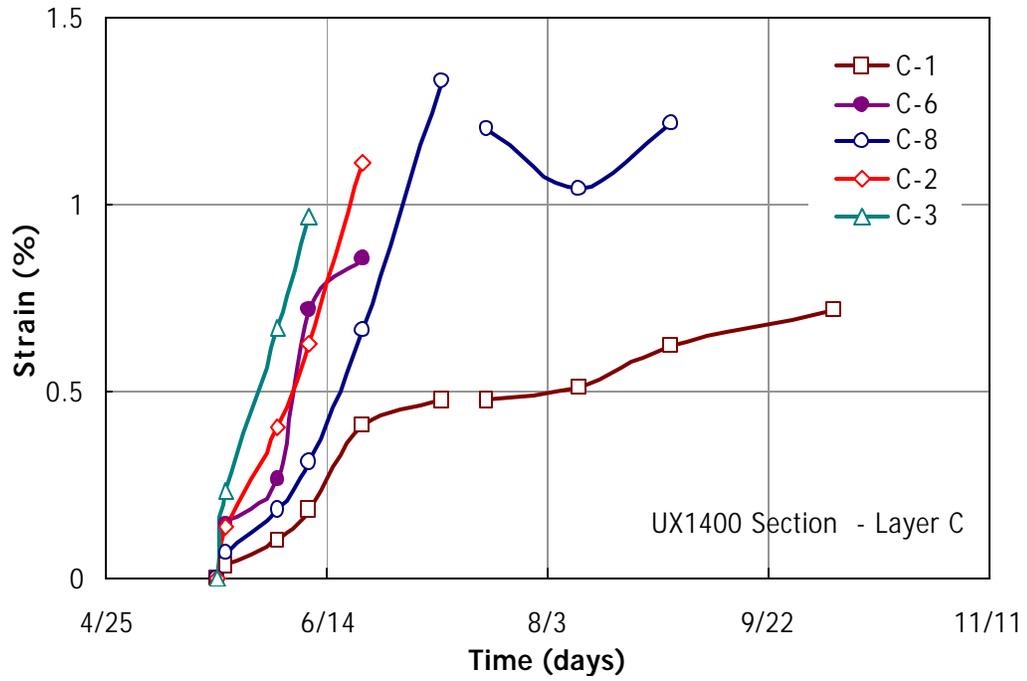
Figure 105
Strain measurements of layer C in test section 2

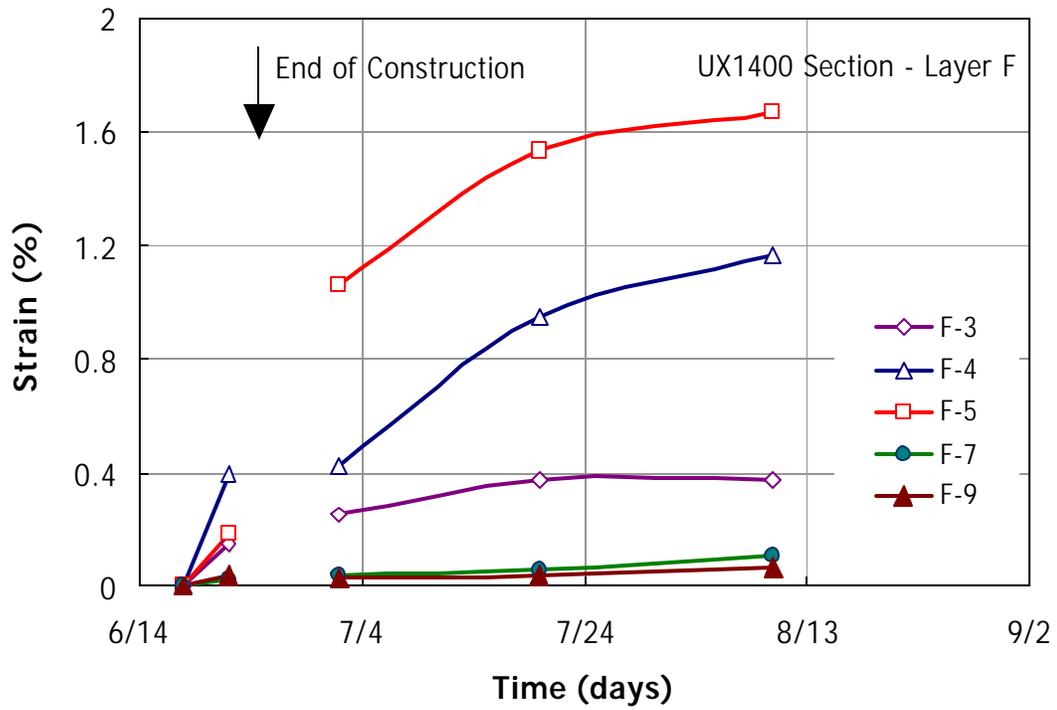
Figure 111
Strain measurements of layer F in test section 2

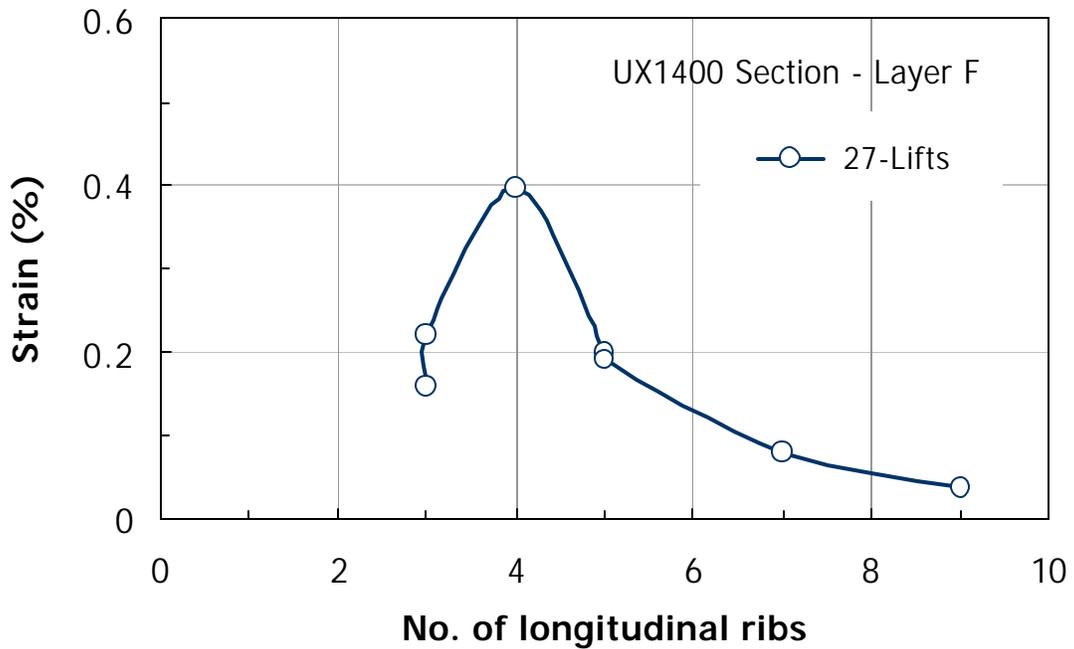
Figure 112
Distribution of strains along the reinforcement in layer F

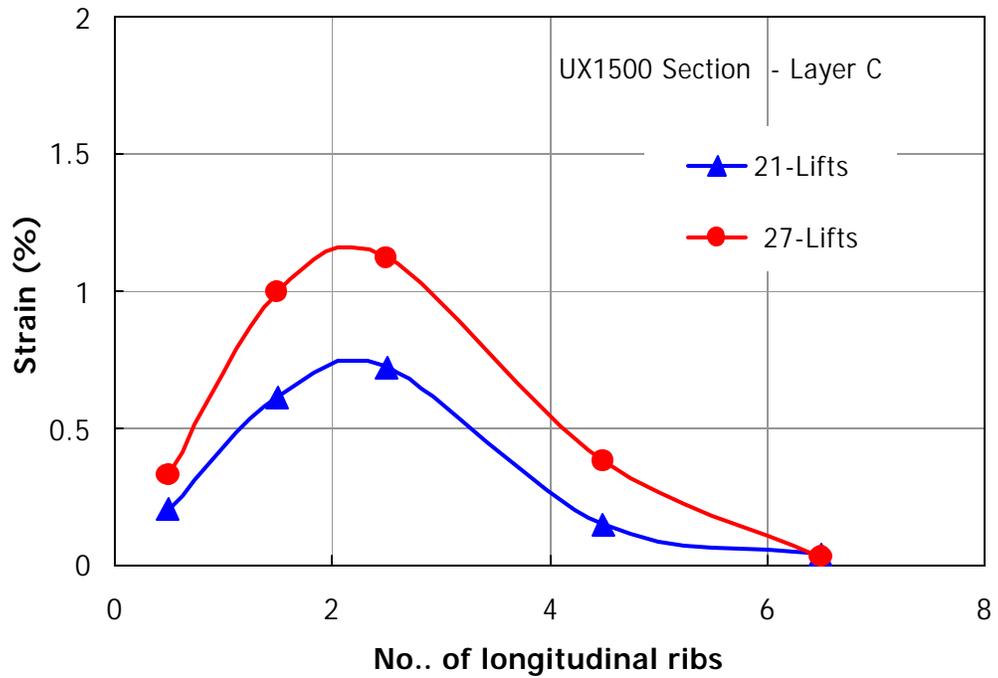
Figure 118
Distribution of strains along the reinforcement in layer C

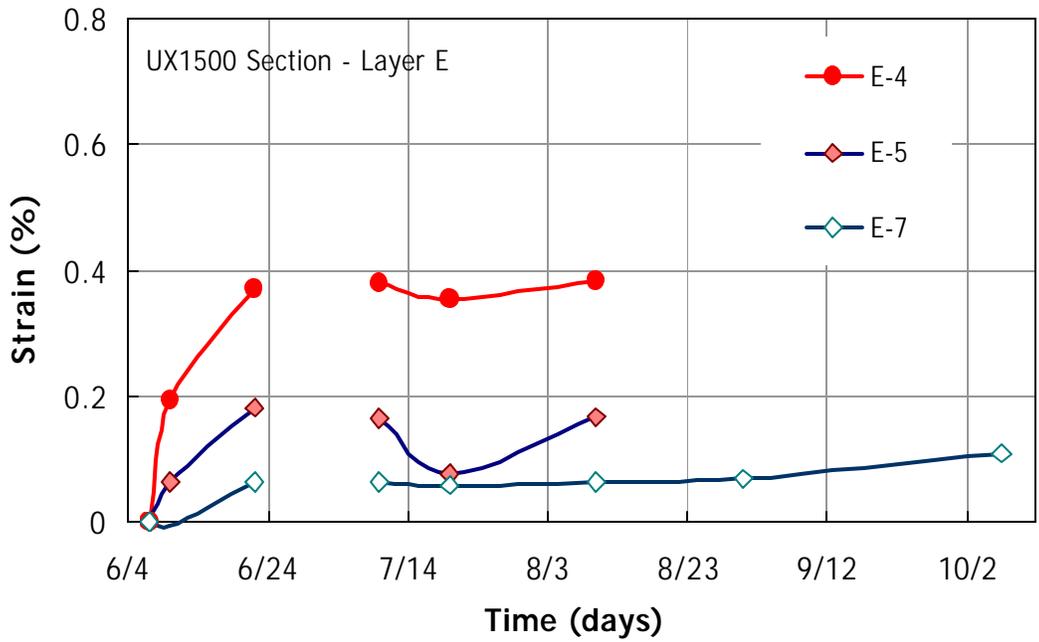
Figure 119
Strain measurements of layer E in test section 3
