1. Report No. FHWA/LA.03/379	2. Government Accession No.	3. Recipient's Catalog No.
4. Title and Subtitle Evaluation of Interaction Properties of Geosynthetics in Cohesive Soils: LTRC Reinforced-Soil Test Wall	5. Report Date January 2004

16. Abstract <p>This report presents the construction and performance evaluation of the LTRC reinforced-soil test wall. The 20 ft. high, 160 ft. long wall was constructed using low quality backfill. Its vertical front facing was constructed with modular blocks. It consisted of three sections reinforced with various geogrid reinforcement types and spacing. The backside of the wall was a one-to-one slope reinforced with woven and non-woven geotextiles.</p> <p>The test wall was constructed to evaluate the design procedure and performance of geosynthetic-reinforced structures constructed with marginal silty-clay backfill over soft clay foundation. The instrumentation program consisted of monitoring wall deformation, foundation settlement, strains in the reinforcement, vertical and horizontal stresses in the soil, and pore water pressure under the wall. Results of the monitoring program from construction through four months after completion of the wall

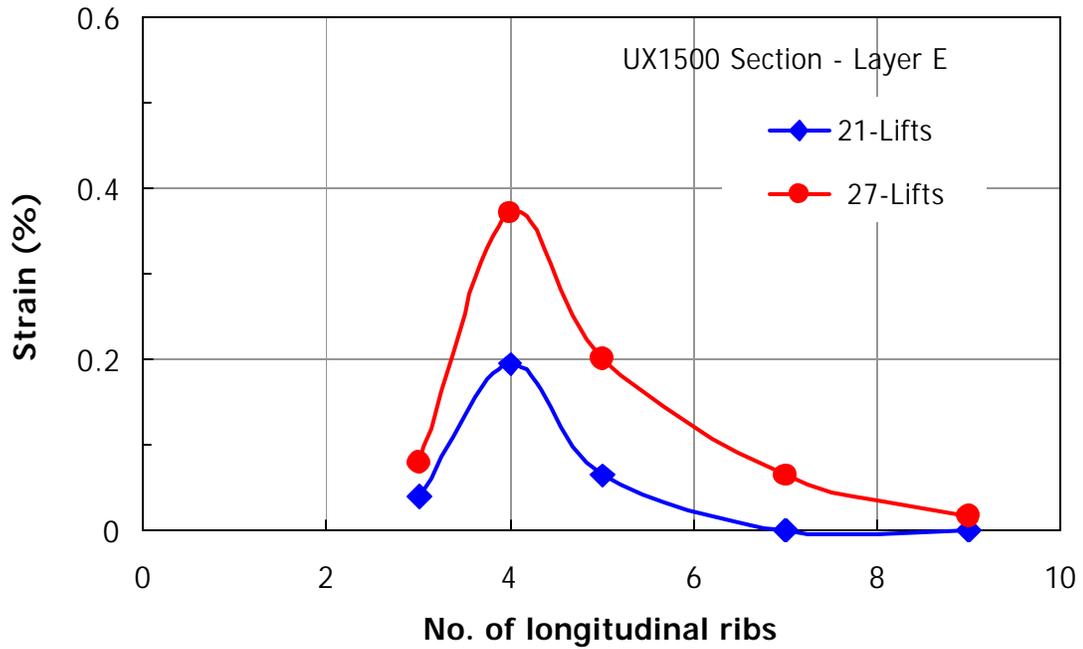
Figure 120
Distribution of strains along the reinforcement in layer E

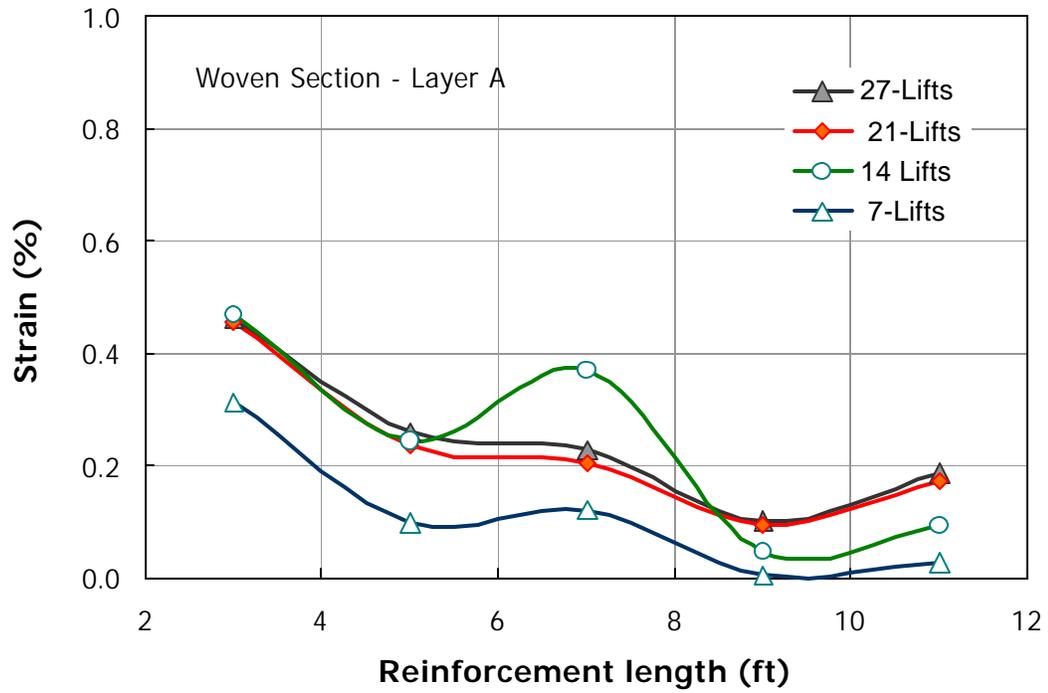
Figure 122
Distribution of strains along the reinforcement in layer A

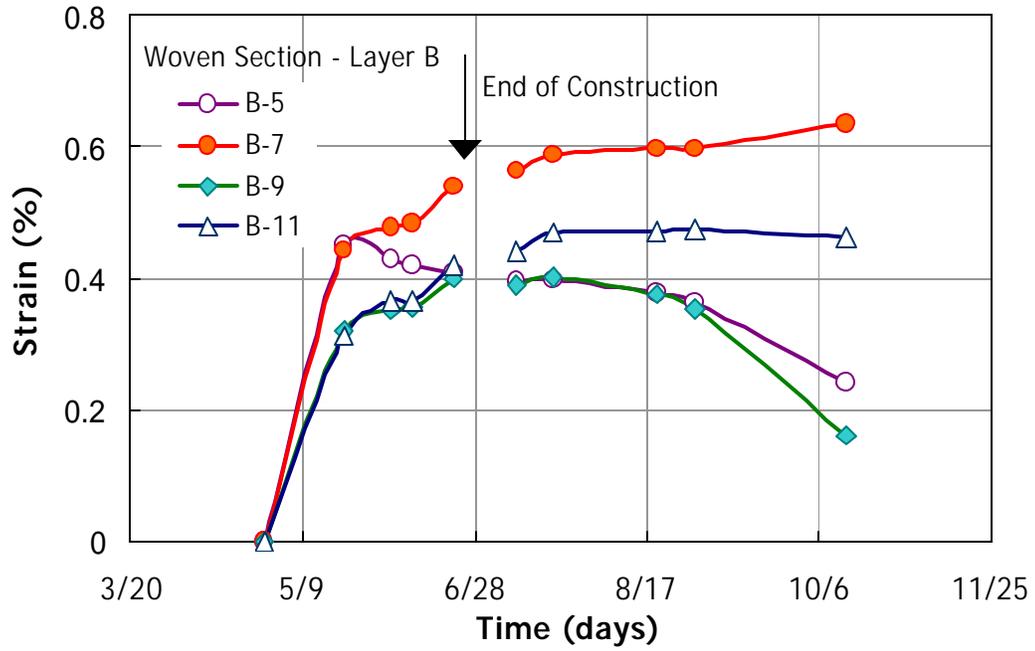
Figure 123
Strain measurements of layer B in woven section

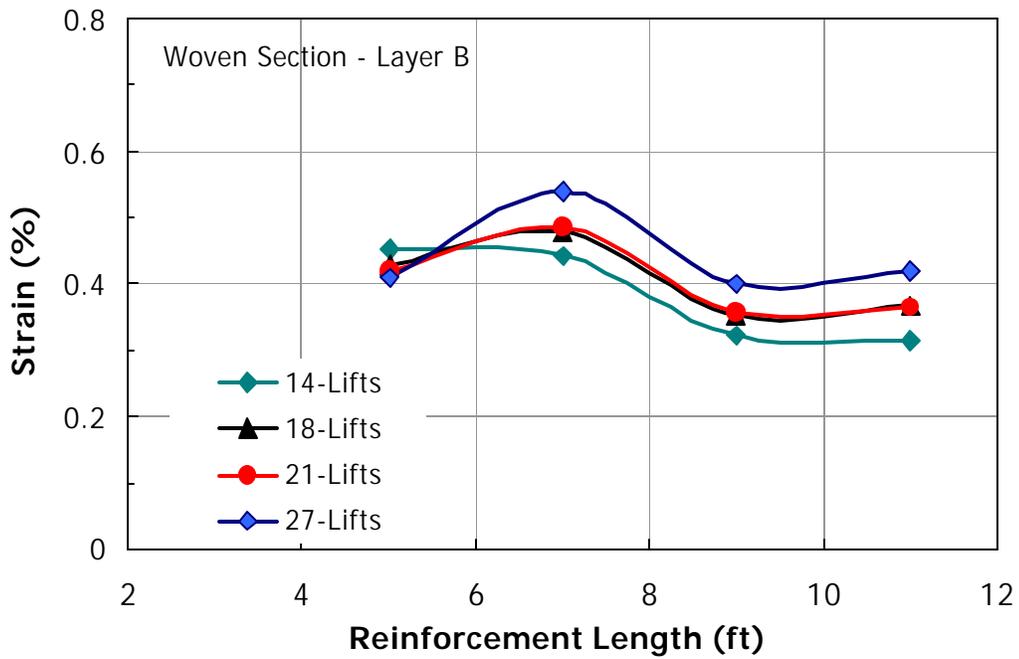
Figure 124
Distribution of strains along the reinforcement in layer B

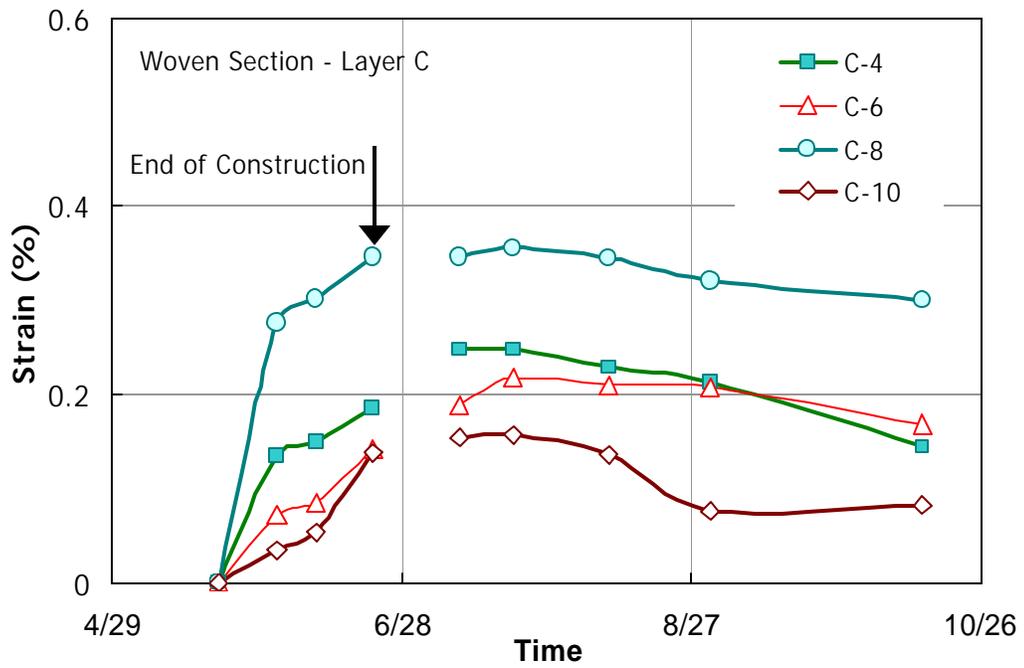
Figure 125
Strain measurements of layer C in woven section

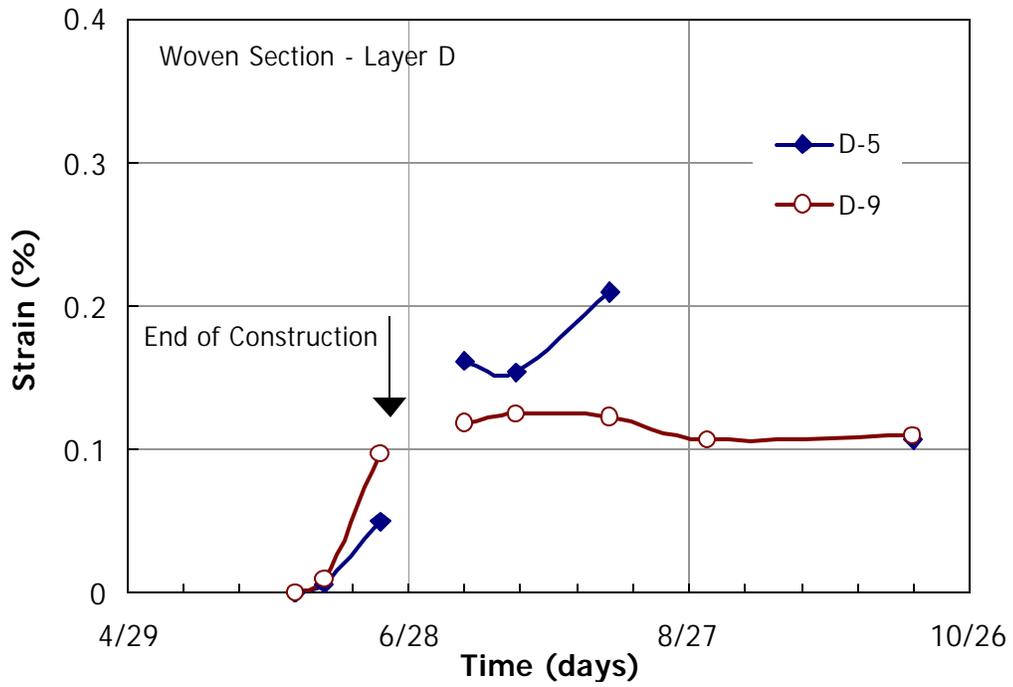
Figure 127
Strain measurements of layer D in woven section

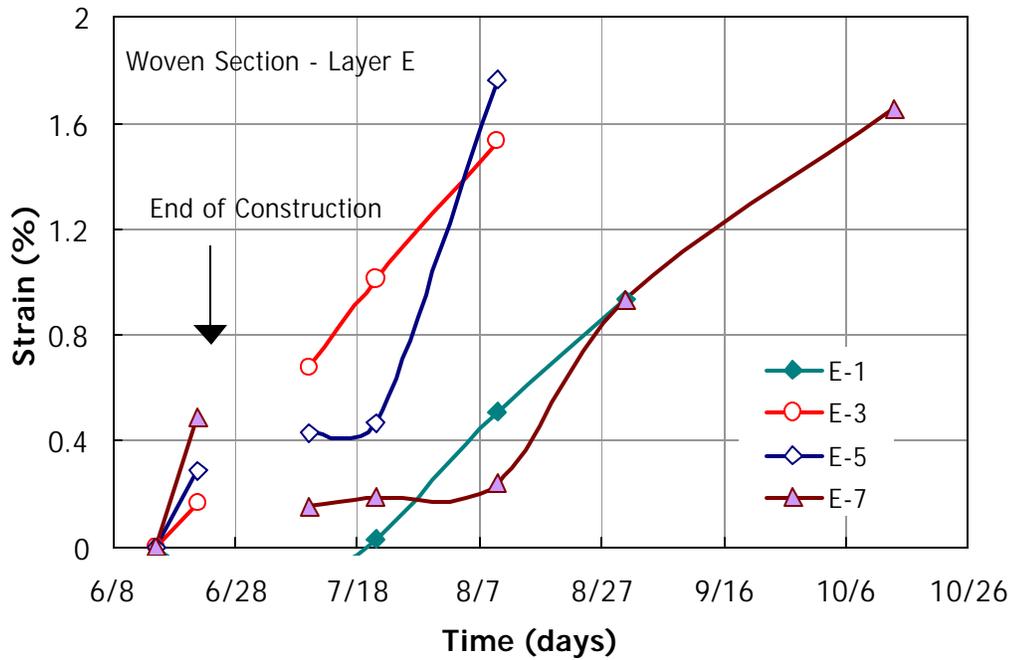
Figure 128
Strain measurements of layer E in woven section

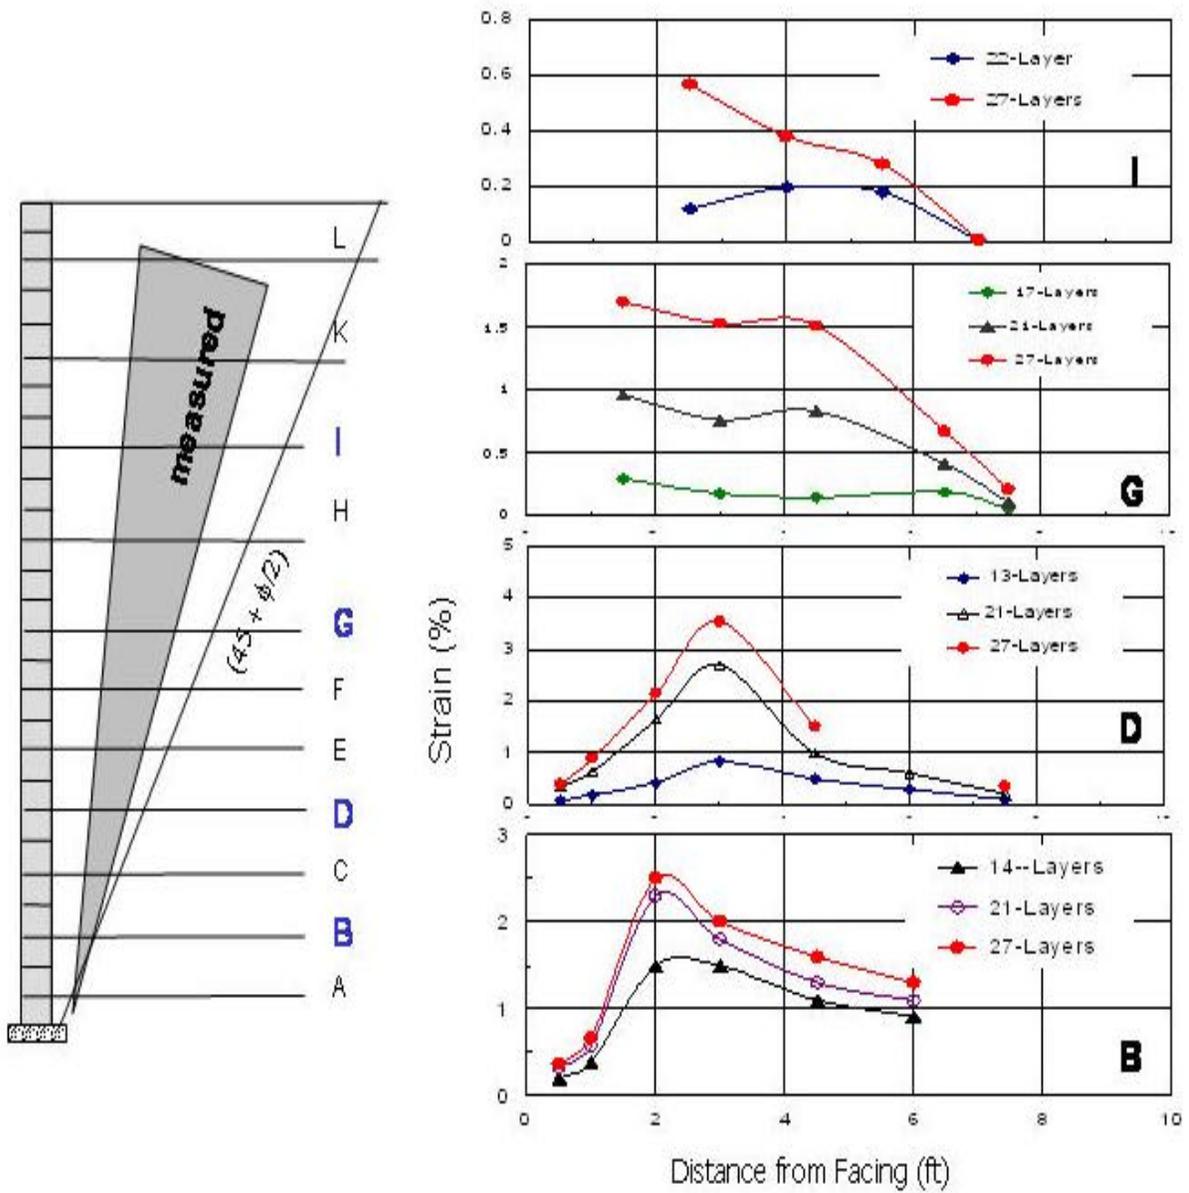
Figure 131
Mobilized strains in the reinforcement in section 1

The critical failure surface is assumed to coincide with the locus of maximum strain in each reinforcement layer. The assumption of Rankine's failure surface of $(45 + \phi/2)$ with the horizontal is usually assumed for extensible reinforcement [1], [2]. Strain measurements show that the locus of the slip surface differed in the three test sections. The locations of maximum strains are plotted in figure 136. The figure shows that maximum strains coincided with the $(45 + \phi/2)$ line only at the bottom halves of the sections. A bilinear slip surface better represented the locus of maximum strains in the section 1 and a line at almost equal distance from the wall facing better represented the locus of maximum strains in section 2.

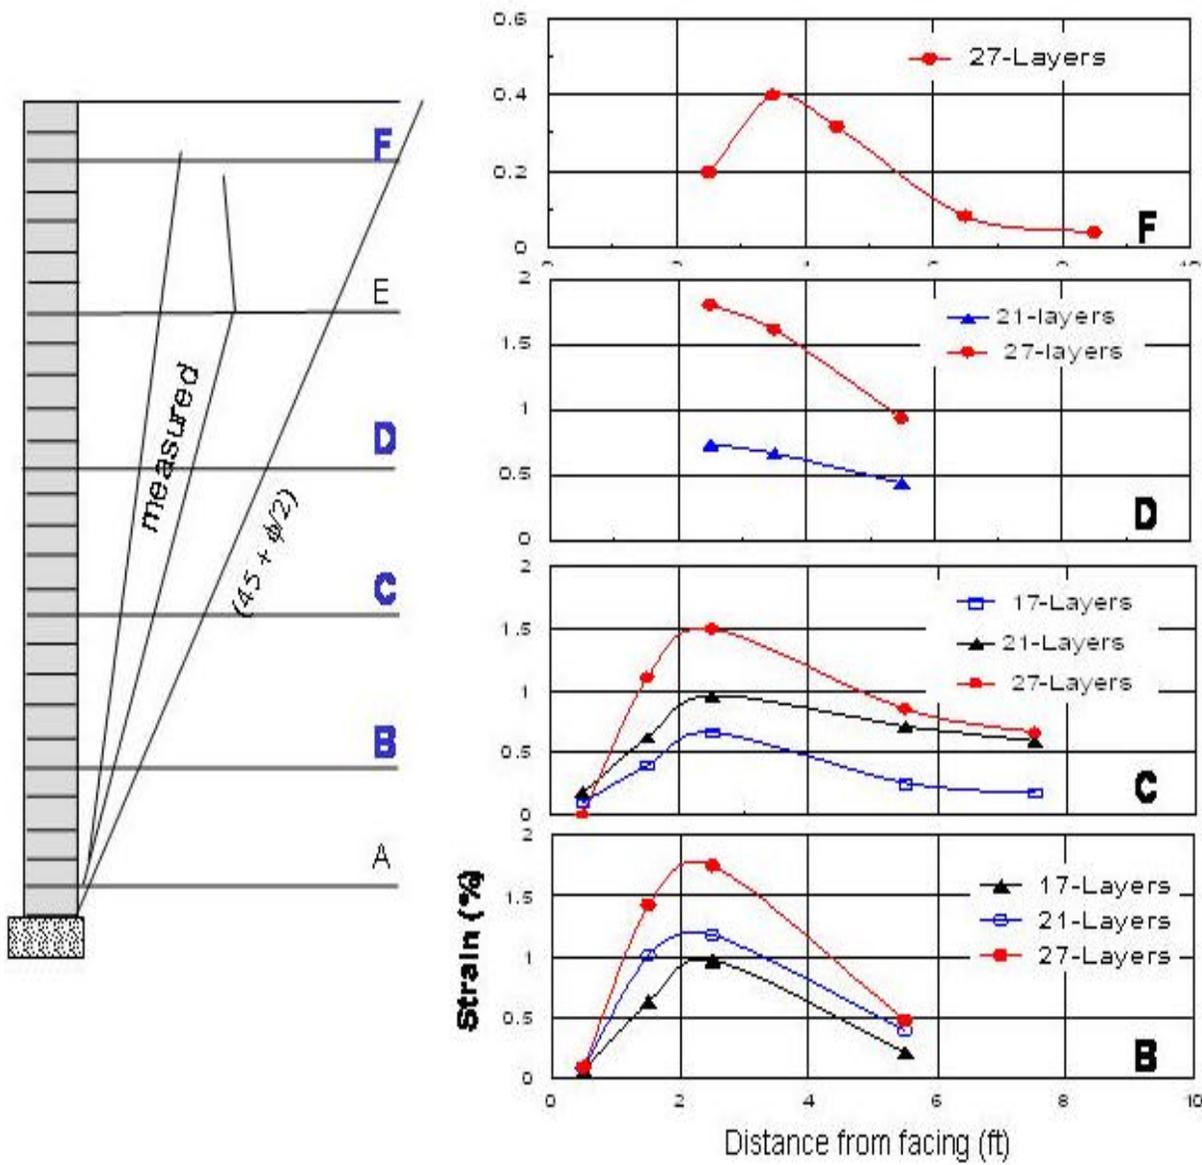
Figure 132
Mobilized strains in the reinforcement in section 2

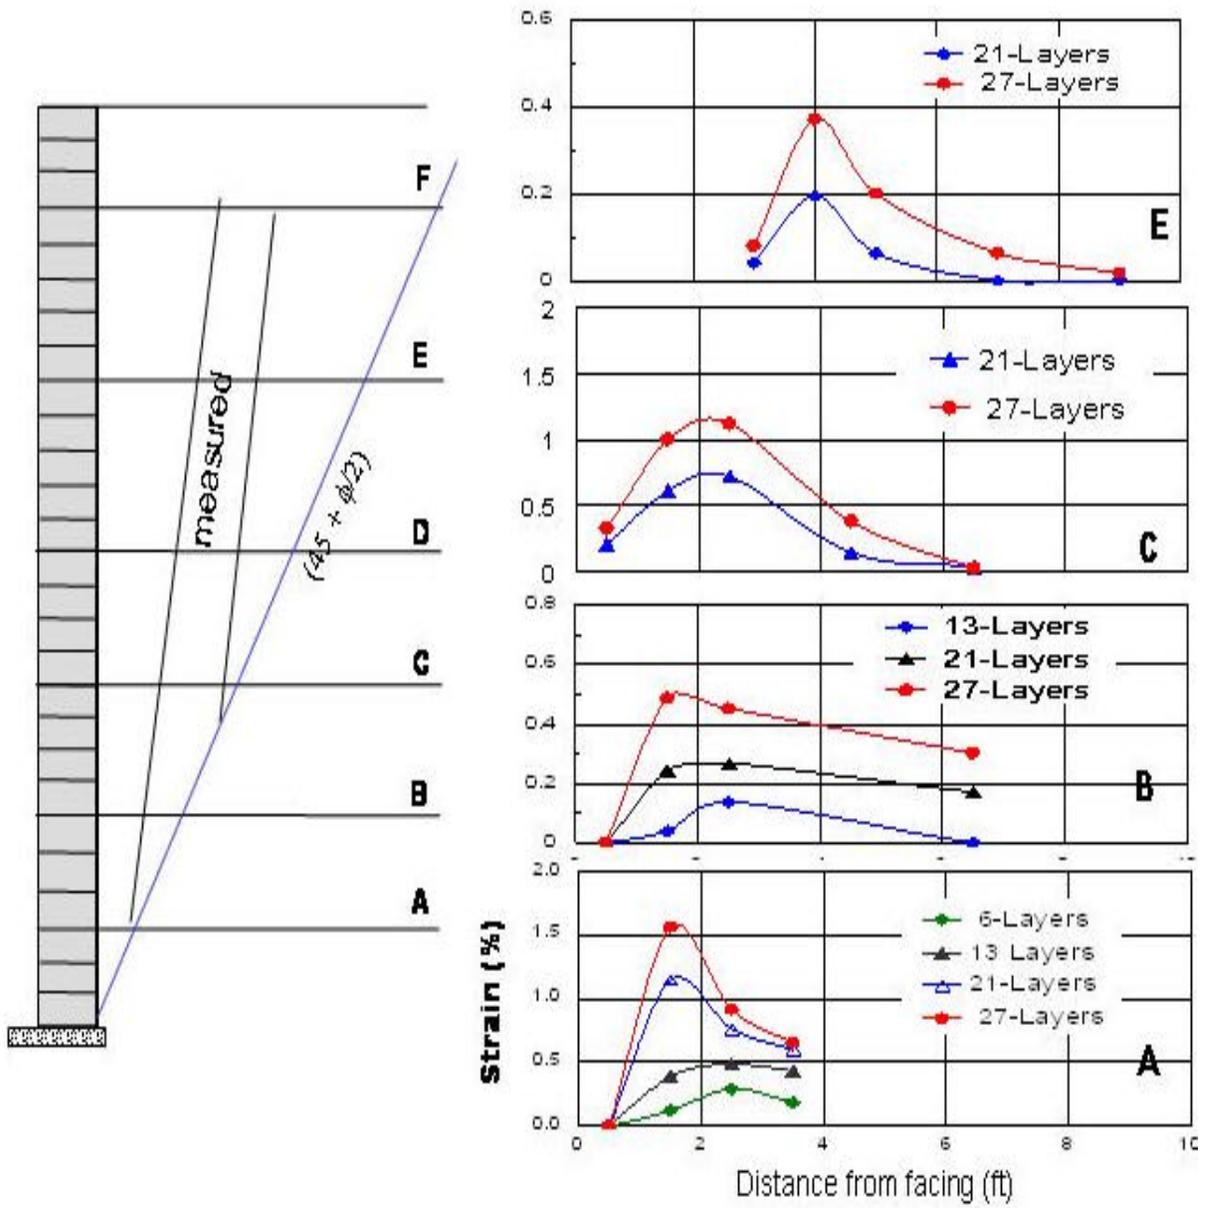
Figure 133
Mobilized strains in the reinforcement in section 3

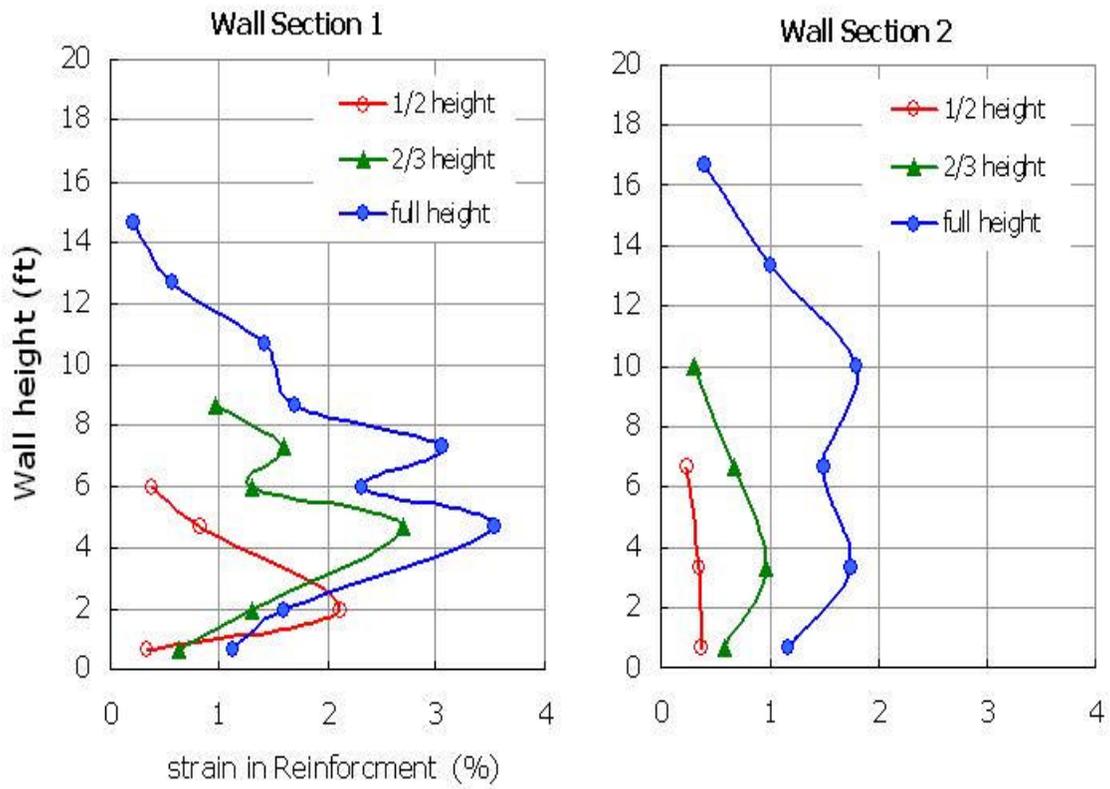
Figure 134
Profiles of maximum strains during construction

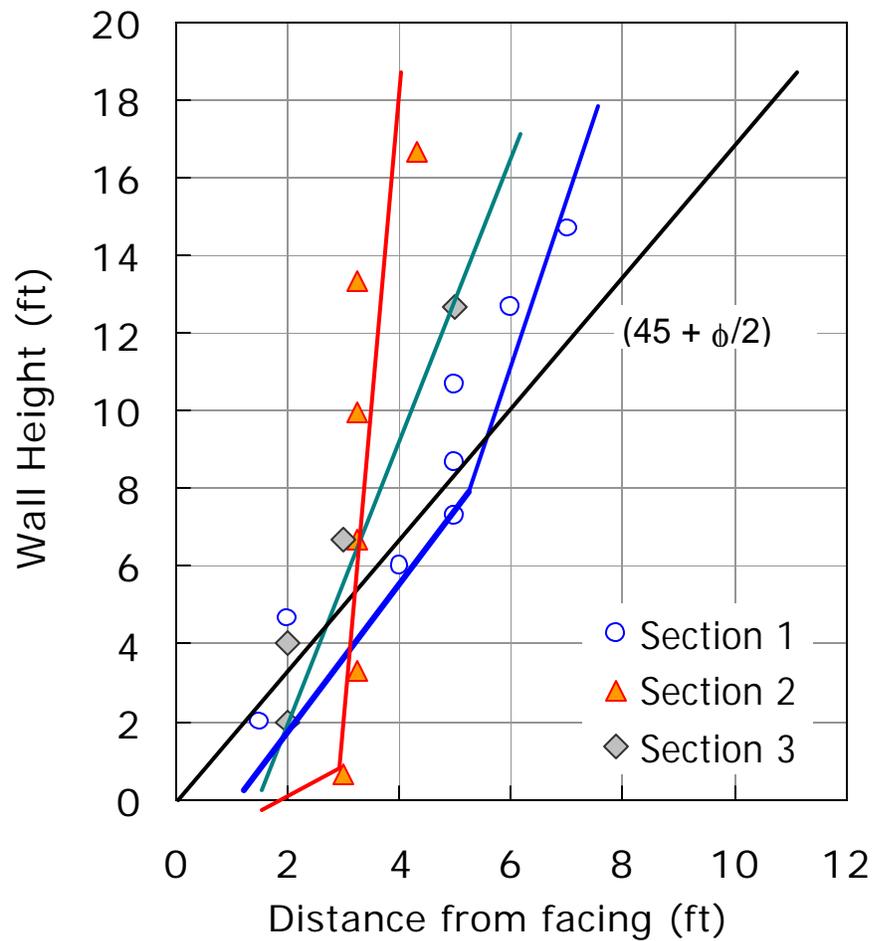
Figure 136
Locus of maximum strains in the test sections

- The locus of maximum strains in the three sections formed an angle less than the theoretical k_a failure surface of angle $(45 + \phi/2)$.
- Measurements of strains near the facing show that the strains were mobilized at the connections between the reinforcement and the modular blocks only at the upper half of the wall.

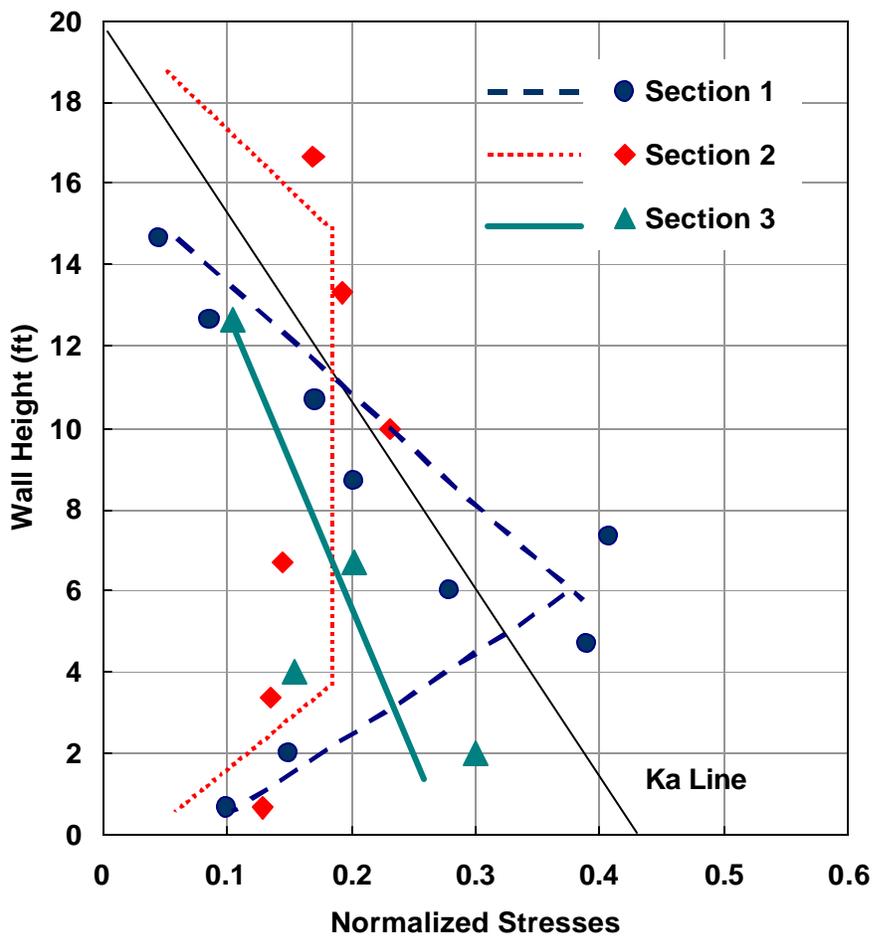
Figure 137
Variations of normalized stresses with wall height
