EVALUATION OF EXPERIMENTAL RAILROAD-HIGHWAY
GRADE CROSSINGS IN LOUISIANA

FINAL REPORT
(1970-1985)

Research Report No. 183

Conducted by
LOUISIANA DEPARTMENT OF TRANSPORTATION
AND DEVELOPMENT
Louisiana Transportation Research Center
In Cooperation with
U. S. Department of Transportation
FEDERAL HIGHWAY ADMINISTRATION

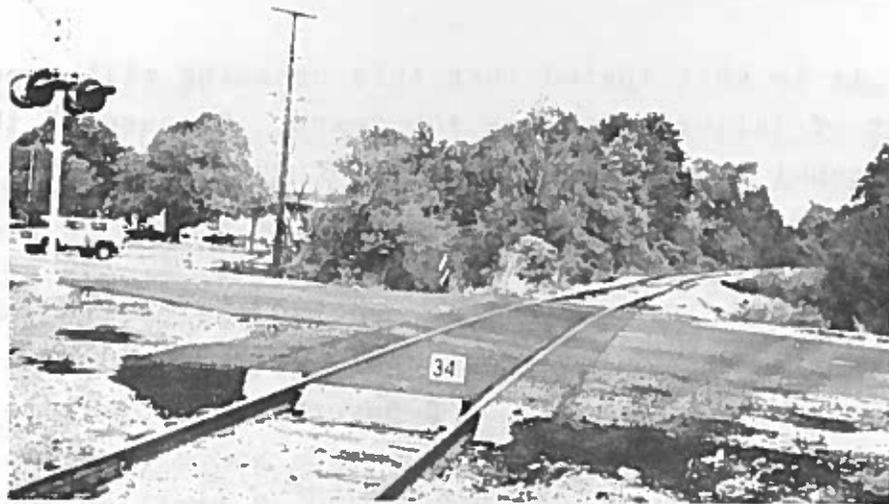
FIGURE 17

Constructed in May 1984, this was Louisiana's first installation utilizing Strail "HI-RAIL" rubber panels. These dense, full-gage rubber panels require no shims and are not affixed to the track structure in any way. Joined by interlocking flanges, they are easily popped in place, jacked together and restrained on either end with steel gooch plates (Figures 17 and 18).

*Strail "HI-RAIL" Rubber Panel Crossing
Shortly After Installation at Crowley*

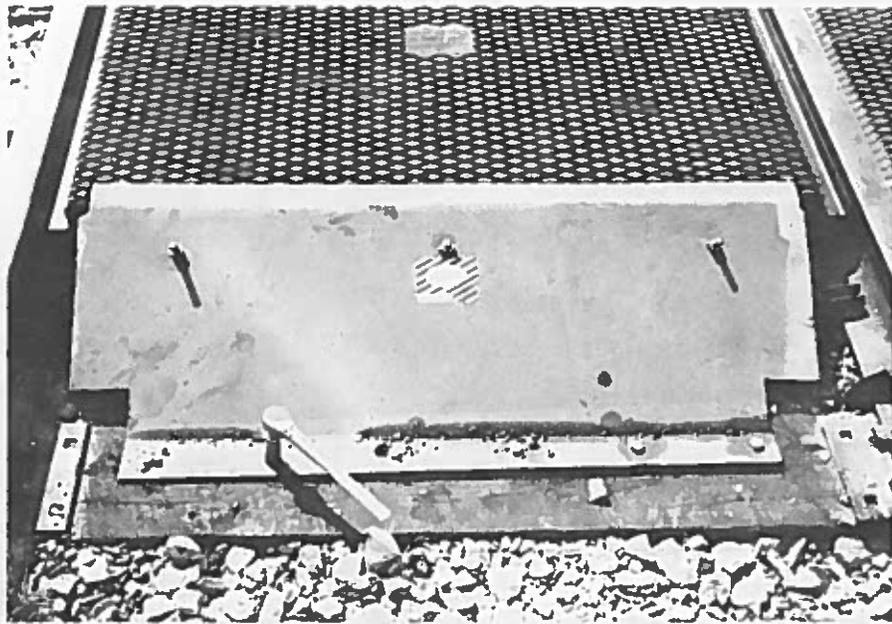
FIGURE 18

*Steel Gouch Plates Used to Restrain
the Full-Depth Rubber Panels*

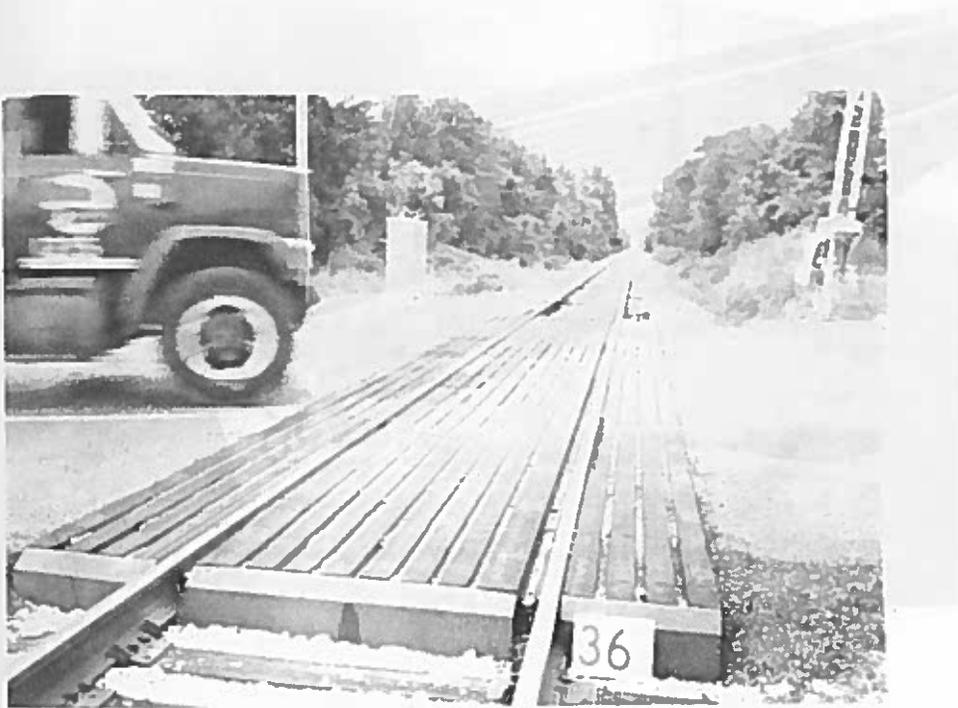
FIGURE 22

Completed in March 1983, during the construction of La.-U.S. 167 (Ext.) where it provides an alternate north-south route pending completion of I-49, this SAF & DRI (Model C) crossing (Figure 22) is performing well after two years.

*SAF & DRI Model C Rubber Panel Crossing
At Nuba Two Years After Completion*

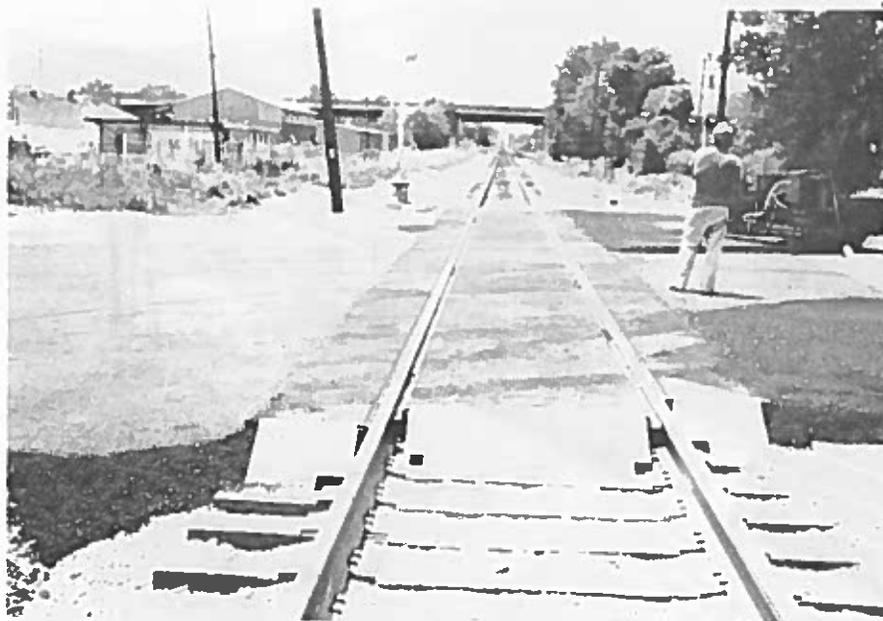
FIGURE 25

In connection with this reconstruction, it was necessary to raise the track six inches in order to restore the integrity of this heavily traveled main line that hosts 4 freight trains per day at approximately 25 mph. The 1985 ADT was 10,310 vpd with 11% trucks. After total reconstruction, panel installation was completed within three hours and the asphalt paving operation initiated (Figure 25).

*Spreading the Second Lift of Asphalt
For the Approach Pavement Tie-in*

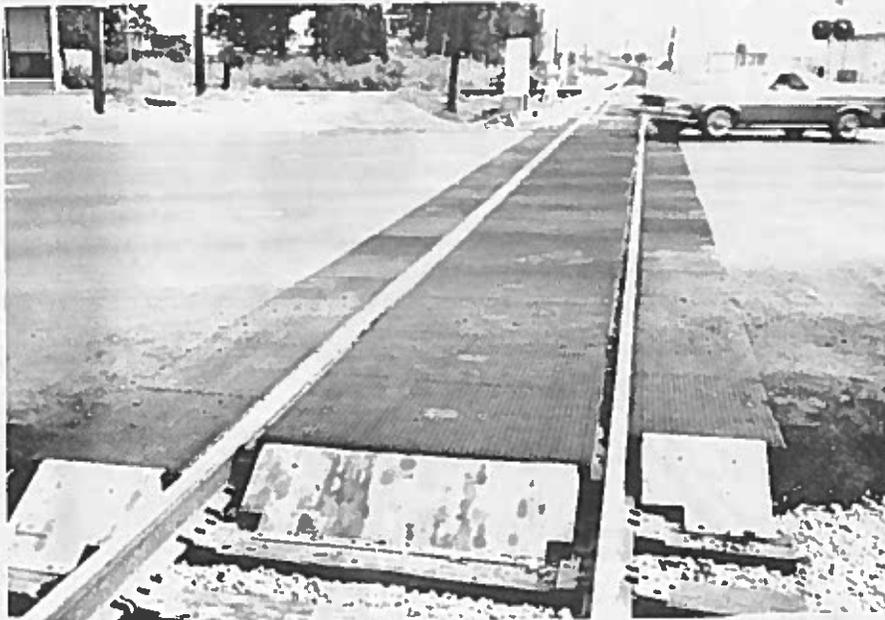
FIGURE 26

With the possible exception of a front-end loader to facilitate moving the heavy, full-depth rubber panels, no other mechanical equipment is required for installation. The "HI-RAIL" panels can be installed or removed using only common hand tools and are not affixed to the track structure in any fashion. They are restrained only by the asphalt, tension and steel gooch plates on either end. Figure 26 shows the finished product with excellent rideability still in evidence after one year of service.

Excellent Rideability After One Year

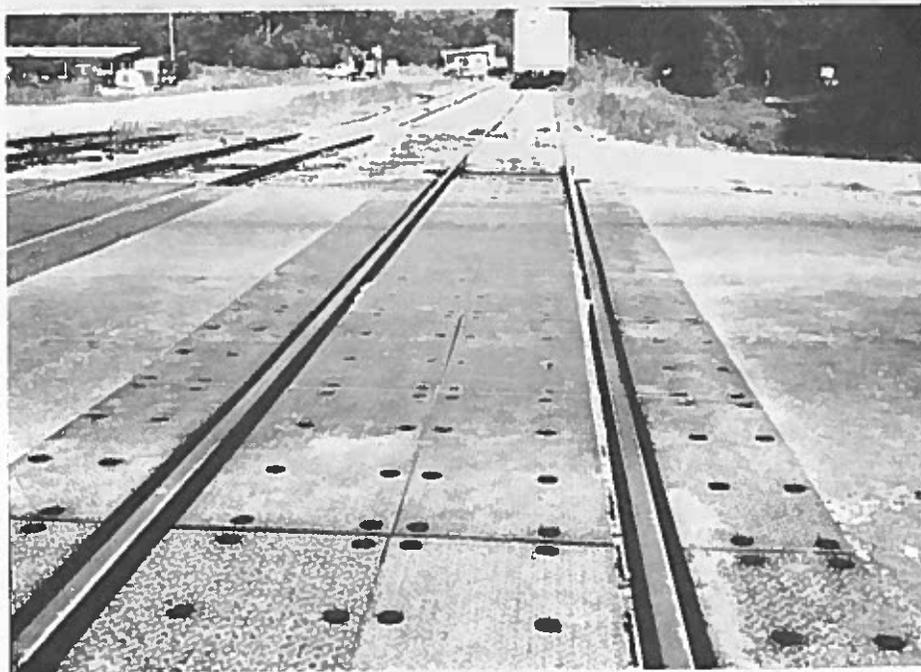
FIGURE 27

In August 1984 Louisiana was afforded the opportunity to install three experimental crossings simultaneously. This marked the first installation utilizing UNI-8 full-depth, solid steel plate panels (Figure 27) and the new Red Hawk rubber panels, as well as the previously installed Strail "HI-RAIL" solid rubber panels.

*UNI-8 Steel Plate Crossing
Six Months After Installation*

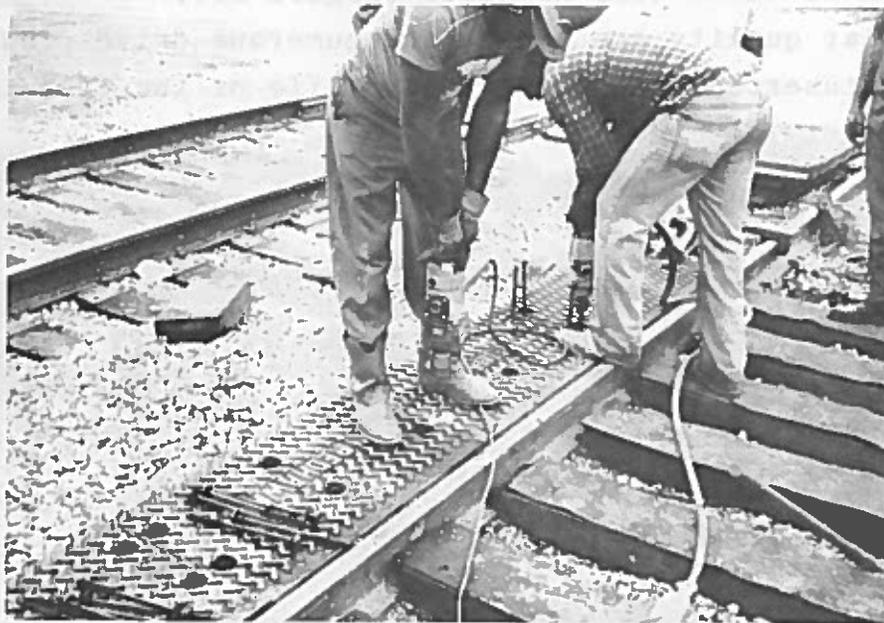
FIGURE 28

Figure 28 shows the counterboring and installation of the recessed head timber screws unique to the Red Hawk rubber panels. Rubber abrasion pads are utilized on top of all shims.

Red Hawk Rubber Panels and Timber Screws

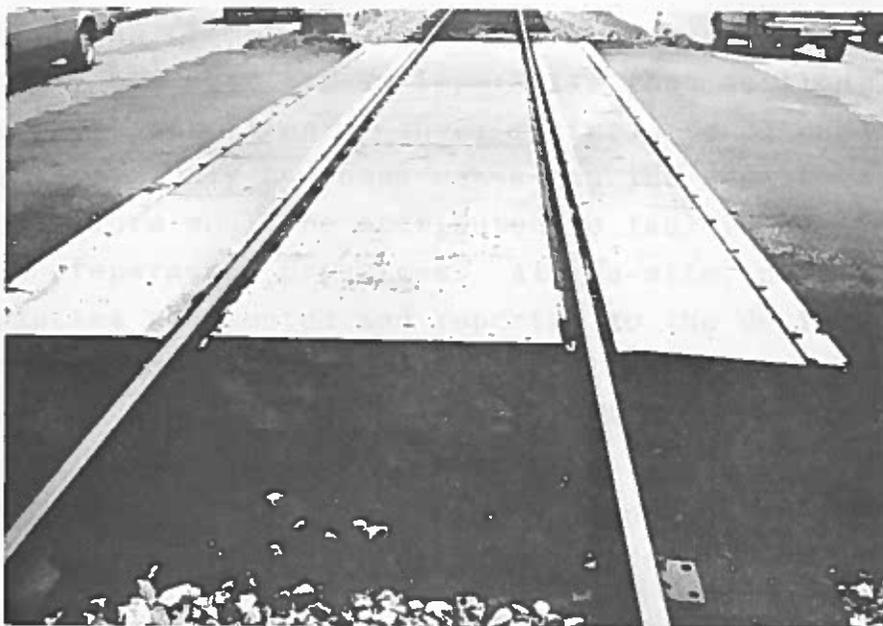
FIGURE 31

Completed in June 1984, this installation using Semprit-Bodan Precast Concrete panels (Figure 31) marked the second application of this type crossing in Louisiana. The first was a triple-track installation at Independence (No. 29) and was introduced mistakenly in Interim Report No. 6 under the trade name of "DOW-MAC".

Semprit-Bodan Precast Concrete Panels

Installation particulars surrounding this crossing are unavailable as R&D was not notified of its existence until it was three months old. On-site inspection revealed no evidence of any installation discrepancies. It has a one-foot concrete base and is very neat with good rideability considering its elevation. This two-lane rural city street carried 4,442 vpd in 1985 with 19% trucks. Too recent to render an opinion, it is performing well with no signs of deterioration after one year. No further installations of this type were projected at the time of this report.
