EVALUATION OF SAND FILLS

Research Report No. 74

Research Project No. S-23

Conducted by  
LOUISIANA DEPARTMENT OF HIGHWAYS  
Research and Development Section

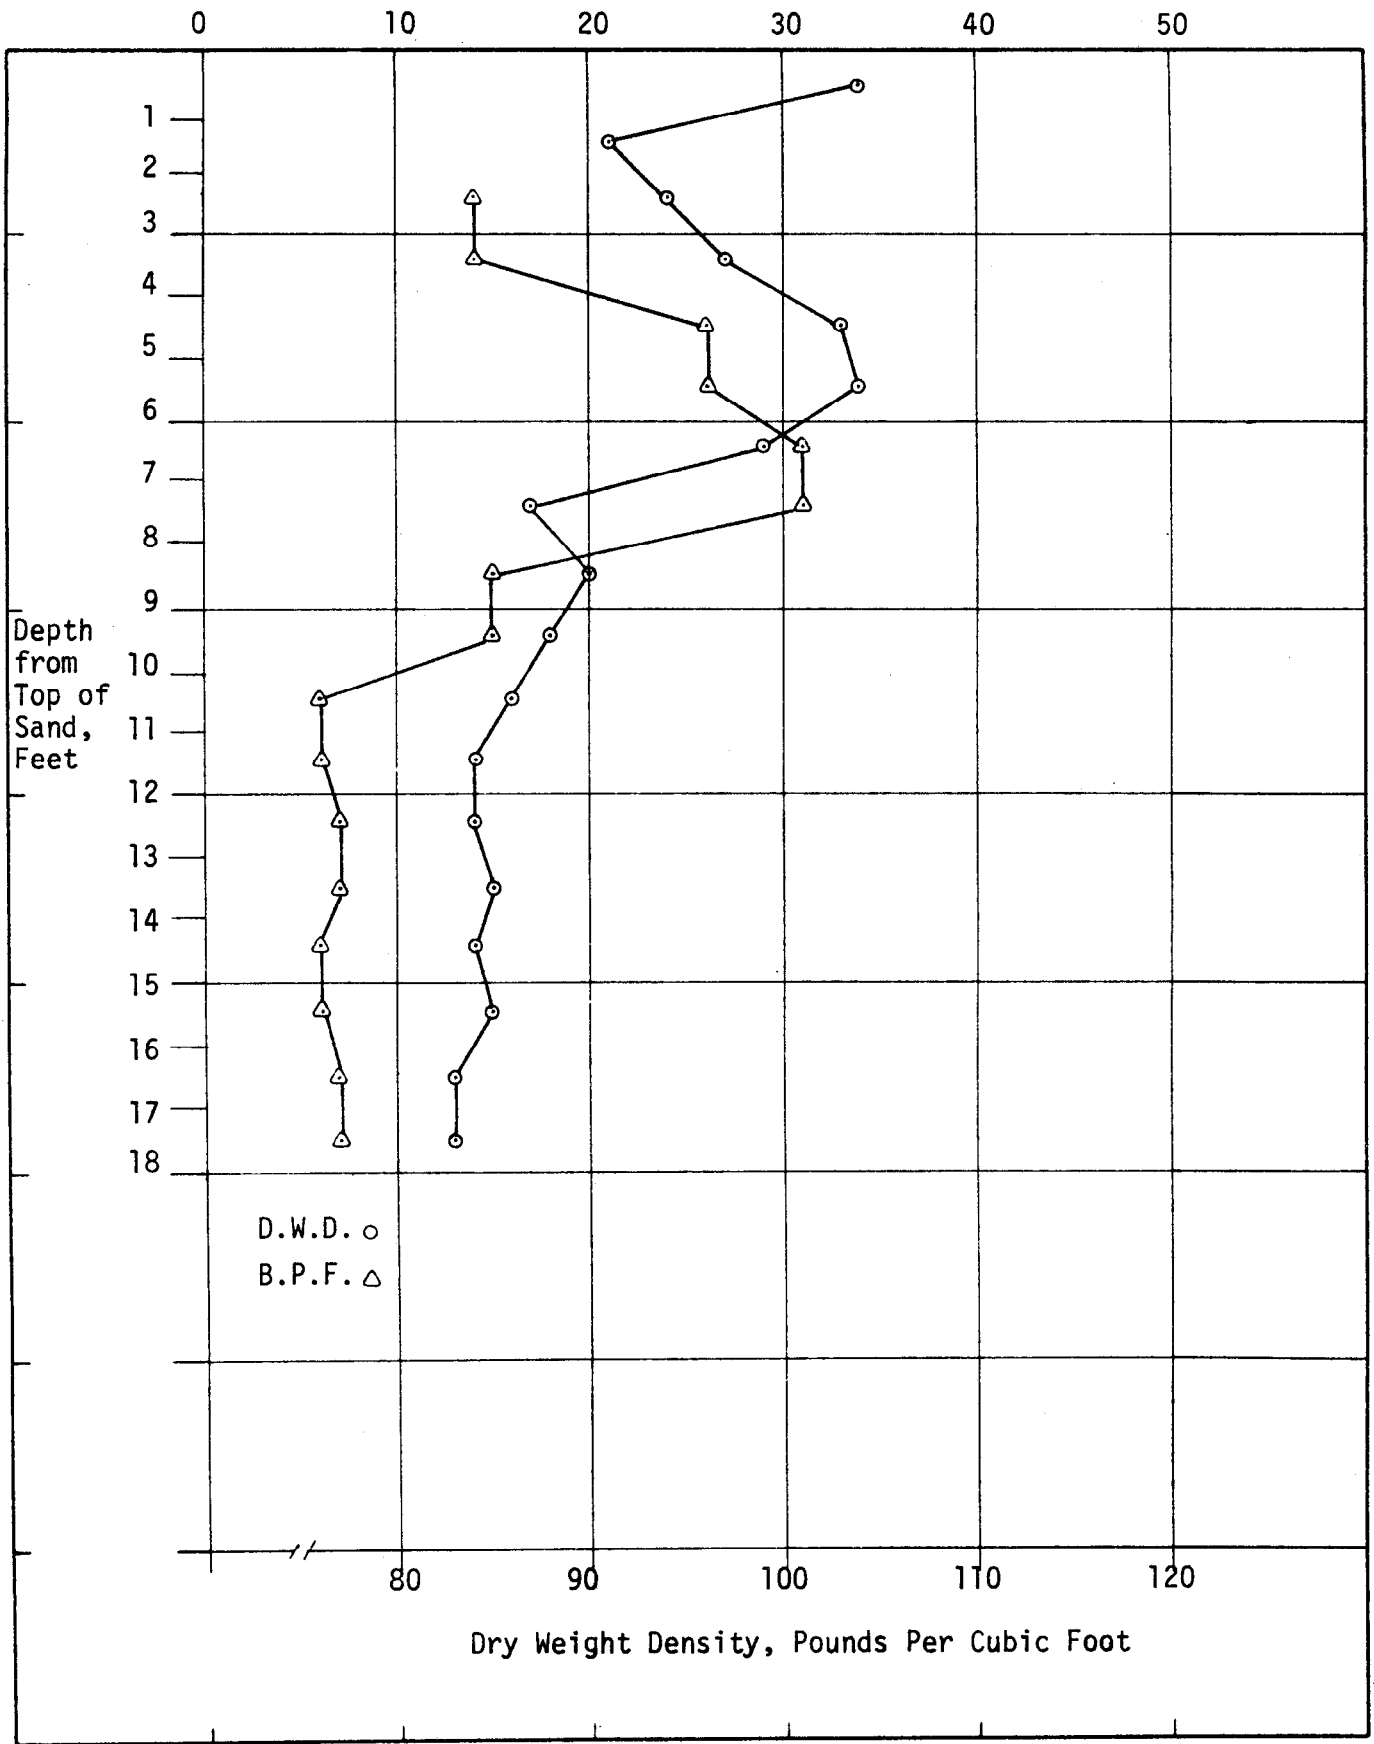
Density and Standard Penetration Values Versus Depth of Sand Fill  
 Slidell - Mississippi State Line Highway  
 Route I-10  
 FIGURE 8

The plots of density per depth and blows per foot of depth of the Standard Penetration Test are very similar from a depth of one foot to the bottom of the density test hole (18 feet). The trend of density for the portion of the fill above the water table is of interest (i.e., increase in density with depth). Please refer to Table 9 (Appendix) and Figure 8.

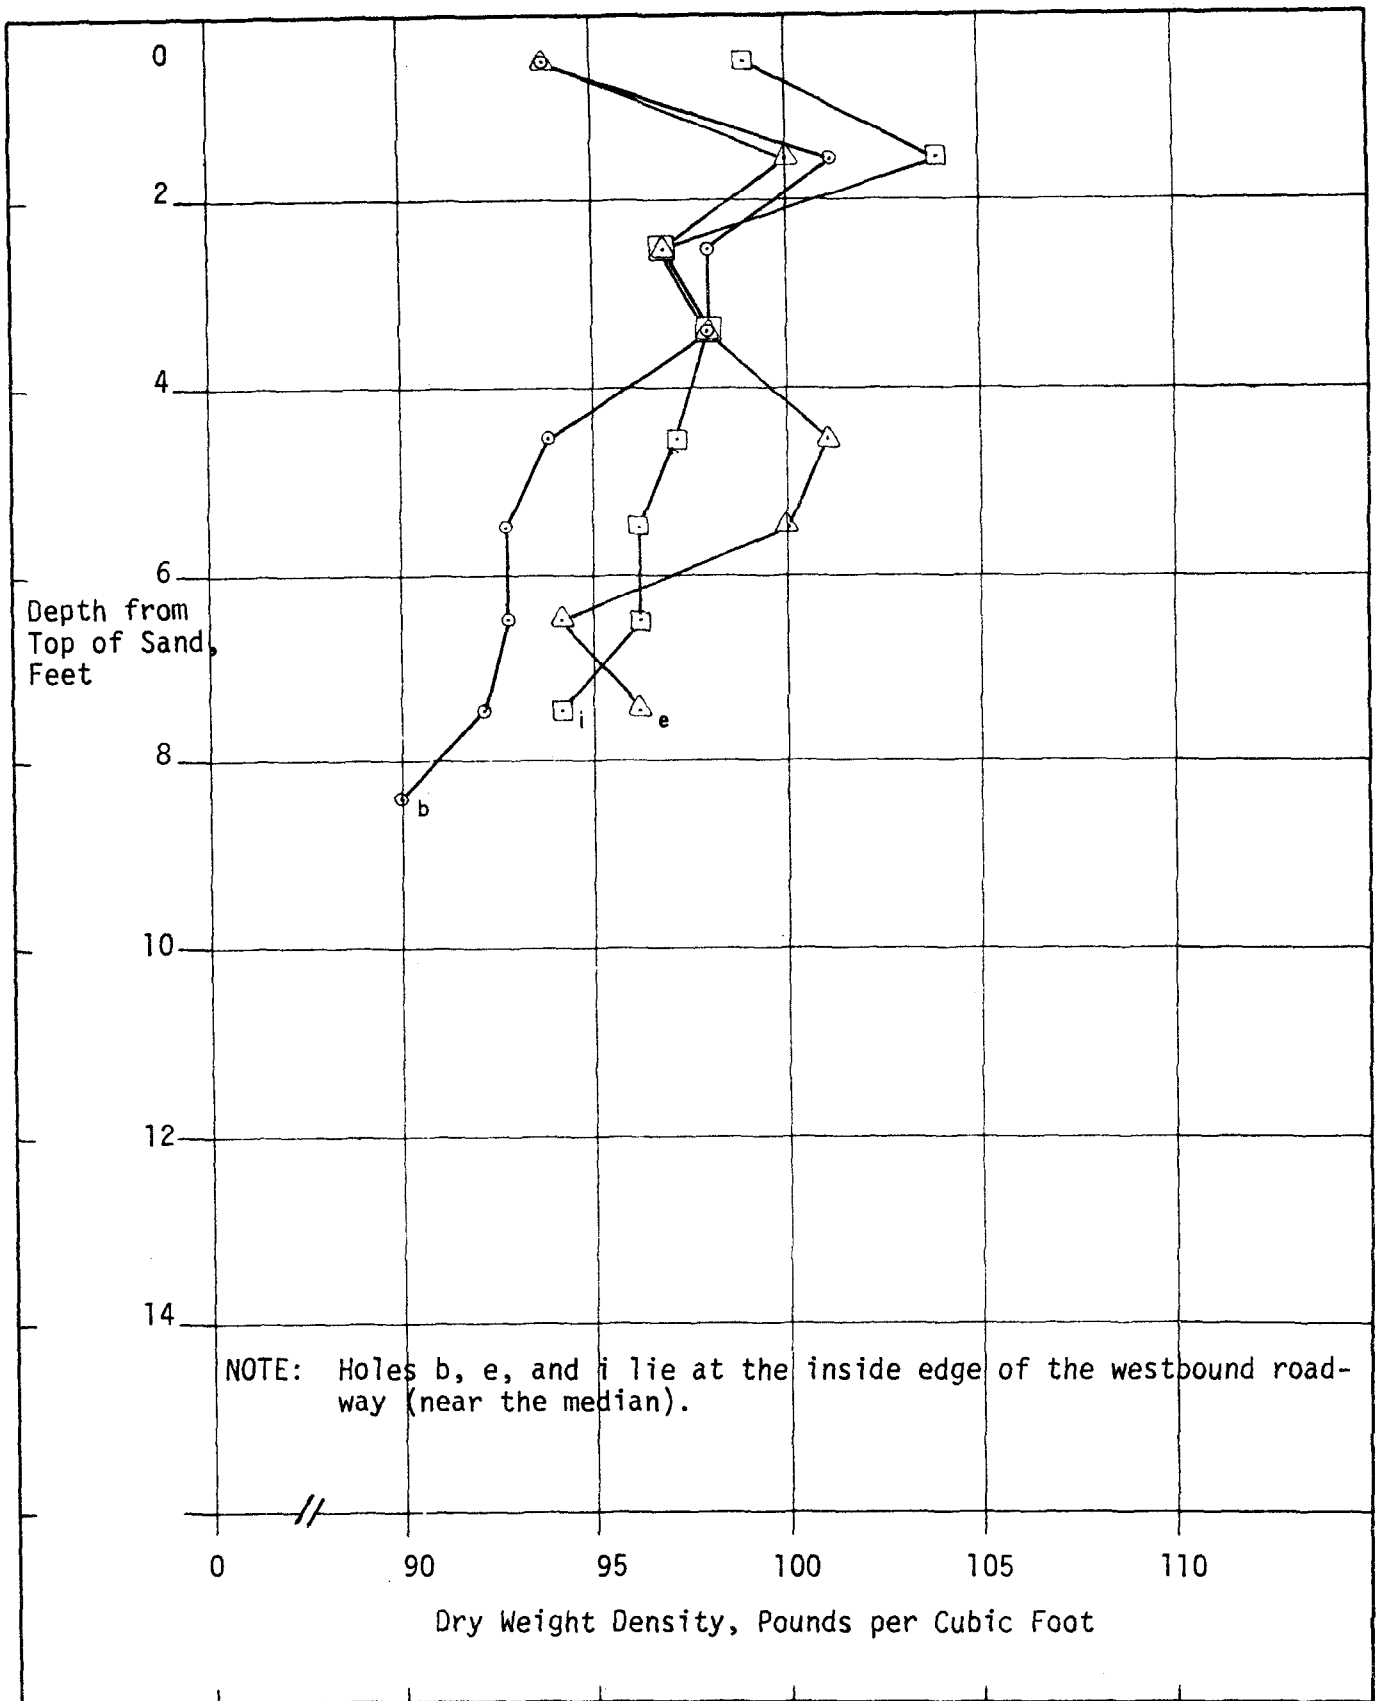
FIGURE 11

Nuclear tests were taken at nine locations along the westbound roadway and an attempt was made to correlate sand fill density values with base course stability. Table 1 in the Appendix lists the moisture-density values for the nine stations, and Figure 2 (and Figures 11 and 12 of the Appendix) depicts the variation in density value with depth. The nine test areas have been identified by alphabetical designation a through i. Locations b, e, and i are near the median of the sand fill and show the greatest density values with depth of the nine sites. This phenomenon is considered a characteristic of a hydraulically pumped sand fill because of the central location of the discharge pipe used in establishing such a fill. No depressions had appeared at these three spots. The density values at the remaining six locations (at the outer edge of the fill) reveal significant reductions in density with depth. Of course, lower density values reflect looser states, which can cause problems if re-adjustment of the sand to a more tight state ever occurs.

Dry Weight Density Values Versus Depth of Sand Fill  
 Route I-10 Sorrento - LaPlace Highway  
 Adjacent to Median of Fill

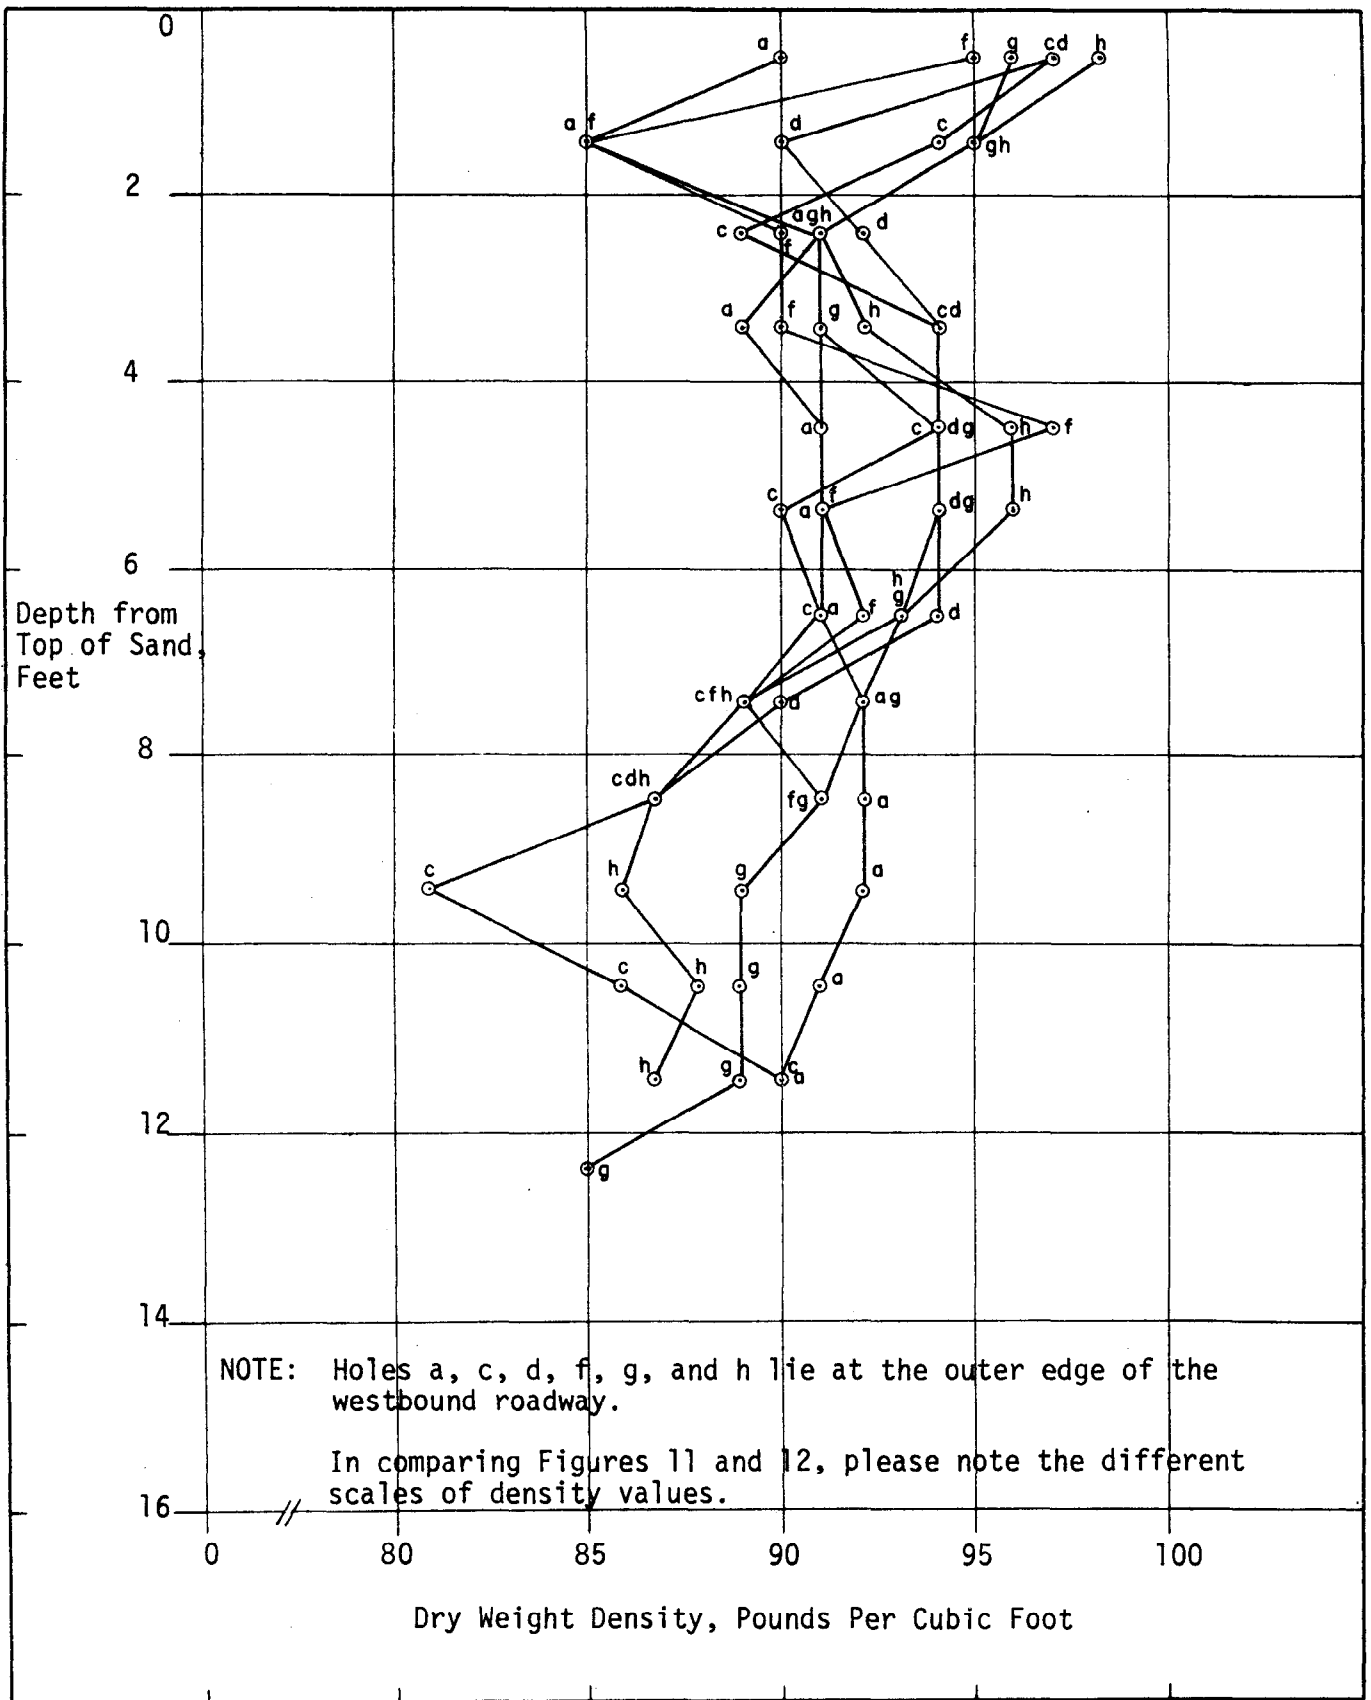
FIGURE 12

Dry Weight Density Values Versus Depth of Sand Fill  
 Route I-10 Sorrento - LaPlace Highway  
 Outer Edge of Fill

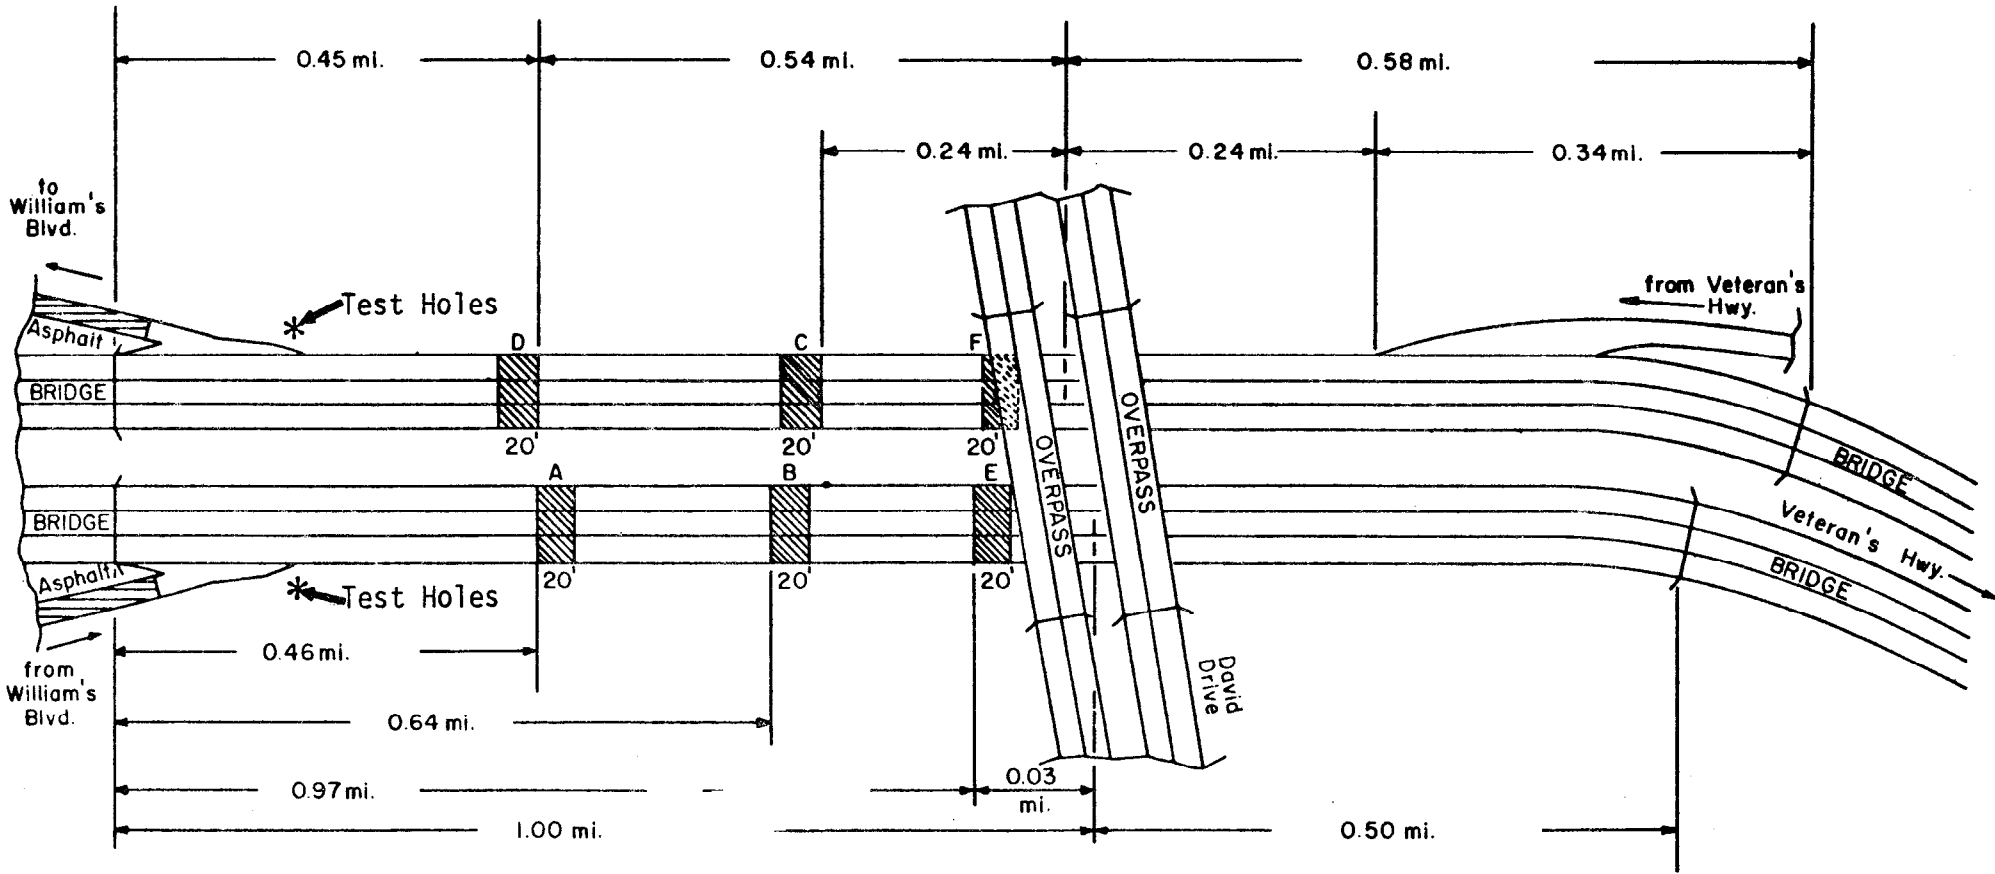
FIGURE 14

Table 6\* (Appendix) gives a thorough performance evaluation of this project since construction in 1968. An average Dynaflect deflection of 0.57 milli-inches and an average Mays Ride Meter roughness value of 63 inches per mile are quite good. In fact, these values are excellent in light of the 242,317 equivalent 18-kip wheel loads (both directions) which the pavement has experienced since opening 4 1/2 years ago. However, one cannot help but wonder what phenomenon is occurring within the 20 foot long test section E where the average deflection is 1.02 milli-inches and the maximum deflection is 1.68 milli-inches. Such deflections would be significant even for jointed portland cement concrete pavement. Further investigation should be initiated within the area of test section E to minimize possible future maintenance. The performance evaluation test sections as well as the sand fill test holes are depicted in Figure 14 of the Appendix.

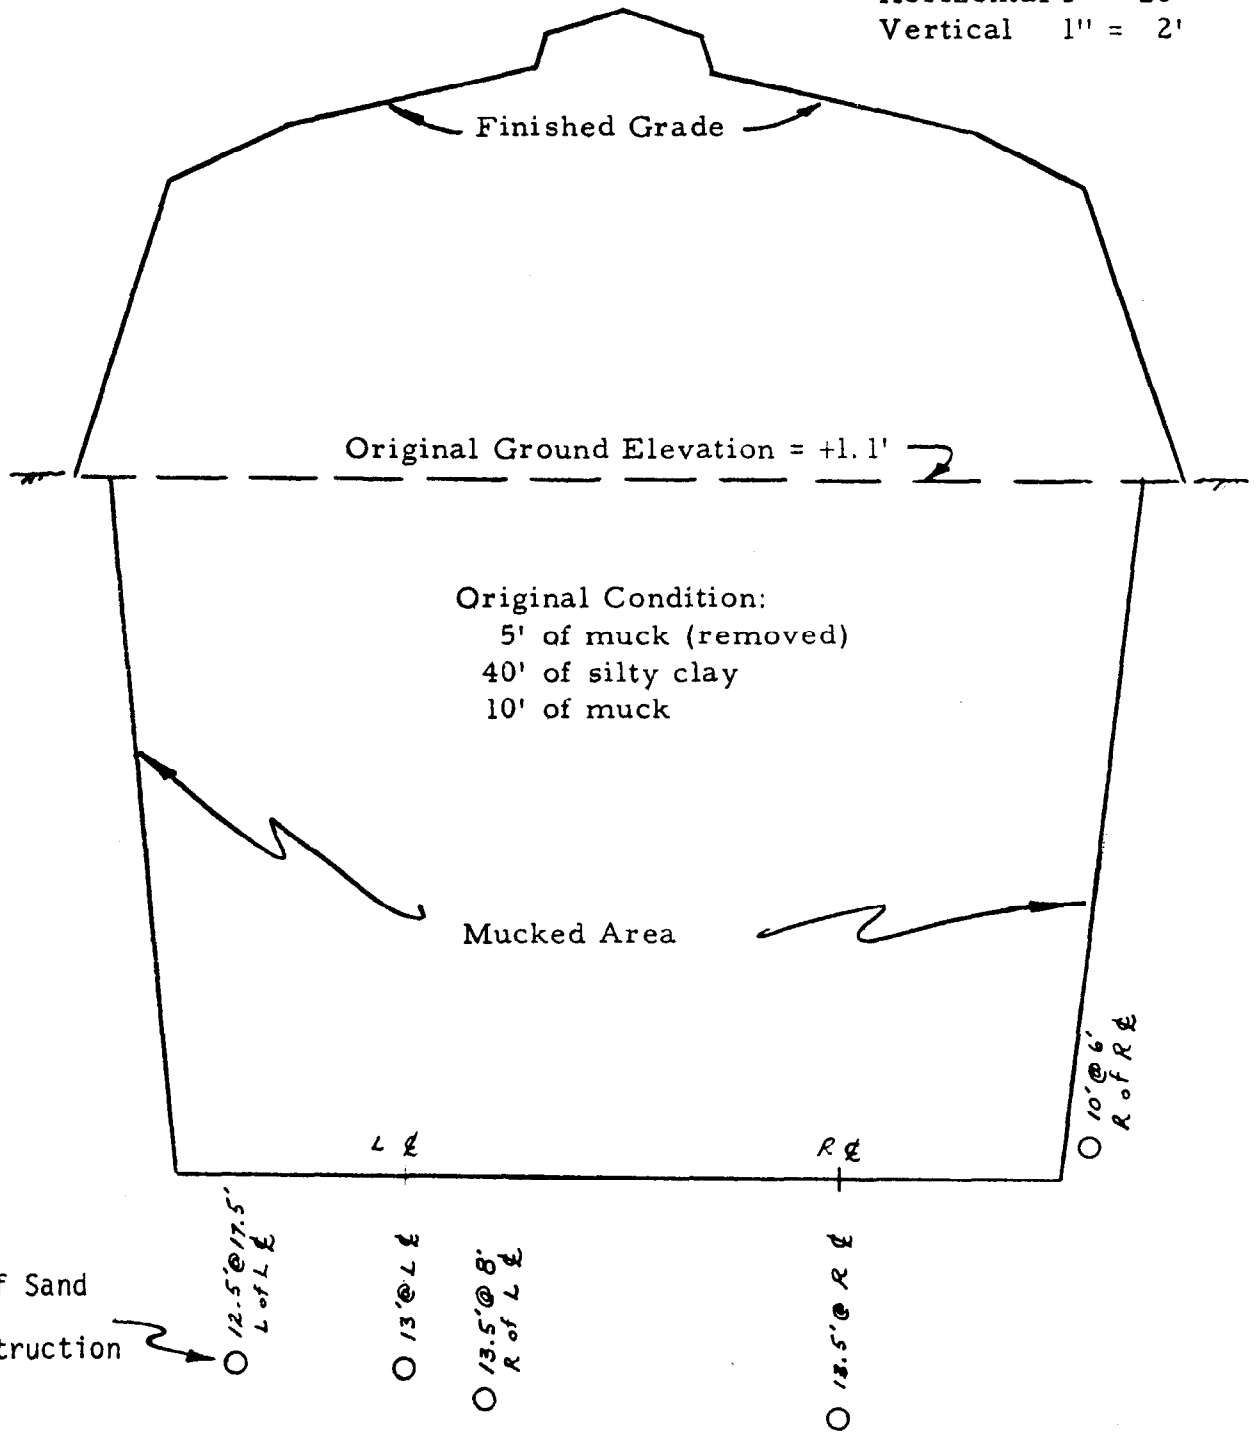
FIGURE 20

Borings taken by the Department in March, 1966, (approximately five years after construction) at three stations along this project indicated that the sand fill had extended the initial limits of mucking both vertically and laterally. Figures 20, 21 and 22 indicate conditions before construction, the general extent of mucking, and the extent to which the sand fill had moved both vertically and laterally. It is likely that much of the movement of the backfill material took place during construction and that such movement was rectified by the addition of sufficient sand to bring the fill to proper grade. Such further movement by this massive fill probably wrought only minor problems for the paved surface. However, determination of "the final resting place of the backfill material"\* was considered worth mentioning in this evaluation of sand fills.

MUCK AND SOIL INVESTIGATION CROSS-SECTION  
 STATION 37+65  
 RACELAND - DES ALLEMANS HIGHWAY  
 ROUTE U. S. 90

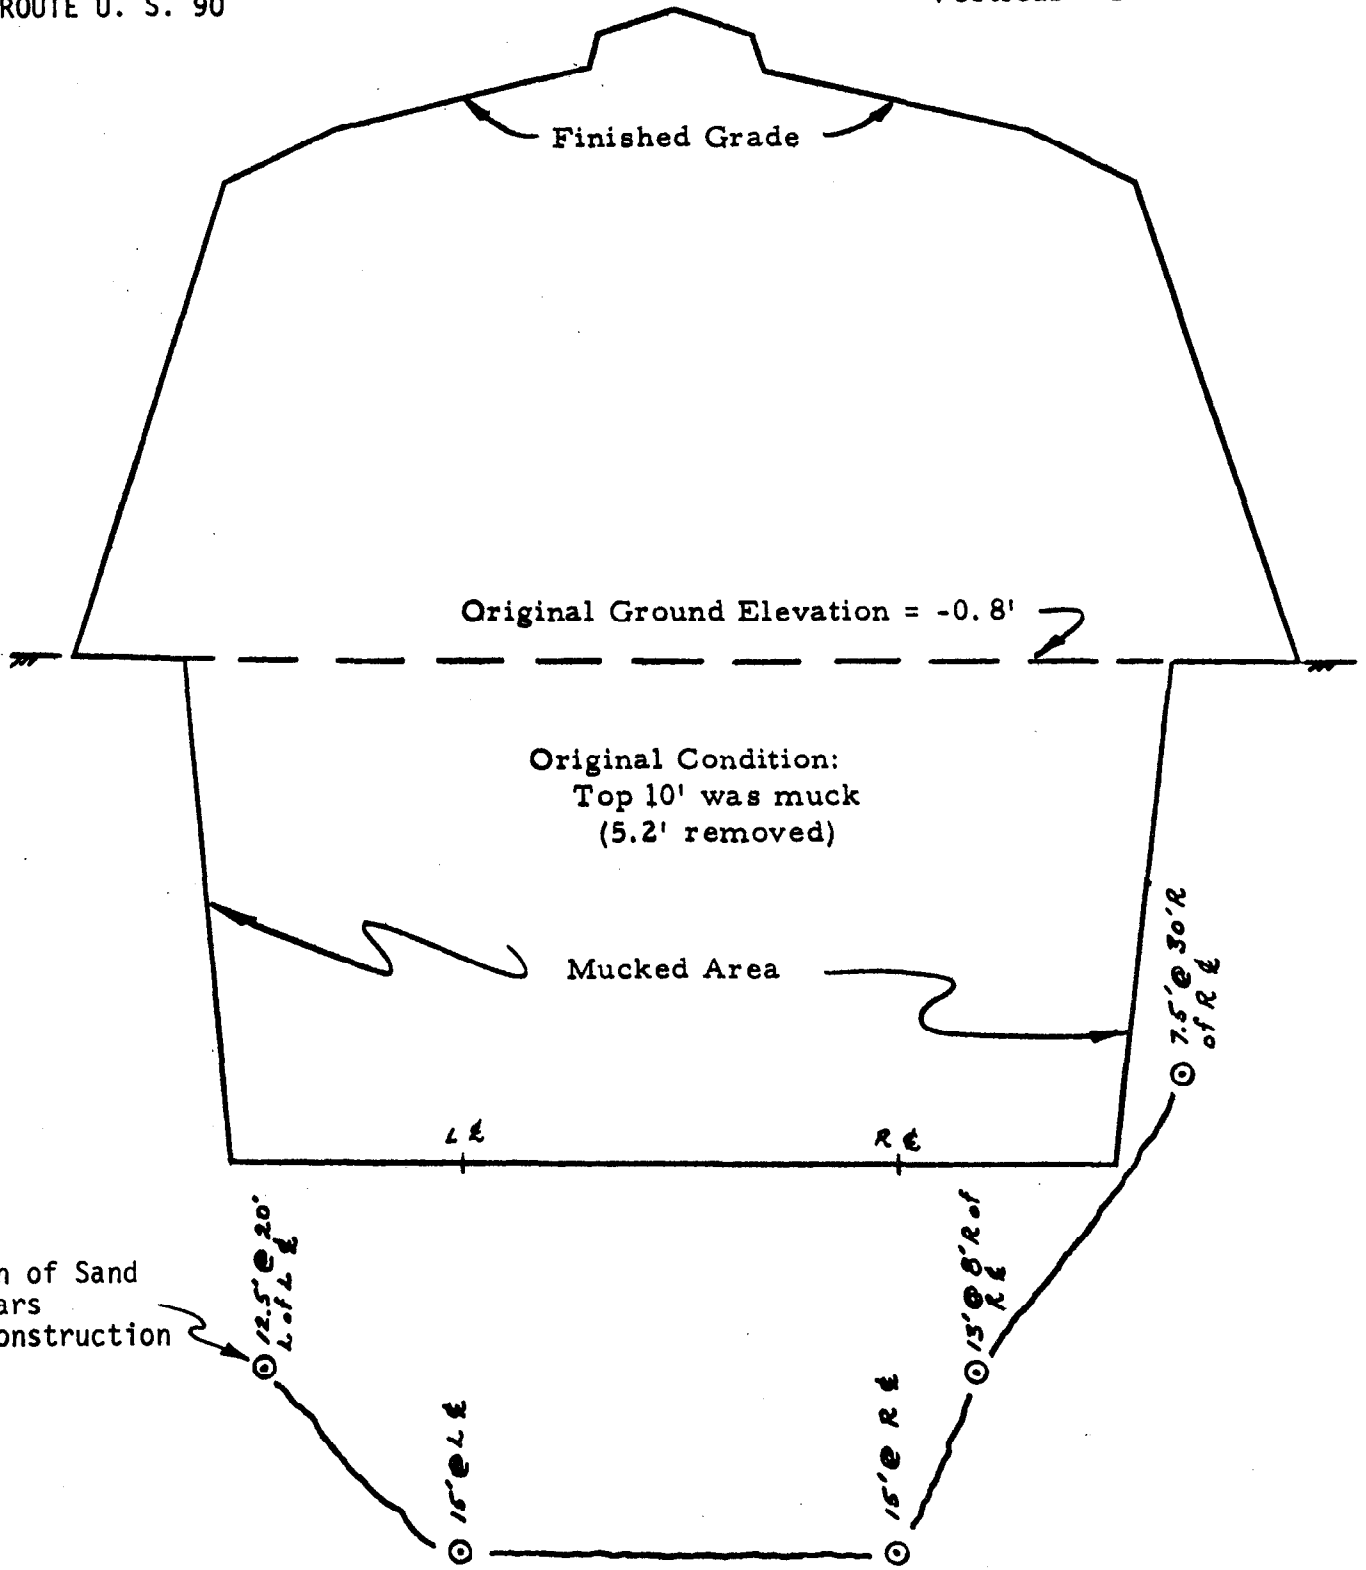
FIGURE 21

MUCK AND SOIL INVESTIGATION CROSS-SECTION  
STATION 119+90  
RACELAND - DES ALLEMANDS HIGHWAY  
ROUTE U. S. 90

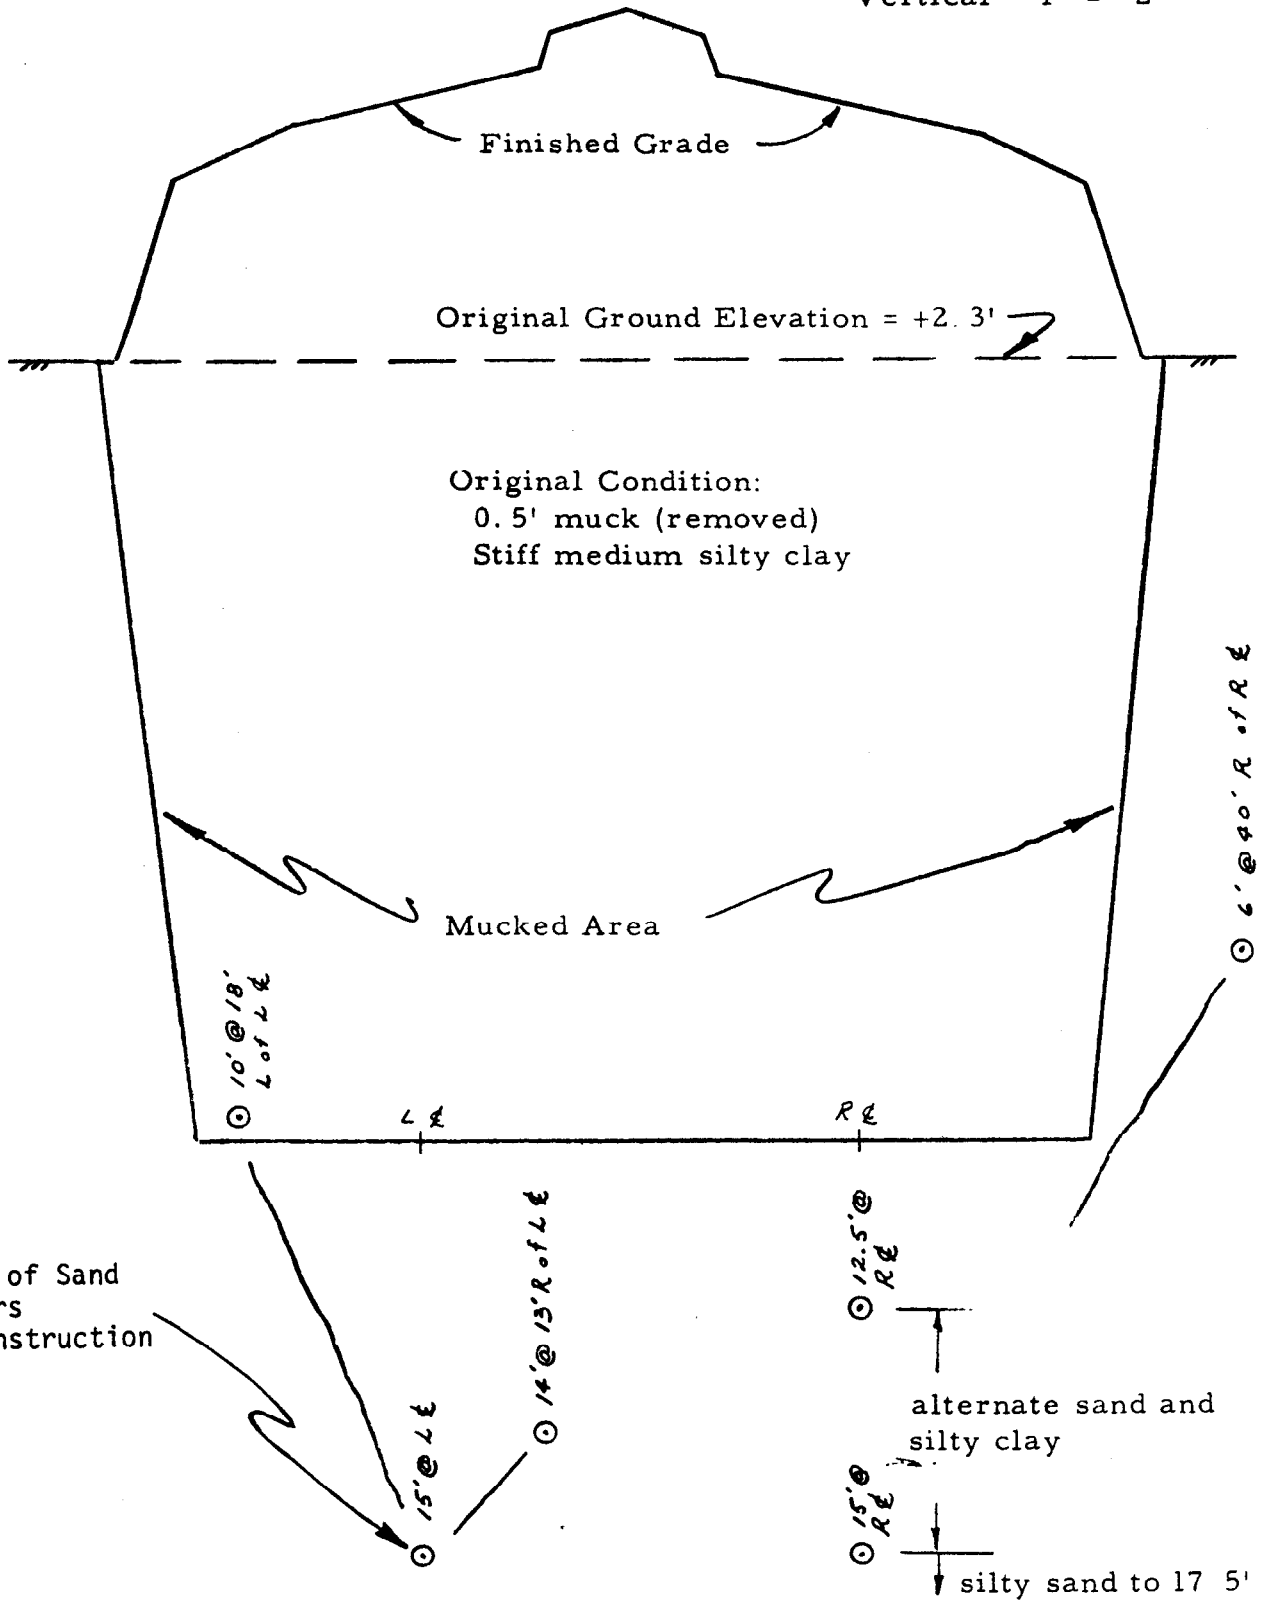
FIGURE 22

MUCK AND SOIL INVESTIGATION CROSS-SECTION  
 STATION 256+18  
 RACELAND - DES ALLEMANS HIGHWAY  
 ROUTE U. S. 90
