EVALUATION OF DRAINAGE PIPE BY FIELD EXPERIMENTATION  
AND SUPPLEMENTAL LABORATORY EXPERIMENTATION

Interim Report No. 1

Research Report No. 101

MARCH 1977

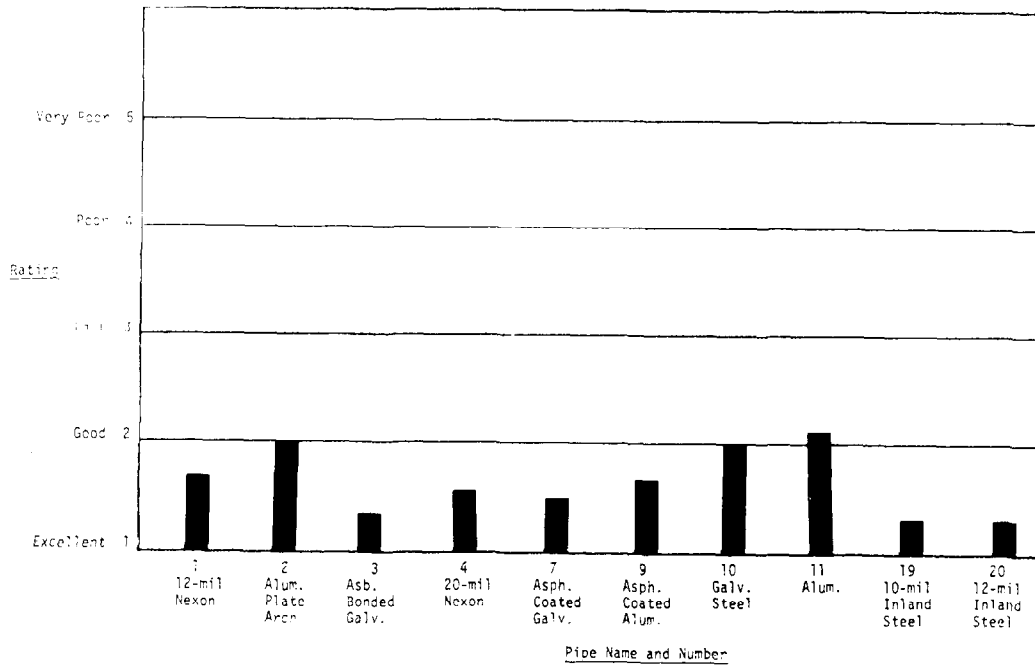
Average Panel Ratings at Ten Sites  
FIGURE 7

The types of culverts providing the best performance after two years of field exposure are the asbestos-bonded asphalt-coated galvanized steel pipe and the Inland Steel polyethylene-coated galvanized steel pipe. The basis of field performance was the ability of the culverts to resist metallic corrosion. An index of corrosion resistance was assigned by a panel inspecting the entire culvert in the field and by an engineer examining a sample of the test culvert in the laboratory.

The field ratings are summarized in Figure 7. The ratings are the collective opinions of a panel of six highway engineering personnel who examined the culverts at the ten test locations and assigned a numerical rating ranging from one (excellent) to five (poor) to each culvert. Neither the two highway engineers nor the four engineering specialists comprising the panel are corrosion experts. However, the authors feel that the technical backgrounds of these individuals qualified them to identify tell-tale signs such as rust on steel and pitting on aluminum and to assign valid ratings to the test culverts.

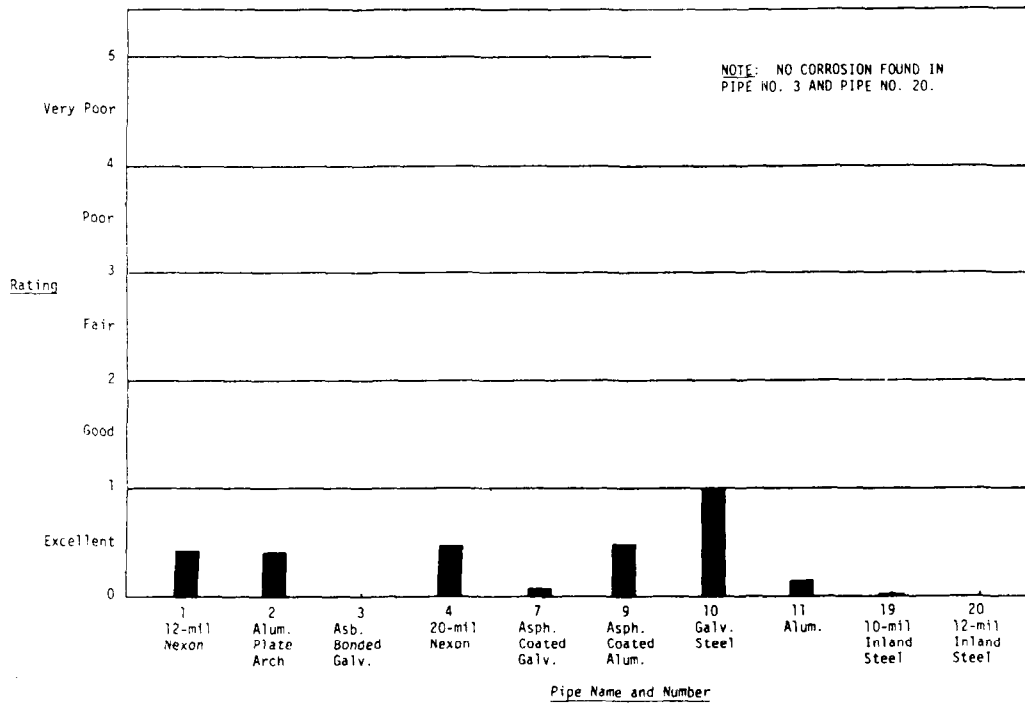
Average Laboratory Ratings at Ten Sites  
FIGURE 8

The laboratory ratings are summarized in Figure 8. These ratings result from a chemical engineer examining each square-inch unit of area of samples from the test culverts in the laboratory and assigning a numerical rating ranging from zero (excellent) to five (poor) to each sample.

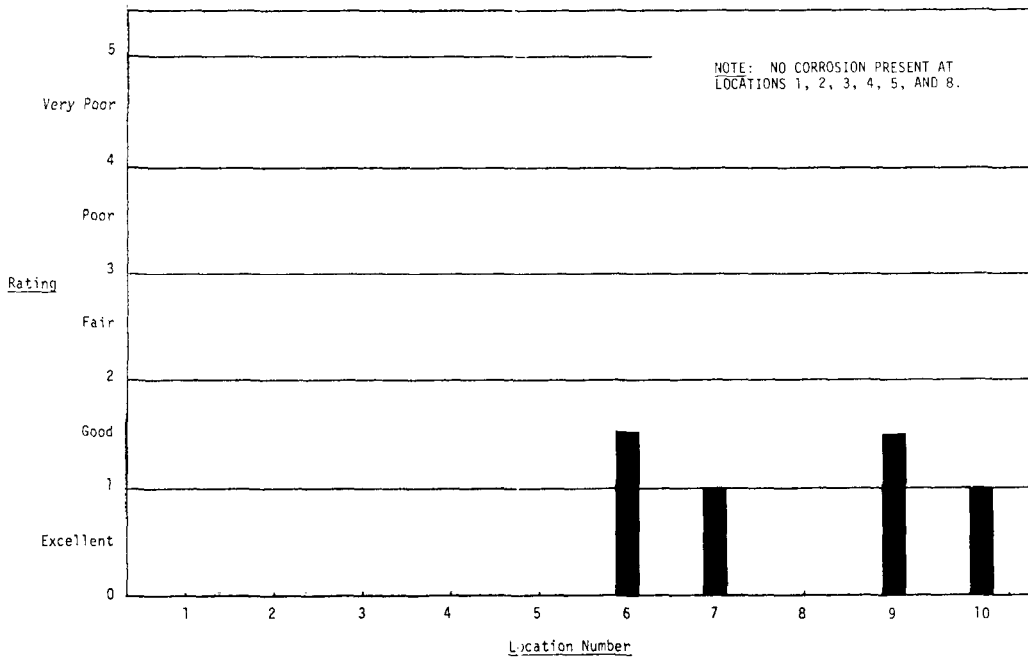
*Laboratory Ratings of Samples from Asphalt-Coated  
Corrugated Aluminum Test Pipes*  
FIGURE 26

The panel's ratings for this type of test pipe are shown in Figure 25. The panel commented that the asphalt coating was extensively removed from these test pipes. The group made special note of the oxidation manifested on the aluminum at sites 3, 6, 7, 9, and 10. Laboratory evaluation revealed that the stains on these pipes at sites 6, 7, 9, and 10 are more than just signs of oxidized cladding, and reported thickness loss penetrating the core alloy at these four sites. For example, the rating of 1.0 at site 7, as shown in Figure 26, indicates an average maximum thickness loss per square inch of 20% of the original thickness.
