INVESTIGATION OF ACCIDENT REDUCTION
BY GROOVED CONCRETE PAVEMENT

Final Report

Research Report No. FHWA/LA-79/133

Research Project No. 73-1G(B)
Louisiana HPR 0010(002)

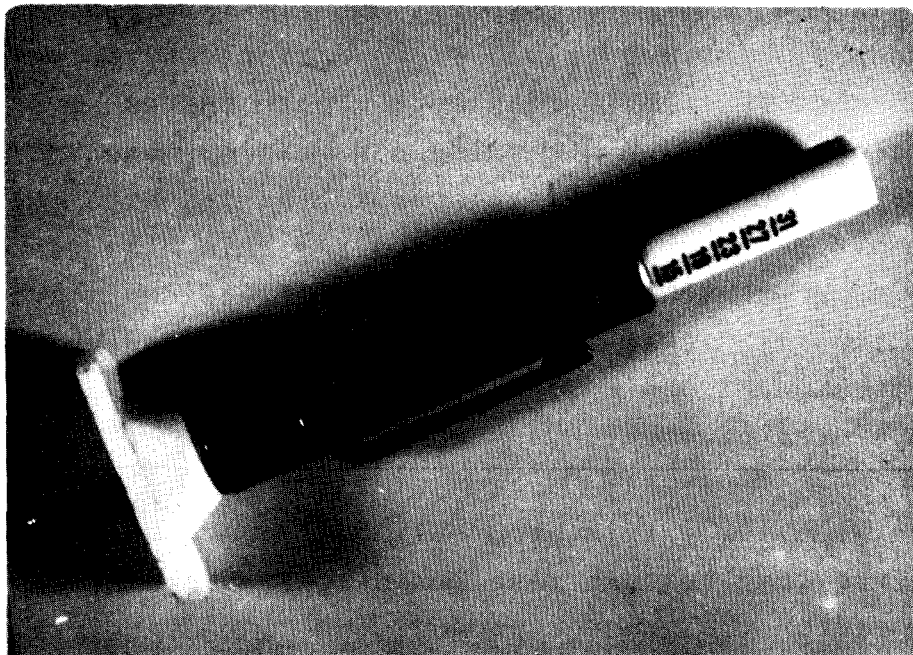
In addition to the patches and photographs, the depth of the grooves was measured with a tread depth gauge used for automobile tires. Figure 9 shows the gauge.

Tire Tread Depth Gauge

The depth of the grooves was measured at each testing date with a tire tread depth gauge (Figure 9) which is graduated in 32nds of an inch (0.794 mm). Table 7 in the appendix shows the results in inches. Figure 11 shows the results plotted as a bar-o-graph. Figure 12 shows the wear of selected sites. In Figure 11 the bars represent the depths from some standard reference plane even though that is not the way the wearing occurred, i.e., the grooves wear from the top down. However, since no reference plane could be established to within $1/32$ inch, the depths were depicted as though

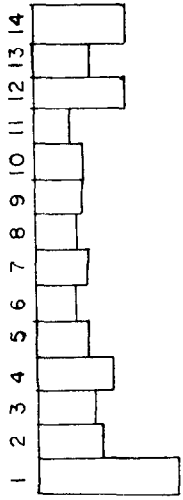
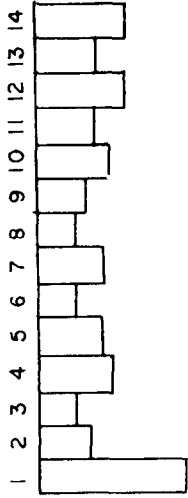
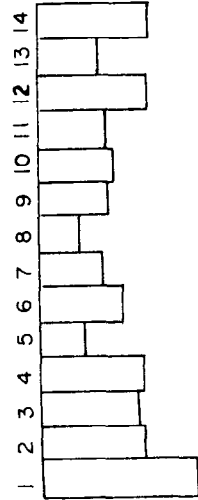
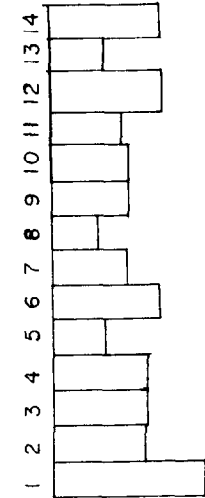
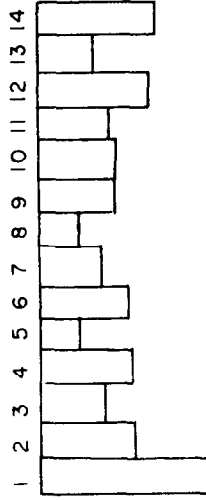
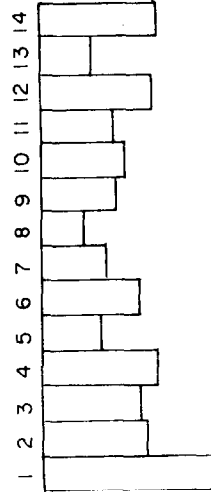
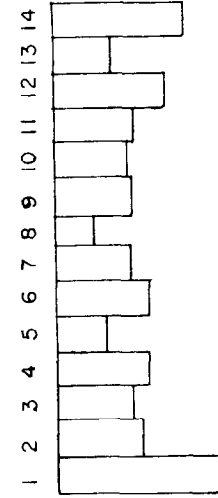
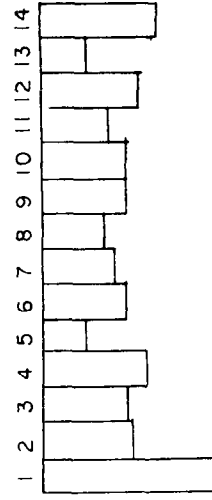
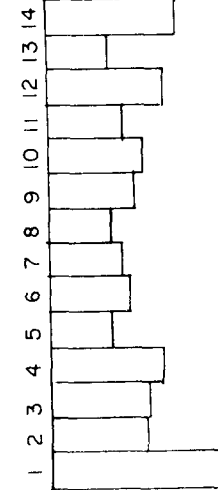
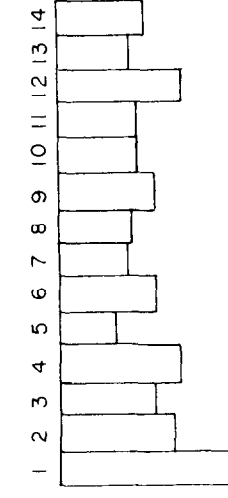
FIGURE II

Depth of Groove
in Inches
