EVALUATION OF DRAINAGE PIPE BY FIELD EXPERIMENTATION
AND SUPPLEMENTAL LABORATORY EXPERIMENTATION

Final Report

Research Report No. 174

Conducted by
LOUISIANA DEPARTMENT OF TRANSPORTATION
AND DEVELOPMENT
Research and Development Section
In Cooperation with
U. S. Department of Transportation
FEDERAL HIGHWAY ADMINISTRATION

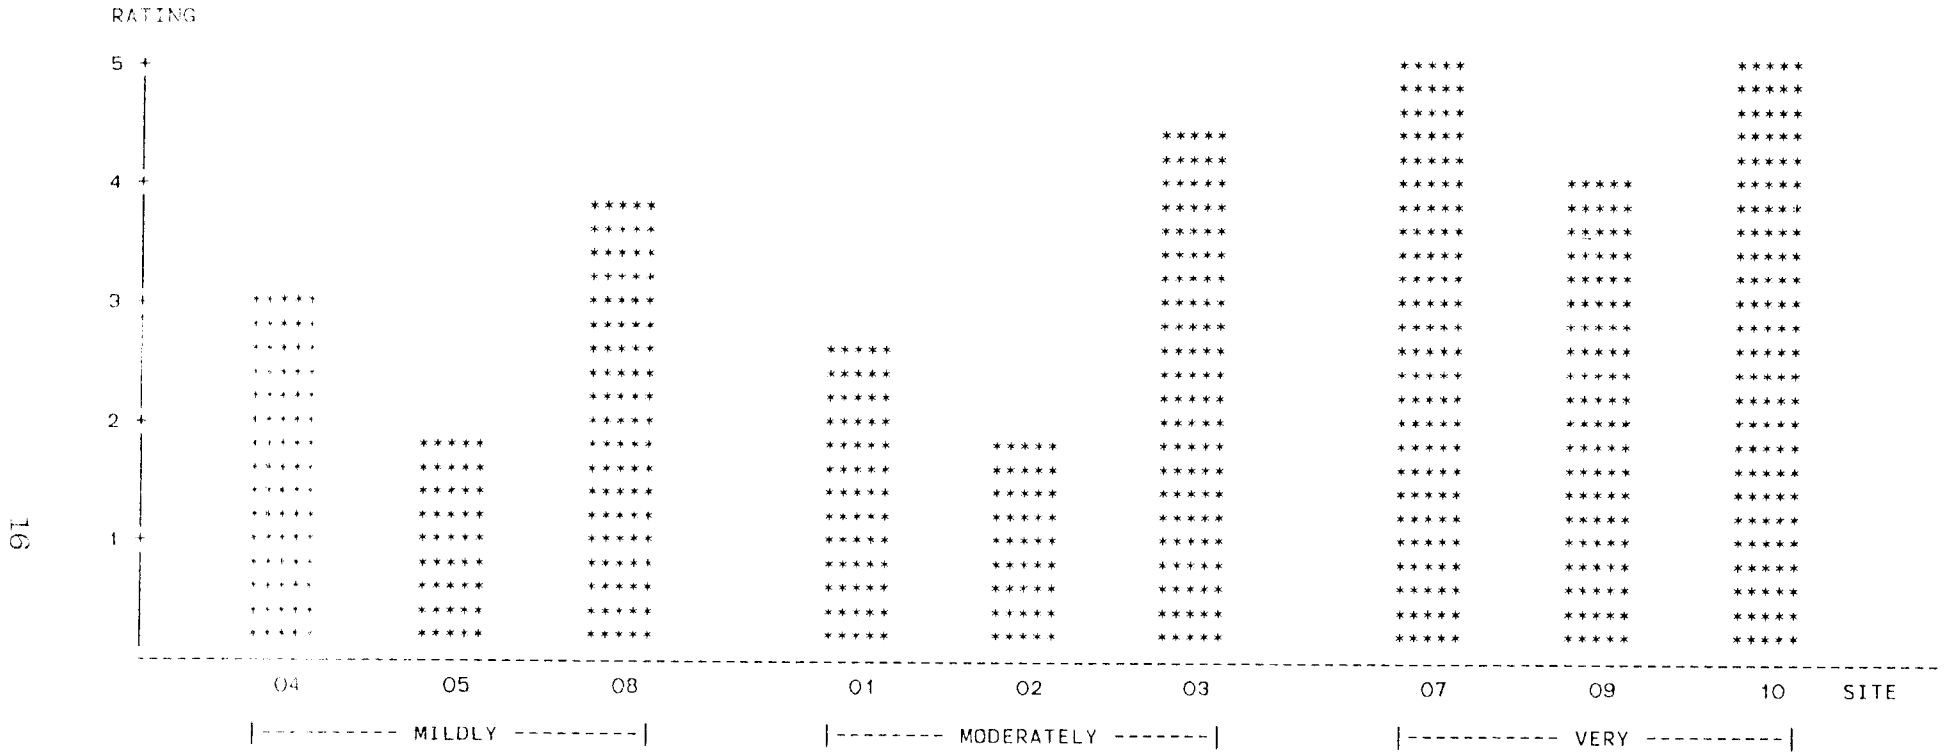
resistivities only, i.e., some galvanized steel pipes located at an assumed moderately corrosive site have a rating lower (better) than the same pipe at what was thought to be a mildly corrosive site. This is graphically illustrated in Figure 2 on page 16. Because of the inconsistencies outlined above, a different criteria of categorization or grouping of the eleven separate sites was established. This different grouping is based upon the combined effect of all environmental influences on corrosion of uncoated galvanized steel as indicated by the assigned rating. In other words, the relative condition of 10-year-old uncoated galvanized steel pipe was used to place the sites into categories of increasing corrosion potential. Figure 3 on page 17 presents a graph depicting the ratings of the uncoated galvanized steel when the sites are placed into the new categories. The limits of each category were established as follows:

RATINGS FOR 16-GAUGE GALVANIZED STEEL PIPE
ORIGINAL GROUPING

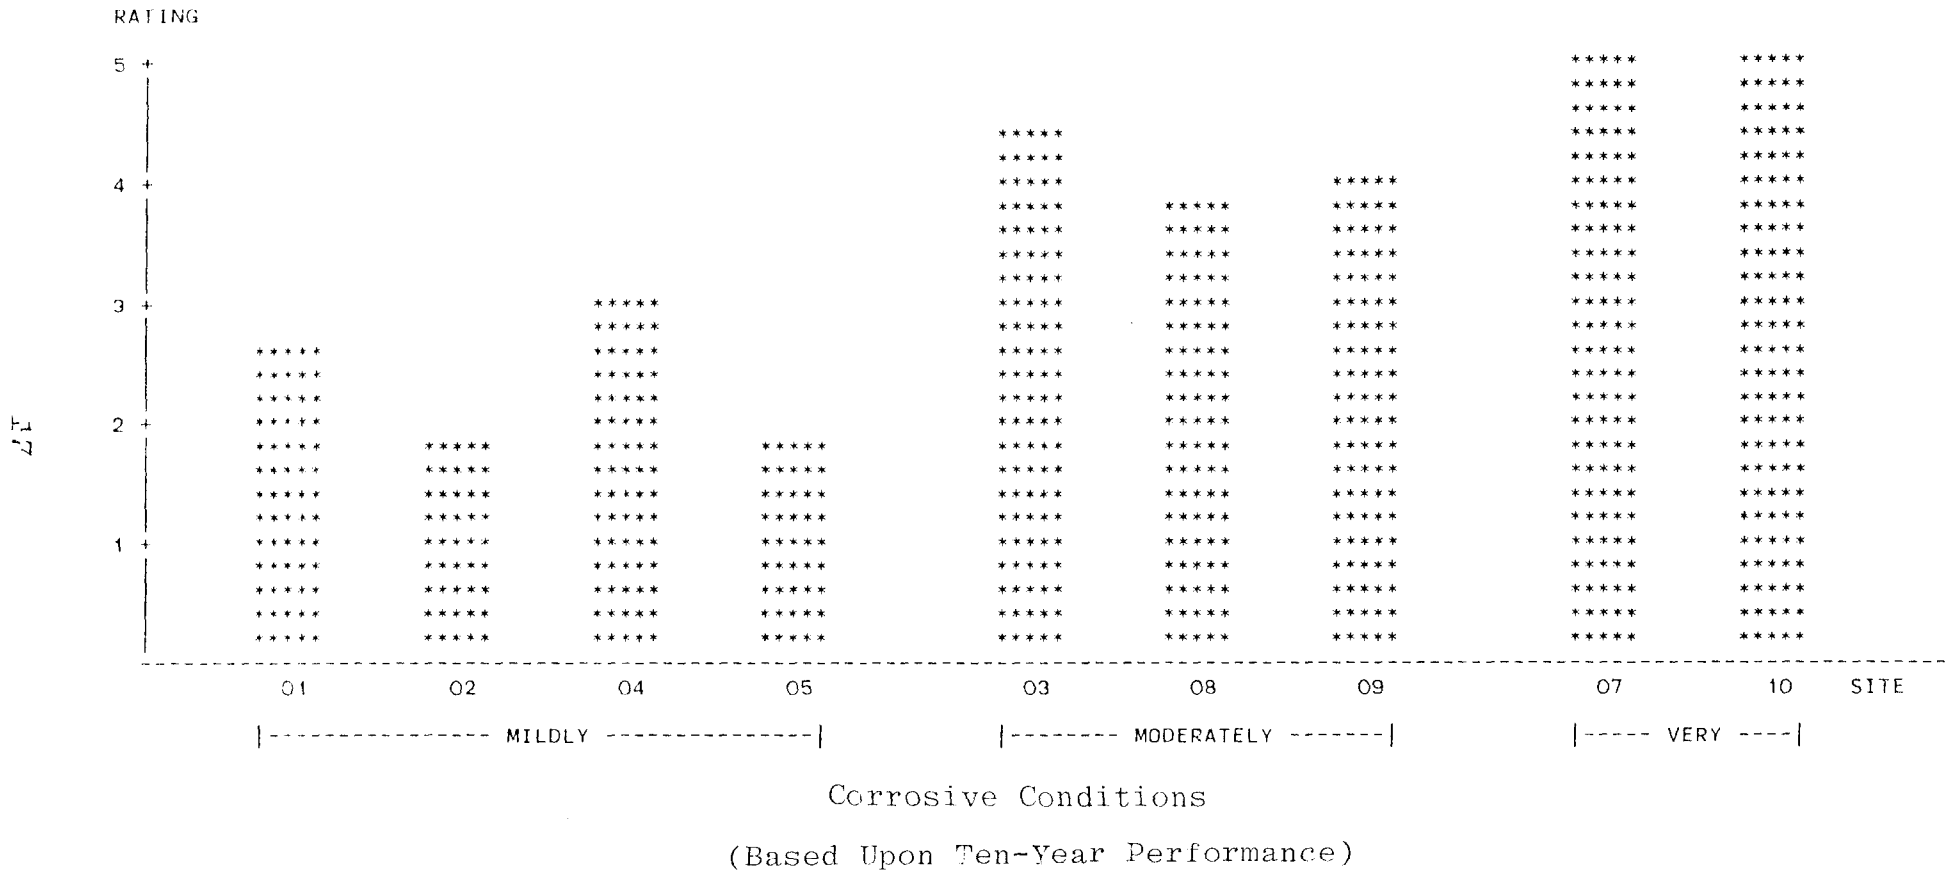
Figure 3

RATINGS FOR 16-GAUGE GALVANIZED STEEL PIPE

NEW GROUPING

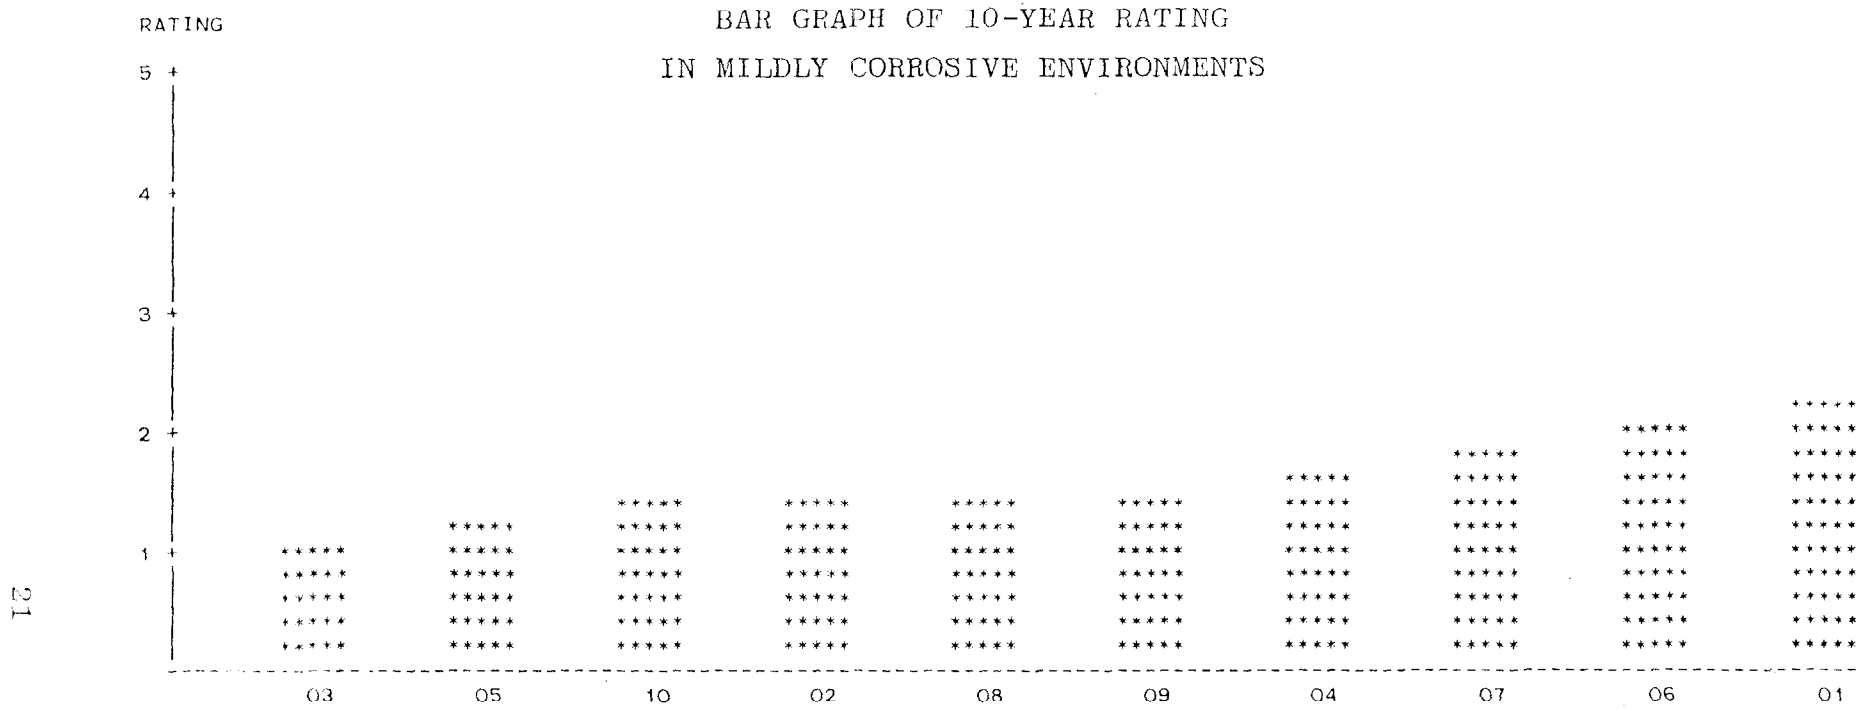
Figure 4

Figures 4, 5, and 6 on pages 21 through 23 depict the average (10-year) ratings under the three environmental conditions. Based upon the average (10-year) ratings within the three corrosive environments the following are indicated:

The asbestos bonded asphalt coated galvanized steel and the asphalt coated aluminum pipes are the best performing pipes tested, with an average rating of 1.1. The 10-year average rating for all pipes ranges from a best of 1.1 to the worst of 2.3. This indicates that all pipes tested performed very well under these mild environmental conditions.

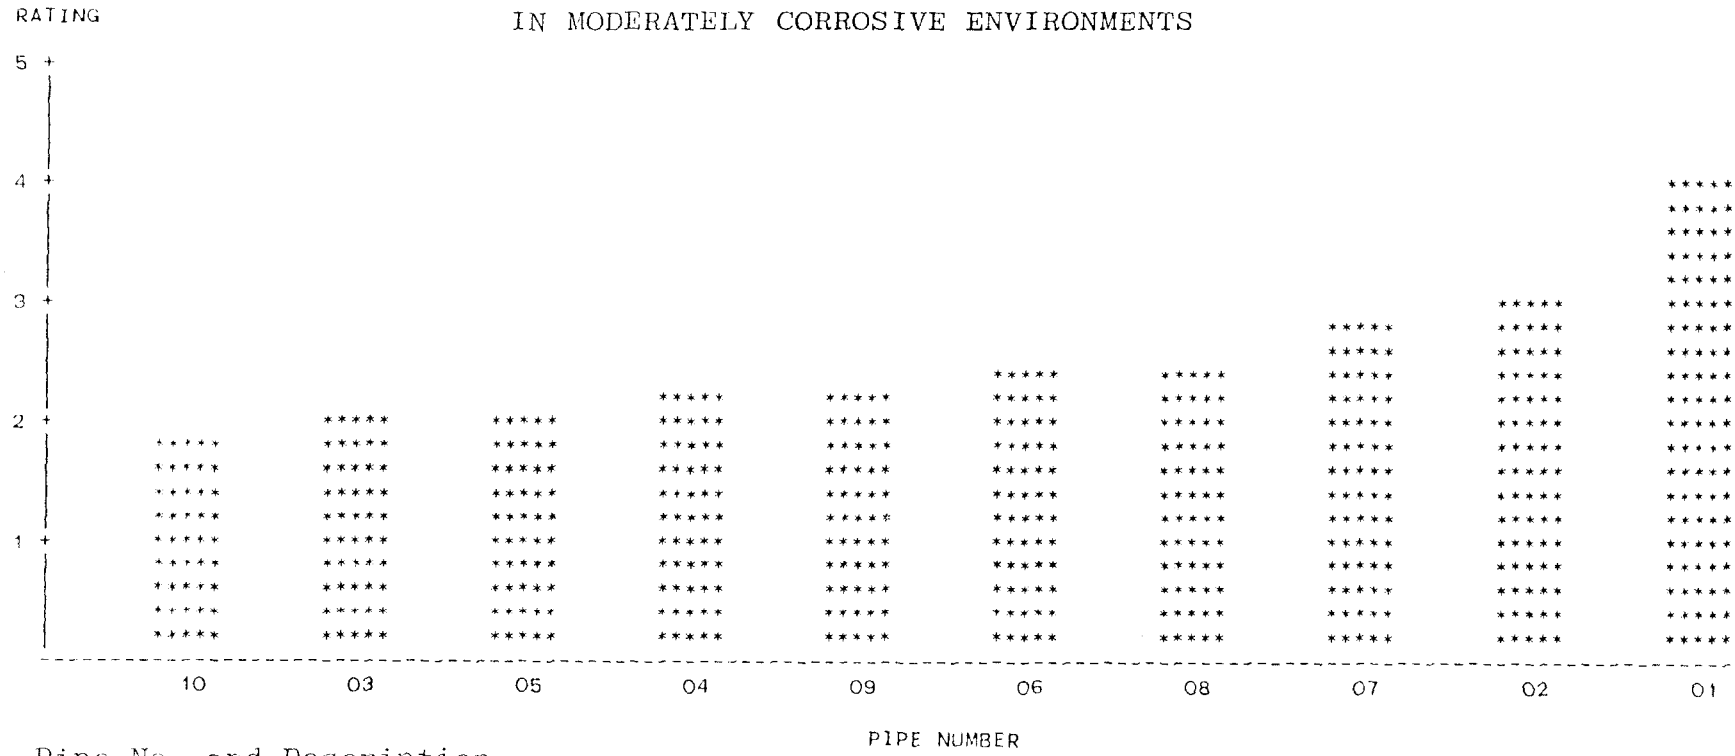
Figure 5

BAR GRAPH OF 10-YEAR RATINGS
IN MODERATELY CORROSIVE ENVIRONMENTS

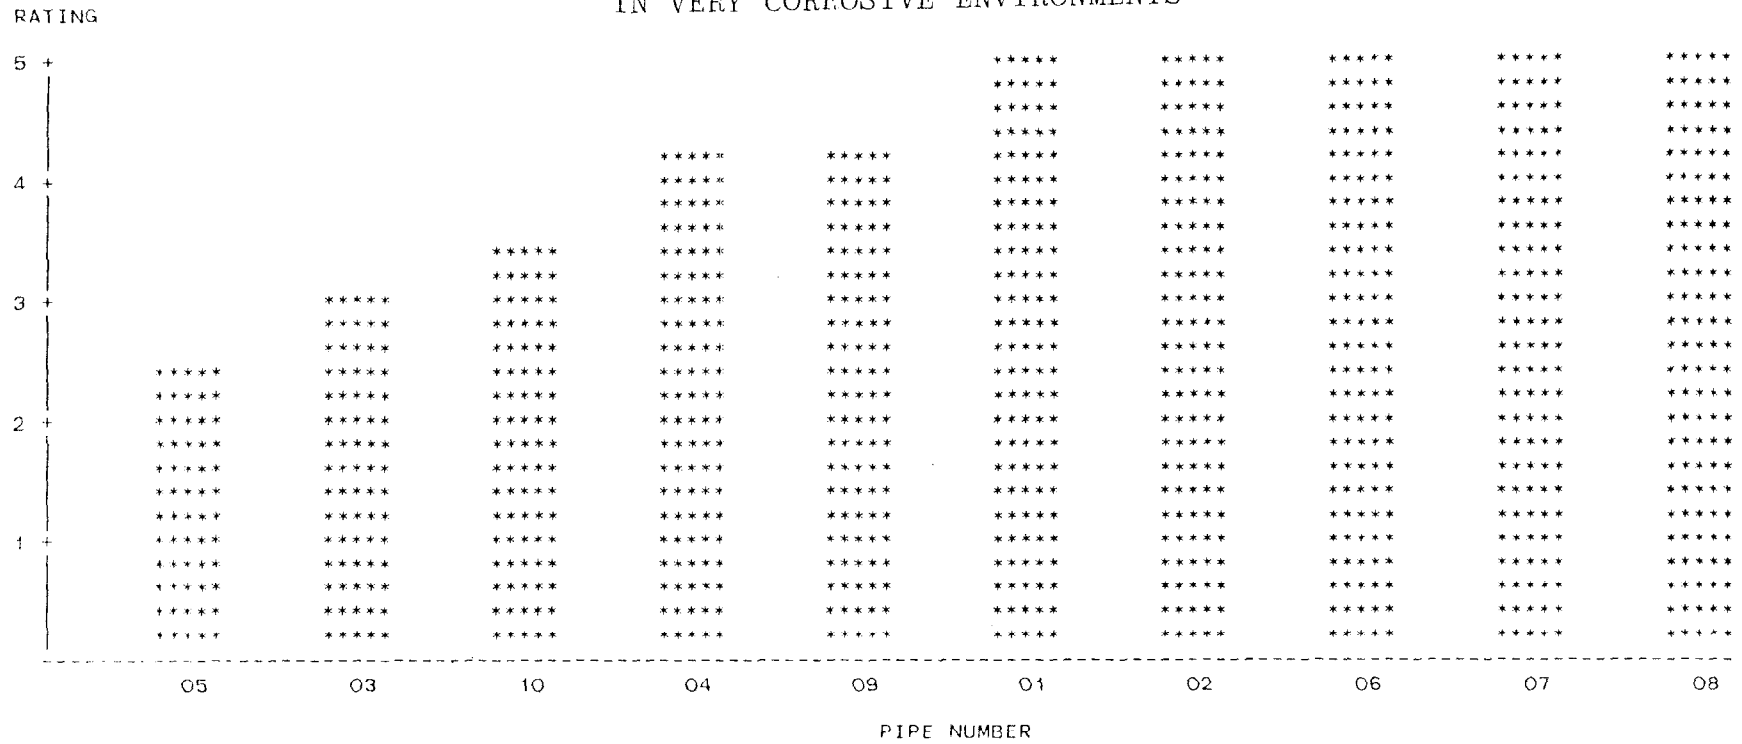
The asphalt coated aluminum (rating of 2.4), asbestos bonded asphalt coated galvanized steel (rating of 3.1) and the 12-mil polyethylene coated galvanized steel (rating of 3.4) are the best performing pipes in the very corrosive environments; these pipes stand out in their ability to resist corrosion under the very harsh conditions, and have some additional life remaining. The other pipes tested are at, or near, their end of life.

BAR GRAPH OF 10-YEAR RATINGS IN VERY CORROSIVE ENVIRONMENTS
