THIN BONDED P.C.C. RESURFACING

FINAL REPORT

Research Report No. 181

Research Project No. 80-3P(B)

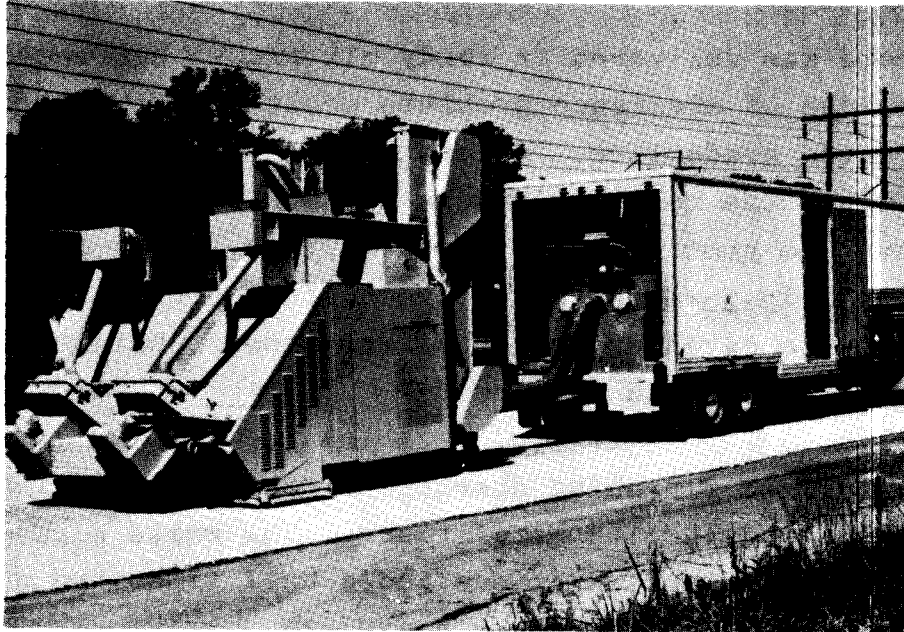
FIGURE 5

The predominant concrete aggregate used in Louisiana is too hard to allow economical scarification by milling. The contractor for this resurfacing elected, instead, to clean the pcc surface by blasting with steel shot. The surface cleaner depicted in Figure 5, page 11,

utilizes centrifugal force to propel the steel shot, with a vacuum arrangement used to catch and bag the concrete dust. Since cleaning was the prime objective in the surface preparation, only approximately 1/8-inch of the pcc surface was removed in each 8-foot wide pass of the cleaner. The newly cleaned surface is depicted in Figure 6, page 11.

Slab Cleaner

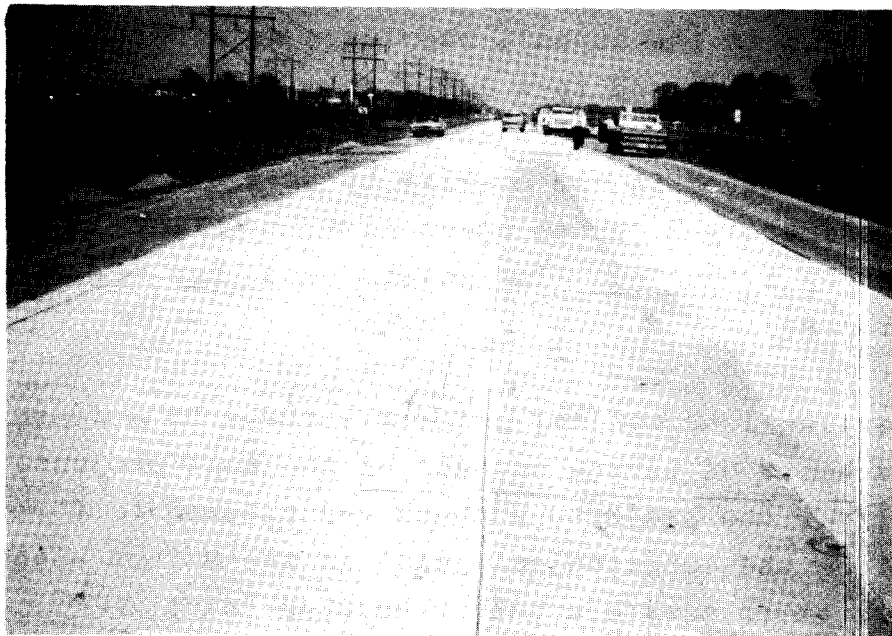
FIGURE 6

Cleaned Concrete Surface

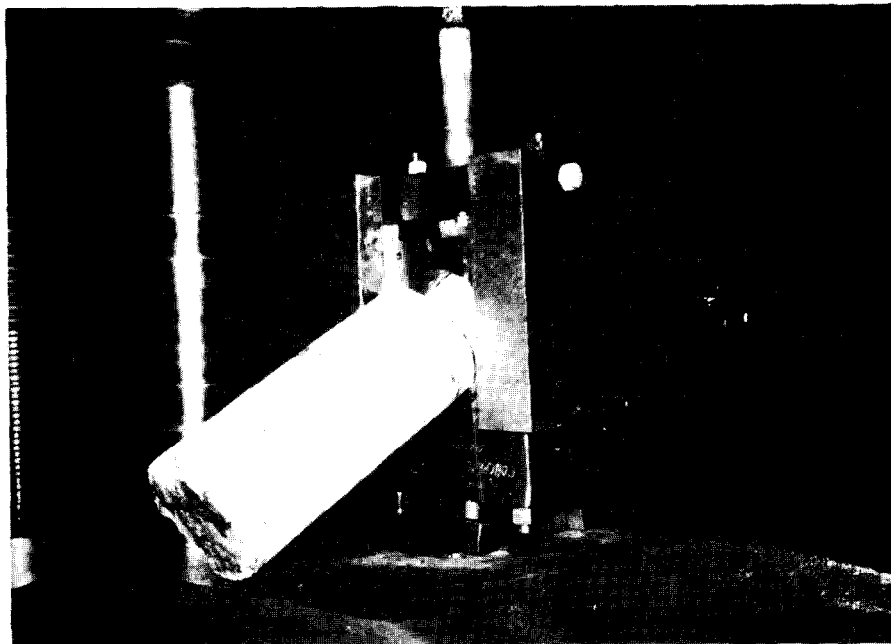
FIGURE 7

The equipment consists of a two-part sliding collar which fits over a four-inch diameter core of the resurfaced pavement as shown in Figure 7. The interface plane between the underlying pavement and resurfacing layer is lined up with the junction of the two sliding parts. The collar is then placed into a concrete testing machine, put in tension, and the load required to shear off the resurfacing is measured. By dividing the cross-sectional area of the core into the required force, the bond strength in lbf/in² is determined.

Bond Measuring Device

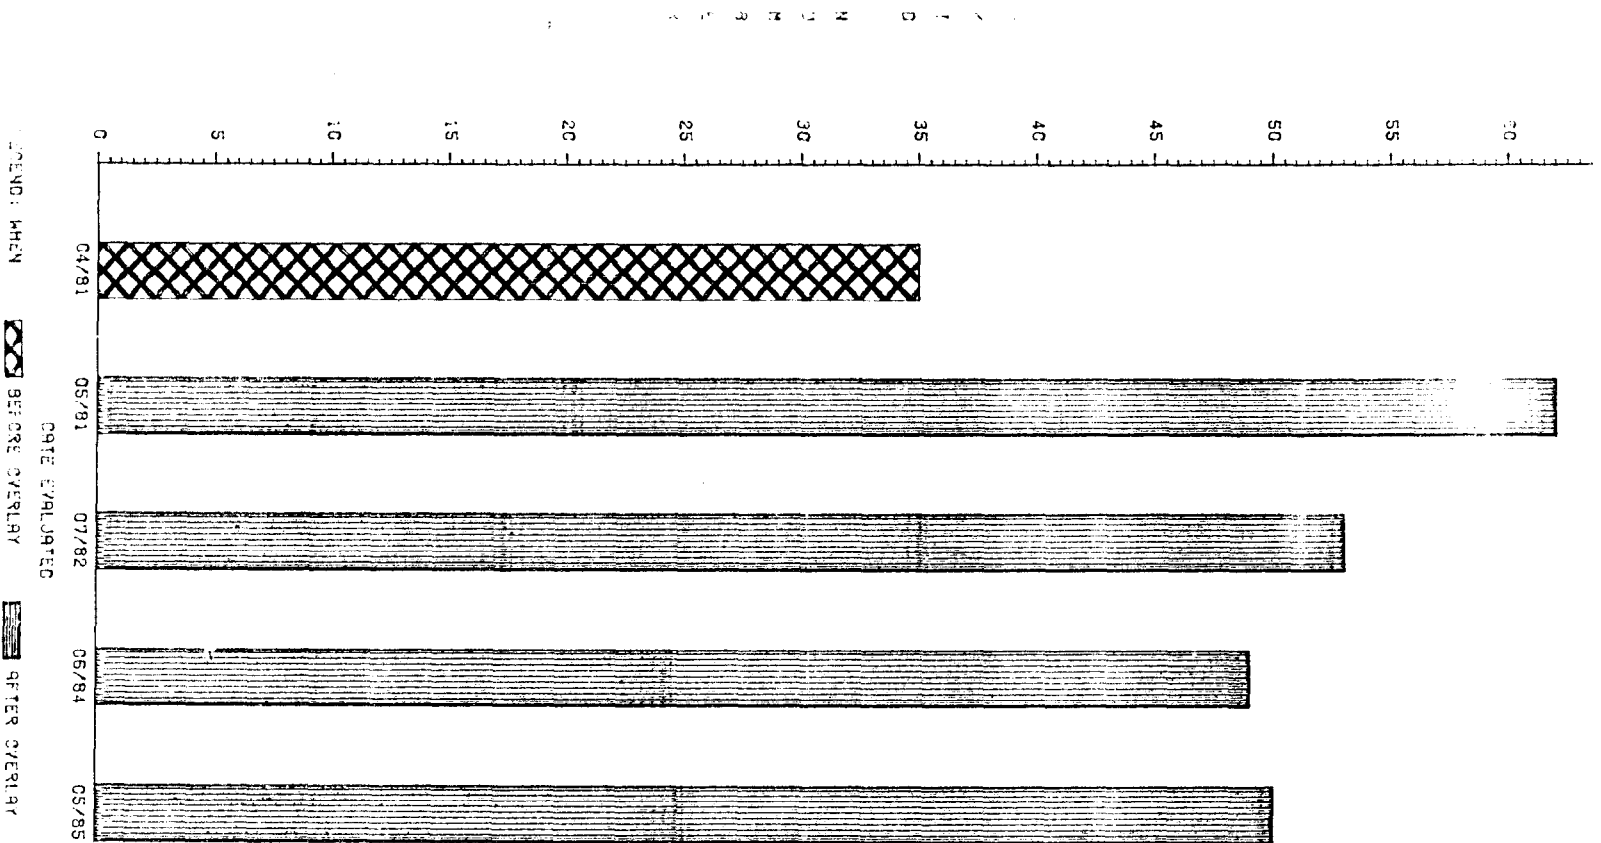
FIGURE 11

wheel paths and has a skid number of 50. Figure 11 is a graphical presentation of the change in skid resistance of the thin-bonded overlay with time.

Bar Graph of Skid Number on Date Evaluated

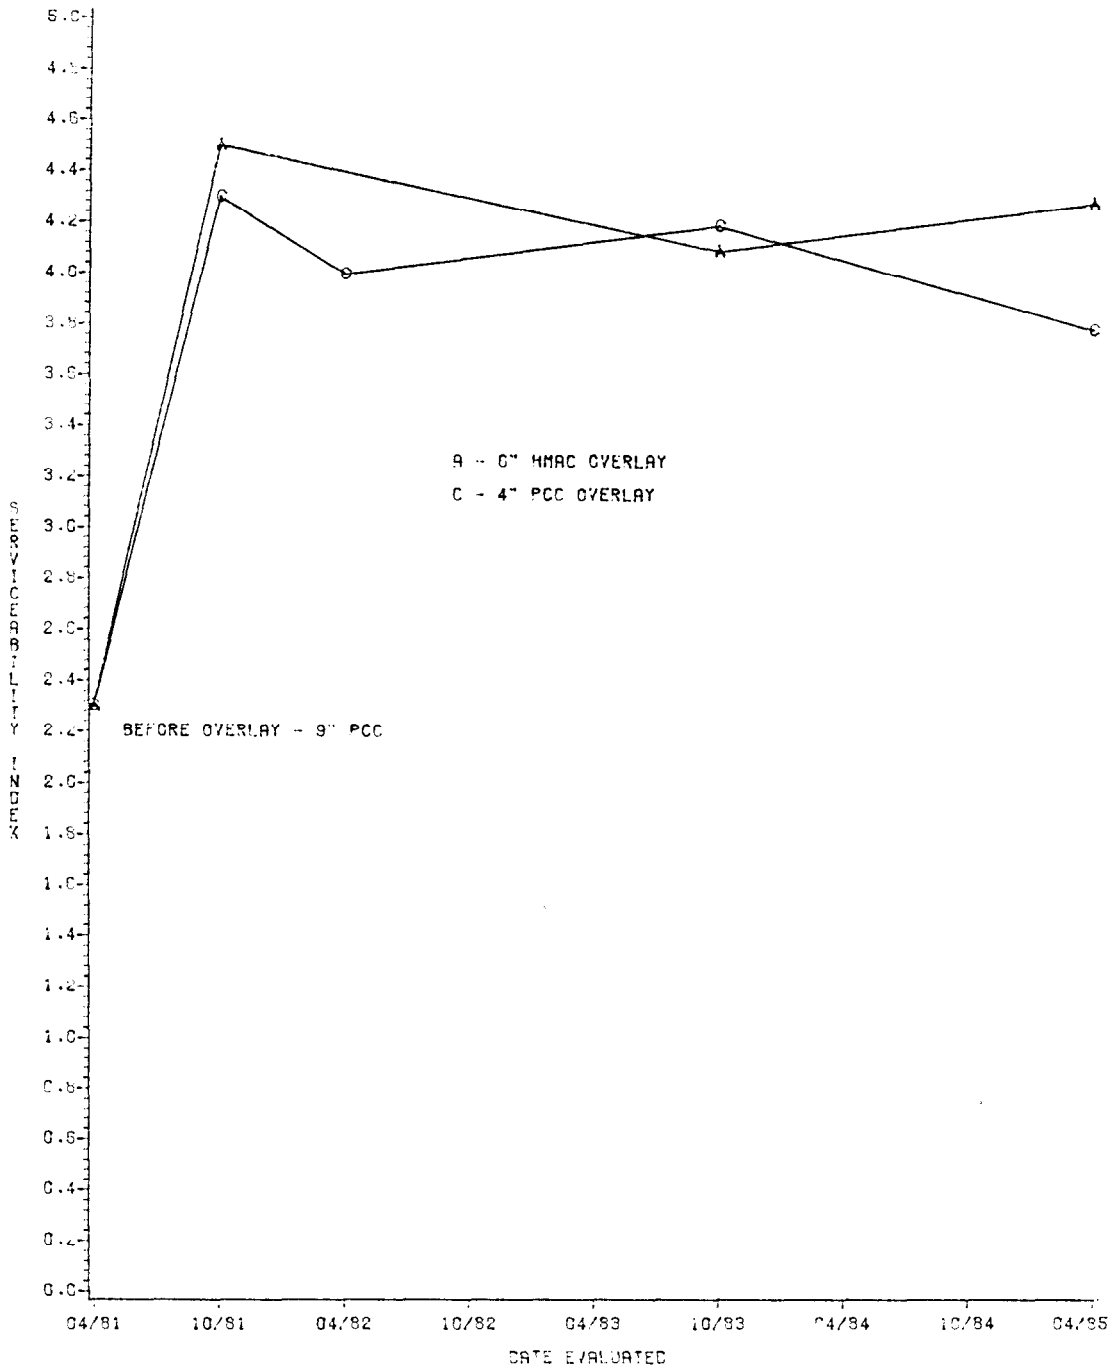
FIGURE 12

The ride quality (S.I. - Serviceability Index) of the thin-bonded pcc resurfacing has been measured periodically with the Mays Ride Meter. A description of the Mays Ride Meter and the S.I. measurement may be found in Appendix D, page 59. As can be seen in Figure 12, both the pcc and HMAC overlays initially increase the ride quality of the pavement from a classification of fair to a classification of very good. To date, the ride quality of both surfaces remain high and are in the good to very good classification.

Plot of Serviceability Index Versus Date Evaluated

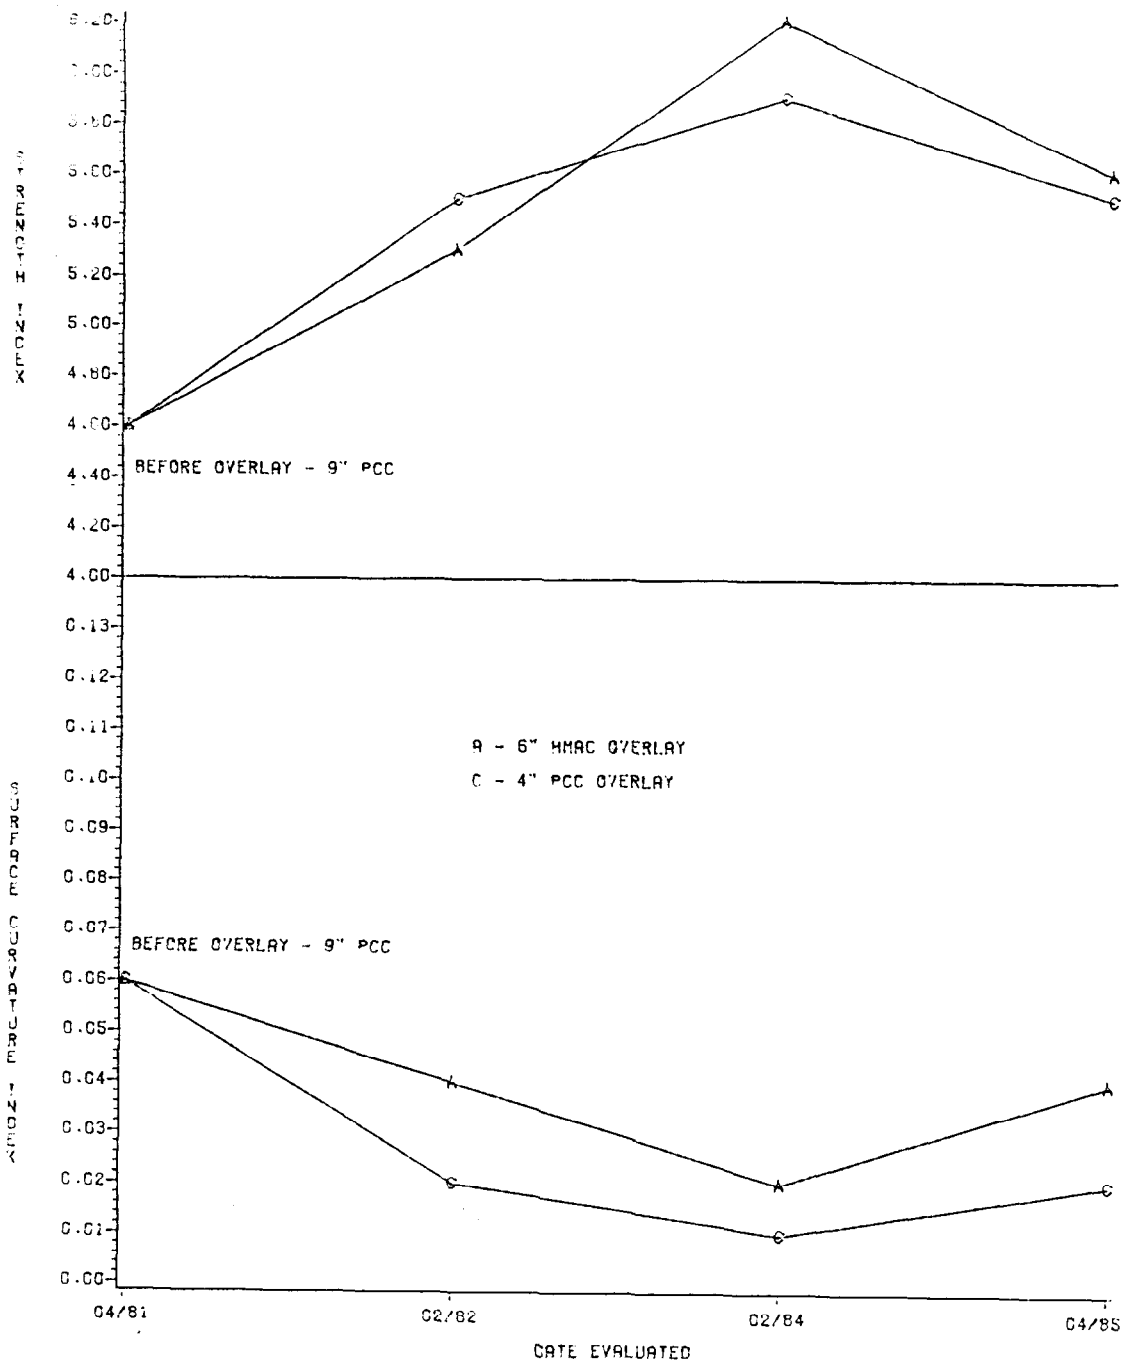
FIGURE 13

Surface deflections were measured before and periodically after resurfacing with the Dynaflect device (Appendix D). The deflection values have been converted to a strength index (ability of the total section to carry load) and to the Surface Curvature Index (S.C.I.), which is an indicator of the stiffness or load transfer capability of the upper pavement layers. The strength index is correlatable to the AASHTO strength design parameter SN by methods outlined in a previous Louisiana research publication (6). The deflection data is presented in graphical form in Figure 13. The data indicates that both the thin-bonded pcc and 6-inch HMAC overlays increased the total structural capacity of the original pavement almost equally and that both overlays have experienced a slight decrease in structural capacity with time and loading.

Plot of Strength Index and Surface Curvature Index Versus Date Evaluated

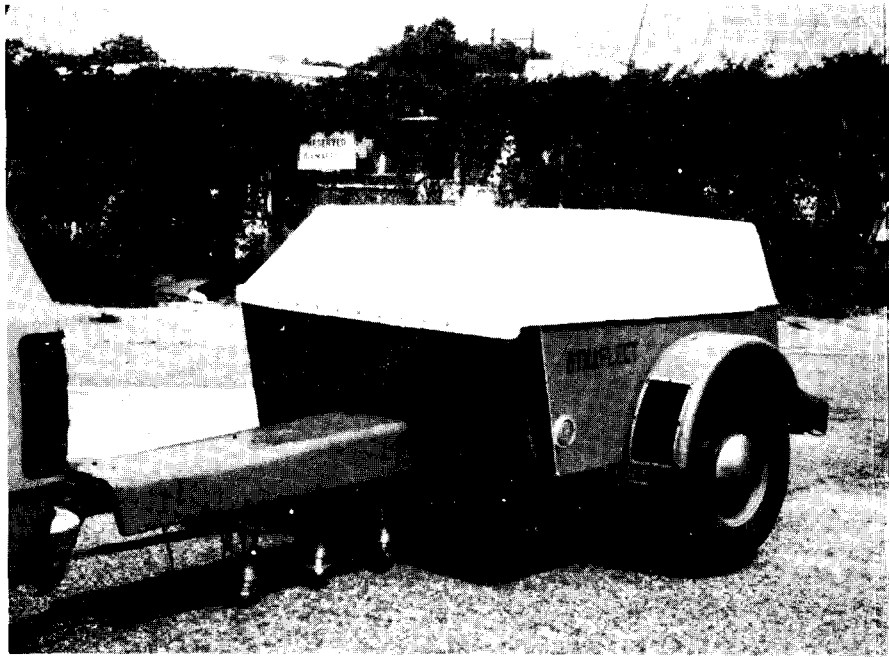
FIGURE 15

Figure 15 is a photograph of the Department's Dynaflect device. Figure 16 is a representation of the deflection basin which the Dynaflect generates. The Dynaflect actually measures the extent of only one half of the deflection bowl, with the other half assumed to be a mirror image of the measured portion. In Figure 16 the measurement W_1 is the maximum depth of the deflection bowl and occurs near the force wheels. The terms W_2 , W_3 , W_4 , and W_5 are the deflections related by geophones 2 through 5, respectively.

Louisiana Department of Transportation and Development
 Dynamic Deflection Determination System (Dynaflect)

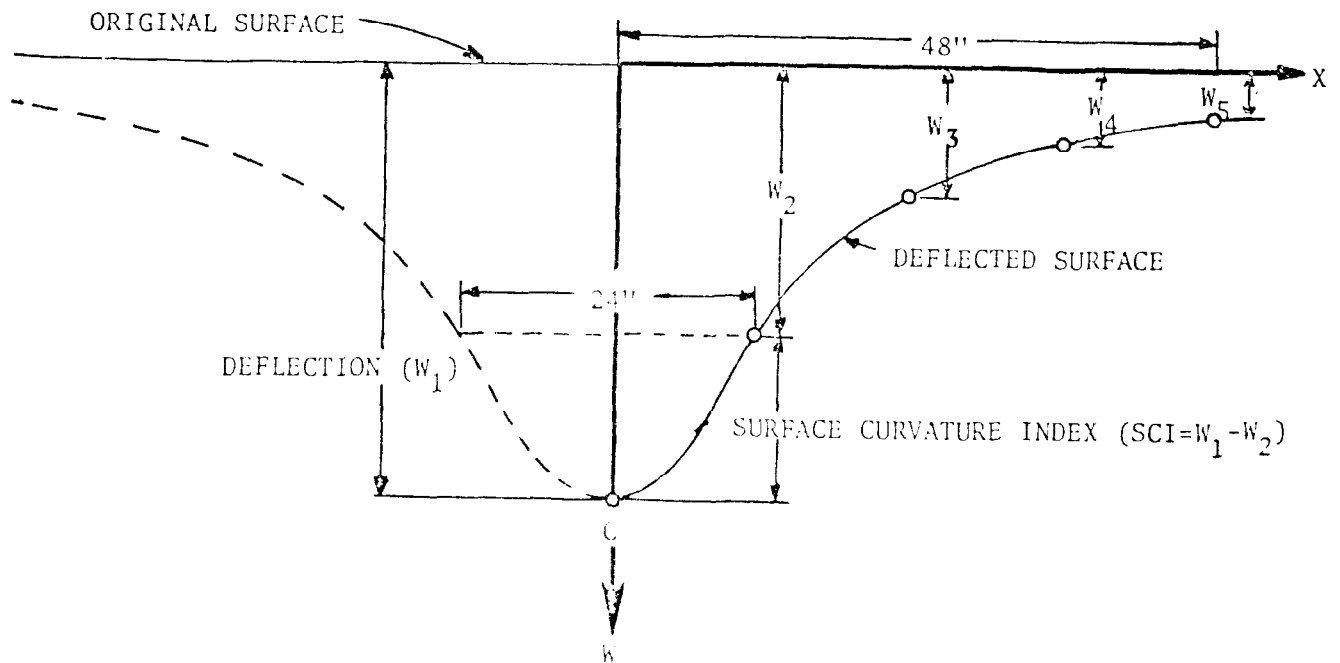
FIGURE 16

The maximum (first sensor) deflection W_1 provides an indication of the relative strength of the total road section. The Surface Curvature Index, S.C.I. ($W_1 - W_2$), provides an indication of the relative strength of the upper (pavement) layers of the road section. The Base Curvature Index, B.C.I. ($W_4 - W_5$), and the fifth sensor value W_5 provide a measure of the relative strength of the foundation. For all four parameters, W_1 , S.C.I., B.C.I., and W_5 , lower values indicate greater strength.

Typical Dynaflect Deflection Bowl
