Assessment of Tri-Dyne Precast Concrete Panels

LTRC Project Number 08-2TA

Louisiana Department of Transportation and Development
Louisiana Transportation Research Center
4101 Gourrier Ave
Baton Rouge, LA 70808
www.ltrc.lsu.edu

January 2008

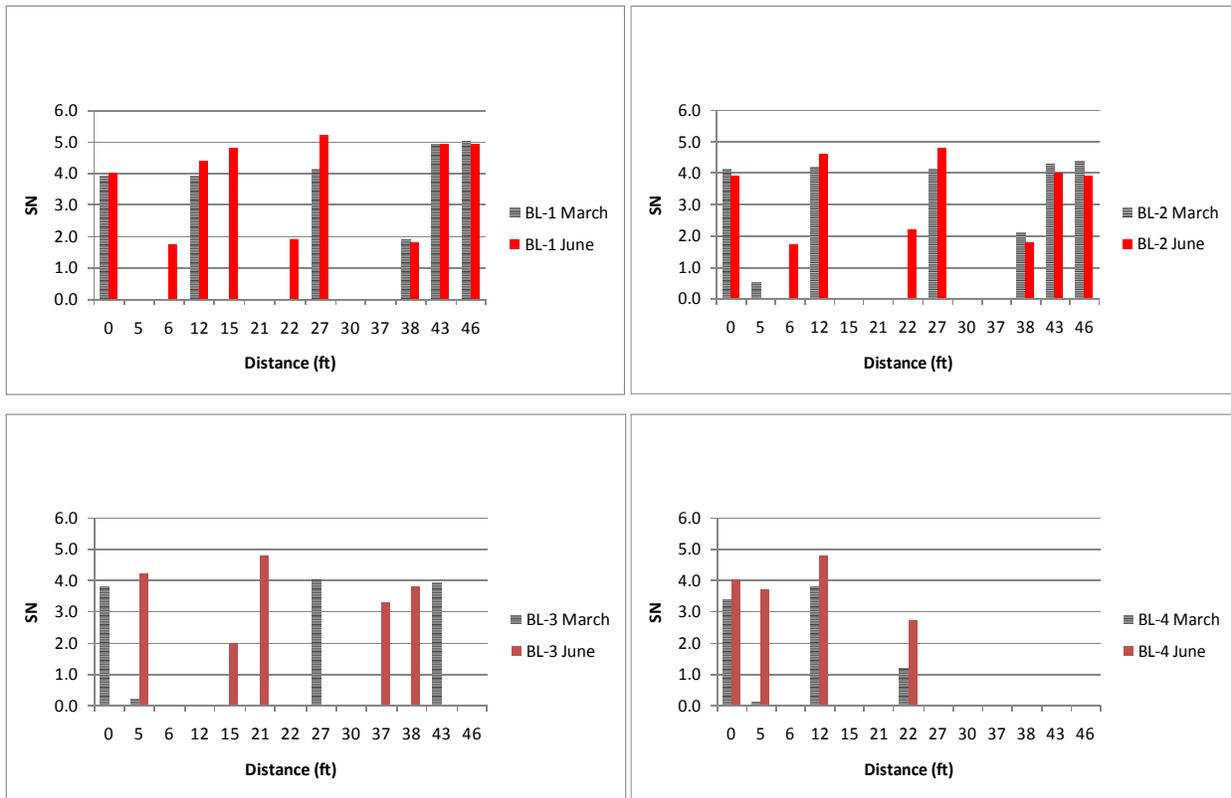
Figure 24: Dynaflect readings

Structural number readings from Dynaflect: As shown in Figure 24, many of the test locations were not plotted, due to questionable data. This phenomenon has been previously observed on concrete slabs that were either unstable or had large cracks. Pavement structures of this thickness generally produce SN values greater than 4.5. Due to the problematic data, Figure 24 is presented for informational purposes only.

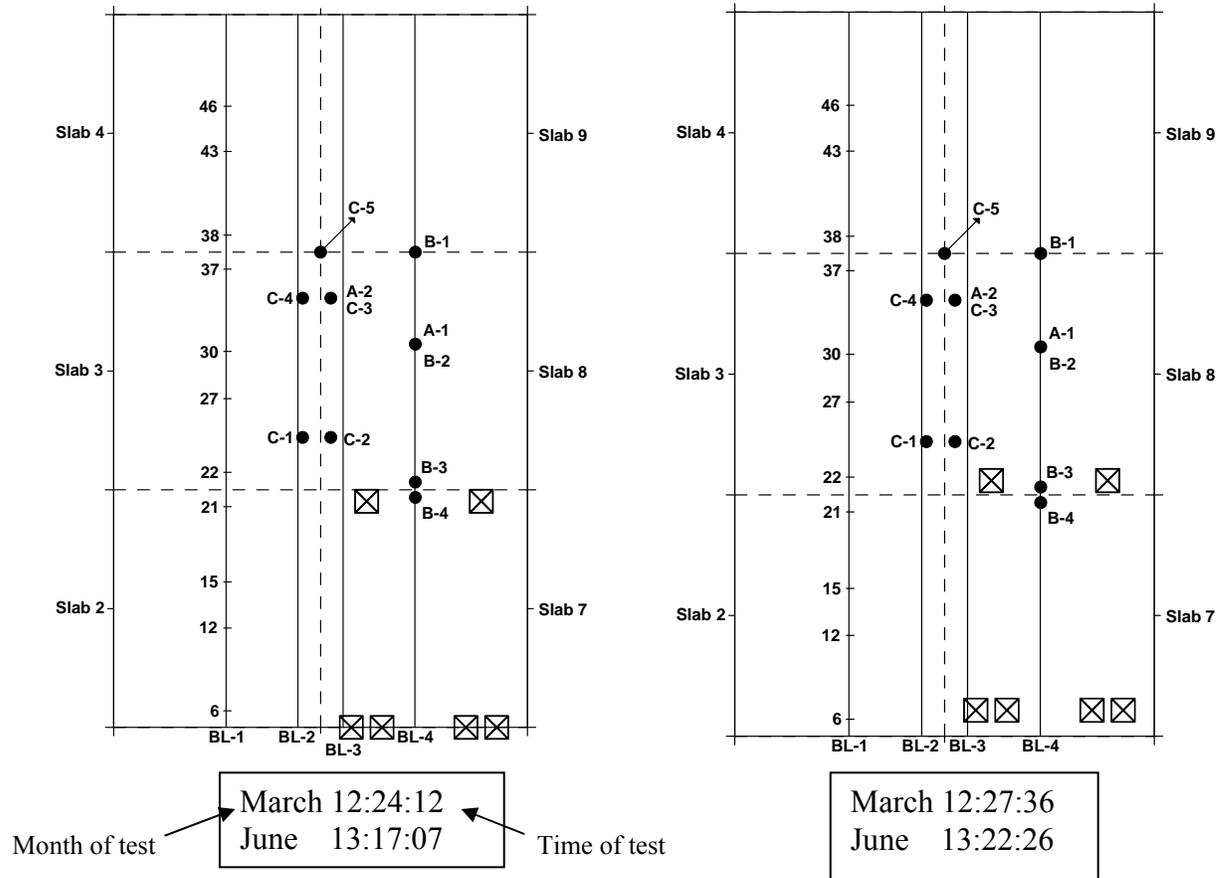
Figure 26: Wheel loading for approach side (21) and leave side (22) of the joint

Loading at locations 21 and 22: Figure 25 presents the pressure cell readings (B-4 and B-3), measured when dead loading from the front wheels of the large cone truck was applied at the approach side (21) and leave side (22) for the March and June evaluations, as shown in Figure 26.

When the load was applied to location 21 (March 12:24:21), the pressure cell readings for B-4 and B-3 were 0.8 psi and 10.1 psi, respectively. If the slabs were equally and fully supported by the base course and properly aligned vertically and horizontally, the pressure readings from pressure cells B-3 and B-4 should be similar when loaded at location 21 and different when loaded at location 22 due to the load transfer mechanism, as shown in Figure 25. However, there was a pressure differential of 9.3 psi across the joint when loaded at location 21. Due to the void

at location 21; profile differential between slabs 7 and 8, as shown in Figure 19; and the mechanism of load transfer, as shown in Figure 25; the load applied at location 21 was carried predominately by the base at location 22 (slab 8).

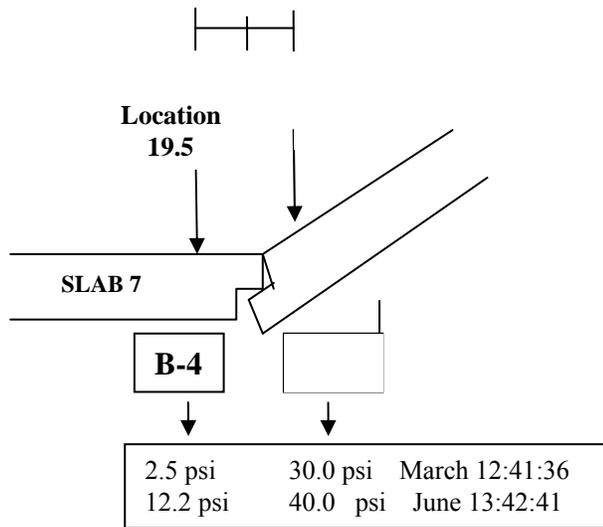
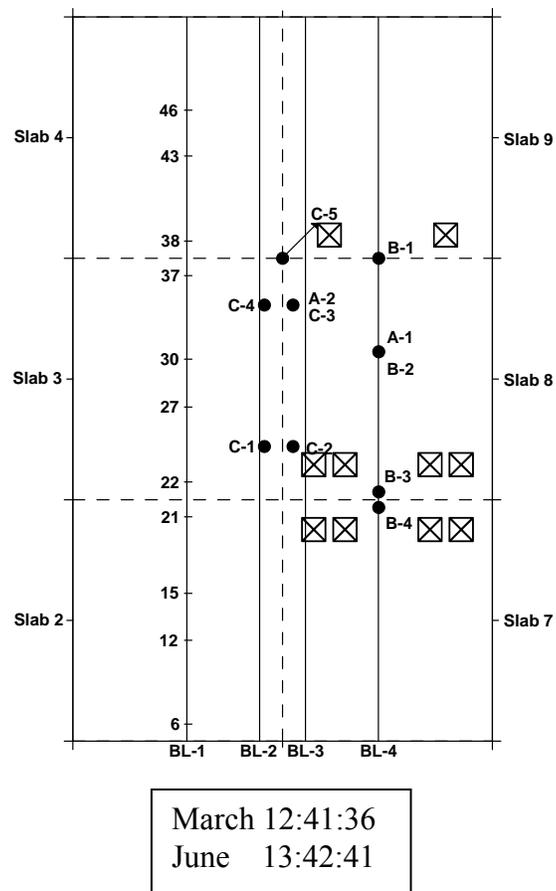
Figure 27: Data summary for slabs 7 and 8

Simultaneous loading at locations 19.5 and 23.5: The pressures for B-4 and B-3 were 2.5 psi and 30 psi, respectively, for the March 12:41:36 data set when the rear wheels of the large cone truck were located equidistant (24 in.) from the joint at slabs 7 and 8, as shown in Figures 27 and 28. Because the lap joint system was a poor load transfer mechanism, slab 8 bears the full load of the tires (location 23.5) over it and the majority of the load applied (location 19.5) to slab 7. This trend was also evident in the June 13:42:21 data, as the pressures for B-4 and B-3 were 12.2 psi and 40 psi, respectively.

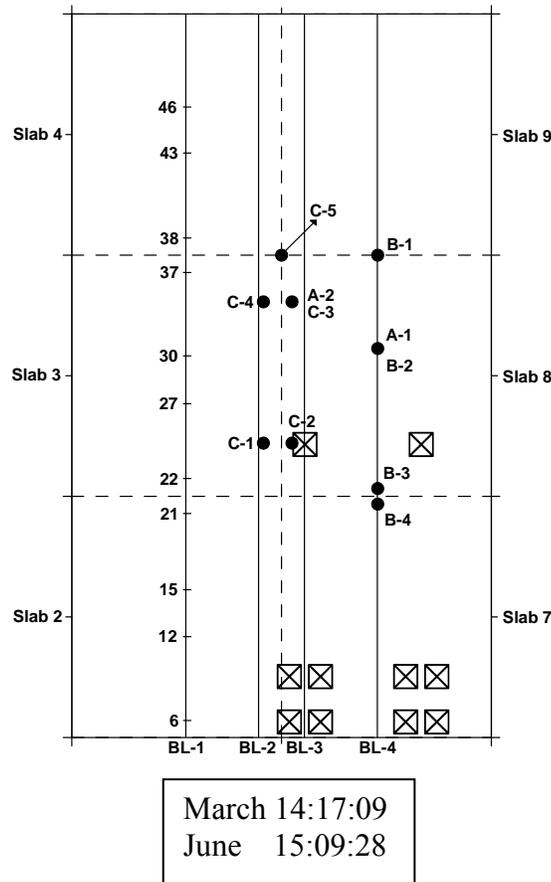
Figure 29: Front wheel load near sensor C-2

Loading near sensor C-2 with front wheels: Figure 29 presents the wheel loading locations as they were when the front wheel of the truck was located near sensor C-2 on slab 8.

As shown in Figure 30, the pressures for C-1 and C-2 were 4.1psi and 6.4 psi, respectively, for the March 14:17:09 data set and 6.9 psi and 4.6 psi, respectively, for the June 15:09:28 data set. Similar pressures across the longitudinal joint at slabs 3 and 8 were observed for both the March and June data sets.

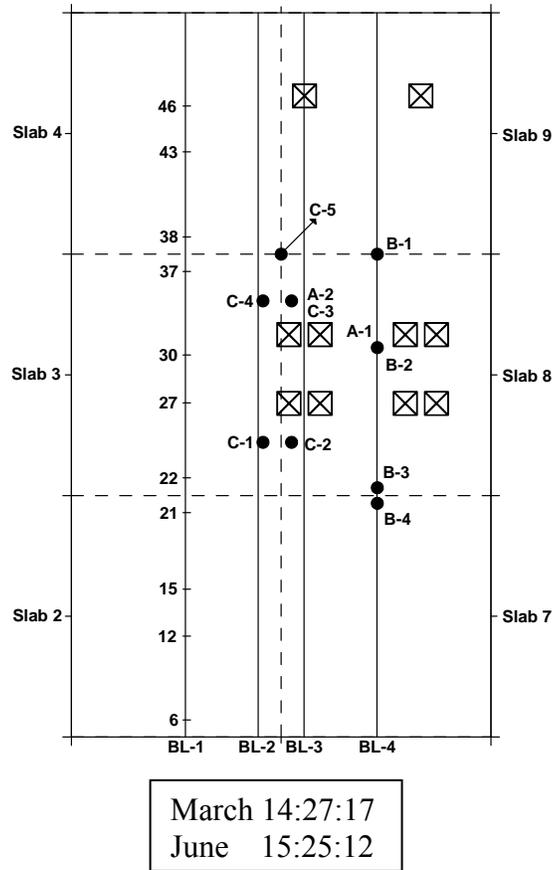
Figure 31: Front wheel load near sensor C-2

Loading between sensor C-2 and C-3 with rear wheels: Figure 31 presents the loading location as it was when the rear wheels of the truck were located between sensor C-2 and C-3 on slab 8. Comments about the sensor C-4 and C-3 relationship will not be presented because sensor C-3 was nonfunctional during the June evaluation.

As shown in Figure 32, the pressures for C-1 and C-2 were 2.8 psi and 8.2 psi, respectively, for the March 14:27:17 data set and 4.3 psi and 4.4 psi, respectively, for the June 15:25:12 data set. The reason for the differing pressures between the March and June data set could be that the better contact between the slab and base course was created by the injection of leveling material in June.

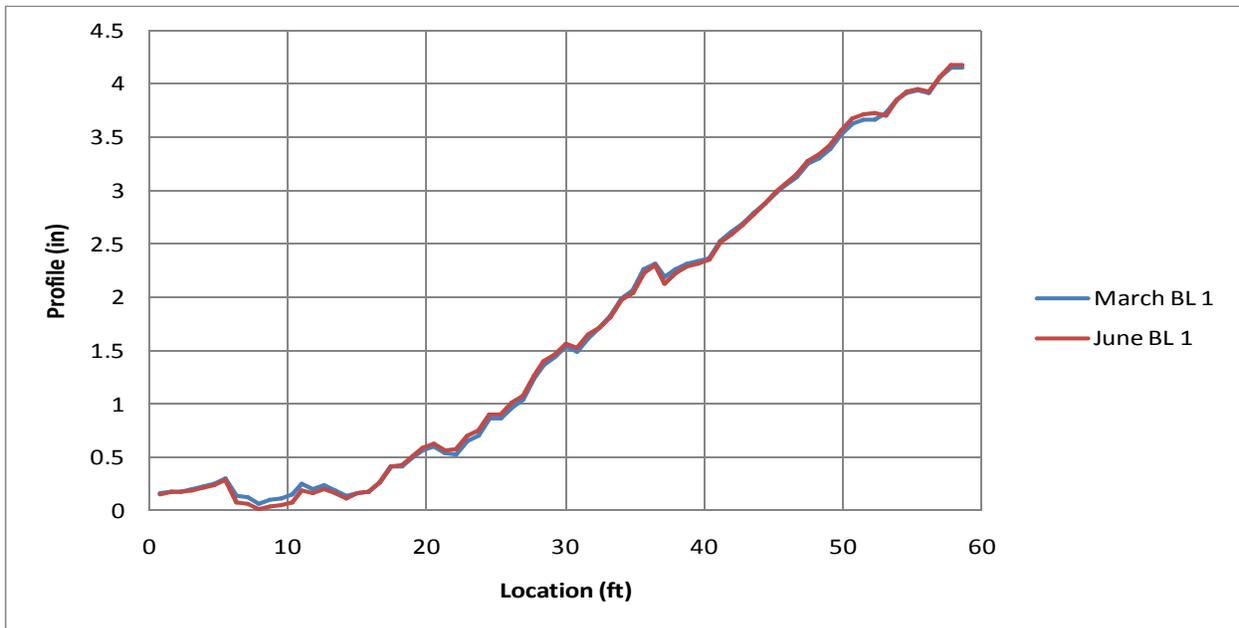
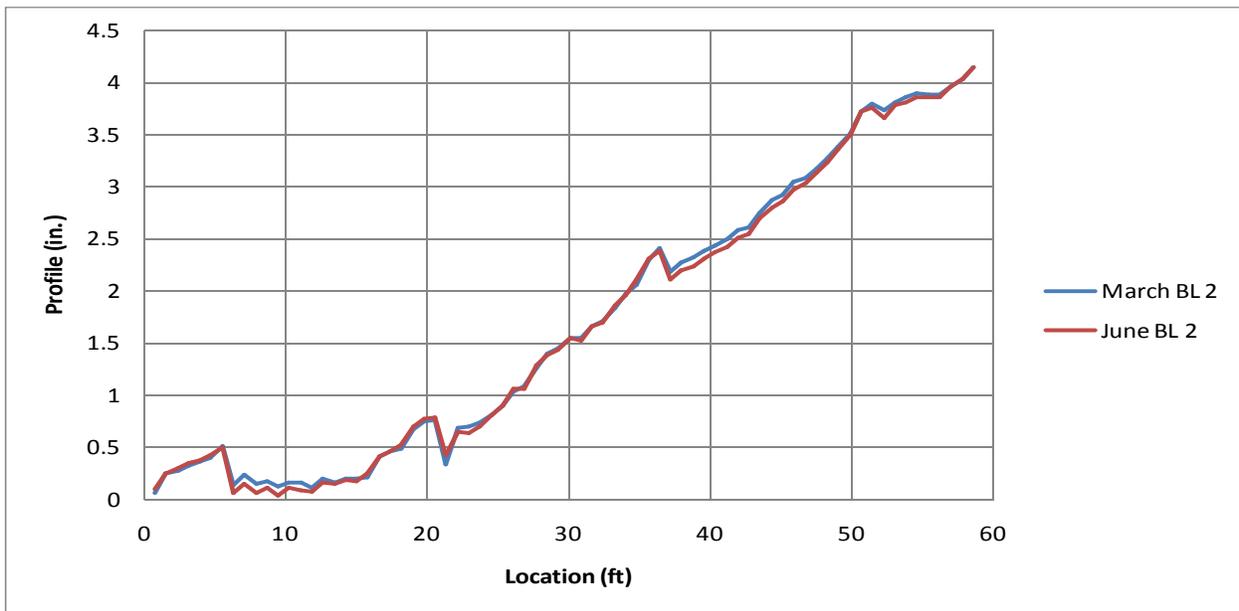
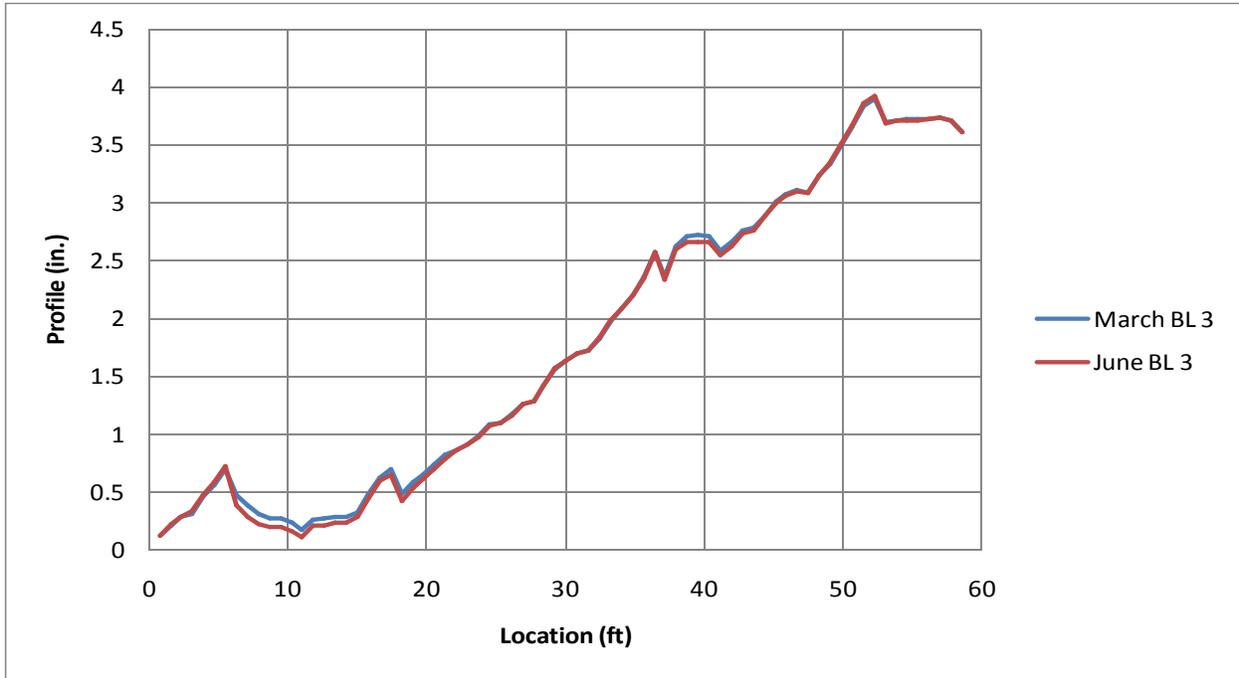
Judging from the profile data, slab 7 appears to have been bending downward in relation to slab 8, as shown in Figure 19. This scenario was observed in slab 2 and 3 profiles also; see Appendix 1. Further discussion of the ramifications of such will be presented in the pressure sensor section.

Construction of the slabs revealed several issues. First, a depression in the first PCPS panels (7—8 and 2—3) was measured with the walking profiler. It may have been caused by a depression in the base course and the PCPS bent to match the base course profile. This depression could have contributed to a vertical misalignment (fault) at the joints between slabs 7—8 and 2—3 as well as voids at that location. Second, voids beneath the slabs were measured both before and after injection with leveling materials, which means that the injection system method and material used on this project was inadequate. Third, the slabs were constructed with joint widths and faults that did not conform to DOTD or Highway Industry standards. The fact that, according to others, these are problems consistent with all PCPS should be noted (3)(4)(5)(6)(7) (8)(9)(10).
