1. Report No. FHWA/LA.13/13-01TA-B		2. Government Accession No.	3. Recipient's Catalog No.
4. Title and Subtitle Evaluation of Rutting Distresses on I-20 near Mound to Delta Scales		5. Report Date January 2014

Evaluation of Rutting Distresses on I-20 near Mound to Delta Scales

LTRC Project No. 13-01TA-B

January 2014

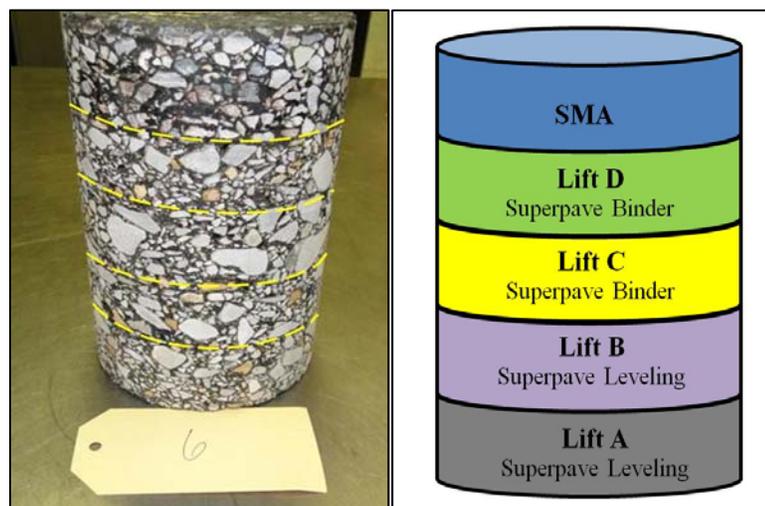
Figure 5
Layers in a roadway core

During the recent coring operation, it was noticed that the permanent deformation was only occurring at the wearing course or SMA lift. However, moisture damage was noticed at a couple of locations where the corresponding cores fell apart completely (Figure 6). The moisture damage was mainly noticed in the binder/ leveling course lifts and the mixtures of those layers seemed to be soft and lacking cohesion. It should be noted that the soil cement base underneath the CRCP is generally highly impermeable to water. It is anticipated that the water or water vapor was getting into the pavement structural system from underneath and finding no place to escape due to an inadequate subsurface drainage conditions. In addition, the differential thermal expansion of water vapor during day-night cycle and the cyclic stresses from moving traffic increases the pore water pressure which may rupture the asphalt-aggregate bond and cause stripping [3].

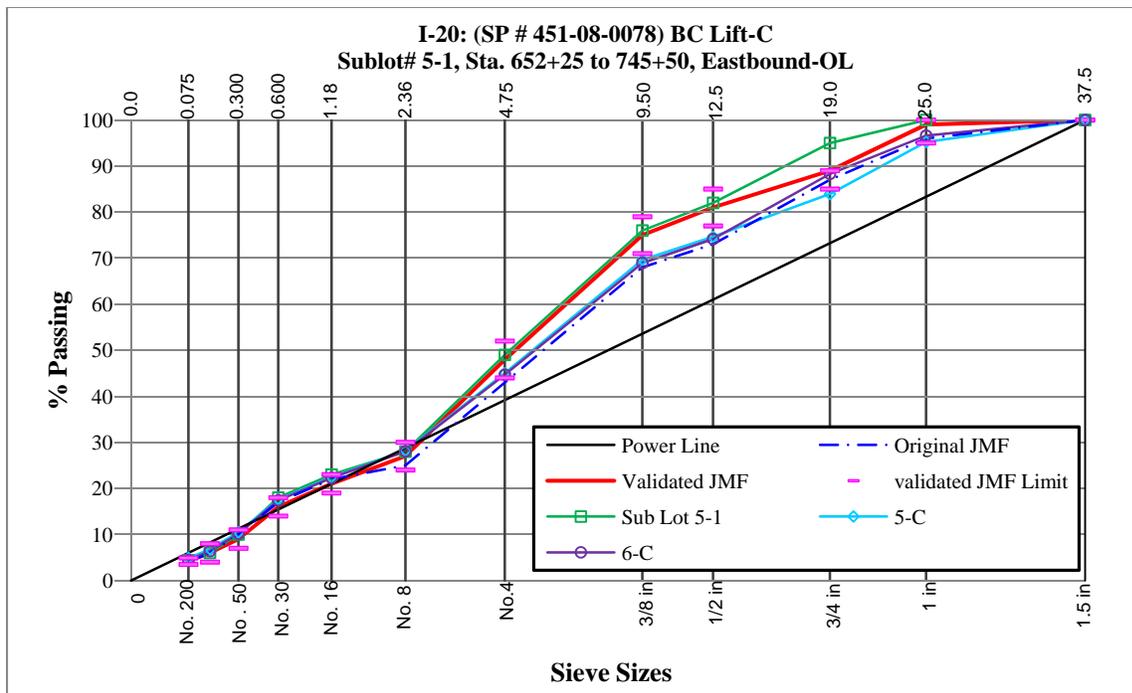
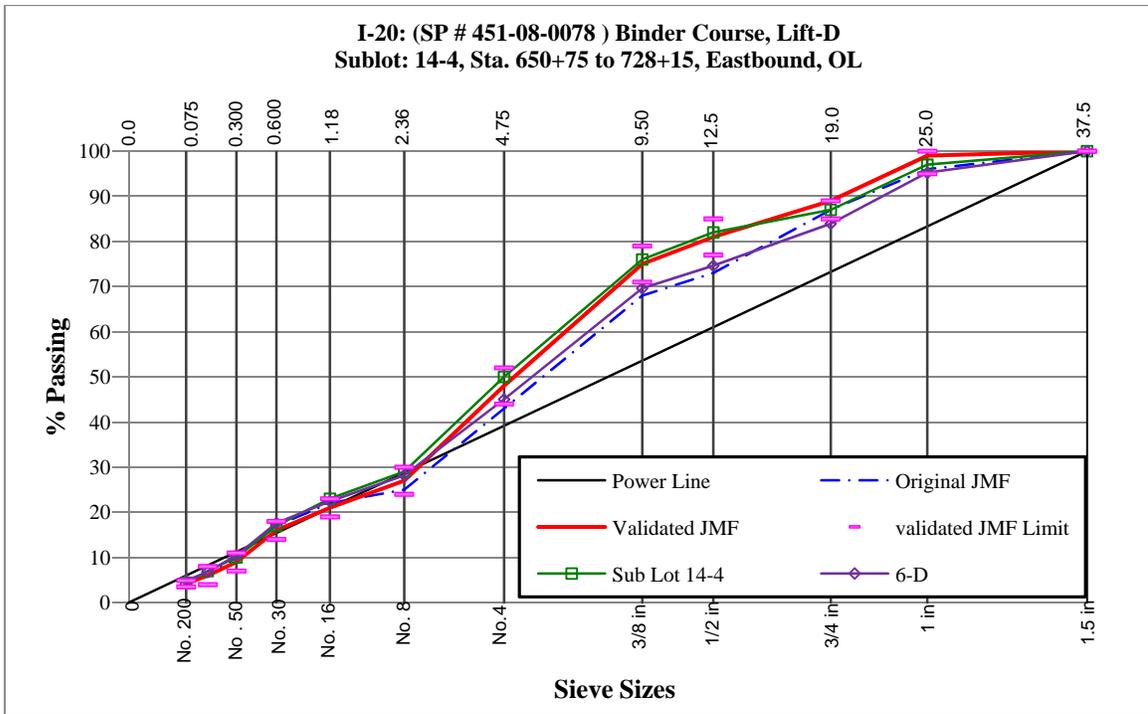
Figure 28

sample, Core 2L, were separated into different lifts and used for burn gradations. It should be noted that Core 5 and Core 6 were collected from station 664+63 to station 664+79 area (Approximate Logmile: 29.17) whereas, Core 2L was collected from station 669+10. The plant records indicate that Lift C for Core 5 and Core 6 represent mix from Sublot 5-1, Lift D for Core 5 and Core 6 represent mix from Sublot 14-4, Lift C for Core 2L represent mix from Sublot 4-1, and Lift D for Core 2L represent mix from Sublot 14-1, respectively. Figures 28 and 29 show a comparison of blended aggregate gradations during production of Sublot 5-1, Sublot 14-4, Sublot 4-1, Sublot 14-1, and the gradations found from the corresponding roadway core lifts. It is evident that the extracted aggregate gradations of roadway cores did not always match the gradations reported in the plant data. In most cases, the aggregate structures from roadway cores were found to be slightly coarser especially on 3/8 inch and 1/2 inch sieves. However, except for Lift C cores 5 and 6, the extracted gradations are very comparable to the gradations reported during production.

Comparisons of blended aggregate gradations for sublots 5-1 and 14-4

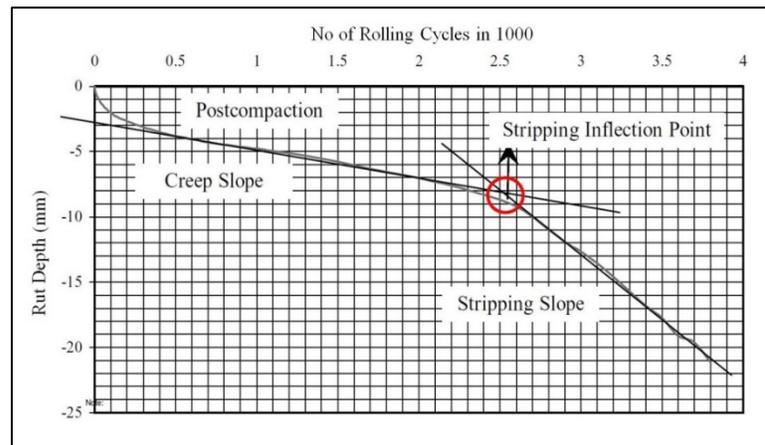
Figure 30
Typical LWT graph

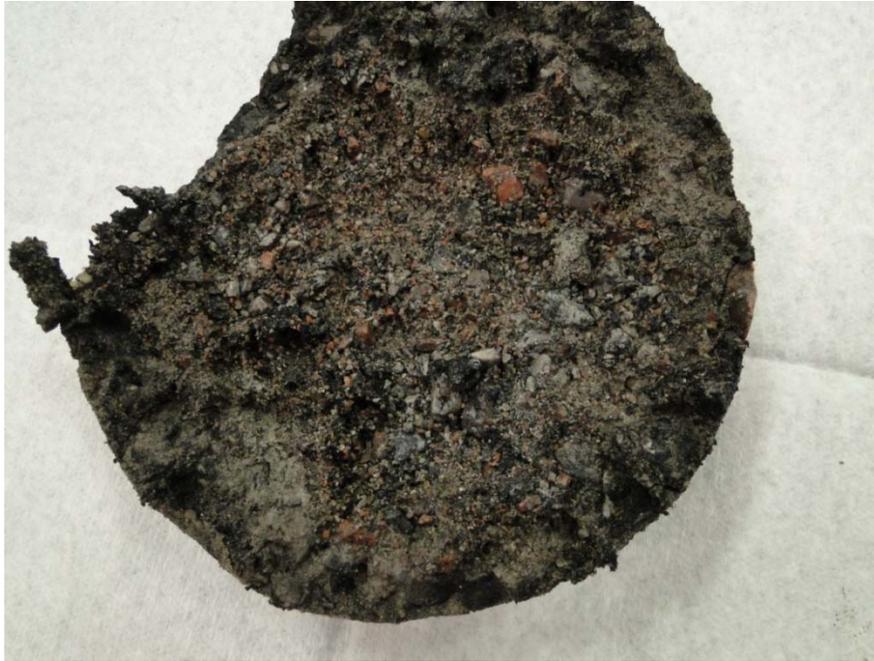
LWT (Hamburg) tests were conducted in accordance with AASHTO T 324 in an effort to evaluate the rutting potential and moisture susceptibility of SMA mixture used in this project. Roadway cores from good and very bad sections were tested in addition to laboratory fabricated superpave gyratory compacted (SGC) specimens supplied by the contractor, D & J Construction. It should be noted that the SGC specimens were prepared to replicate the plant production of the mixtures from the actual aggregate stockpiles during the construction of the project. Results presented in Figure 37 indicate that roadway cores from the good section and laboratory fabricated SGC specimens met the maximum allowable rut depth requirement of 6.0 mm after 20,000 passes. Also, no sign of stripping was observed for those specimens. Alternatively, roadway cores from the very bad section failed immediately after 6300 wheel passes and showed sign of severe stripping. As shown in Figure 38, the roadway cores from very bad section were crushed and completely destroyed after the test.

Figure 38
Condition of roadway core specimens after LWT testing

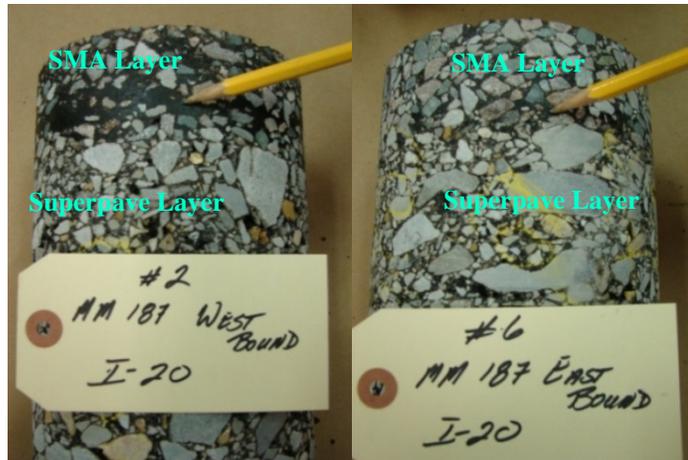
Figure 40
Aggregate arrangement in the SMA mixture
