1. Title and Subtitle
**Forensic Evaluation of Pavement Structure:
Ponderosa Drive in East Baton Rouge Parish**
2. Author(s)
Qiming Chen, Ph.D., P.E., Nicholas Ferguson, P.E., Moses Akentuna, Ph.D., P.E., Saman Salari, P.E., Gavin Gautreau, P.E., Samuel Cooper, III, Ph.D., P.E.

5. Report No.
FHWA/LA.17/21-01TA-P
6. Report Date
January 2022
7. Performing Organization Code
LTRC Project Number: 21-01TA-P
8. Type of Report and Period Covered
Technical Assistance Report
August 2020-August 2021

Forensic Evaluation of Pavement Structure: Ponderosa Drive in East Baton Rouge Parish

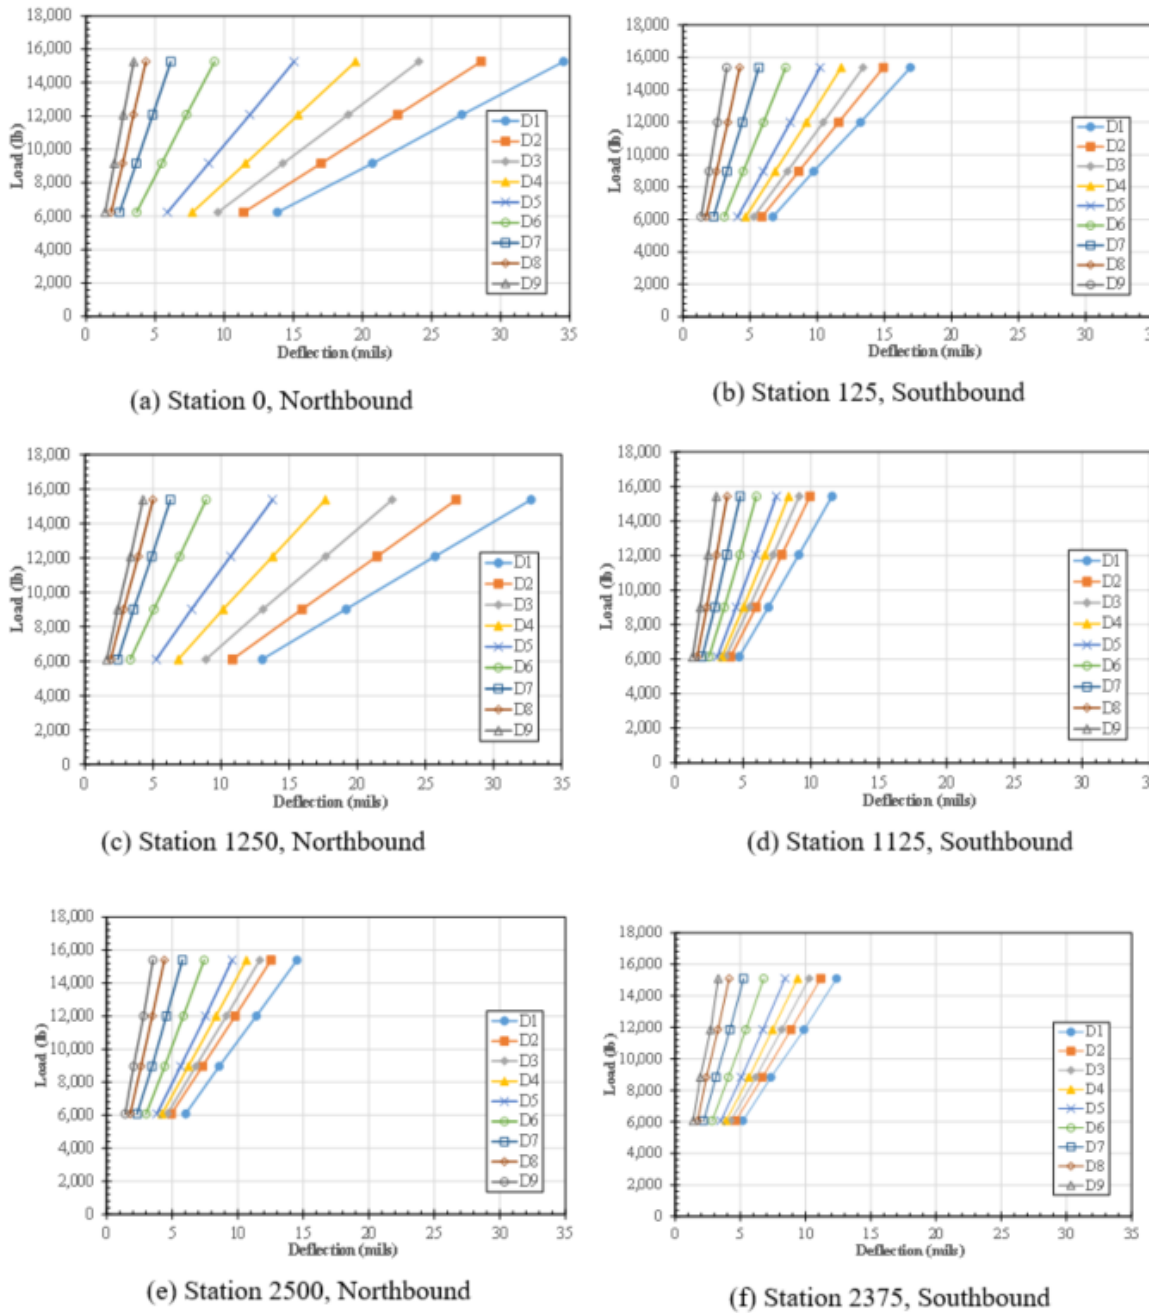
Figure 8. FWD load versus sensor deflection

In addition to general data checks, FWD deflection data were checked for linearity. Figure 8 compares the load versus sensor deflection for selected locations in both North and Southbound lanes. The measurements show the data is good for linear analysis.
