# MONITORING LIVE LOAD FORCES ON 150 FOOT PRE-STRESSED BULB-T GIRDERS DURING TRANSIT AND INSTALLATION

*Louisiana Department of Transportation and Development  
1201 Capital Access Road  
PO Box 94245  
Baton Rouge LA 70804*

**BRIDGE DIAGNOSTICS, INC.**  
1965 57<sup>th</sup> Court North Suite 120  
Boulder, CO 80302  
303.494.3230  
[www.bridgetest.com](http://www.bridgetest.com)

January 2007

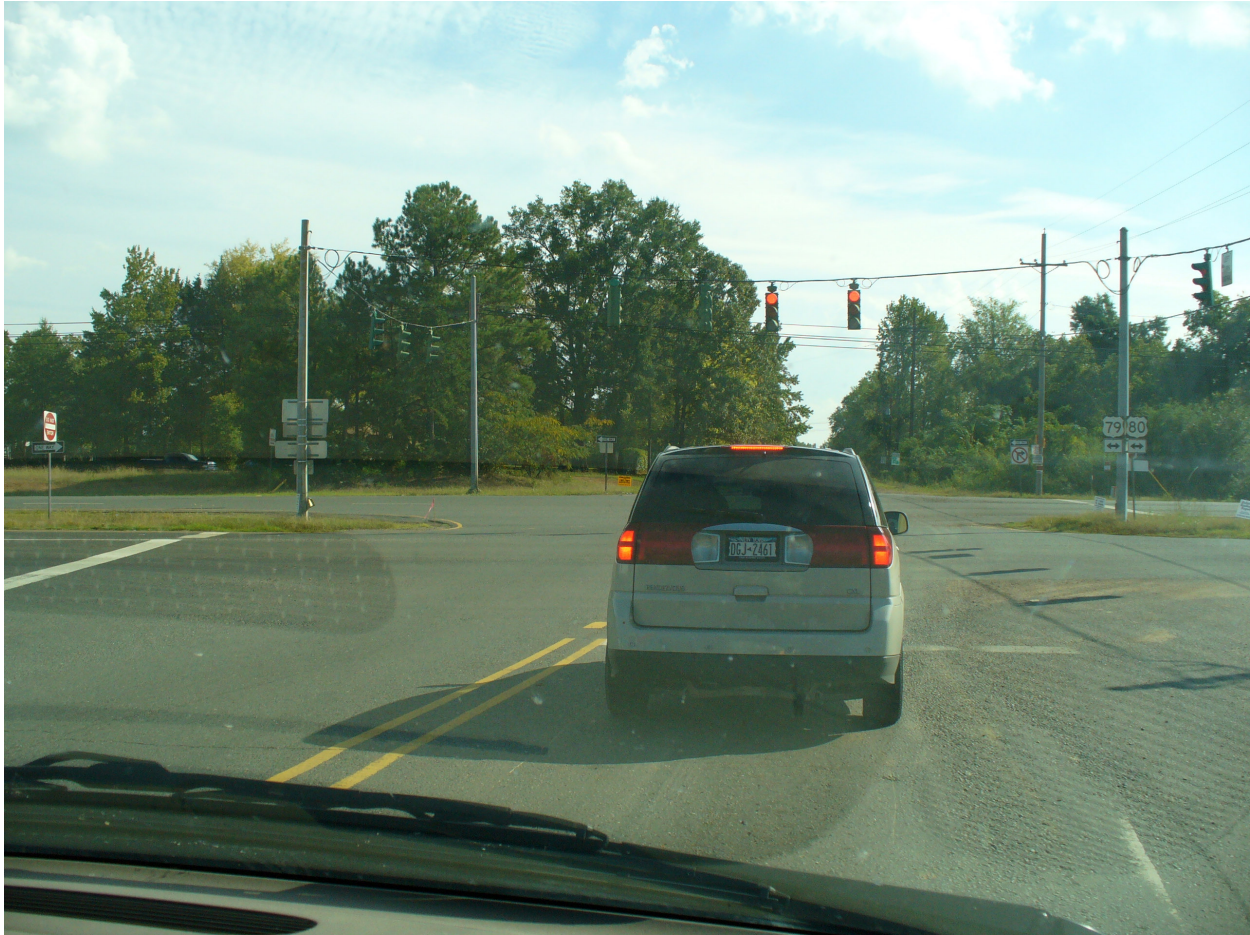
**Figure 42 Left turn onto HW-80.**

Details: Hard left turn onto HW-80. Both the tractor and the trailer had to use the dirt medians in order to make the turn. Due to the very high strains, Girder A has a data clip during this turn. As a result, the peak strain was not read. Data acquisition equipment was modified to allow for the reading of higher strain before Girder B initiated this turn. Pictures of the girders making this turn can be seen on the attached CD under “DOTD Picts”, files 464 thru 468.

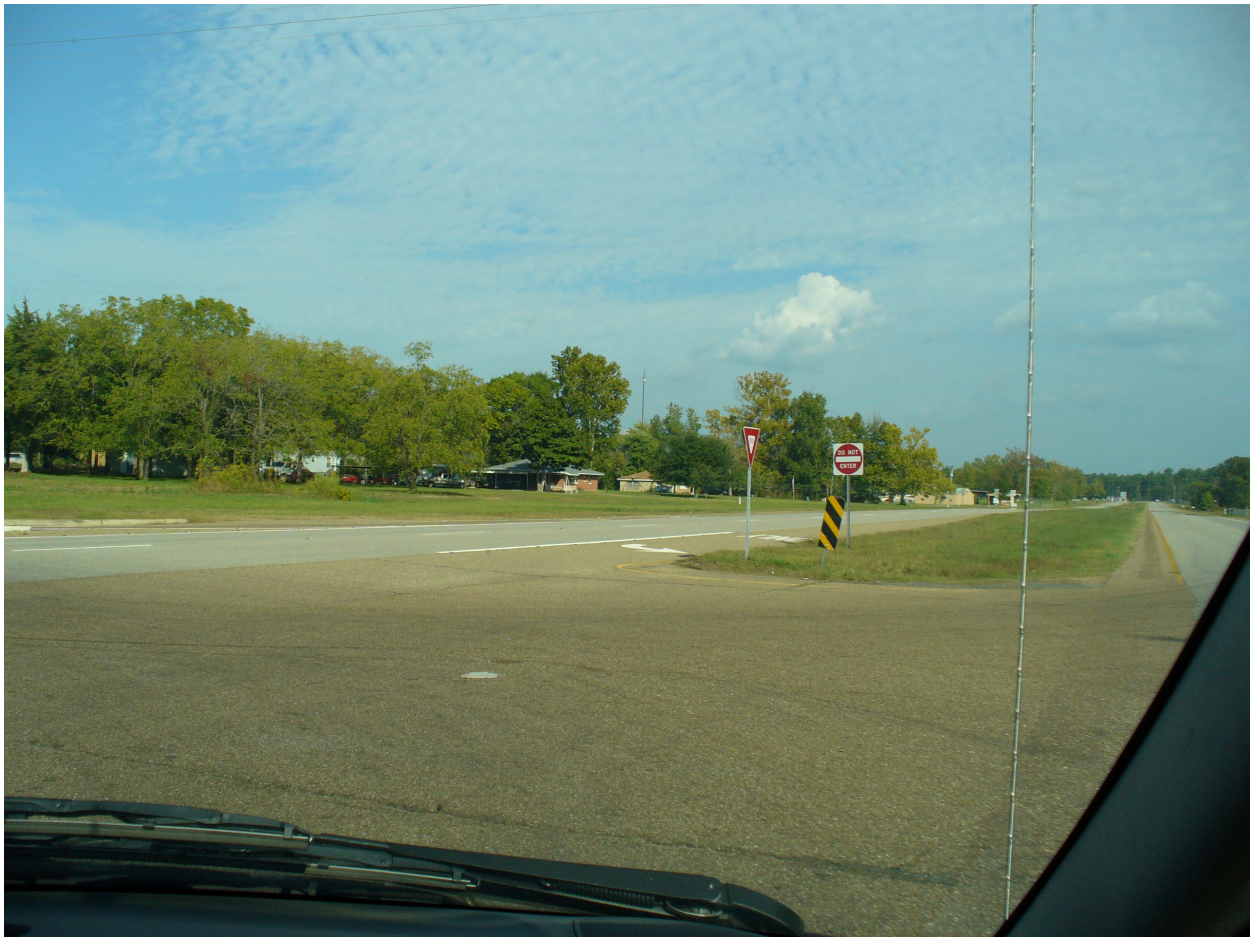
**Figure 53 Left turn onto PR-117.**

Details: Hard left turn onto PR-117. Both the tractor and the trailer had to use the dirt medians and drive over the center lane dividers in order to make this turn. This divider was concrete curbs containing a concrete slab. Pictures of the girders making this turn can be seen on the attached CD under “DOTD Picts”, files 473 thru 492.

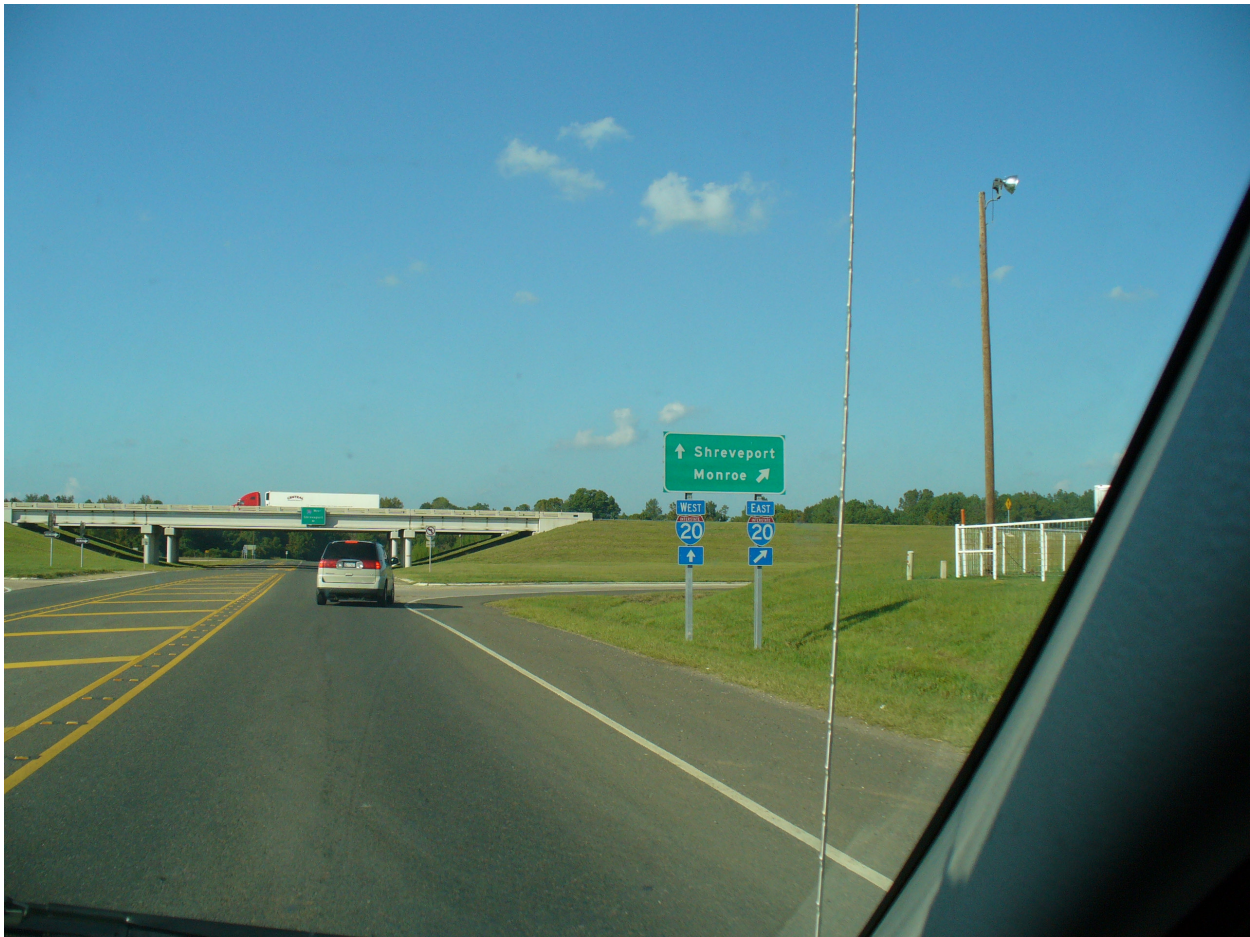
**Figure 64 Right turn onto I-20.**

Details: Hard right turn onto I-20. Both the tractor and the trailer had to use the dirt medians and drive over the center lane dividers in order to make this turn. This divider in this case was a concrete curb containing a grassy area. Pictures of the girders making this turn can be seen on the attached CD under “DOTD Picts”, files 493 thru 504.

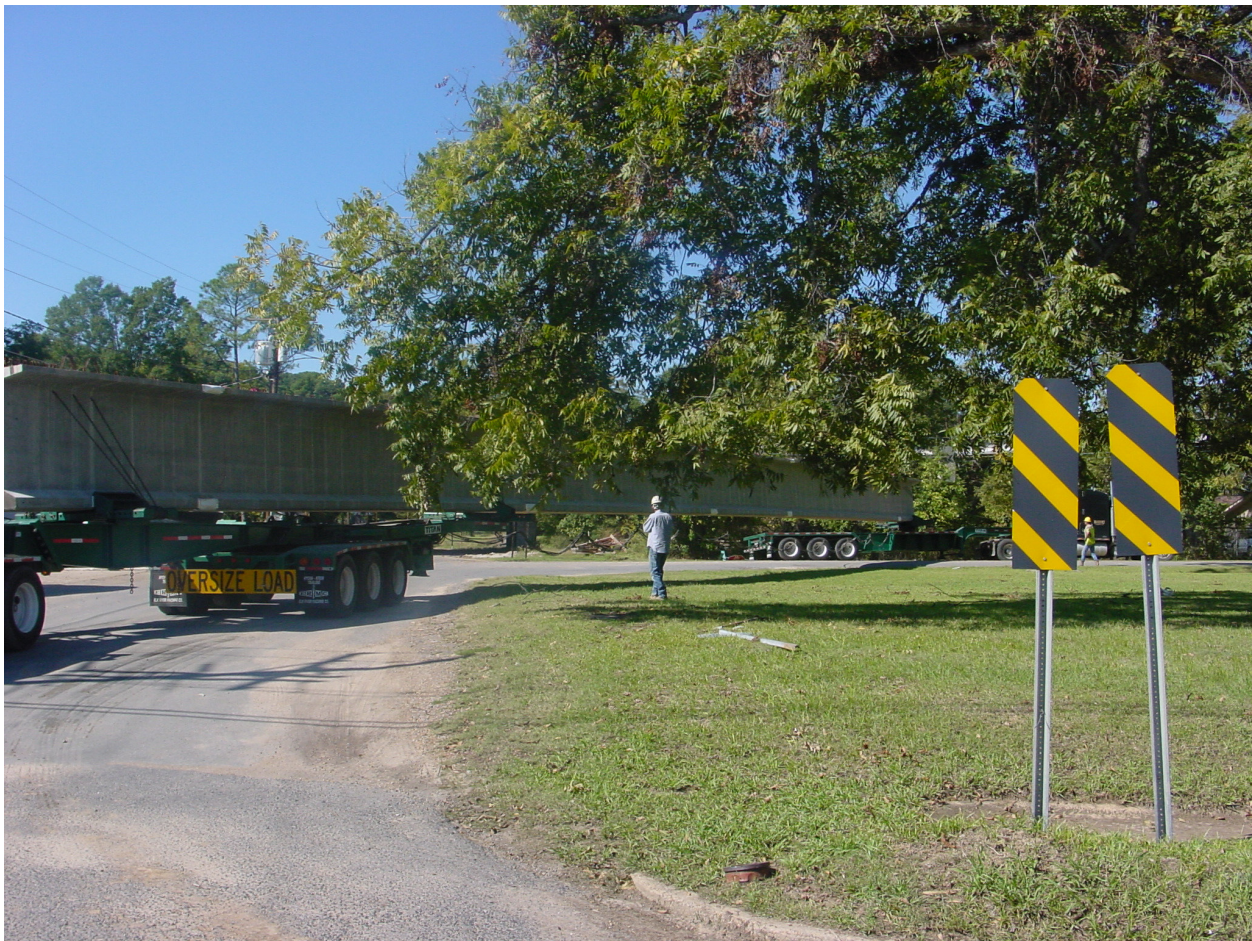
**Figure 75 U-turn in Columbia from the highway to the construction site.**

Details: Right U-turn from the highway to the side street leading to the construction site. Both the tractor and the trailer had to drive on uneven ground, curbs, and dirt in order to make this turn. Once the girders were on the job site, the tractor portion had to drive onto a dirt ramp (likely 7+ percent grade). Due to the muddy conditions at the job site, the trucks had to back down the ramp multiple times and reposition themselves in order to be in the correct locations for the cranes to pick the beams from the trailers. The long flat spots on the response histories coincide with the trucks being parked while coordination between the drivers and the foreman was going on. Pictures of the girders making this turn can be seen on the attached CD under “DOTD Picts”, files 310 thru 319 and 516 thru 518.
