# **US 84 Mississippi River Bridge**

U29 And U49 Pin Rehabilitation

Justin Walker, PE – MDOT Director Of Structures, State Bridge Engineer James Gregg, PE – HNTB Bridge Department Manager

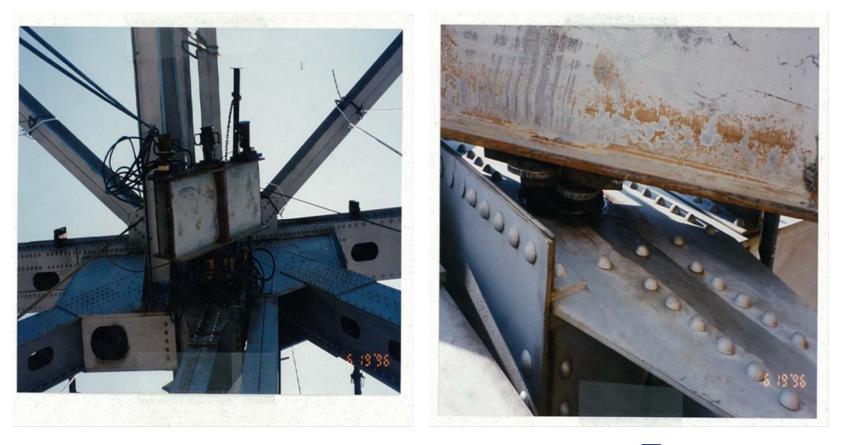
# 1996 U29 Pin Rehabilitation Project

- O" extension observed
- HNTB advised MDOT that pin could move another 1/2" before adversely affecting the Factor of Safety
- MDOT decided to reset U29 Lower
  Pin

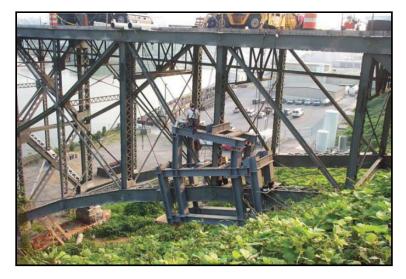
#### Gay Street Bridge (Knoxville, TN)

- Spandrel arch truss bridge
- Replaced 125 pin joints and gussets
- Created a pin bypass
- Regional steel contractor awarded project
- Bridge Closed during rehabilitation
