# Longitudinal Joint Construction Study

**David Allen  
Kentucky Transportation Center  
University of Kentucky**

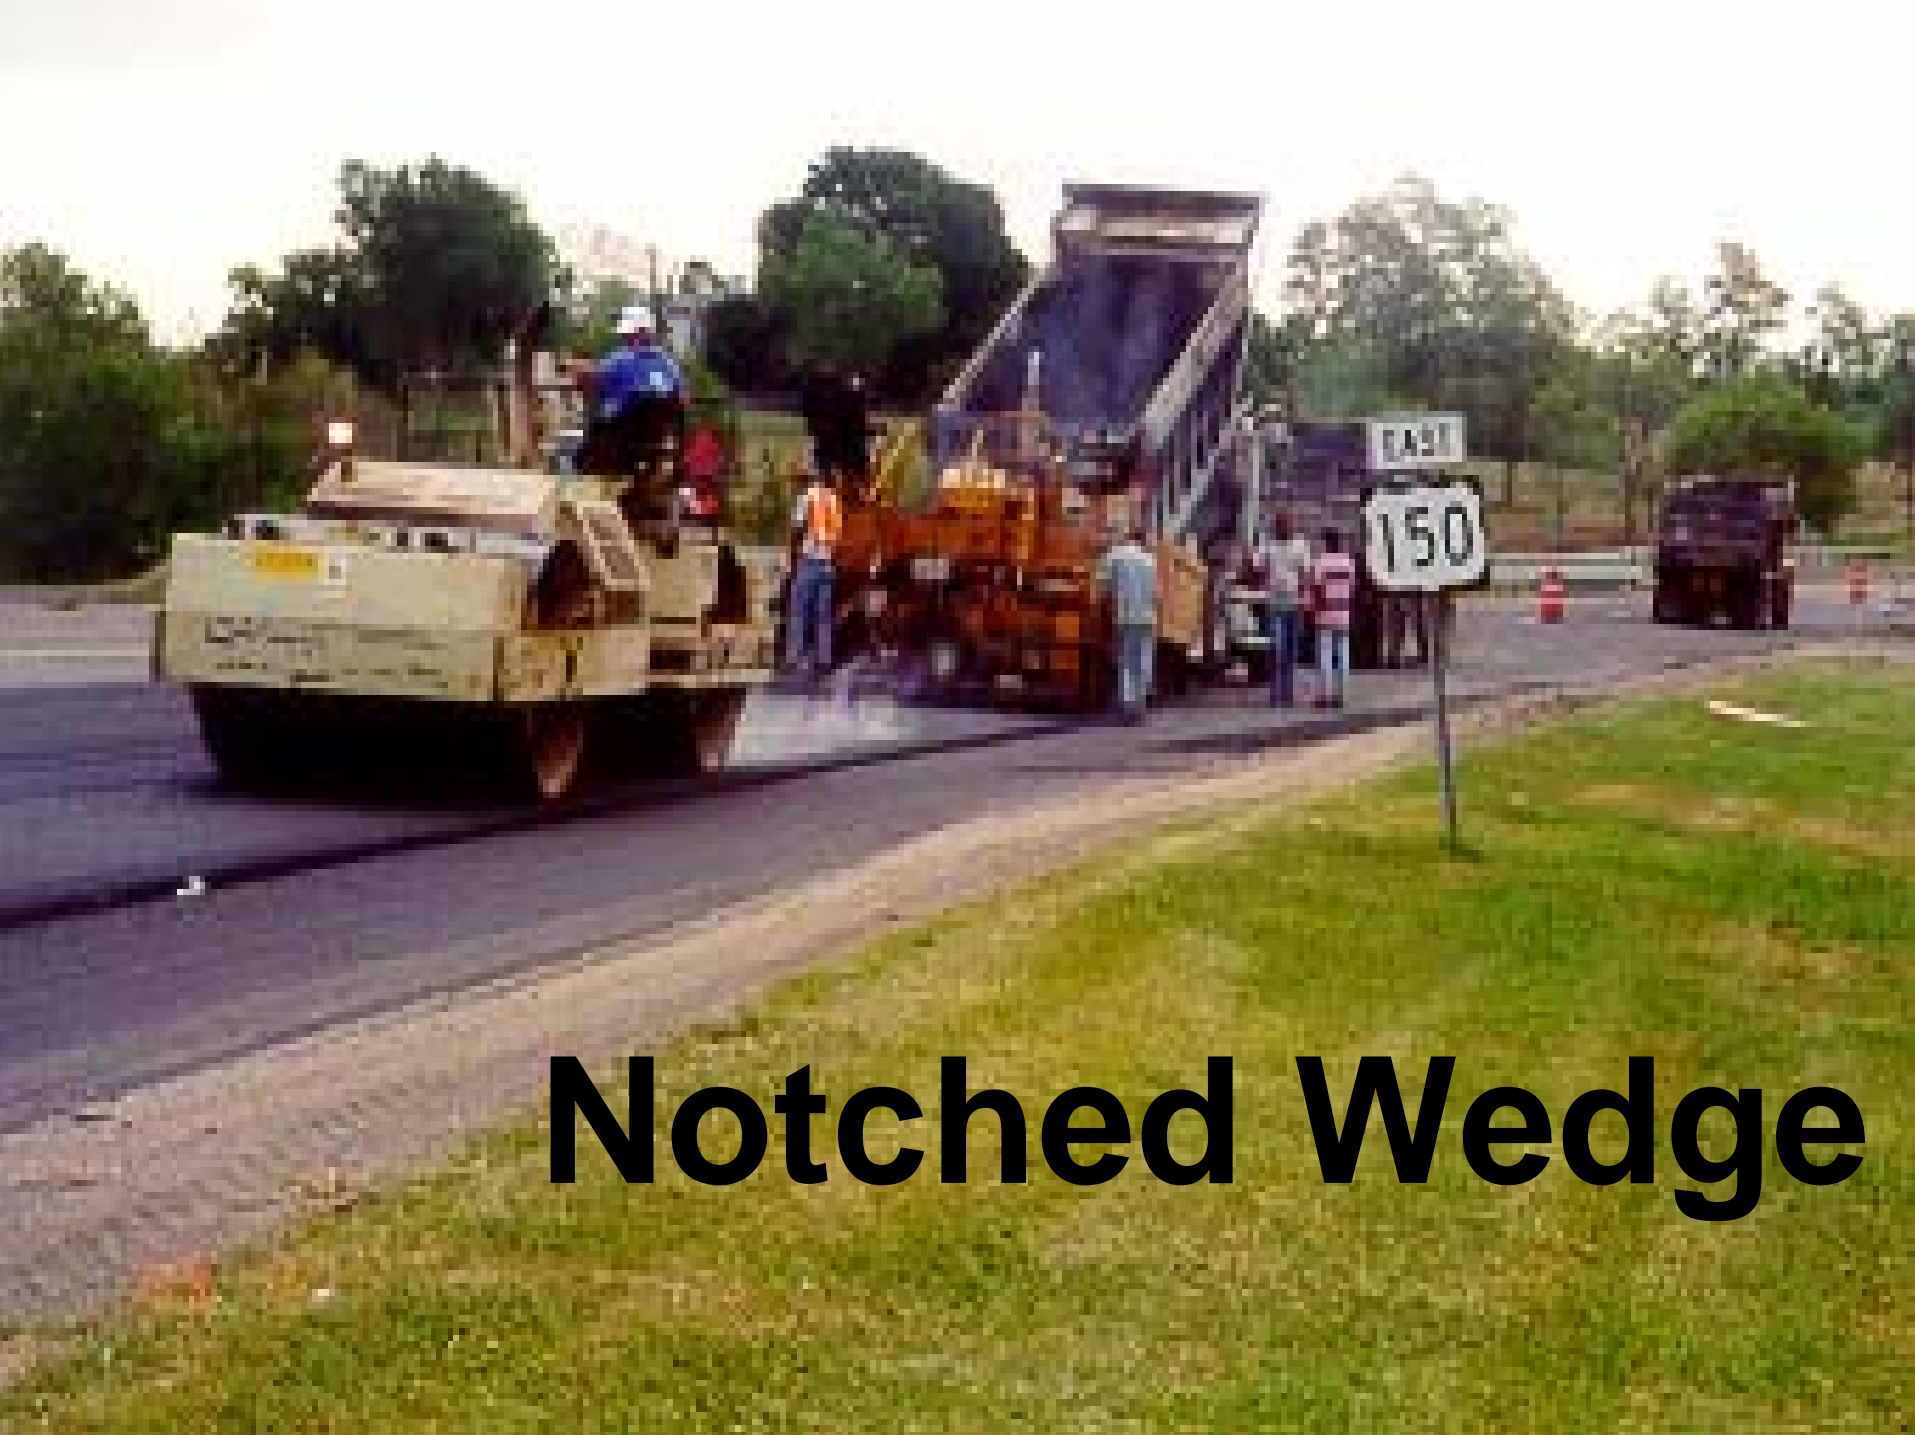
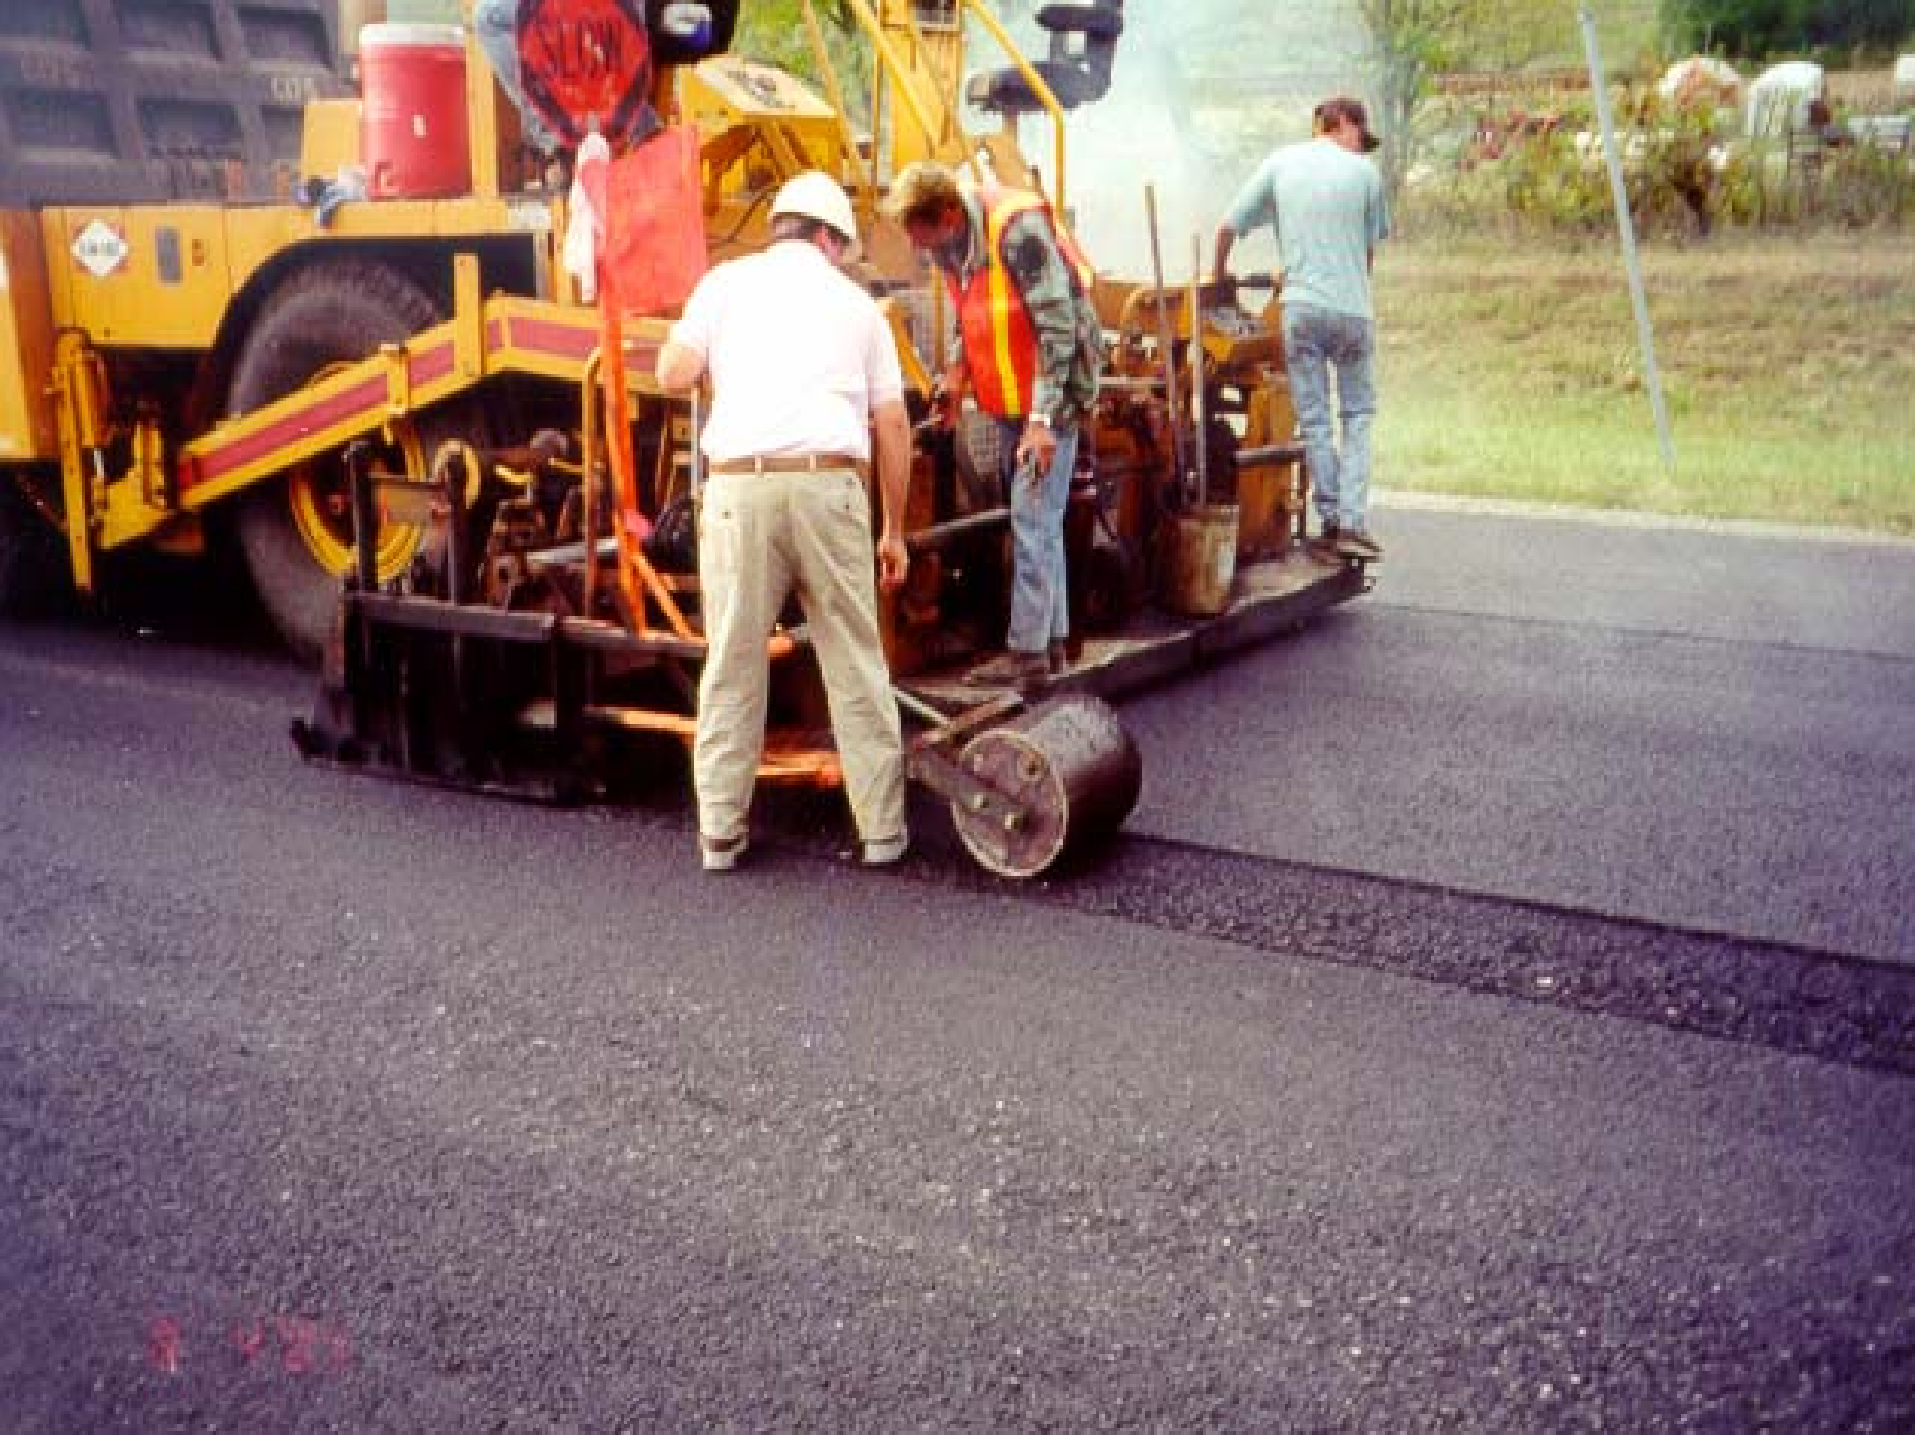
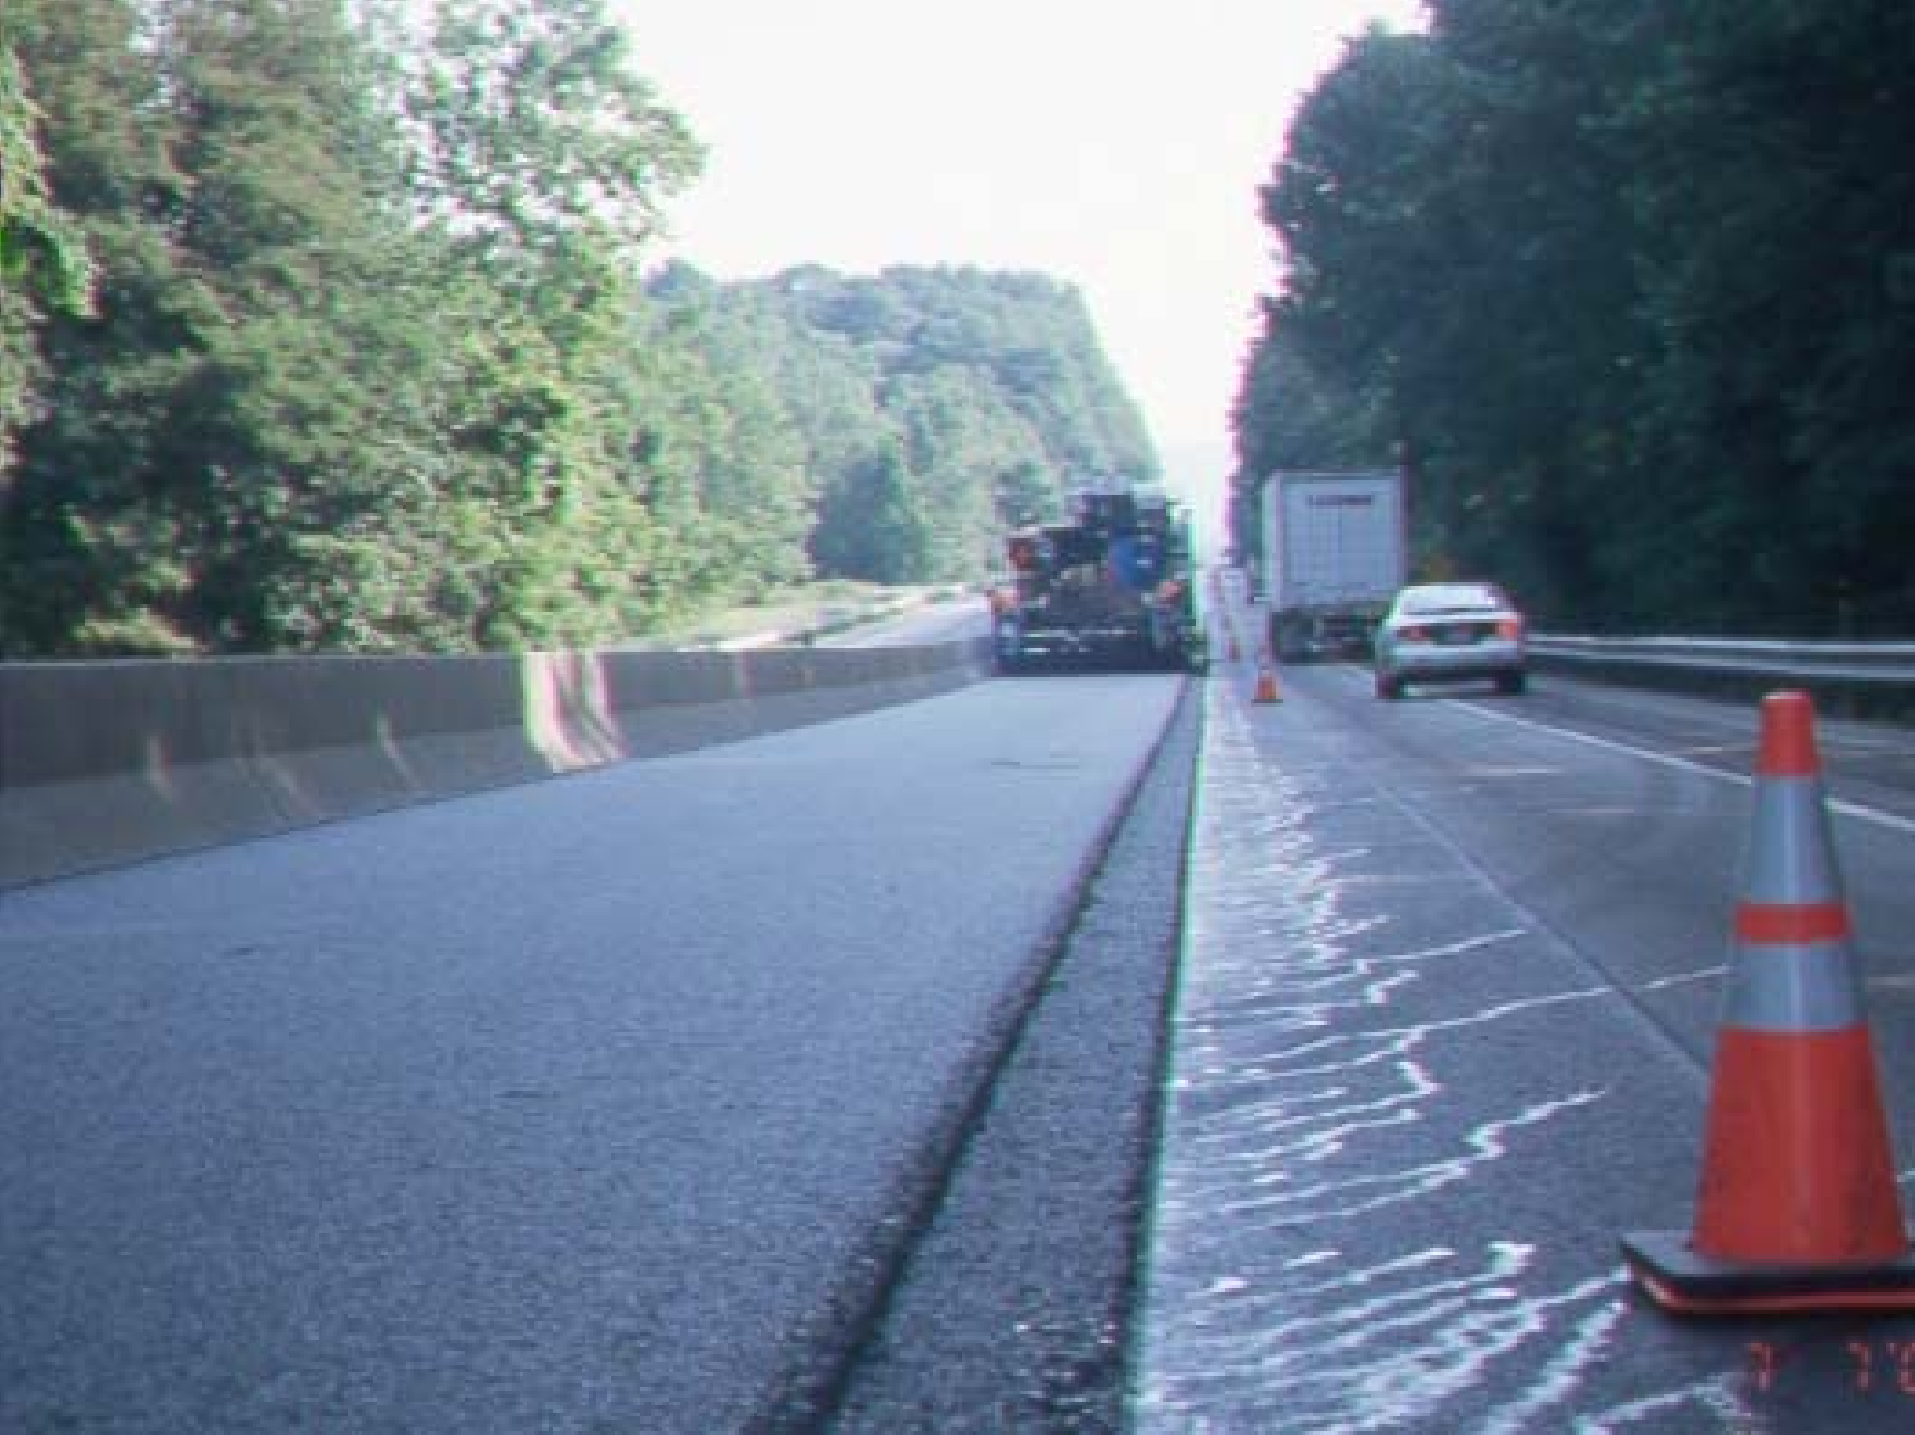
# Notched Wedge

- 1. Maintaining the upper notch during compaction.*
- 2. Raveling on the lower portion of the wedge.*
- 3. Aggregate pickup by the small wedge roller.*

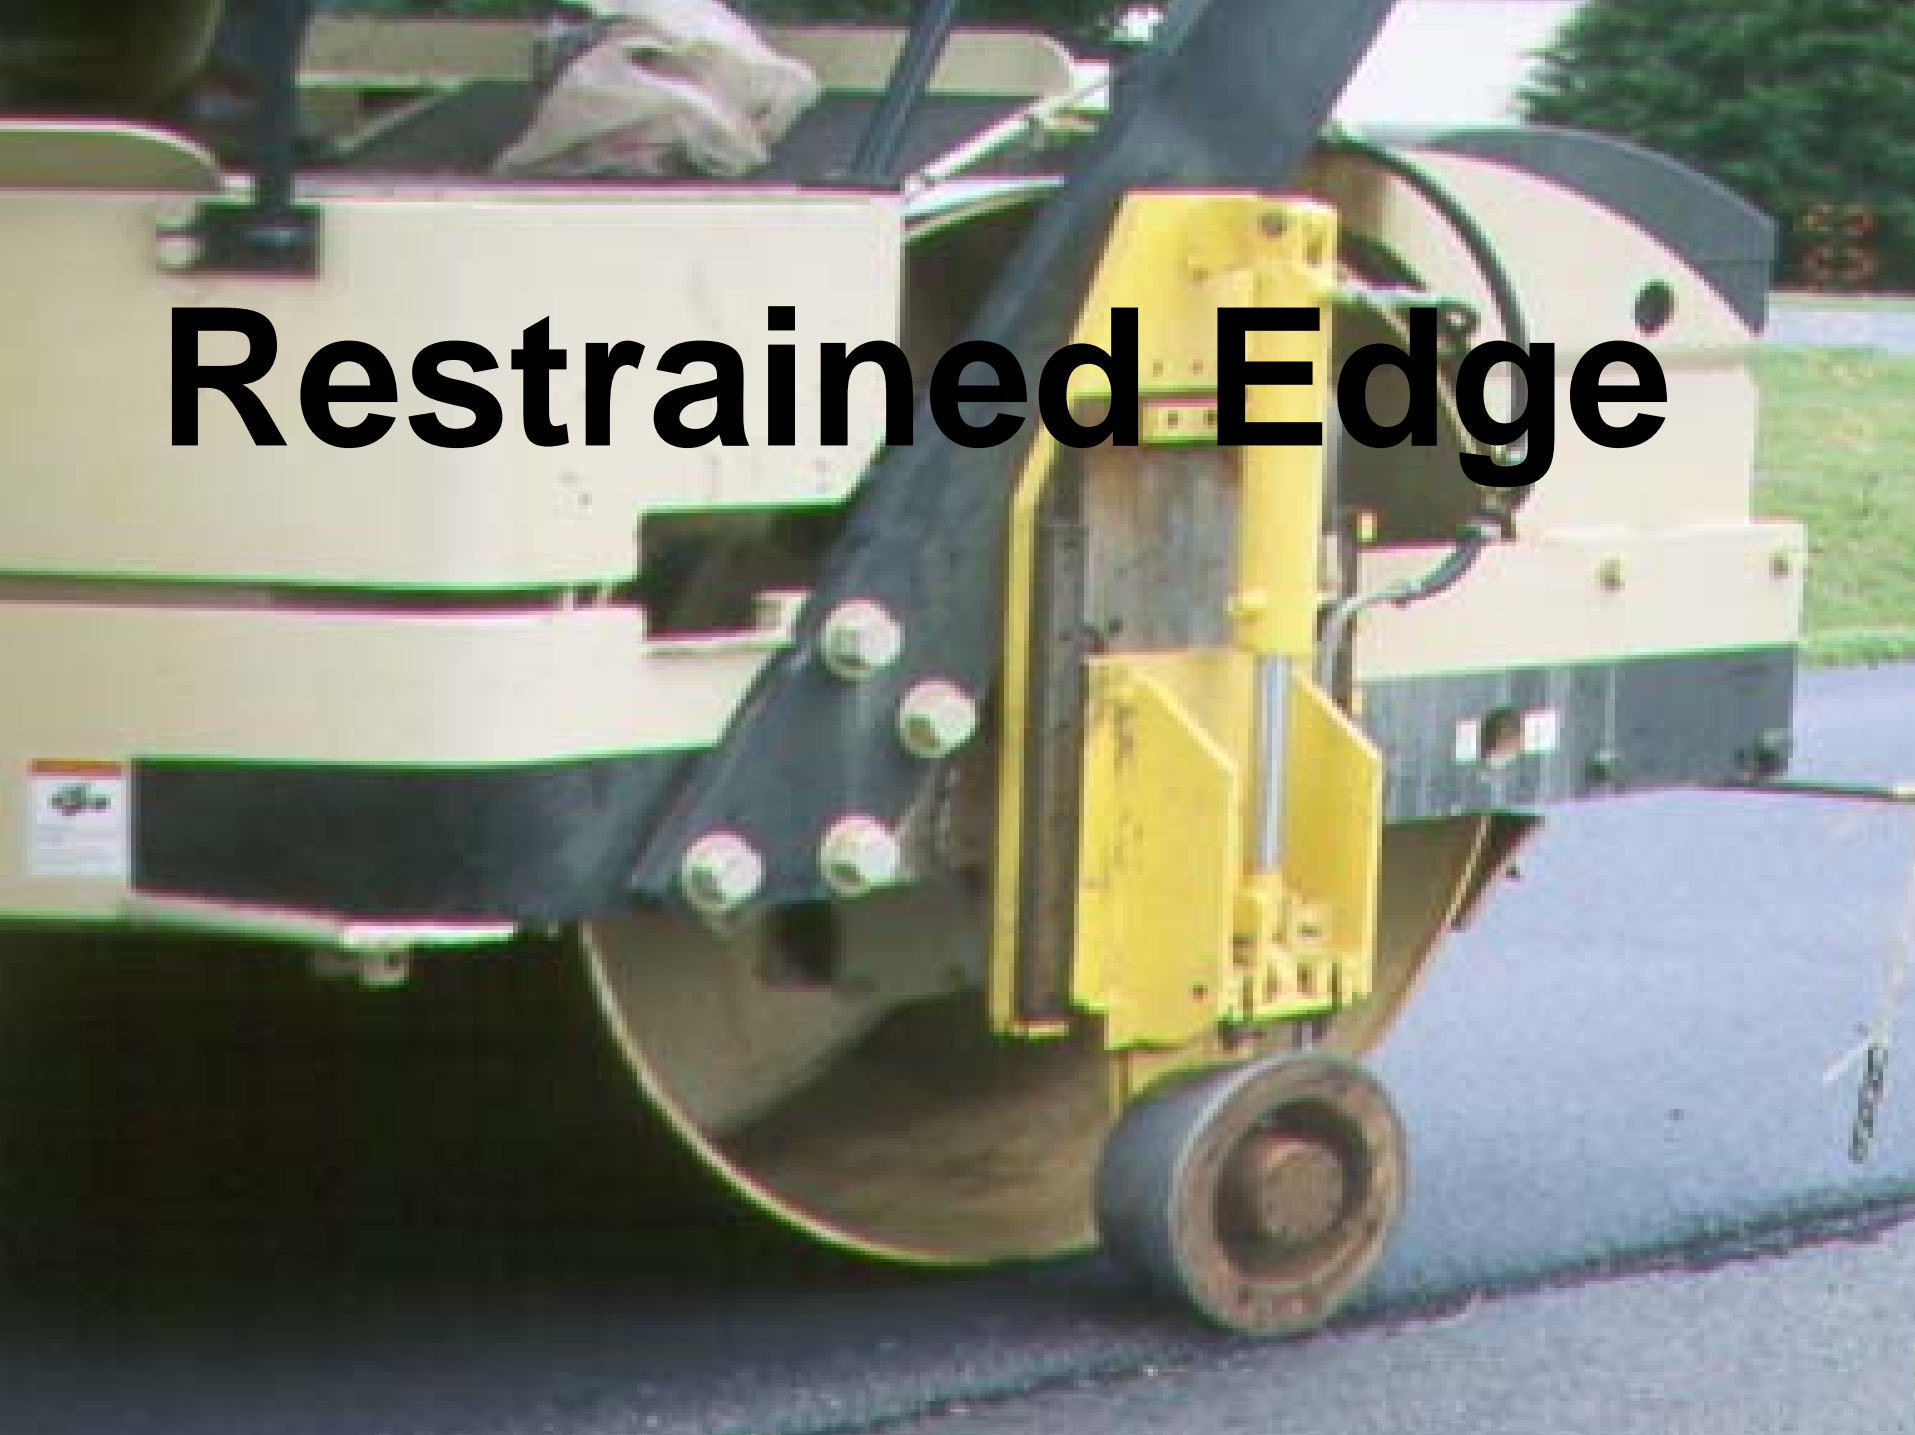
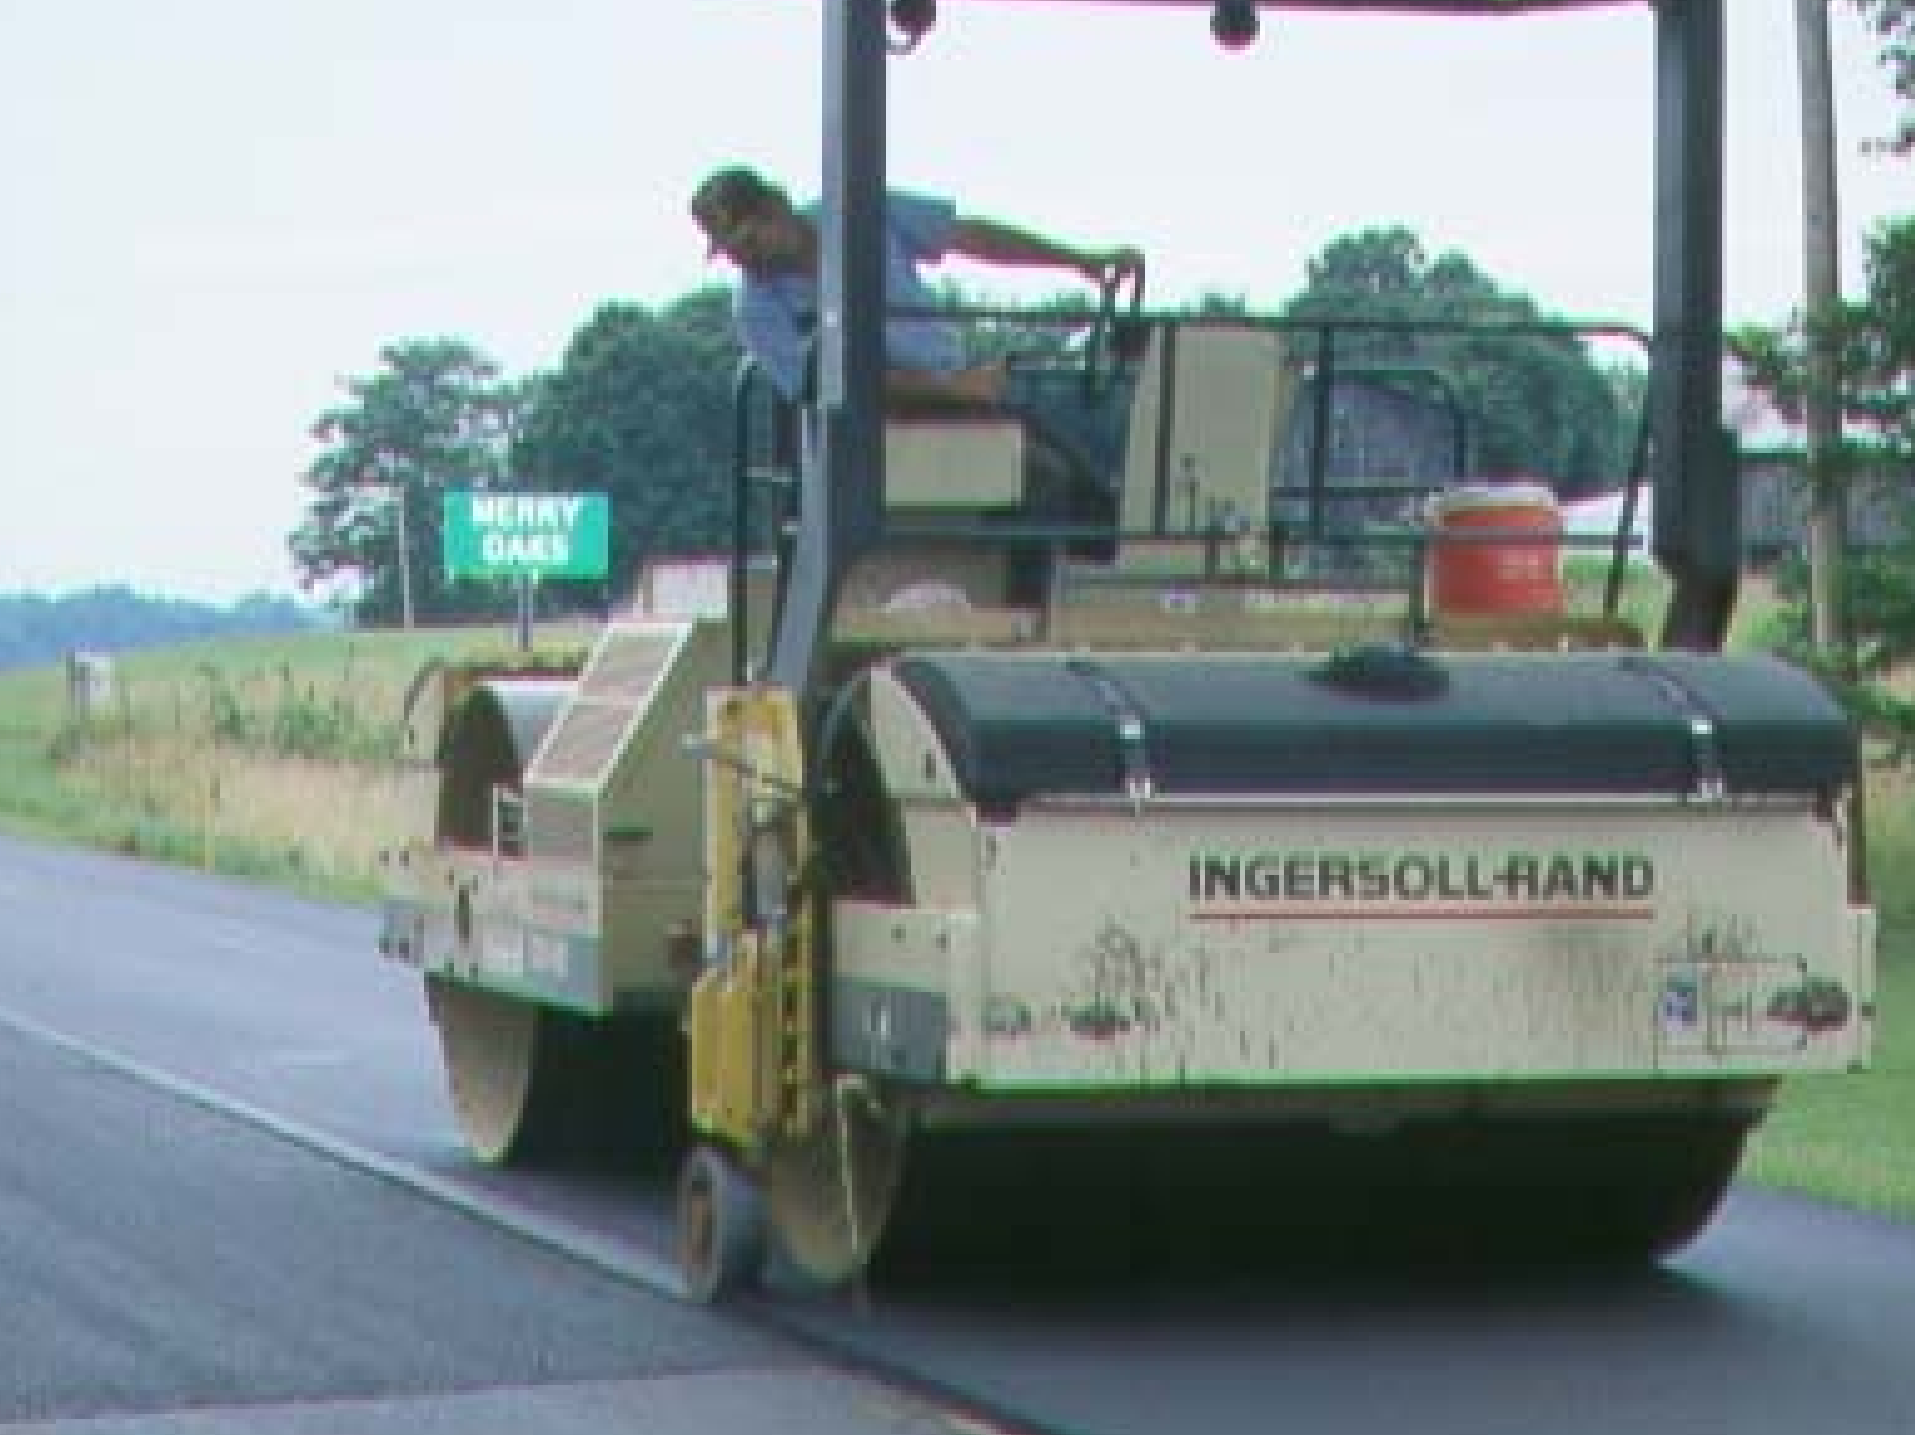
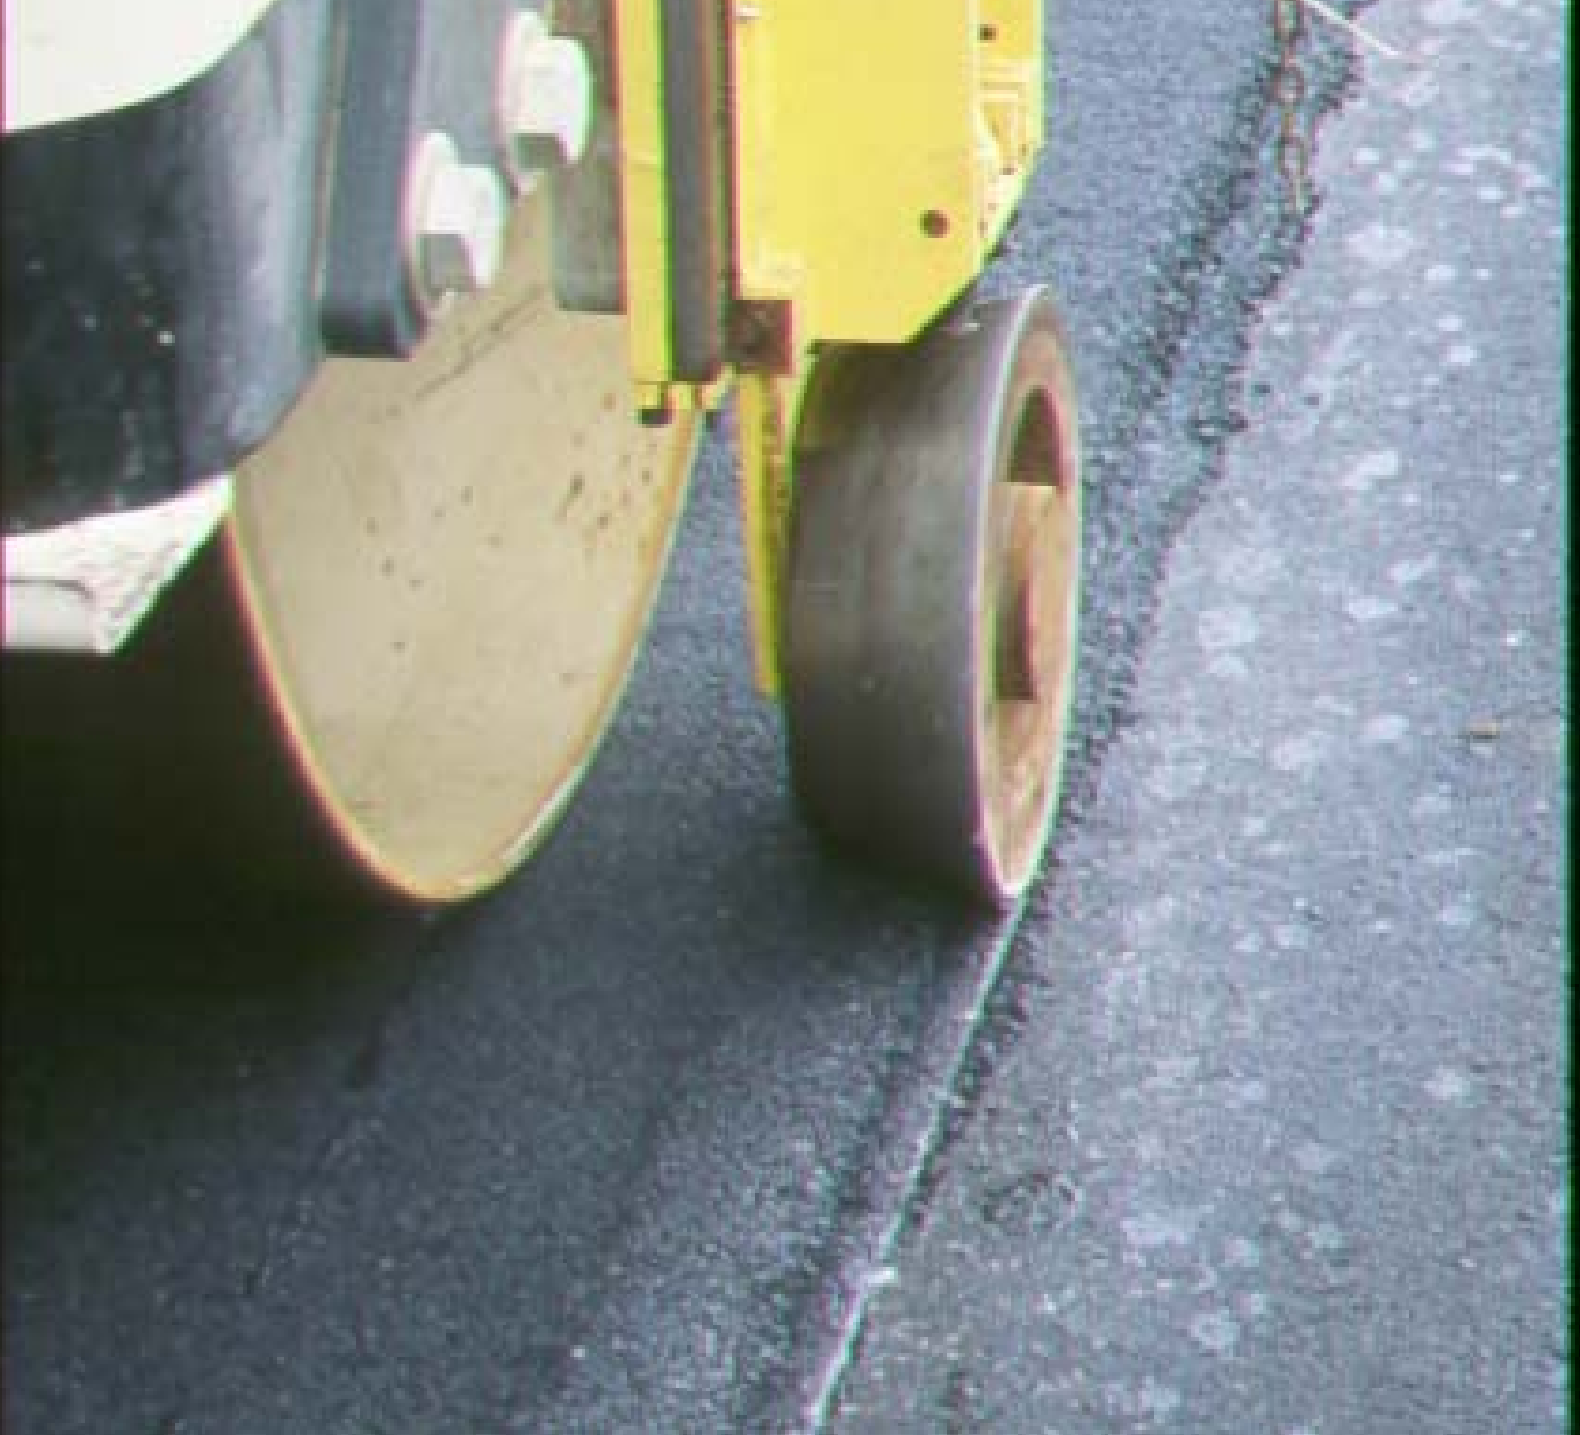
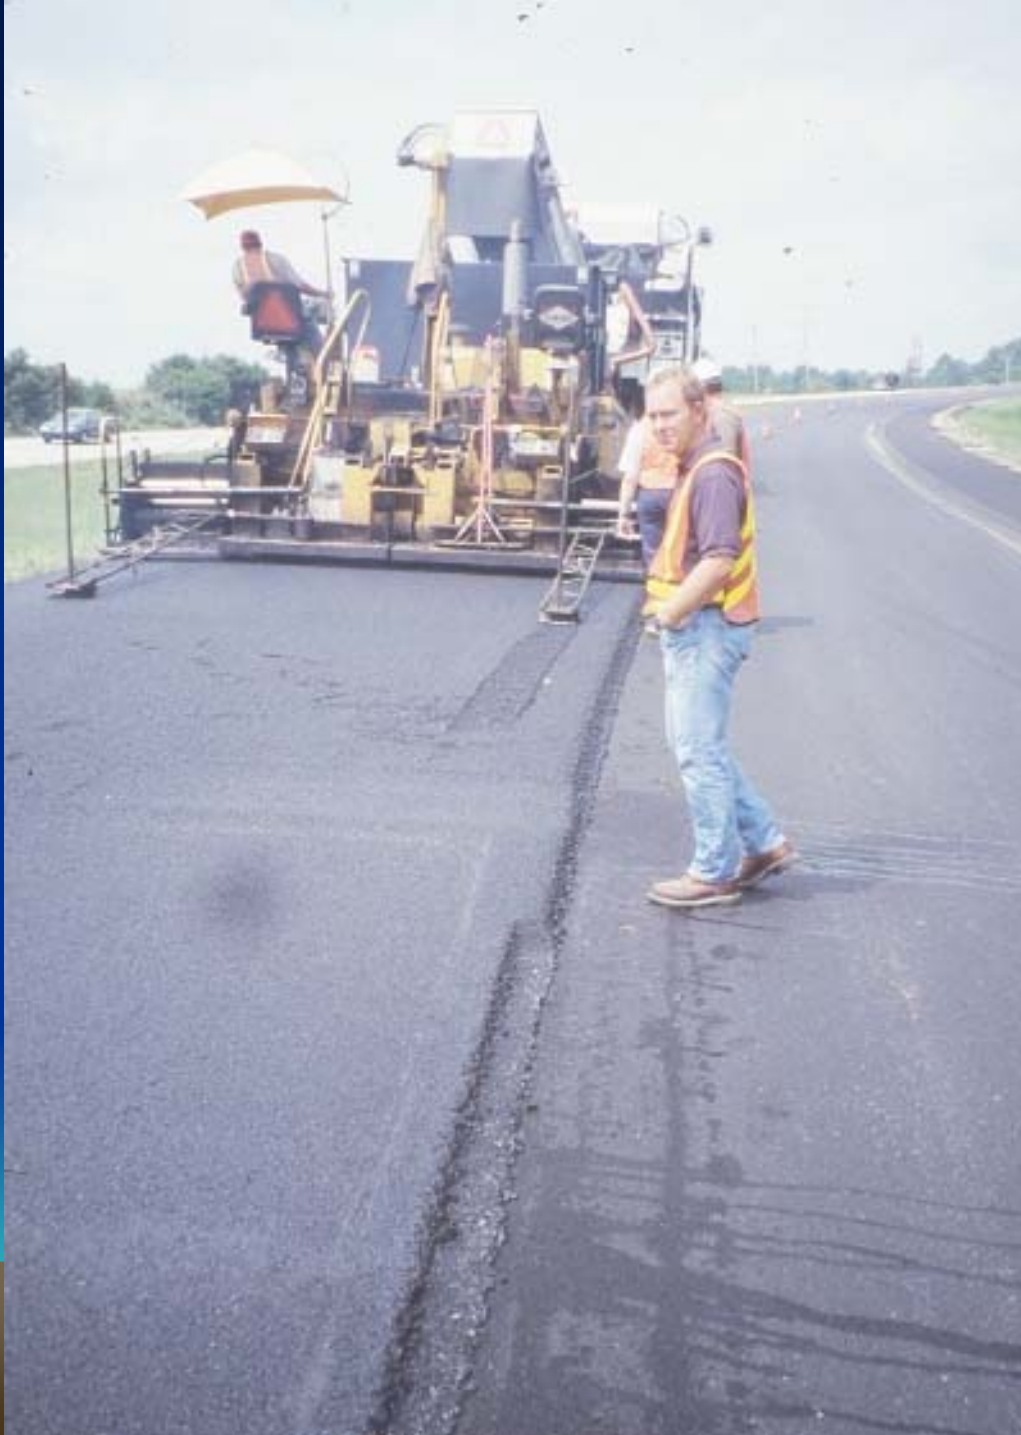
# Restrained Edge

- 1. The beveled wheel did not have enough to properly compact the uncompacted material.**
- 2. The beveled wheel caused the mixture to push up on the inside edge of the wheel. This created a longitudinal ridge in the mat.**
- 3. Because of Problem No. 1, the breakdown roller made two passes before using the beveled wheel. This reduced its effectiveness.**

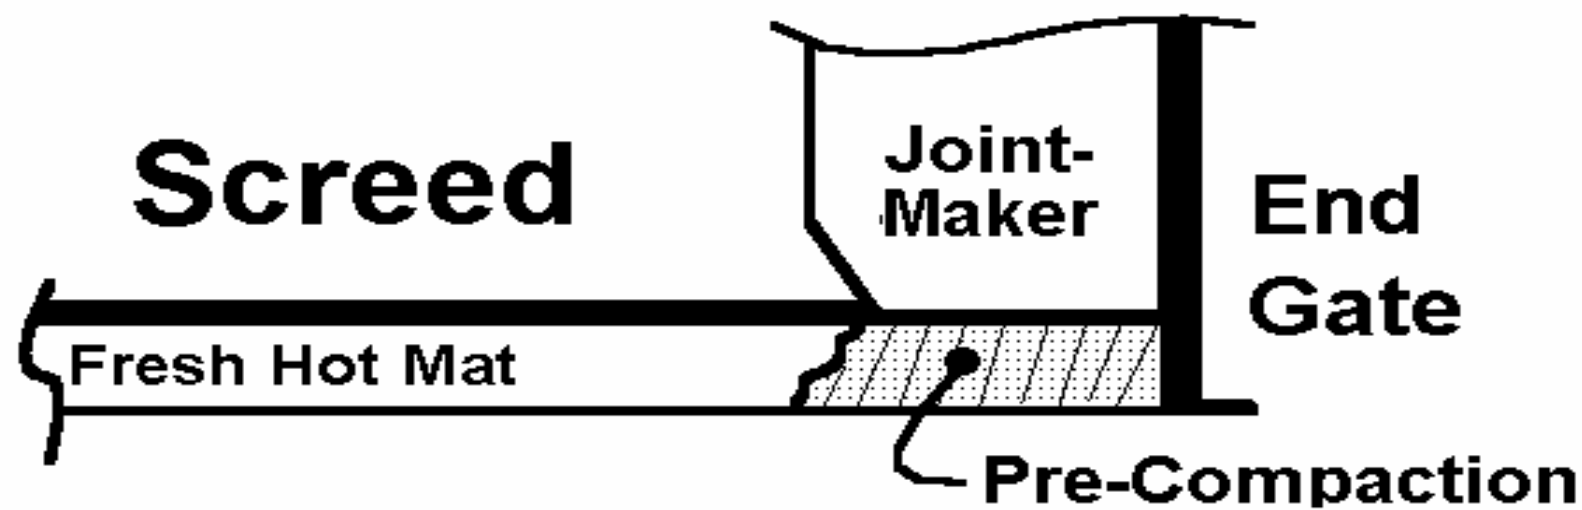
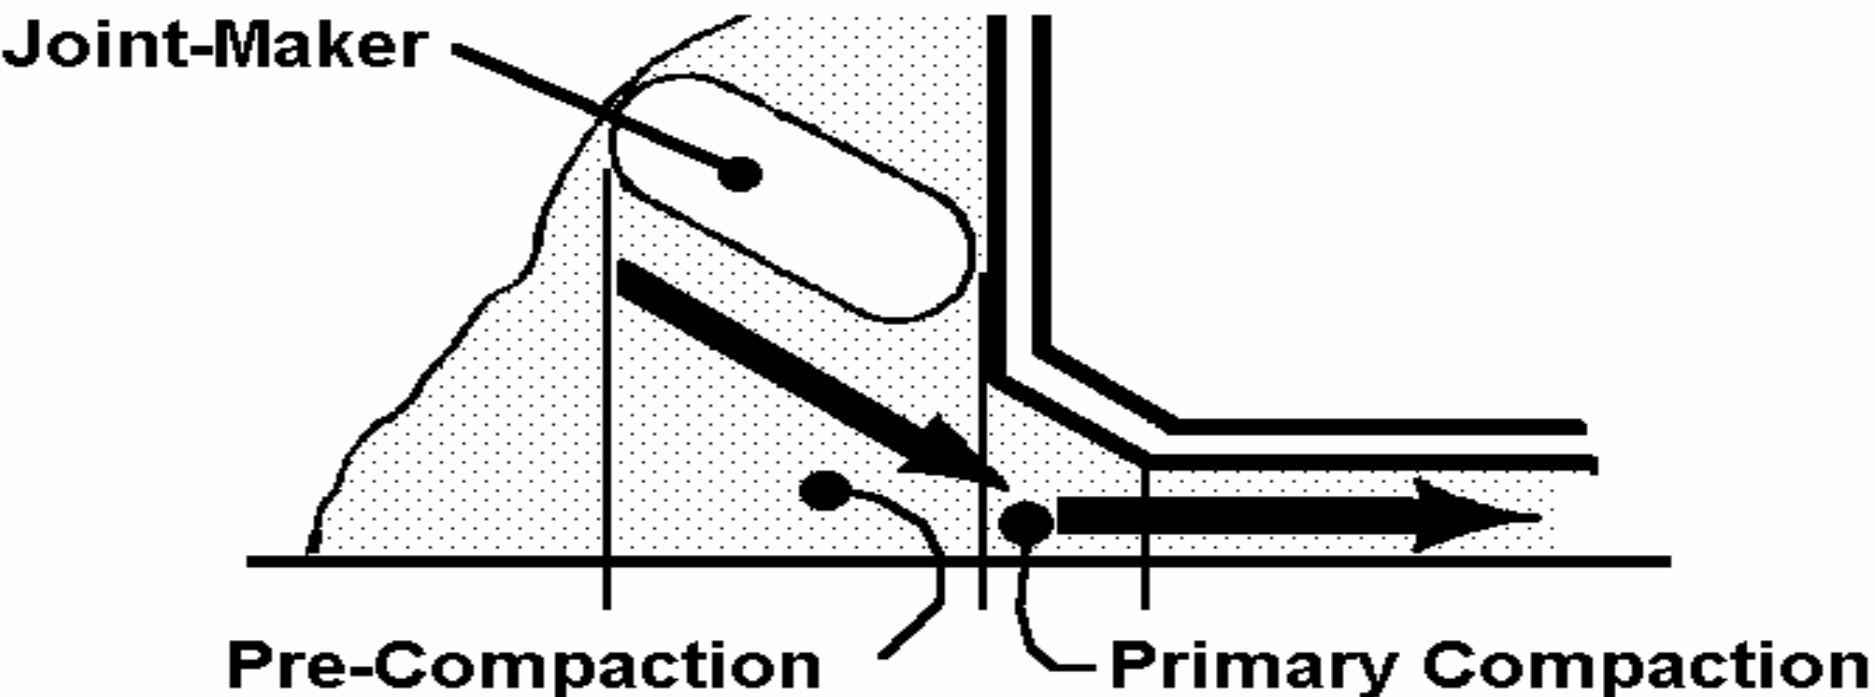
# Joint Maker

1. **Difficult to set up and get the correct angle to achieve compaction.**
