# Longitudinal Joint Construction Study

**David Allen  
Kentucky Transportation Center  
University of Kentucky**

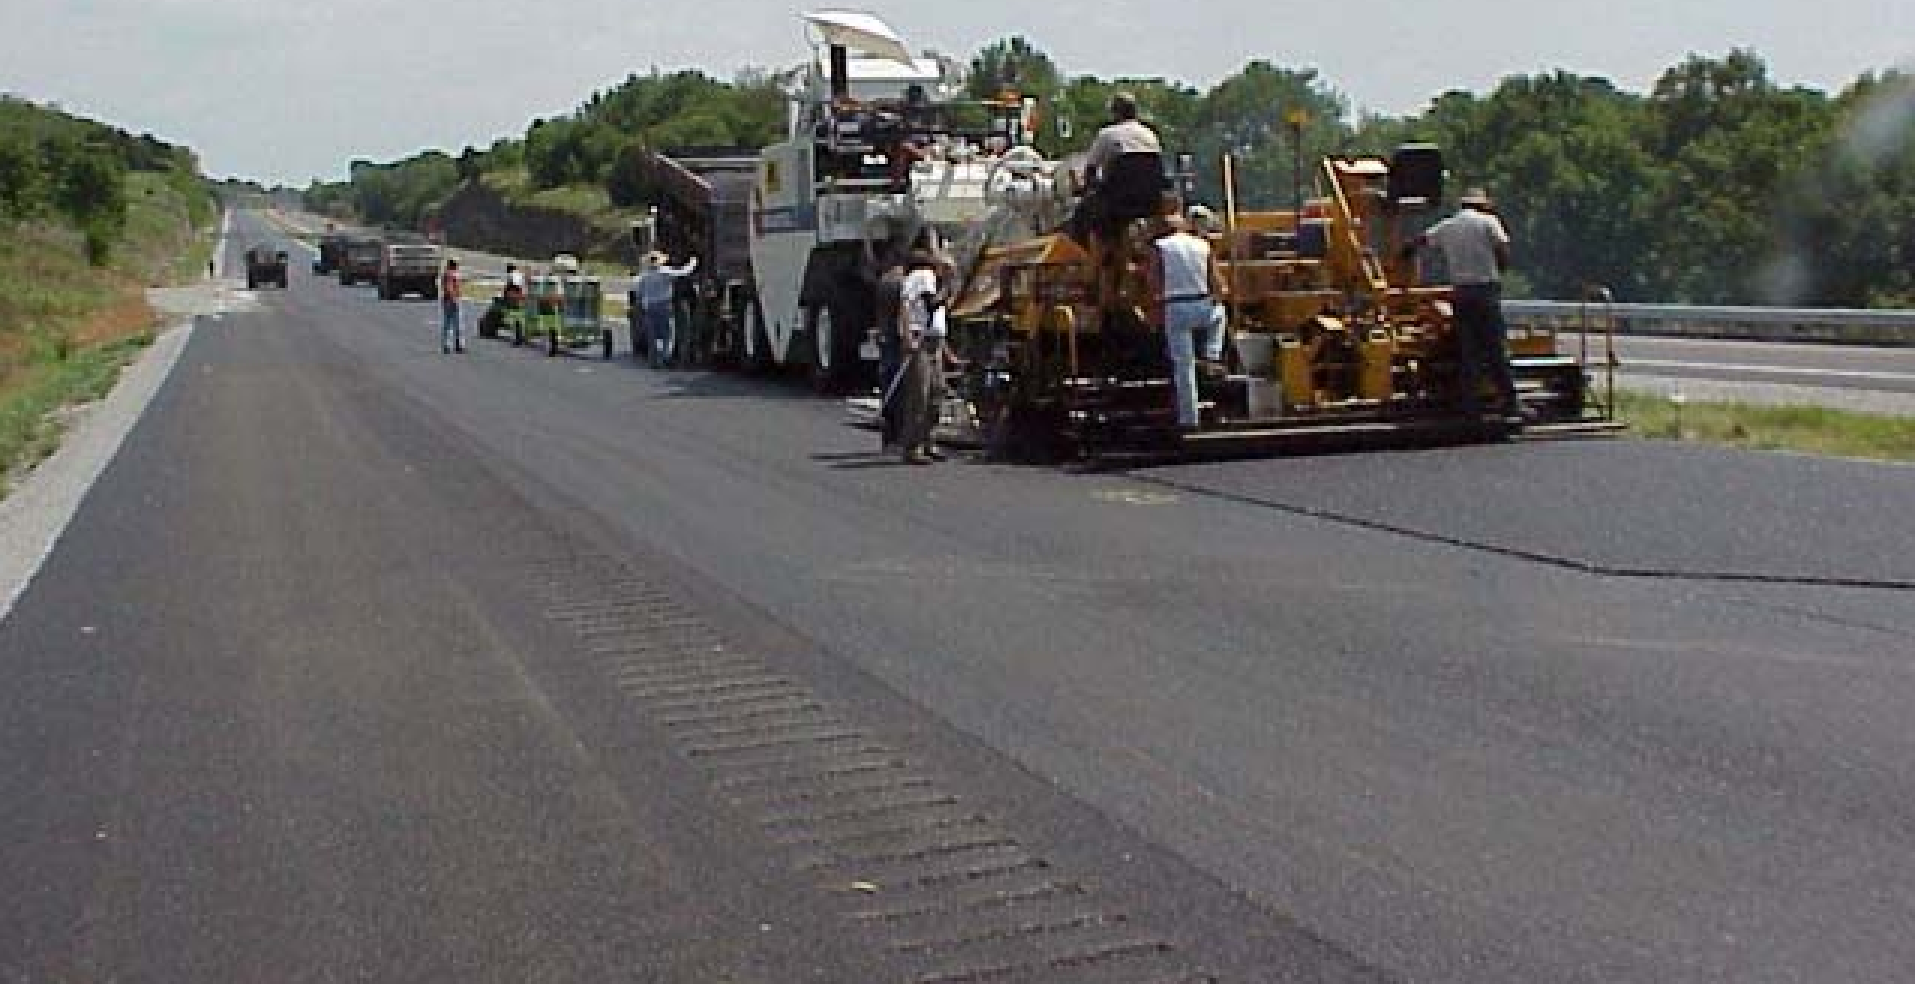
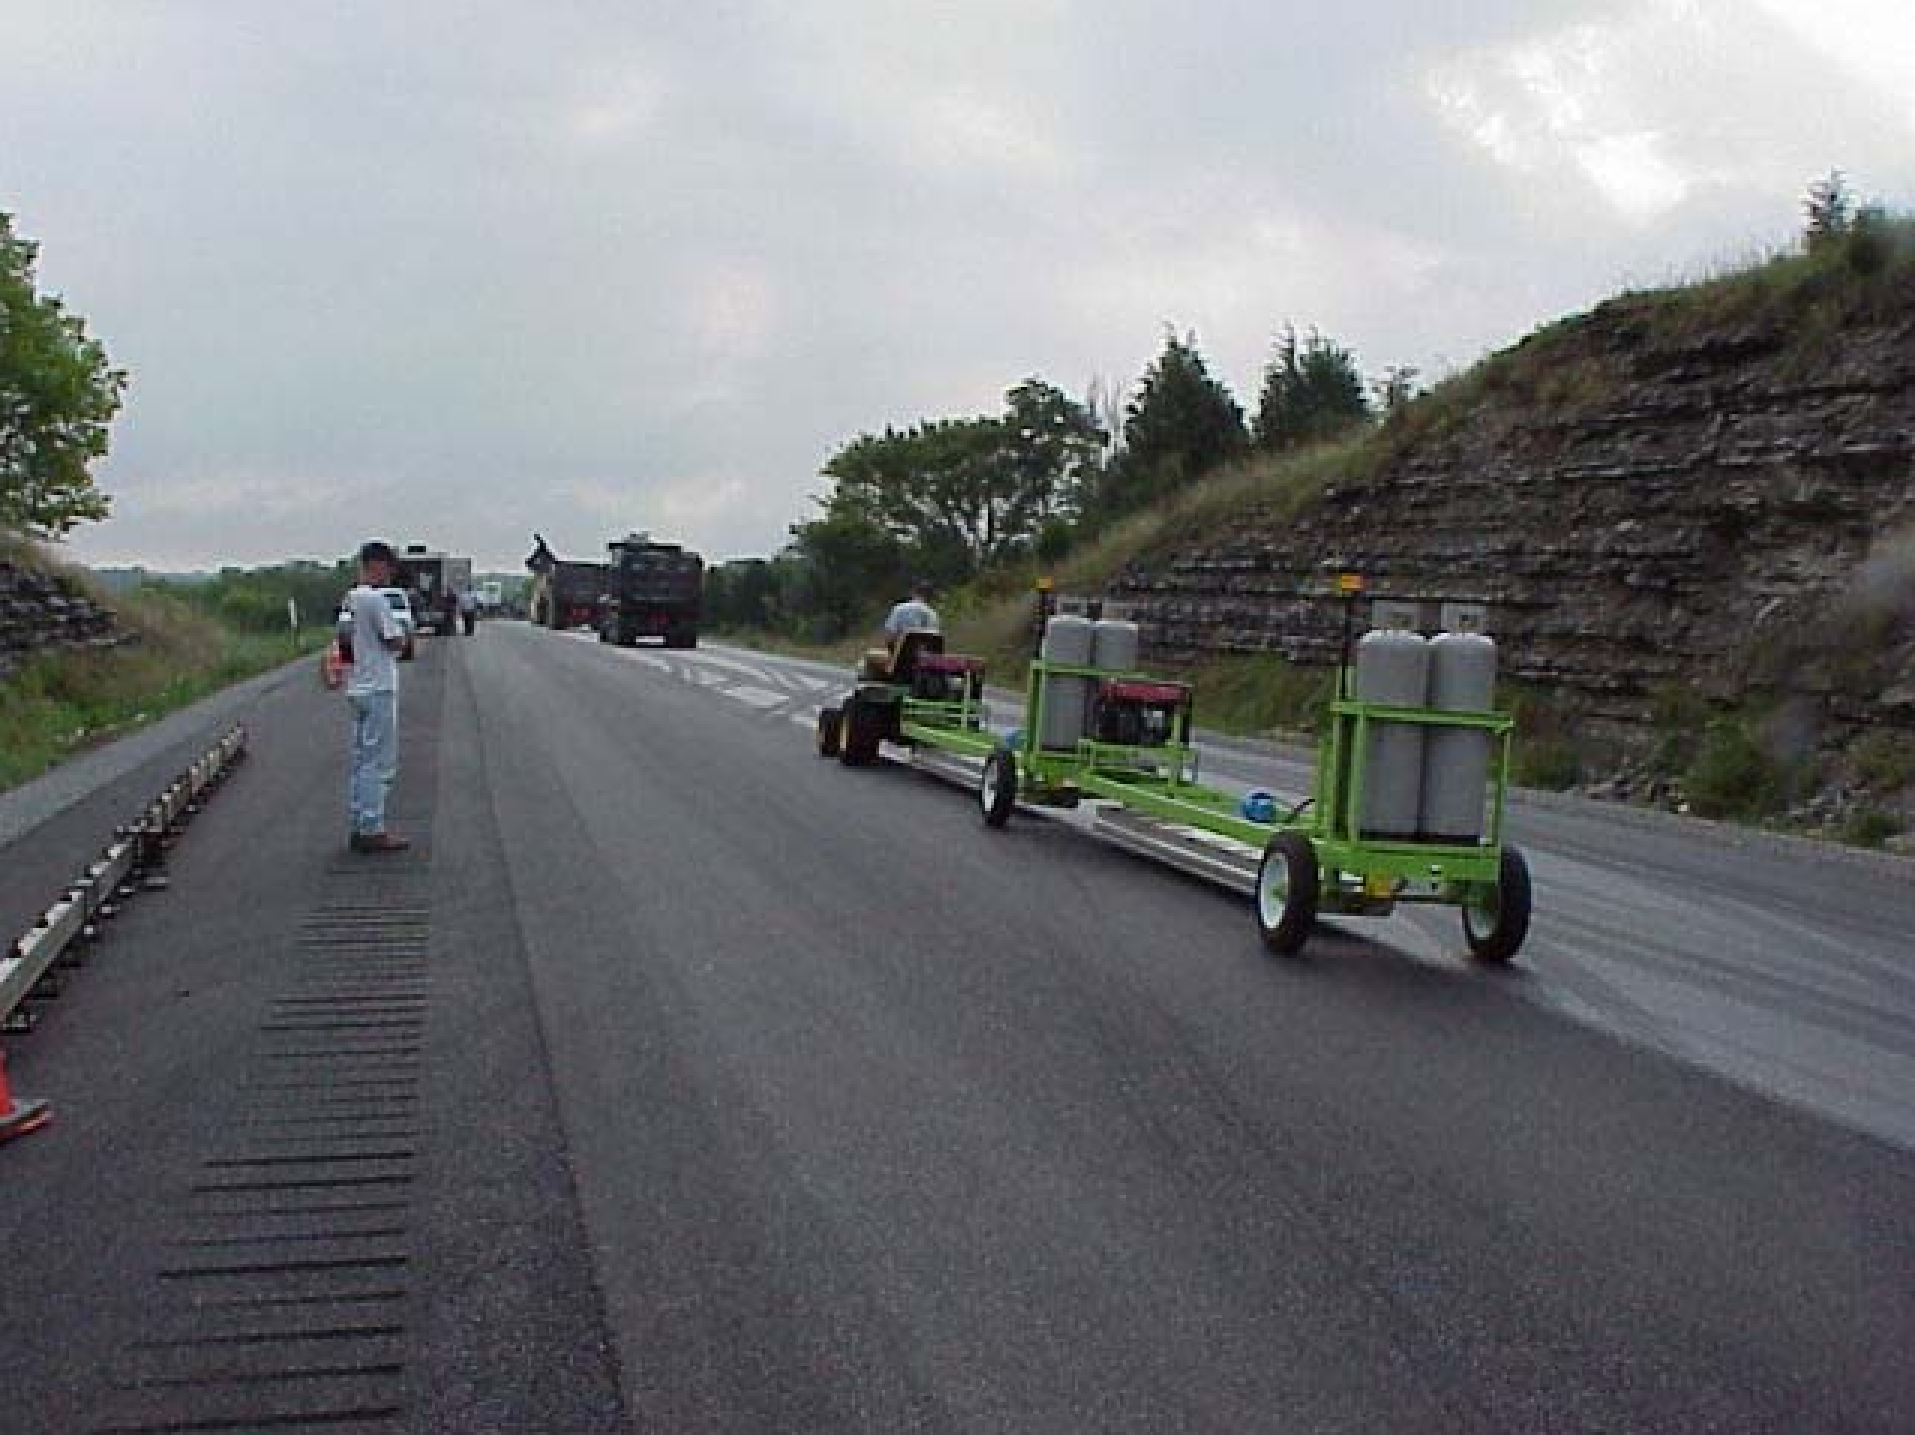
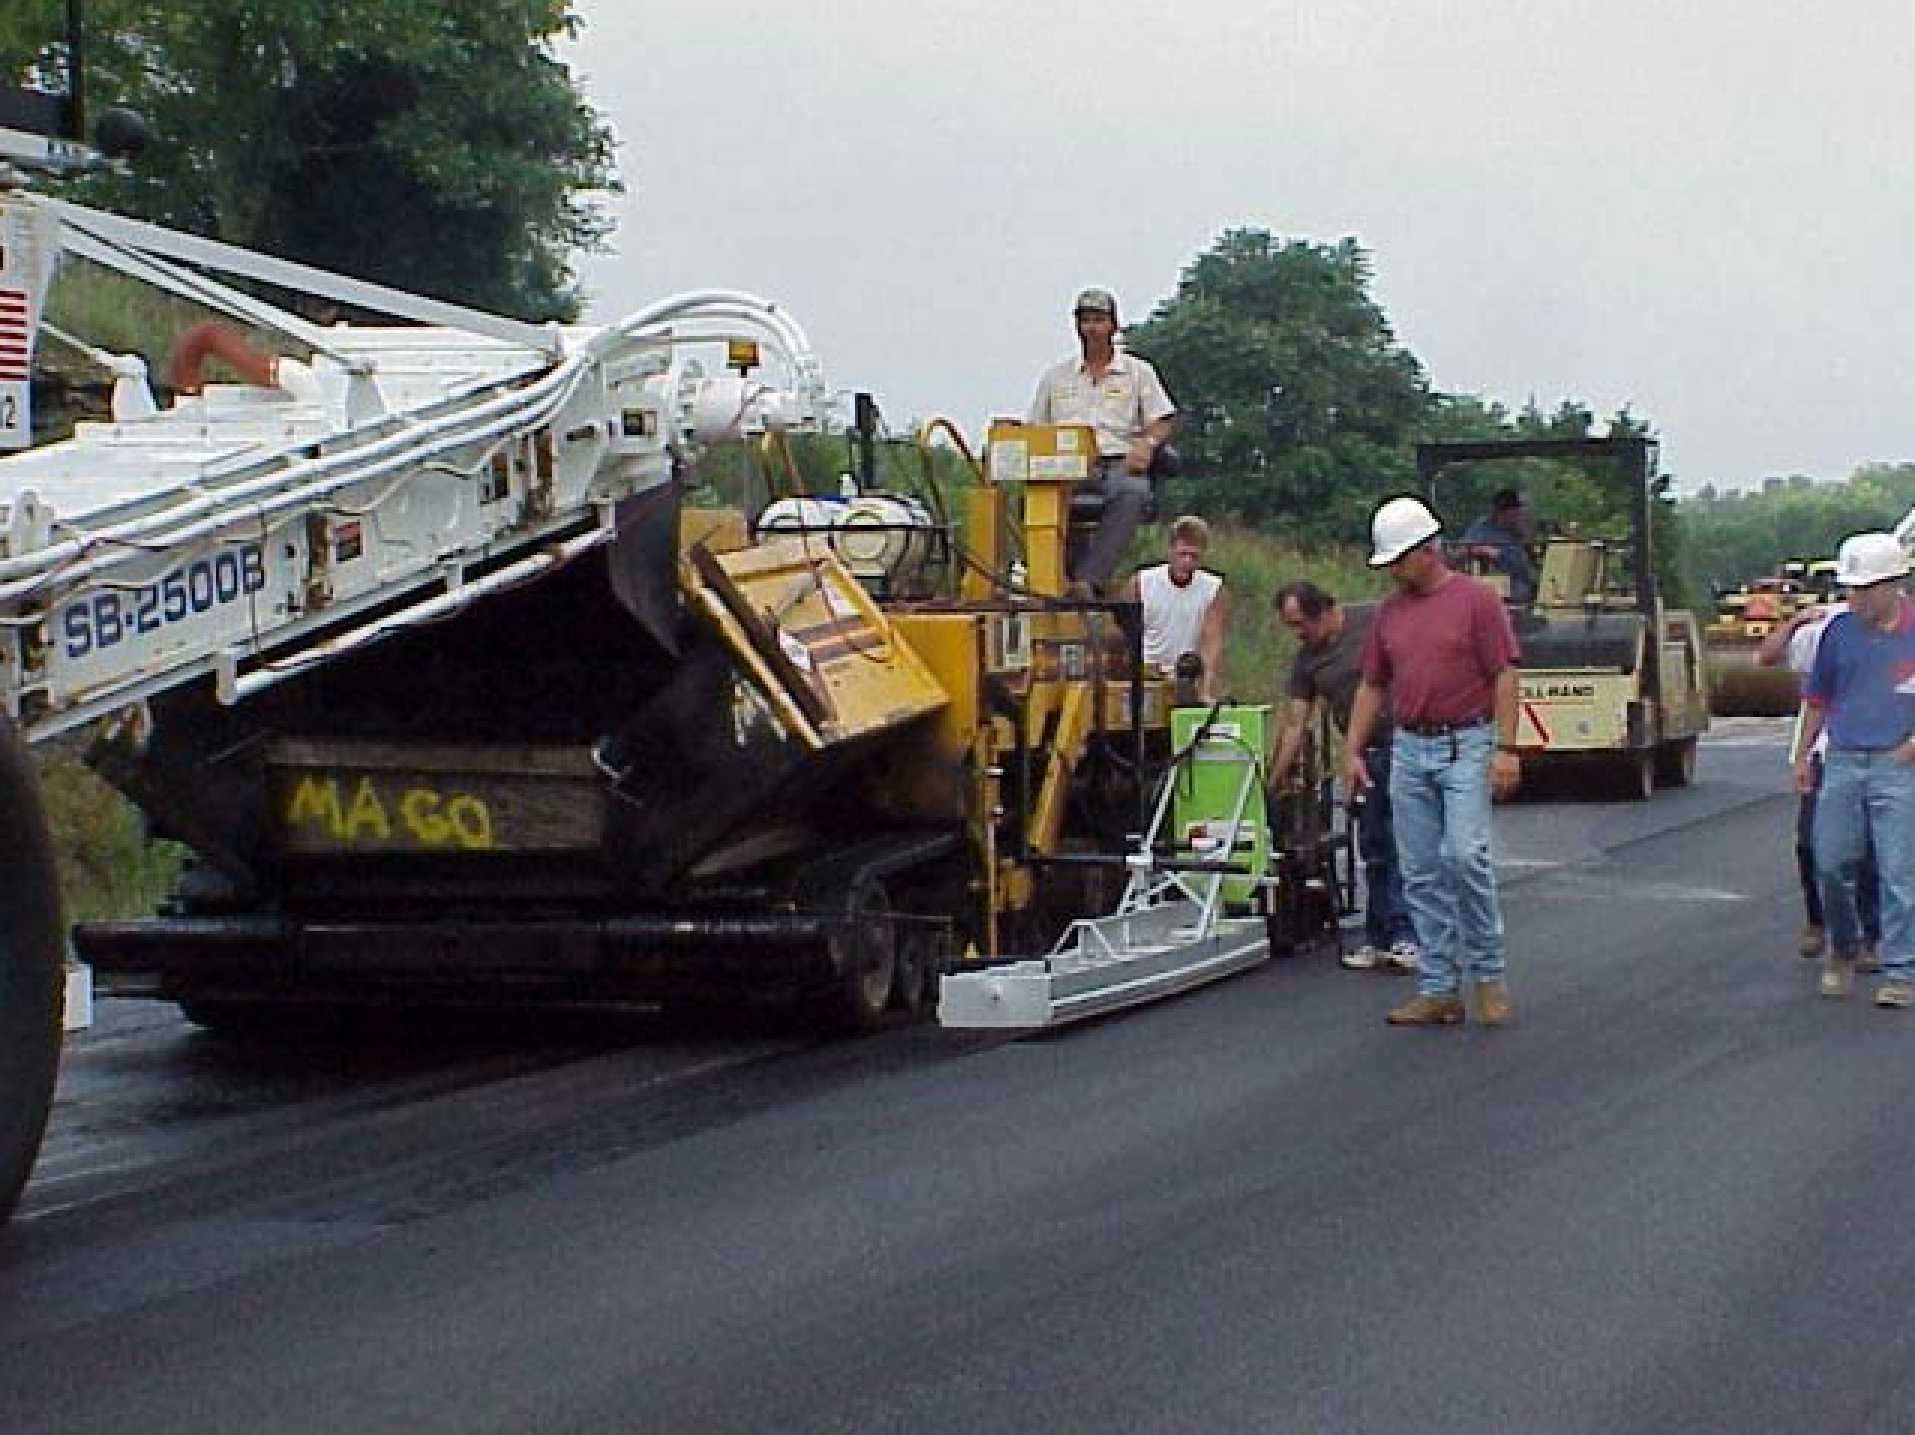
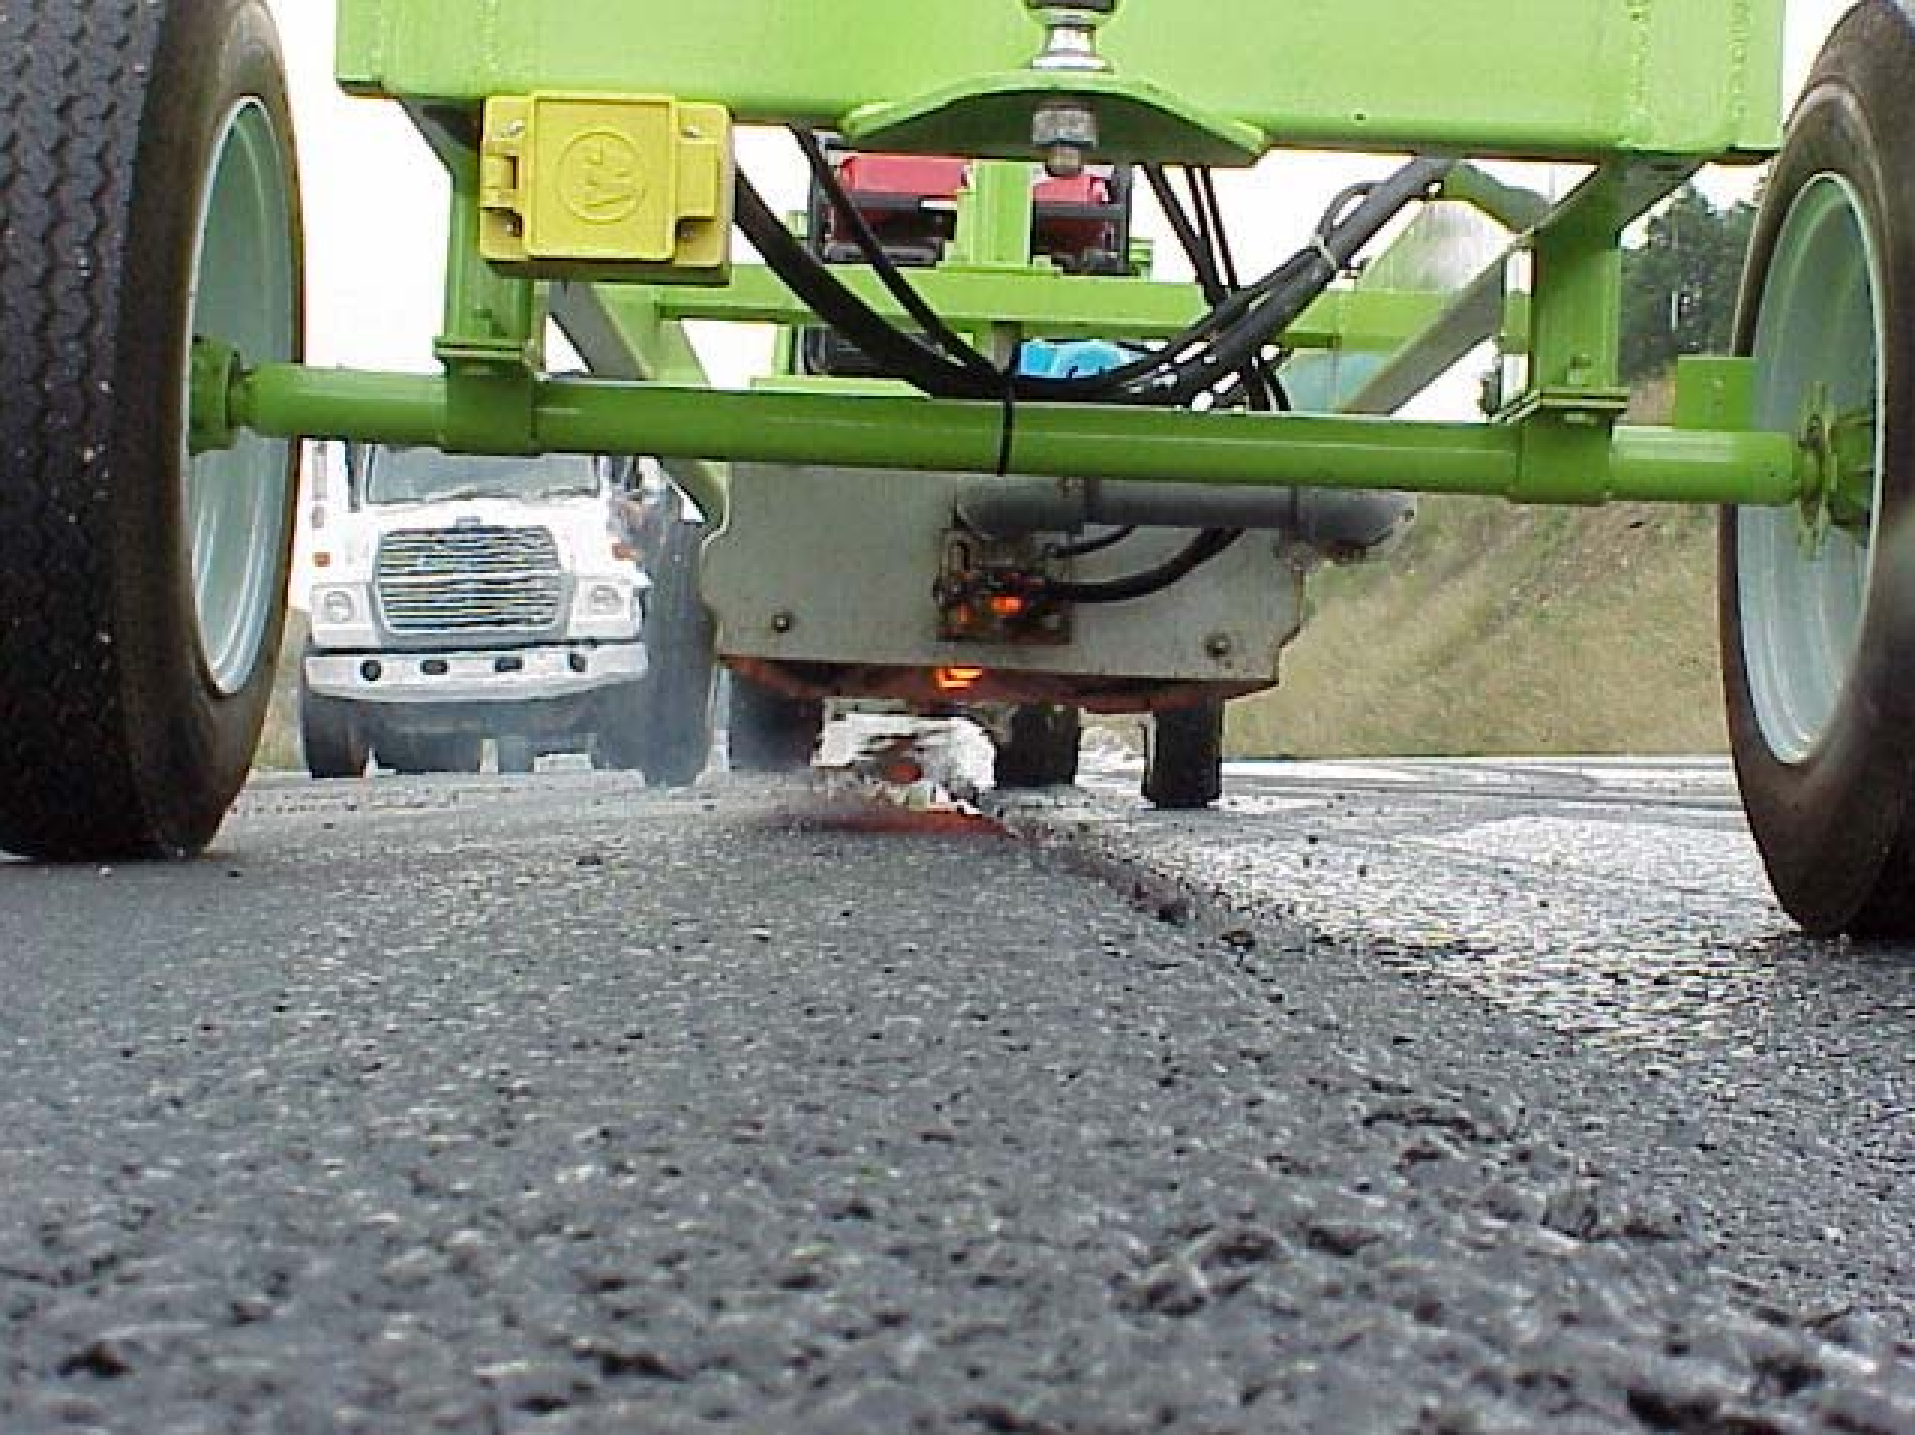
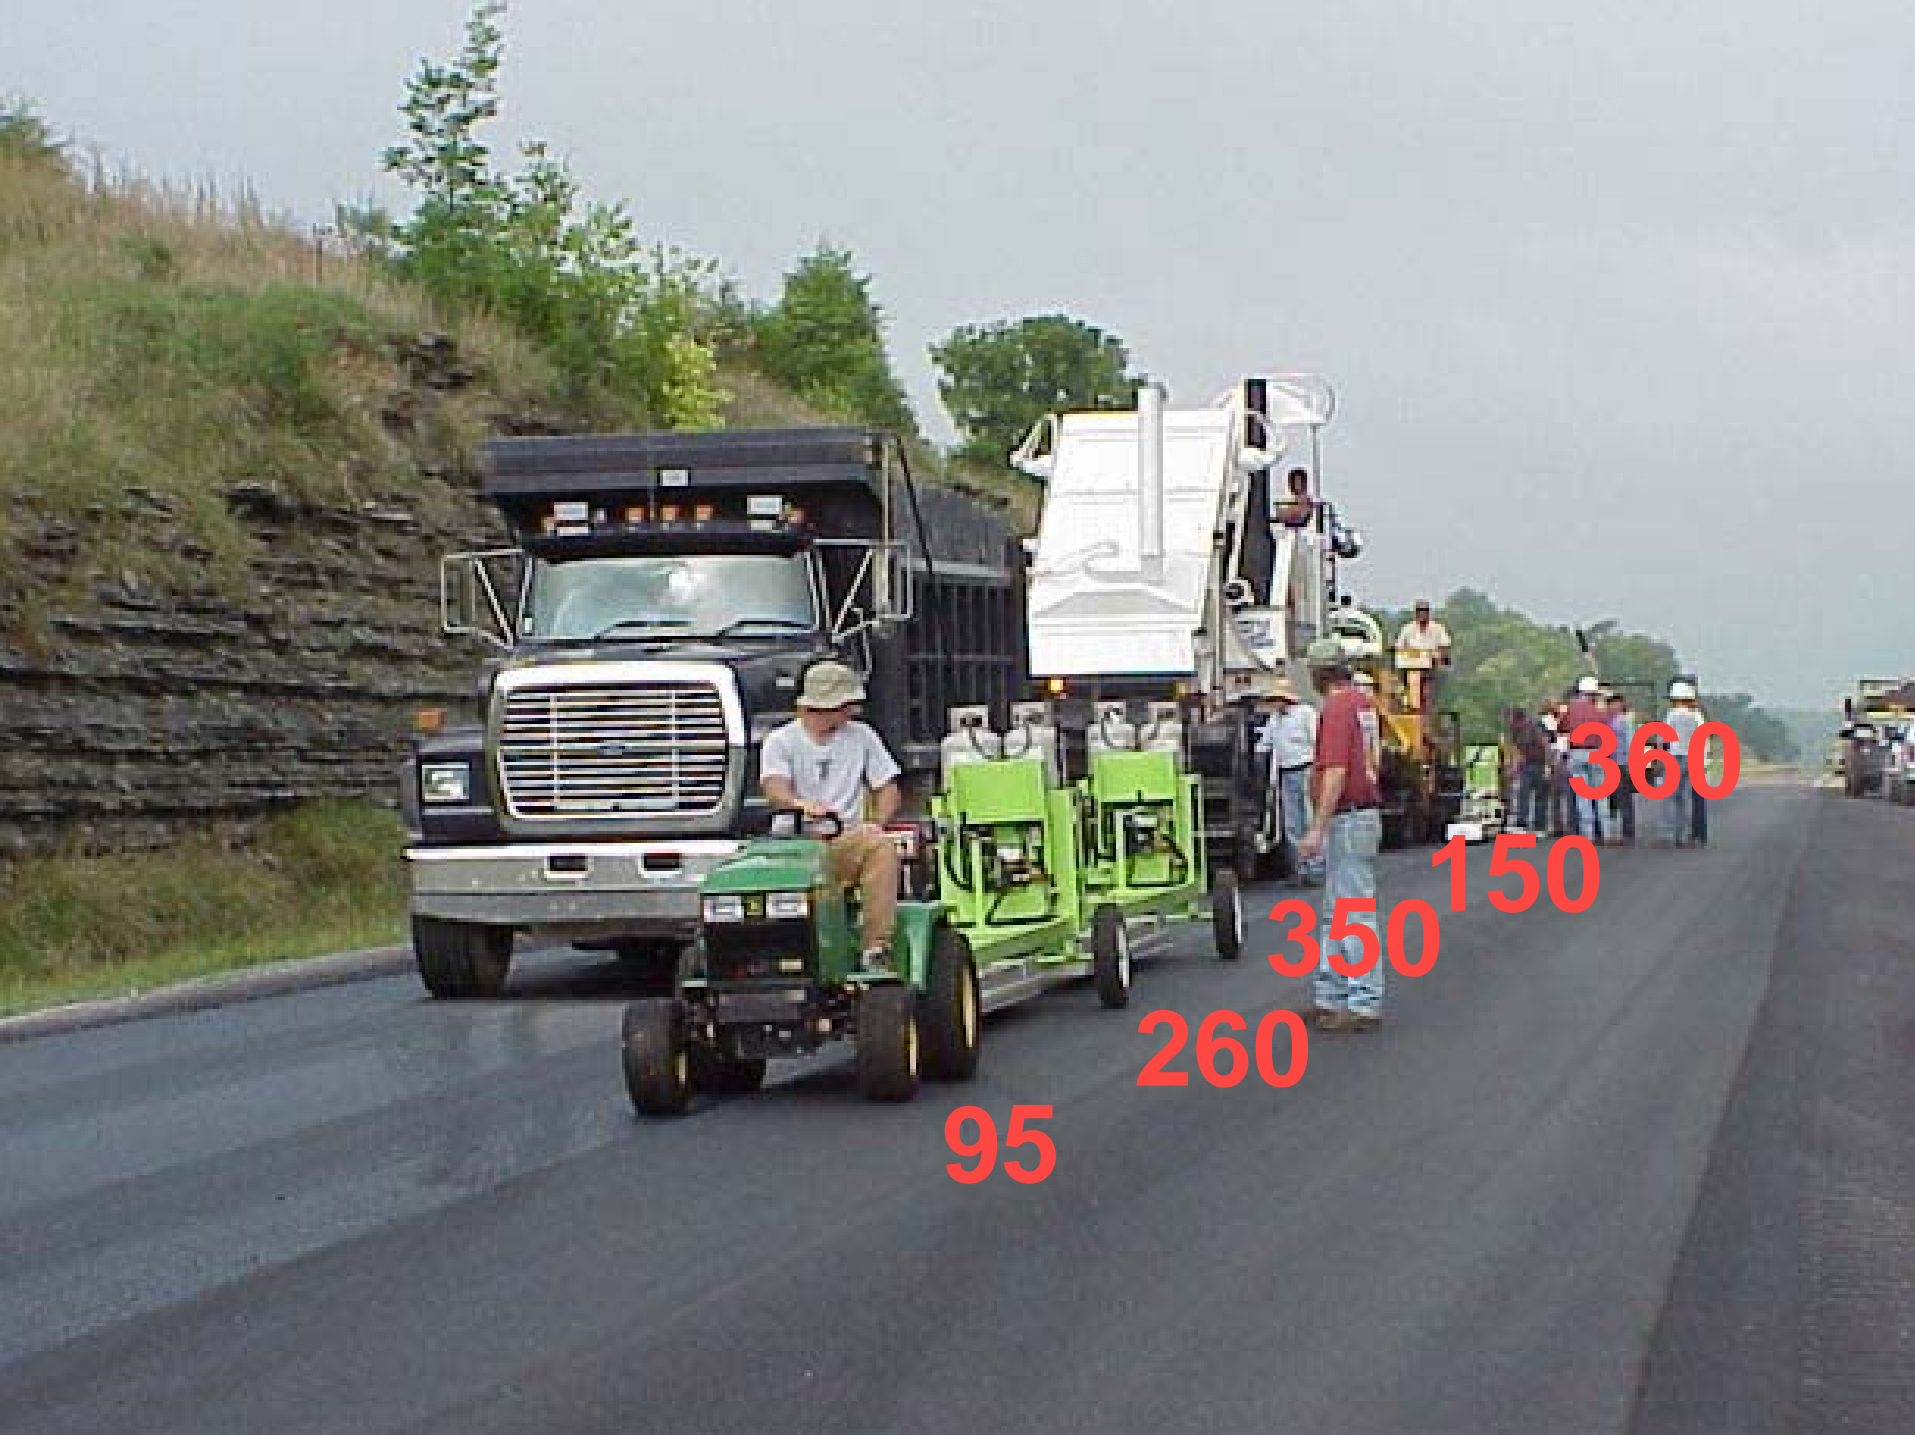
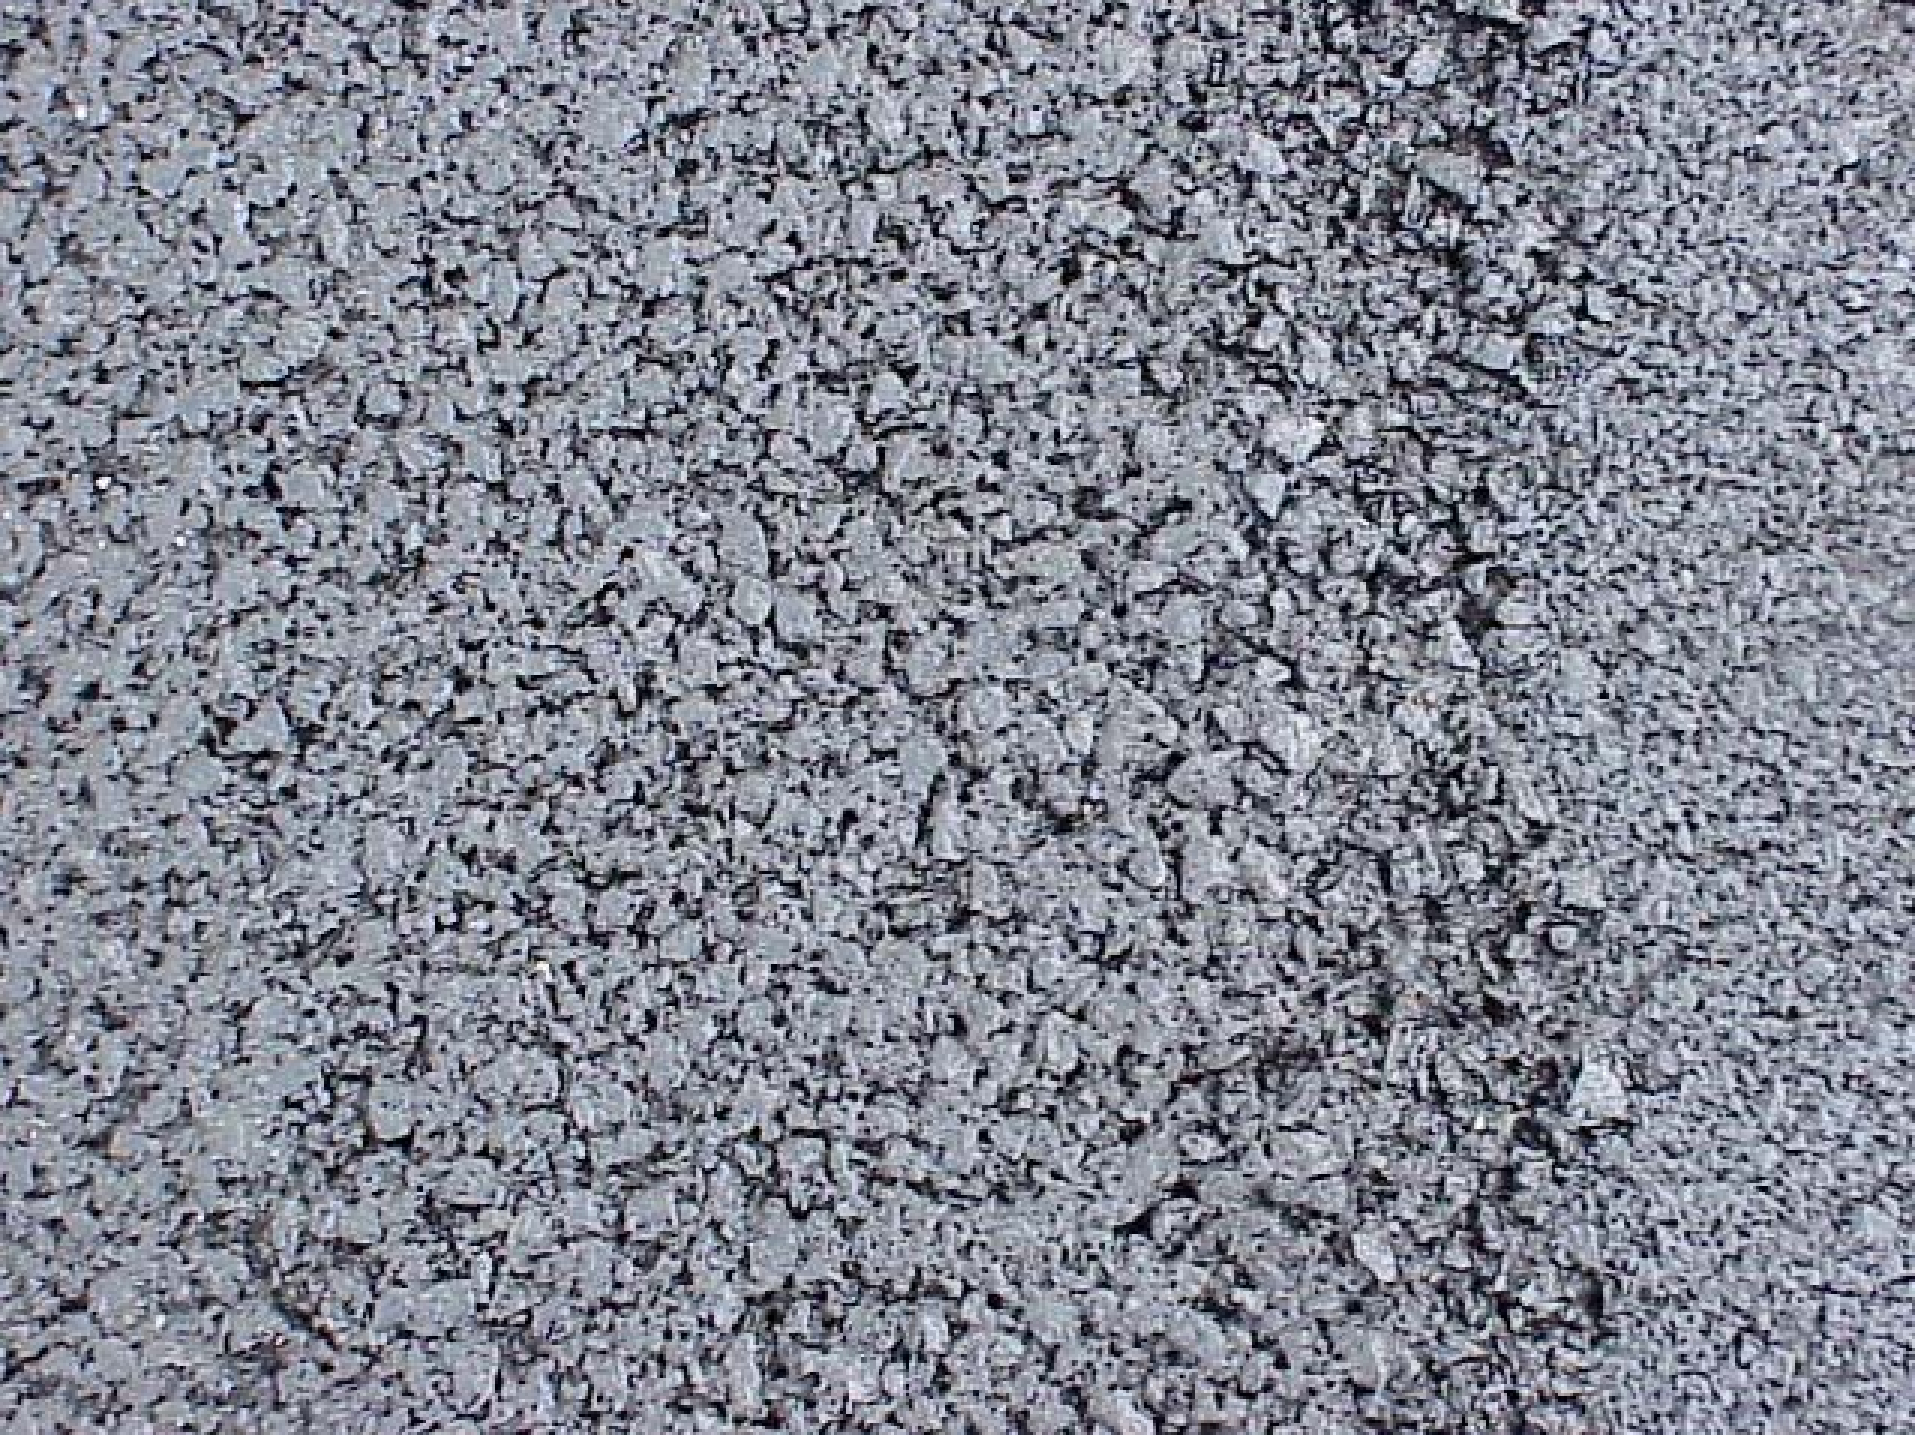
# Bluegrass Parkway Joint Reheater

- 1. Temperatures on the heaters had to be adjusted manually. The sensors to control the heaters had not been shipped.**
- 2. In some places, the joint was overheated.**
- 3. Could not use the “ski poles” on the paver.**
- 4. Slower production because of having to reheat.**
