# Longitudinal Joint Construction Study

**David Allen  
Kentucky Transportation Center  
University of Kentucky**

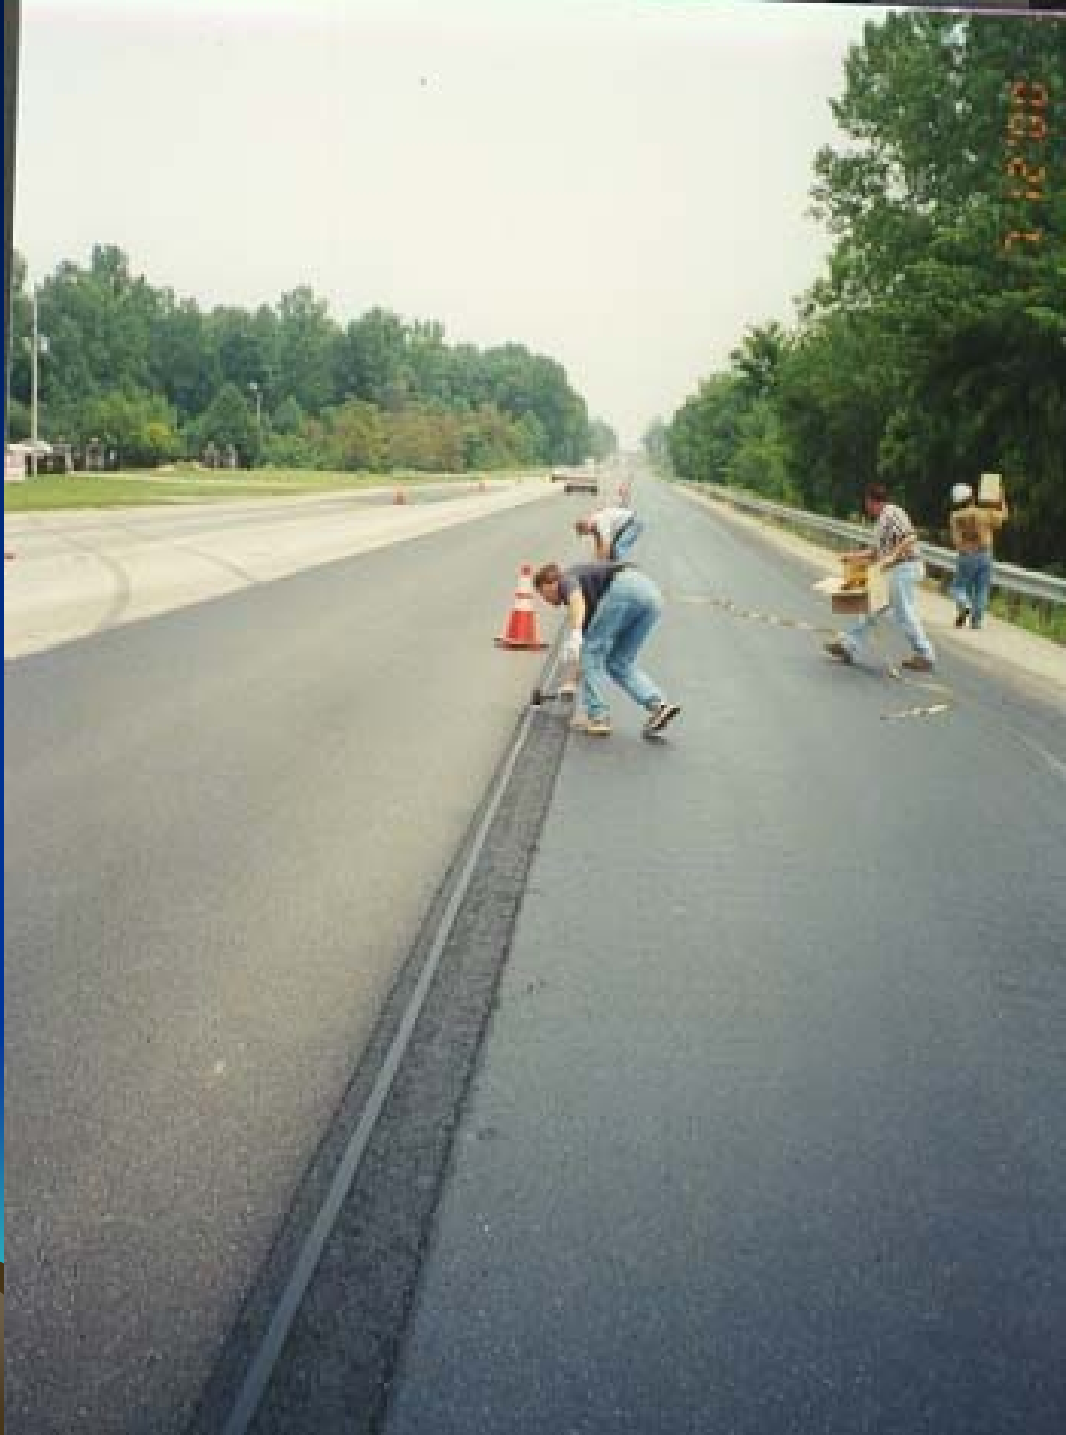
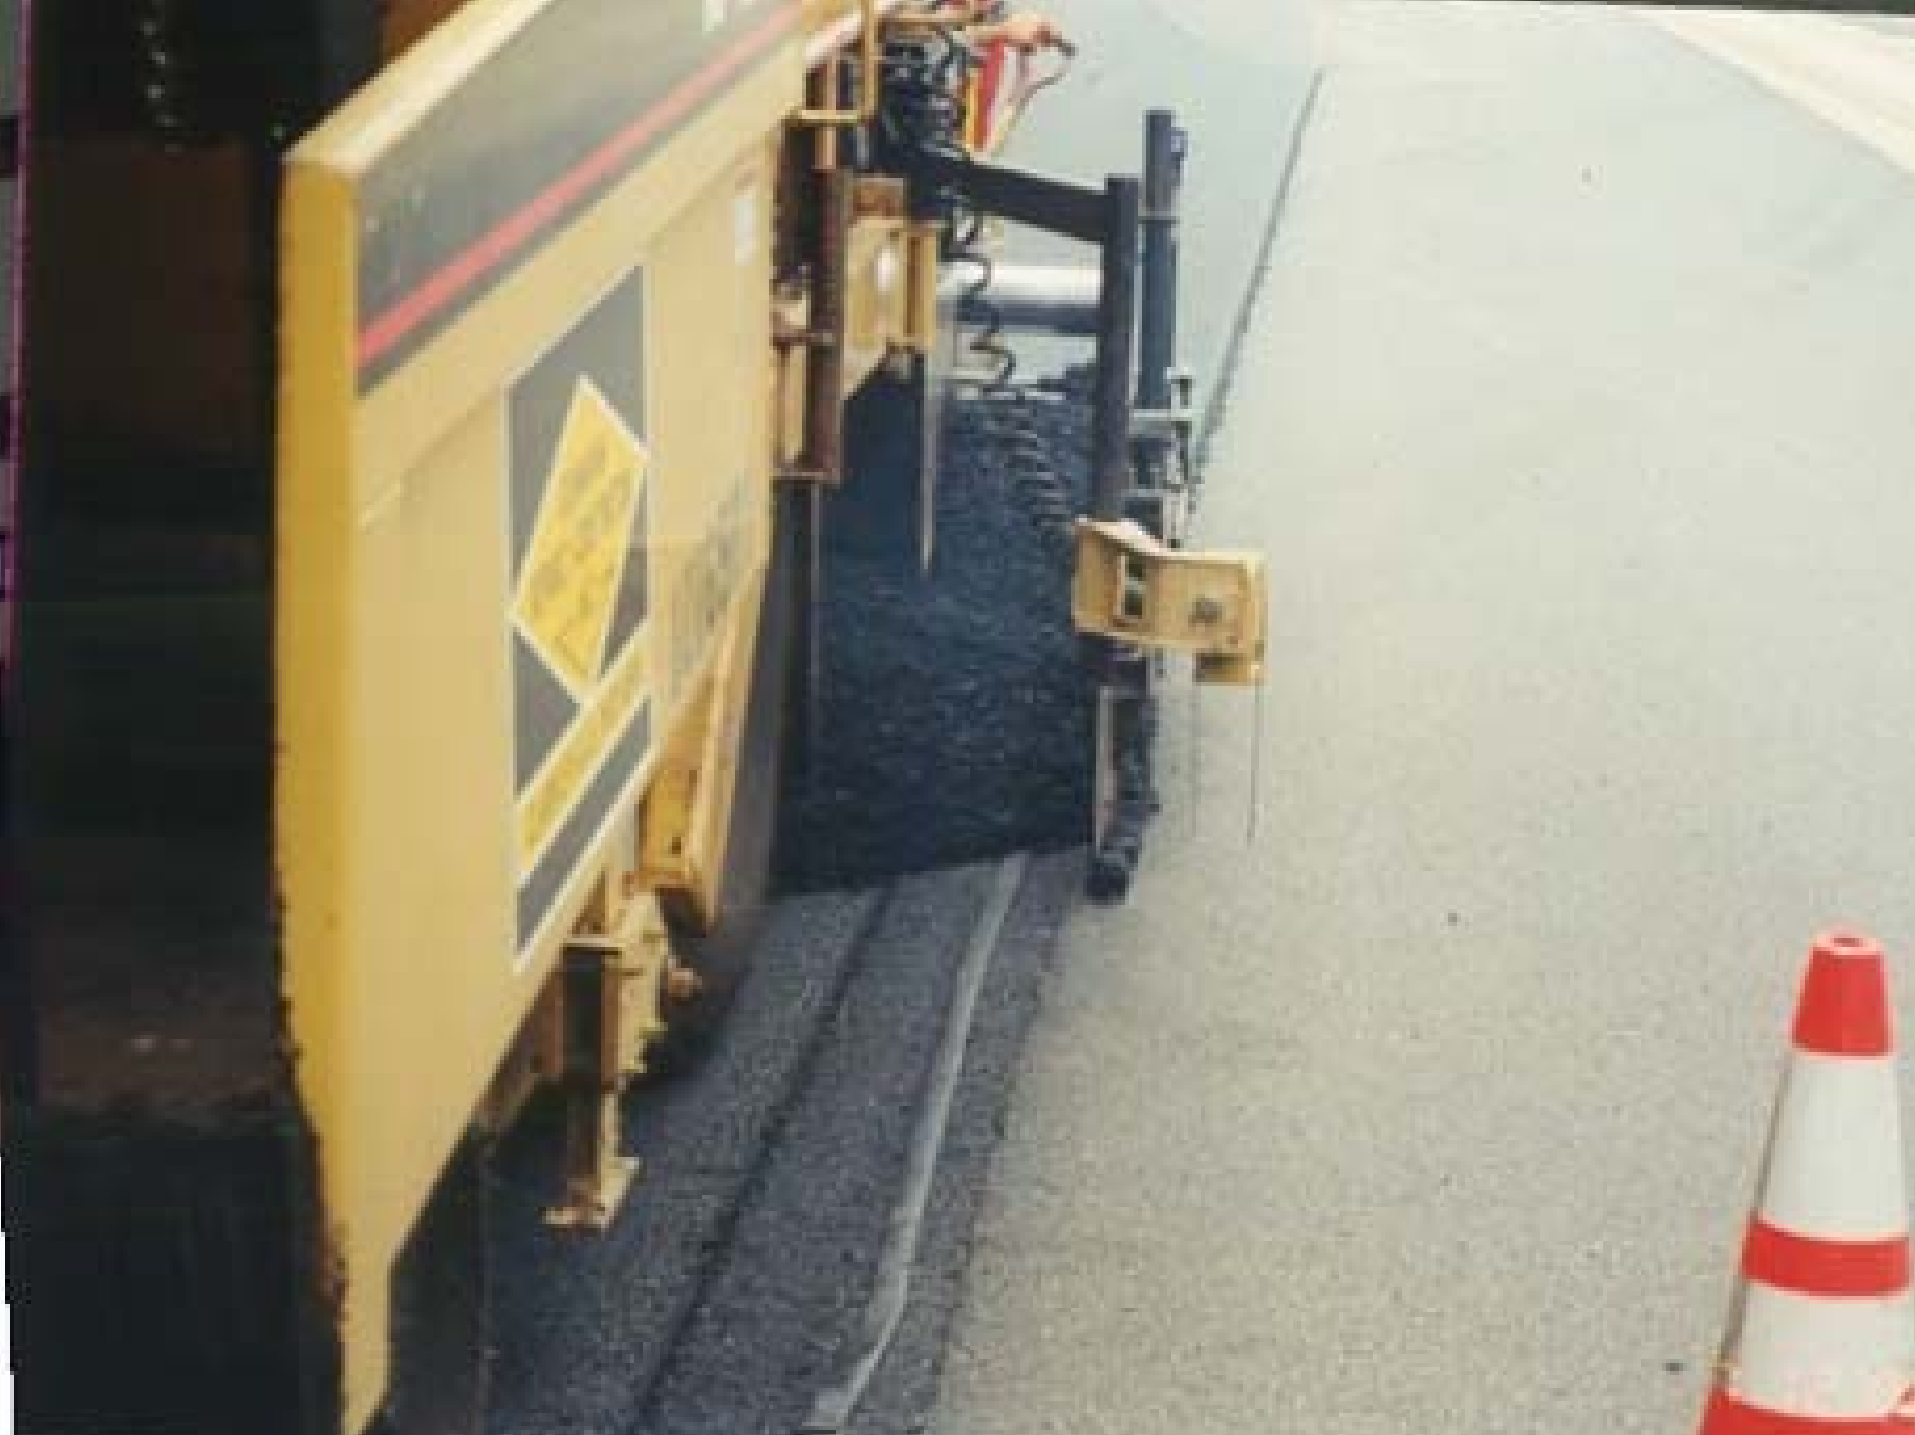
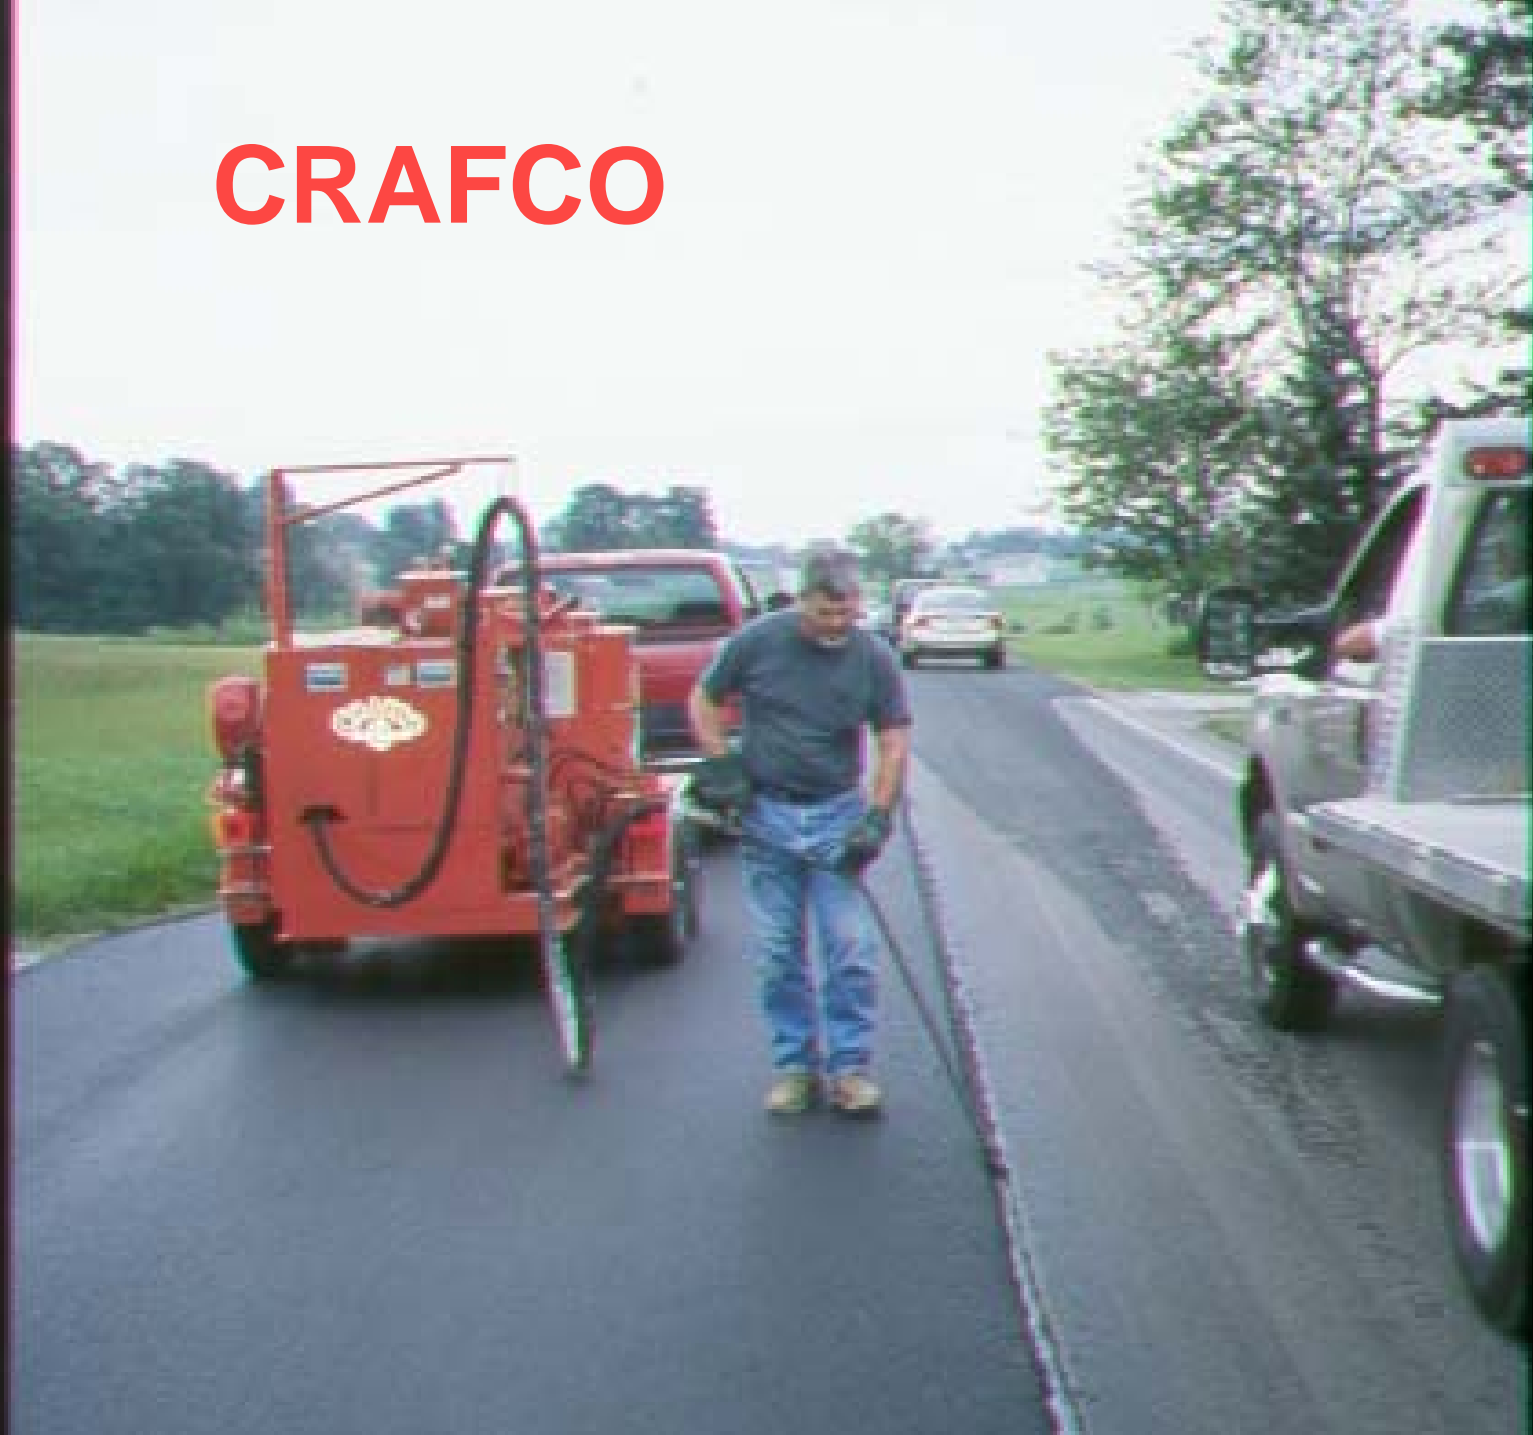
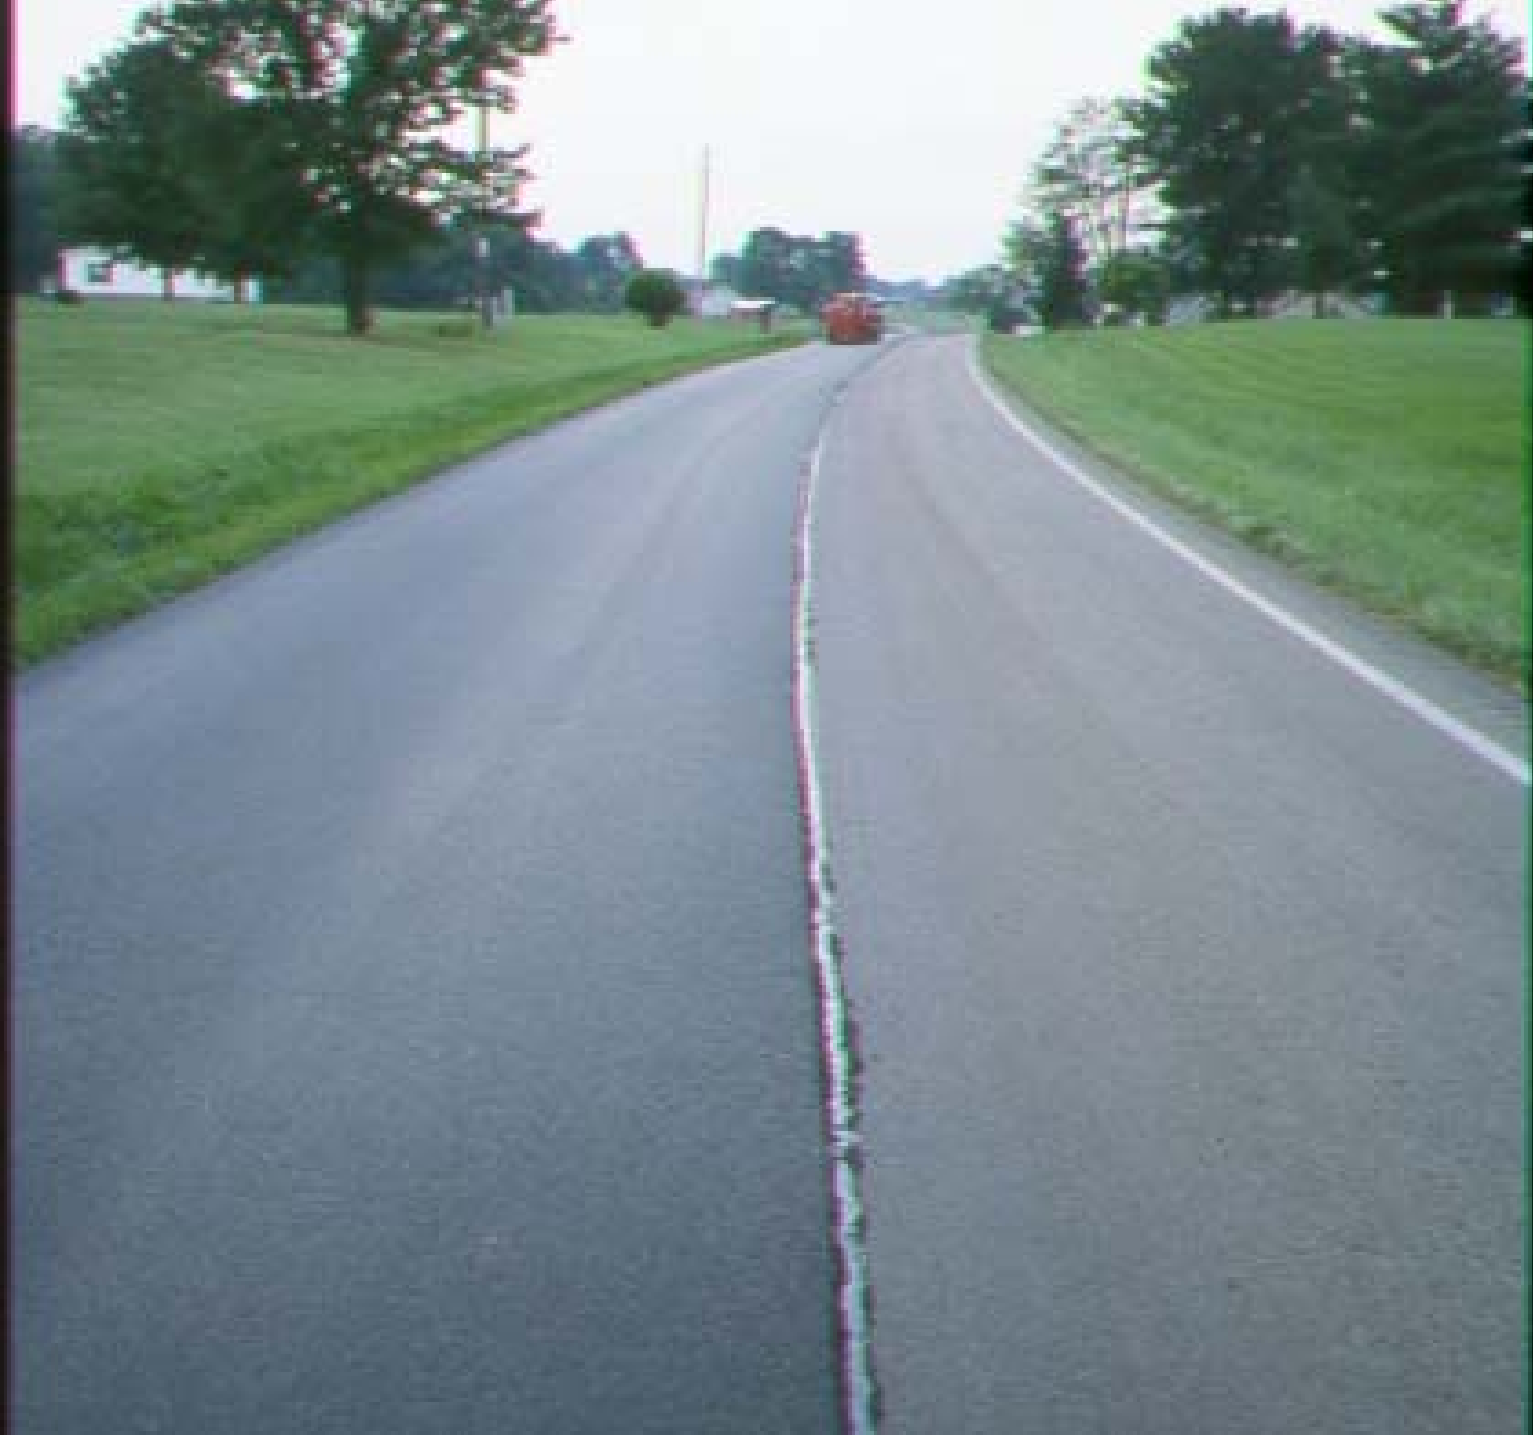
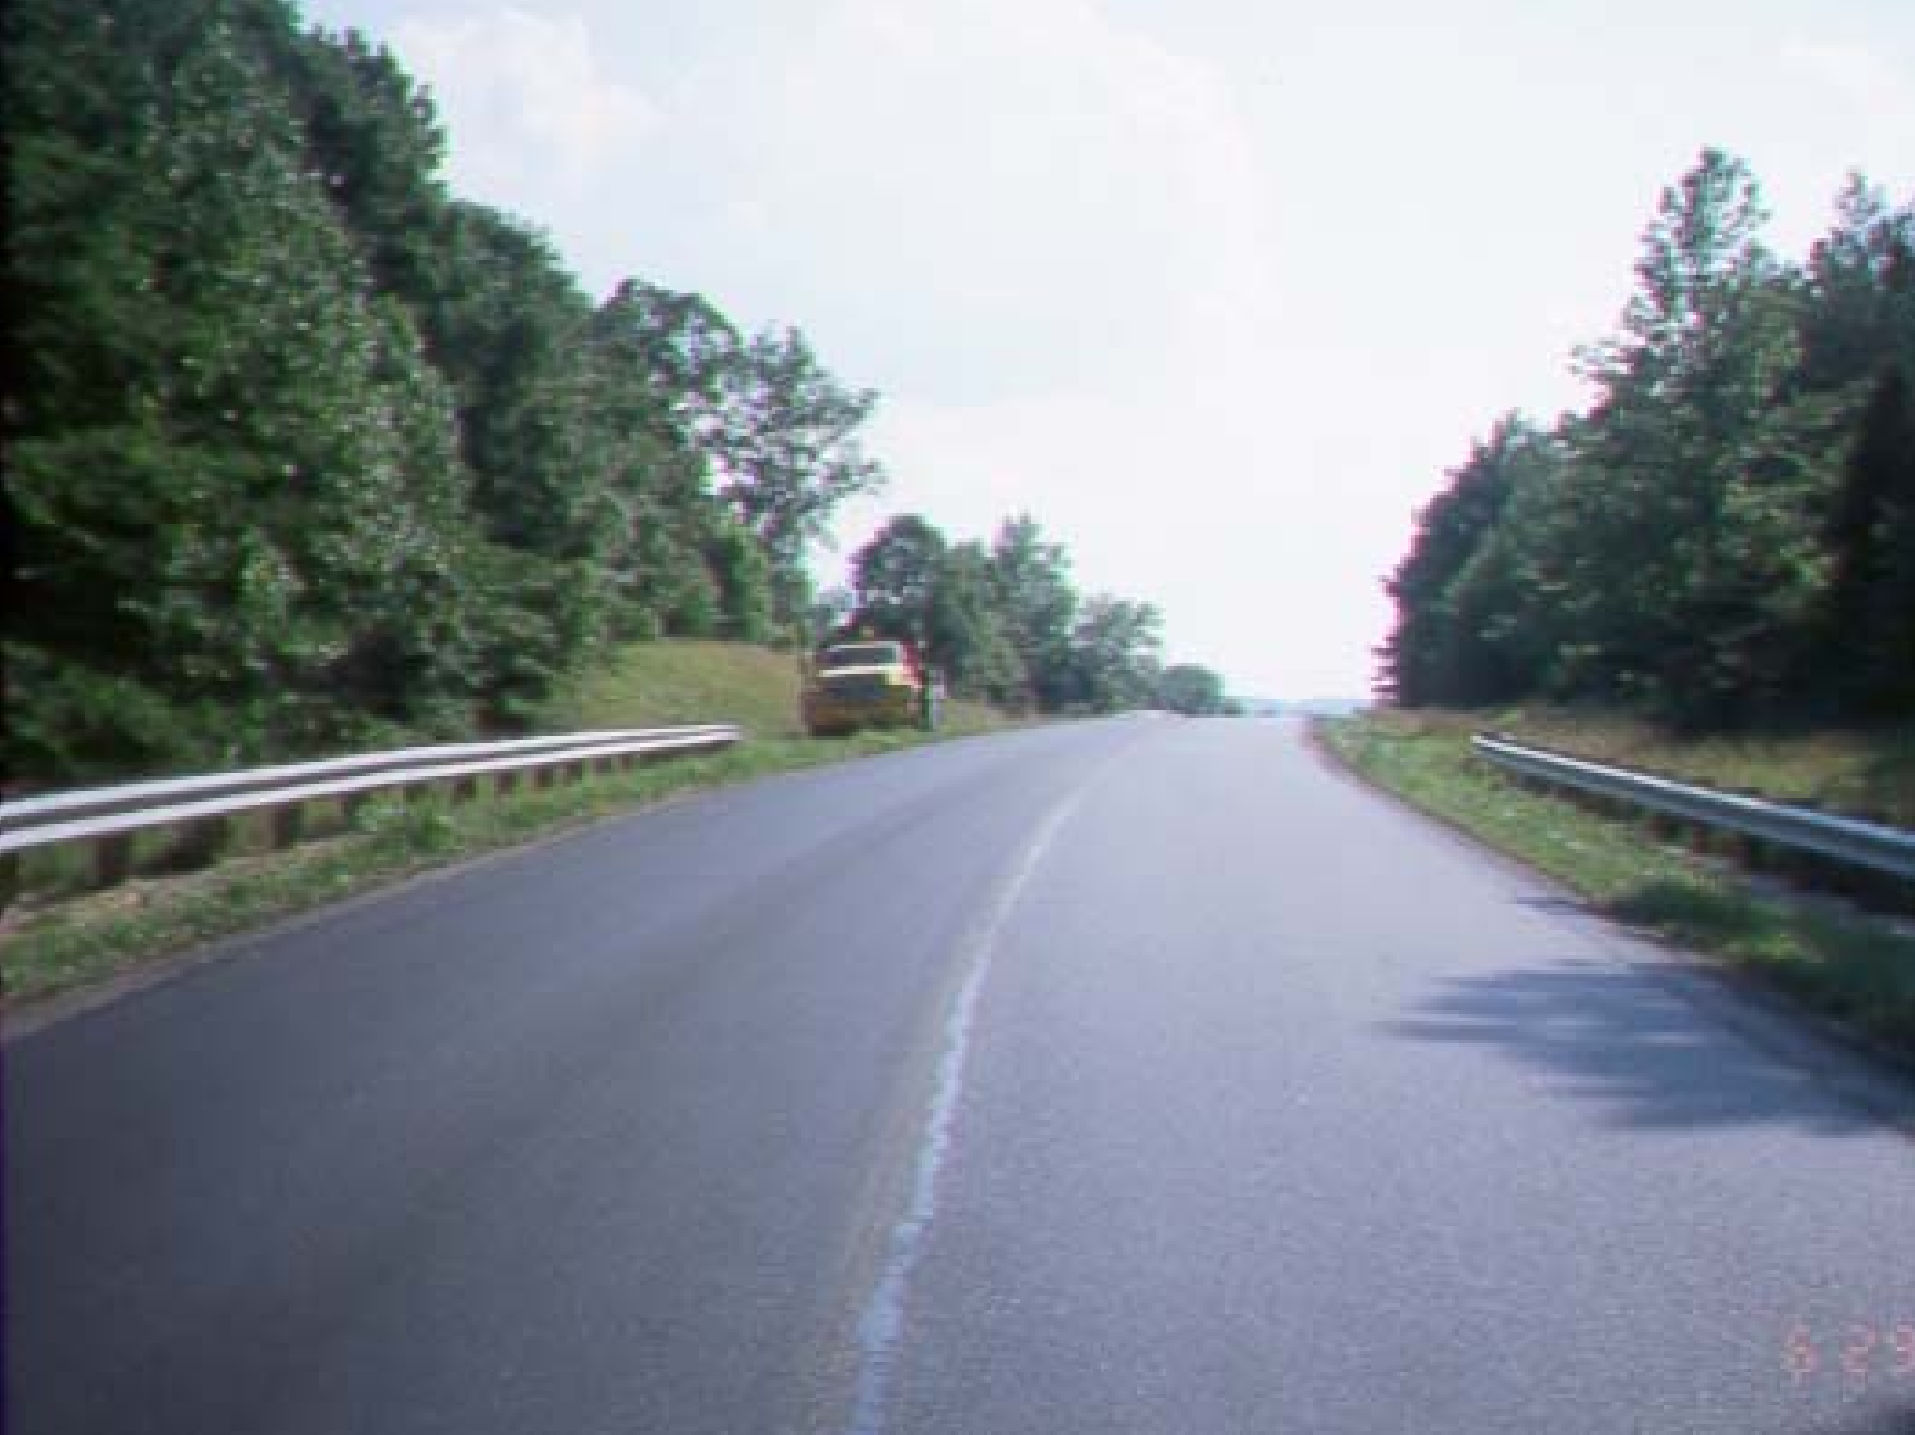
# Joint Adhesives

- 1. Require more personnel.**
- 2. Need to be protected to avoid “pickup” by construction traffic.**
- 3. Tape is more labor-intensive.**
- 4. Some “bleed-through” occurs.**
