EDWARD J. BRECKWOLDT PAVEMENT RESEARCH ENGINEER

Research Report No.38

Final Report

Research Project No. 68-1M(B) Louisiana HPR 1 (6)

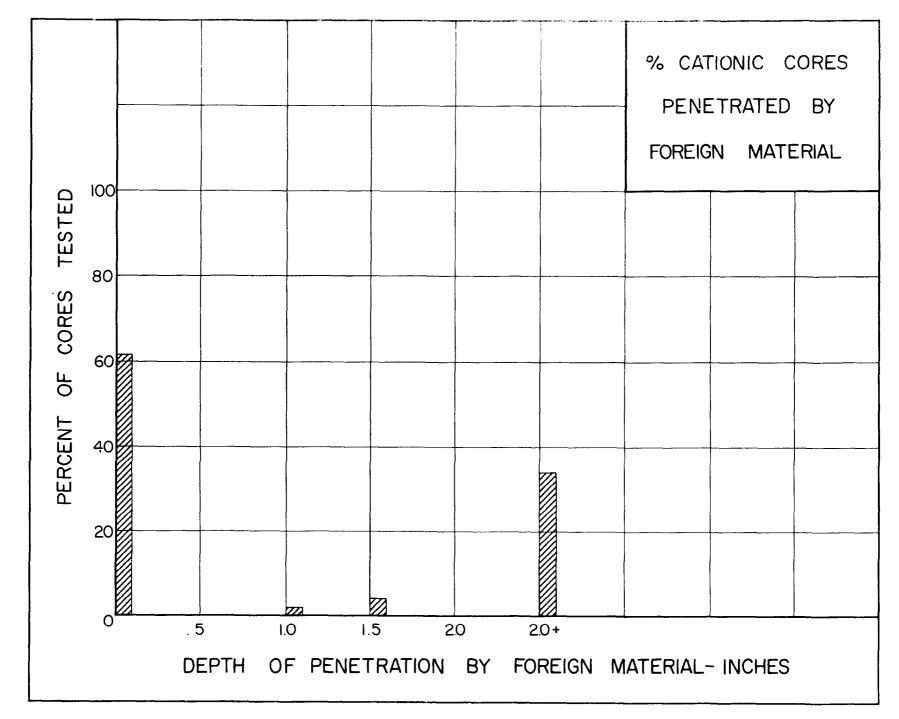
Figure 5: September 1968

Again these results were in agreement with above data, in that the RS-3K was the most effective in preventing infiltration of foreign material. Cracks sealed with Reclamite had less penetration of foreign material than did the unsealed cracks. (Figures 5, 6 and 7). It was noted that for 77.7% of the cores obtained from the untreated sections the foreign material had penetrated to a depth of more than 2 inches. It was also especially noted that this material was not tightly packed.

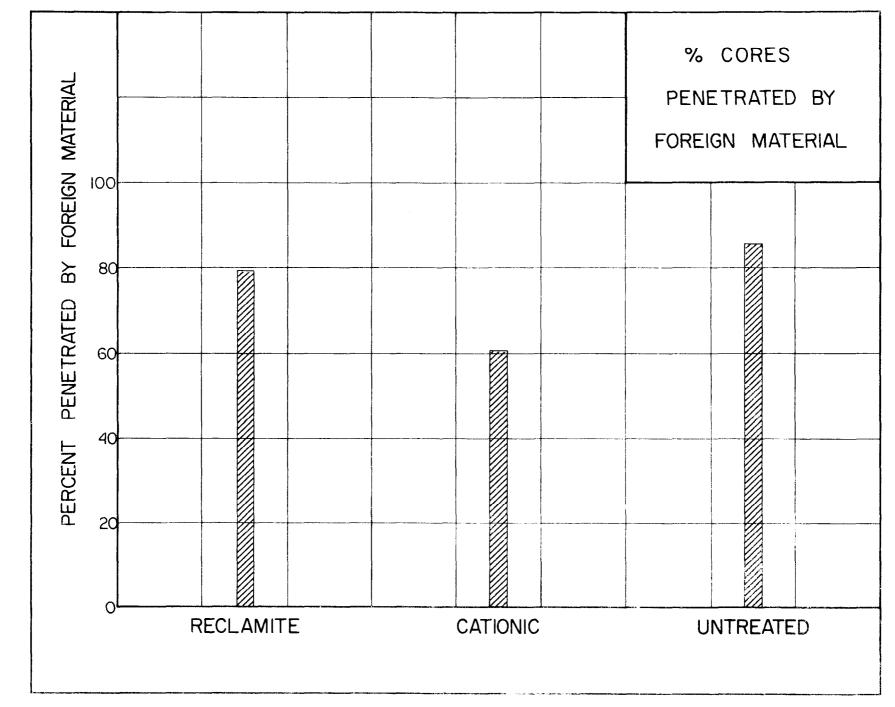
Figure 9: Two Eight Year Old Pavements September 1968

year old projects were tightly packed and almost sealed (78% not penetrated by water) with foreign matter even prior to placing any sealant material. (Photograph No. 10).

The application of the Reclamite material to these cracks brought the effectiveness of the seal to 100%, whereas the RS-3K only increased this effectiveness to 90%. (Photograph No. 2). Review of the data (Figure 9) showed that the cracks in the Reclamite section had possibly been better sealed initially by foreign matter than were the cracks in the RS-3K section.
