Louisiana Transportation Research Center

Technical Assistance Report 16-03TA-C

Evaluation of Cores from Jefferson Highway Near Airline Highway

Petrographic Investigation of Concrete Cores Extracted from Cracked
Pavement Slabs on Jefferson Highway in Baton Rouge, Louisiana
(RE: LTRC Project 16-1TA-C)

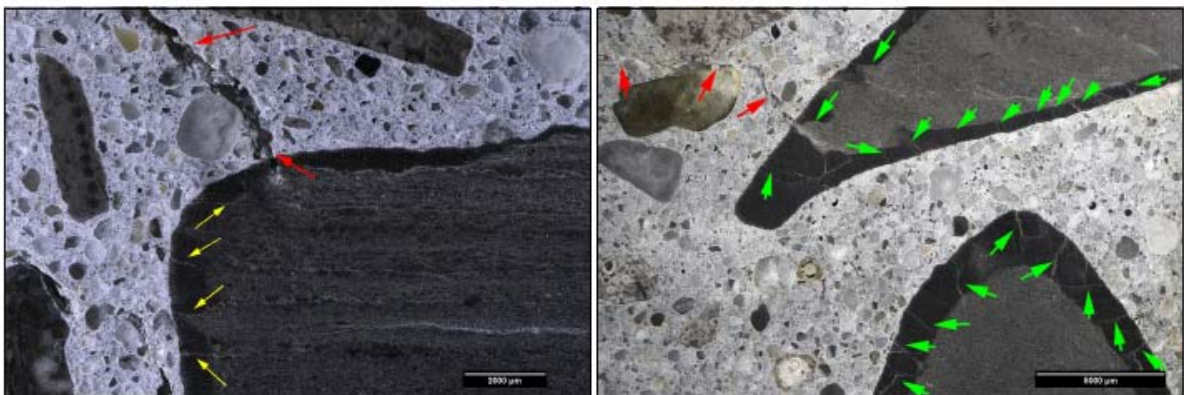
All three cores showed evidence of ACR, but the most advanced evidence was exhibited in Core 3. Numerous limestone particles show microcracking around the perimeter of the aggregate particle (See Figure 2). Yellow and green arrows indicate the microcracking around the perimeter of the aggregate with the red arrows showing cracks cutting from the aggregate into the paste. Figure 3 shows another image of Core 3 with the microcracking and cracking occurring in the paste. Note that the purple arrows show the thickness of the reaction rim of an ACR aggregate.

Figure 2
Images of Core 3 showing perimeter microcracking and cracks cutting into the paste

Being that the evidence strongly indicates that this pavement section is affected by ACR, possible remedies include continued patching efforts and a full-depth replacement of the affected section since ACR cannot be mitigated with an overlay.

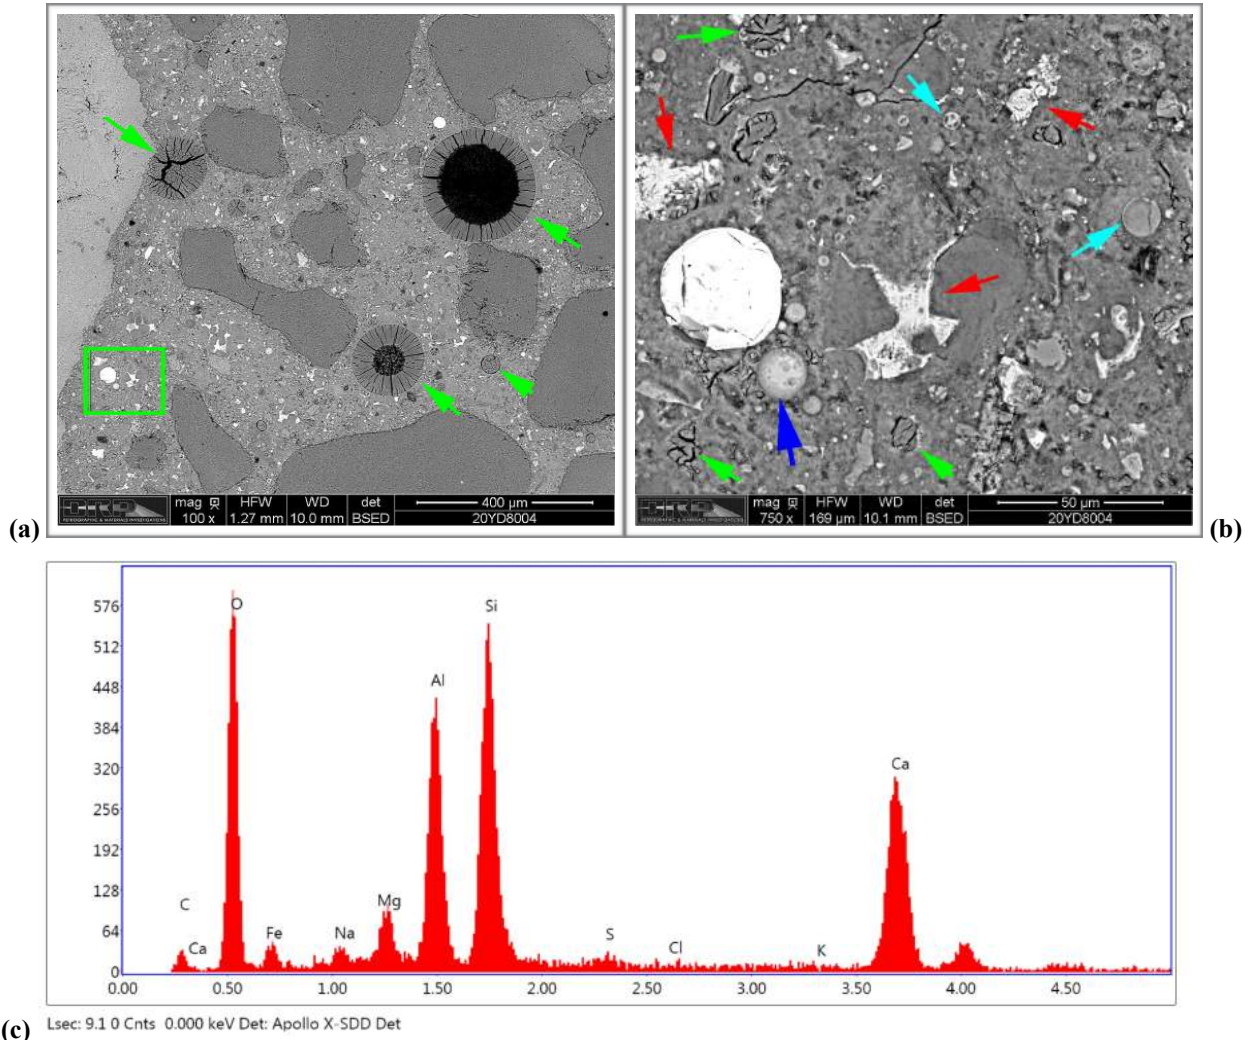
Figure 5. Backscatter electron (BSE) micrographs of paste from Core 3. The green box in (a) shows the area of (b). The green arrows indicate deposits of ettringite in both micrographs and the red and blue arrows in (b) indicate relict and residual cement grains and fly ash, respectively. (c) EDS spectrum obtained from fly ash particle indicated by the darker blue arrow in (b). Note the high peak for calcium (Ca), which is typical of Class C fly ash.

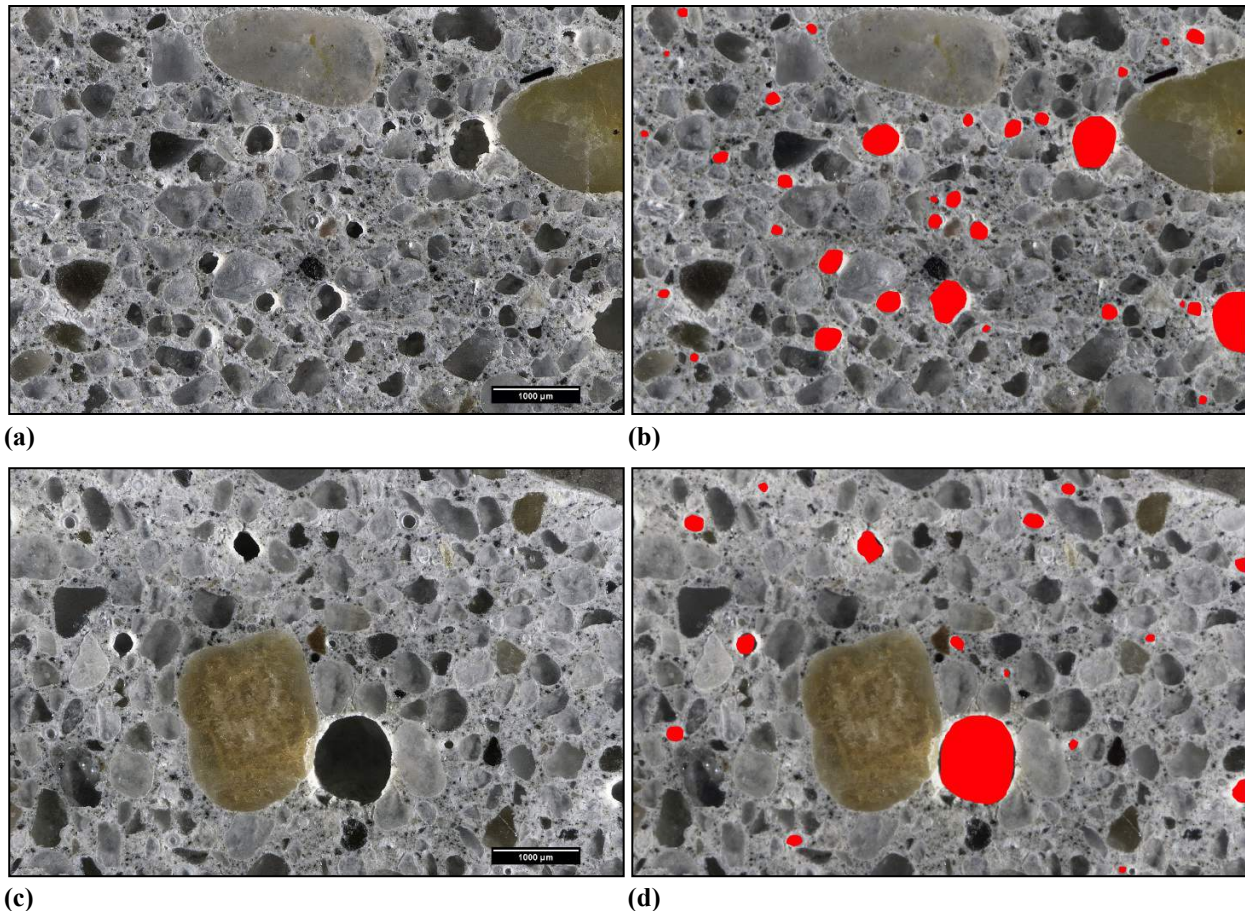
3.3 Components: Air Core 1 and Core 3 show marginal entrainment of air voids where most voids are spherical in shape and less than 1 mm (40 mil) across (**Figure 6**). However, the total air contents, which were estimated at 3-4% from visual and microscopical observations, are well below those typically observed in purposefully air-entrained concrete. Core 2 showed markedly lower air content estimated at less than 2%. However, none of the cores are subjects of a quantitative measurement of hardened air per ASTM C457 [3]. All three cores were well consolidated with no major entrapped air voids, water voids or consolidation voids observed.

Figure 6. Air voids. (a) and (b) are reflected light photomicrographs of the same are of the polished surface of Core 1 showing air voids, which appear as black areas in (a), were filled in with a red marker as shown in (b). The image in (b) was then subjected to image analysis and the red areas make up ~4% of the area. (c) and (d) are reflected light photomicrographs of the same are of the polished surface of Core 3. The air voids, which appear as black areas in (c), were filled in with a red marker as shown in (d). The image in (d) was then subjected to image analysis and the red areas make up ~3% of the area.

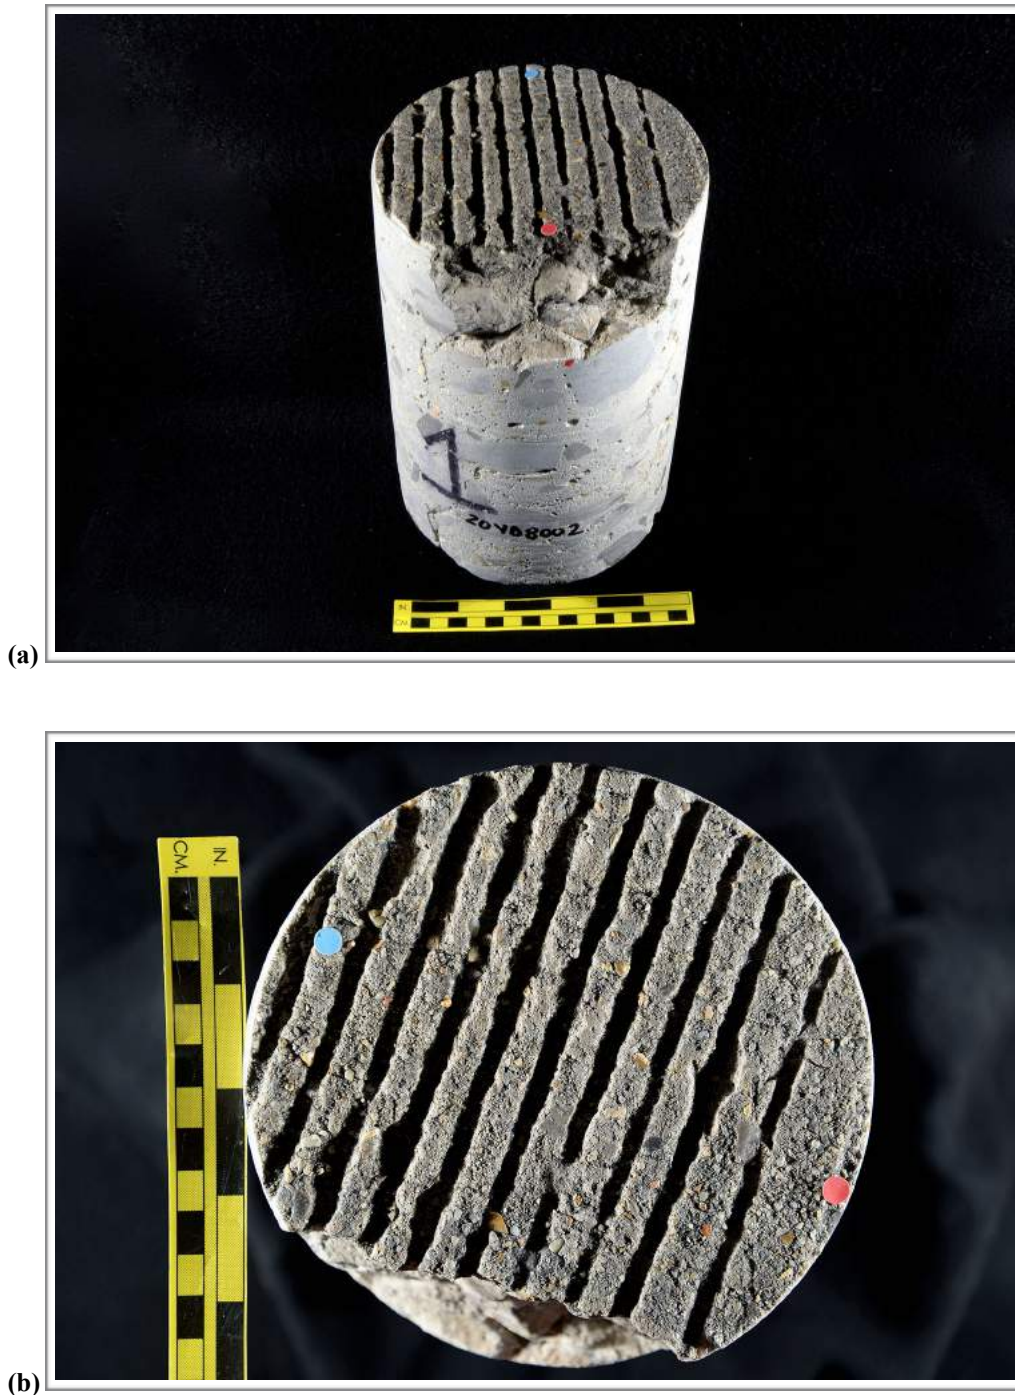
Figure A1. Photographs showing (a) oblique view of the top and side of the core with identification labels and (b) the top of the core. The red and blue dots in (b) show the orientation of the saw cuts used to prepare the sample. The yellow bar is ~ 150 mm (6 in.) long.

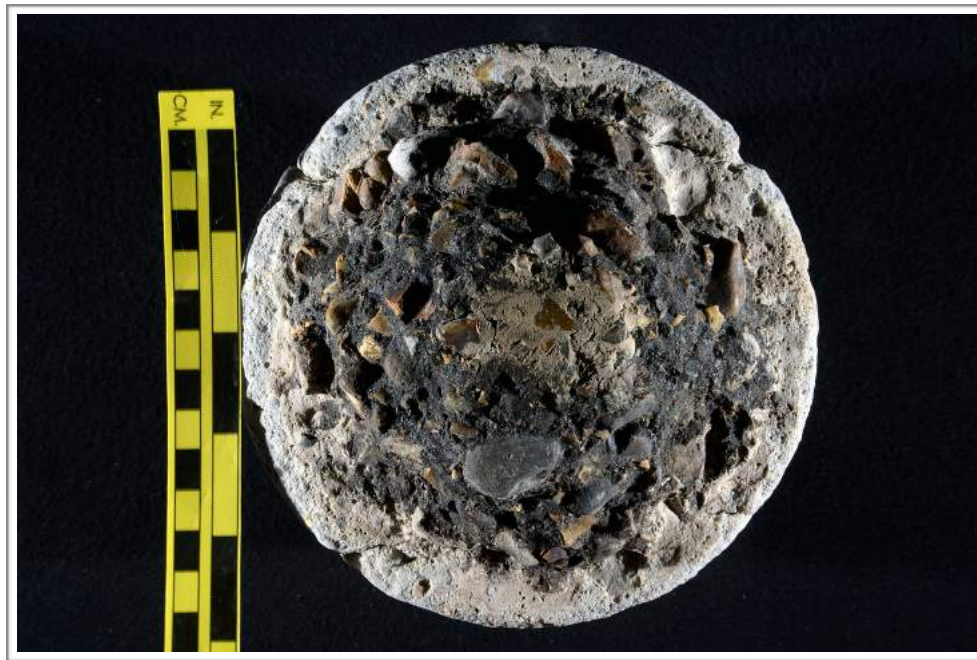
Figure A1 (cont'd). (c) Photograph showing the bottom surface of the core.

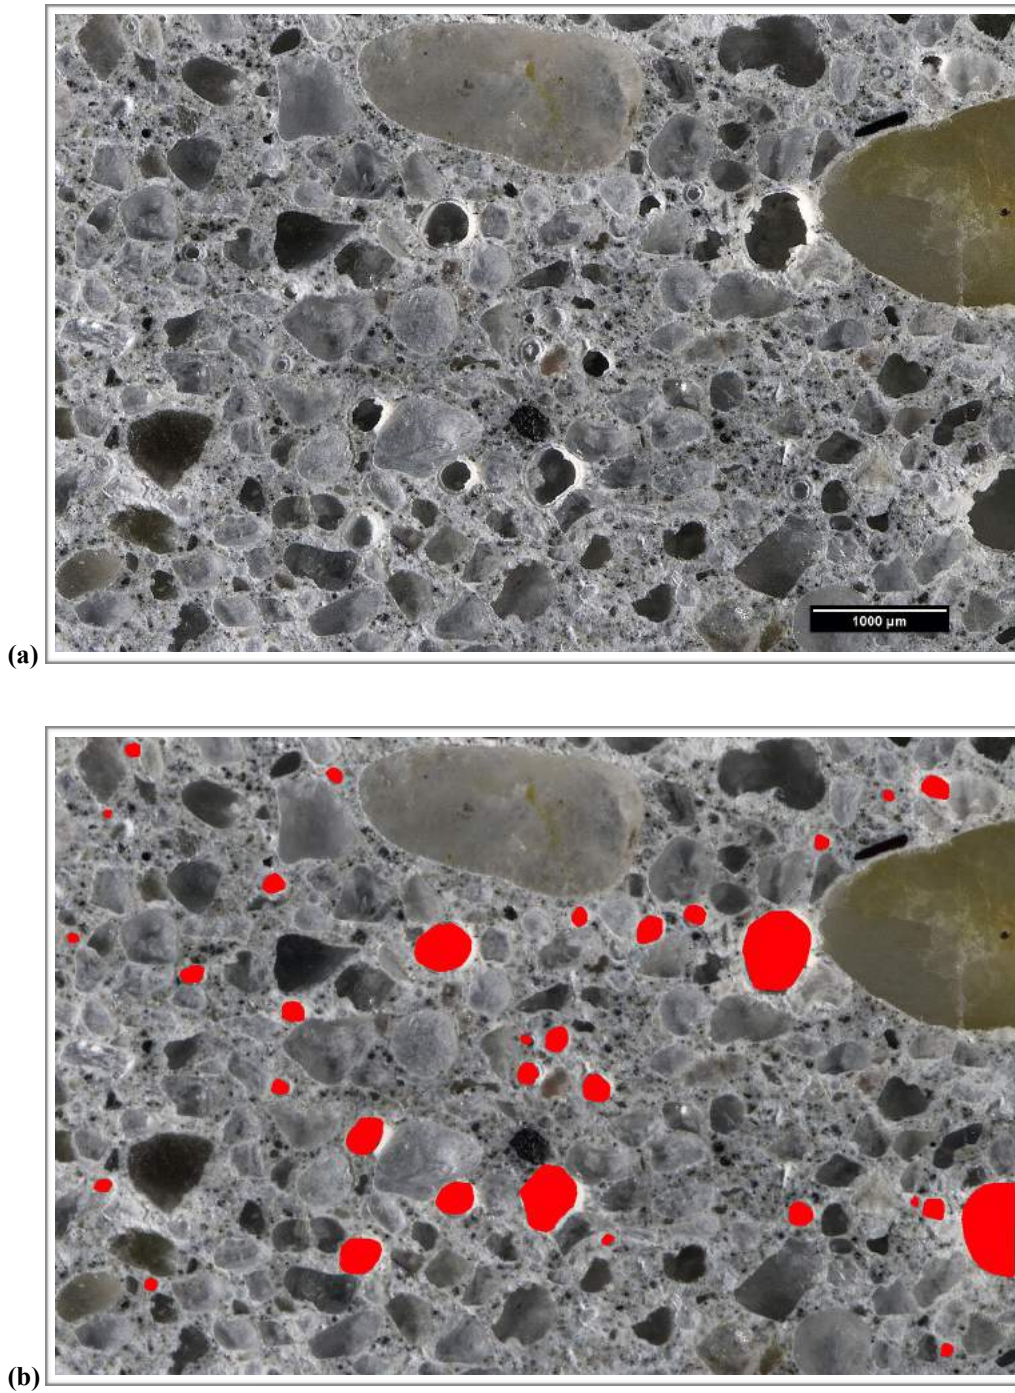
Figure A12. (a) Oblique reflected light photomicrographs of polished surface showing voids (dark circles). (b) Image of same area as (a) where red circles indicate voids. This image was analyzed and found to contain ~ 4% air.

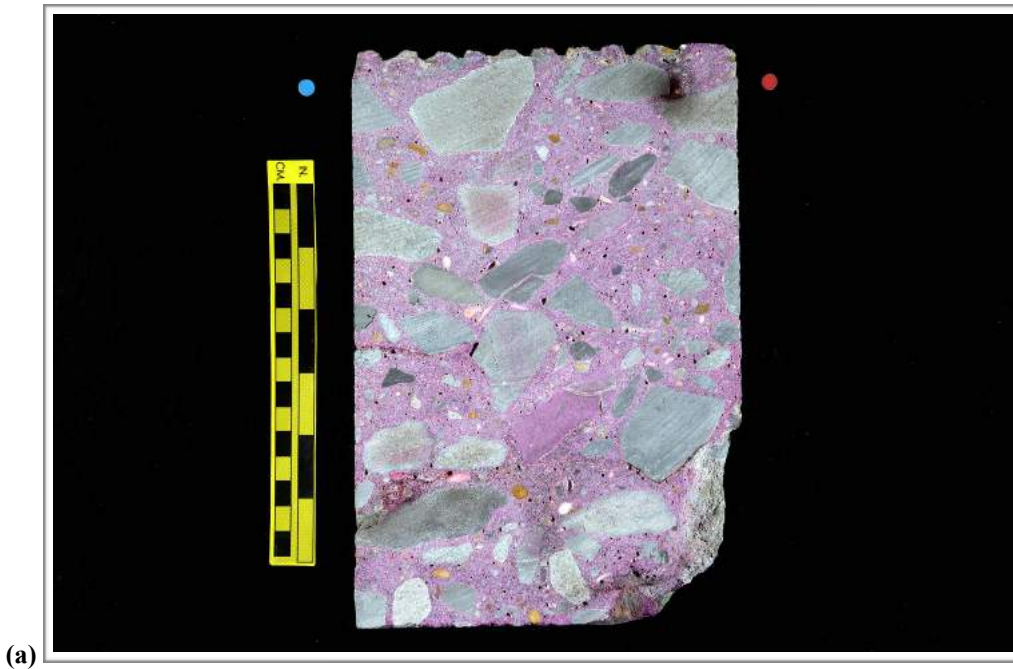
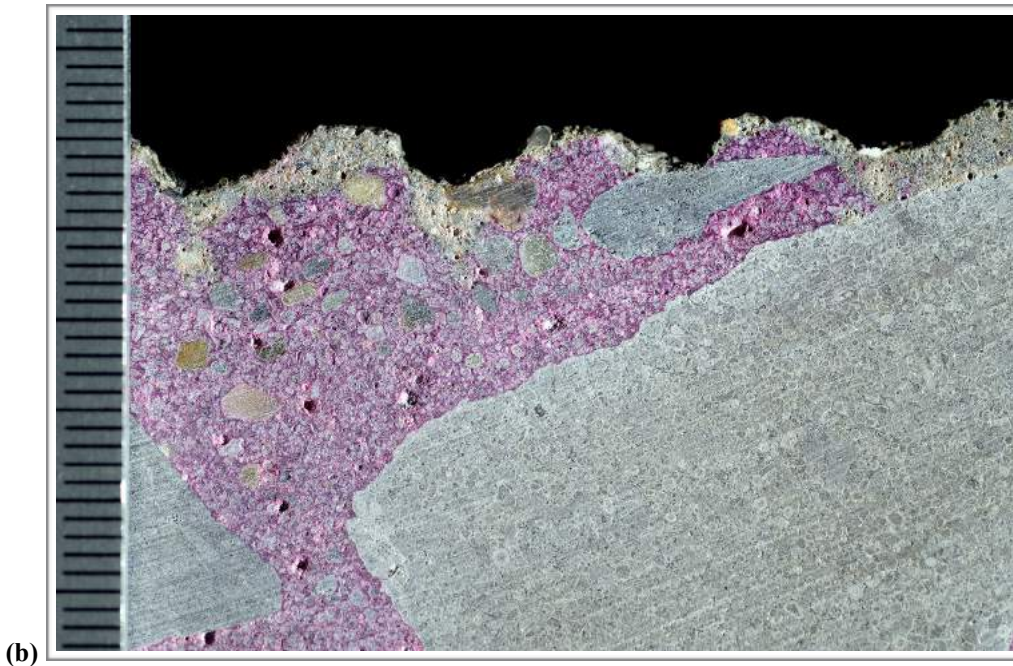
8. SECONDARY DEPOSITS	
PHENOLPHTHALEIN	Entire surface stains purple except along irregular zones (microcracks) at the top of the core where not staining was observed to 6 mm (¼ in.) depth (Figure A19).
DEPOSITS	No significant carbonation observed. Deposits of ettringite observed commonly in voids throughout core and in microcracks that cut through the paste and in the ITZ along aggregate particles (Figure A20). Deposits of ASR gel observed in occasional microcracks, commonly in association with coarse aggregate particles. Occasional cracks and numerous microcracks filled with gel observed cutting from chert particles into the paste (Figure A8, A10, A11, A21). SEM/EDS analysis indicates the gels are richer in calcium than alkali, suggesting they are mature (Figure A22, A23).

Figure A19. Photographs showing (a) overview of phenolphthalein stained surface and (b) detail of surface near the top of the core. Scale in millimeters in (b).

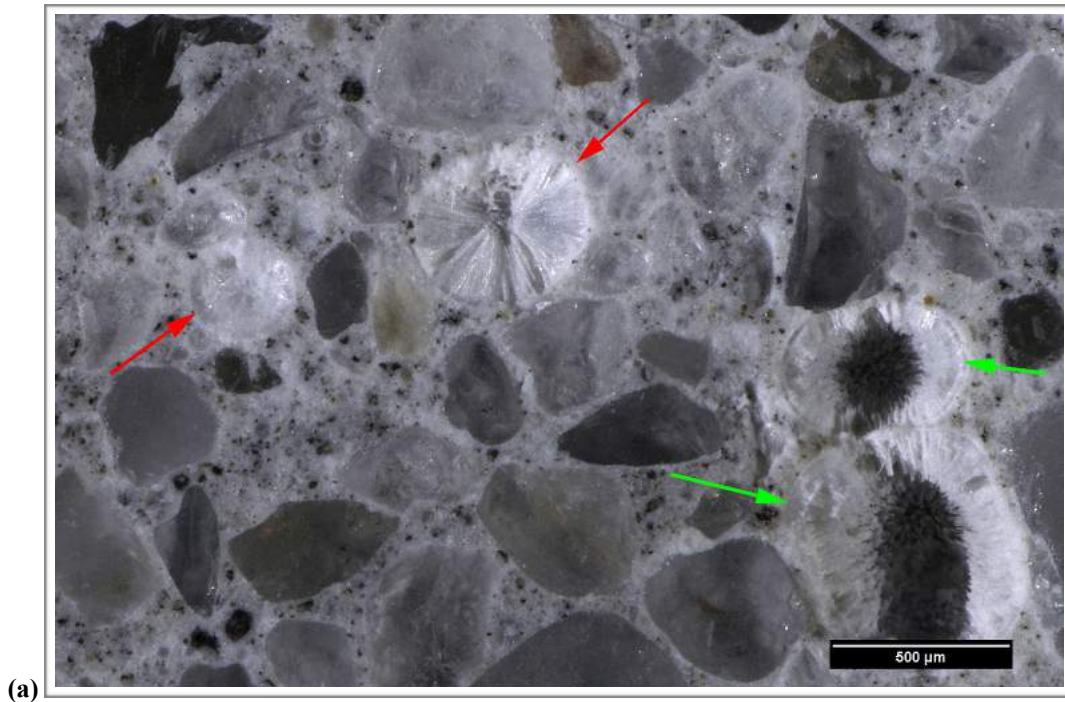
Figure A20. (a) Reflected light photomicrograph of the polished surface showing deposits of ettringite filling voids (red arrows) and lining voids (green arrows). (b) Cross-polarized transmitted light photomicrograph of thin section showing voids lined and filled with ettringite (red arrows).

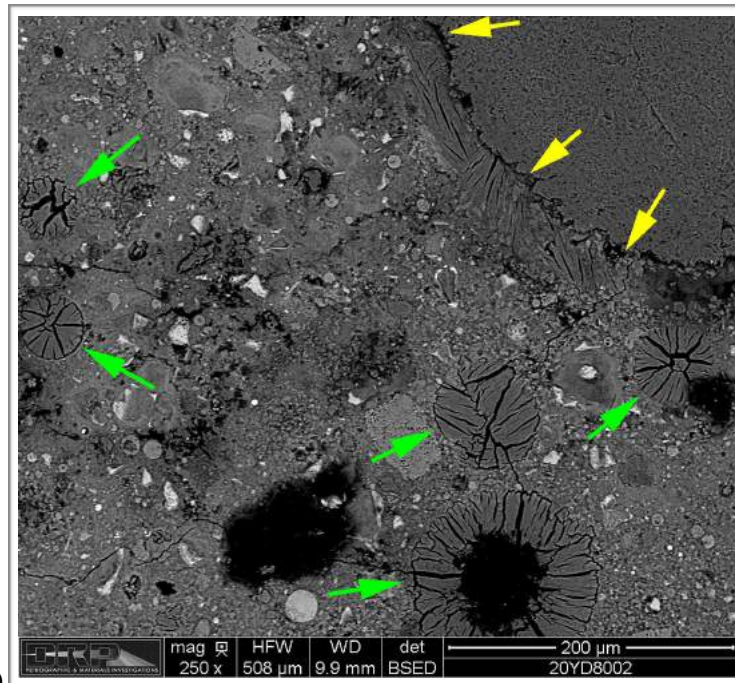
Figure A20 (cont'd). (c) Cross-polarized transmitted light photomicrograph of thin section showing microcrack with deposits of ettringite (yellow arrows) being replaced by calcium carbonate (green arrows). (d) BSE micrograph of polished surface showing ettringite in voids (green arrows) and along the ITZ of an aggregate particle (yellow arrows).

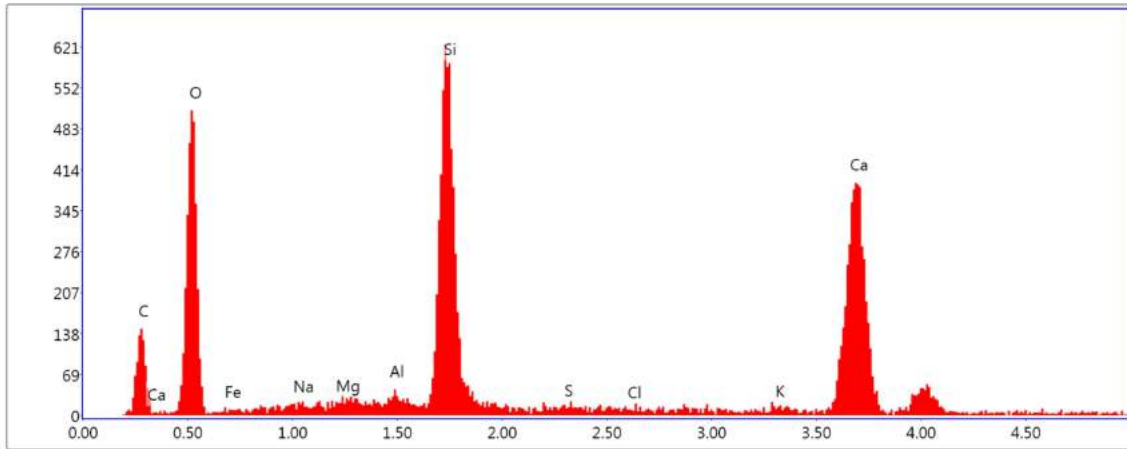
Figure A21. (a) BSE micrograph of gel in microcrack shown in Figure A8. The red dot in (a) shows area subject to EDS analysis that produced the spectra shown in (b). Similar spectra were obtained for the gel when it was scraped from the surface and analyzed separately. Note the high calcium content of the gel.

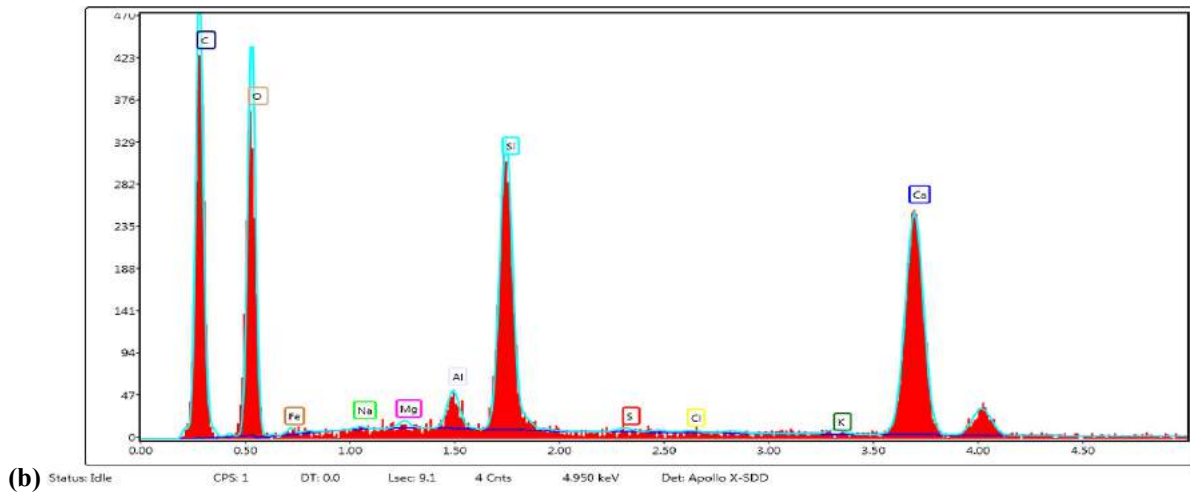
Figure A23. (a) Combined BSE and secondary electron micrograph of gel that was scraped from microcrack shown in Figure A11 and placed on a carbon tape for EDS analysis. (b). EDS spectra obtained for the gel. Note the high calcium content of the gel.

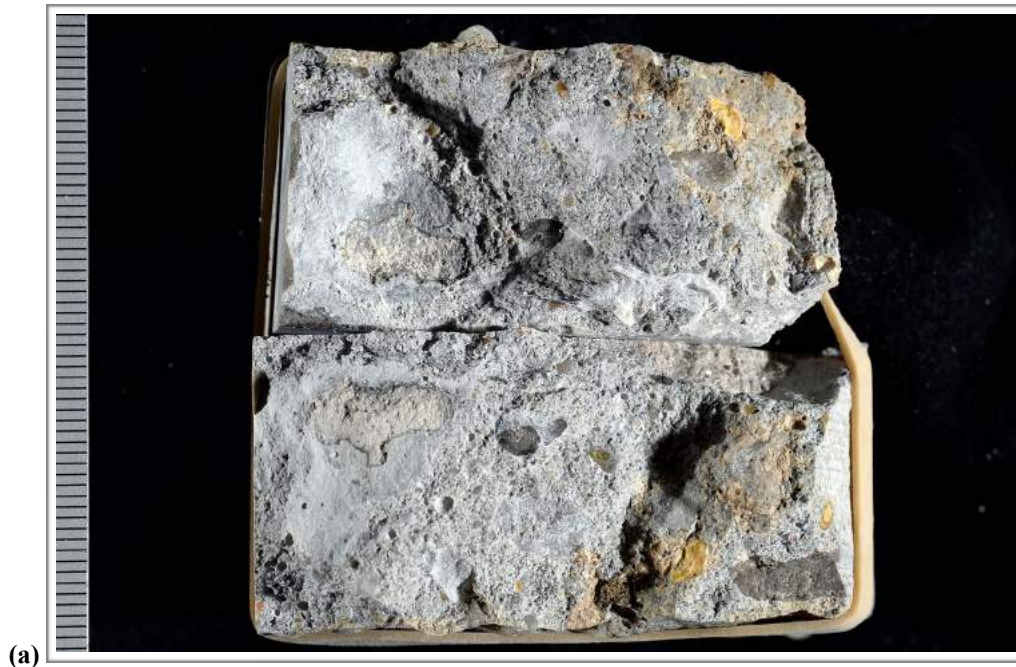
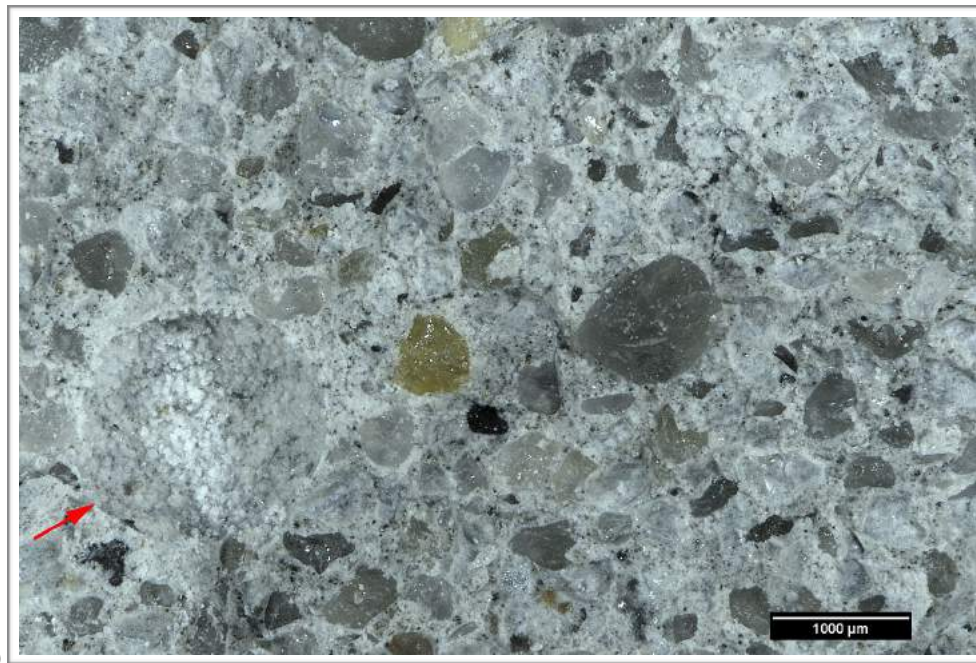
Figure B16. (a) Photograph and (b) reflected light photomicrograph of fresh fracture surface. The scale is in millimeters in (a). In (b) the red arrow shows a void with ettringite.

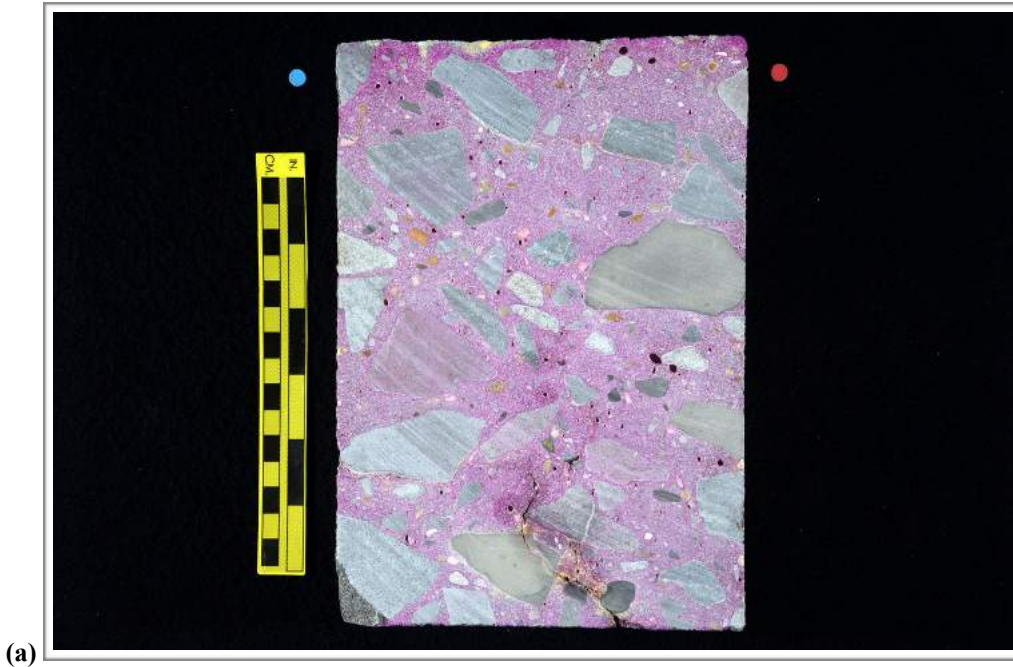
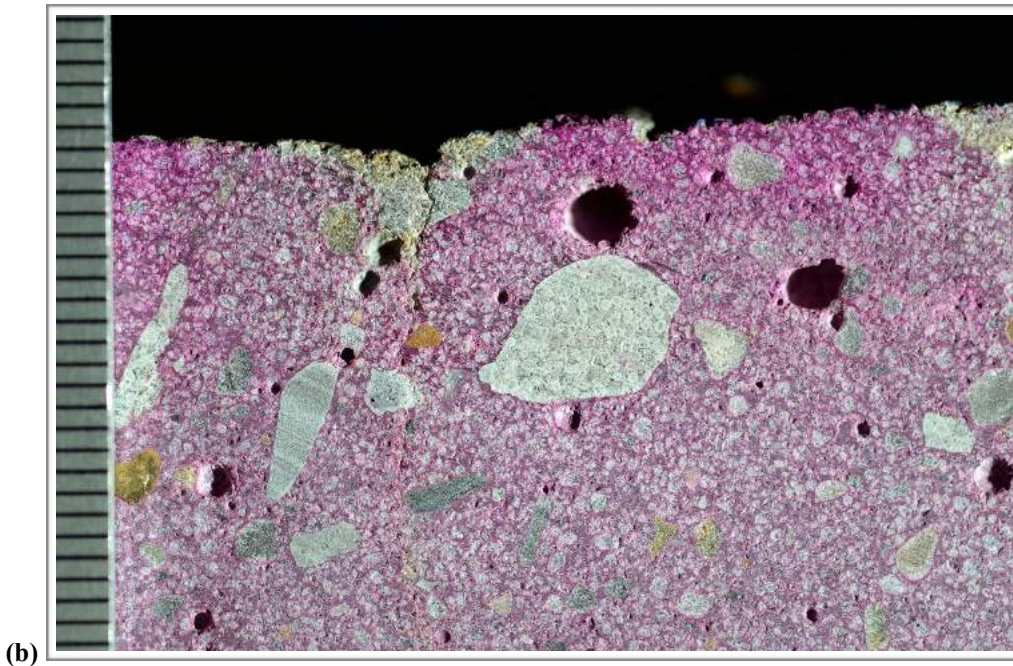
8. SECONDARY DEPOSITS	
PHENOLPHTHALEIN	Entire surface stains purple except along irregular zones (microcracks) at the top of the core where not staining was observed to 6 mm (¼ in.) depth (Figure B19).
DEPOSITS	No significant carbonation observed. Minor deposits of ettringite observed in occasional voids and microcracks (Figure B20). Traces of gel observed but much less gel than in Core C-1. A few cracks cut from limestone particles with peripheral microcracking into the paste (Figure B21). Minor deposits of Mg-rich material detected by EDS around some limestone particles with peripheral microcracking (Figure B22).

Figure B19. Photographs showing (a) overview of phenolphthalein stained surface and (b) detail of surface near the top of the core. Scale in millimeters in (b).

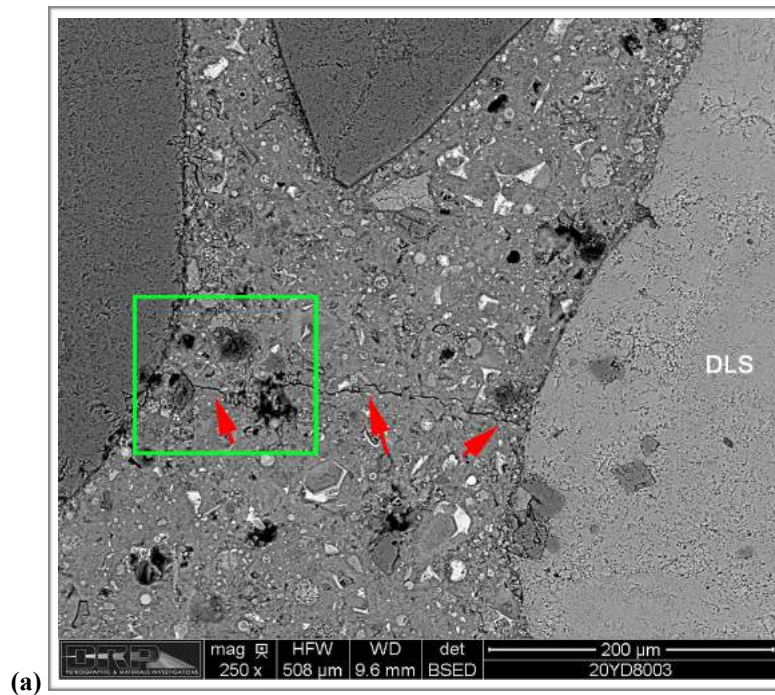
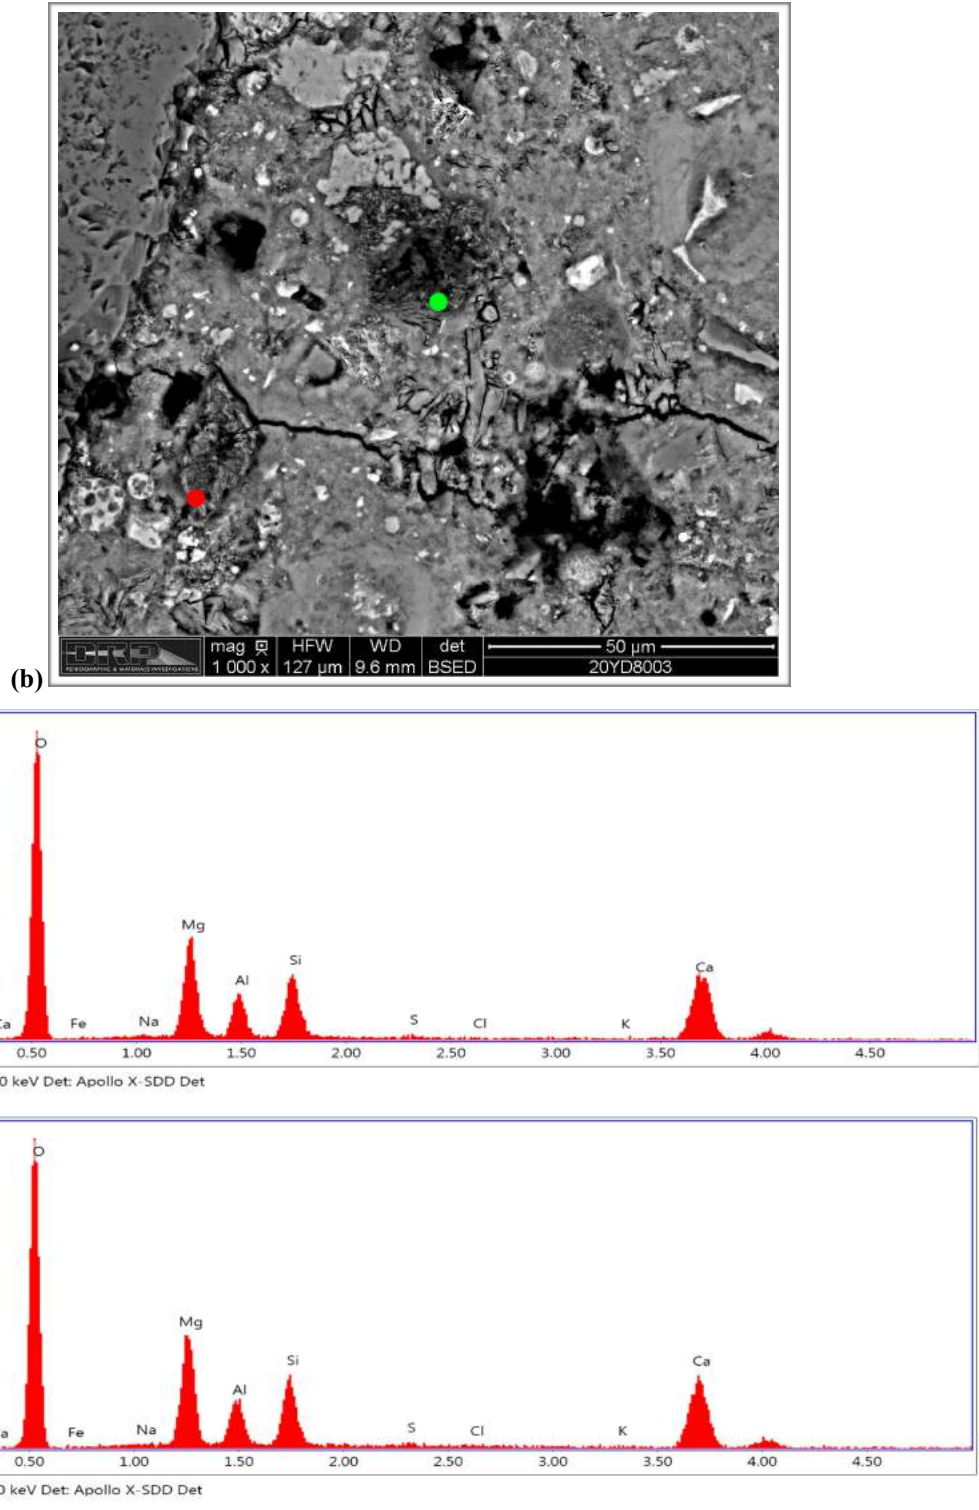
Figure B22. (a) BSE micrograph of polished surface showing location of area where EDS analyses were performed. The green box shows the area of (b). The red arrows indicate a microcrack that cut from the dolomitic limestone particle (DLS) on the right side of the image.

Figure B22 (cont'd). (b) BSE micrograph of polished surface showing location of EDS analyses. (c) and (d) are EDS spectra obtained from areas indicated by the red and green dots, respectively. These spectra show much higher concentrations of magnesium (Mg) than other areas, suggesting mobilization of Mg consistent with alkali-carbonate reaction.

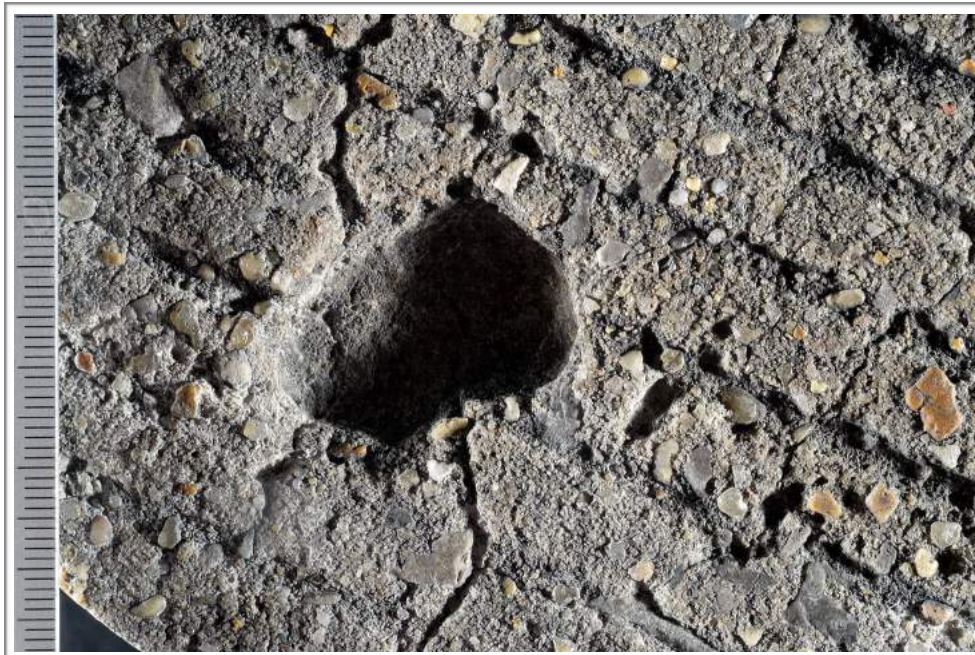
1. RECEIVED CONDITION	
ORIENTATION	Vertical core through pavement slab measures 150 mm (6 in.) in diameter and 225 mm (~ 9 in.) in length (Figure C1, C2).
SURFACES	The top surface is tined and worn with exposed fine aggregate particles on the surface (Figure C3) and the lower surface is cast on asphalt such that the core represents the full thickness of the portland cement concrete pavement.
GENERAL CONDITION	The concrete is hard and compact and rings lightly when sounded with a hammer. A pit measuring ~ 19 x 35 mm ($\frac{3}{4}$ -1 $\frac{3}{8}$ in.) in area is present on the top surface (Figure C4).

Figure C4. Photograph of top of core showing pit; scale in millimeters.

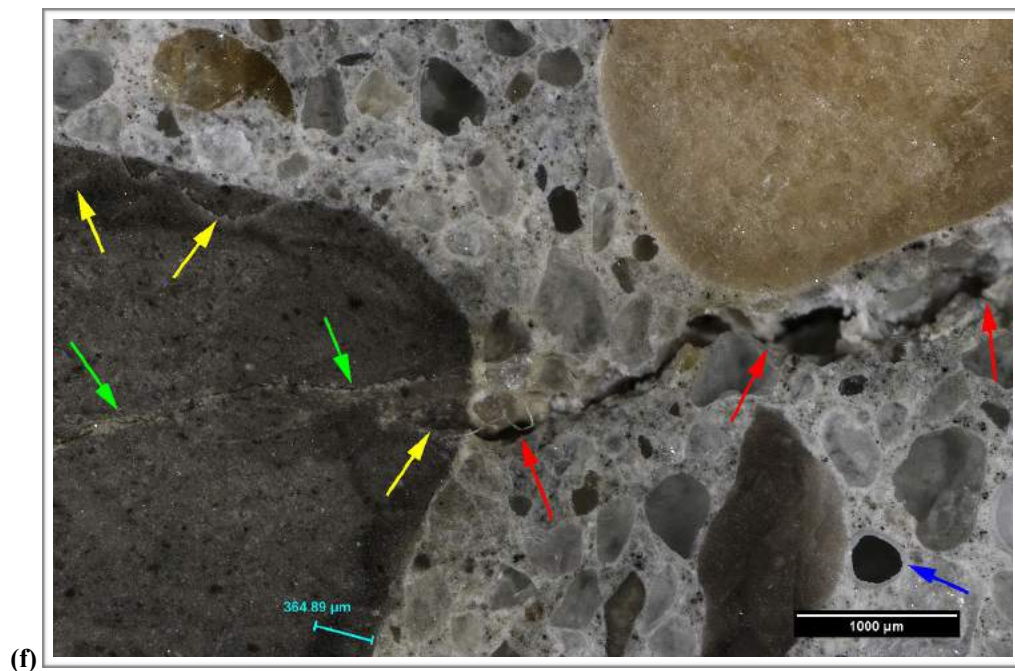
Figure C9 (cont'd). Reflected light photomicrographs of the polished surface showing microcracks (red arrows) that cut from dolomitic limestone particles into the paste about (e) 150 mm (6 in.) and (f) 165 mm (6 ½ in.) below the top surface. In (e) green arrows indicate peripheral microcracks that are mostly orthogonal to the perimeter of the particle. In (f) the yellow arrows indicate peripheral microcracks and the green arrow indicates an internal microcrack. The blue bar in (f) measures the width of a reaction rim and the blue arrow highlights a void lined by ettringite.

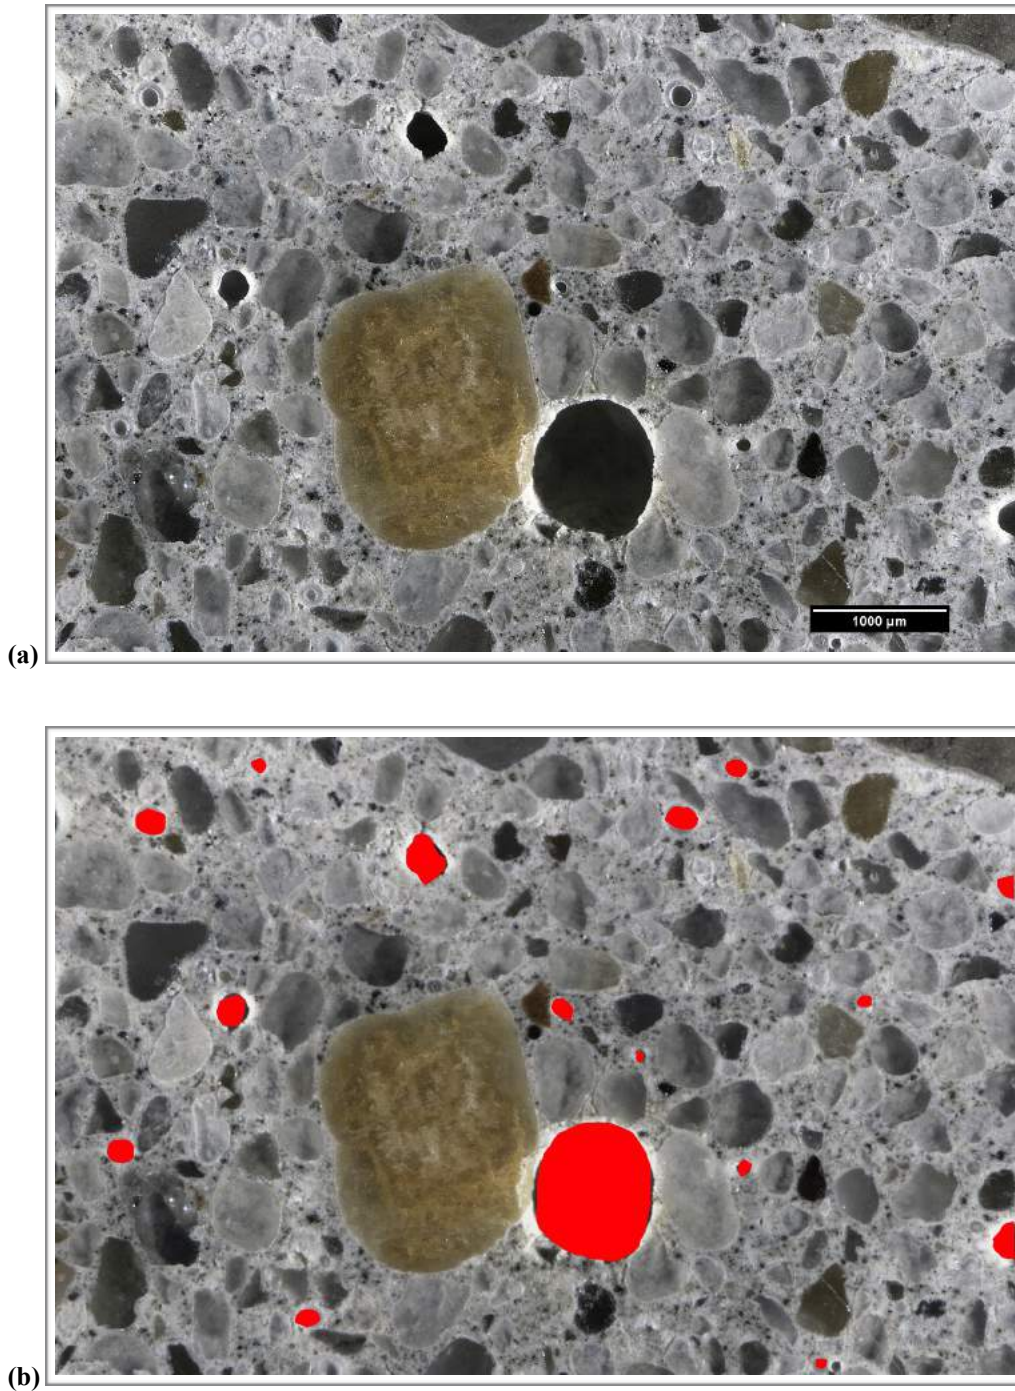
4. VOIDS	
VOID SYSTEM	Concrete is marginally air-entrained and contains ~ 3% total air as estimated from visual and microscopical observations (Figure C10). The concrete is well consolidated with no significant entrapped voids or water voids observed.
VOID FILLINGS	Voids commonly contain deposits of ettringite that rim and fill the voids.

Figure C10. (a) Oblique reflected light photomicrographs of polished surface showing voids (dark circles). (b) Image of same area as (a) where red circles indicate voids. This image was analyzed and found to contain ~ 3% air.

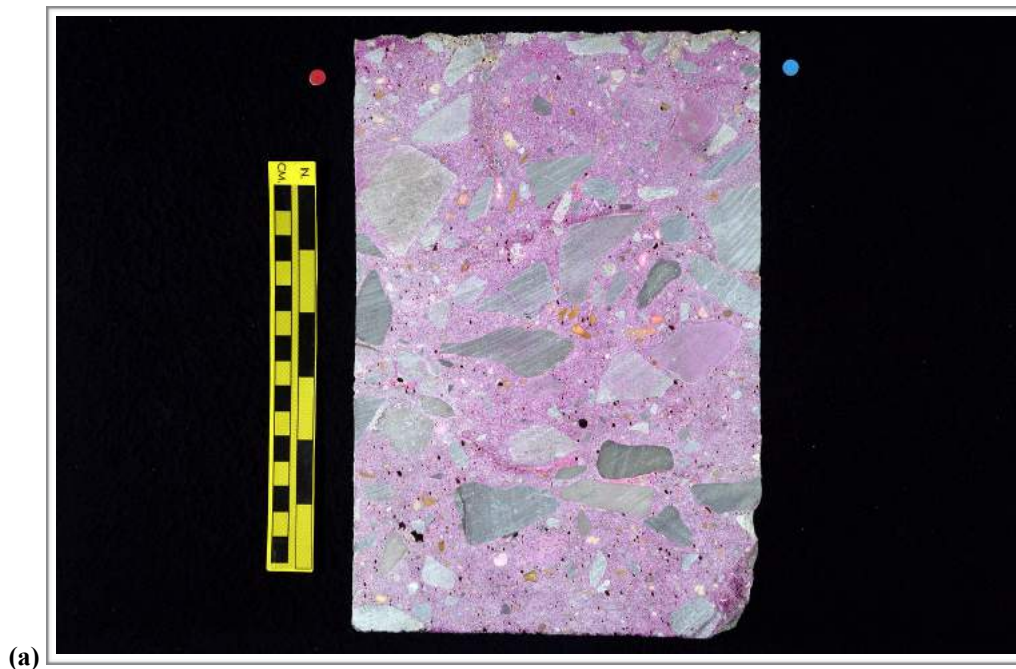
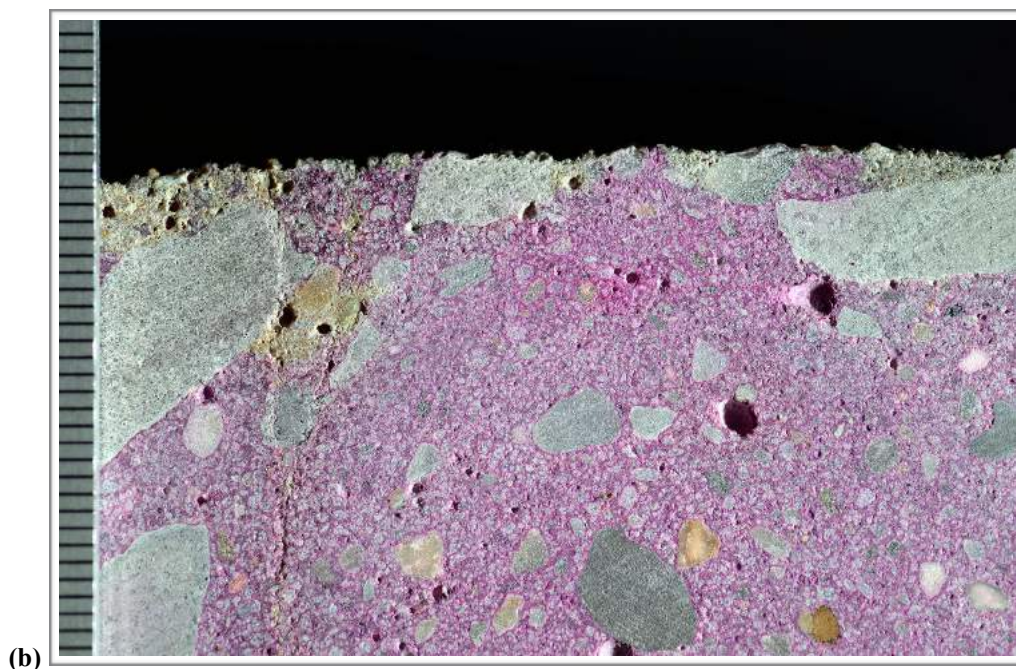
PHENOLPHTHALEIN	Entire surface stains purple except along irregular zones (microcracks) at the top of the core where not staining was observed to 6 mm (¼ in.) depth (Figure C17).
DEPOSITS	No significant carbonation observed. Minor deposits of ettringite observed in occasional voids (Figure C18). Deposits of ASR gel observed in ITZ of occasional aggregate particles and in occasional voids (Figure C19, Figure C20).

Figure C17. Photographs showing (a) overview of phenolphthalein stained surface and (b) detail of surface near the top of the core. Scale in millimeters in (b).
