Louisiana Transportation Research Center

Technical Assistance Report 16-03TA-C

Evaluation of Cores from Jefferson Highway Near Airline Highway

Petrographic Investigation of Concrete Cores Extracted from Cracked
Pavement Slabs on Jefferson Highway in Baton Rouge, Louisiana
(RE: LTRC Project 16-1TA-C)

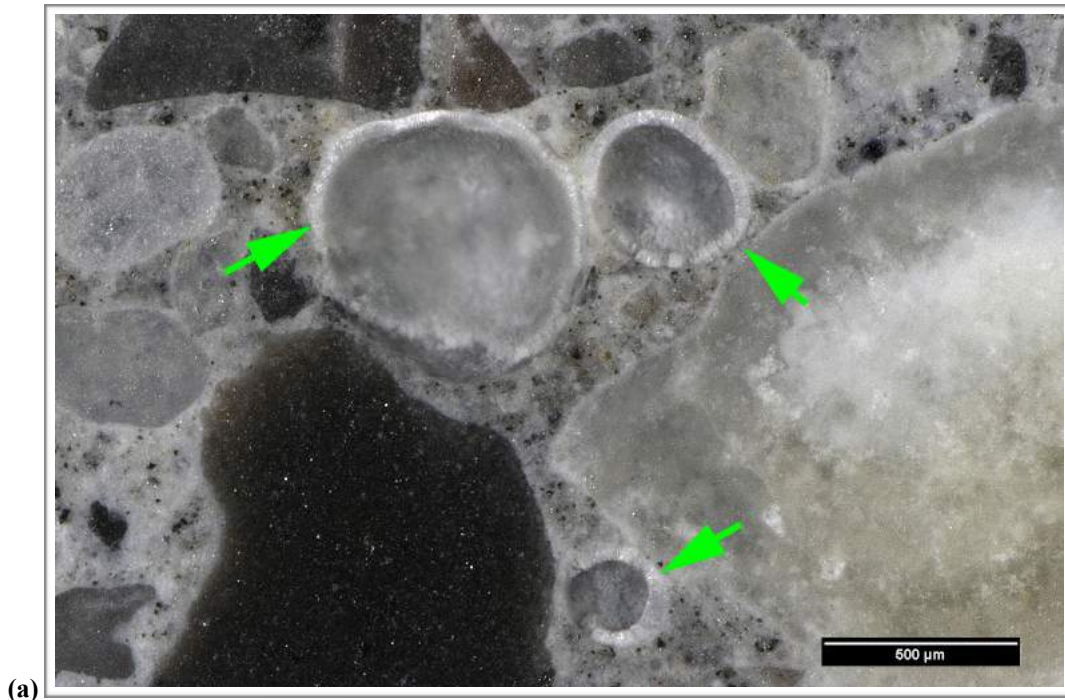
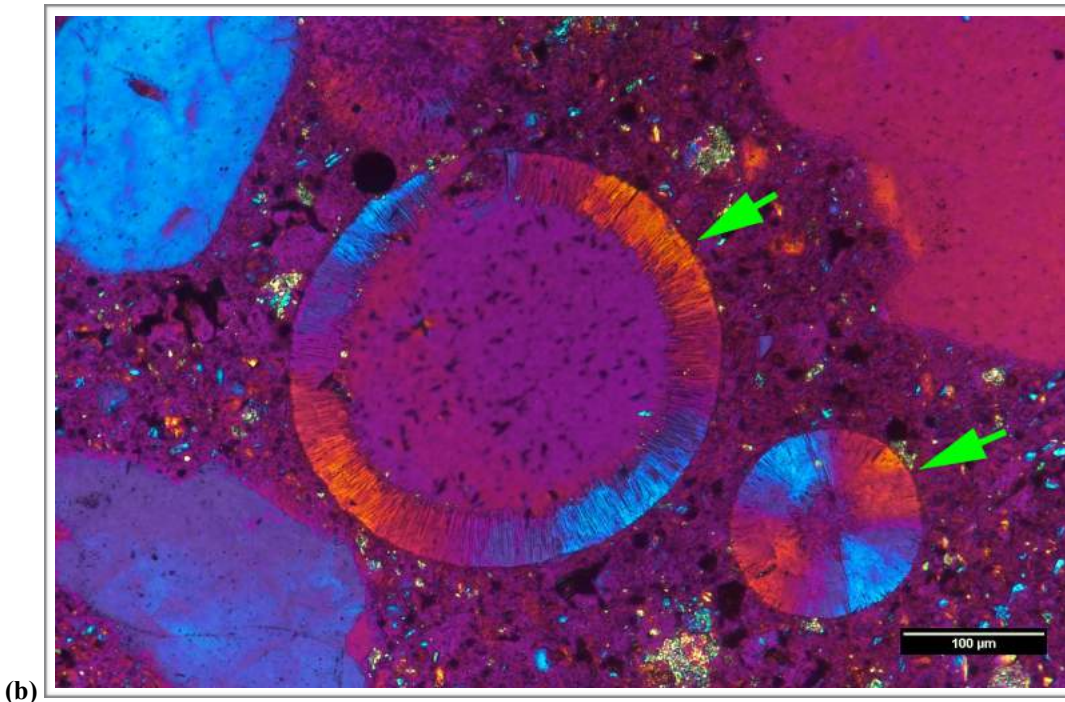
PHENOLPHTHALEIN	Entire surface stains purple except along irregular zones (microcracks) at the top of the core where not staining was observed to 6 mm (¼ in.) depth (Figure C17).
DEPOSITS	No significant carbonation observed. Minor deposits of ettringite observed in occasional voids (Figure C18). Deposits of ASR gel observed in ITZ of occasional aggregate particles and in occasional voids (Figure C19, Figure C20).

Figure C18. (a) Reflected light photomicrograph of the polished surface showing deposits of ettringite lining voids (green arrows). (b) Cross-polarized transmitted light photomicrograph of thin section with gypsum plate inserted showing voids lined with ettringite (green arrows).
