1. Report No. FHWA/LA.03/378	2. Government Accession No.	3. Recipient's Catalog No.
4. Title and Subtitle Monitoring of the Bonnet Carré Spillway Bridge During Extreme Overload	5. Report Date October 2003

Monitoring of the Bonnet Carré Spillway Bridge During Extreme Overload

LTRC Project No. 03-6ST

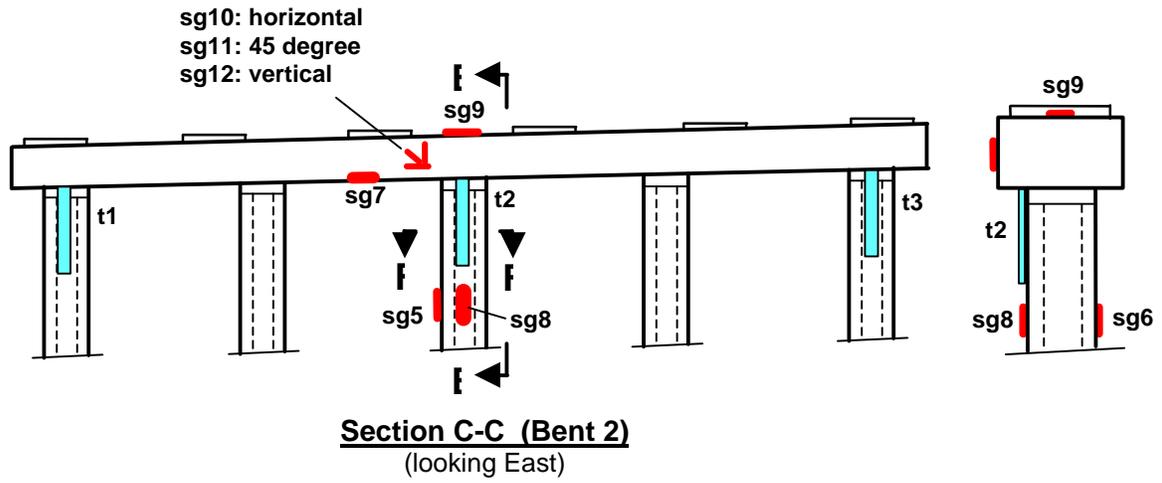
Figure 10
Strain gauge and target numbering (bent 2)

Gauge 7 was placed in the positive moment region of the pile cap of bent 2. The location of this gauge is shown in figure 10. This gauge malfunctioned prior to the passage of the overload. Time did not allow for weatherproofing of this gauge.

Gauges 10 and 12 of the shear rosette on the pile cap of bent 2 (gauges 10, 11 and 12) malfunctioned (locations shown in figure 10). Therefore, the results from this rosette could not be used. Time did not allow for weatherproofing of these gauges, which may have been the source of the problem. A similar rosette was placed in a similar location on bent 1 prior to the passage of the overload. The results from this rosette are described below.

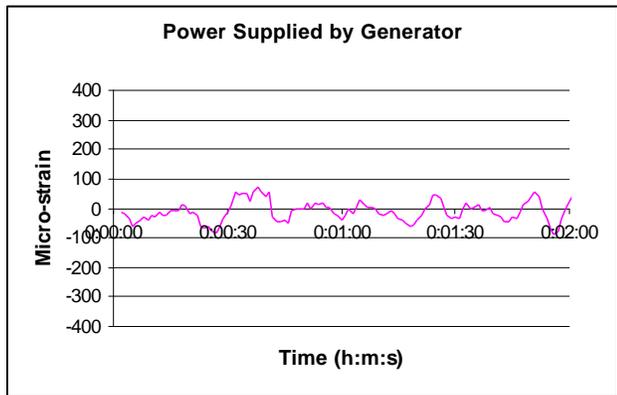
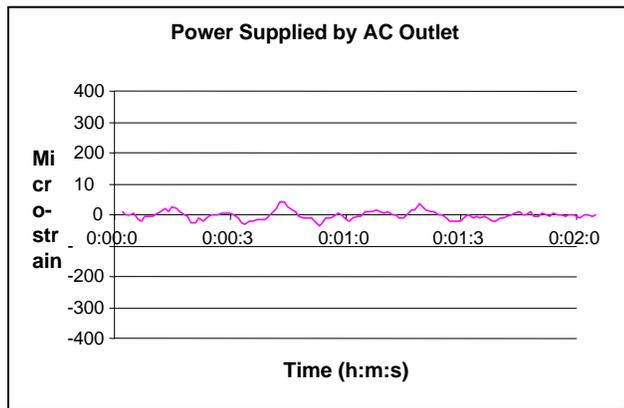
Figure 15
Interference due to portable generator

The effect of providing power to the data acquisition system with a portable generator was investigated in a separate test. For this investigation, 80-foot long wire runs of 18-gauge wire were connected to two strain gauges. One gauge was mounted on a small (1 in by 7 in by 3/8 in fiber-reinforced polymer specimen with Devcon epoxy while the other gauge was mounted to the same specimen with AE-10 adhesive. Strains were then monitored under a condition of no load for a period of two to three minutes. The results of this investigation are shown in figure 15. Some background noise was noticed in the 70-foot run of wire when power was provided from the wall outlet. This noise typically stayed in the range of ± 30 micro-strain. A significant amount of background noise occurred when the power was provided by the

portable generator. This noise lied, for the most part, in the range of ! 100 micro-strain. The noise experienced by the portable generator shows greater variability when compared to the noise data gathered during the wall outlet investigation.

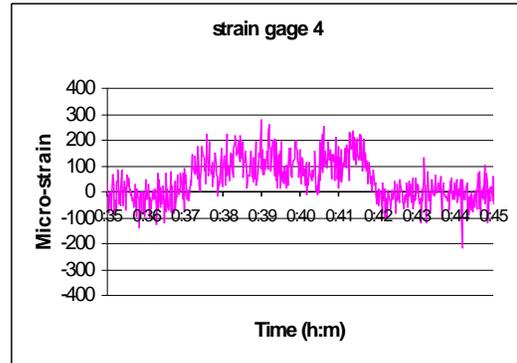
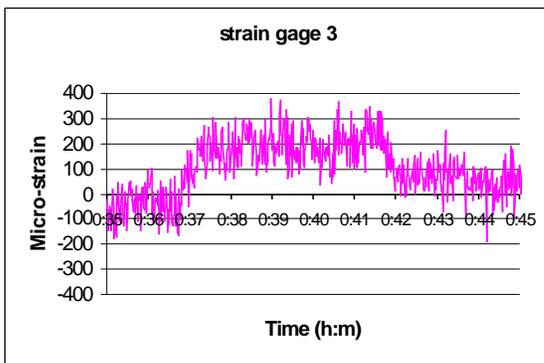
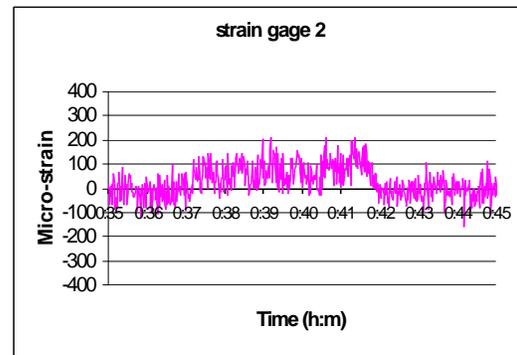
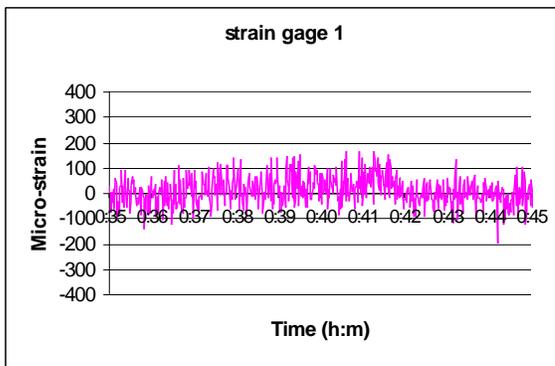
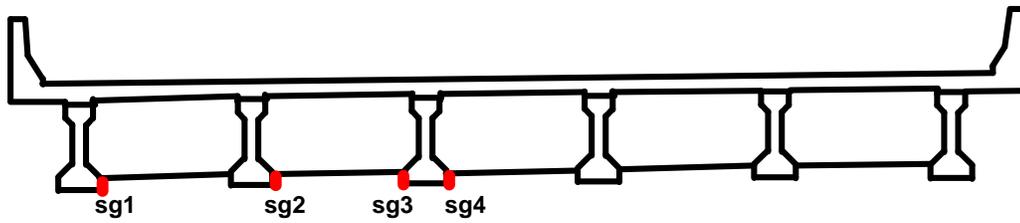
Figure 19
Actual results for strain gauges 1-4 (midspan of girders)

strains on the innermost girder (gauges 3 and 4) are of similar magnitude, however gauge 3 recorded slightly higher strains than gauge 4. This is to be expected even though these gauges are placed on opposite sides of the same girder. Reasons for disagreement between the two gauges include misalignment of gauge 4, heterogeneity of the concrete, and the possible presence of micro-cracks crossing gauge 3 but not gauge 4. The maximum recorded strain due to the overload in these locations occurred in gauge 3 and was approximately 300 micro-strain (micro-strain is defined as engineering strain $\times 10^{-6}$). This compares to the value of approximately 100 micro-strain recorded in the outer girder by gauge 1. With the exception of gauge 3, all of the gauges began in the zero position prior to the load and returned to the zero position after the load passed. Gauge 3, however, began slightly below zero and returned to a reading of slightly above zero after the load passed. This may indicate the malfunction of this gauge or the development of a crack during the passage of the load. The results from this set of gauges (1, 2, 3 and 4) are considered to be the most reliable due to the fact that these were weatherproofed, and, thus, there was no adverse effect of moisture due to weeping as was the case for most of the other gauges.

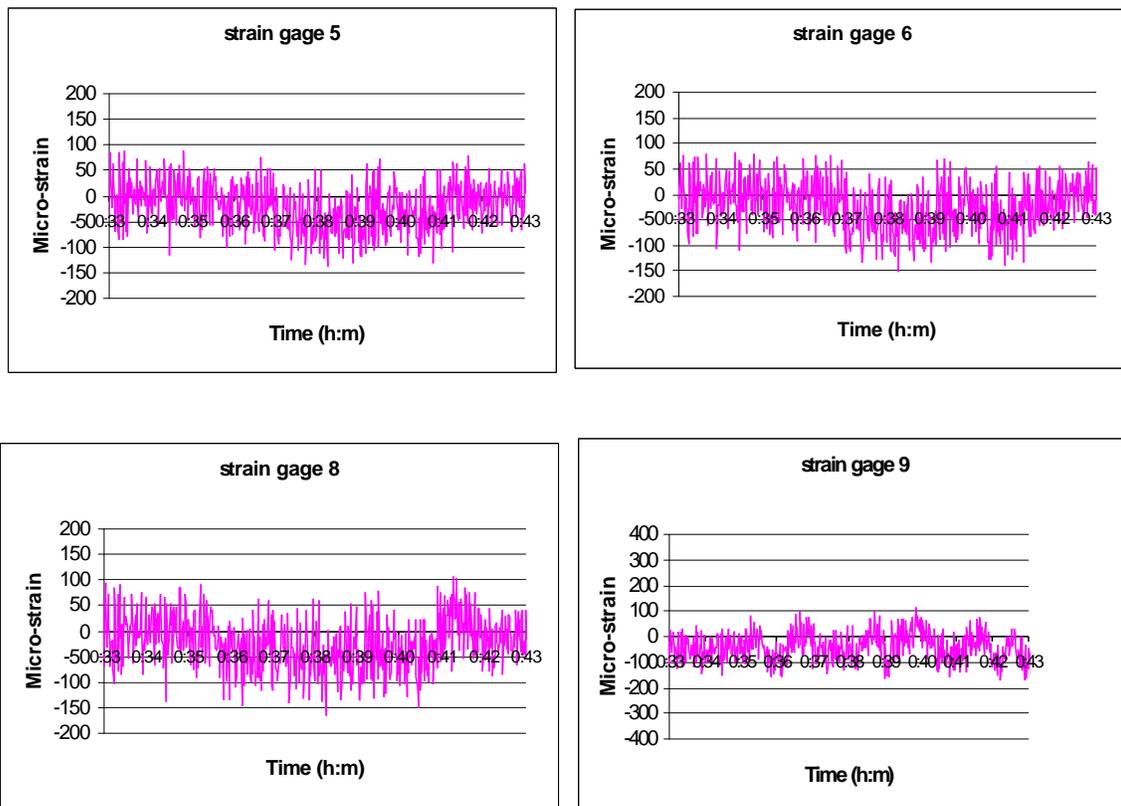
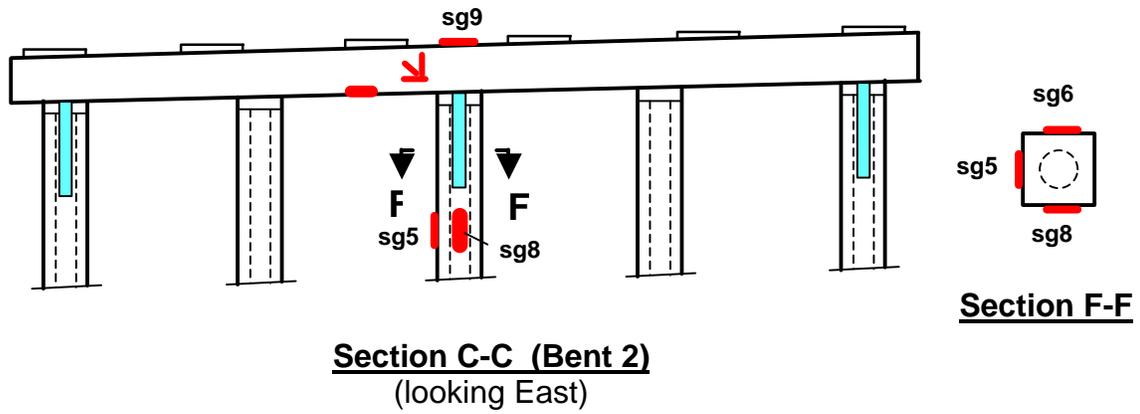
Figure 21
Actual results of strain gauges 5,6,8, and 9 (bent 2)

The recorded results for the strains during the passage of the overload at gauge locations 5, 6, 8 (central pile of bent 2), and 9 (negative moment region of the pile cap of bent 2) are shown in figure 21. The smoothed results for the same gauge locations are shown in figure 22. Figure 22 gives a clearer picture of the strain gauge data. The locations of these gauges are shown in Figure 10. These results are plotted for the time span of 33 to 43 minutes after the start of data acquisition. Regarding the recorded strains on the central pile, the strains are negative as expected due to compression in the pile. If the strains from gauge 6 and 8 are compared at similar times, some evidence of bending about the axis of the pile cap can be inferred. The maximum recorded strain on the central pile occurred in gauge 9 and was approximately 100 micro-strain (negative). Similar maximum values were obtained from gauges 6 and 8. All three gauges began in the zero position and returned to the zero position once the load had passed. The results from this set of gauges are believed to be reliable because those gauges were weatherproofed and the data were generally inspected. The readings from gauge 9 (negative moment region on pile cap of bent 2) alternate between positive and negative. The readings contradict the expected results of positive or zero micro-strain in all cases. Gauge 9 begins at approximately 50 micro-strain (negative) and does not return to this value or to zero after the load has passed. Based on this behavior the results from this gauge are not considered.

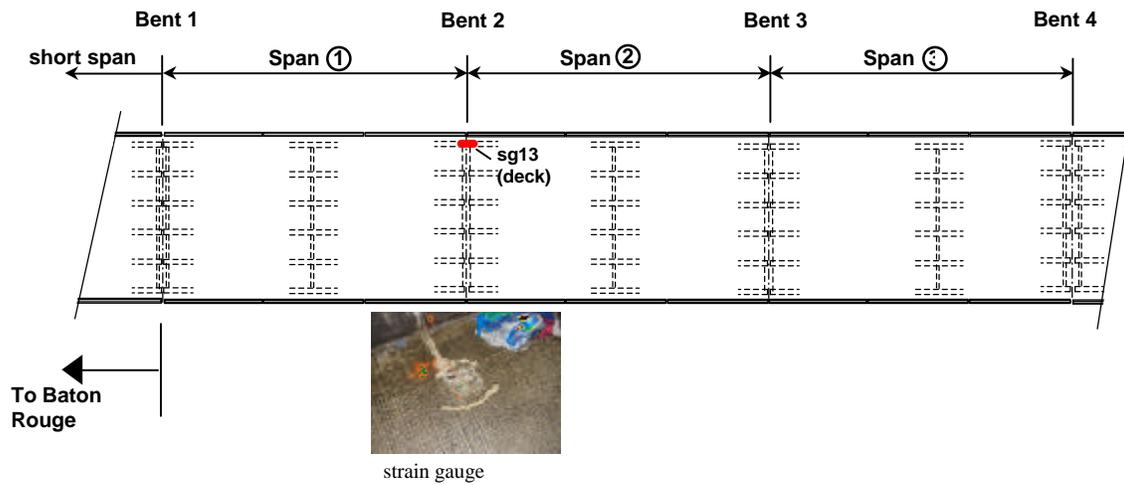
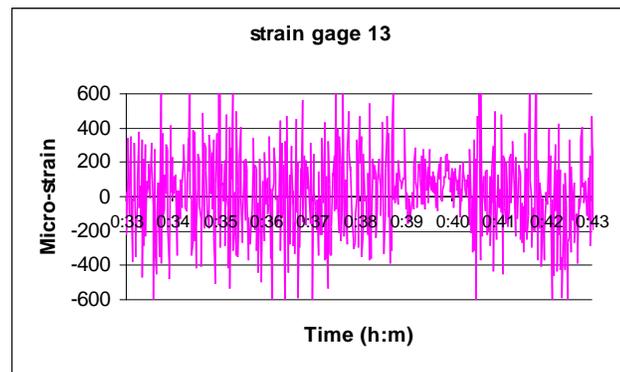
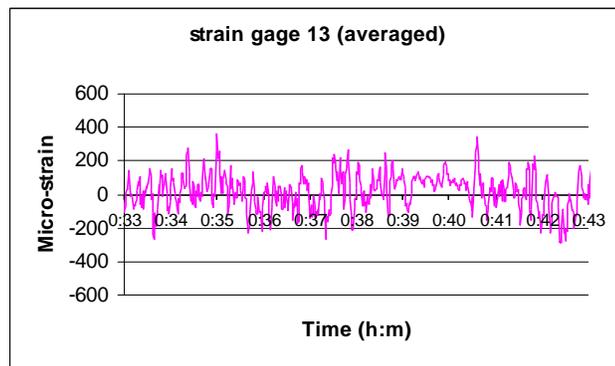
Figure 23
Actual and smoothed results for strain gauge 13 (in deck over bent 2)

The recorded results for the strains during passage of the overload at gauge location 13 (gauge placed on top longitudinal reinforcing bar in the deck above bent 2) are shown in figure 23. These results are plotted for the time frame of 33 minutes to 43 minutes after the start of data acquisition. The smoothed results are shown in the same figure. In this case, the smoothed results give only slightly better insight into the behavior of this gauge during the passage of the overload. The noise in the data from this gauge location is of a high magnitude when compared to the noise from other locations. This high volume of noise may be due to the following factors. First, the wire for this gauge was located on top of the bridge as opposed to beneath the bridge. This may have exposed the wire to electrical fields from the generators or the overload itself. Next, the gauge itself was not weatherproofed and water did come into contact with the gauge and the leads. This may have caused the unusual behavior of this gauge. When viewing the data, it appears that the maximum strain due to the overload in this gauge was approximately 200 micro-strain (positive). The strain measured as expected and the gauge began approximately at zero and returned to zero after the passage of the overload.

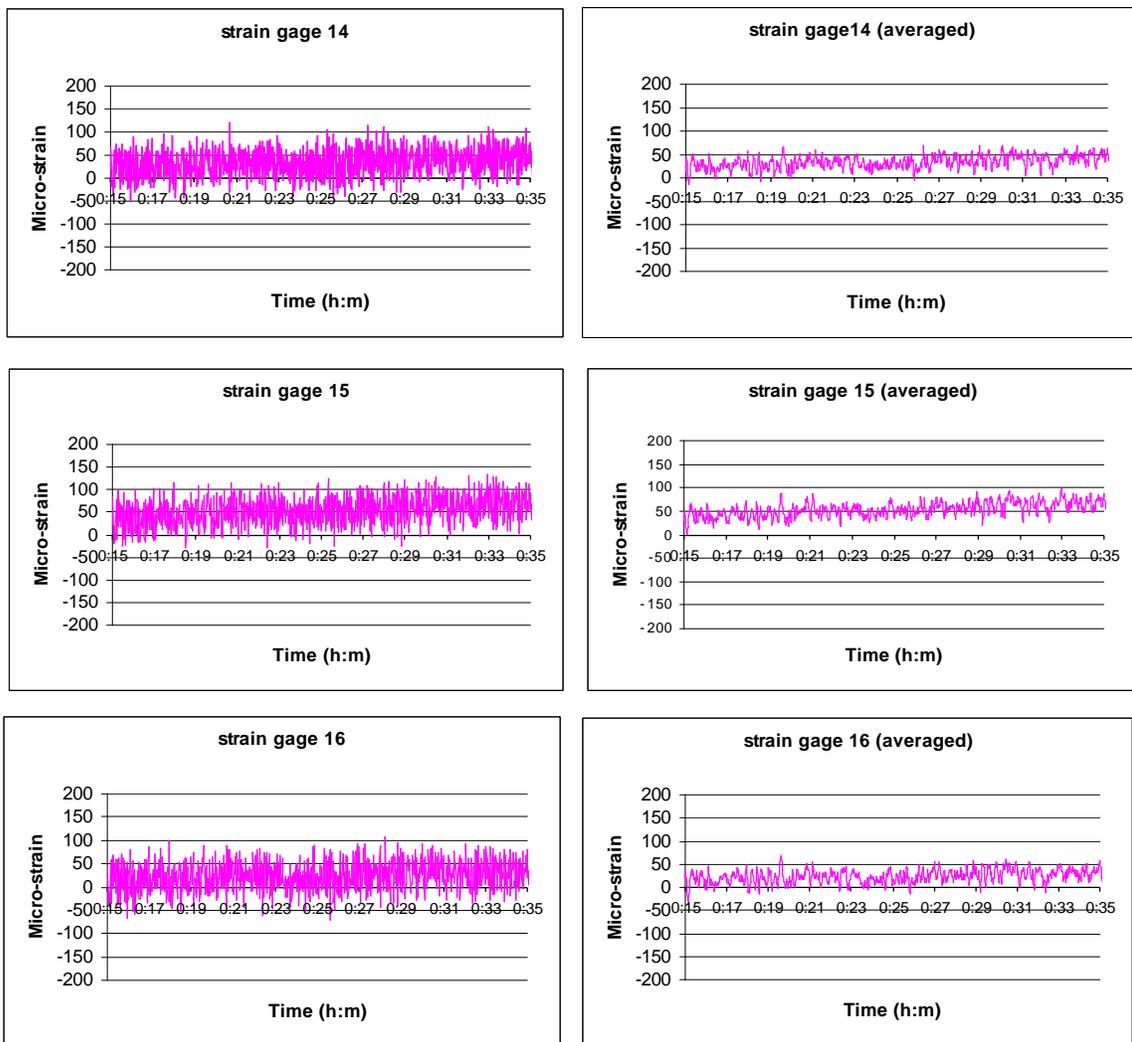
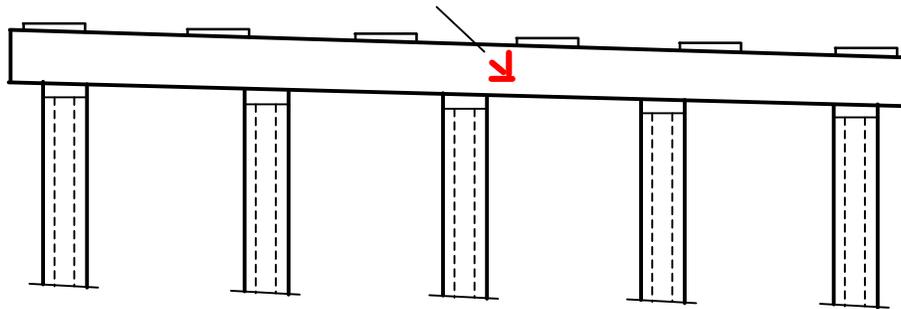
Figure 24
Actual and smoothed results for strain gauges 14, 15, and 16

The recorded results for the strains during passage of the overload at gauge locations 14, 15 and 16 (shear rosette on pile cap of bent 1) are shown in figure 24 as well. The smoothed results for these gauges are shown in the same Figure. These results are plotted for the time period of 15 minutes to 35 minutes after the start of data acquisition. No clear pattern or maximum can be seen in the results for this set of gauges. The actual strains are expected to be small and may be obscured by the noise in the data. Each of the gauges in this set also experienced significant drift (did not return to zero). Due to time constraints these gauges

were not weatherproofed and may have malfunctioned. It is recommended that the results from this set of gauges be disregarded.

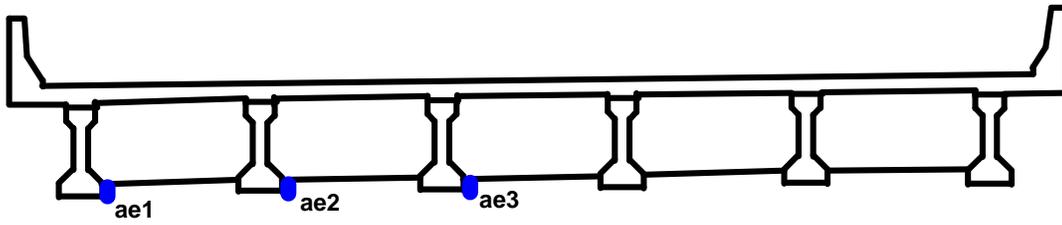
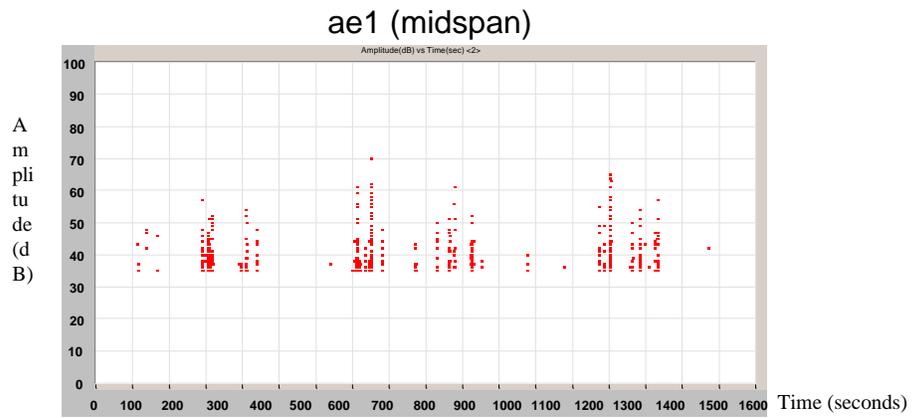
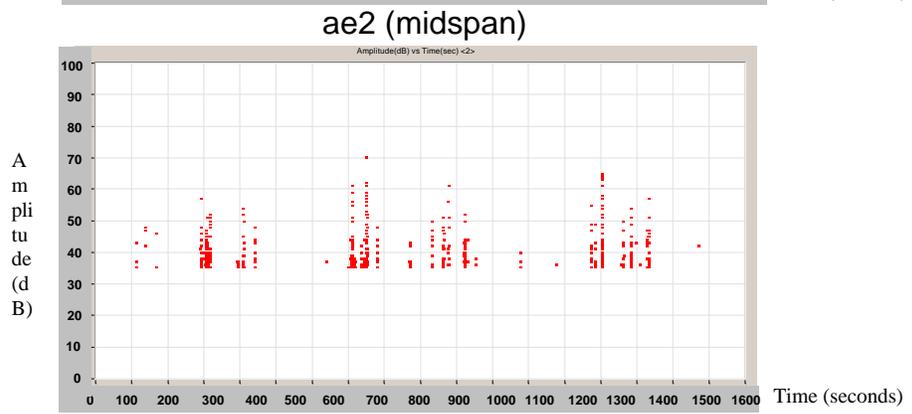
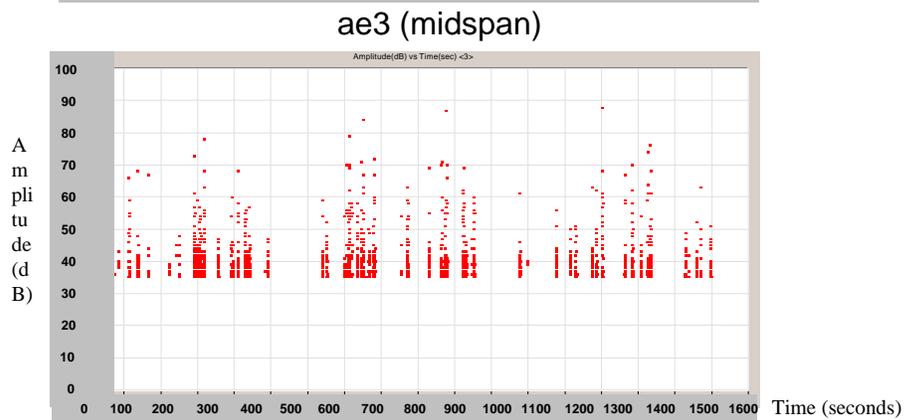
Figure 28
Amplitude vs. time - Traffic Scan 1

To establish a baseline of acoustic emission activity, emissions were monitored continuously for a period of approximately 30 minutes while traffic crossed the bridge. Plots of amplitude of each recorded acoustic emission hit versus time for all three sensors and for two different periods of time are shown in figures 28 and 29. These acoustic emission scans took place during the night of Saturday, November 9, and the early morning of Sunday, November 10. Therefore, the acoustic emission recorded is not representative of normal traffic loading. For traffic scan 1, high amplitude hits of up to 80 dB were recorded by sensor ae3. This sensor was affixed to the innermost of the three monitored girders. The outer girders showed significantly less activity. For traffic scan 2, high amplitude hits of approximately 90 dB were recorded by sensor ae3. In this traffic scan, the outer girders again showed significantly less activity than the innermost girder. This is to be expected and is indicative of larger portions of the traffic load being carried by the innermost girders.

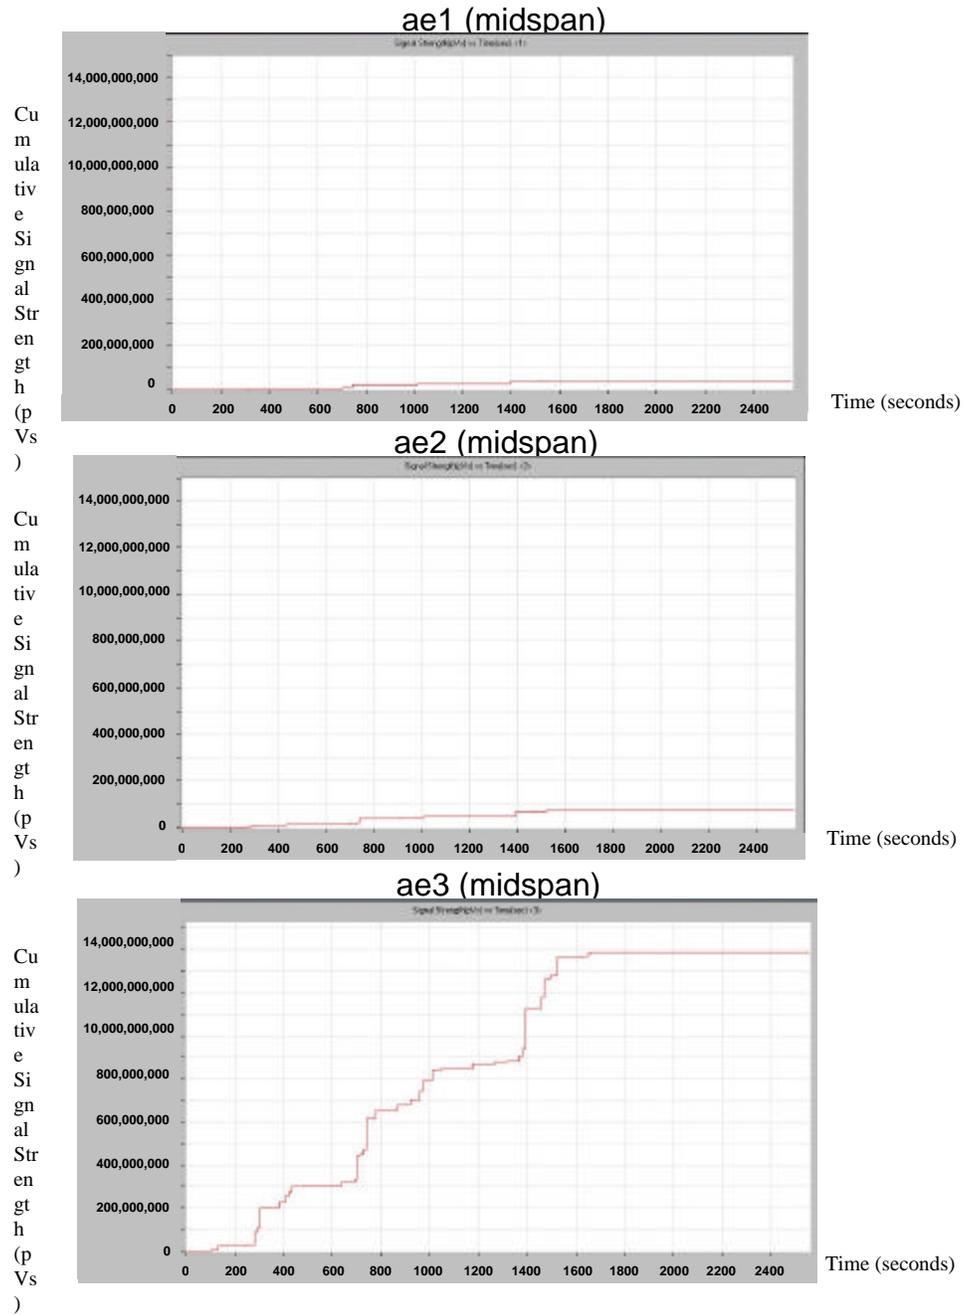
Figure 30
Cumulative Strength Signal - Traffic Scan 2

Another convenient way to view acoustic emission data is to plot cumulative signal strength versus time. Signal strength is essentially the area under the positive and negative envelope of each acoustic emission hit. Signal strength includes the amplitude of the acoustic emission hits while also considering the duration of the hits. Plots of signal strength give an indication of the energy released during crack growth. A plot of cumulative signal strength versus time for traffic load number 2 is shown in figure 30. Similar to the plots for amplitude versus time, this plot also indicates that the majority of the acoustic emission energy is coming from the girder near the center of the bridge under this traffic load.

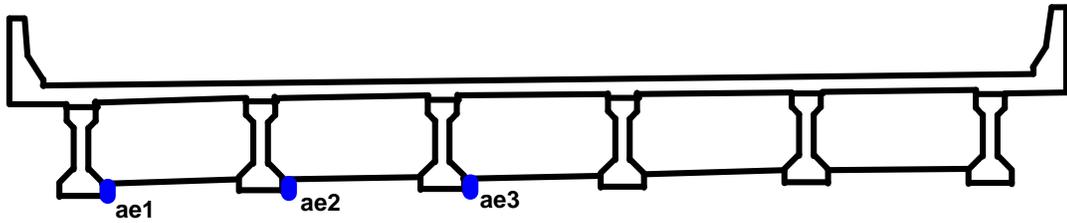
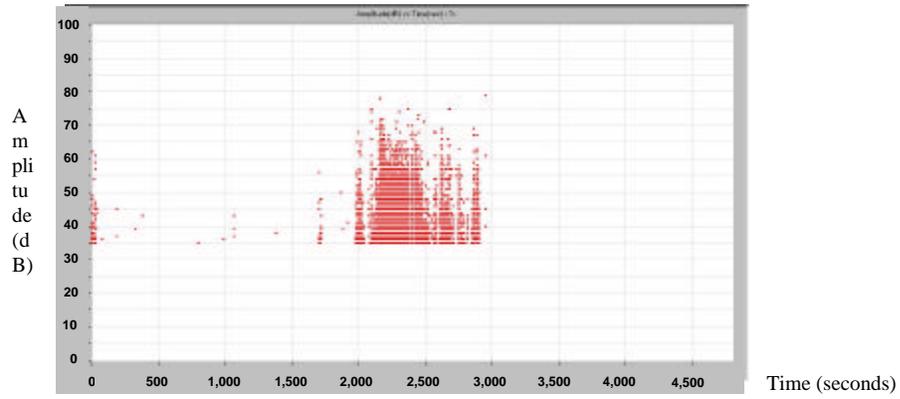
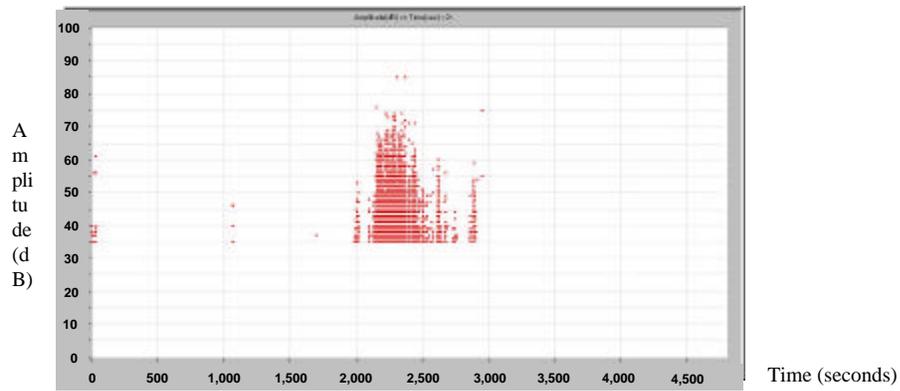
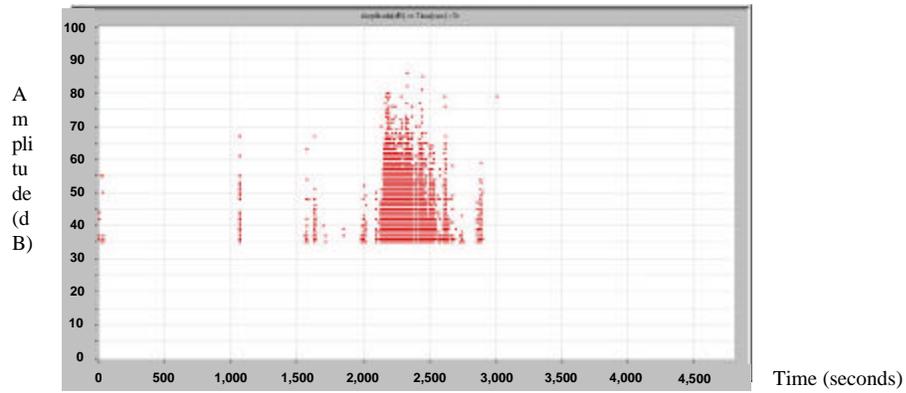
Figure 31
Amplitude vs. Time - Overload 2

Plots of amplitude versus time for the time period before, during, and after the passage of overload 2 are shown in figure 31. The effect of this overload on the acoustic emission activity is clear in this figure. From this figure, it appears that the outermost girder is more acoustically active due to the passage of the overload than the interior girders. This is consistent with the formation of new cracks in the outermost girders due to the passage of the overload. Increased acoustic emission activity in the outer girders would be expected since these girders had, most likely, not been as heavily loaded as the innermost girders prior to the passage of the overload. Hits of approximately 80 dB were recorded in the outermost girder, while hits of approximately 90 dB were recorded in the two inner girders. This is consistent with a larger percentage of the overload being carried on the inner girders. The lack of recorded hits above 90 dB indicates that major events such as breakage of prestressing strands did not occur in the monitored portions of the structure.

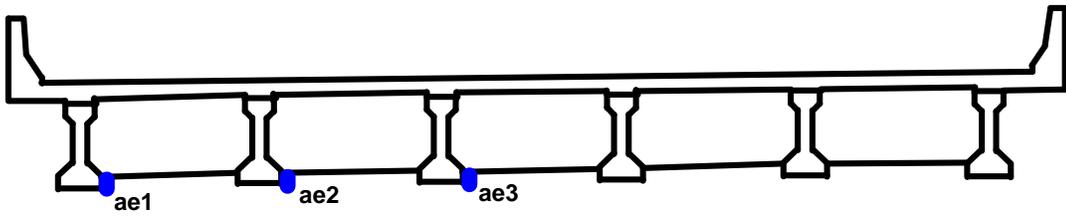
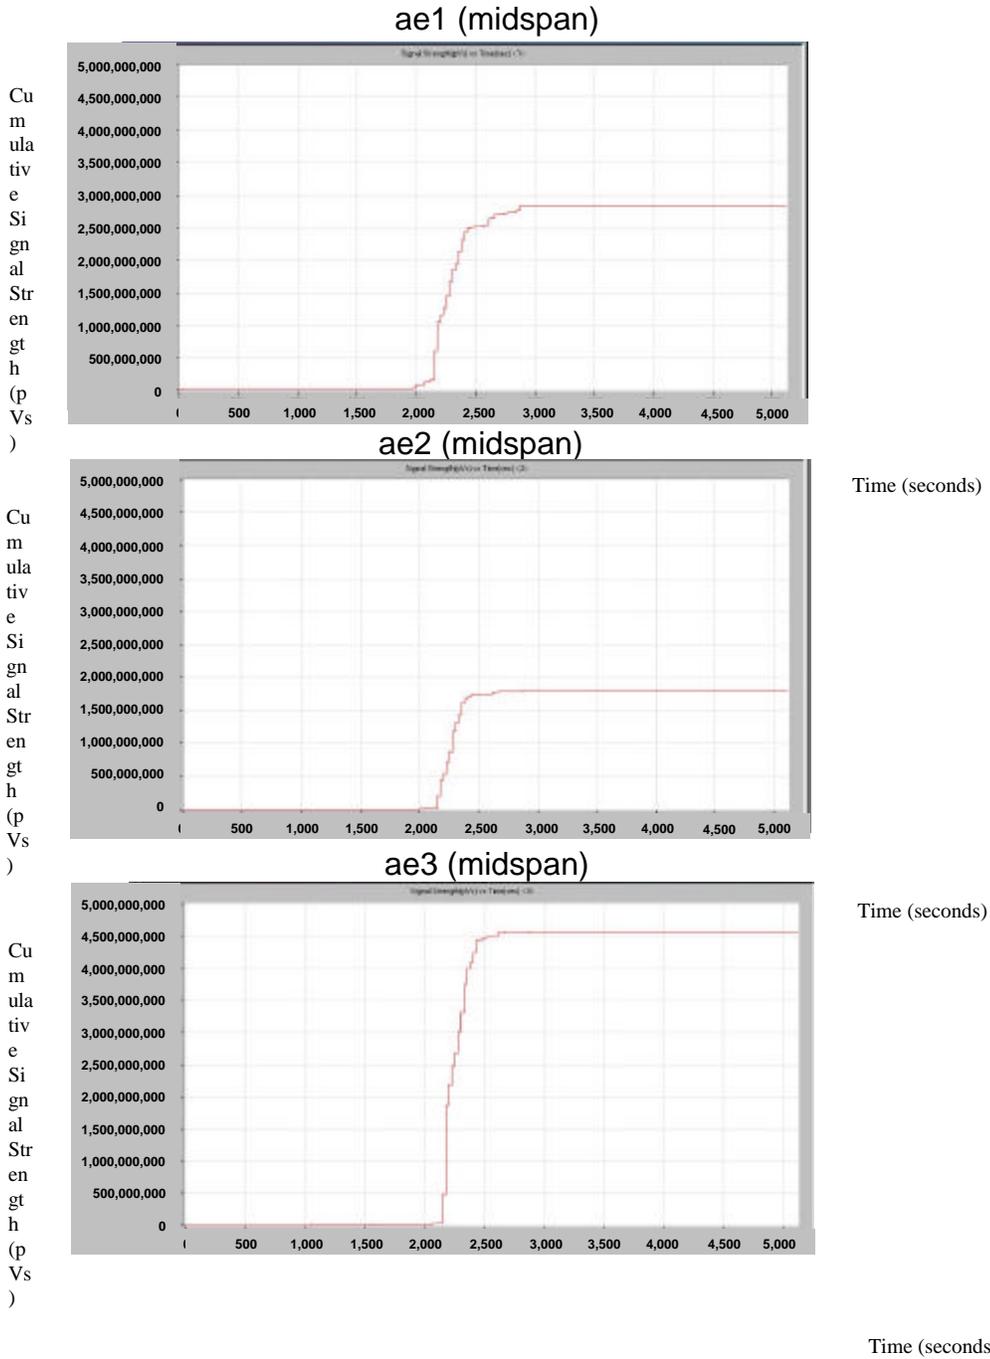
Figure 32
Cumulative Signal vs. Time - Overload 2

A plot of cumulative signal strength versus time for the passage of the overload is shown in figure 32. This figure indicates that the acoustic emission energy generated was the largest in the central girder, which is again consistent with a larger percentage of the overload being carried by this girder. Interestingly, the second largest cumulative signal strength value was generated in the outermost girder. This is consistent with a large number of new cracks being formed in this outer girder, even though these cracks were of lesser energy content than those activated in the innermost girder.
