# Replacement of Fender System at I-10 Mississippi River Bridge

Zolan Prucz and Yu Ouyang, Modjeski and Masters, Inc.

2008 LTRC Seminar Series: Bridge Structures

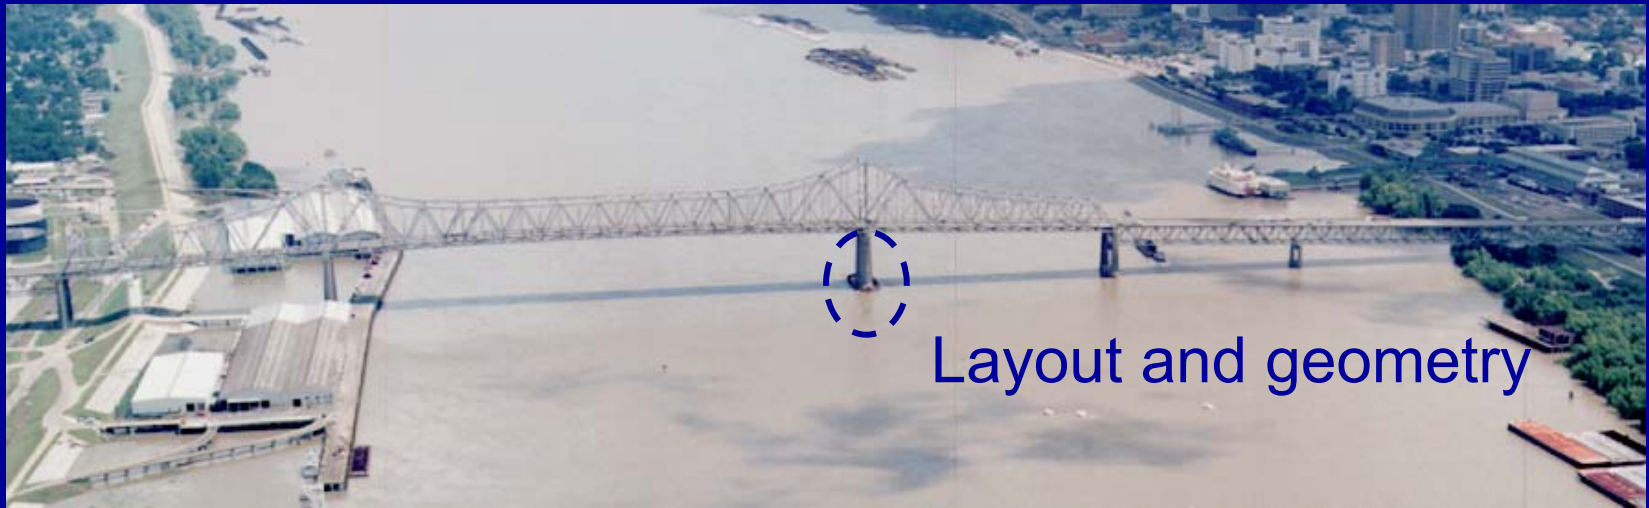
Layout and geometry

# Bridge and Existing Fender Characteristics

## Pier Geometry Findings:

- The pier columns could be exposed to ship deck contact and the criteria for the new fender should address prevention of access to the columns.
- The top of the distribution block forms an underwater shelf which could damage ship hulls and the criteria for the new fender should address prevention of protruding underwater ledges.

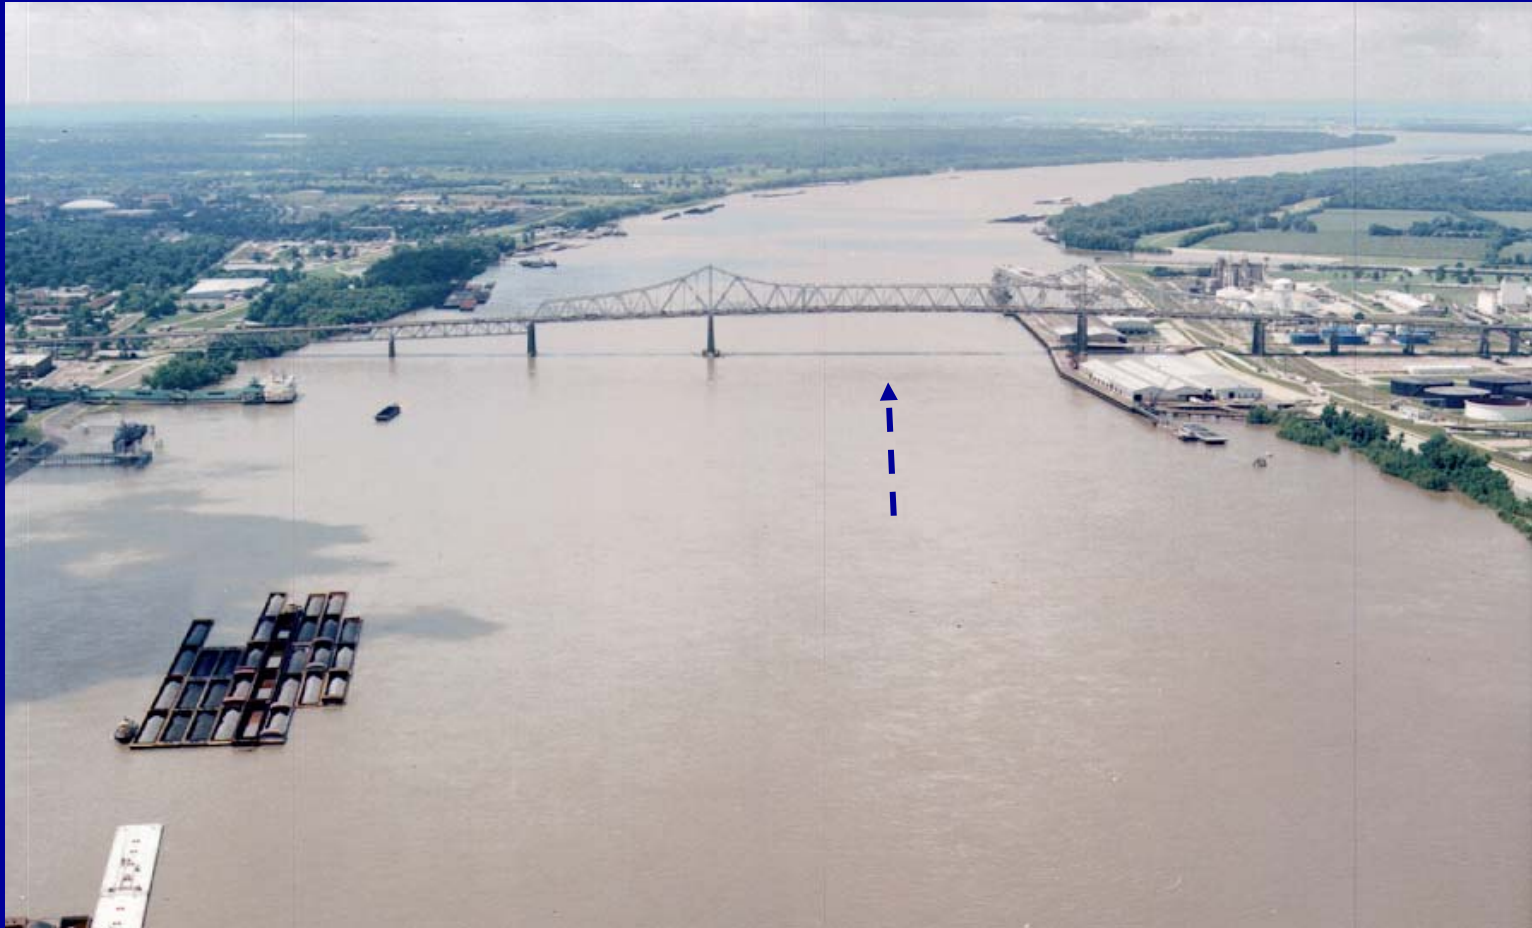
Bridge View Looking Downstream

# Waterway Characteristics and Docking Facilities

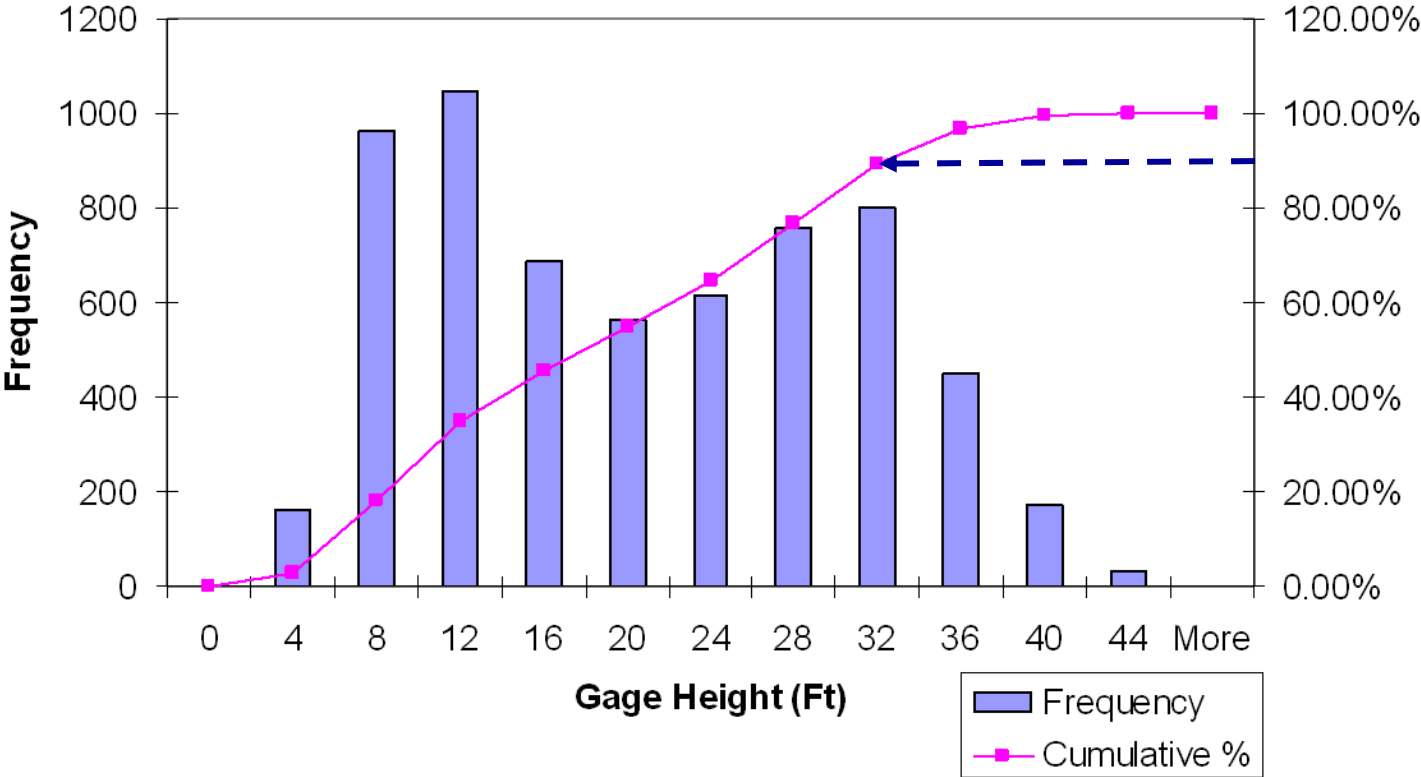
## Gage Height Histogram

# River Stage Statistics

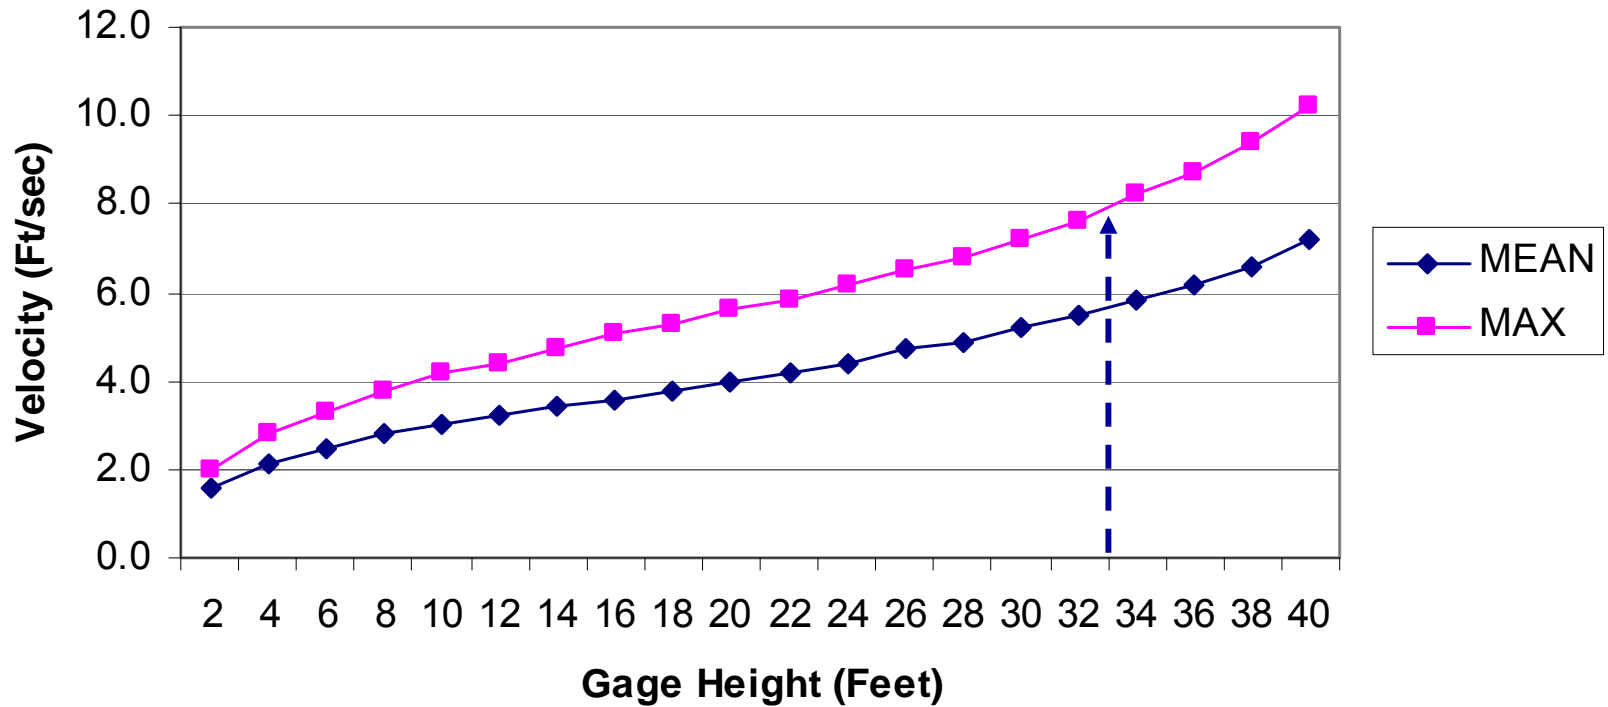
# River Velocities at Baton Rouge Gage

River Velocity at Baton Rouge Gage (Mile 228.4) at 60% Depth

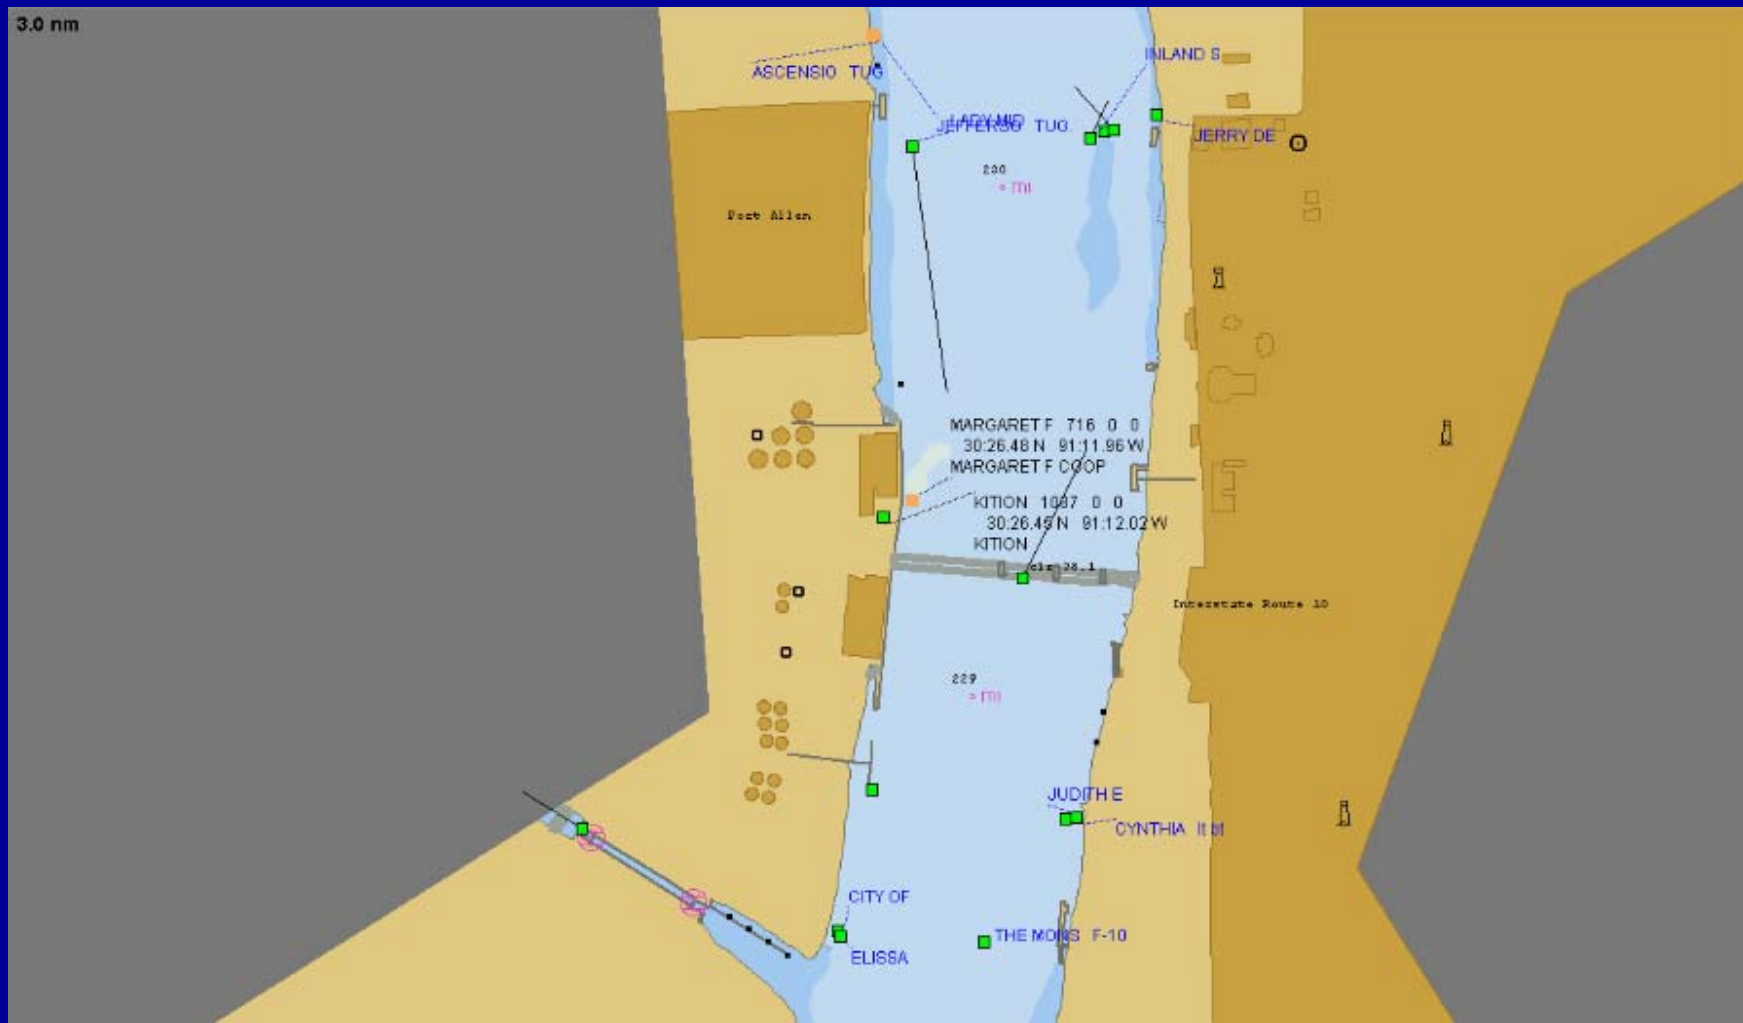
# Vessel Traffic Identification (AIS) and Monitoring System

AIS provides precise information on ship identification, position, speed and heading to a vessel traffic control center and to other AIS-equipped vessels

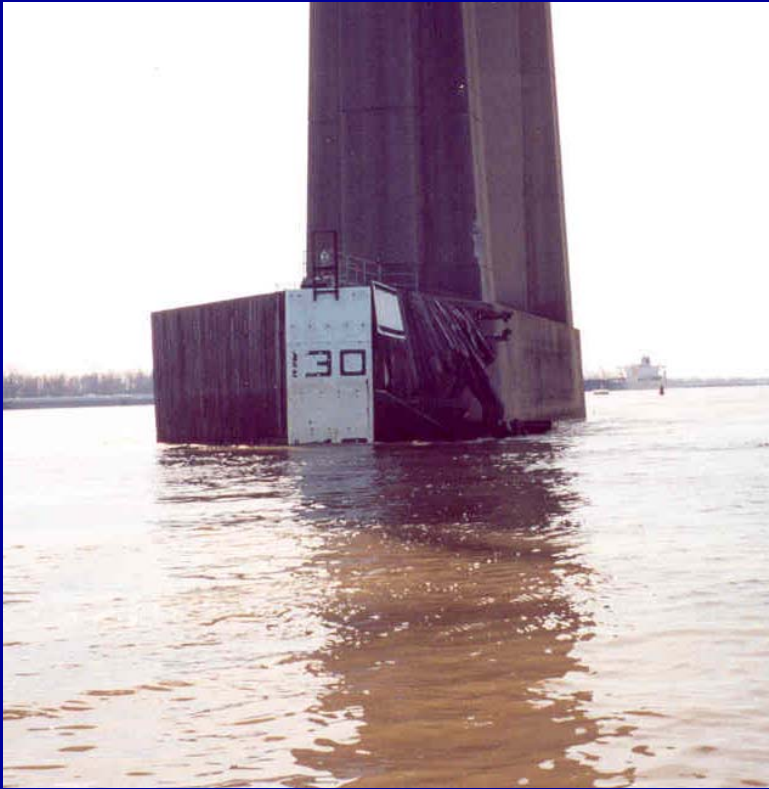
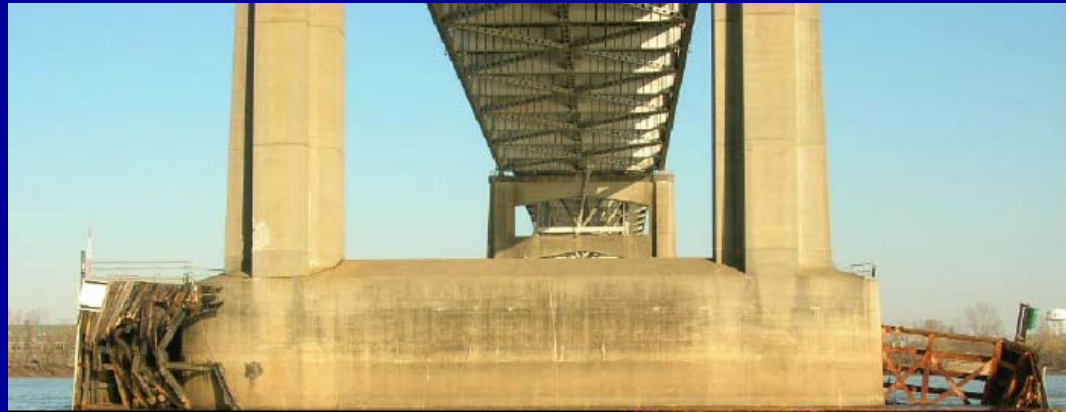
*February 10, 2007 – M/T Kition*

**Loa = 798 Feet**

**B = 137 Feet**

Accident Number	Date	Location of Damage		Baton Rouge Gage
		Substructure	Superstructure	River Stage (feet)
1	3/12/77	South end of the Pier 5 fender system		23.08
2	5/27/77	North end and the east side of the Pier 5 fender system		10.00
3	12/5/77	West side of Pier 5 fender system		22.12
4	3/5/79	North end and east side of the Pier 5 fender system		29.43
5	6/14/82		Green navigation light was torn off	27.37
6	12/21/01	North end of the Pier 5 fender system		31.70
7	2/10/07	West side of the Pier 5 fender system		26.09

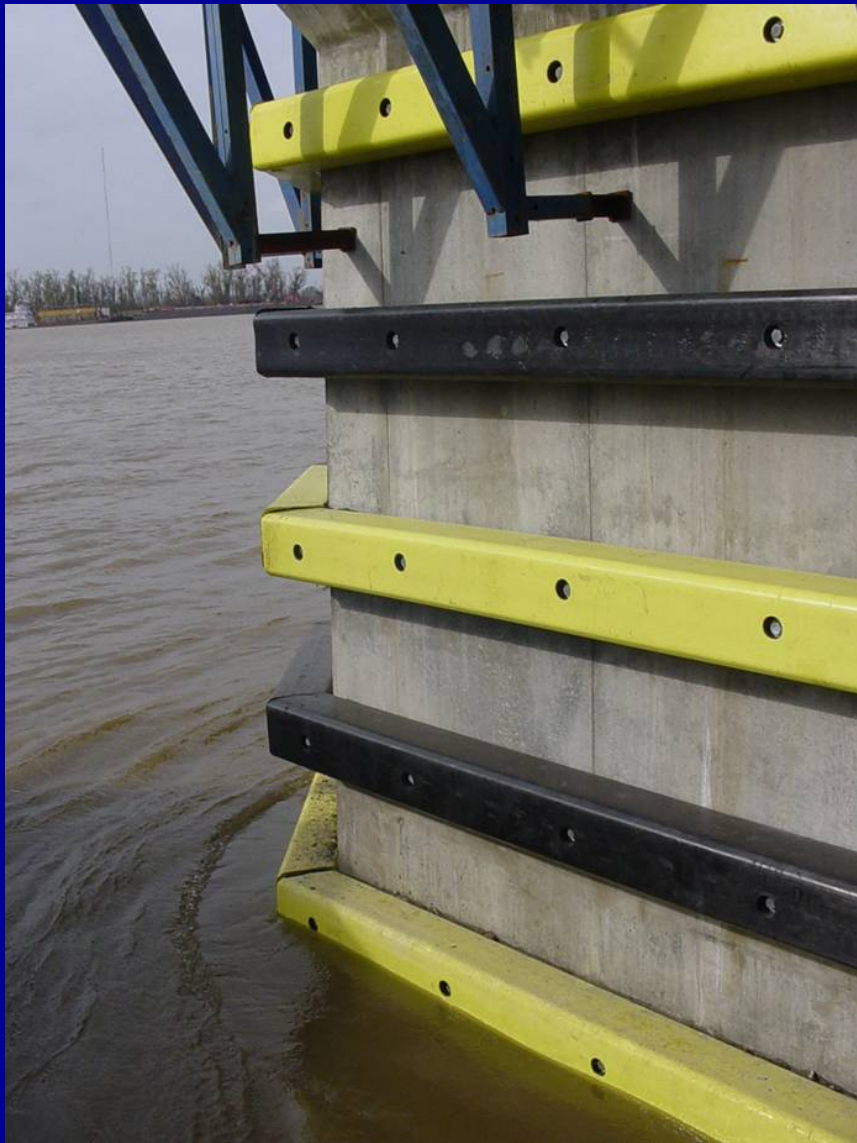
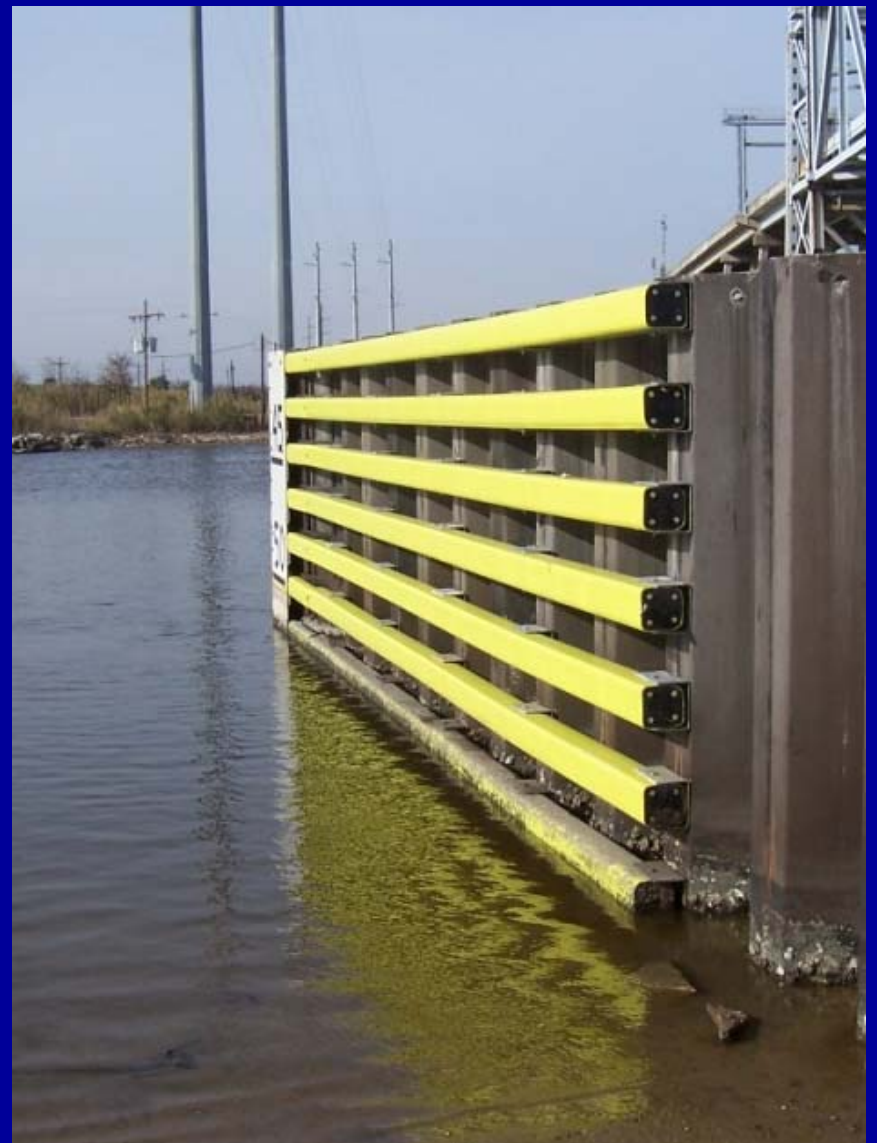
## Composite Marine Timber Wales

- Low coefficient of friction
- High abrasion resistance
- Durable

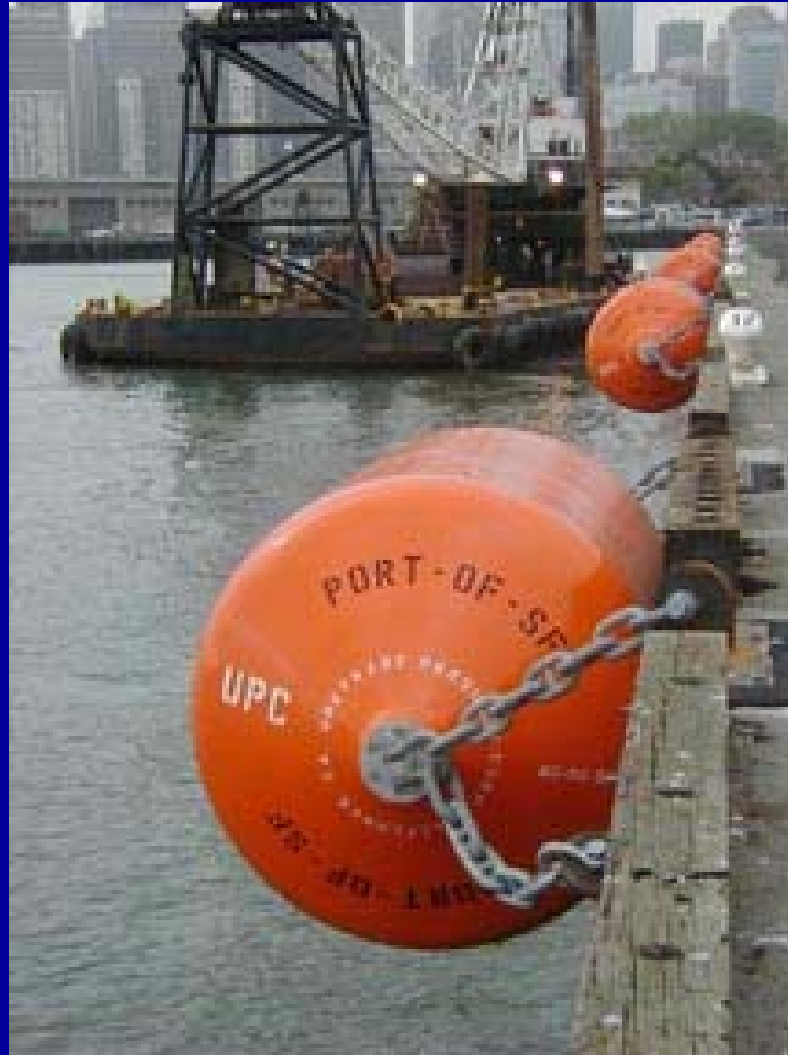
## A. Floating Foam Filled Fenders

- Effective for frequent low energy sideways berthing scenarios.
- Installation is relatively easy and the initial cost is relatively low.

- Relatively soft with the energy absorption capacity rated at about 60% compression. Not effective in preventing vessel access to the pier columns and the underwater pier “shelf”.
- Little capacity in the longitudinal direction, ineffective and easily damaged after collisions at an angle.
- High maintenance costs of hardware.

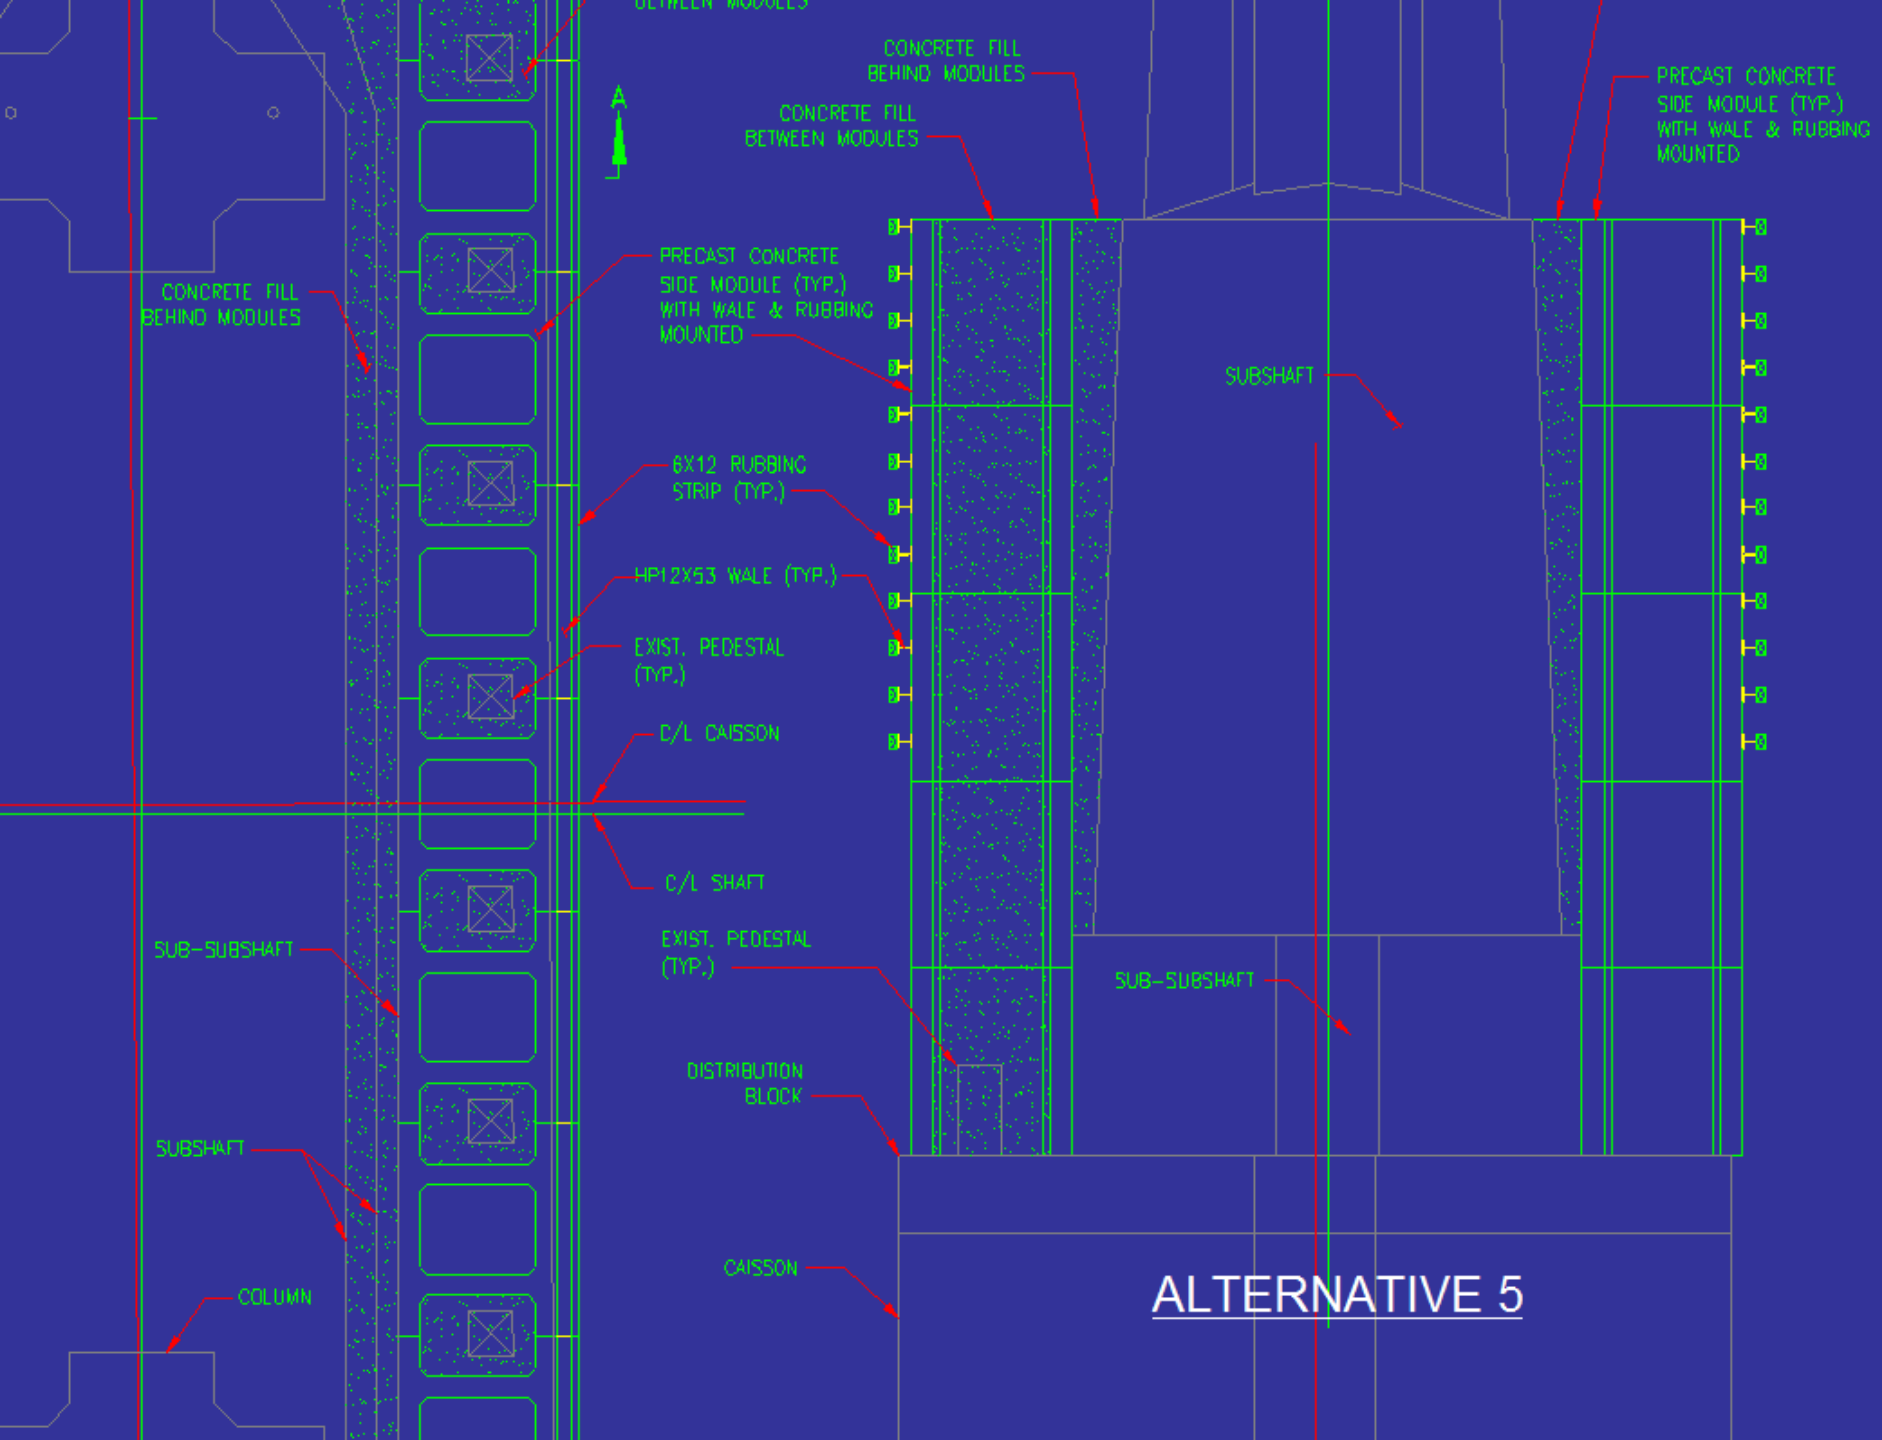
## Alternative 5 – Full Depth Precast Concrete Modules

- Satisfies performance requirements for both the nose and the side sections of the fender.
- Damaged concrete modules can be replaced.

- There is more effort involved in the erection of the bottom concrete modules.

- Alternative 1 – Steel Pipe Fender
- Alternative 2 – Full Height Precast Concrete Cells
- Alternative 3 – Steel Pipes with Brackets and Precast Concrete Modules
- Alternative 4 – Steel Pipes with Full Depth Precast Concrete Modules
- Alternative 5 – Full Depth Precast Concrete Modules
