# ***Louisiana Transportation Research Center***

**Final Report 14-1TIRE**

## **Improvements to Highway Guardrail Assemblies**

1. Report No. <b>FHWA/LA.15/14-1TIRE</b>		2. Government Accession No.	3. Recipient's Catalog No.
4. Title and Subtitle <b>Improvements to Highway Guardrail Assemblies</b>		5. Report Date May 2016

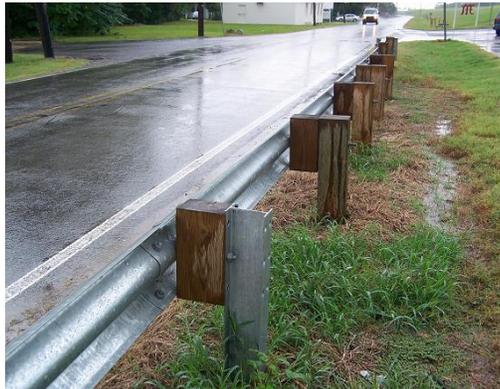
**Figure 1**  
**Highway guardrail assembly**

This assembly shows wooden posts and blocks with the exception of one steel post in the forefront of the picture.

Guardrail assemblies are an important means to increase the safety of highway travel. A typical installation includes a series of metal guardrail attached to wooden posts that are driven into the ground (Fig 1). The blockouts connect the wooden posts to the metal guardrail. Blockouts usually have a dimension of 6 x 8 x 14 in. and help absorb kinetic energy during a vehicular crash. Since steel blocks were proven ineffective based on NCHRP 350, the primary material for new blockouts is wood, which is frequently preservative treated with chromated copper arsenate (CCA) (Figure 1) [1].

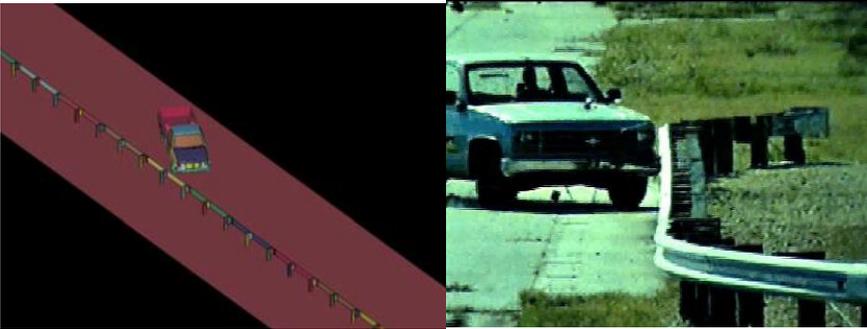
**Figure 2**  
**Vehicle collision presentation**

A single car vehicle collision was simulated as presented in Figure 2. In this case, a vehicle has crashed into the guardrail at a 30° angle in the horizontal plane. Group one from Task 2 was chosen as the blockout for the rail assembly. For simplicity, the car was simulated as a rigid ball; the diameter of the ball equaled to the bumper height. In the simulation process, only the translational degree of the ball was considered and the self-rotational degree was ignored. The dimensions of a typical highway guardrail assembly are presented in Figure 3. The key guardrail components include post, block, bolt, and double corrugated guardrail. The post was assumed to be typical southern pine solid wood and the block was assumed to be Group 1 (see Task 2). The bolts and double corrugated guardrail were assumed galvanized

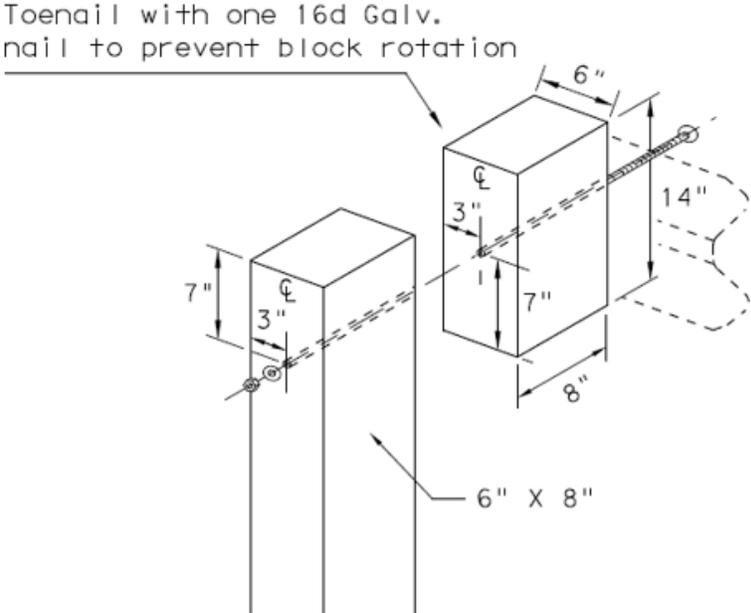
**Figure 3**  
**Dimensions of posts, blocks, bolts, and guardrails used in the simulation process**

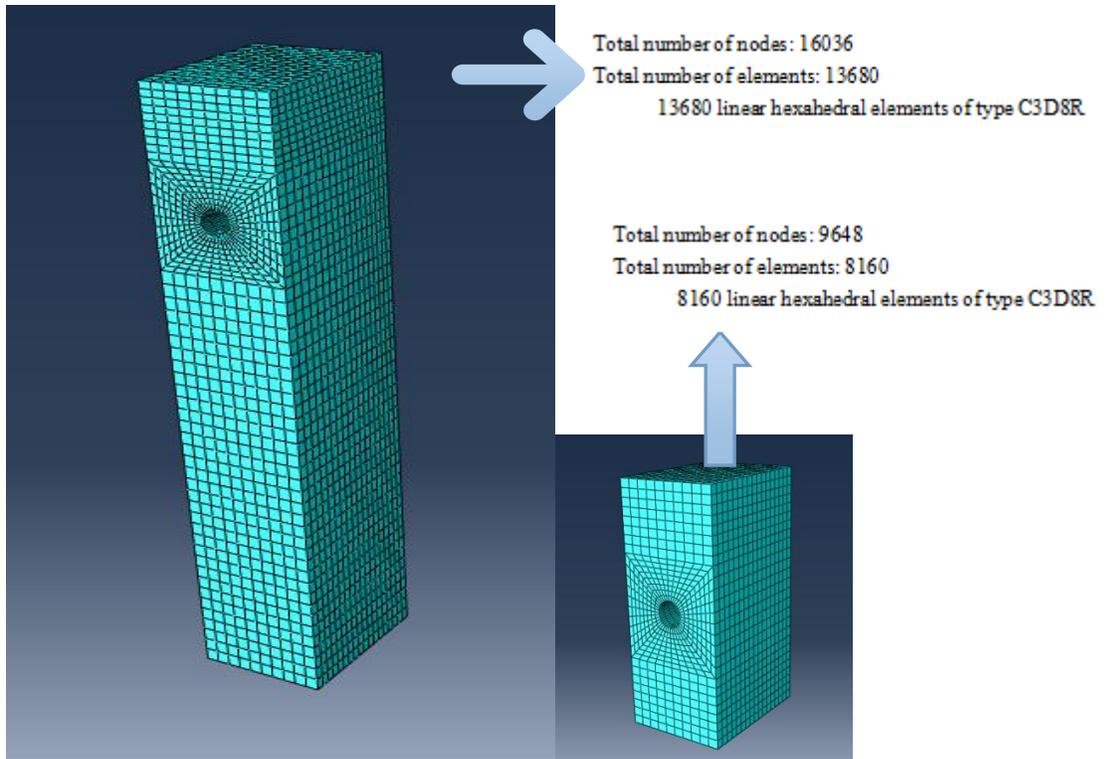
**Figure 4**  
Finite element meshing and model of post and block

The finite element mesh and modeling were conducted with the ABAQUS software. The post and block model and finite element mesh are shown in Figures 4-6. Figure 7 shows the whole mesh and model of the highway guardrail being impacted by the ball. The C3D8R unit was selected for this model.

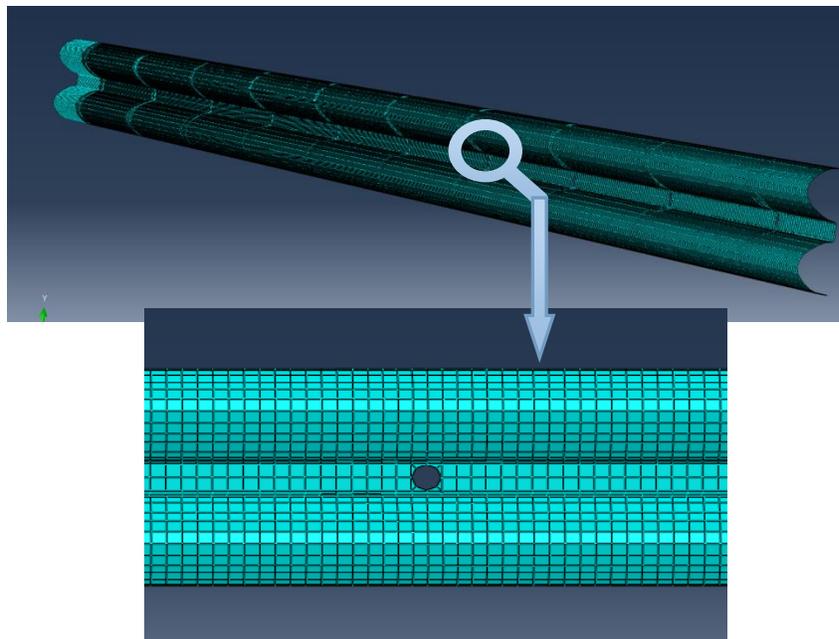
**Figure 5**  
Mesh and model of guardrail

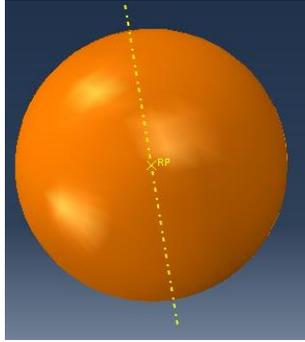
**Figure 6**  
Rigid ball (weight 1.5 ton and speed of 20m/s)

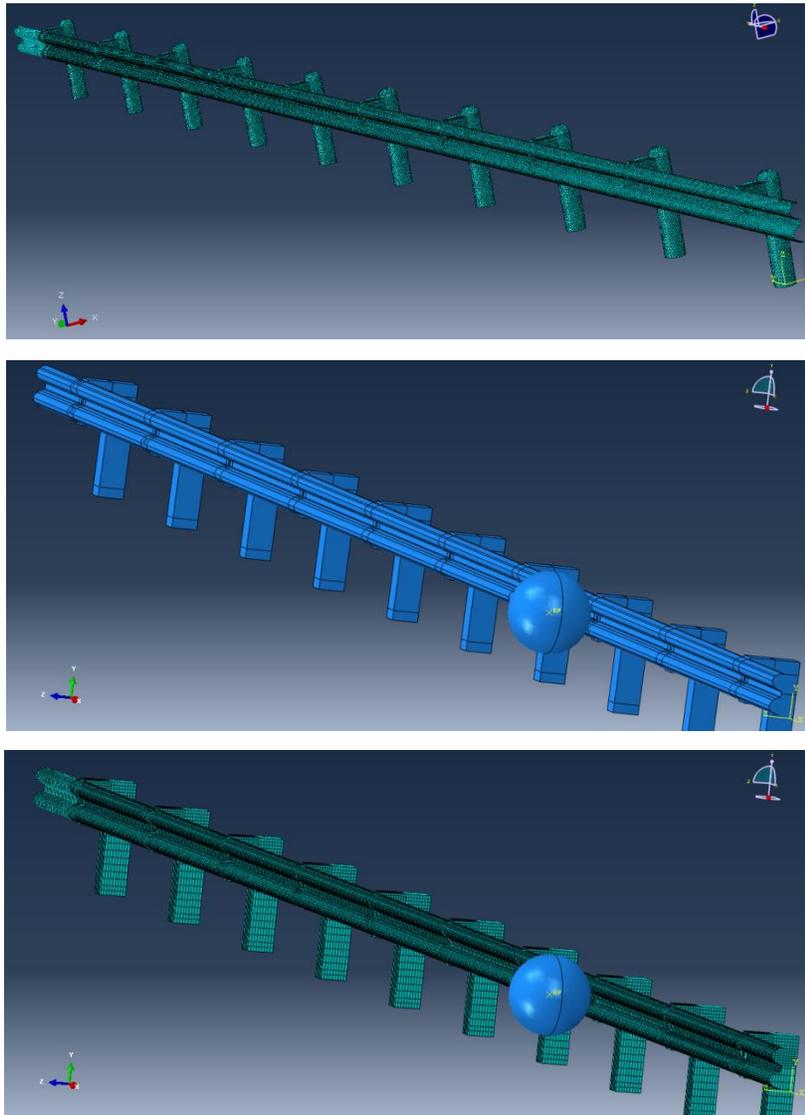
**Figure 7**  
A whole mesh and model of the highway guardrail

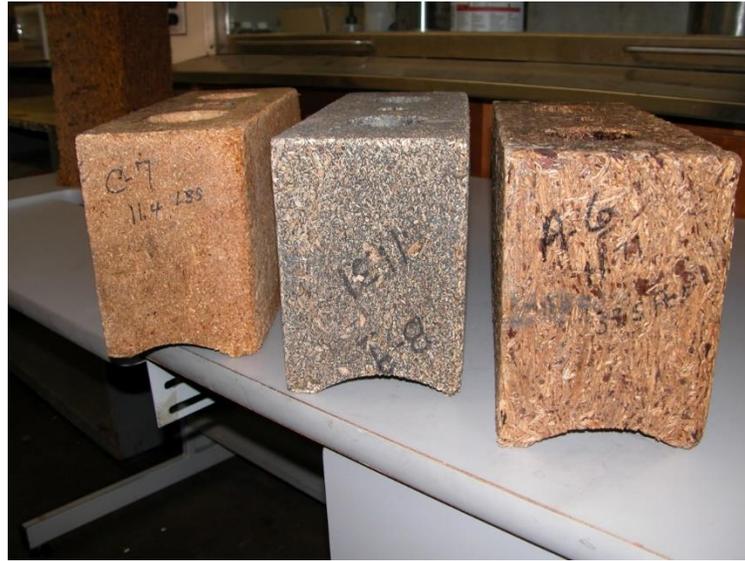
**Figure 8A**  
**Guardrail block (side view)**

Figures 8A-C illustrate some examples of the compression-molded blocks that were fabricated. Figures 9-11 show the MOR, MOE, and IB, respectively, of the test groups. Group 1 provided the highest values for all three mechanical properties. However, this finding is likely due to the higher density of Group 1. It is well established that most mechanical properties are well correlated with wood density. Therefore, from a logistics perspective Groups 2 and 3 merit consideration. These groups will be easier to handle and cheaper to transport in bulk. It is noted that AASHTO has no mechanical requirements for highway blockouts [10]. The blockout serves as an integral part of a guardrail assembly by securing the guardrail to the post. It is essential that the post yield the soil in the event of a vehicular accident.

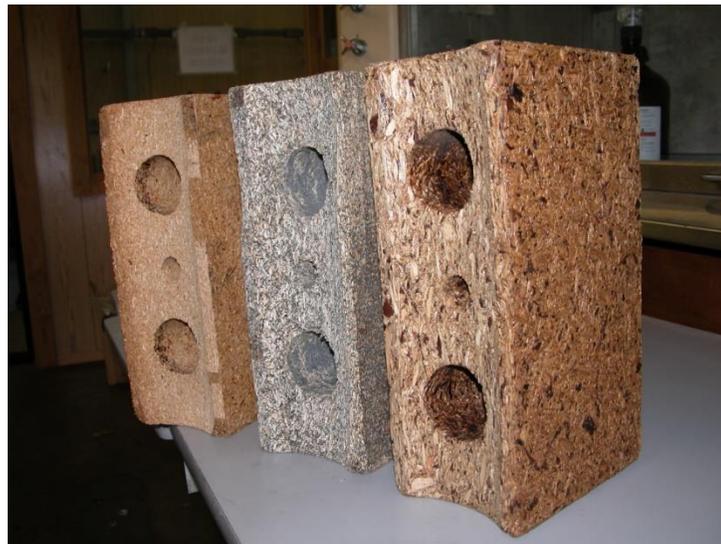
**Figure 8B**  
**Guardrail block (side view)**

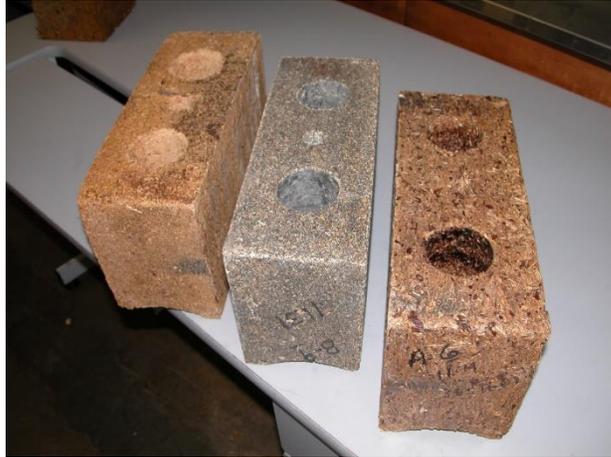
**Figure 8C**  
**Guardrail block (side view)**

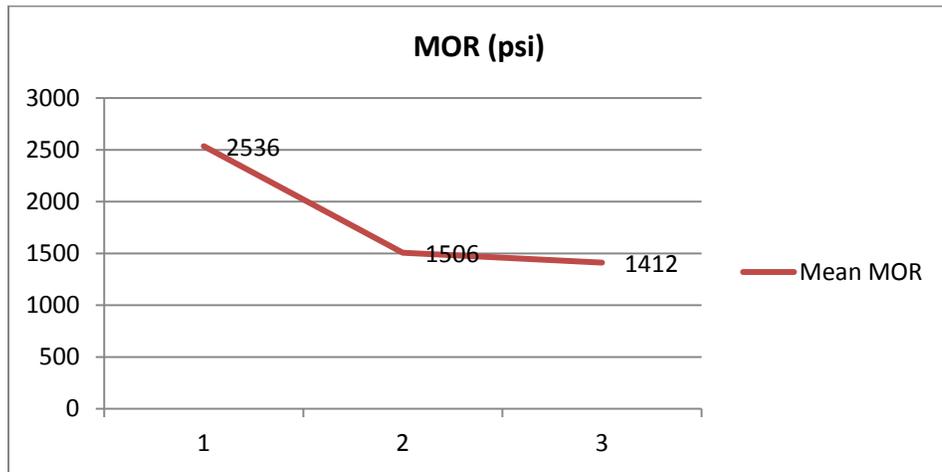
**Figure 9**  
**Flexural Modulus of Rupture, MOR, of the three experimental groups**

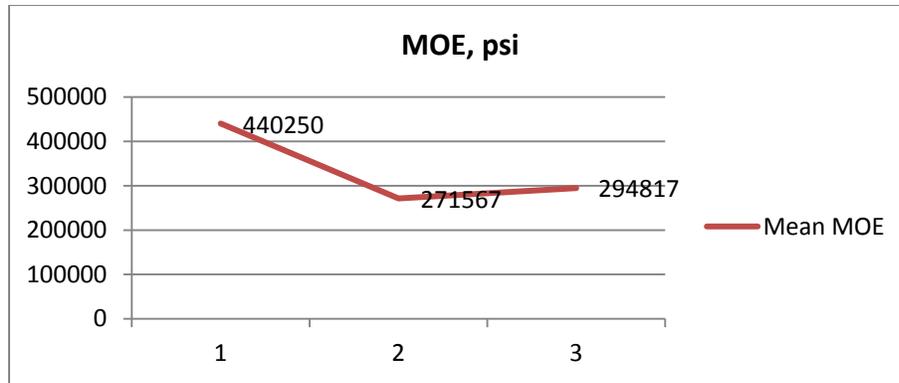
**Figure 10**  
**Flexural Modulus of Elasticity, MOE, of the three experimental groups**

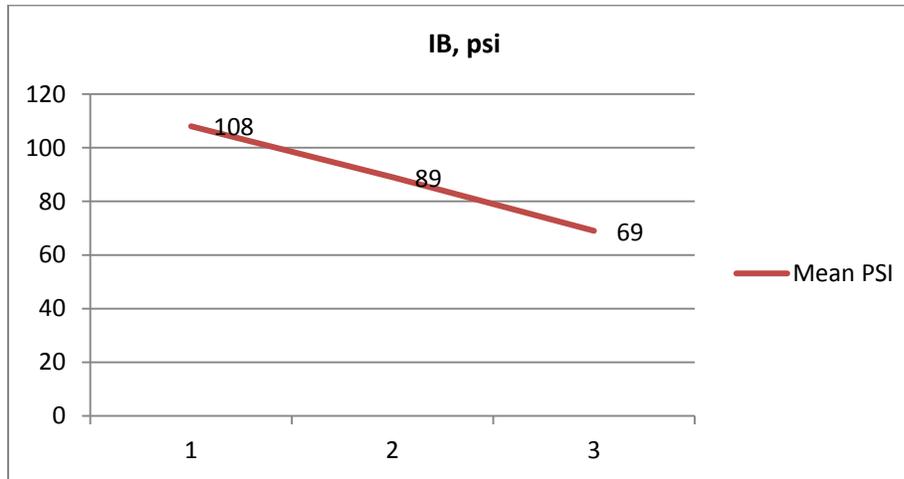
**Figure 11**  
**Internal bond strength, IB, of the three experimental groups**

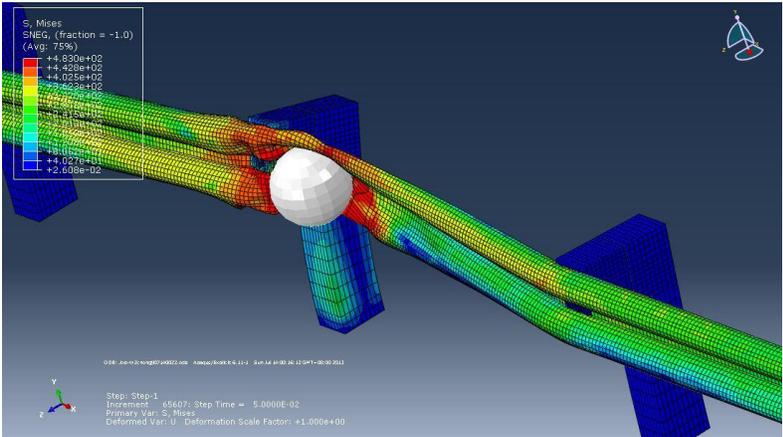
**Figure 12**  
Simulation of impact stress

The results of the finite element analysis are presented in Figures 12-14. Figure 12 shows the simulation of the impact stress. Figures 13-14 show the static stress distribution and static simulation displacement, respectively.

Based on this simplified analysis, the impact energy was mainly absorbed by the guardrail and deformation of the post and block. A finite element model of the deformation and energy conversion was established. During the simulation, the rigid ball bounced back with a lower speed after collision into the guardrail. In the collision process, the deformation energy was less than the initial kinetic energy, while the final deformation energy and the final kinetic energy were equal to the initial kinetic energy.

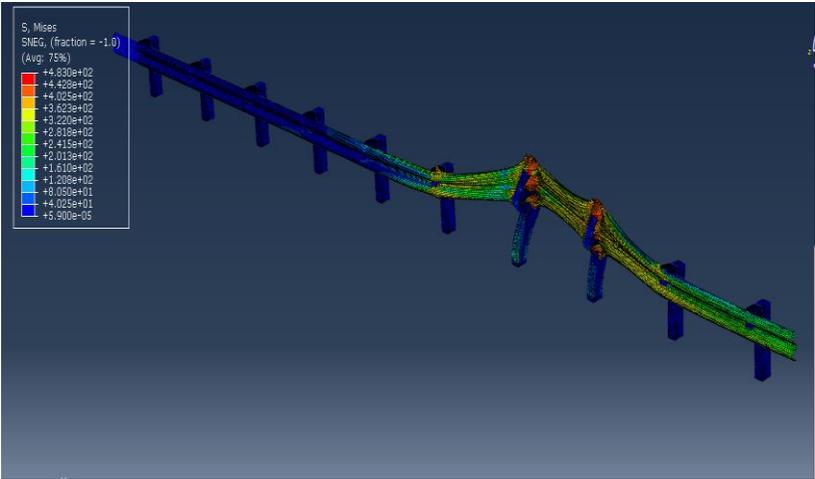
**Figure 13**  
Static simulation results of von Mises stress distribution

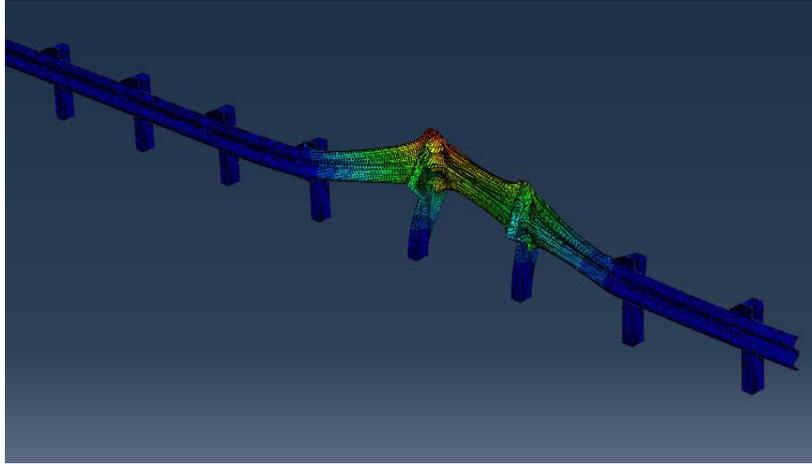
**Figure 14**  
Static simulation displacement
