1. Title and Subtitle  
**Maintenance of Roadway Edge Drop-Off Utilizing Readily Available Materials**
2. Author(s)  
Gavin P. Gautreau, P.E., and Nicholas Ferguson, P.E.
3. Performing Organization Name and Address  
Louisiana Transportation Research Center  
Geotechnical Group  
4101 Gourrier Avenue  
Baton Rouge, LA 70808
4. Sponsoring Agency Name and Address  
Louisiana Department of Transportation and Development  
P.O. Box 94245  
Baton Rouge, LA 70804-9245
5. Report No.  
**FHWA/LA.22/675**
6. Report Date  
January 2023
7. Performing Organization Code  
LTRC Project Number: 19-1GT  
SIO Number: DOTLT1000283
8. Type of Report and Period Covered  
Final Report  
02/2019 – 09/2022
9. No. of Pages  
93

13. Abstract

The Louisiana Department of Transportation and Development (DOTD) District 05, which is in the northeastern corner of the state, spent 55,000 hours and over \$1 million in 2016 attempting to maintain roadway edges along non-paved shoulders.

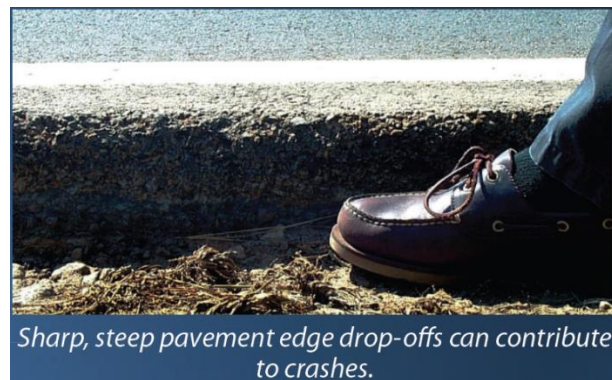
**Figure 1. Extreme example of edge drop-off [2]**

Edge drop-offs can also be created by overlay operations. Figure 1 shows an extreme example of an edge drop-off created and/or exacerbated by an overlay. Depending upon the timing of any adjacent shoulder work to level the shoulder to the road edge, this drop-off can remain and create safety issues.

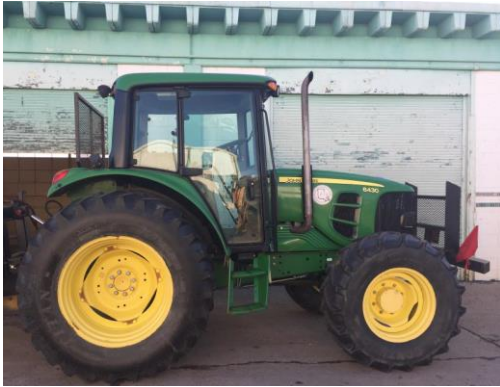
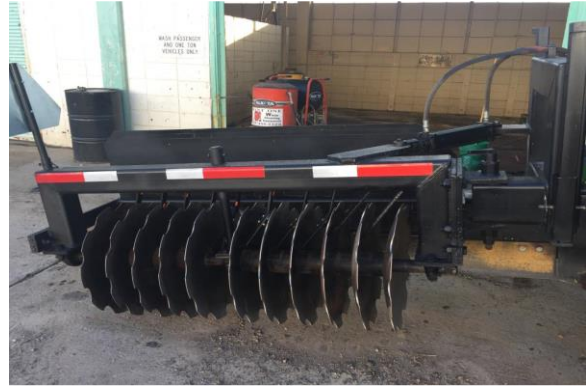
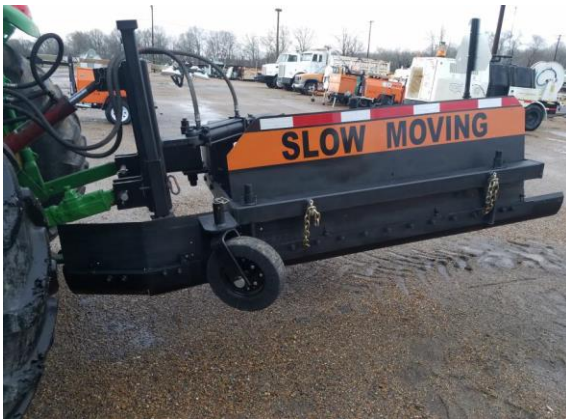
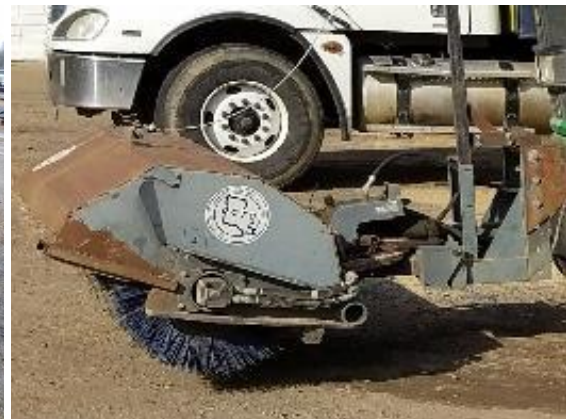
**Figure 3. DOTD District 58 repair equipment**

The District 58 shoulder restoration equipment consists of four main components, shown in Figure 3.

- Tractor – a heavy-duty vehicle used for towing or pulling attachments that are extremely hard to move.
- Disc attachment – a device used to break, turn, and raise existing materials.
- Blade attachment – a piece of heavy equipment designed specifically for leveling purposes.
- Broom attachment – optional attachment used to clean the travel lane of excess dirt, loose aggregate, etc. after restoring operation.

(a) Tractor

(b) Disc Attachment

(c) Blade Attachment

(d) Broom Attachment

Their LTC presentation showed the value of the edge disc, blade, and broom attachments. District 58 realized labor cost savings (See Table 1) and material costs by utilizing readily available RAP at \$10/cubic yard (cy.). Other benefits they documented are summarized below:

- Creates ease of mobilizing the equipment
- Contains flexible connections – common three-point tractor hitch
- Reduced mowing due to disc-cutting/blending of material
- Extends/increases road life by removing high points, allowing for drainage
- Increases road safety by reducing the road crew and equipment for repair
- Increases road safety by repairing/leveling shoulder
- Reduces disruption to the traveling public
- Enhances road appearance

The survey collected district information regarding what methods and equipment they utilized for their shoulder repairs. Table 5 presents a summary of these responses. Small excavators along with motor graders were the most commonly utilized. District 58 responded with a shoulder widener, which refers to the equipment outlined in Figure 3 (tractor, discs, a blade, and broom attachments for the tractor). The District 58 attachments are shorter in width than normal equipment and is ideal for narrow shoulders.

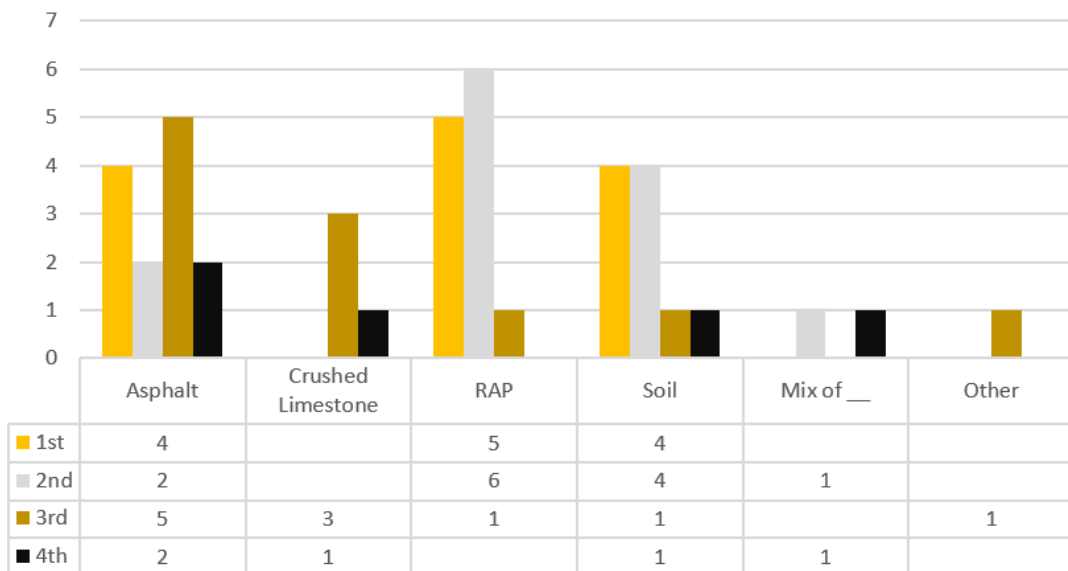
Figure 4. Road shoulder material's ranking (how common) by district

One survey question asked about existing shoulders and the most common materials existing in these shoulders. Figure 4 shows the rankings of common materials composing district road shoulders. The gold bars in the following charts represent the number of 1<sup>st</sup> place votes (ranking most common); the silver bars the second most common votes, and so forth. Asphalt and RAP are the most common shoulder materials, but soil shoulders are also common. Asphalt received the second most 1<sup>st</sup> place votes, but it received the most total votes indicating that the material is common in the districts.

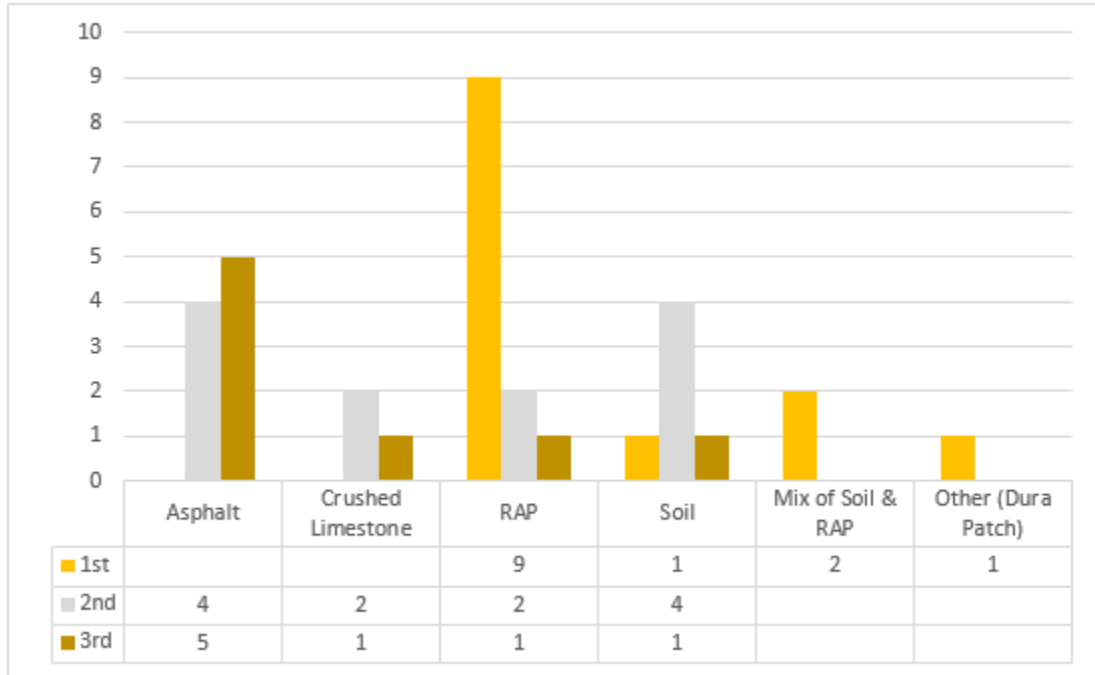
**Figure 5. Materials utilized by the DOTD districts for shoulder repair**

The survey indicated that DOTD districts utilize different materials to repair existing shoulders. Figure 5 shows the votes for their choices of shoulder repair material. RAP received the most 1<sup>st</sup> place votes indicating it is a very common repair material. Other repair materials included soil, a mix of soil and RAP, and a DuraPatch (cold patch mix).

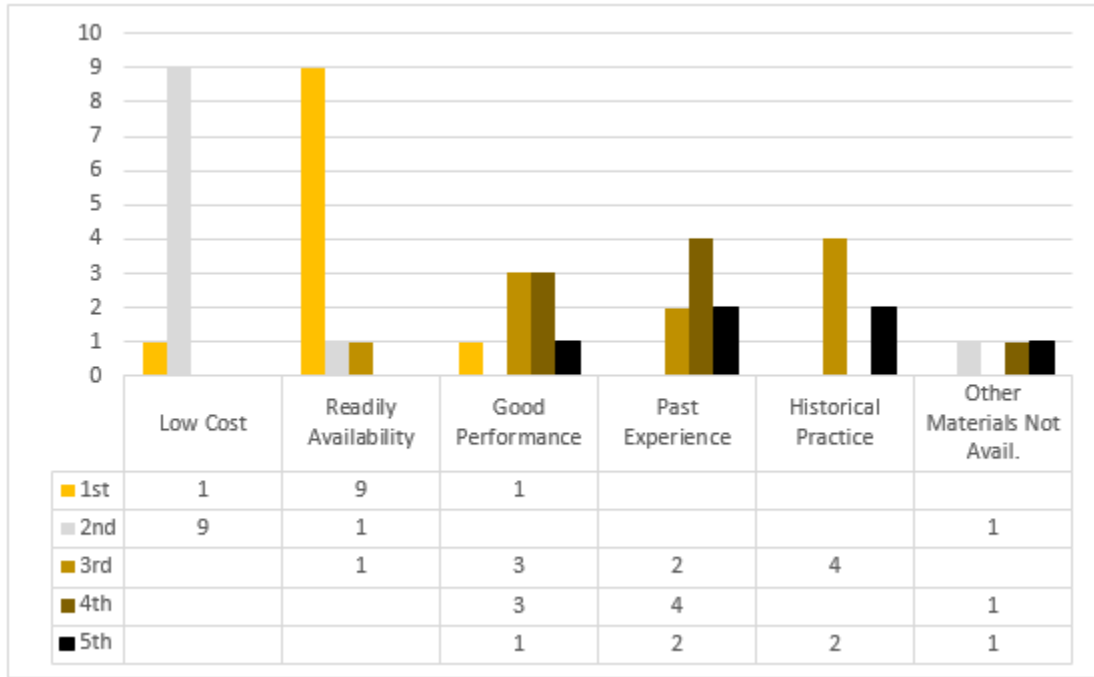
**Figure 6. Reasons why districts utilize the materials for shoulder repair**

The next survey question asked districts why they gave their 1<sup>st</sup> place votes to the material listed in Figure 5. Figure 6 shows survey responses, which indicate the preferred repair material (most commonly RAP) was selected primarily for its availability and for its low cost. The majority of district engineers mentioned that RAP is utilized over asphalt due to its low cost.

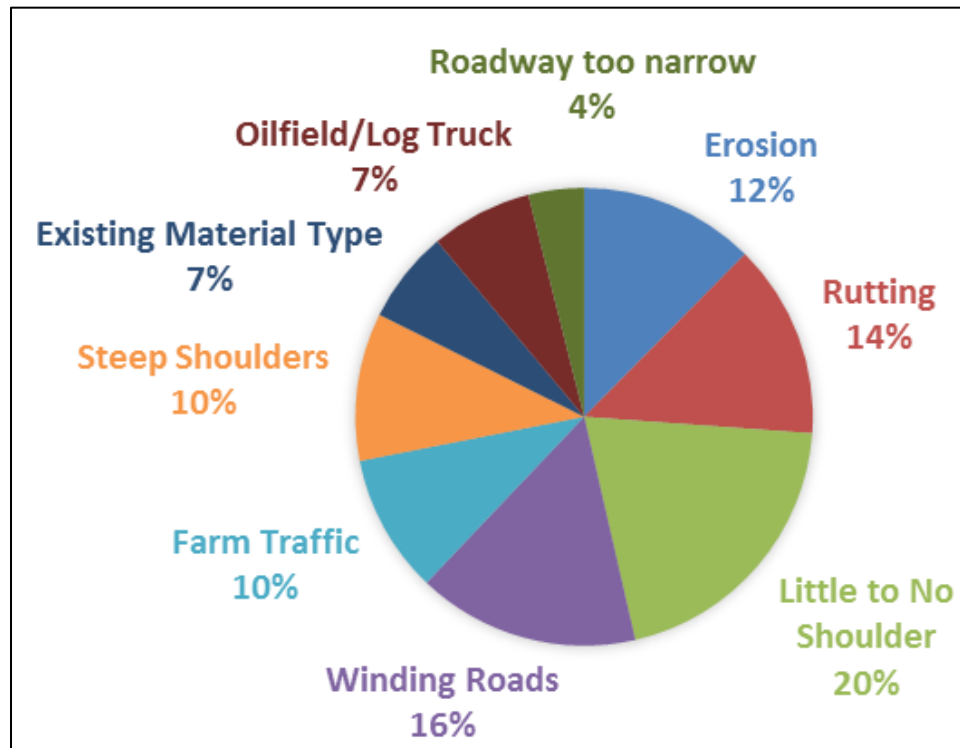
Figure 7. Causes of edge drop-off

The survey collected district information on average shoulder width. Table 4 presents the reported average shoulder widths, which ranged from 8 ft. to 2 ft. Average values and comments from the districts indicate that there are some zero width shoulders (i.e., no shoulders in parts of the state). Figure 7 shows survey results indicating that district personnel believe that *little to no shoulder* is most often the cause of edge drop-offs (20%). These areas with *little to no shoulder* are likely exacerbated by narrow *winding roads* (16%) when *farm trucks* (10%) *rutting* (14%), and *erosion* (12%) occurs and moves the materials off the *steep shoulders* (10%). This comports with the age of these roads and the lack of right-of-way in many areas. Combining these factors, it is easy to see the potential for edge drop-off problems.

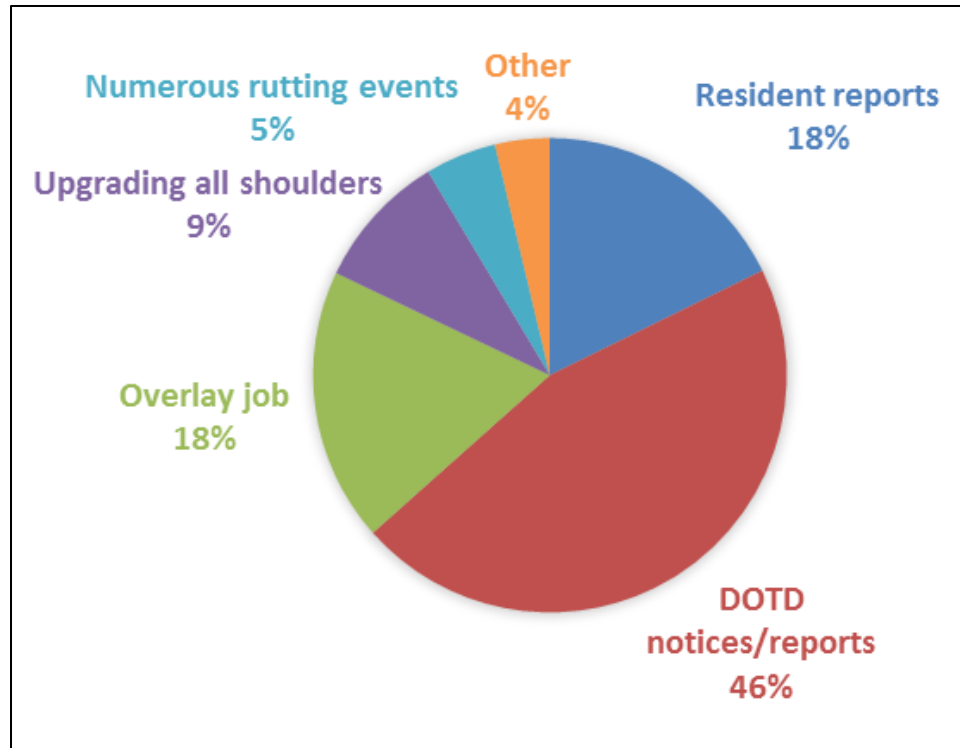
Figure 8. Edge drop-off notification decision factors

The survey asked districts how they selected shoulders for repair. Figure 8 shows the different factors and indicates DOTD most often finds and reports. This likely occurs through DOTD visual, routine inspections, or through their own commutes to work through the area. The responses did not indicate that the edge drop-offs were located via the pavement management section (PMS) scans. These scans will be addressed in another section of this report.

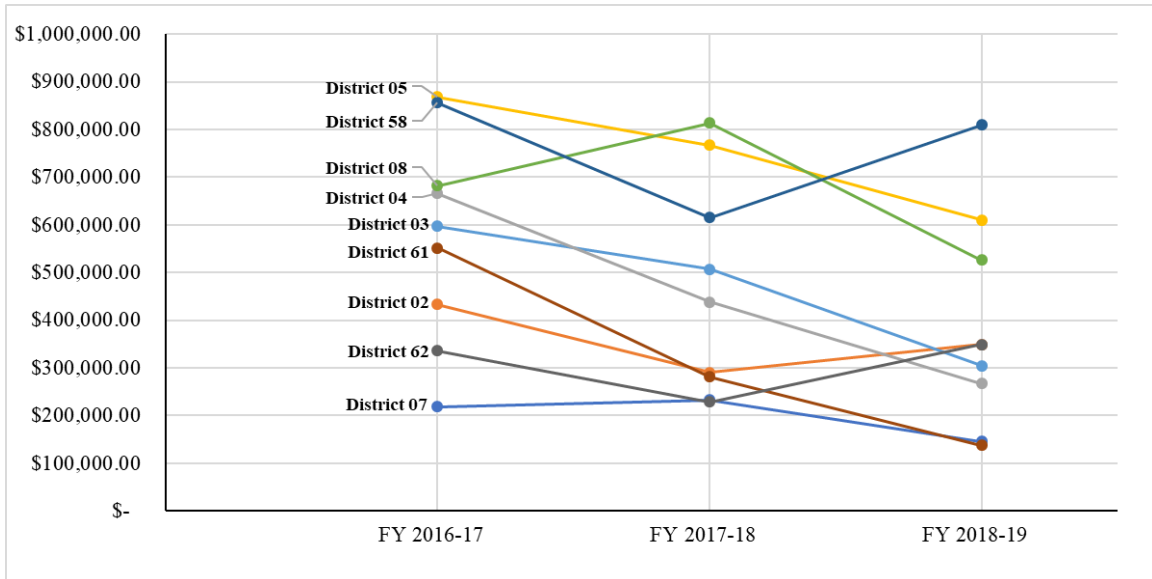
**Figure 9. District shoulder repair FY cost totals**

Figure 9 shows the district trends from year to year. Six of the nine districts saw a decrease in expenditures from FY 2017-2018 to 2018-2019 including two of the northern districts (05 and 08). There were increases in the Districts 02, 58, and 62. District 58 spent over \$800,000 in repairs in 2019. Though most districts saw a downward trend in costs, keeping this trend likely requires finding the most economical solutions, including utilizing readily available material, which requires fewer man-hours for shoulder repairs and fewer recurring visits.

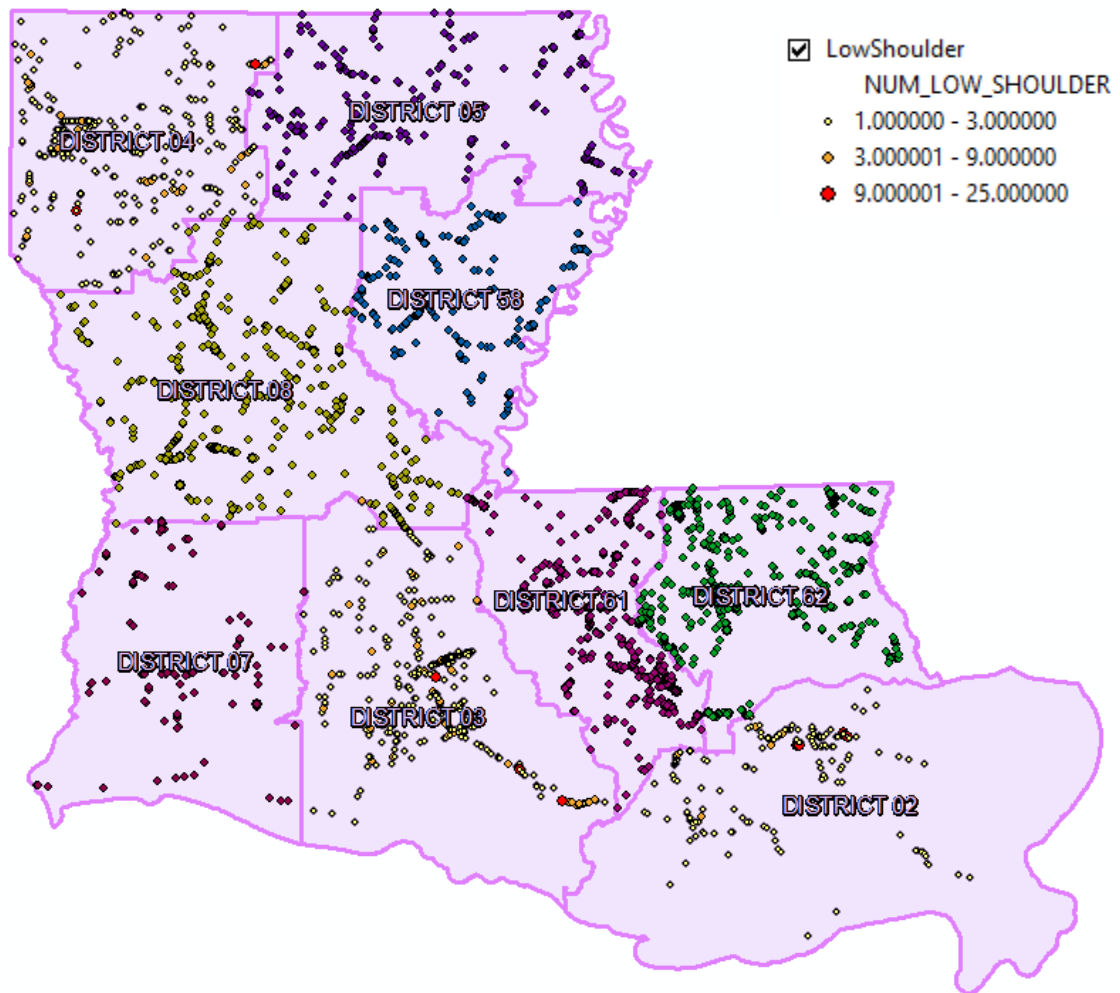
Figure 10. Example of edge drop-off data

Some of the data was difficult to interpret, and the data points may be in question. See Figure 10.

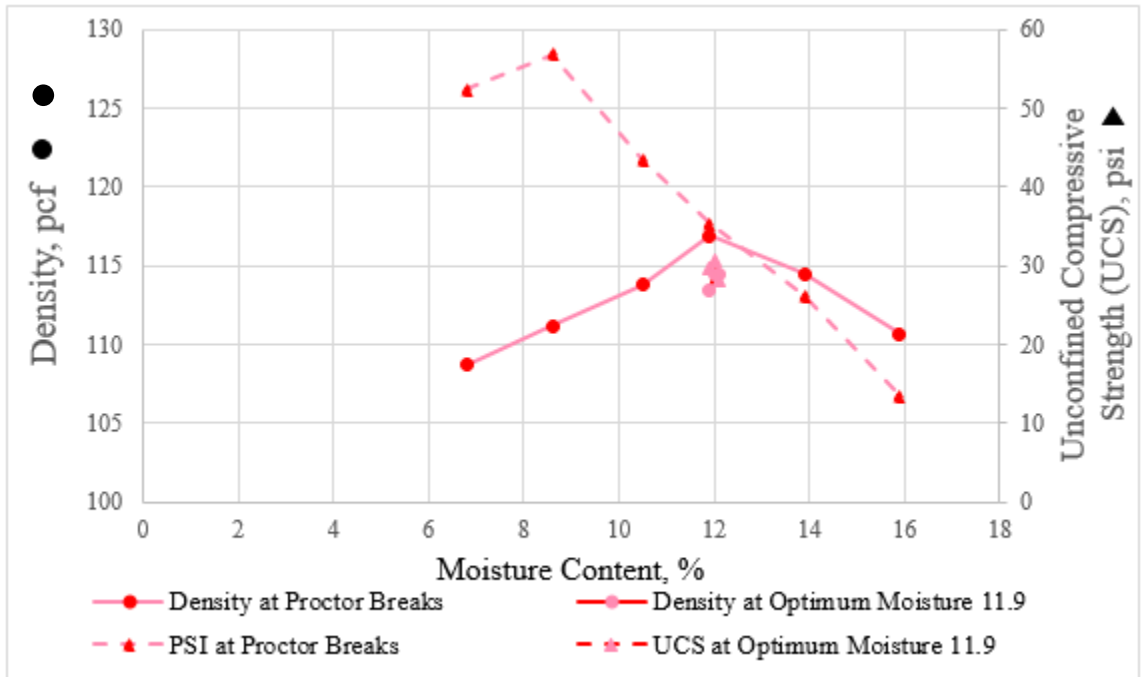
Figure 12. Density and UCS of Mix 3: 25% RAP and 75% Clay

The moisture content affects the density and strength of the molded material. The following figures show the proctor curves and the UCS break strength of those molded samples for each mixture. Figure 12 shows Mix 3 (25% RAP and 75% Clay) test samples. Figure 13 shows Mix 2 (50% RAP and 50% Clay) test samples, while Figure 14 shows Mix 1 (75% RAP and 25% Clay) sample results. The circular points represent proctor results, while the triangular symbols represent the UCS for the sample at that moisture. Figure 15 is a collection of all three mixes, and it shows that the density increases as the sample includes more RAP. However, the relationship is reversed when talking about the UCS break strength decreases as the sample incorporates more RAP material.

Proctor densities in the table increase as RAP with aggregate particles is added to the lean clay; however, the RAP alone has a low density due to void spaces between the aggregate. In the mixtures, the smaller clay particles fill void spaces of the RAP, creating denser mixes when combining the clay and RAP materials. The RAP was non-plastic (NP), meaning the material has little to no cohesion (silt or clay) in the sample. By adding CL to the RAP, we create more dense material that has cohesion to hold loose RAP particles in place on the road shoulder.

Table 10 shows the unconfined compressive strengths (UCS) of each material molded with standard Proctor compaction at the optimum moisture content. The laboratory-molded samples were compacted with an automatic Proctor hammer, extruded, and compressed to determine their strength on the same day, thus same-day breaks. The UCS results in pounds per square inch (psi) and decrease as more RAP is added to the lean clay, likely due to increasing the percentage of cohesionless RAP in the sample. Researchers conducted California Bearing Ratio (CBR) tests on the all samples to account for the cohesionless RAP. CBR mold confinement will help represent in-place strength of all material for comparison since RAP is non-plastic (NP). Table 10 shows the average moisture and average density of the tested samples. The values are similar to the original Proctor values of OMC and MDD.

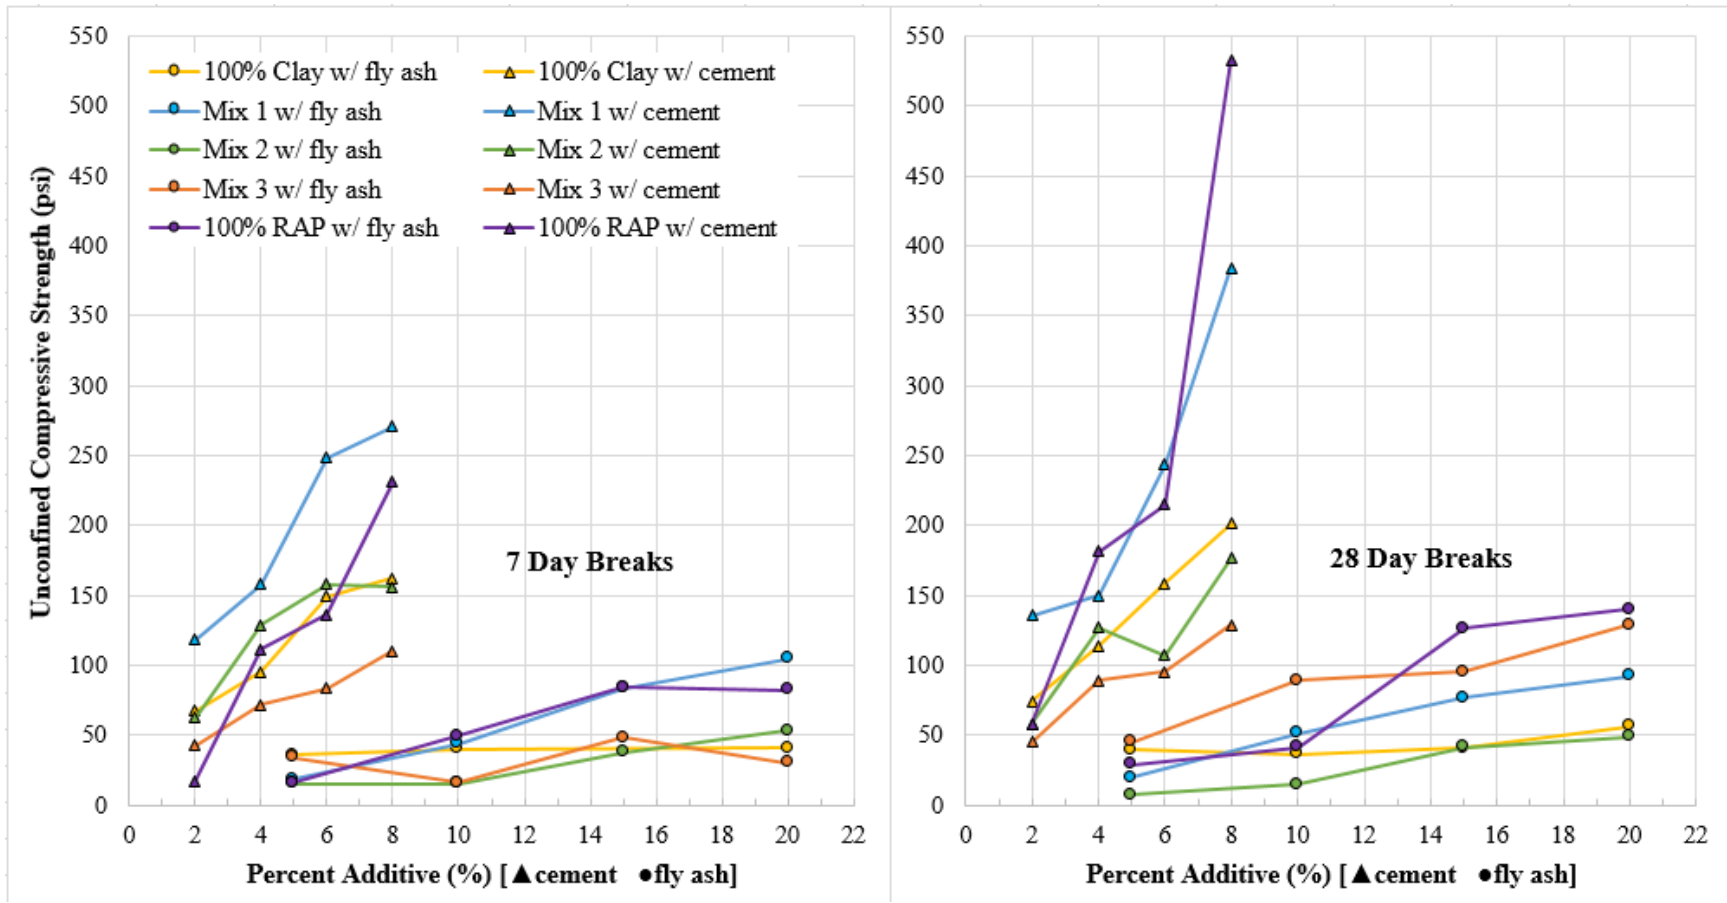
Figure 16. Average compressive strengths

The data shows that strengths generally increased with more additive and time; however, fly ash percentages are relatively high and did not prove to have the compressive strength needed to provide an adequate roadway edge for the effort. Regarding cost, fly ash is less expensive than cement, yet fly ash requires a higher quantity of material to produce the strengths that of cement. Figure 16 shows the comparison of average compressive strengths of both cement and fly ash additives. A huge increase of strength is indicated when cement additive cures longer from 7 days to 28 days; however, this is not the case for the fly ash results.

Note: Gray shaded boxes for Mix 1 and 100% fly ash incorporated a different fly ash from New Roads, LA.

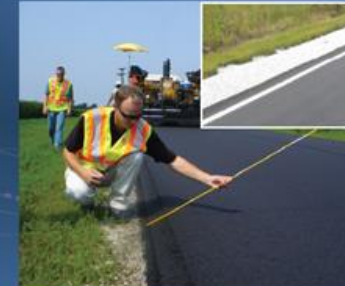
The Safety Edge is shown here in the main photo during construction. Upon project completion, the adjacent unpaved material should be graded flush with the top of the pavement (inset photo). The Safety Edge creates a more durable pavement edge and makes recovery from any future drop-off much easier and safer.

The Safety Edge is an effective solution to reduce pavement edge-related crashes, by shaping the edge of the pavement to 30 degrees using a commercially available device (called a shoe) that can be attached to the paver. The asphalt is extruded under the shoe, resulting in a durable edge that resists edge raveling. Research has shown this 30-degree shape allows drivers to re-enter the roadway safely.

After paving with the Safety Edge, the adjacent material should be regraded flush with the top of the pavement. This is considered the best practice, and provides the safest pavement edge. The difference is that when the edge becomes exposed, this shape can be more safely traversed than a vertical edge.

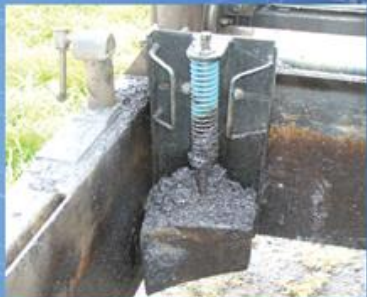
The shoe that creates the Safety Edge is a special edging device that asphalt paving contractors can install on new or existing resurfacing equipment.

Very few changes are needed. The key item is to add a specially designed shoe, per manufacturer's instructions, to the paver to create the Safety Edge. While paving, the shoe should be monitored and adjusted to keep the bottom edge of the device in contact with the road shoulder surface. Using the Safety Edge should not affect the rate of production.

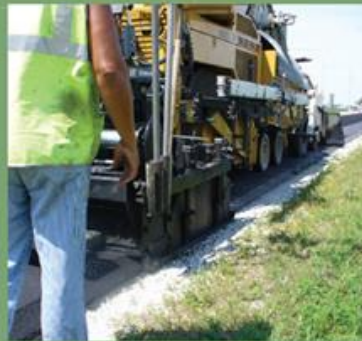
Safety Edge treatment being applied during an asphalt overlay.

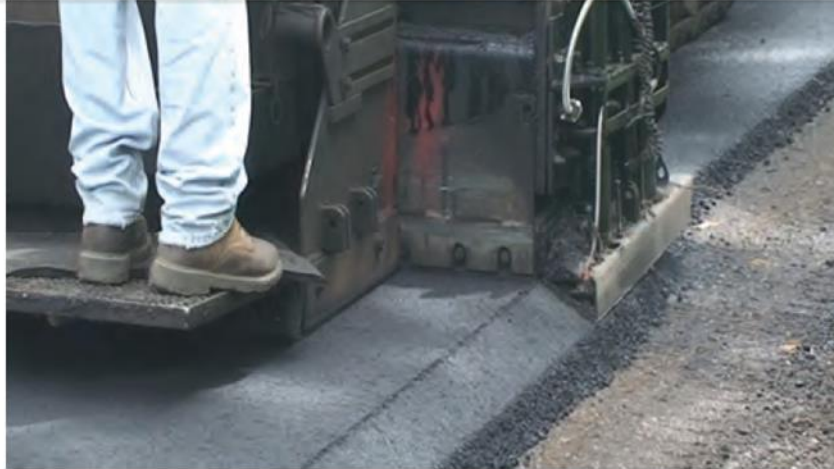
## Carlson Safety Edge<sup>SM</sup> - brochure information [22]

Every Carlson Safety Edge comes standard with an electric heat element. These long lasting, state-of-the-art elements provide even and efficient heat to the attachment, enabling extrusion of material and sealing of the edge. Heating of the attachment also eliminates cold spots from forming, allowing for clean formed edges. Built with heavy duty components, including 450 Brinell rated steel, the Carlson Safety Edge outlasts similar attachments while ensuring consistent paving quality use after use.
