1. Report No. FHWA/LA.09/440		2. Government Accession No.	3. Recipient's Catalog No.
4. Title and Subtitle Field Verification for the Effectiveness of Continuity Diaphragms for Skewed Continuous P/C P/S Concrete Girder Bridges		5. Report Date October 2009

Field Verification for the Effectiveness of Continuity Diaphragms for Skewed Continuous P/C P/S Concrete Girder Bridges

LTRC Project No. 06-3ST
State Project No. 736-99-1373

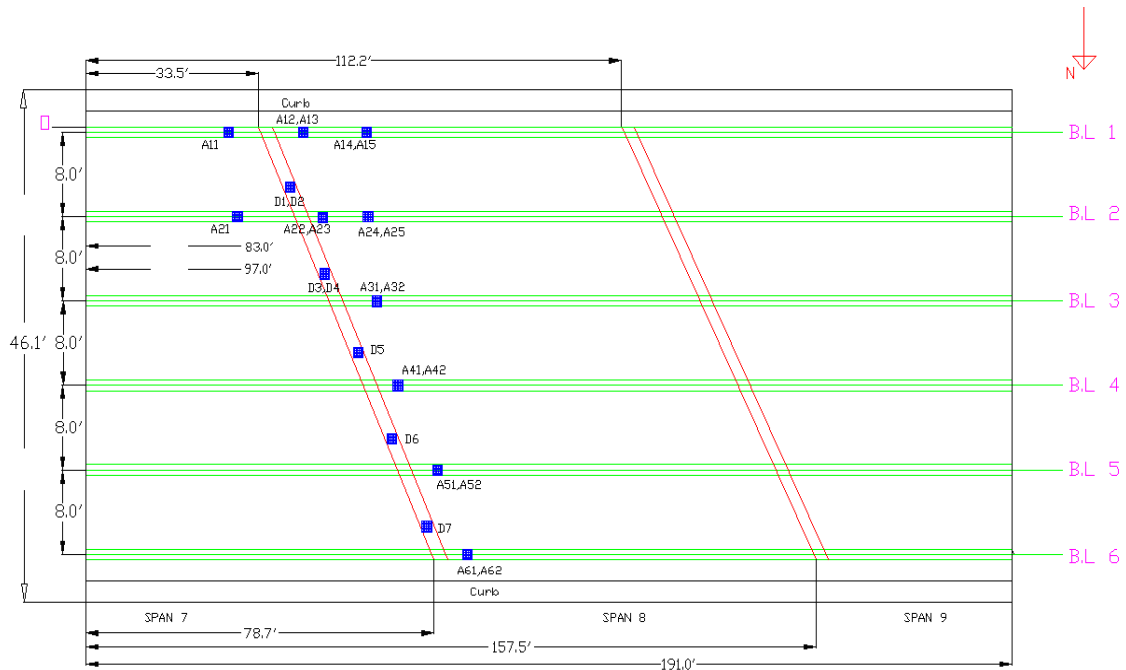
Figure 8
Instrumentation on the bridge

The superstructure of the bridge was instrumented with 25 reusable transducers. The location of the transducers can be seen in Figure 8. The transducers were placed at the critical locations in Spans 7 and Span 8. Several transducers were placed on Span 8 since it was the longest span in the bridge and would give the largest response to the applied loads. Girders 1 and 2 were instrumented with five gauges each. Girders 3, 4, 5, and 6 were instrumented with two gauges each. Continuity diaphragms were instrumented with seven gauges. For each beam, two gauges were placed at the same location; one at the top of the flange and one at the bottom of the girder. Gauges on the top flange were placed 3 inches below the deck, gauges on the bottom side of the girders were placed 4 inches from one end. For the continuity diaphragms five gauges were placed 6 inches below the deck, and two gauges were placed 6 inches above the bottom of the continuity diaphragm.

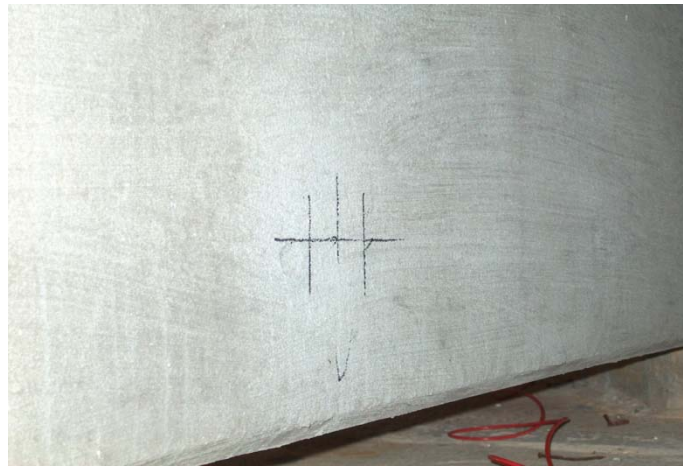
Figure 11
Marking on girder for placing of transducers

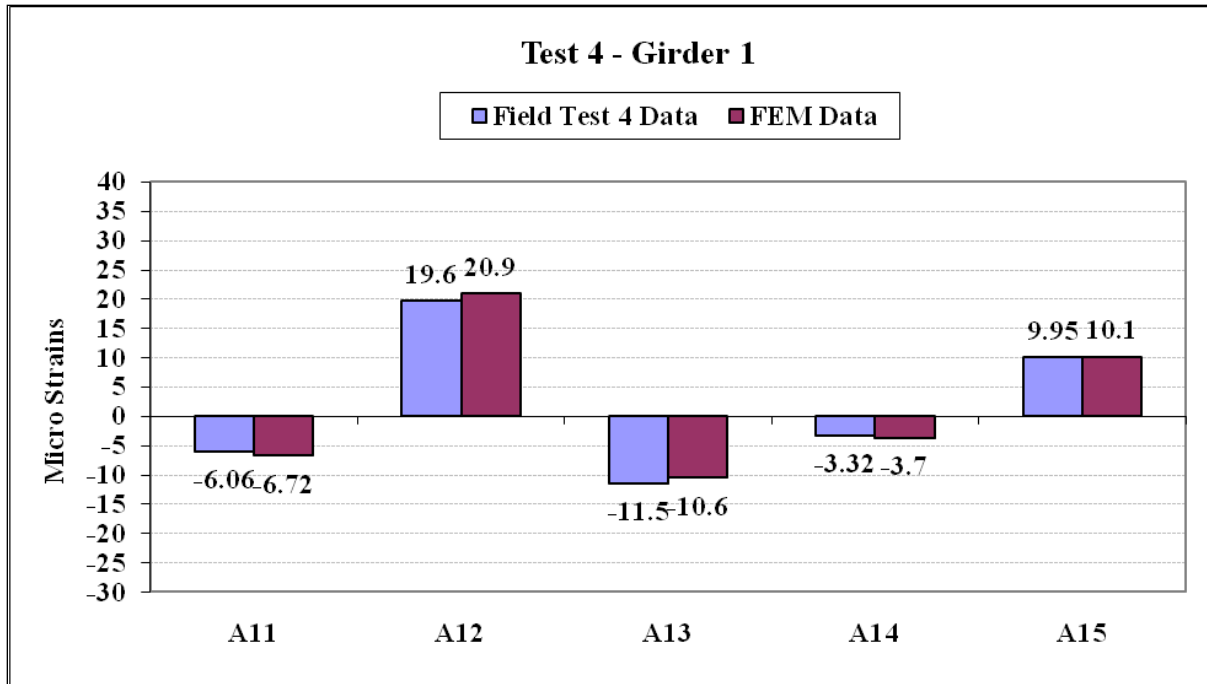
Figure 27
Comparison of strains in Girder 1 of test 4

The test truck traveled from east to west at 3 to 5 mph. When the test truck's back tire crossed the 63-ft. mark, the truck was stopped and data was collected. The 63 ft. were marked from a reference point which is the south corner of the exterior curb. In the transverse direction, the truck was traveling 8 ft. 9 in. from the south exterior curb. Predicted and actual strains are within 10 percent as shown in Figures 27, 28, and 29. The gauge number and location are shown in the bridge instrumentation plans in Appendix A.

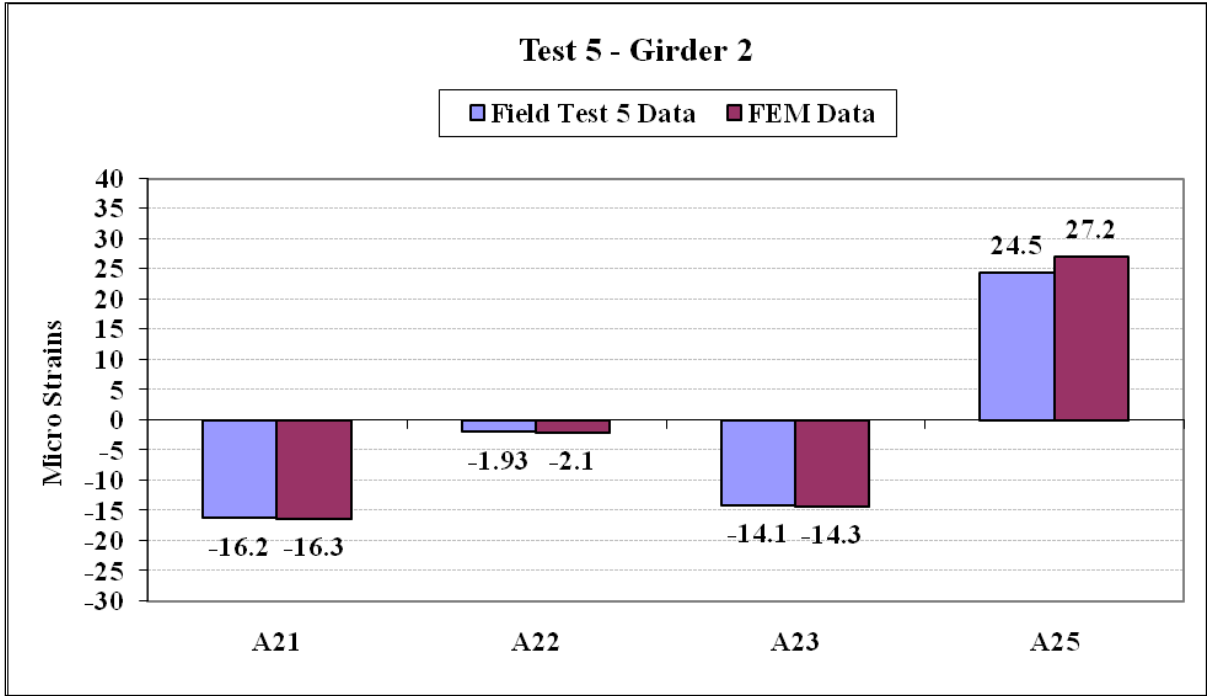
Figure 31
Comparison of strains in Girder 2 of test 5

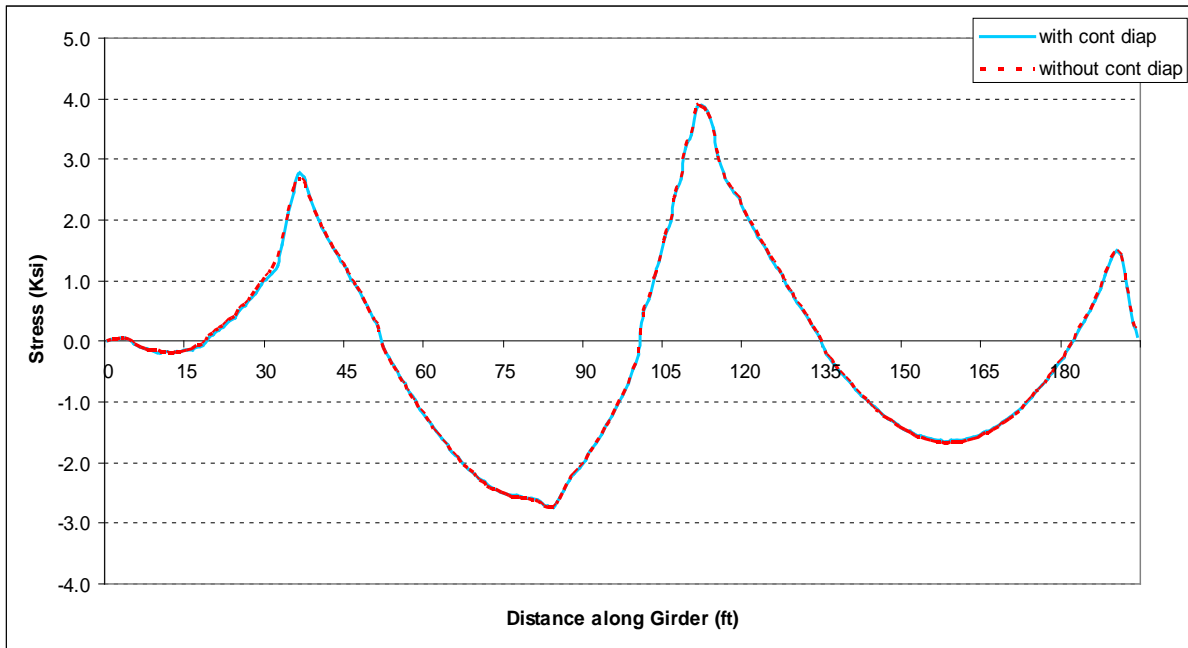
Figure 36
Comparison of stresses of Case I and Case III for top elements in Girder 1

The stresses were compared for the top elements and bottom elements of Girder 1 and Girder 2 of Case I and Case III. The results are shown in Figure 36 to Figure 43. Case I refers to the maximum positive moment in the girders with continuity diaphragms, and Case III refers to the maximum positive moment in the girders without continuity diaphragms. The effects of continuity diaphragms on maximum stresses in bridge girders are negligible.

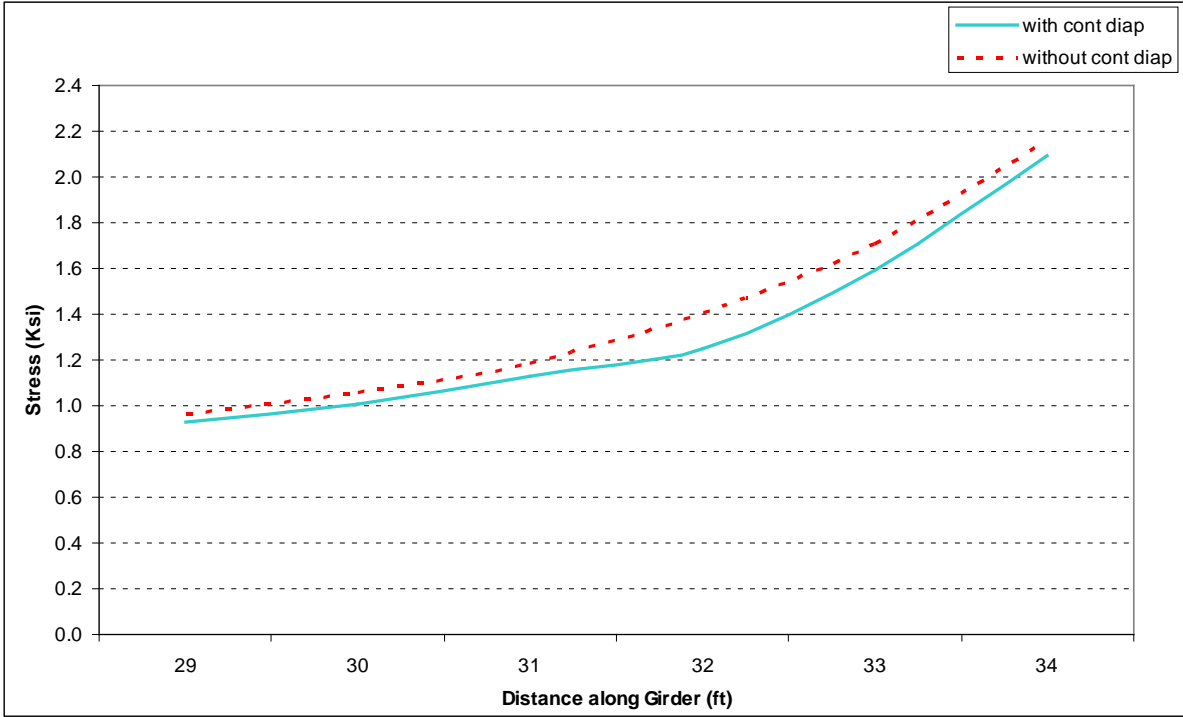
Figure 37
Enlarged view of stresses of top girder elements of Girder 1

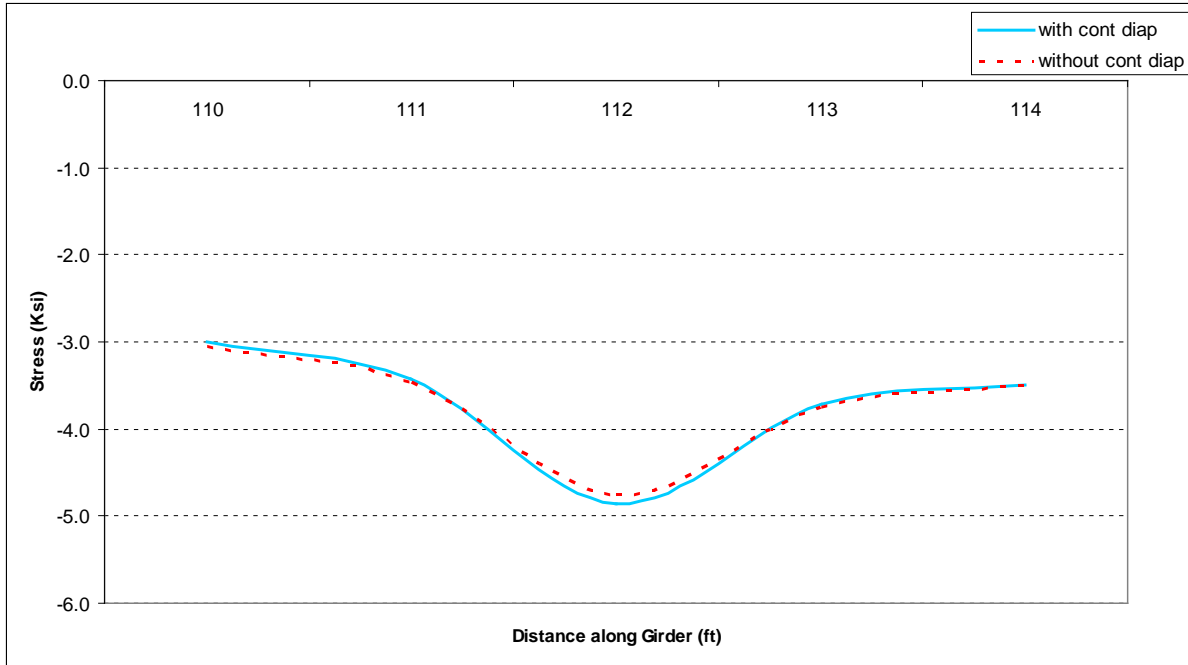
Figure 39
Enlarged view of stresses of bottom girder elements of Girder 1

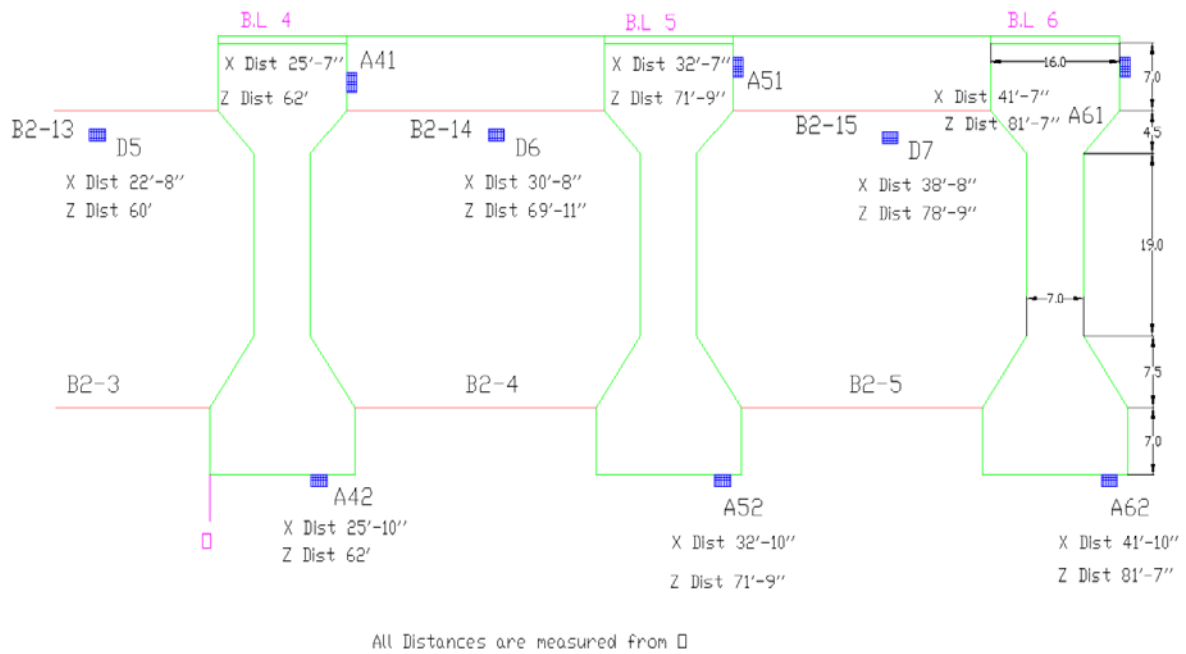
Figure 58
Cross section at section D of Case I

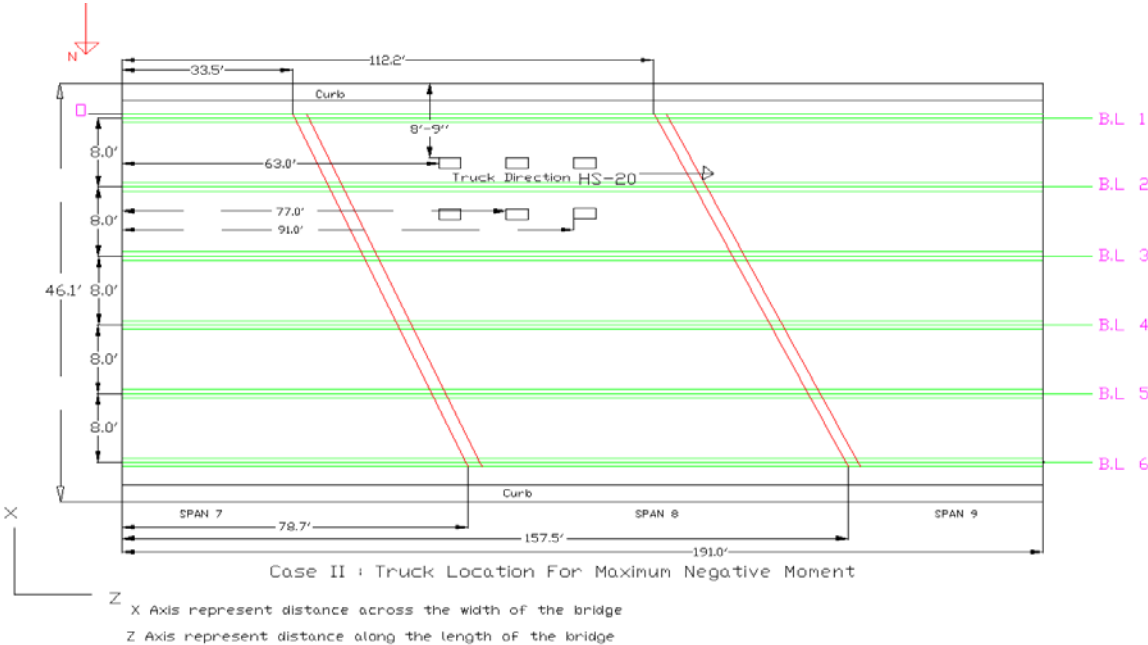
Figure 59
Truck location for maximum negative moment in girder

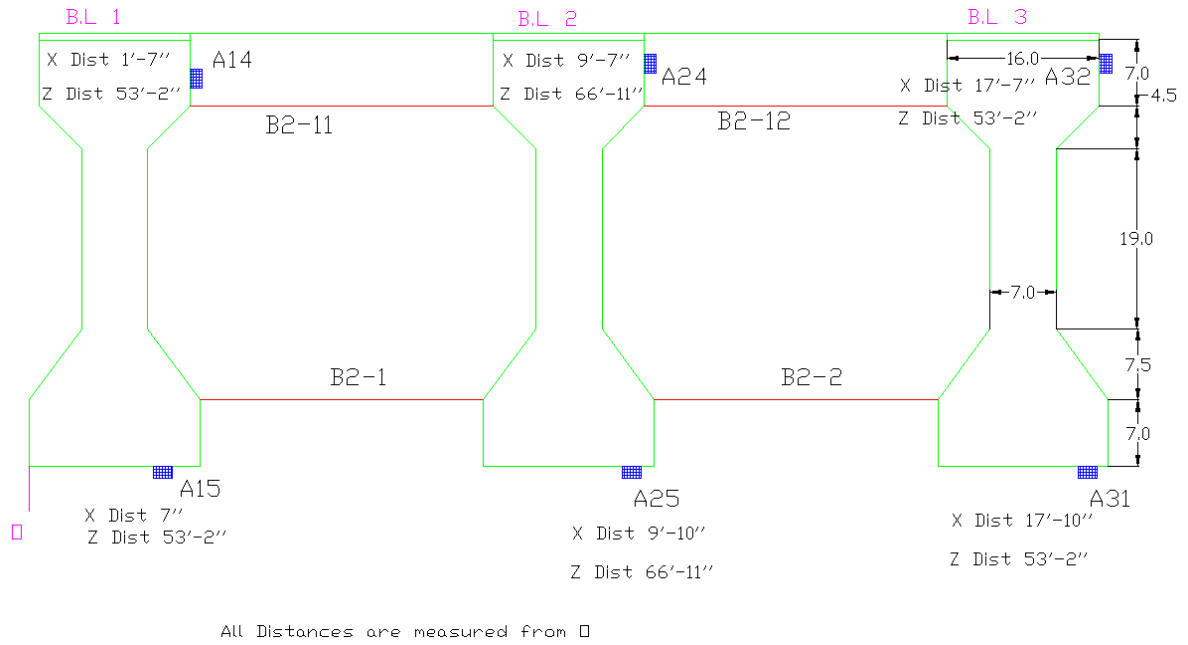
Figure 63
Cross section at section C of Case II

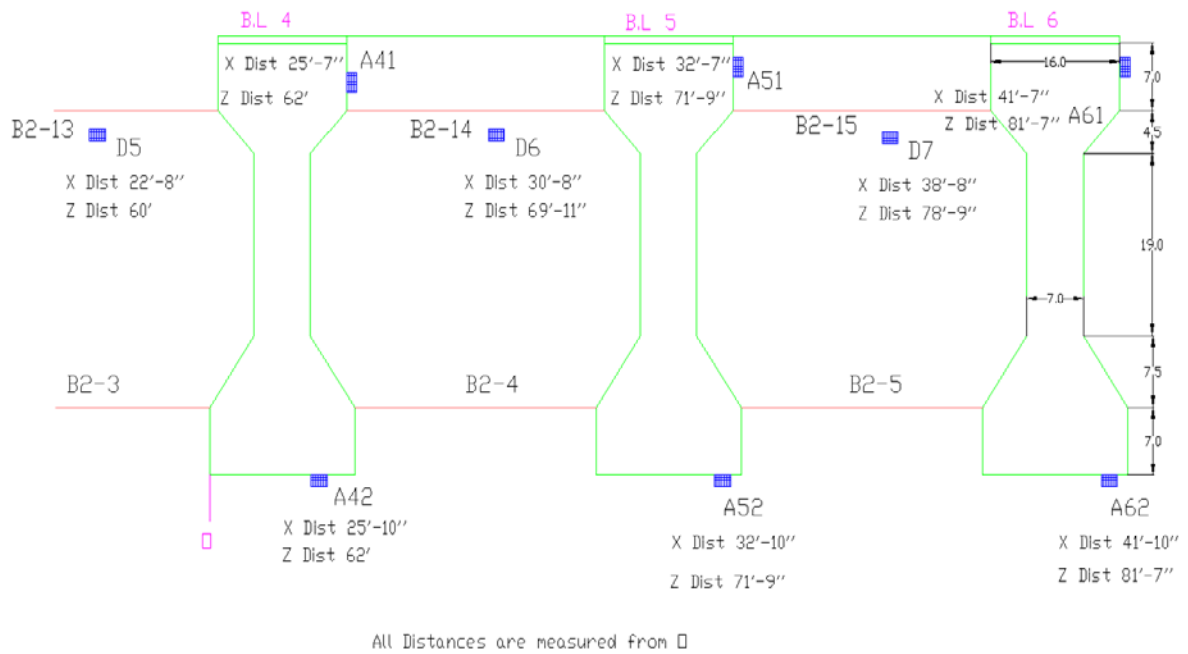
Figure 64
Cross section at section D of Case II
