Louisiana Transportation Research Center

Final Report 613

Field Validation of Equivalent Modulus for Stabilized Subgrade Layer

Mark Martinez, P.E.

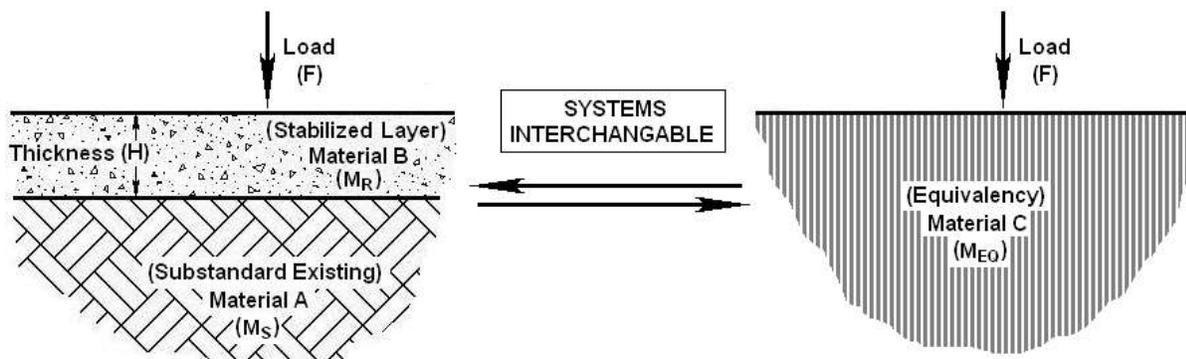
Figure 1
Pavement system equivalency

In analytical terms, designers must envision a site as a two-layer system if they are to take advantage of a lime treatment's added structural capacity. The left side of Figure 1 illustrates such an arrangement with Material-B (the portion of the existing soil matrix that is to be lime treated) serving as the first layer of such a two-layer system. Material-A (the semi-infinite remainder of the existing soil matrix that the treatment effort will not impact) serving as the second.

The MET used in conjunction with the Boussinesq Equation serve as the methodology by which an equivalency like that depicted in Figure 1 can be realized [1, 2]. There are numerous references available that thoroughly detail this methodology along with the theory that underlies the MET and, as such, the details will not be recounted here. For those interested, however, a fuller treatment has been provided in Appendix A.

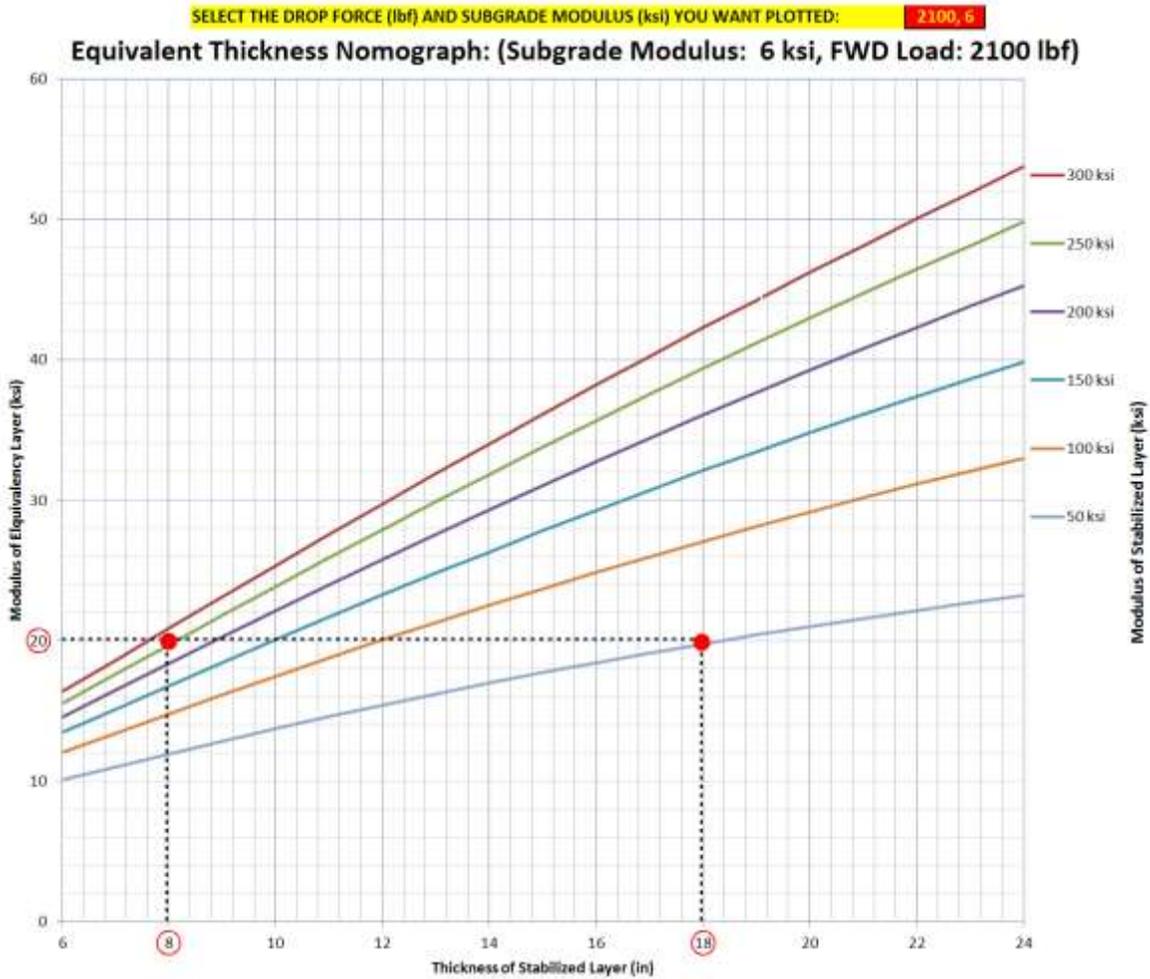
Figure 2
Output from LTRC's EMA spreadsheet

The field at the top of Figure 2, highlighted in yellow and red, indicates where the user's inputs have been logged into the spreadsheet. The "2100, 6" figure shown in this field indicates that the user wishes to log a condition wherein a site is exhibiting a subgrade modulus of 6 ksi under a load application of 2100 lbf. The resulting five plots show the equivalency conditions that can be achieved when treatments to a given depth and modulus are applied.

For example, the plot shows that if the top 18 in. of subgrade material are treated so as to achieve 50 ksi performance then the resulting equivalency would be 20 ksi. Note, however, that the same 20 ksi equivalency can be achieved through the treatment of only 8 in., provided that this treatment achieves 250 ksi within that 8 in. The advantage of the EMA spreadsheet is that it permits the user to quickly explore design alternatives without having to directly carry out iterative O-B calculations.

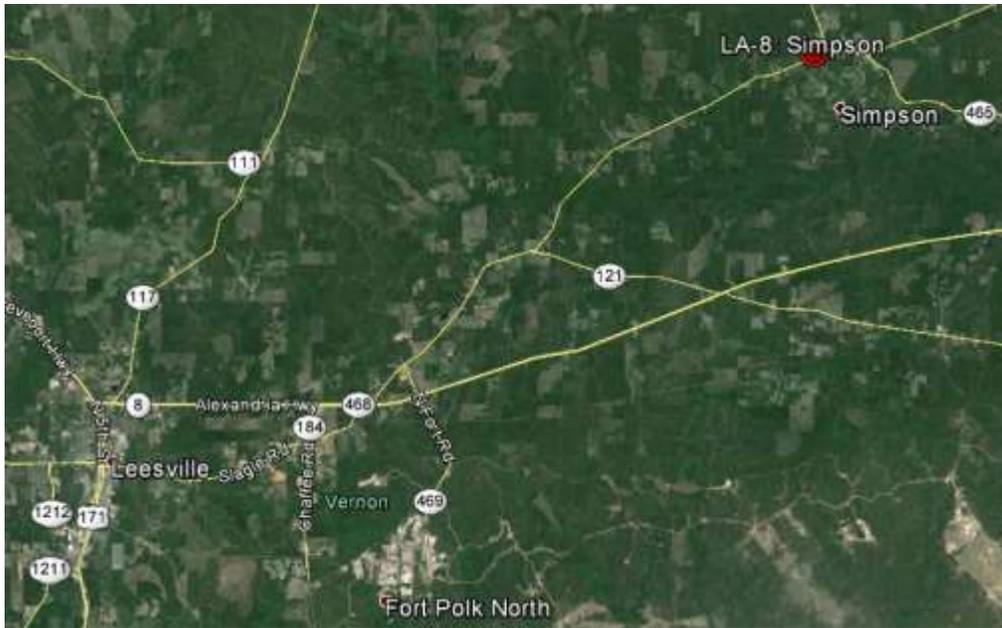
Figure 4
Map of LA 8 project (detail)

Figure 4 depicts a detailed map of one of the sites tested as an example (LA 8 near Simpson in Vernon Parish). Figure 5 shows the layout of 29 FWD test points that were tested on LA 8 and Figure 6 provides a cross-section of the LA 8 pavement depicting the layer thicknesses and lime content. Figure 7 provides a detailed summary of LA 8’s Natural Subgrade Properties as per NCHRP 9-23b and USDA NCRS Soil Unit Data.

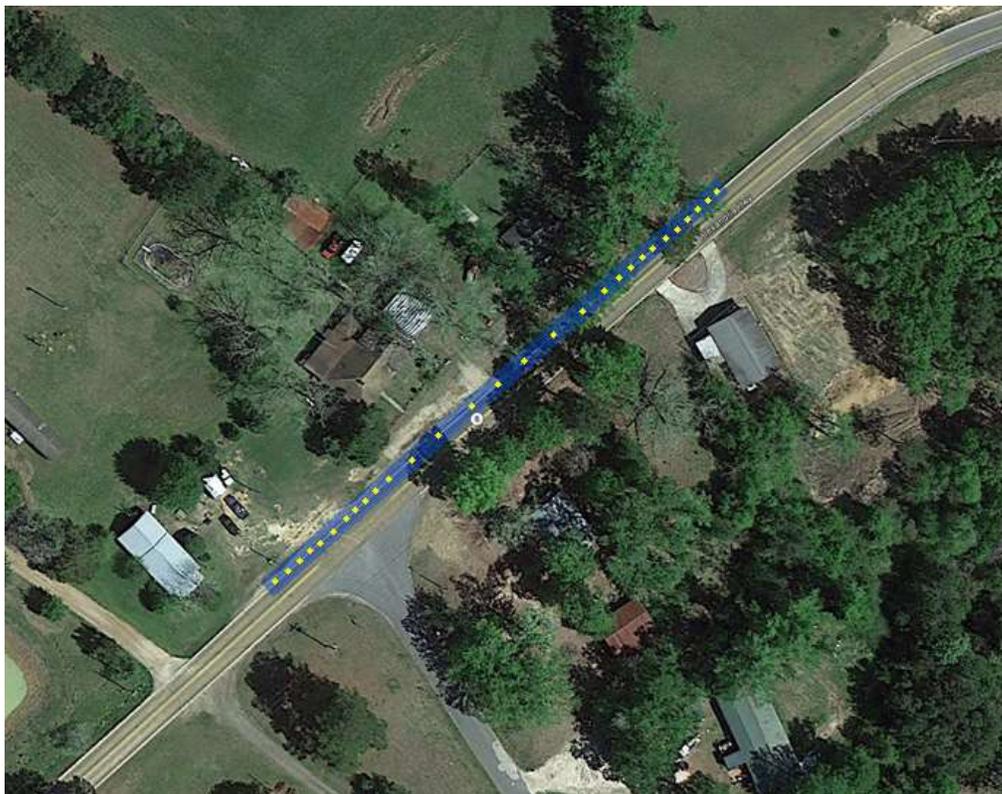
Figure 5
FWD test locations along LA 8

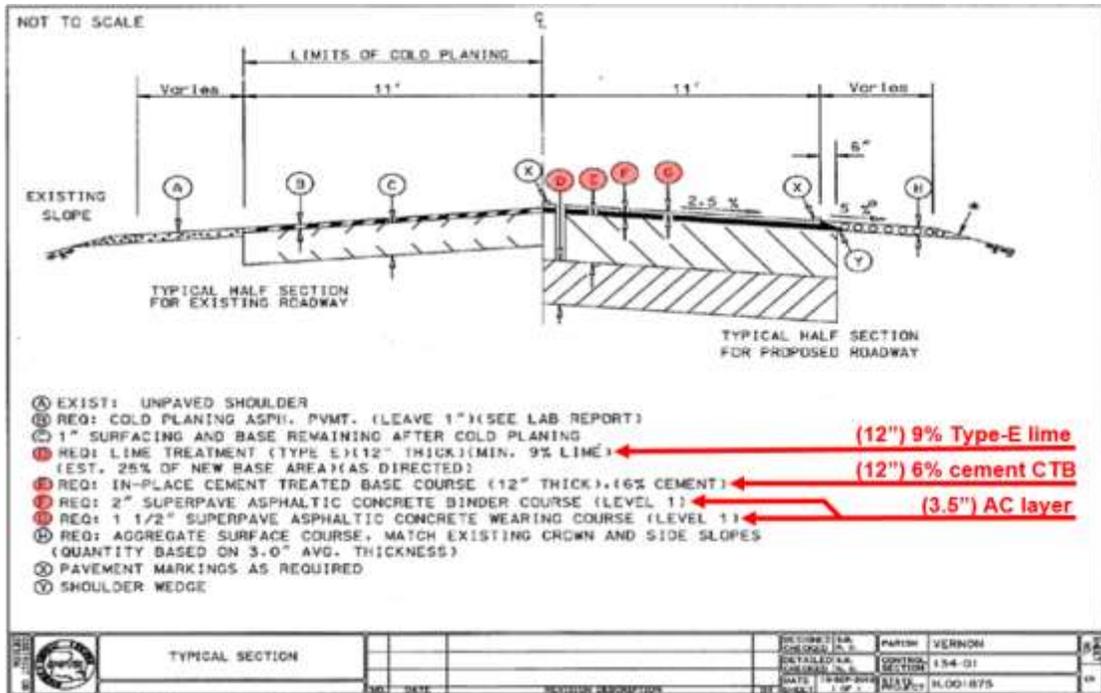
Figure 6
LA 8 cross-section

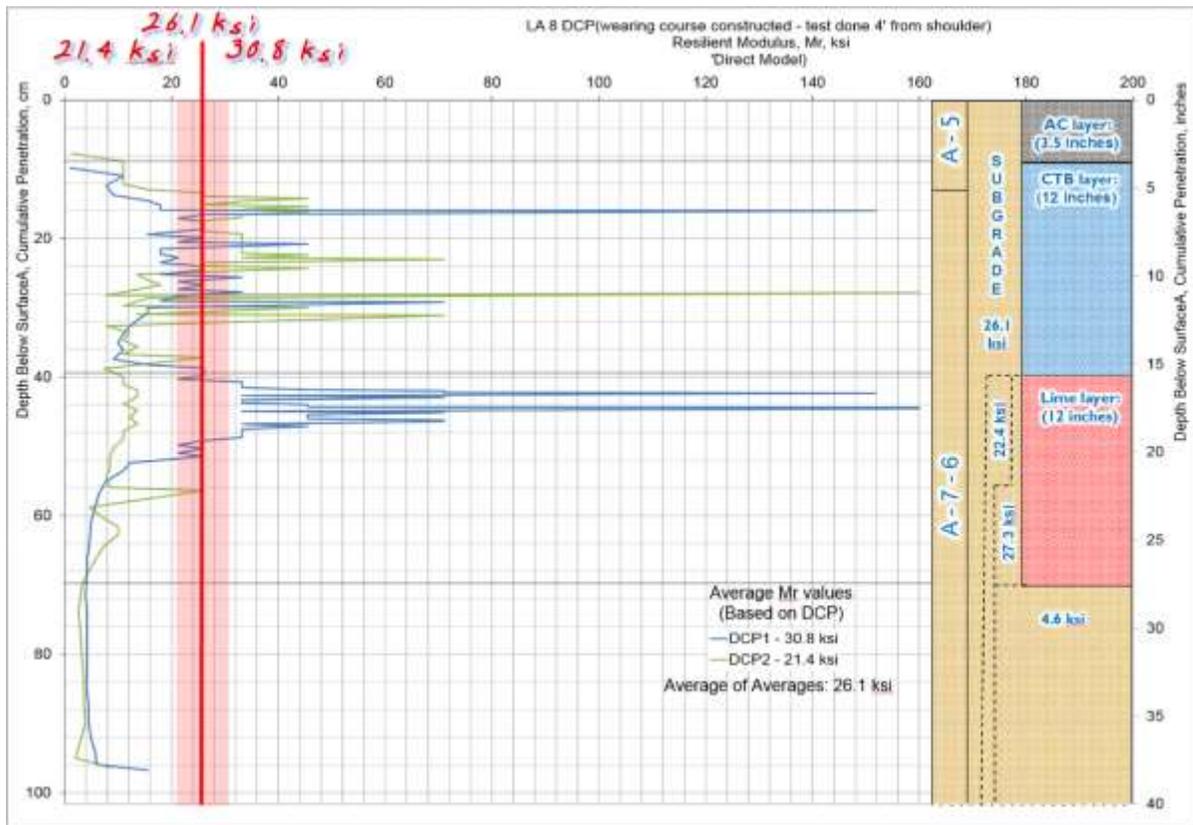
Figure 8
LA 8 DCP results

Figure 8 shows that there were two DCP tests that were run on LA 8. The blue curve represents the first DCP test (DCP1) and the green curve represents the second DCP test (DCP2). Roughly 40 in. of soil were penetrated as can be seen on the vertical axis. The horizontal axis displays the modulus values that were recorded with respect to depth.

Average M_s values on LA 8 as derived from the DCP curves can be read directly off of Figure 8. It can be seen, for example, that the average M_s for the full 40 in. for DCP1 was 30.8 ksi. For DCP2 it was 21.4 ksi. Combining DCP 1 and DCP2, the average full-depth M_s was 26.1 ksi.

The colored area to the right of Figure 8 presents LA 8's cross-sectional layering referenced against the DCP plots. It shows, for example, that the DCP encountered the interface between the A-7-6 soil and the A-5 soil (see Figure 7) at a depth of about 5 in. very close to the location that the first large spike in the blue DCP1 curve of Figure 8 appeared.

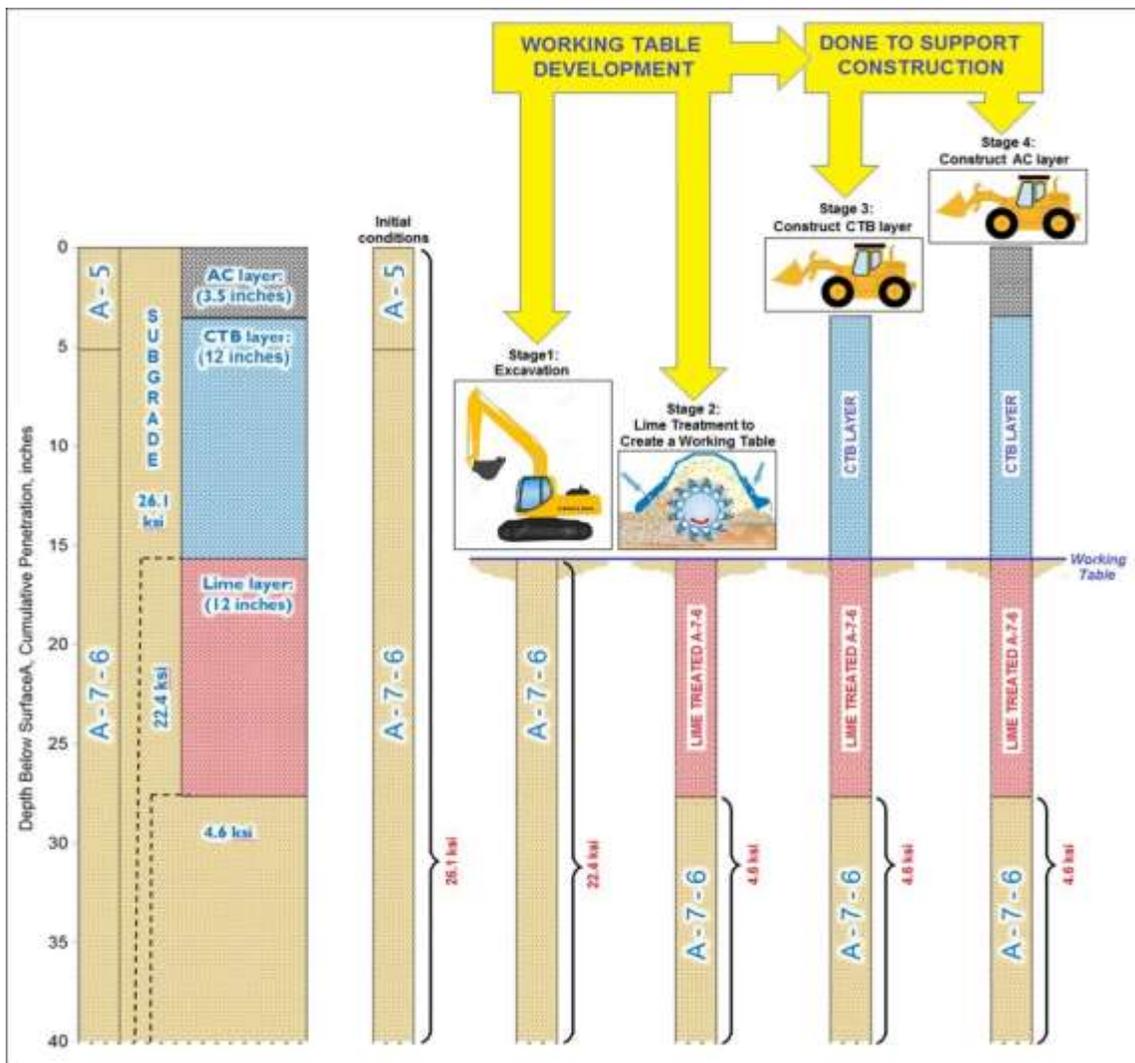
Figure 9
LA 8 stages of construction

The colored zone, repeated in Figure 9, illustrates where the pavement layer interfaces were located relative to the Figure 8 DCP plots. It can be seen, for example, that the heavily spiked region in the two DCP plots of Figure 8 are almost entirely spread out across those depths where the cement treated base (CTB) and lime layers were going to be built. The construction process, illustrated more comprehensively in Figure 9, shows that much of this strength was lost during construction because that stronger soil above what would become the working table was hauled away during Stage 1 excavation.

Figure 9 demonstrates how the DCP curves in Figure 8 predicted the untreated subgrade would continue to weaken even further as construction progressed. Under “initial conditions,” it can be seen that the entire 40-in. column of raw soil had a M_s of 26.1 ksi on average. “Stage 1 excavation” called for the removal of the top 15 in. of overlying soil which reduced the M_s from 26.1 ksi to 22.4 ksi.

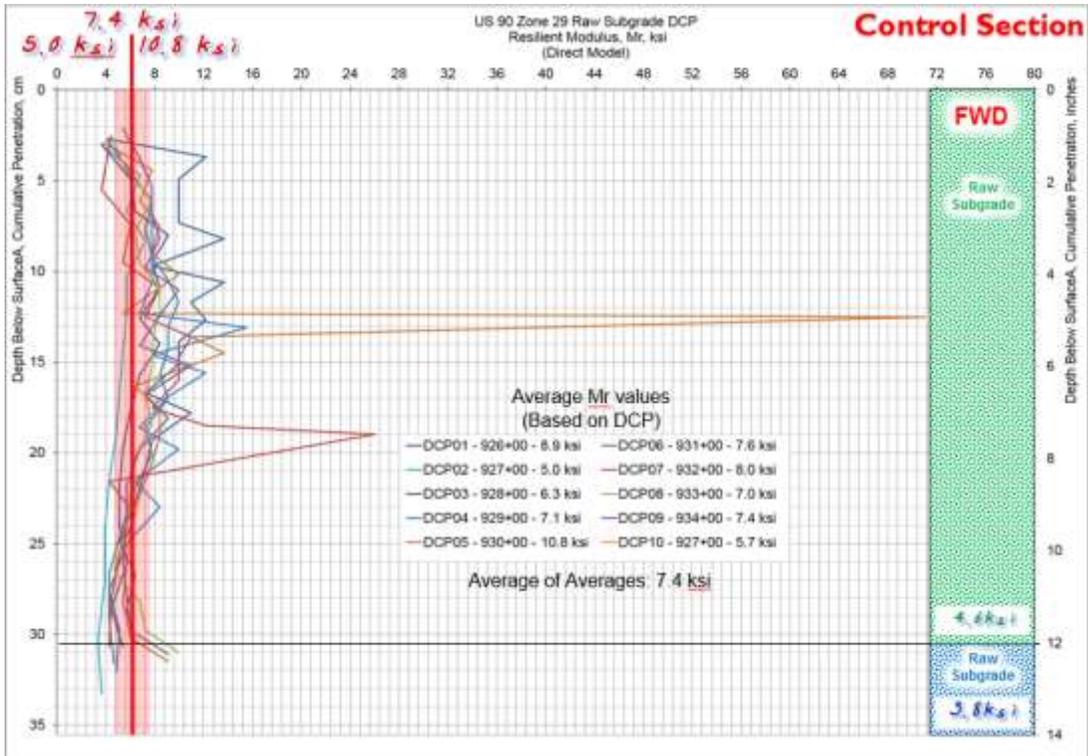
Figure 10
US-90 DCP results on raw subgrade

Figure 10 shows the DCP plots taken on the raw subgrade of US-90. Figure 11 shows the DCP plots taken on the US-90’s treated subgrade. Figure 12 shows the DCP plots taken on US-90’s treated Class II base.

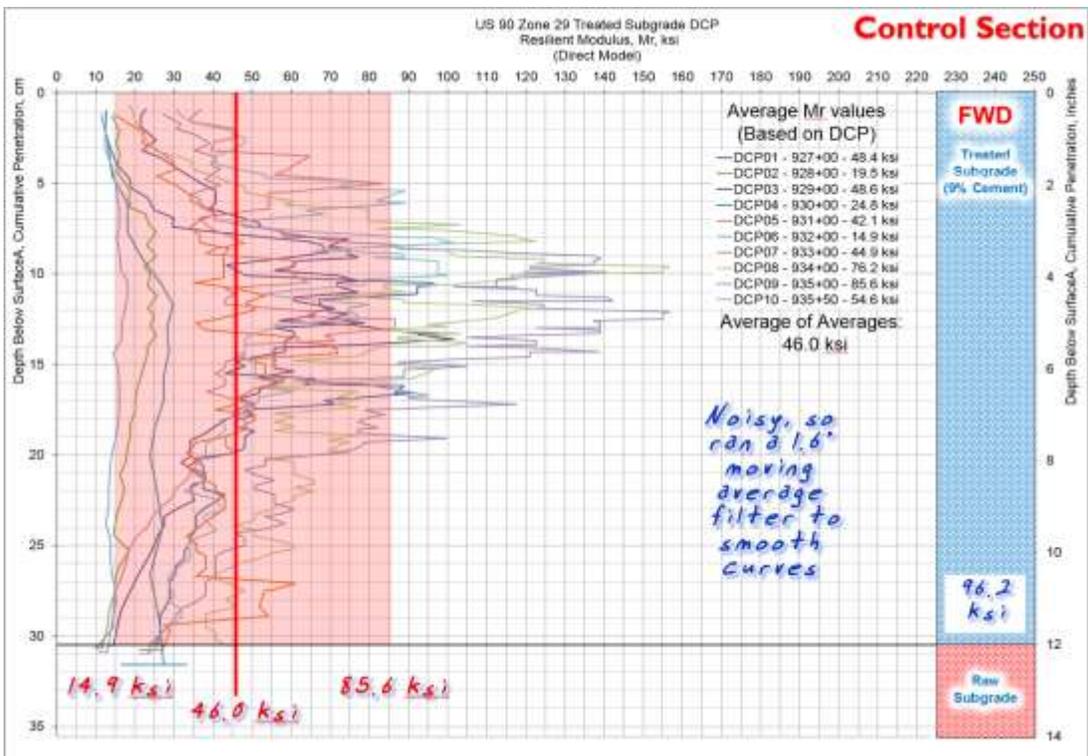
Figure 11
US-90 DCP results on treated subgrade

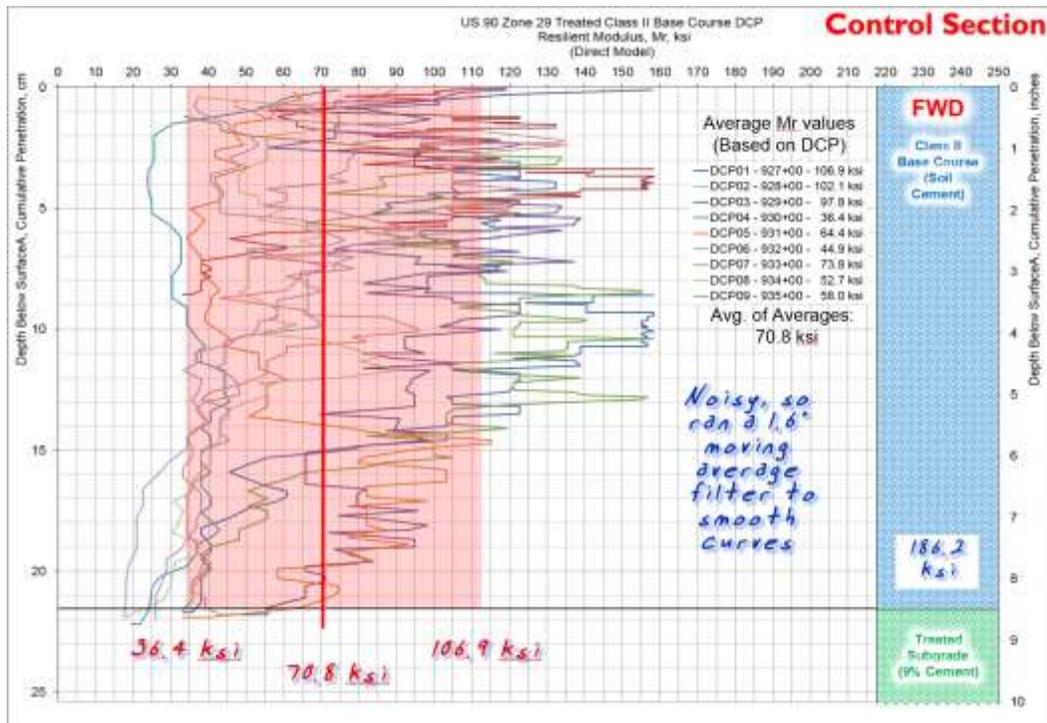
Figure 12

US-90 DCP results on treated Class II base

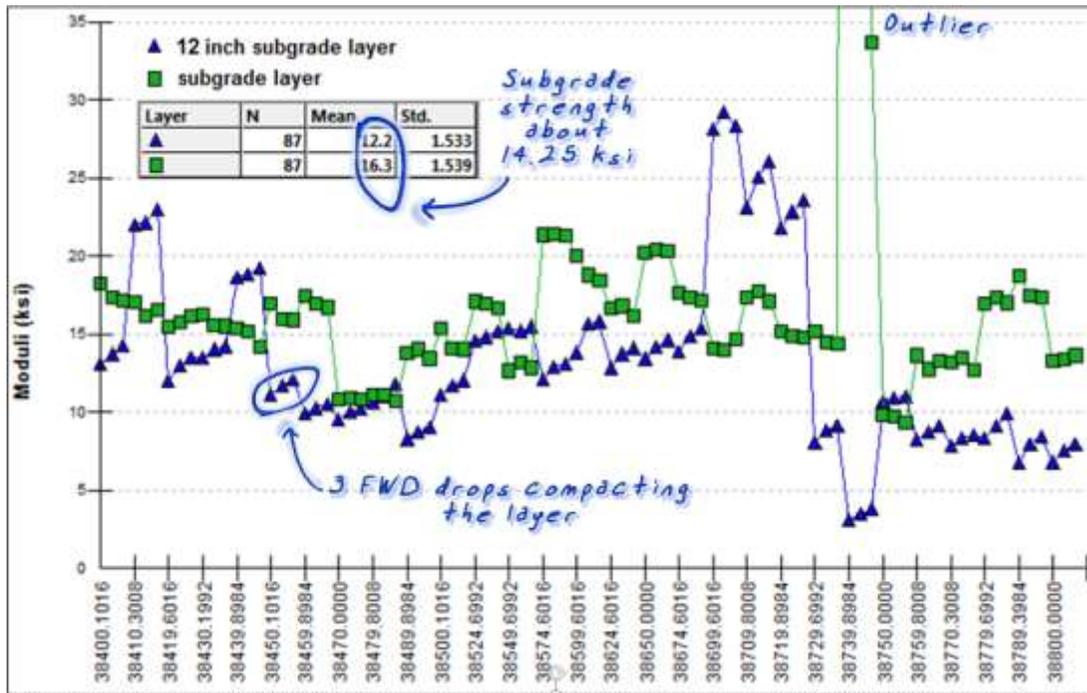
Figure 13
LA-8 FWD results on raw subgrade

The FWD results collected on LA 8, presented in Figures 13-16, show what the FWD data collected as detailed in Table 2 looked like. Figure 13 shows the FWD results as tabulated from tests run atop the raw subgrade, Figure 14 from tests run atop the lime treatment, Figure 15 from tests run atop the soil cement layer, and Figure 16 from tests run atop the AC wearing course.

to be cut into the subgrade to a depth of 12 in. So, that thickness was entered into ELMOD. But, in reality, the two layers implied in Figure 13 are not actual.

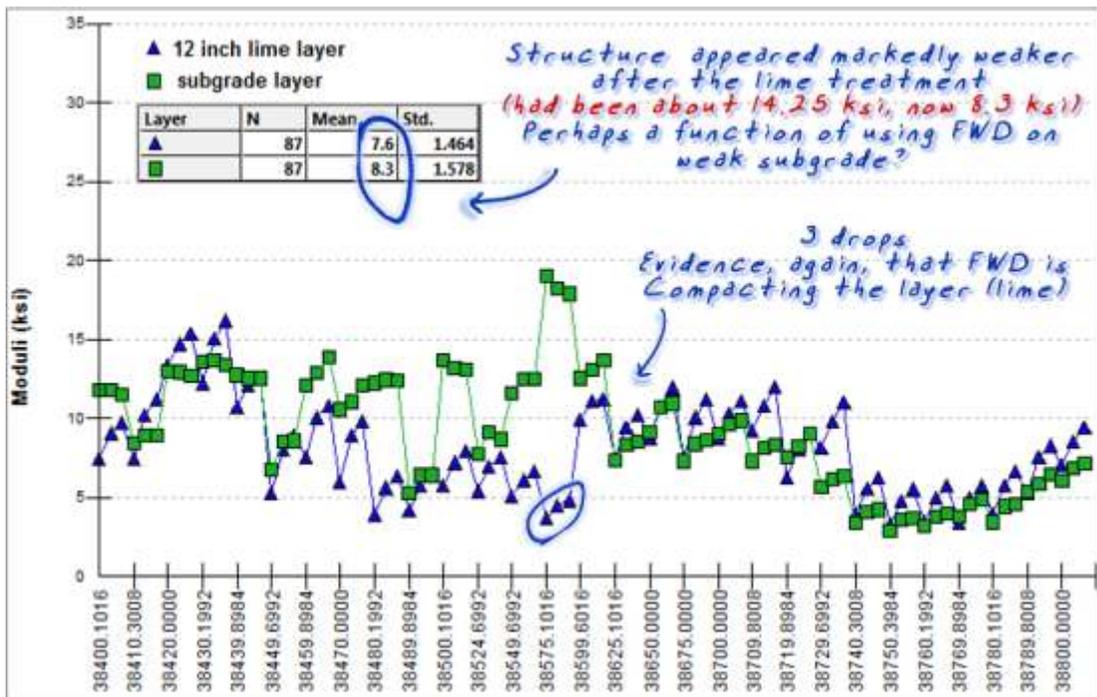
Figure 14
LA-8 FWD results on lime treatment

The various curves shown in Figures 14-16 represent strength figures derived from “true” distinguishable layers (distinct layers having measurable differing properties). It must be noted, however, that the two curves shown in Figure 13 do not represent truly distinguishable layers. As explained in the methodology, all single-layer subgrade systems had to be divided into two arbitrary layers for ELMOD to be able to run. On LA 8, it was known that lime was

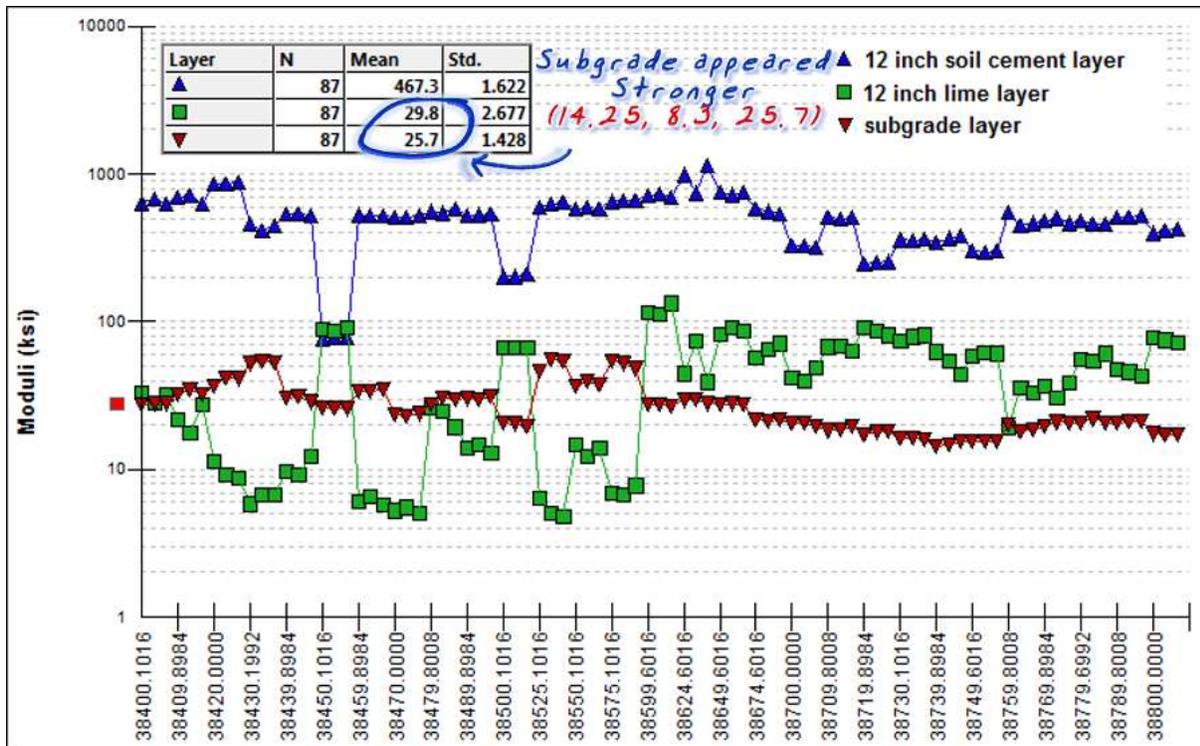
Figure 15

LA-8 FWD results on soil cement

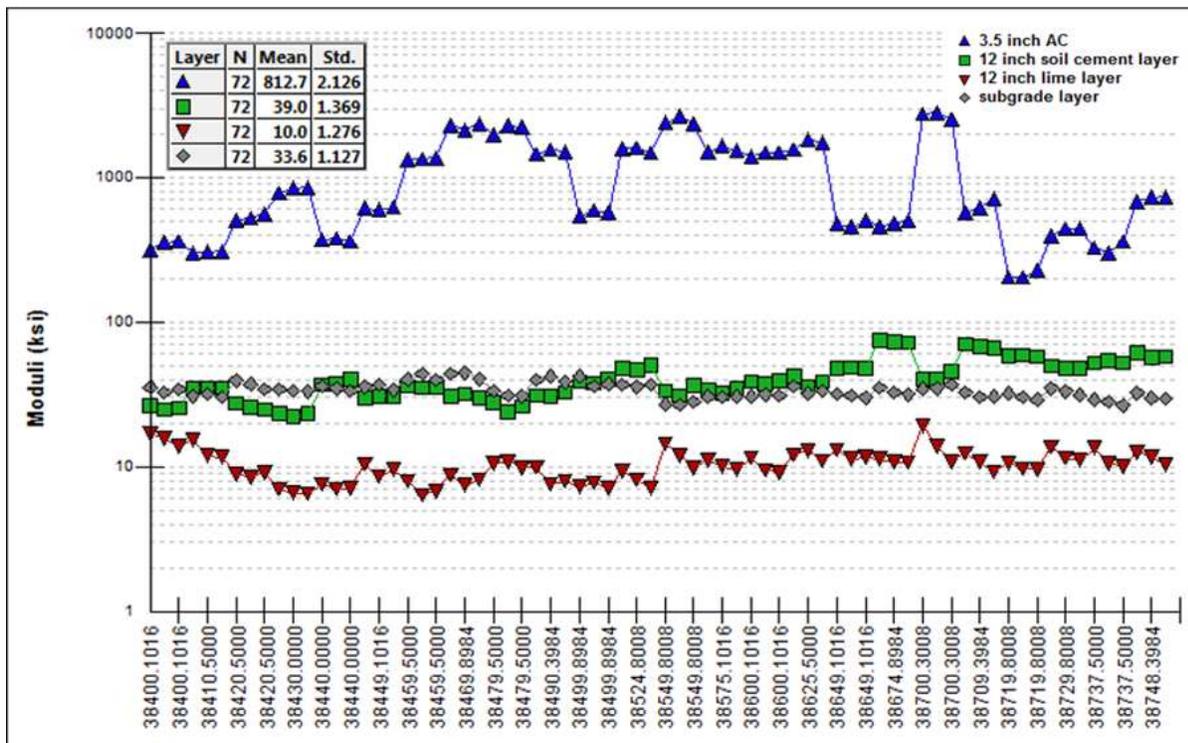
Figure 16

LA-8 FWD results on AC wearing course

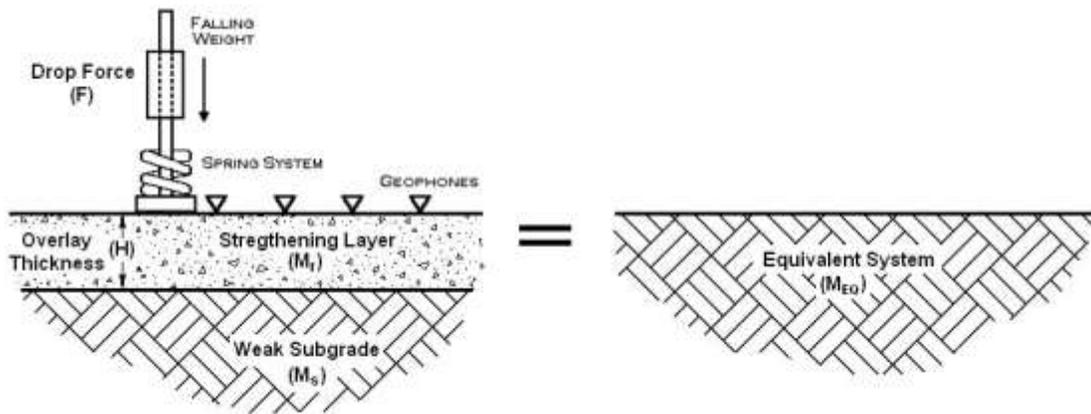
Figure A1

Representation of variables associated with pavement system equivalency

Determination of this Single Equivalent Resilient Modulus is a complex proposition as there are four parameters which govern the equivalency. These four factors include the Subgrade Modulus of Elasticity (M_S), the Overlay Material Modulus of Elasticity (M_R), the Thickness of the Overlay (H), and the Drop Force (F) as applied during Falling Weight Deflectometer (FWD) testing. A Falling Weight Deflectometer is used to stimulate the pavement so that the other variables can be evaluated. A diagram which shows these four variables as well as the single layer equivalent they can be modeled as is provided in Figure A1. The Equivalent Resilient Modulus (M_{EQ}) on the right side of the figure summarizes the equivalency:

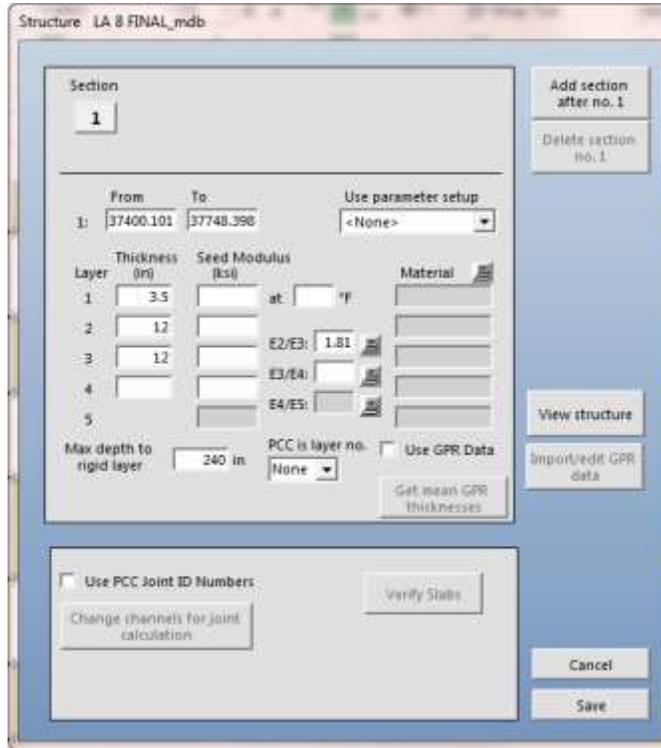
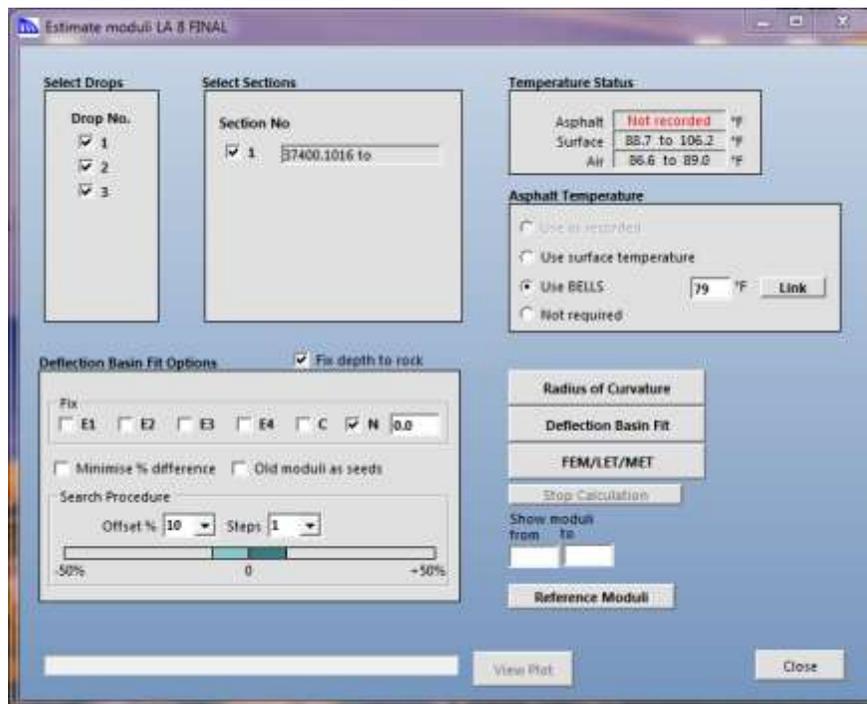
Figure B1

ELMOD multi-layer settings for LA-8

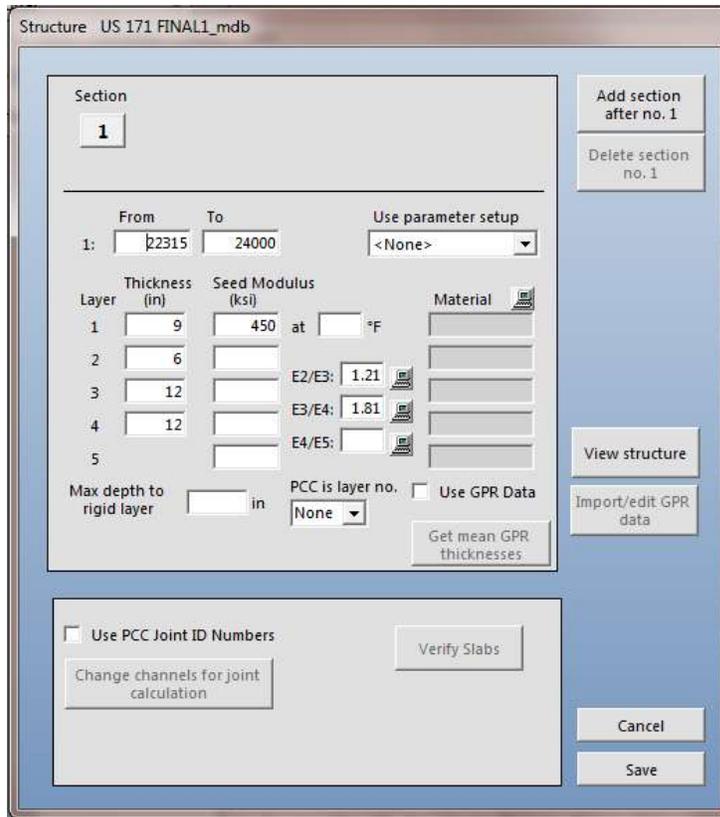
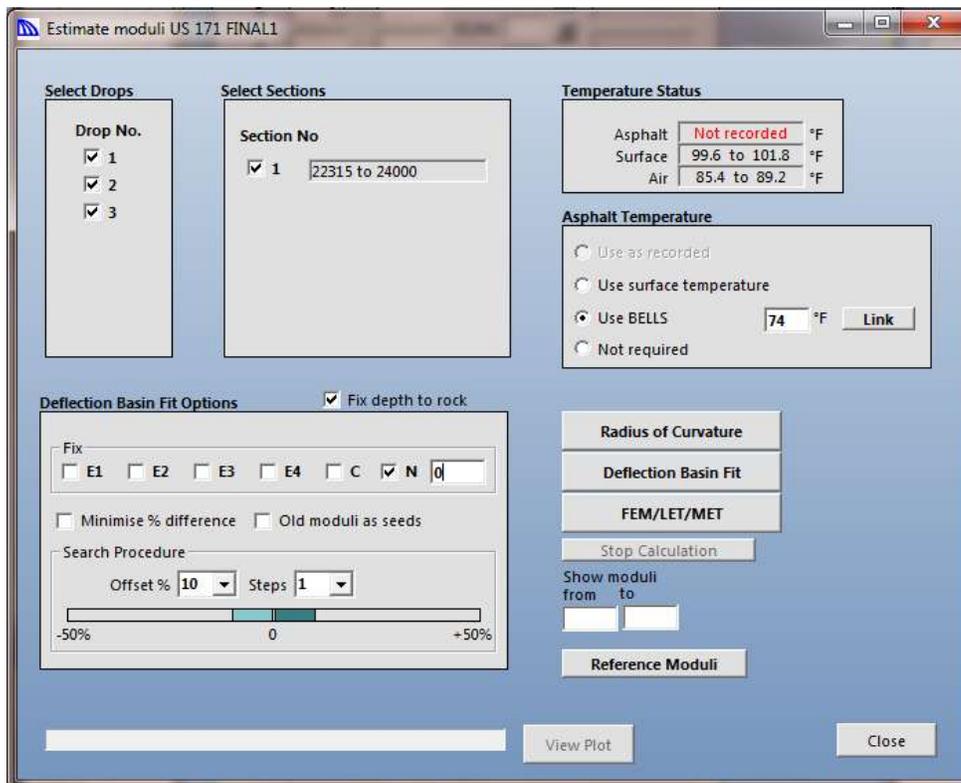
Figure B2
ELMOD multi-layer settings for US-171

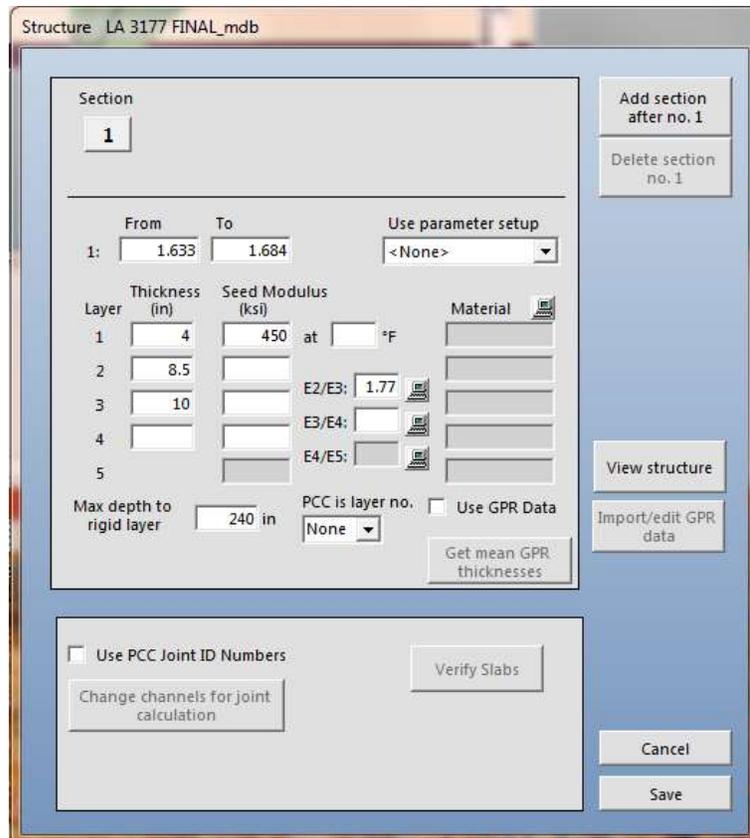
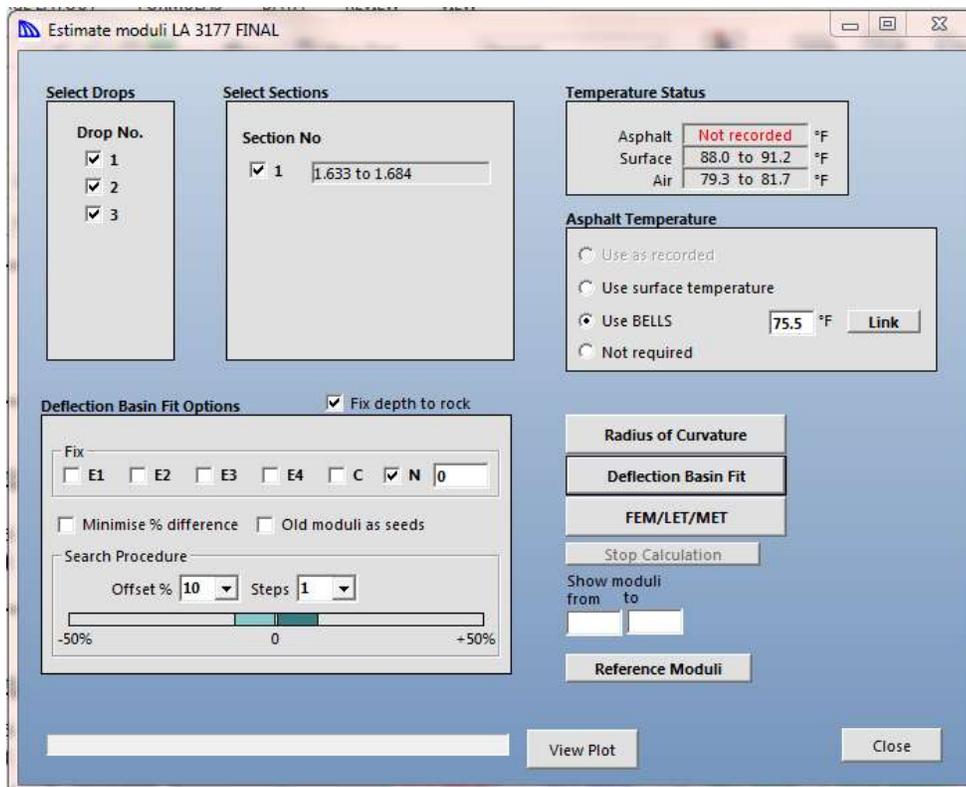
Figure B3
ELMOD multi-layer settings for LA-3177

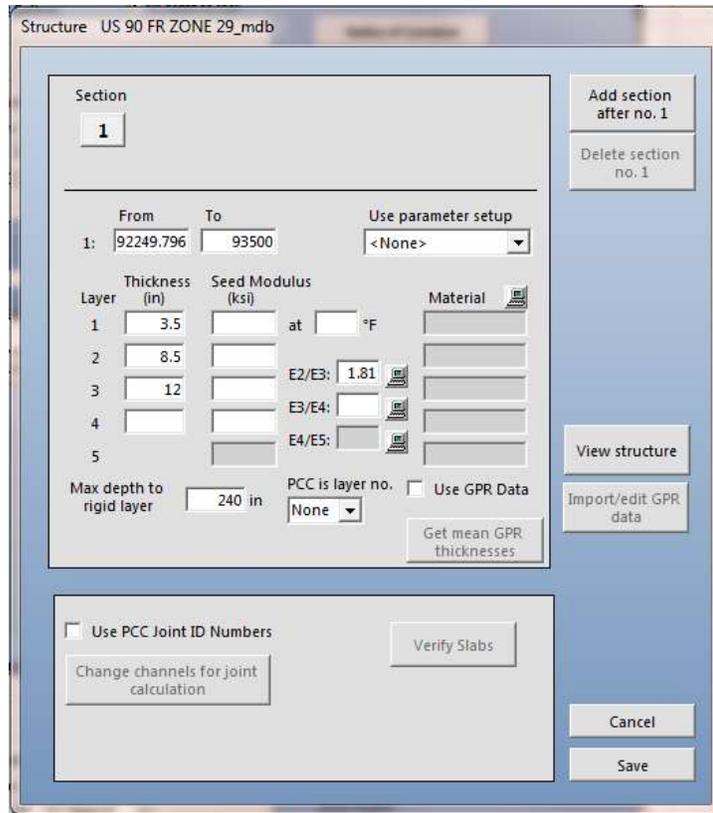
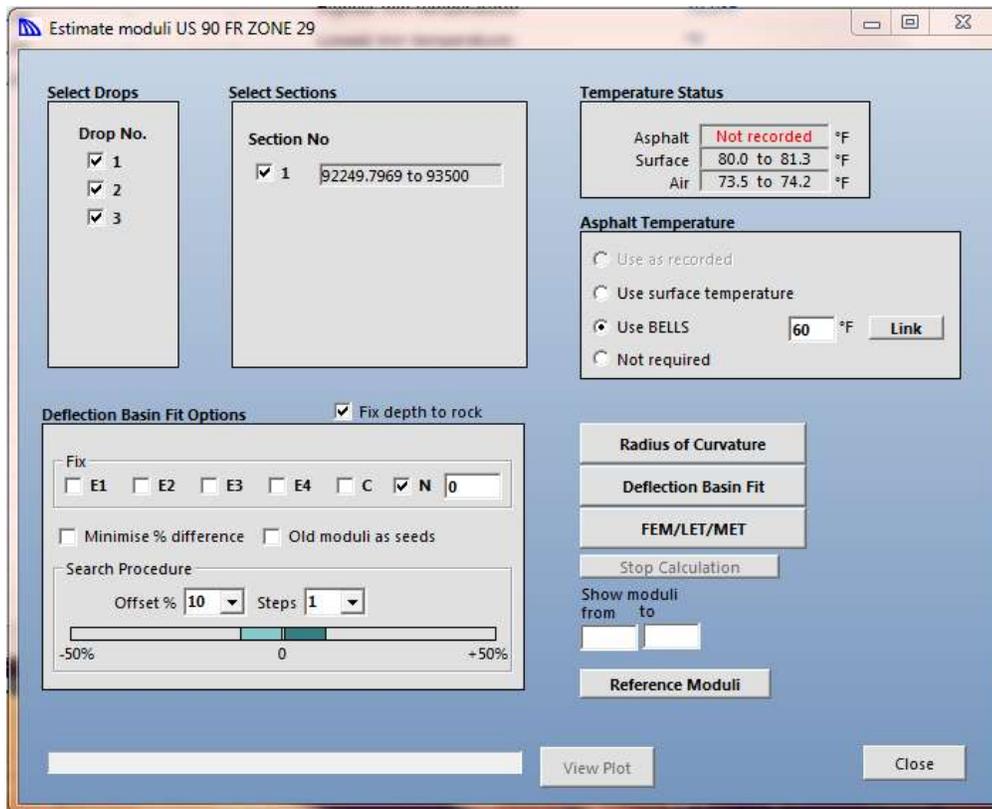
Figure B5
ELMOD multi-layer settings for US-90

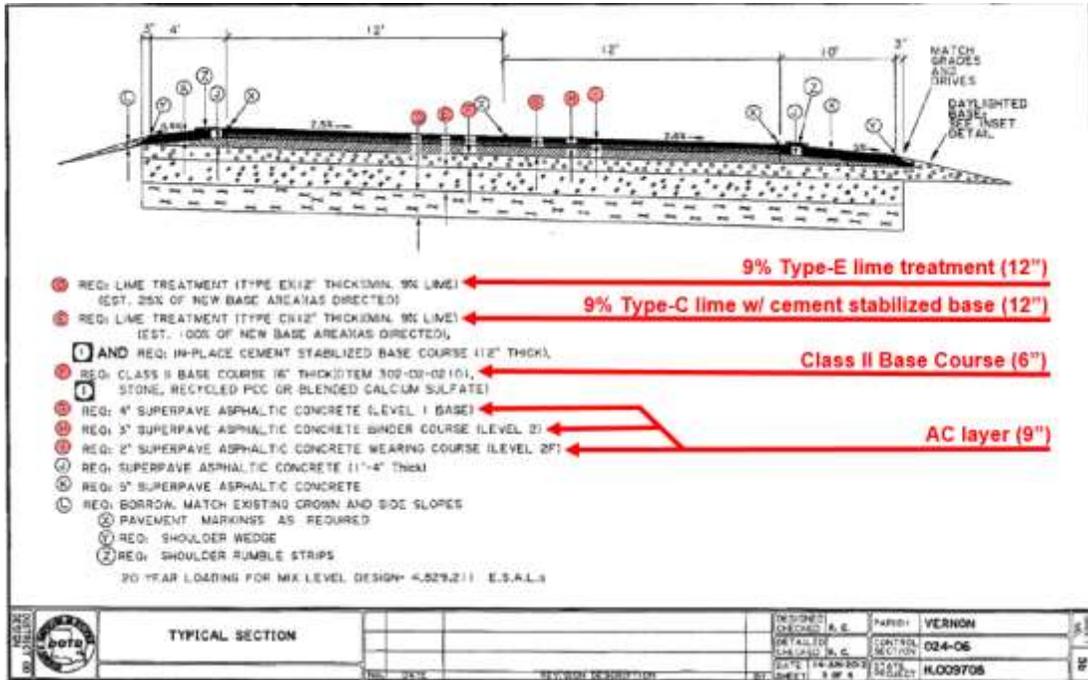
Figure D1
US 171 cross-section

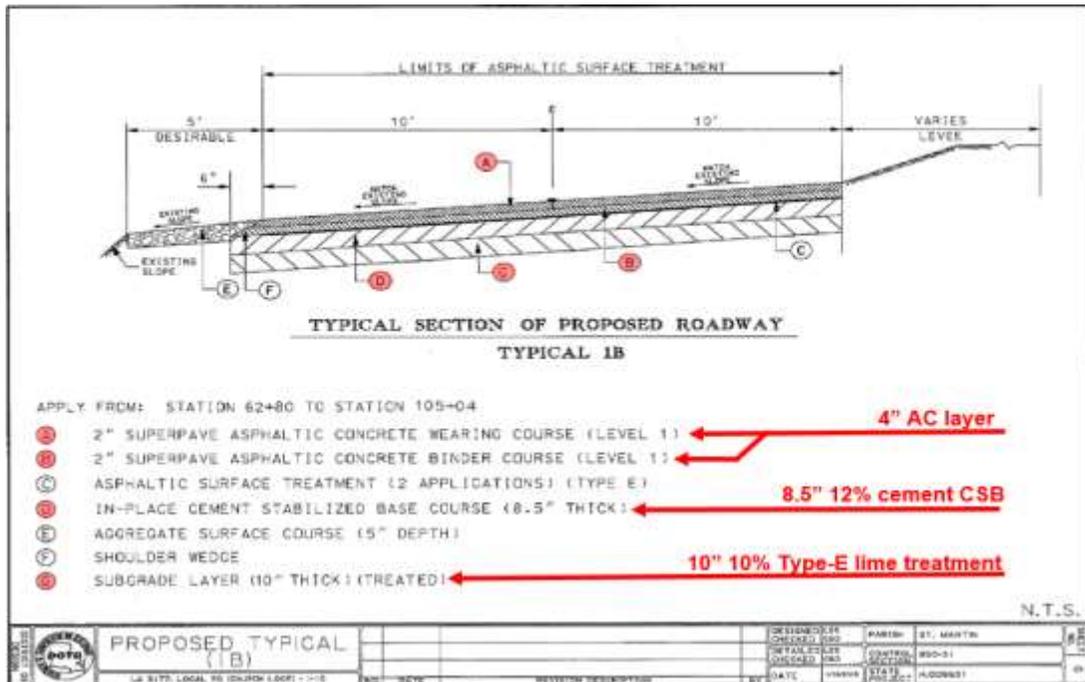
Figure D2
LA 3177 cross-section

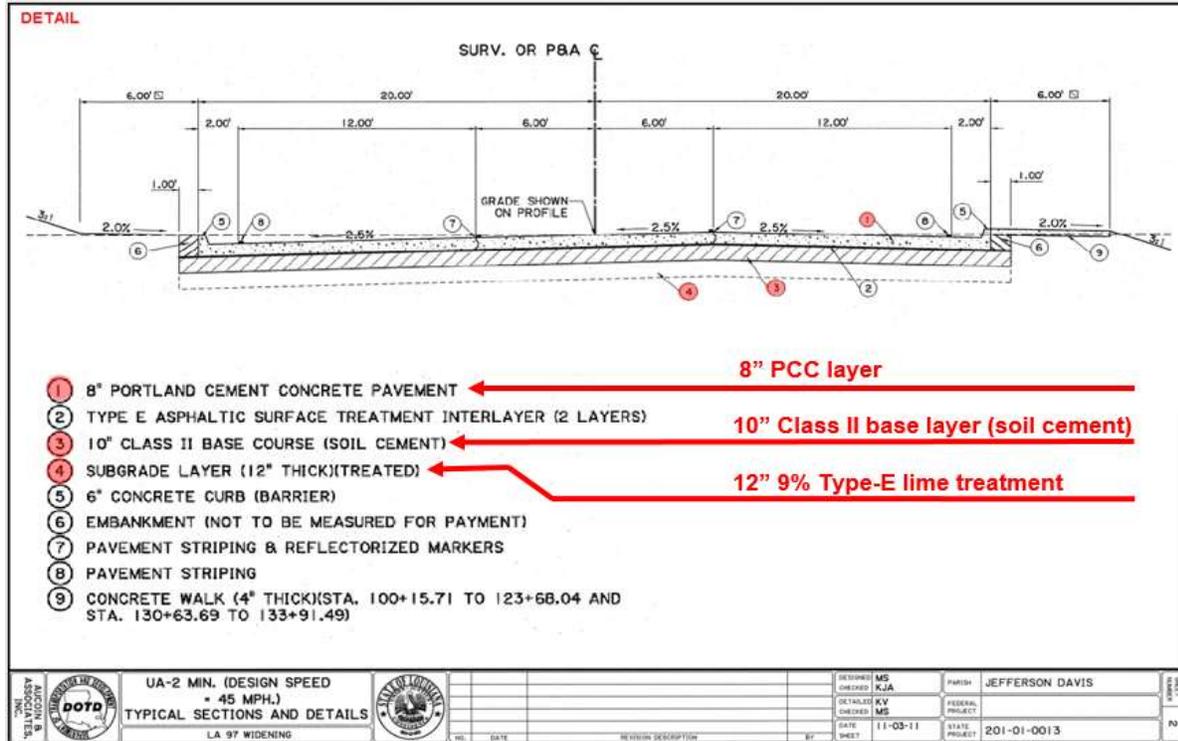
Figure D3
LA 97 cross-section

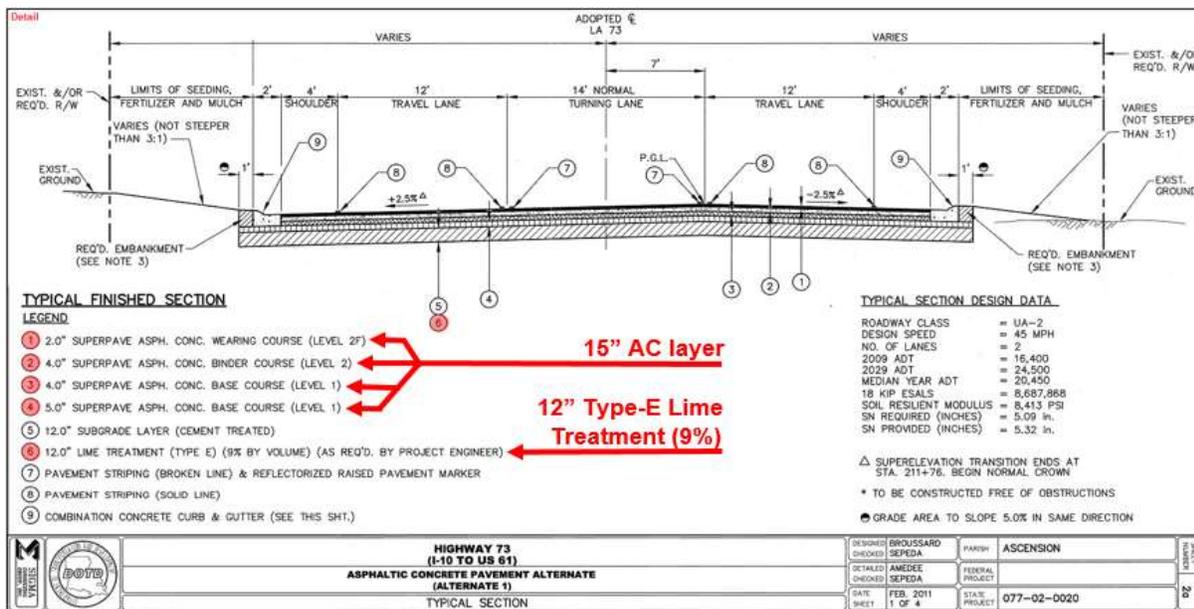
Figure D4
LA 73 cross-section
