Louisiana Transportation Research Center

Final Report 613

Field Validation of Equivalent Modulus for Stabilized Subgrade Layer

Mark Martinez, P.E.

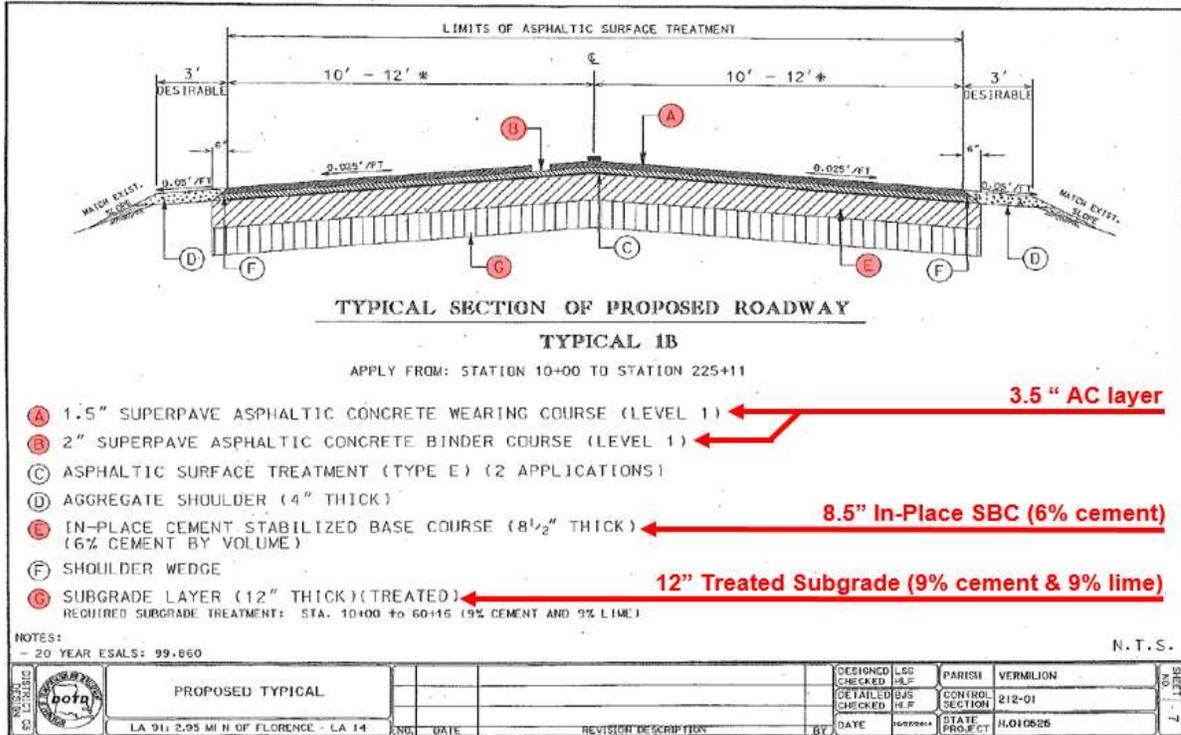
Figure D5
LA 91 cross-section

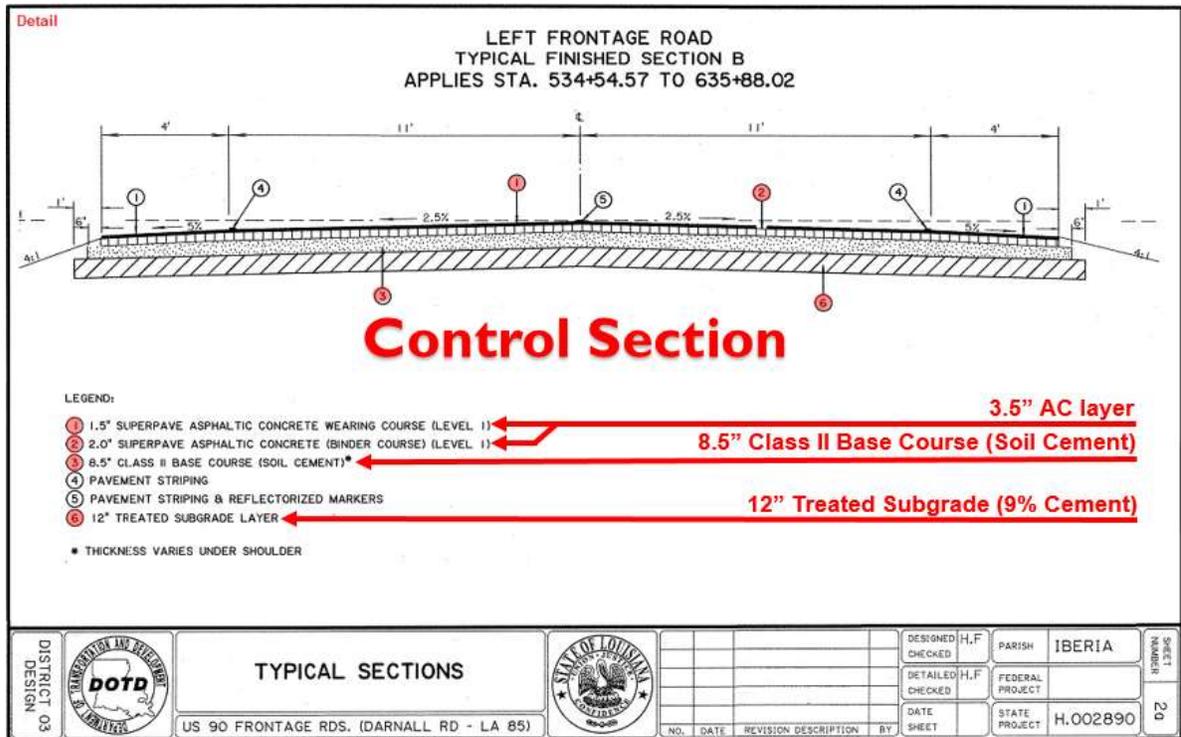
Figure D6
US 90 cross-section

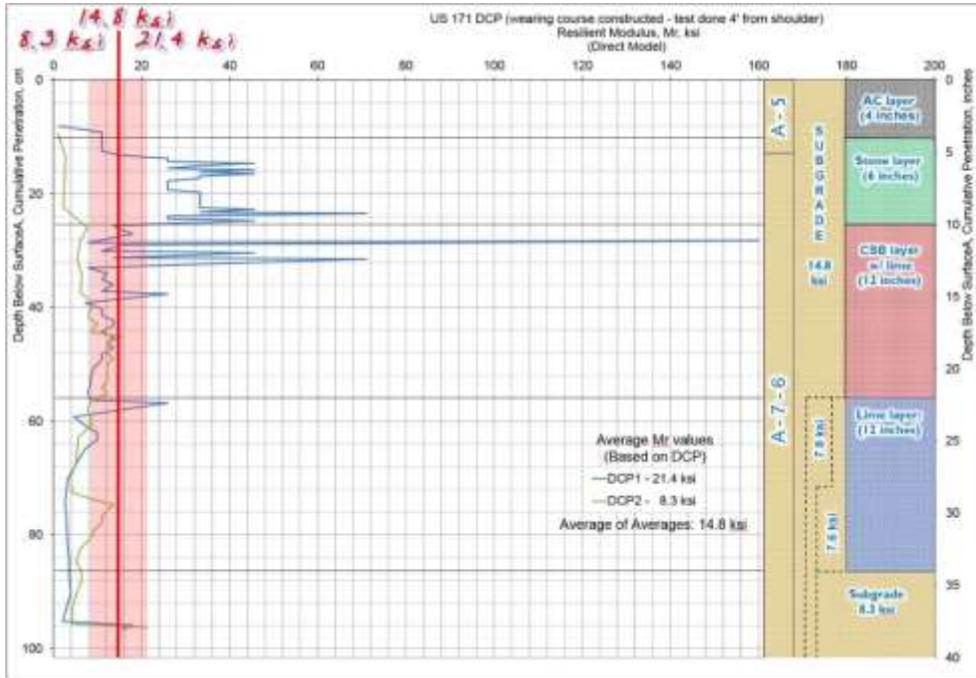
Figure F1
US 171 DCP results

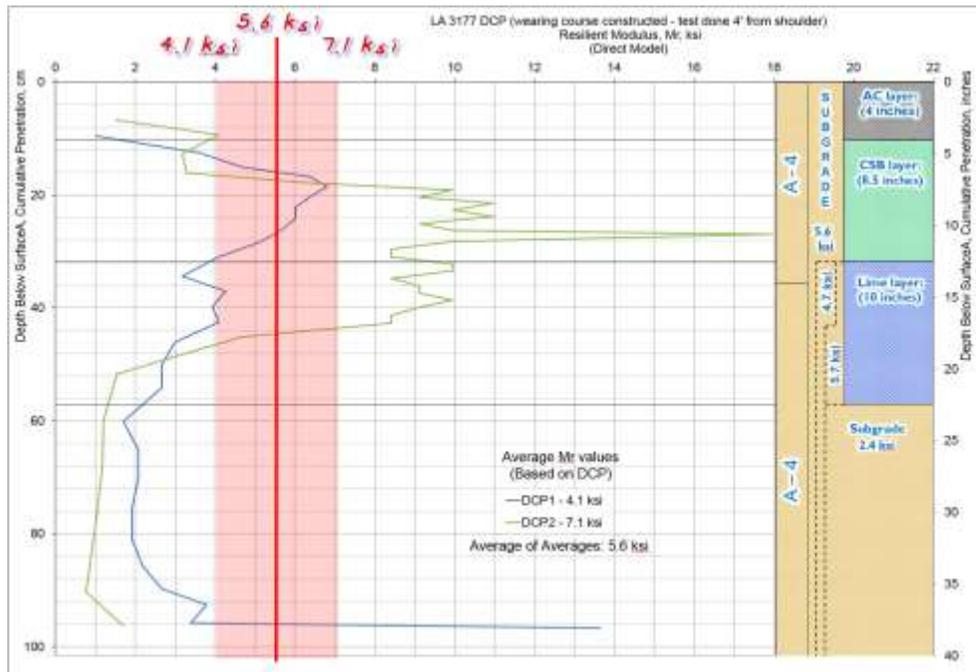
Figure F2
LA 3177 DCP results

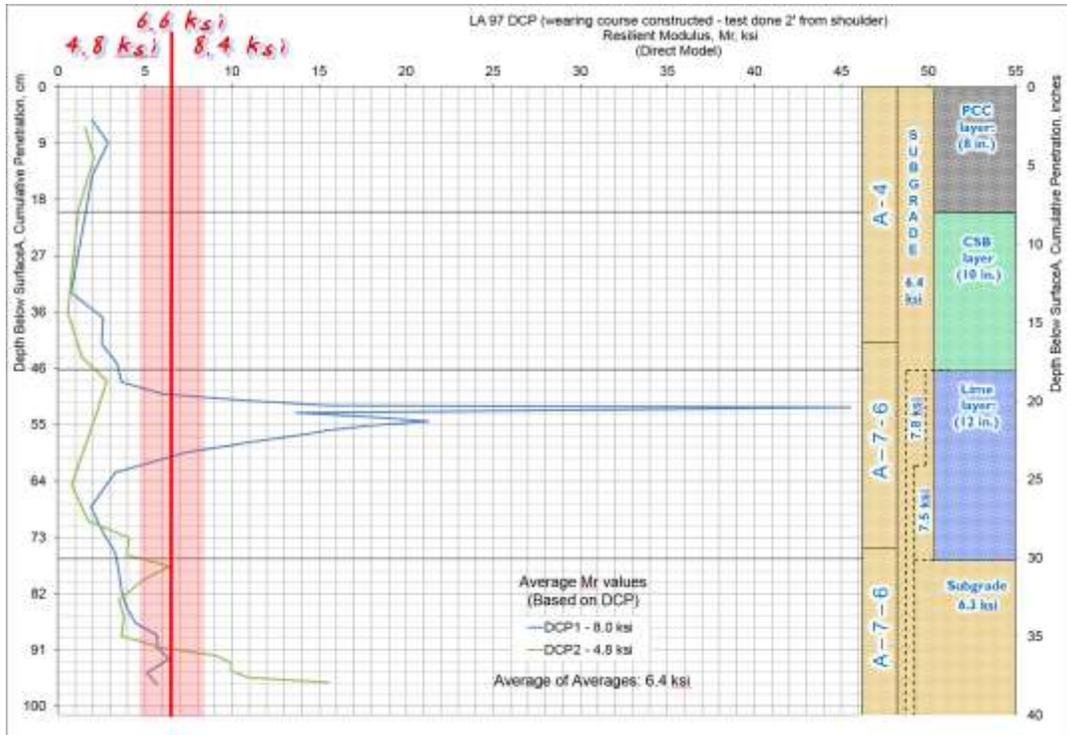
Figure F3
LA 97 DCP results

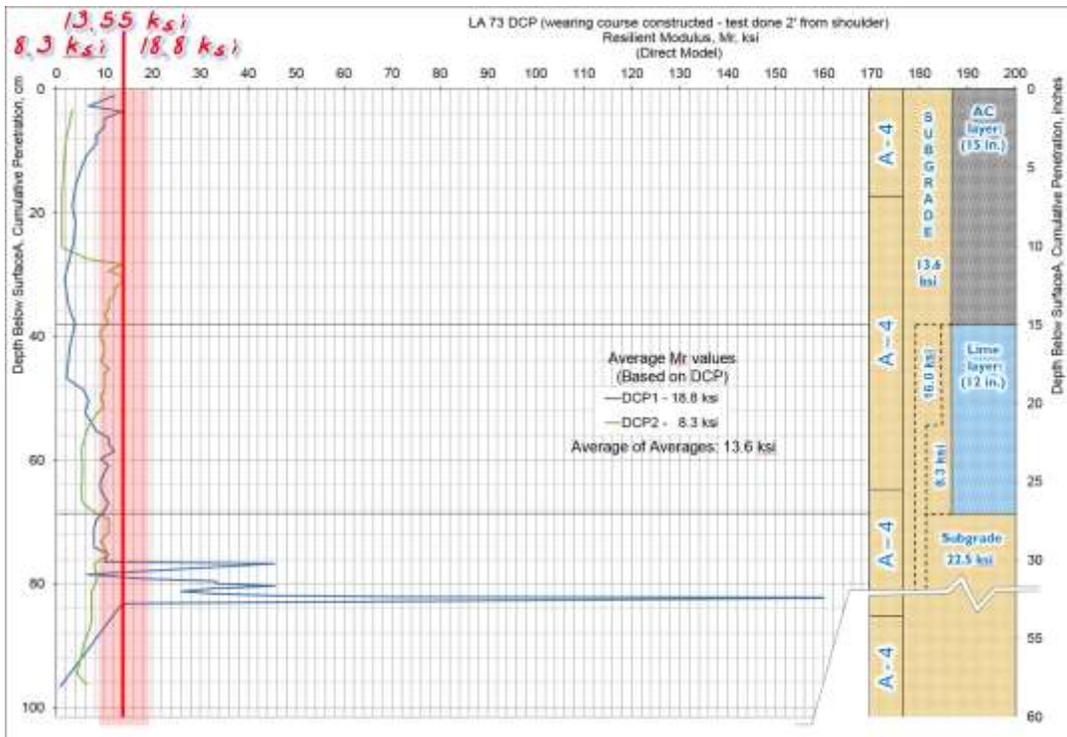
Figure F4
LA 73 DCP results

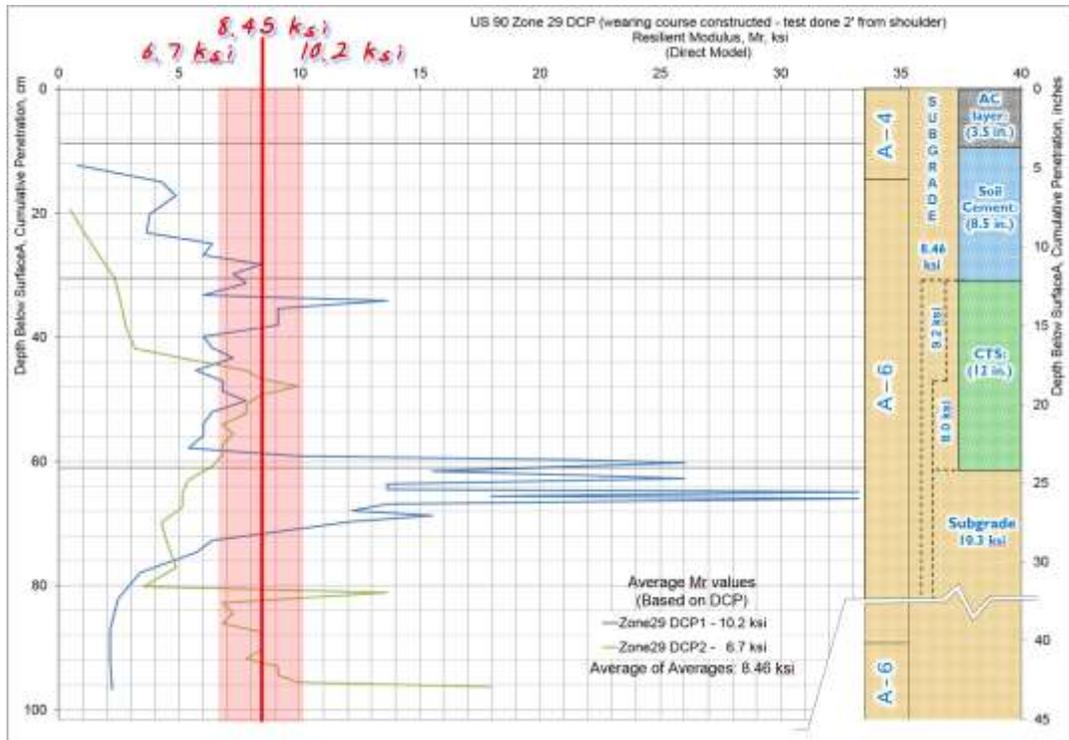
Figure F5
US 90 DCP results

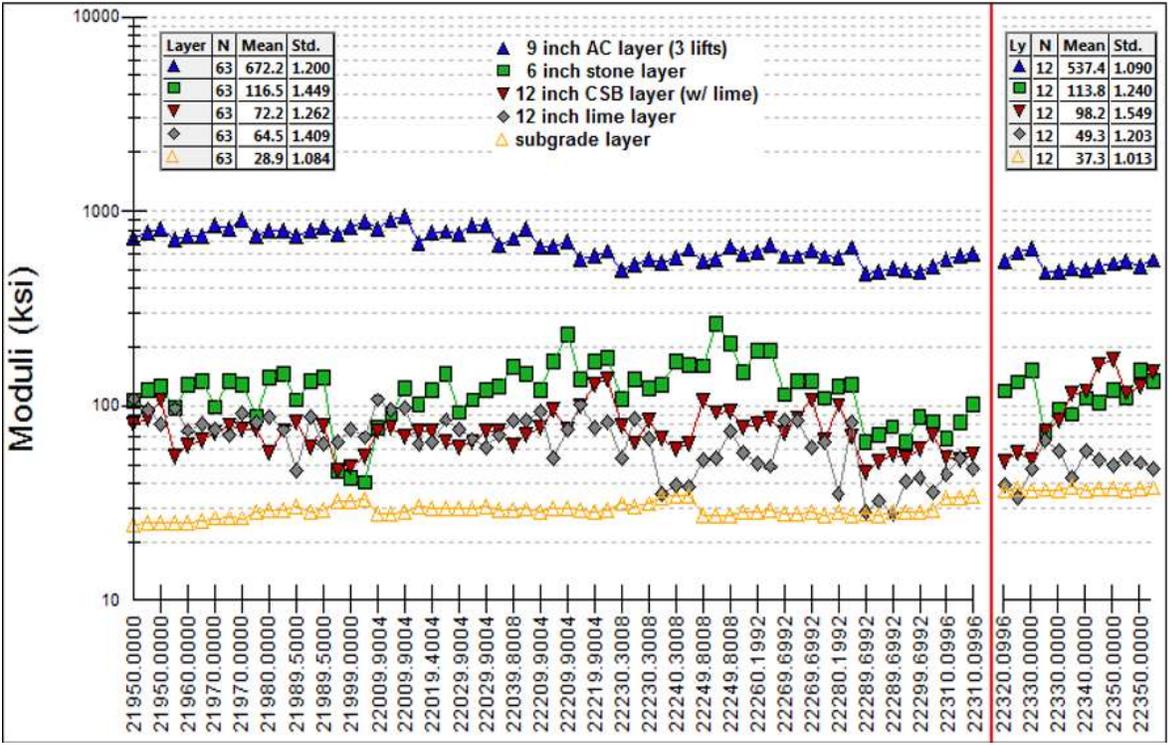
Figure G3

US-171 FWD results on AC wearing course

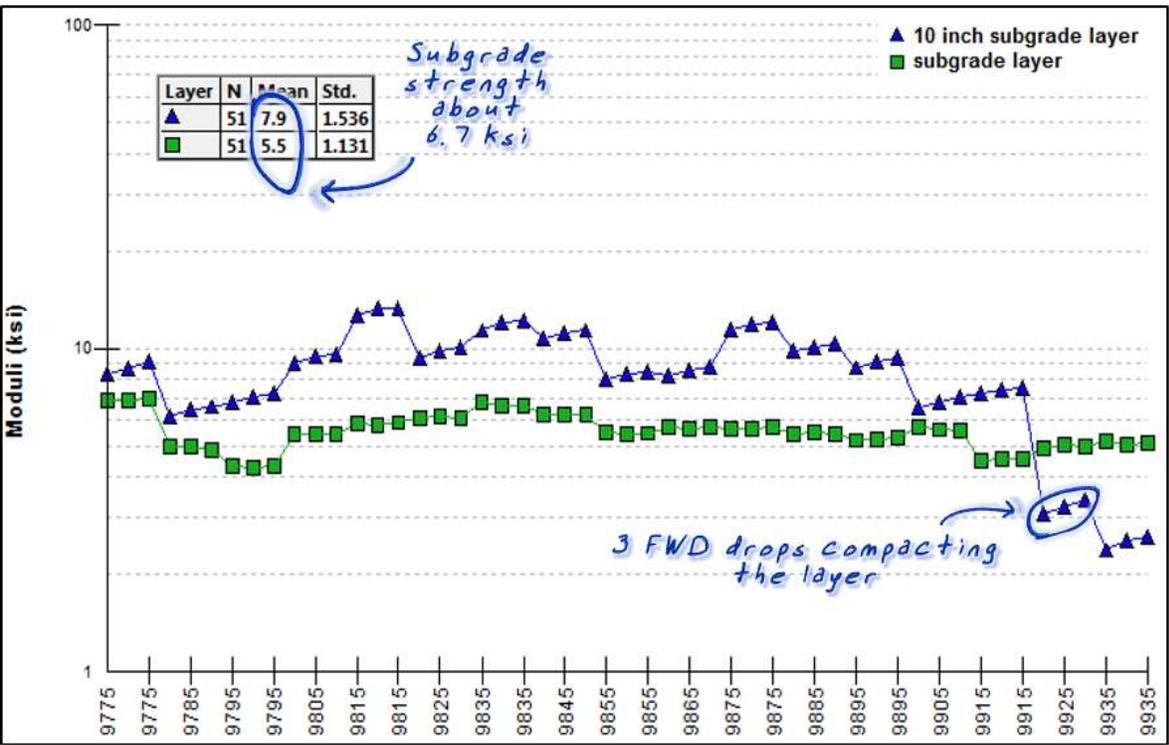
Figure G4

LA-3177 FWD results on raw subgrade

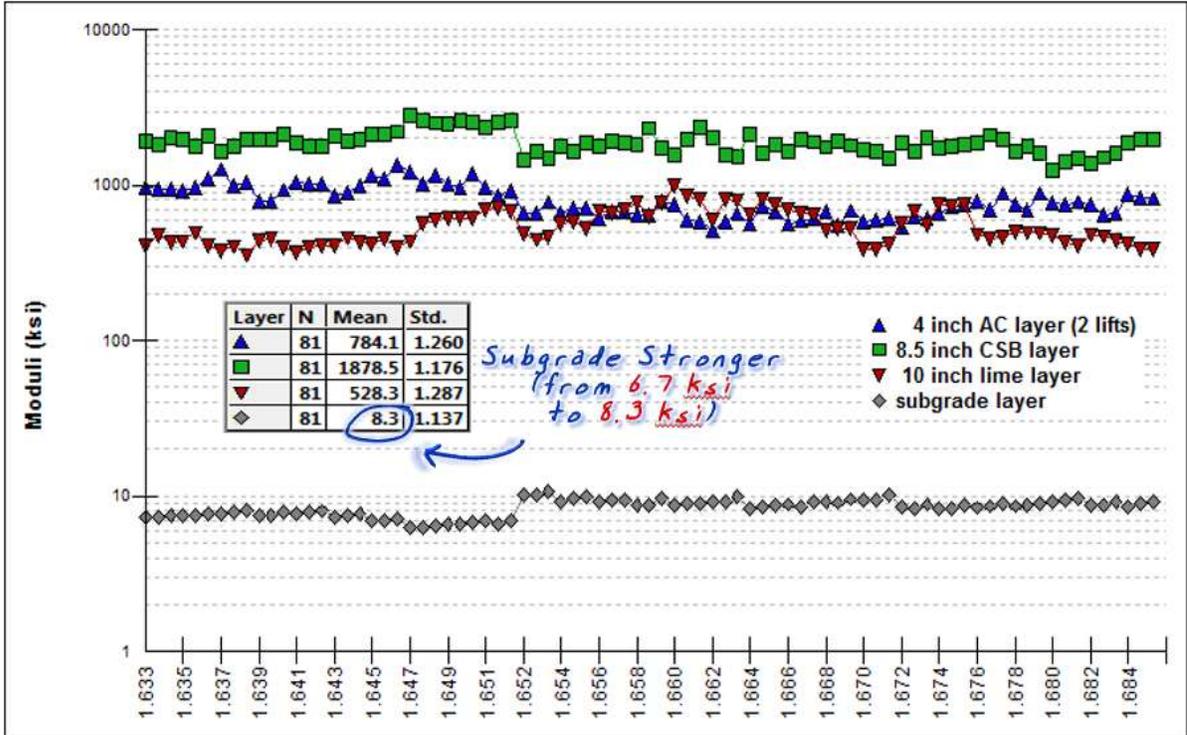
Figure G5

LA-3177 FWD results on AC wearing course

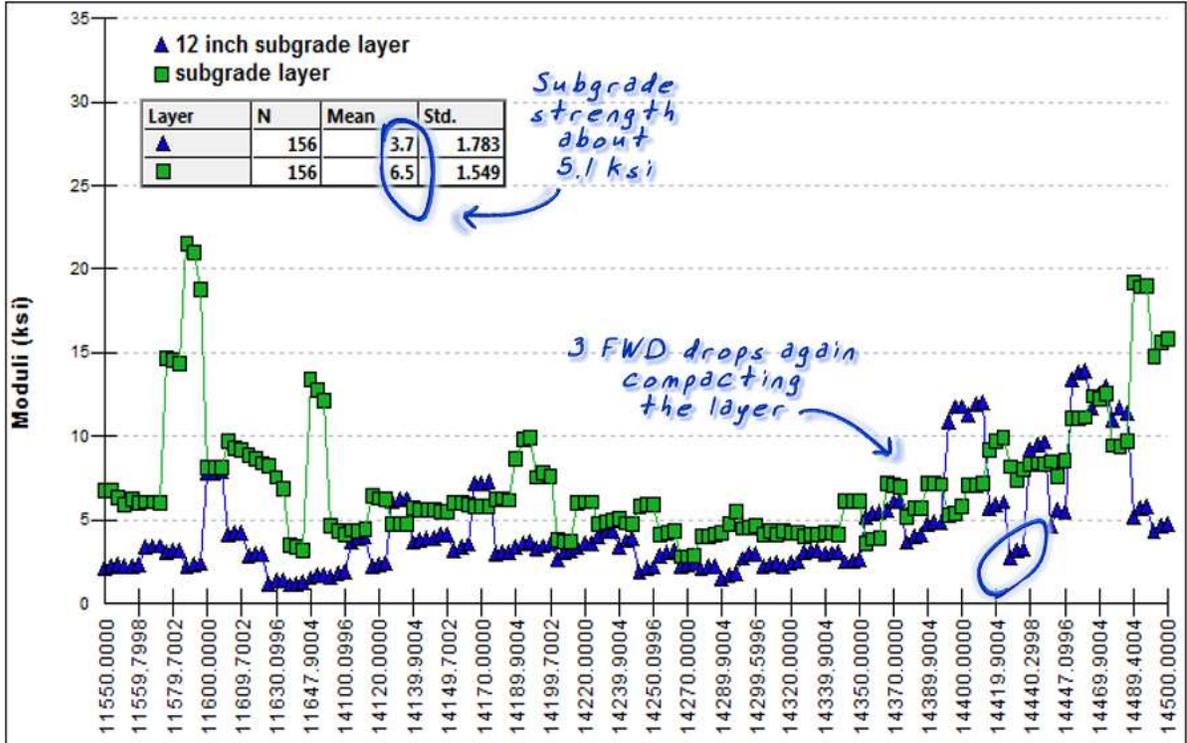
Figure G6

LA-97 FWD results on raw subgrade

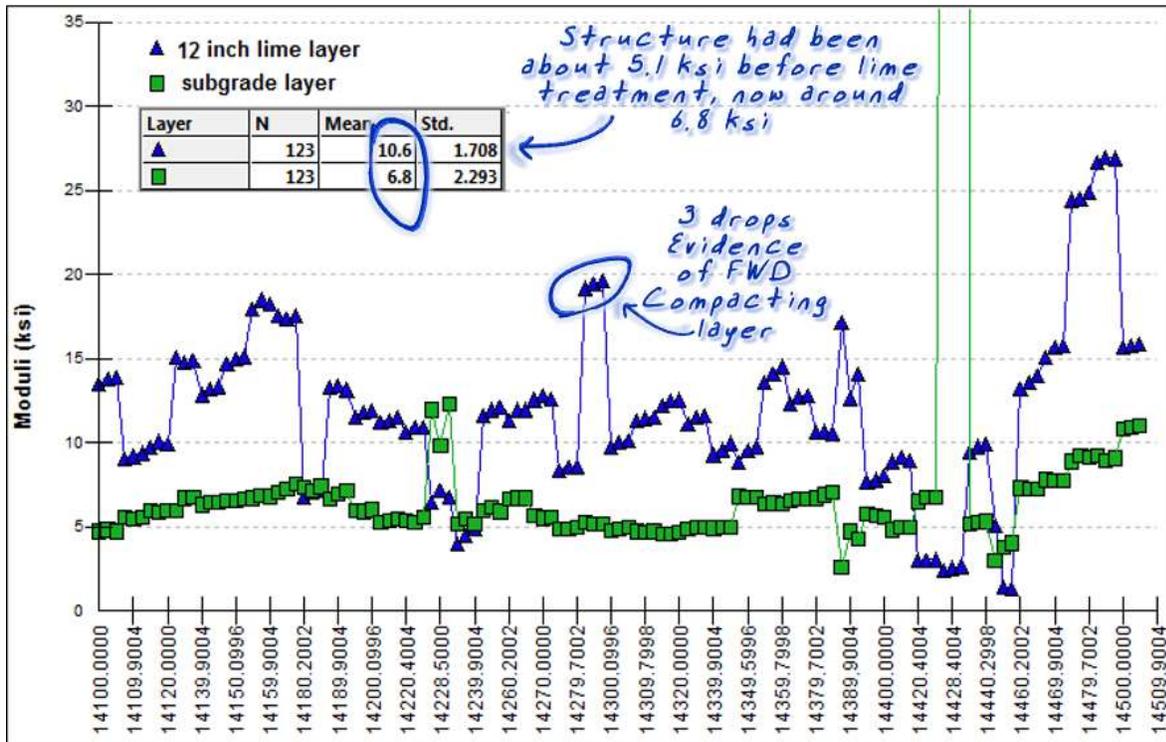
Figure G7
LA-97 FWD results on lime layer

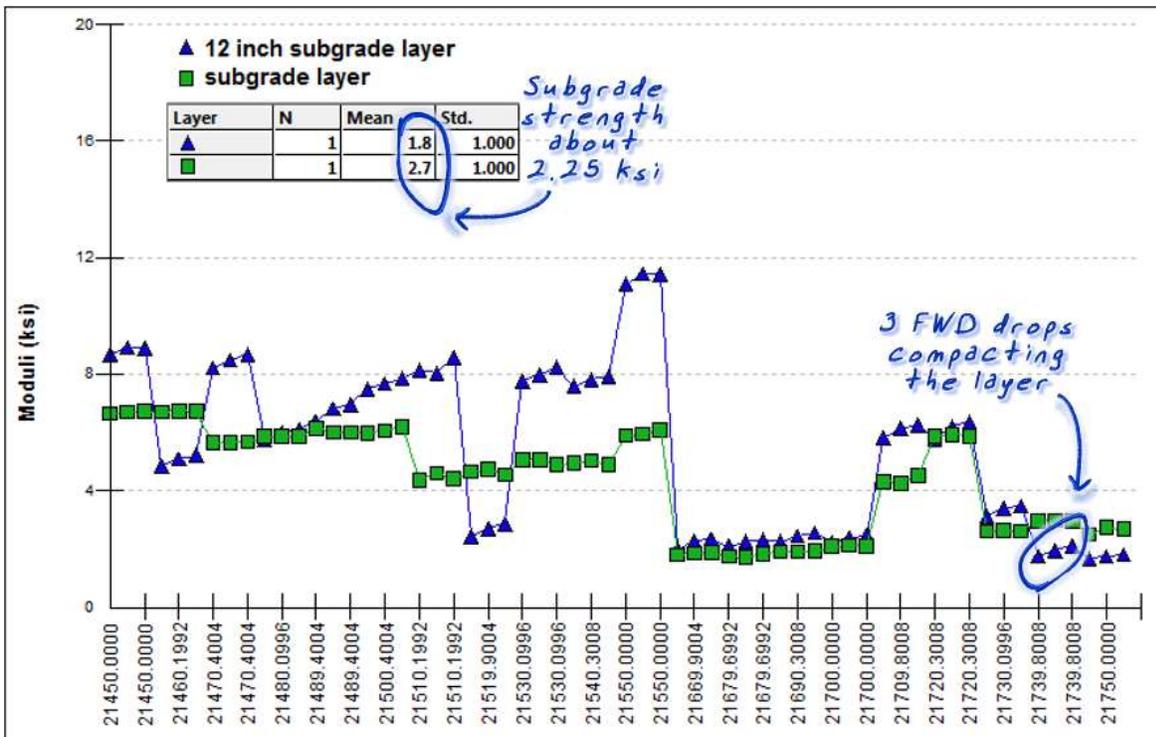
Figure G8
LA-73 FWD results on raw subgrade

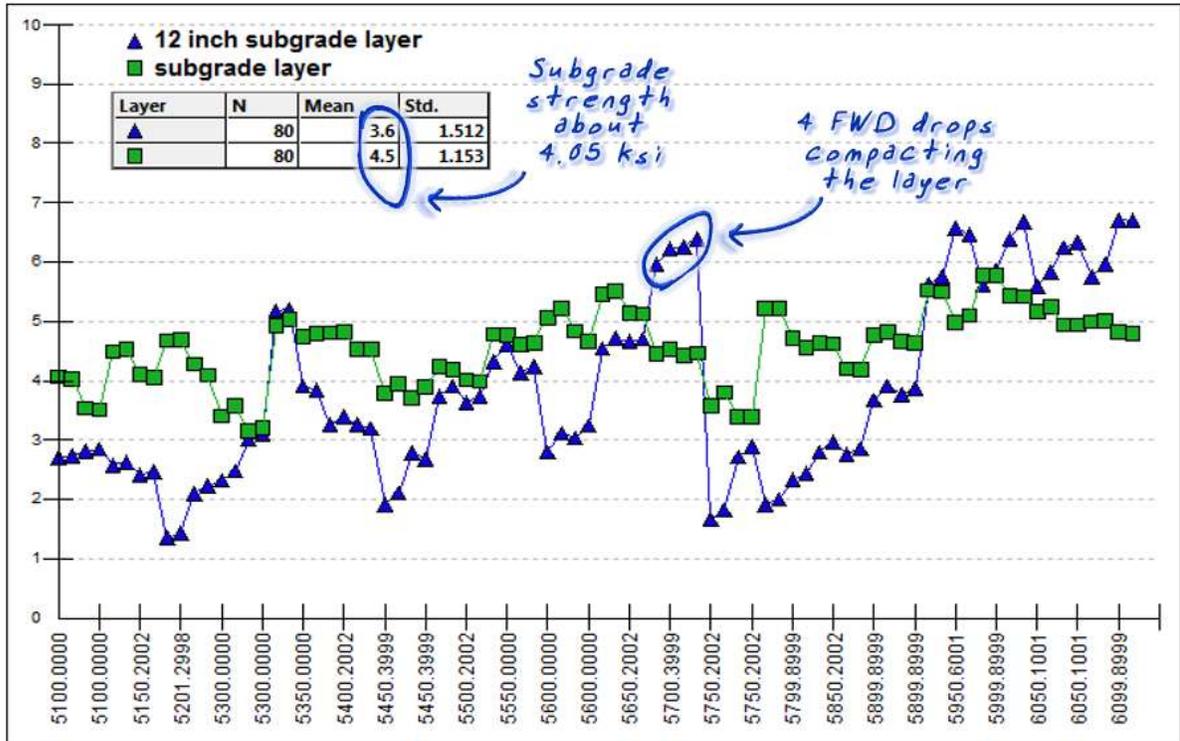
Figure G9

LA-91 FWD results on raw subgrade

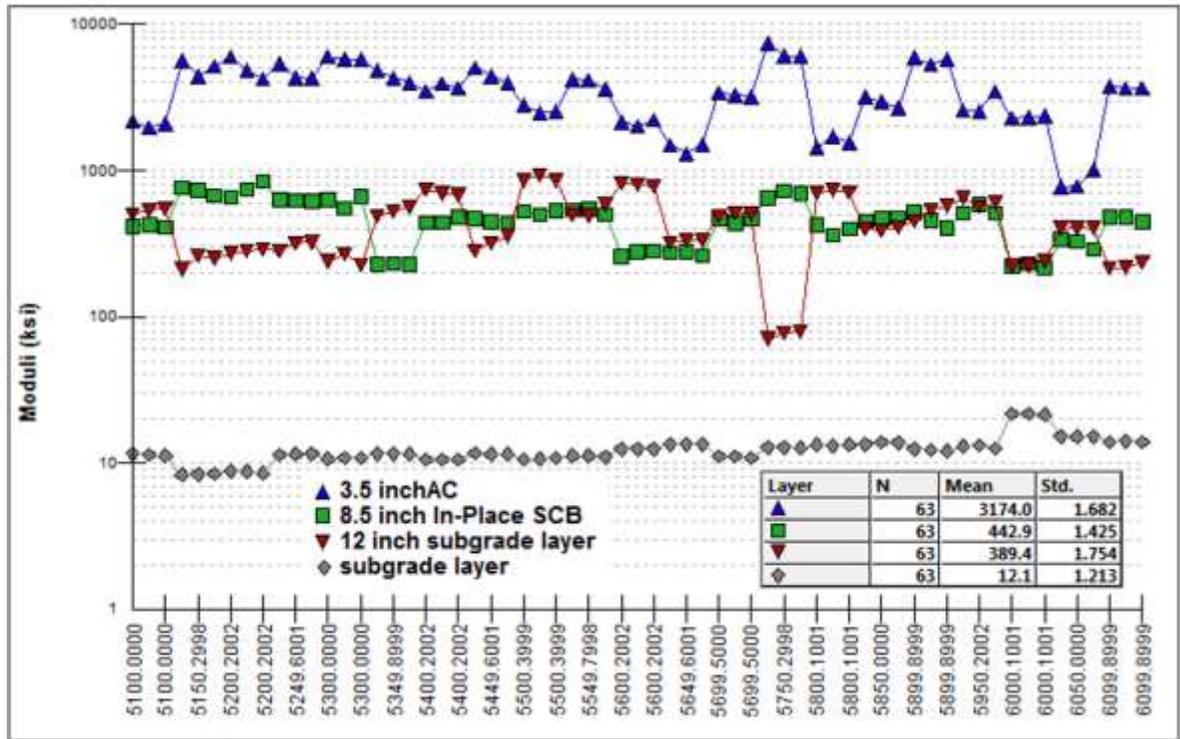
Figure G10

LA-91 FWD results on AC wearing course

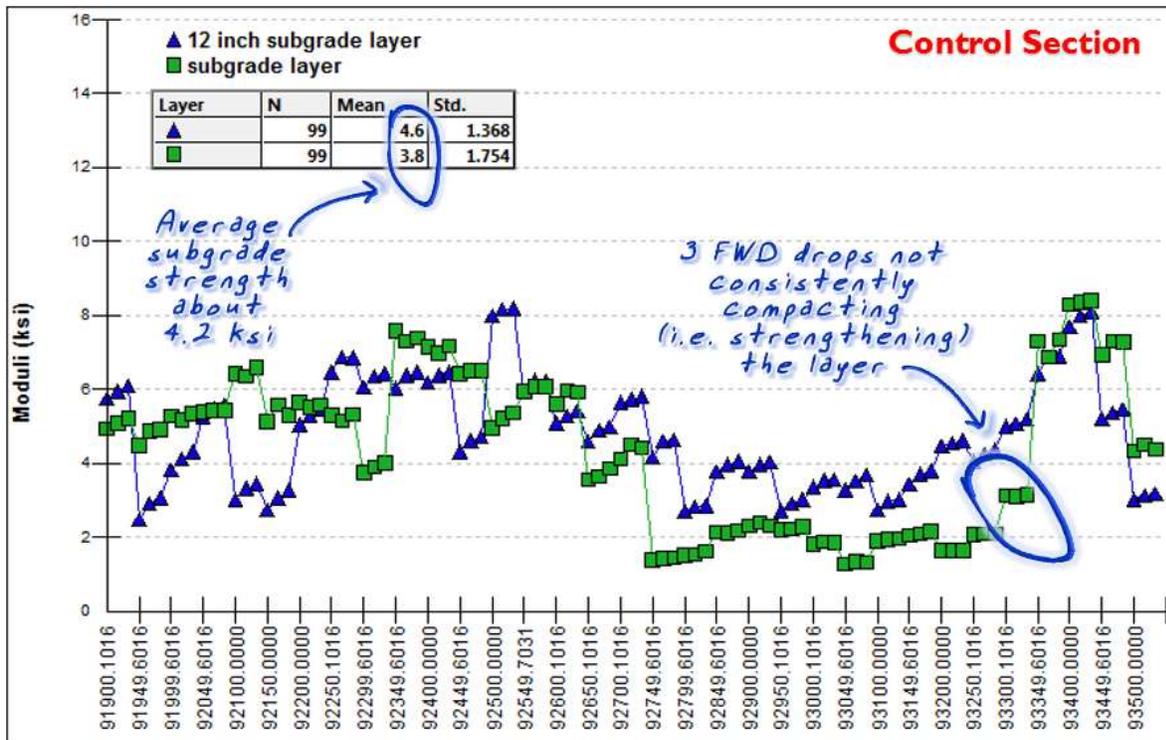
Figure G11

US-90 FWD results on raw subgrade

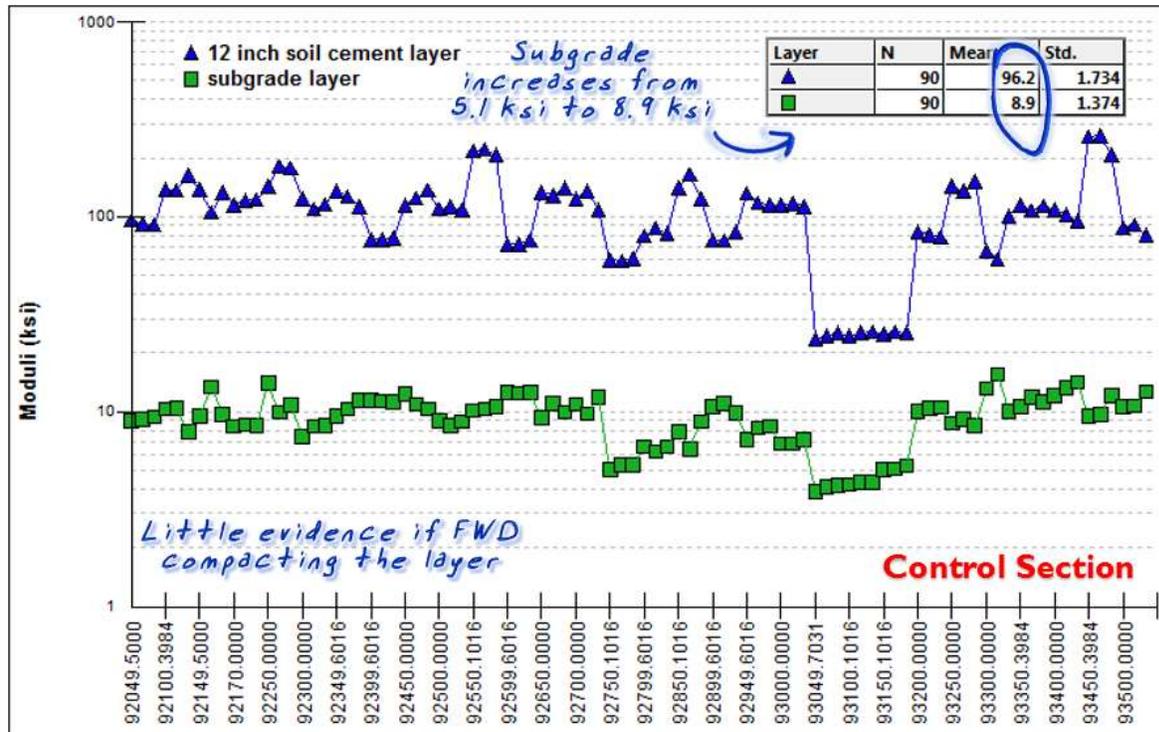
Figure G12

US-90 FWD results on soil cement layer

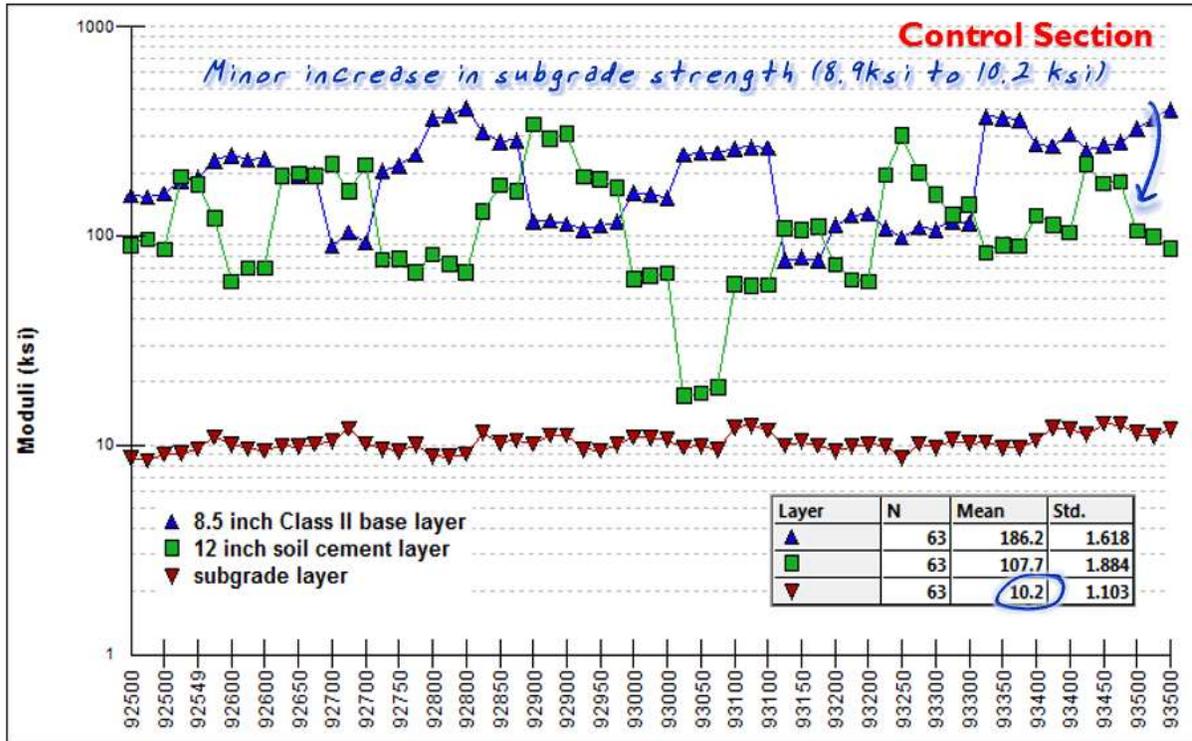
Figure G13
US-90 FWD results on Class II base layer

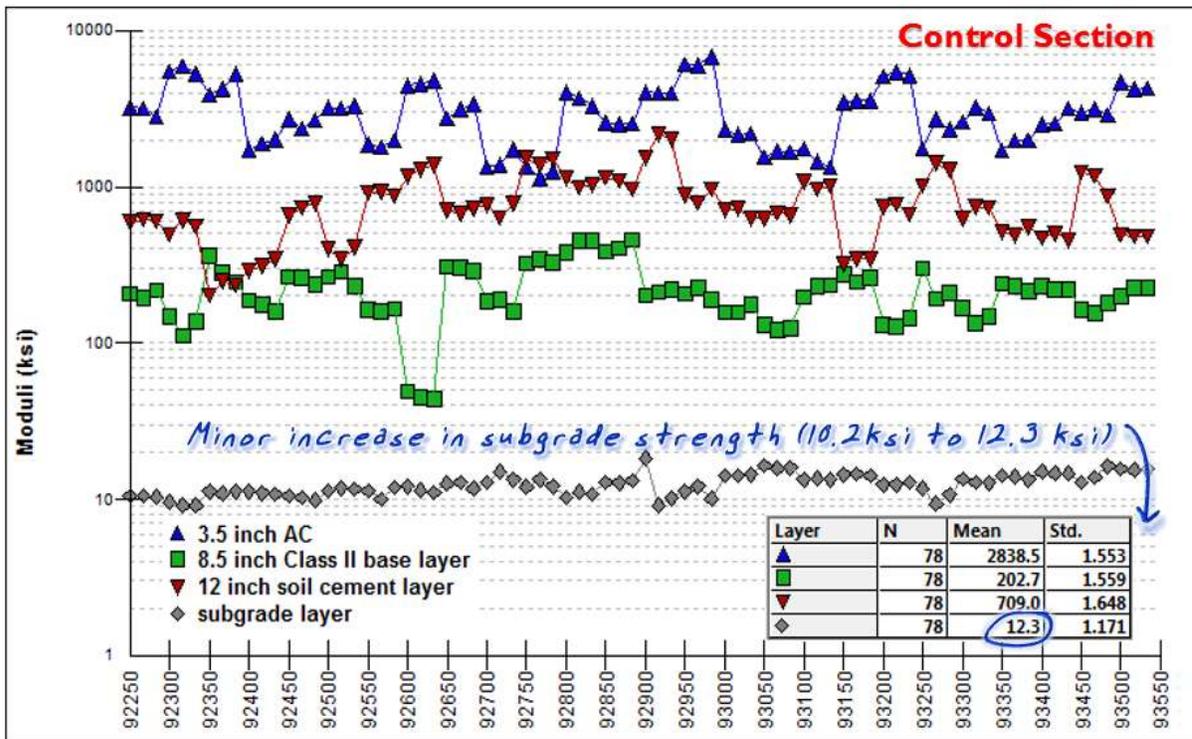
Figure G14
US-90 FWD results on AC wearing course
