# TECHSUMMARY January 2022

State Project No. DOTLT1000099 | LTRC Project No. 16-1ST

## Retrofit of Existing Statewide Louisiana Safety Walk Bridge Barrier Railing Systems

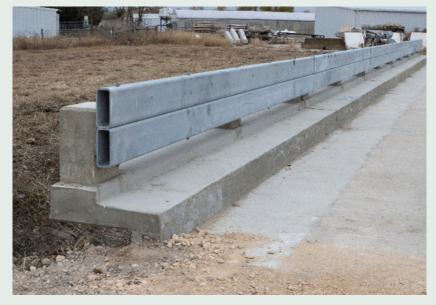
Figure 1. Retrofit Post and Beam Bridge Rail with Safety Walk Option 2

During MASH Test 3-10 on the Louisiana Retrofit Post and Beam Bridge Rail with Safety Walk Option 1, the vehicle experienced high occupant ridedown accelerations above the limit of 20.49 g as specified in MASH specifications. MASH Test 3-10 was not successful on the Option 1 design. As a result, information was learned and used from this unsuccessful crash test and a second retrofit bridge rail option (Option 2) was designed and developed. A full-scale prototype installation with concrete post and beam bridge rail with concrete safety walk was constructed with the new Option 2 bridge rail retrofit design. After completion of the new Option 2 test installation, MASH Tests 3-10 and 3-11 were performed (repeated) on this new design. The Retrofit Post and Beam Bridge Rail with Safety Walk Option 2, shown in Figure 1 below, met all the requirements for MASH Test Level 3 for longitudinal barriers.

The retrofit bridge rail Option 2 anchored to the safety walk concrete post and beam bridge rail, as shown herein in Figure 1 and reported herein, met all the safety and performance requirements of MASH Test Level 3 specifications. This retrofit bridge rail design is recommended for use on all concrete post and beam and solid concrete barriers with safety walks 10 in. high or less and 18 in. wide or less. The retrofit bridge rail should be installed as per the recommendations provided in the final research report submitted for this project. Please refer to the section entitled "Developing Retrofitting Methods and Procedures for Single Bridge Rail Design" in the final research report. The height of the retrofit bridge rail should always be 40 in. from the roadway surface as successfully crash tested for this research. The retrofit bridge rail shall be installed as per the specifications and procedures provided in the referenced section in the final research report. In cases where the retrofit bridge rail using the L6×4×1/2 angle brackets is lower than the as-tested height of 40 in., short steel baseplated posts, designed, detailed, and presented in the final report, shall be used instead of the  $L6 \times 4 \times \frac{1}{2}$  angle brackets. These posts are necessary to achieve the required height of 40 in. These
