High Performance Concrete Bridge Deck Investigation

November 2009

FHWA Publication No. FHWA-HRT-10-028

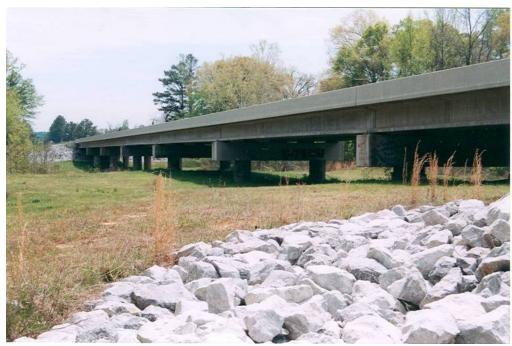
Figure 1. Photo. Uphapee Creek Bridge, Alabama Highway 199 (Macon County, Alabama).

The visual inspection of the bridge decks was performed about two years after the bridge opened to traffic. A total of 121 transverse, diagonal, and longitudinal cracks were recorded on the bridge with a combined total crack length of 528 m (1,732 ft) over a bridge deck area of 2,969 m² (31,920 ft²). All cracks on the bridge were hairline cracks with a width of less than 0.08 mm (0.031 in.). No major distress was observed in the bridge survey.

With respect to the types of cracking, 108 transverse, 8 diagonal, and 5 longitudinal cracks were observed. The total crack length for the transverse, diagonal, and longitudinal cracks was 510 m (1,673.5 ft), 9.2 m (30.0 ft), and 8.7 m (28.5 ft), respectively. This yielded crack densities of 0.172 m/m² (0.052 ft/ft²) transverse, 0.003 m/m² (0.001 ft/ft²) diagonal, and 0.003 m/m² (0.001 ft/ft²) longitudinal. The crack density for the entire deck including all transverse, diagonal, and longitudinal cracks was 0.178 m/m² (0.053 ft/ft²).

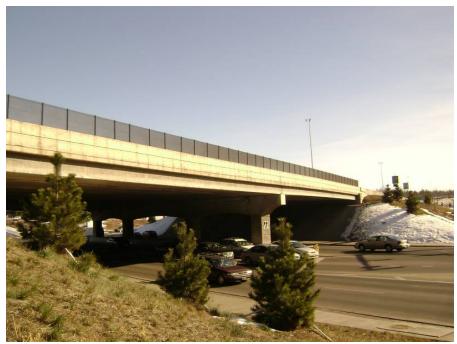
Figure 2. Photo. Interstate 25 Bridge over East Yale Avenue (Denver, Colorado).

The visual inspection of the bridge decks as part of our study was performed about 9 years after the construction. The bridge deck was covered by an asphalt overlay of about 76- to 102-mm (3- to 4-in.) thickness. No cracks were visible on the asphalt pavement. There was a pothole in the inner northbound lane close to the parapet, adjacent to the expansion joint. There were some hair-size cracks on the parapet, but no significant damage was observed.

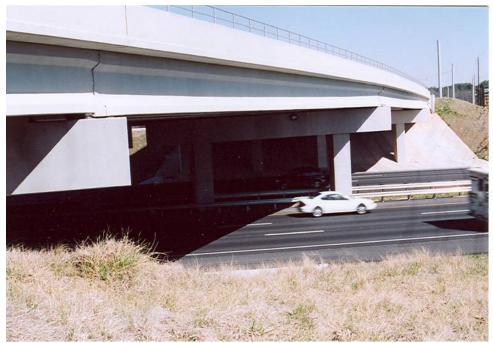
Figure 3. Photo. Jonesboro Road Bridge over Interstate 75 (Atlanta, Georgia).

The visual inspection of the bridge decks was performed about 2 years after the bridge opened to traffic. A total of 91 transverse and diagonal cracks were recorded on the bridge with a combined total crack length of 191.0 m (626.2 ft) over a bridge deck area of 2,970 m² (31,937.6 ft²).

However, about 89 percent of the cracks on the two bridges were hairline cracks with a width of less than 0.8 mm (0.031 in.). The remaining 11 percent of the cracks were classified as fine cracks with widths in the range of 0.8 to 1.6 mm (0.031 to 0.063 in.). No major distress was observed in the bridge survey.

With respect to the types of cracking, 61 transverse, 30 diagonal, and 0 longitudinal cracks were observed. The total crack length for the transverse, diagonal, and longitudinal cracks was 125.8 m (412.4 ft), 65.2 (213.8 ft), and 0.0 m (0.0 ft), respectively. This yielded crack densities of 0.042 m/m 2 (0.013 ft/ft 2) transverse, 0.022 m/m 2 (0.007 ft/ft 2) diagonal, and 0.000 m/m 2 (0.000 ft/ft 2) longitudinal. The crack density for the entire deck including all transverse, diagonal, and longitudinal cracks was 0.064 m/m 2 (0.020 ft/ft 2).

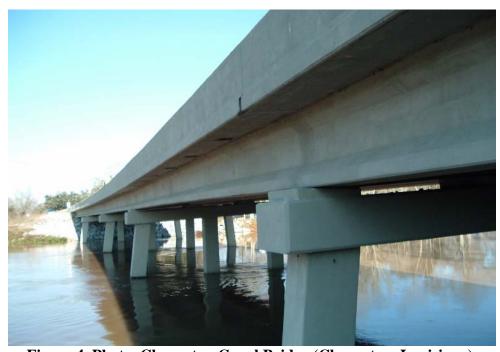
Figure 4. Photo. Charenton Canal Bridge (Charenton, Louisiana).

The visual inspection of the bridge deck was performed about 4 years after the bridge opened to traffic. The eastbound and westbound lanes are exhibiting a comparable magnitude and pattern of cracking. A total of 46 transverse cracks were recorded on the bridge with a combined total crack length of 57.2 m (187.4 ft) over a bridge deck area of 1,494 m² (16,060 ft²). However, all these cracks were hairline cracks with width less than 0.4 mm (0.016 in.). There were no diagonal or longitudinal cracks observed. No major distress was observed in our bridge survey.

The crack density for the entire deck including all transverse, diagonal, and longitudinal cracks was 0.038 m/m^2 (0.012 ft/ft^2). Though the number of transverse crack counts for eastbound lanes (33 cracks) is more than that for the westbound lanes (13 cracks), the crack densities on eastbound and westbound lanes appear to be similar (i.e., 0.039 m/m^2 (0.013 ft/ft^2) for the eastbound lanes and 0.031 m/m^2 (0.010 ft/ft^2) for the westbound lanes).

Compared to other spans in the bridge, the crack count in span 1 is greater on both eastbound and westbound lanes. A higher crack density is calculated. Span 1 ends along the skew. Some of these cracks were exhibiting spalling due to breaking of the edges. The layout of the cast-in-place deck at span ends may partly be attributed to the development and widening of these cracks. In addition, the structural system of the Charenton Canal Bridge is flexible compared to conventional bridges considering the wider beam spacing and longer span length. This relatively flexible structural system might have contributed to the development and widening of some cracks.

It is noted that relatively large numbers of short-length transverse cracks were observed in span 4 eastbound lanes and span 5 westbound lanes. Settlement of foundation supporting the eastern end of the westbound bridge piers may contribute to the observed transverse cracks.

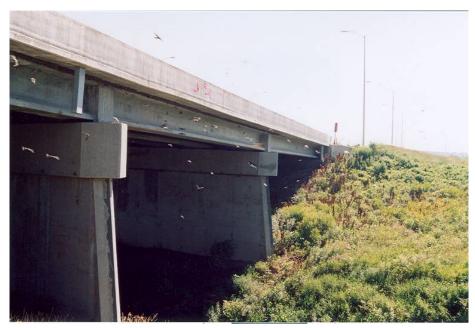
Figure 5. Photo. 120th Street and Giles Road Bridge near Omaha, Nebraska.

The visual inspection of the bridge deck was performed about 8 years after the bridge was opened to traffic. A total of 259 cracks were recorded during the visual survey of the bridge

deck. The sum of crack lengths was 507.7 m (1,664.5 ft) over a bridge deck area of 1,716 m² $(18,450 \text{ ft}^2)$.

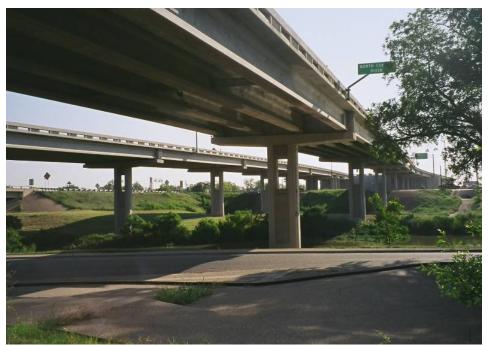
Figure 16. Photo. U.S. Route 67 Bridge (San Angelo, Texas). The eastbound bridge is in foreground, and the westbound bridge is in the background.

With respect to the types of cracking, 204 transverse, 11 diagonal, and 125 longitudinal cracks were observed on the eastbound bridge. The total crack length for the transverse, diagonal, and longitudinal cracks was 384.8 m (1,261.6 ft), 11.0 m (36.2 ft), and 190.8 m (625.6 ft), respectively. This yielded crack densities of 1.005 m/m² (0.306 ft/ft²) transverse, 0.029 m/m² (0.009 ft/ft²) diagonal, and 0.498 m/m² (0.152 ft/ft²) longitudinal. The crack density for the entire

eastbound deck including all transverse, diagonal, and longitudinal cracks was 1.532 m/m^2 (0.467 ft/ft²).

With respect to the types of cracking, 179 transverse, 12 diagonal, and 177 longitudinal cracks were observed on the westbound bridge. The total crack length for the transverse, diagonal, and longitudinal cracks was 645.0 m (2,114.8 ft), 13.5 m (44.4 ft), and 306.3 m (1,004.2 ft), respectively. This yielded crack densities of 1.625 m/m² (0.496 ft/ft²) transverse, 0.034 m/m² (0.010 ft/ft²) diagonal, and 0.772 m/m² (0.235 ft/ft²) longitudinal. The crack density for the entire westbound deck including all transverse, diagonal, and longitudinal cracks was 2.431 m/m² (0.741 ft/ft²).

The eastbound bridge where both the precast deck panels and the cast-in-place decks were constructed utilizing HPC has exhibited better cracking performance compared to the westbound bridge where HPC was used only in the cast-in-place decks of a limited number of spans (1 through 5). Comparing the cast-in-place deck of spans 1 through 5 of the westbound bridge with that of the eastbound bridge, the performance of the eastbound cast-in-place deck is found to be superior. This could be attributed to a better quality HPC used in the cast-in-place deck of the eastbound bridge. The class K (HPC) used in the cast-in-place deck of the eastbound bridge was reported to have a lower water-to-cementitious material ratio compared to the class S (HPC) used in the cast-in-place deck of the westbound bridge. The water-to-cementitious material ratio of class K (HPC) was specified as 0.31 compared to 0.42 of class S (HPC).

It is noted that a relatively large number of short-length transverse cracks were observed in spans 5 through 8 of the eastbound bridge. The eastbound bridge along the southern edge is also the side where the beams have a longer span and larger skew angle. These factors may have contributed to more cracking.

The rectangular pattern cracking particularly observed in spans 8 and 9 of the westbound bridge may be attributed to a combination of factors. These may include single pour construction of a number of spans, as indicated by Texas DOT, and the higher shrinkage of non-HPC mixture at these locations. The class S concrete used in the cast-in-place decks of spans 6 through 9 of the westbound bridge had a cement content of 363 kg/m³ (611 lb/yd³), without any pozzolans, and had a water-to-cement ratio of 0.42.

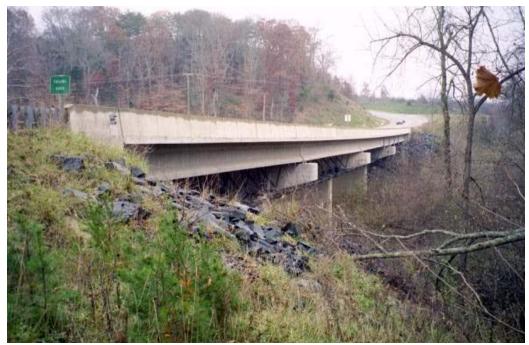
Figure 17. Photo. Route 40 Bridge over Falling River (Brookneal, Virginia).

The visual inspection was performed on November 19 through 21, 2002. There were longitudinal, transverse, and diagonal corner cracks on the surface of the deck. According to ACI 201, these crack widths are classified as hairline cracks. Small spalls and fractured fins from deep grooving were also observed.

With respect to the types of cracking, 21 transverse, 9 diagonal, and 27 longitudinal cracks were observed on the bridge. The total crack length for the transverse, diagonal, and longitudinal cracks was 61.3 m (201.0 ft), 15.9 m (52.0 ft), and 141.8 m (465.0 ft), respectively. This yielded crack densities of 0.090 m/m² (0.027 ft/ft²) transverse, 0.023 m/m² (0.007 ft/ft²) diagonal, and 0.207 m/m² (0.063 ft/ft²) longitudinal. The crack density for the entire deck including all transverse, diagonal, and longitudinal cracks was 0.320 m/m² (0.098 ft/ft²).

In addition to the different types of cracking noted, a few isolated small defects were found on the deck. These defects included small spalls and D-spalls. Deep irregular grooving was found in some areas of the deck, and the grooves were deep enough to contribute to the fracturing of the fins. On the other hand, very shallow grooves were also found on the deck surface.

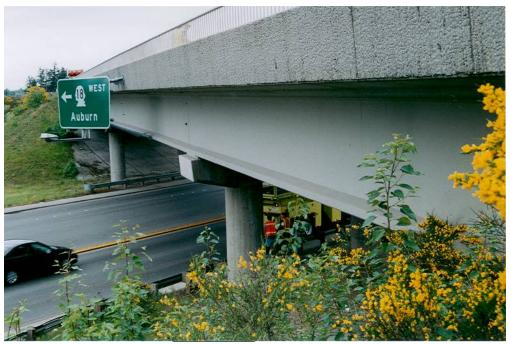
Figure 19. Photo. Eastbound SR18 over SR 516 (King County, Washington).

The total length of transverse cracks and number of cracks for span 2 are greater than those for other spans at the bridge. The crack density on eastbound span 2 is the largest.

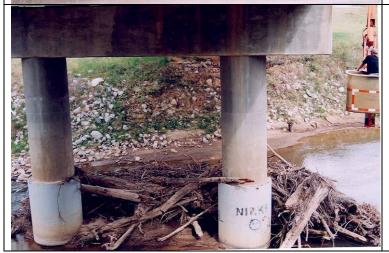
Photo 6: General condition of the piles at Span 2 east facing bridge. Accumulation of debris observed near the pile.

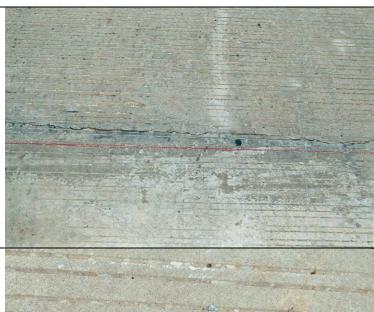
Photo 8: Close up view of typical transverse crack at deck joints.

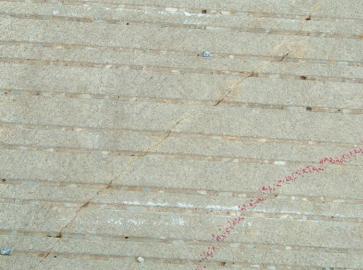
Photo 9: Close up view of typical longitudinal crack.

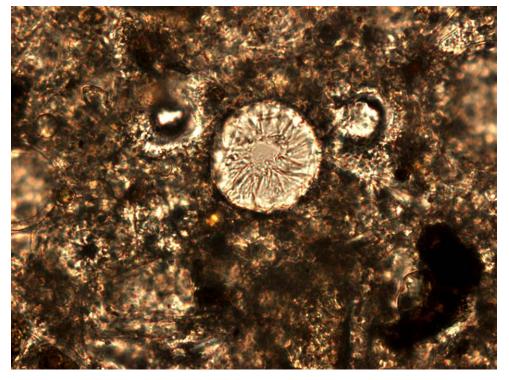
Figure A1-8: An air void fully filled with ettringite. Width of field is 0.165 mm. Thin section image.

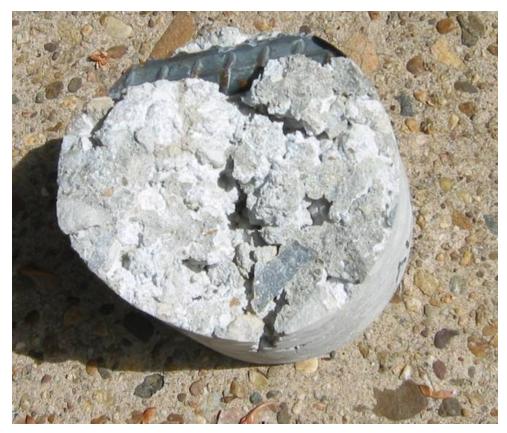
Figure A1-9: Honeycombing in core AL-5.

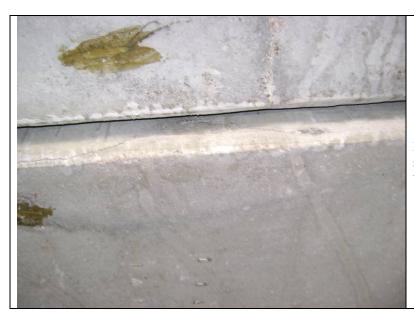
Photo 11: Close-up view showing of the impact crack in the 16th girder.

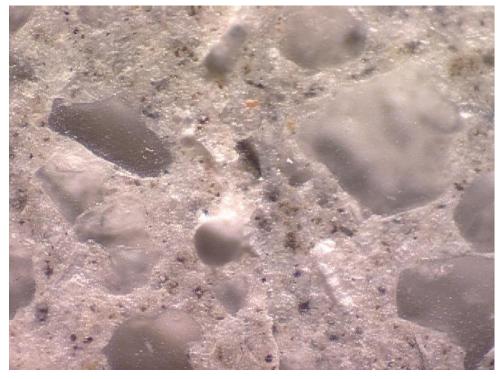
The cement was well hydrated, with some unhydrated cement particles present in the paste. The concrete was air entrained, and the entrained air voids were well distributed in the concrete. In general, the bond between the aggregate and the paste appears moderately strong. Micro-cracks exist in the paste. The cause of the cracking in five of the cores is uncertain. It is speculated that shrinkage, among other mechanisms, may be the major cause of the cracking. There is no evidence of material-related distress in the concrete.

Figure C1-4: The bonding between aggregate and cement paste is moderate. Width of field is 2.0 mm. Polished surface image. Note a crack is at the center of the image.

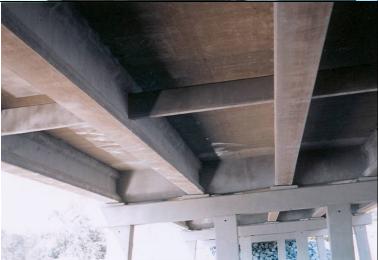
Photo 6: General condition of the girders at Span 2 facing west (southside).

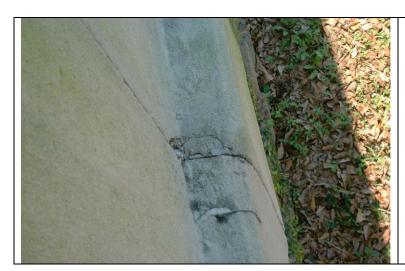
Photo 13: Close up view of the settlement related cracking at the eastern end of bridge Span 5.

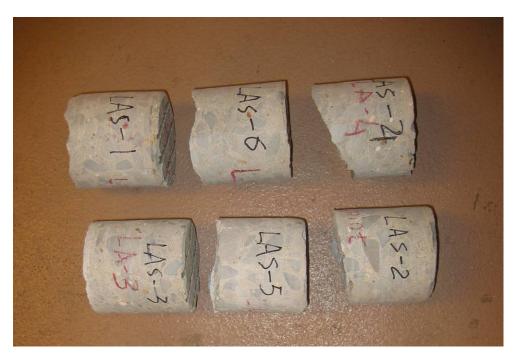
Visual inspection of the concrete cores revealed that cores LA-1, LA-2, LA-4 and LA-5 have longitudinal cracks. No gross visual defects were observed in the other cores. The findings from microscopic examination indicate that the concrete has normal level of entrained air voids; the hydration of the cement is reasonable; the presence of some unhydrated cement particles is also observed in the paste; ground granulated blast-furnace slag is present in the concrete as supplementary cementitious material; occurrences of porous interface zones between coarse aggregate and paste were found; cracking is present in both the paste and at the aggregate-cement interface.

Figure D1-1: Six concrete cores as received.

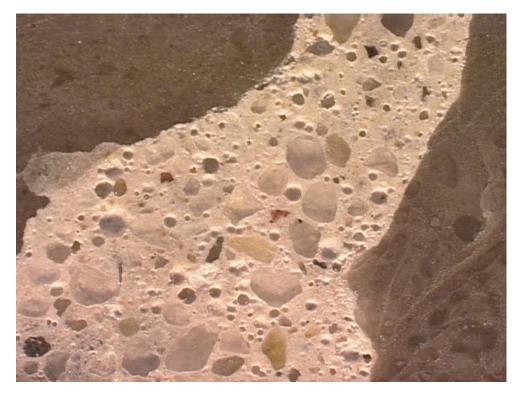
In general, the cement/aggregate interface is poor to moderate, as shown in Figure D1-5. Very porous interface is not uncommon in this concrete (Figure D1-6), suggesting a rather weak bonding between the aggregate and paste. Cracking at the fine aggregate-

Figure D1-5: The bonding between aggregate and cement paste is poor to moderate. Width of field is 4.0 mm. Polished surface image.

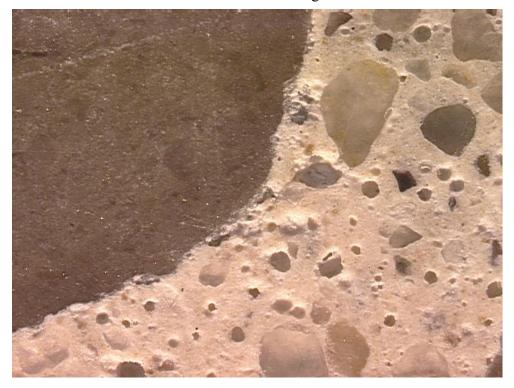
Very porous interface is present in the concrete, and it is mainly associated with the coarse aggregate-paste interfaces. The bond between the aggregate and the paste appears poor to moderate. At some fine aggregate-paste interface cracking is also found.

Figure D1-6: Very porous interface between coarse aggregate and cement paste. Width of field is 4.0 mm. Polished surface image.

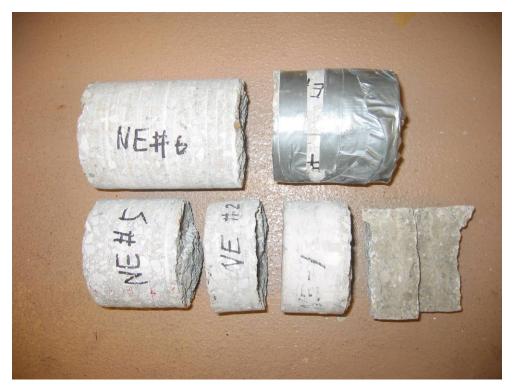
Major cracks are visible in two of the six cores, and two cores were split into halves by cracking. Smaller size cracks are also found in the concrete samples. They exist in cement paste as well as at the interfacial region between the aggregate and paste. It is speculated that shrinkage may be the cause of the cracking.

Figure E1-1: Six concrete cores as received.

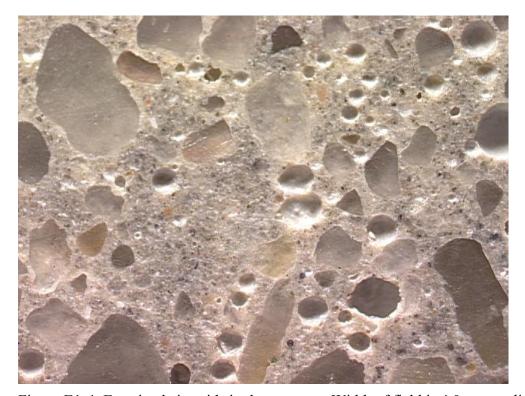
Figure E1-4: Entrained air voids in the concrete. Width of field is 4.0 mm, polished surface image.

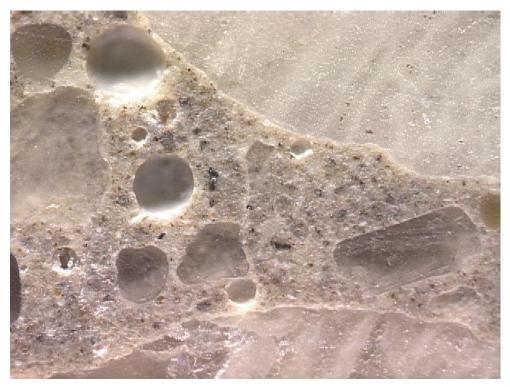
Figure E1-9: A crack in the paste between two aggregate particles. Width of field is 2.0 mm, polished surface image.

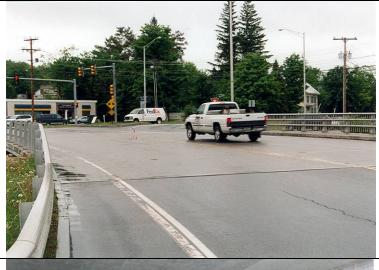
Photo 4: General view of longitudinal crack on bridge deck.

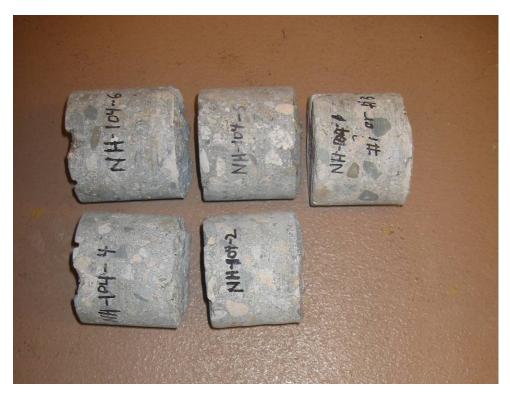
Figure F1-1: Five cores as received.

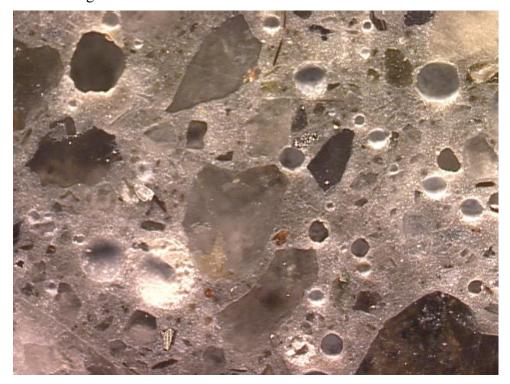
Figure F1-4: Entrained air voids in the concrete. Width of field is 4.0 mm. Polished surface image.

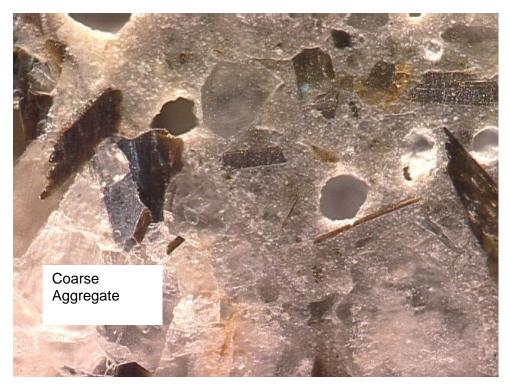
Figure F1-5: The bonding between aggregate and cement paste is strong. Width of field is 2.0 mm. Polished surface image.

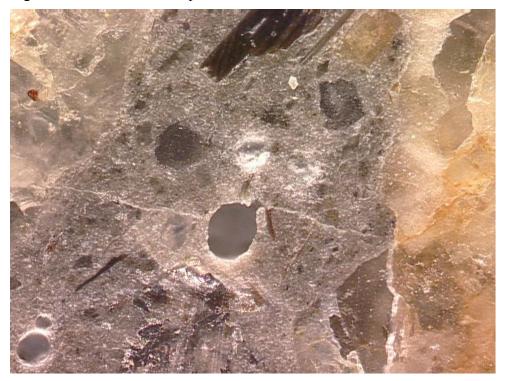
Figure F1-8: A crack connecting two aggregate pieces. Width of field is 2.0 mm. Polished surface image.

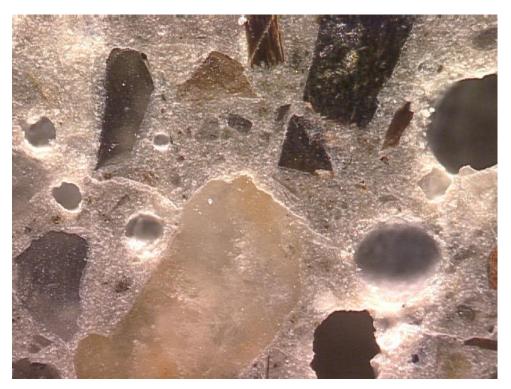
Figure F1-9: Cracks in the aggregate peripheral zone. Width of field is 2.0 mm. Polished surface image.

Occasionally, cracks were observed under the microscope. Micro-cracking was present in the cement paste. Cracking was also found in the peripheral zone between the paste and aggregate. Cracks that were adjacent to the exposed surface were much larger than those found in the bulk of the concrete. Large cracks were mostly found in the region of about 1 in. from the exposed surface. It was speculated that cracking was probably due to drying shrinkage, although other mechanisms might also contribute to the distress.

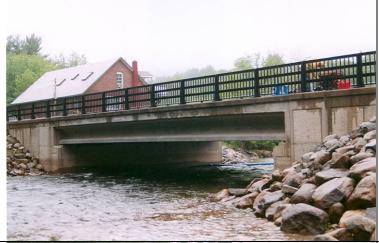
Photo 2: View looking north from the southern end of west facing bridge.

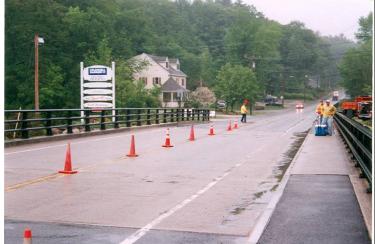
Photo 3: View looking south from the northern end of east facing bridge.

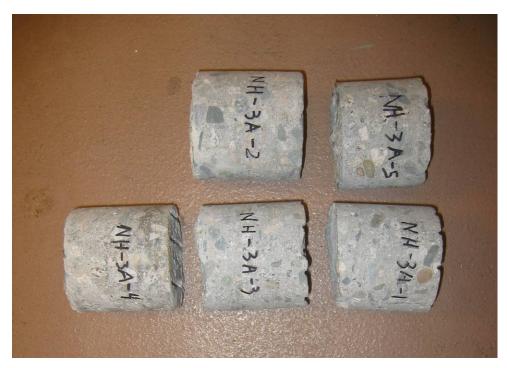
Figure G1-1: Five cores as received.

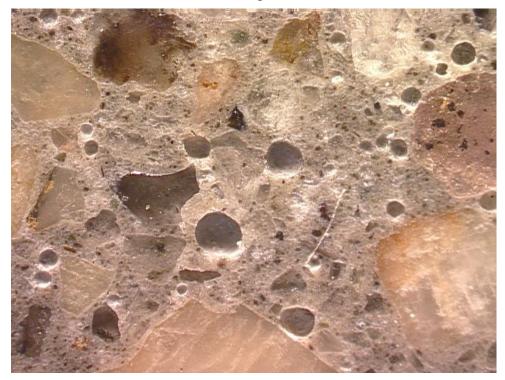
Figure G1-4: Entrained air voids in the concrete. Width of field is 4.0 mm. Polished surface image.

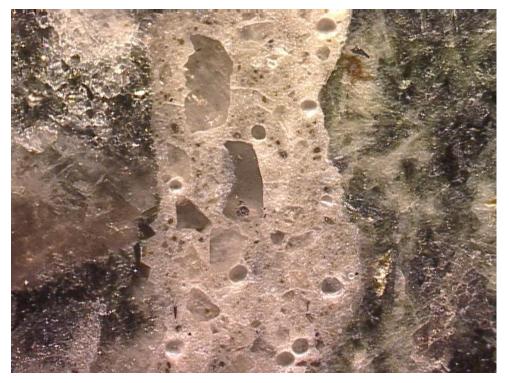
Figure G1-5: The bonding between aggregate and cement paste is strong. Width of field is 4.0 mm. Polished surface image.

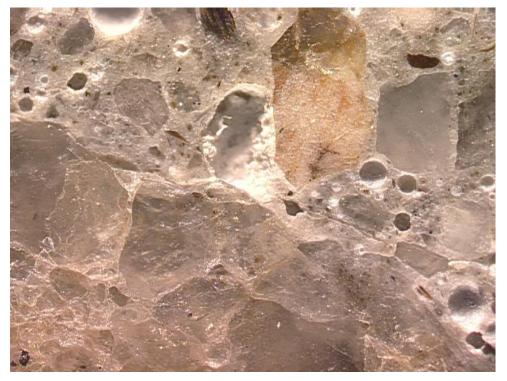
Figure G1-8: Crack in the aggregate-paste interfacial region. Width of field is 4.0 mm. Polished surface image.

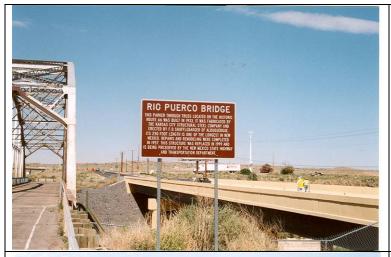
Photo 1: View looking from the western end of the historical bridge at the west facing bridge.

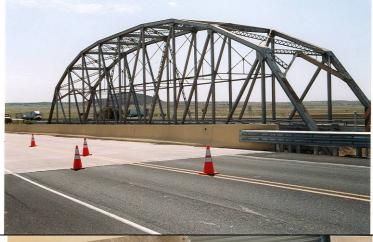
Photo 2: View looking from the eastern end of east facing bridge. Historical bridge in the background.

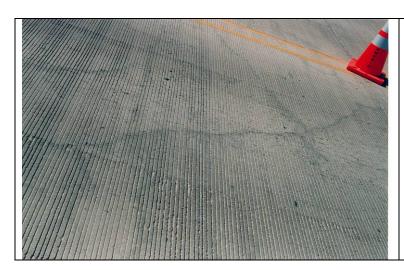
Photo 10: Close up view of the cracks at deck joints.

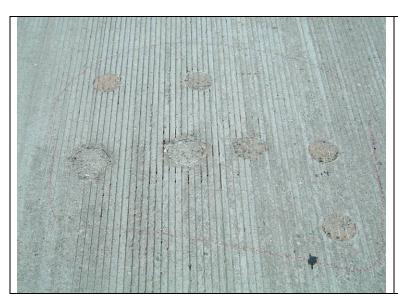
Photo 10: Failed patching work on bridge deck.

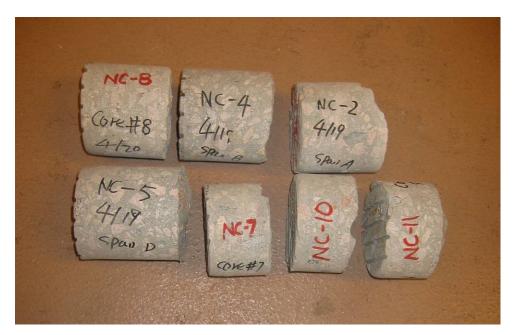
The bond between the aggregate and paste is good. There is no microscopical cracking in the concrete. Major cracks are visible in four of the seven cores. It is speculated that shrinkage may be the cause of the cracking. However, other factors may also have contributed to the cracking, such as mechanical failure.

Figure I1-1: Seven concrete cores as received.

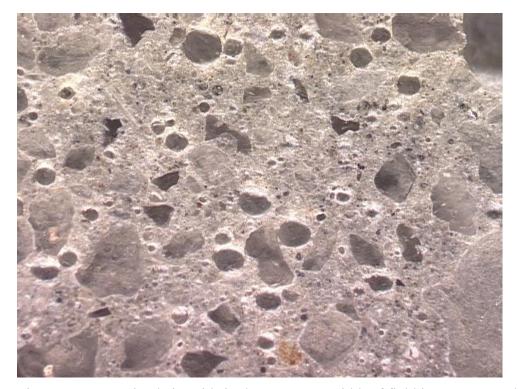
Figure I1-4: Entrained air voids in the concrete. Width of field is 4.0 mm. Polished surface image.

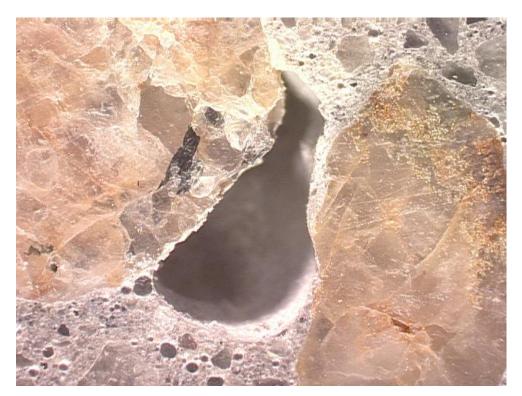
Figure I1-5: An entrapped air void between two aggregate particles. Width of field is 4.0 mm. Polished surface image.

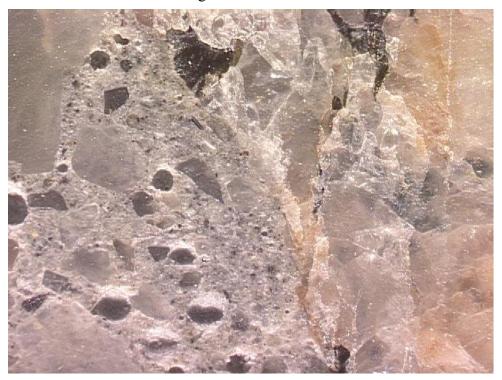
Figure I1-7: The bonding between aggregate and cement paste is good. Width of field is 4.0 mm. Polished surface image.

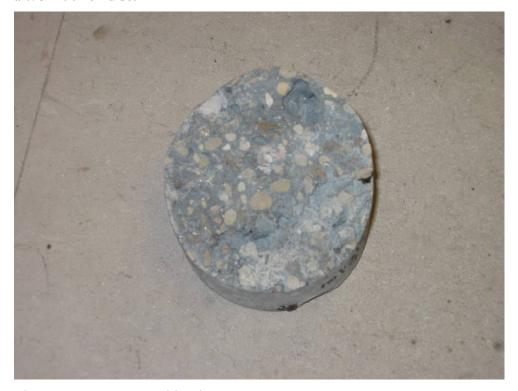
Visual inspection of the concrete cores revealed that core OH-6 has honeycombing, as shown in Figure J1-2. No gross visual defects were observed in the other cores. The findings from microscopic examination indicate that the concrete has normal levels of entrained air voids; the hydration of the cement was reasonable; the presence of some unhydrated cement particles was also observed in the cement paste; a significant amount of cracking is present in the concrete, and it is believed that the cracking is due to shrinkage.

Honeycombing, as shown in Figure J1-2, is found in core OH-6, indicating that some sections of the concrete was poorly consolidated.

Figure J1-2: Honeycombing in core OH-6.

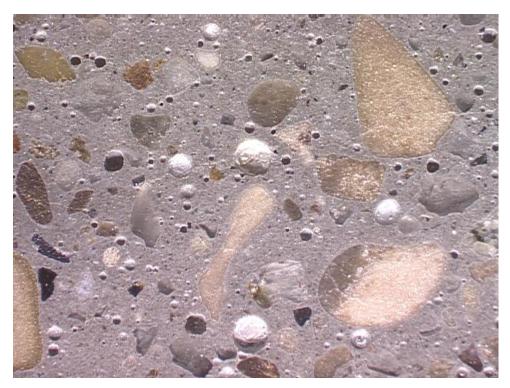
In general, the cement/aggregate interface is moderate to poor, as shown in Figure J1-5. And, cracking is observed at some aggregate/paste interface locations (Figure J1-7 and Figure J1-8).

Figure J1-5: The bonding between aggregate and cement paste is moderate to poor. Width of field is 6.5 mm. Polished surface image.

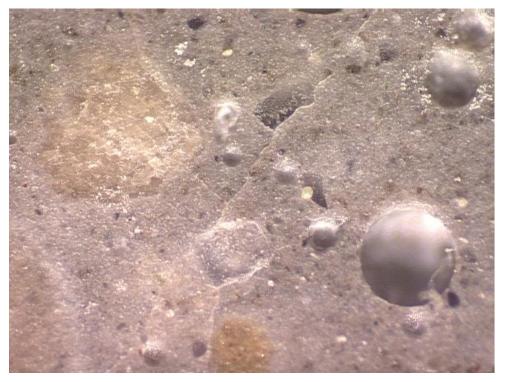
Examination of thin sections and polished slabs revealed numerous random cracks throughout the cement paste (Figure J1-6). Some cracks partially surrounded fine and coarse aggregate particles (Figure J1-7 and Figure J1-8). Cracks going through cement paste connect to the cracks at the interface of cement paste and aggregate in some cases (Figure J1-9).

Figure J1-9: Cracks as seen in the polished slab. Width of field is 1.1 mm.

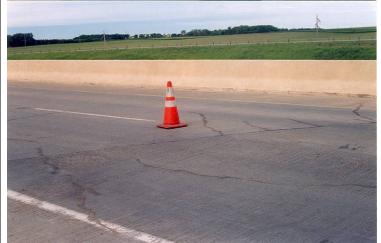
Photo 3: Cracks on the north side approach slab on the I-29 Northbound Bridge.

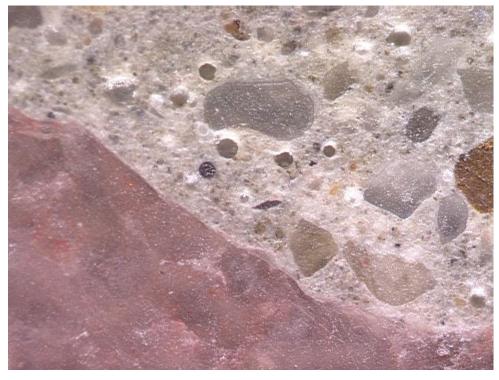
The concrete was air entrained, and the entrained air voids were well distributed in the concrete. In general, the bond between the aggregate and the paste appears moderately strong. However, cracks do exist at the paste-aggregate interface. The cause of the cracking in three of the cores is uncertain. It is speculated that shrinkage, among other mechanisms, may be the major cause of the cracking. Chalcedony, a potentially alkalisilica reactive form of silica, is present in both coarse aggregate and fine aggregate. However, there is no evidence of alkali-silica reaction in the concrete.

Figure L1-4: The bonding between aggregate and cement paste is moderately strong. Width of field is 2.0 mm. Polished surface image.

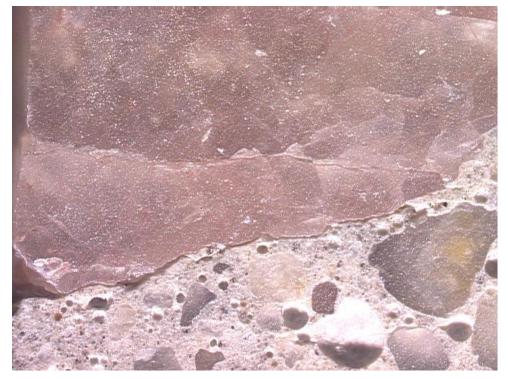
Figure L1-10: Crack at the aggregate-paste interface. Width of field is 4.0 mm. Polished surface image.

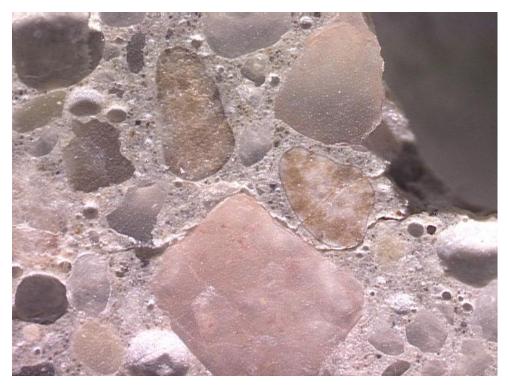
Figure L1-11: Crack at the aggregate-paste interface (crushed pink quartzite). Width of field is 4.0 mm. Polished surface image. Also a crack through an aggregate particle (a rounded natural sand particle with a weathering rim).

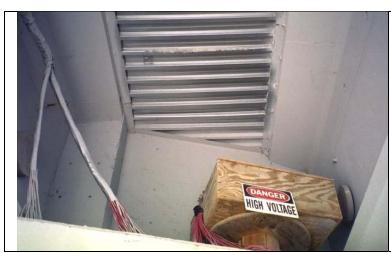
The girders were inspected from the ground, without the aide of any access equipment. No signs of distress were noted on any of the girders. Girders 1 (6A2) and 2 (6B2) in Span 2 are instrumented with both electrical strain gauges and a mechanical string line (see photo 16).

Photo 16: Underside of the deck. Note the instrumentation at abutment 2, girder 1 (exterior) left.

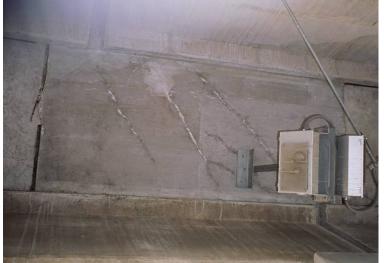
Photo 8: View showing spalling associated with cracks in the deck at span ends.

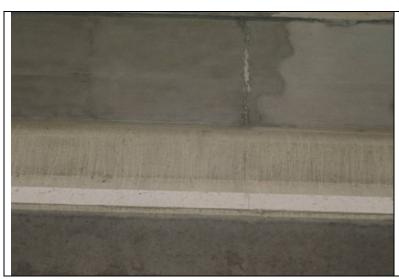
Photo 10: Cracks with efflorescence along the overhang on the westbound bridge.

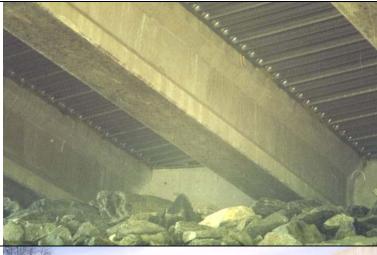
Photo 22: Underside of deck abutment B, exterior Girder A on left.

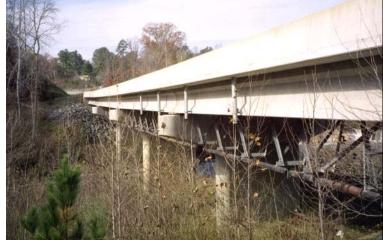
Photo 23: South elevation, exterior Girder E. Note 8-in. sewer pipe below Girders D & E.

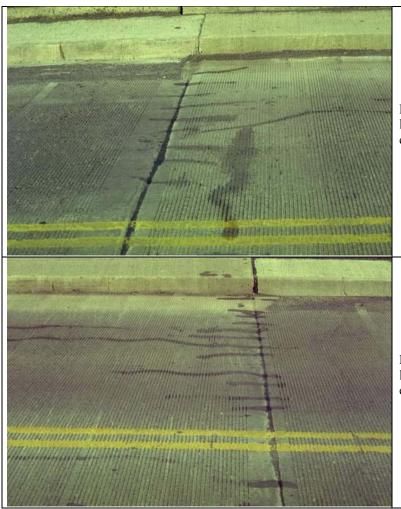
Photo 4: General view of the longitudinal cracks at the south end of the bridge.

Photo 5: General view of the longitudinal cracks at the north end of the bridge.

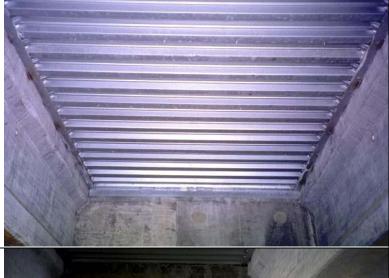
The undersurface of the deck was not visible due to the presence of stay-in-place deck forms. However, the exterior cantilever portions of the deck were exposed, which exhibit no signs of distress. Photo 16 shows a general view of the underside of the deck.

Photo 16: View of the underside of the deck showing the stay-in-place forms.

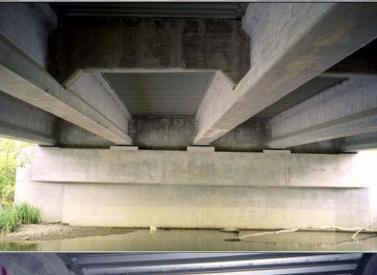
The girders were inspected from the ground, without the aide of any access equipment. No signs of distress were noted on any of the girders. Photos 17 through 19 show general views of the girders.

Photo 17: View of the girders A through E, Span A, Pier 1 (fascia girder A is on the left).

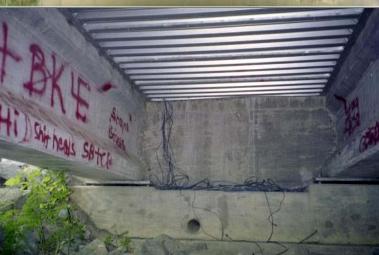
Photo 18: View of the girders A and B, Span B, abutment B (Fascia girder A is on the left).

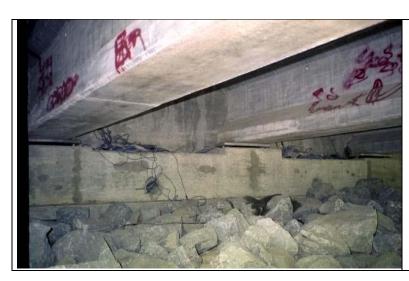
Photo 19: View of the girders B and C, abutment B (interior girder B on the left).

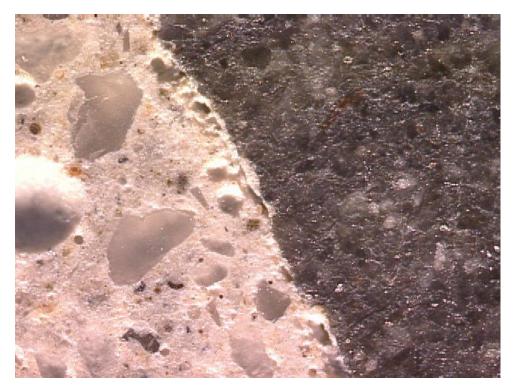
The concrete was air entrained, and the entrained air voids were well distributed in the concrete. Gaps and cracks that have formed in the coarse aggregate/paste interfacial region are the result of bleeding—the rising of water in the concrete due to the settling of more dense constituents while the concrete is still plastic. This results in water being trapped underneath of coarse aggregate particles. The cement paste in the interfacial region is porous. The bond between the aggregate and the paste is weakened by the gaps/cracks and the porous paste in the transition zone. Cracks also exist in cement paste and in the fine aggregate/paste interfacial region. Despite the defects in microscopical scale, the concrete appeared solid and sound, and no deterioration was shown visually.

Figure R1-5: Gaps and voids in the paste/coarse aggregate interfacial region. Width of field is 2.0 mm. Polished surface image.

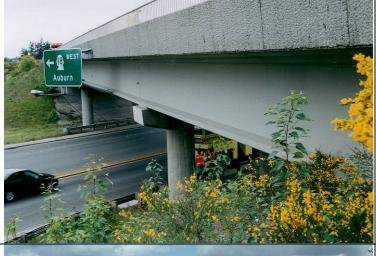
Photo 1: View looking northwest. The eastbound bridge is in foreground.

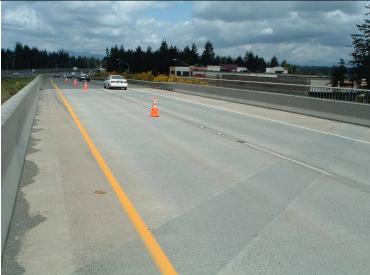
Photo 2: View looking southeast from the western end of the eastbound bridge.

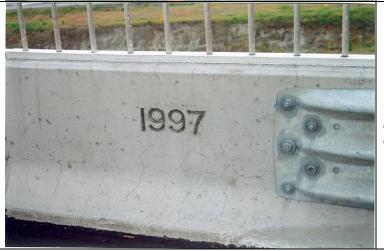
Photo 3: North facing side of the eastbound bridge at the western end.

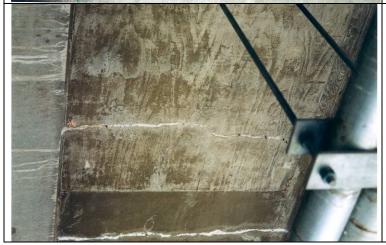
Photo 6: Close up view of the cracking at underside of bridge deck.

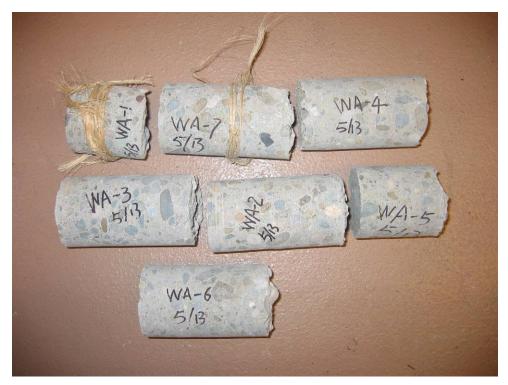
Figure S1-1: Seven concrete cores as received.

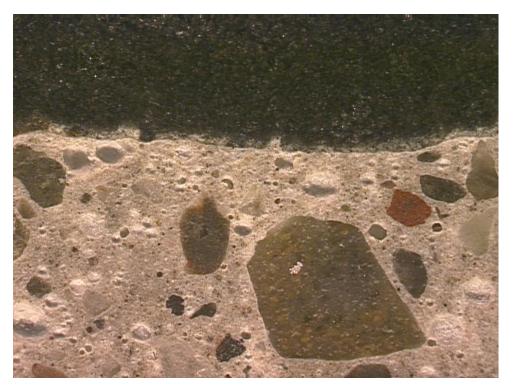
The concrete is air entrained and the air content is estimated to be at a normal level. The entrained air voids are well distributed in the concrete. Cement was reasonably hydrated and unhydrated cement particles are present in the concrete. In addition to the major cracks visible in four of the seven cores, much smaller size cracks are found sporadically in the concrete as observed under the microscope. These small cracks exist mainly in the cement paste and the interfacial region between the aggregate and paste. It is speculated that shrinkage may be the cause of the cracking.

Figure S1-9: Cracking at the interfacial region between the paste and coarse aggregate. Width of field is 4.0 mm. Thin section image.
